Visual Site Inspection Report

Project Name	H-600 Pipeline Spread I	AFE	124300139	Spread	H-600 Pipeline Spread I
Contractor	Precision			Report #	17441
Inspector	Justin Burch			Date/Time	11/30/2020 8:49 AM
Permit #	TBD	Inspection Type	VA SWPP	Station Begin	14928+52
State	VA	Inspection Area	Full	Station End	15063+85
County	Franklin/Pittsylvania	Ground	Wet	Temperature (°F)	57.00
Municipality	Chatham	Weather	Heavy Rain	Rain Gauge (in)	2.50
				Rain Accumulation Time (days)	7.00

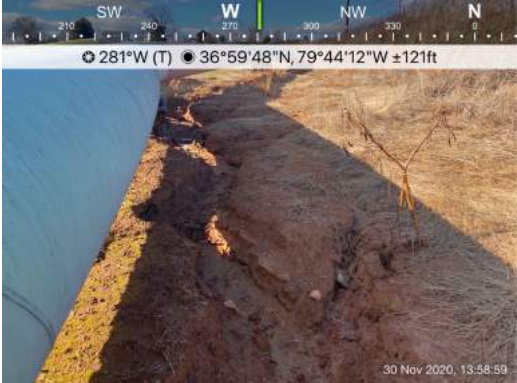
GPS Location	0	GPS Location			
Field Station#	14605+00	Field Station#			
Pic 7 Desc.	Approximately 14605+00. Erosion rills observed during inspection.	Pic 8 Desc.			
Insert image here		Insert image here			
GPS Location		GPS Location			
Field Station#		Field Station#			
Pic 9 Desc.		Pic 10 Desc.			
Insert image here		Insert image here			
GPS Location		GPS Location			
Field Station#		Field Station#			
Pic 11 Desc.		Pic 12 Desc.

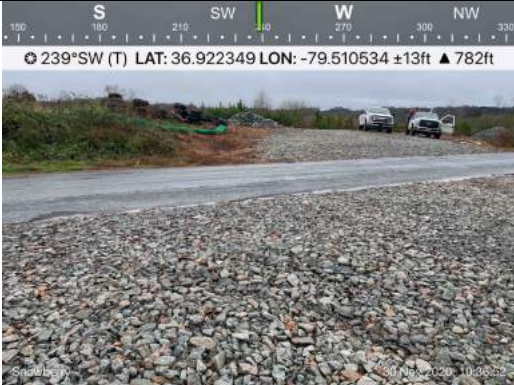
GPS Location	See photo		GPS Location	See photo	
Field Station#	15370+62		Field Station#	15377+00	
Pic 1 Desc.	CEs in good condition at Snowberry and Toshes Rd.		Pic 2 Desc.	Waterbar channel obstructed and needs to be regraded.

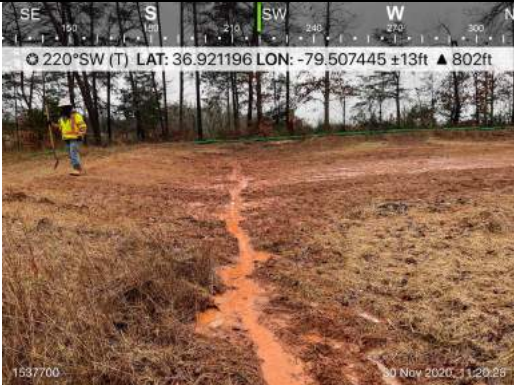
GPS Location	See photo		GPS Location	See photo	
Field Station#	15377+00		Field Station#	15384+00	
Pic 3 Desc.	Environmental crew has corrected this issue.		Pic 4 Desc.	Equipment bridge ECDs in good condition and functioning.

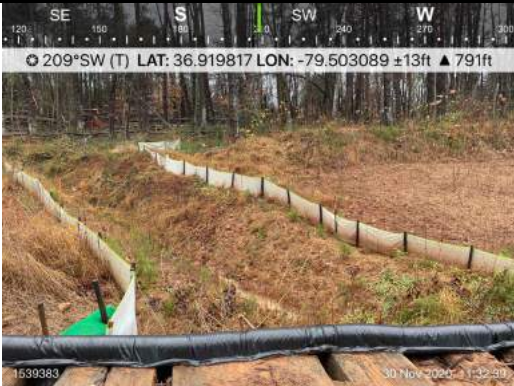
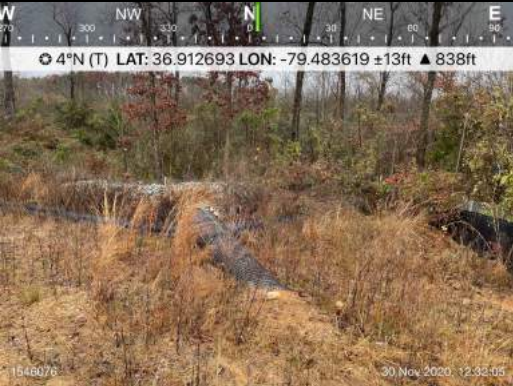
GPS Location	See photo		GPS Location	See photo	
Field Station#	15393+83		Field Station#	15460+76	
Pic 5 Desc.	Perimeter controls are in good condition.		Pic 6 Desc.	CWDs throughout this section are functioning.

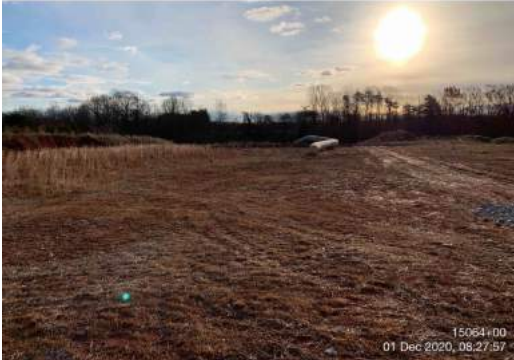
GPS Location	0	GPS Location	0		
Field Station#	15064+00	Field Station#	15069+00		
Pic 1 Desc.	Temporary vegetative stabilization in acceptable condition		Pic 2 Desc.	CFS on waterbar end treatment requires maintenance

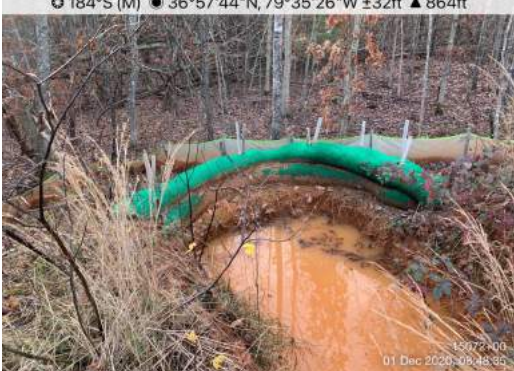
GPS Location	0	GPS Location	0		
Field Station#	15072+00	Field Station#	15083+00		
Pic 3 Desc.	CFS on waterbar end treatment requires maintenance		Pic 4 Desc.	CFS at clean water diversion plunge pool is undermined and dislocated

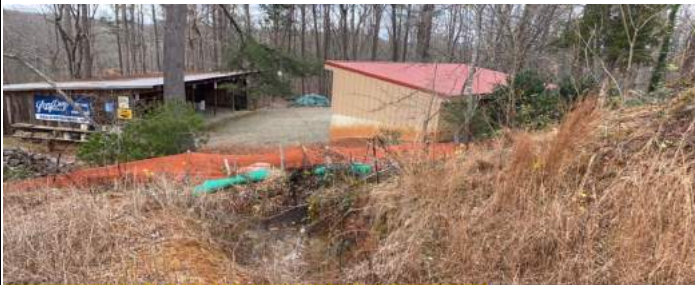
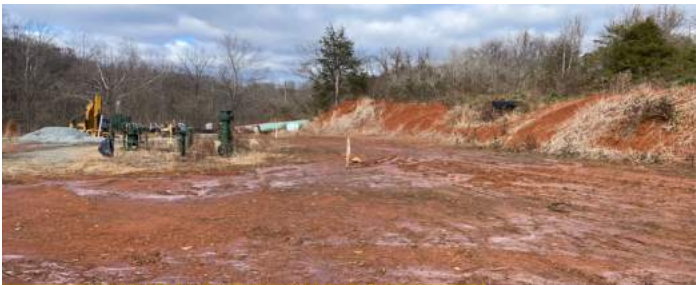
Field Station#	14220+58	Field Station#	14235+00		
Pic 3 Desc.	Routine maintenance. CFS end treatment full of sediment (landowner damage) and not filtering properly.		Pic 4 Desc.	Seed and stabilize denuded area of ROW.

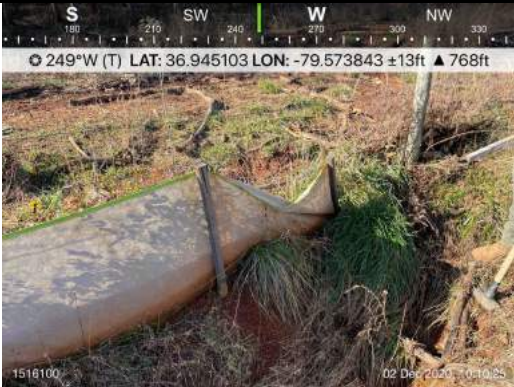
GPS Location	See photo		GPS Location	See photo	
Field Station#	15161+00		Field Station#	15161+00	
Pic 1 Desc.	P1 needs to be restaked.		Pic 2 Desc.	Environmental crew has corrected this issue.

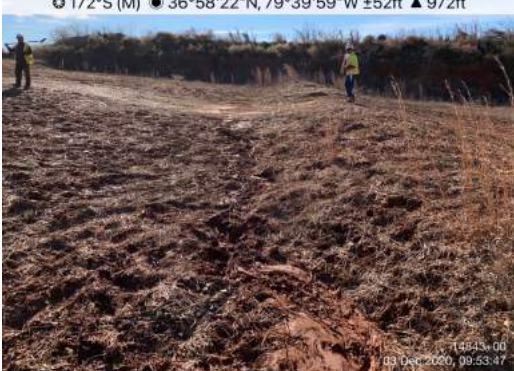
GPS Location	0	GPS Location	0		
Field Station#	14843+00	Field Station#	14916+30		
Pic 3 Desc.	Waterbar in acceptable condition	Pic 4 Desc.	Wattle on equipment bridge is torn

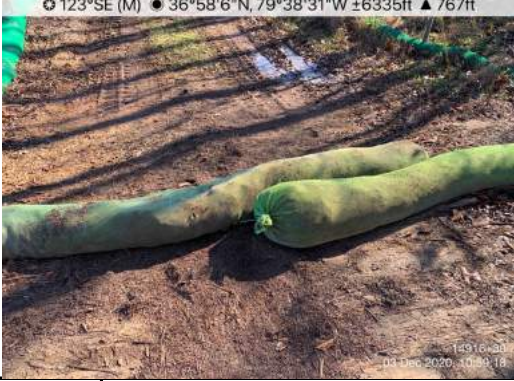
GPS Location	0	GPS Location	0		
Field Station#	14916+30	Field Station#	14927+00		
Pic 5 Desc.	Torn wattle on equipment bridge was repaired	Pic 6 Desc.	Permanent vegetative stabilization in acceptable condition

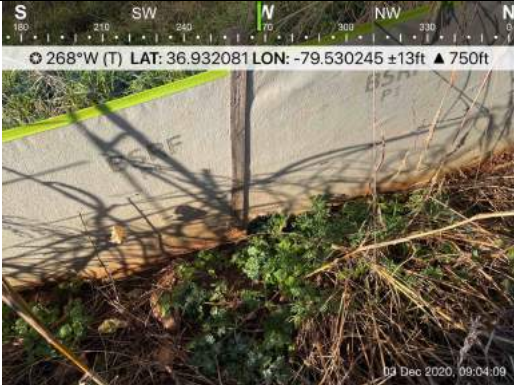
GPS Location	See photo	GPS Location	See photo		
Field Station#	15300+00	Field Station#	15300+00		
Pic 1 Desc.	P1 is damaged and needs to be replaced.	Pic 2 Desc.	Environmental crew has corrected this issue.

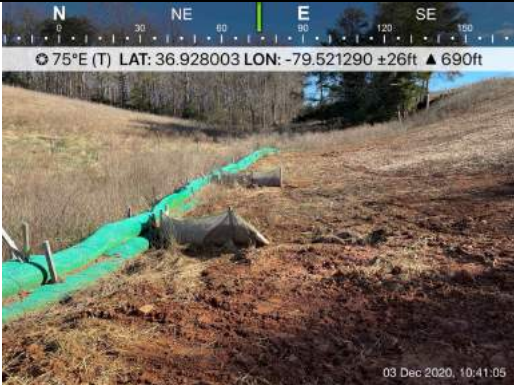
GPS Location	See photo	GPS Location	See photo		
Field Station#	15331+00	Field Station#	15331+00		
Pic 3 Desc.	P1 is damaged and needs to be replaced.	Pic 4 Desc.	Environmental crew has corrected this issue.

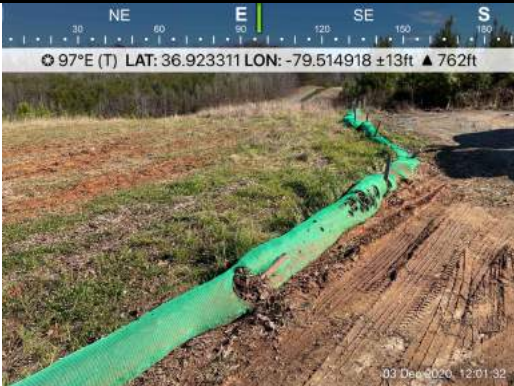
GPS Location	See photo	GPS Location	See photo		
Field Station#	15355+00	Field Station#	15330+00		
Pic 5 Desc.	CFS damaged along MVP-PI-332 needs to be replaced.	Pic 6 Desc.	Crew replacing bridge fabric

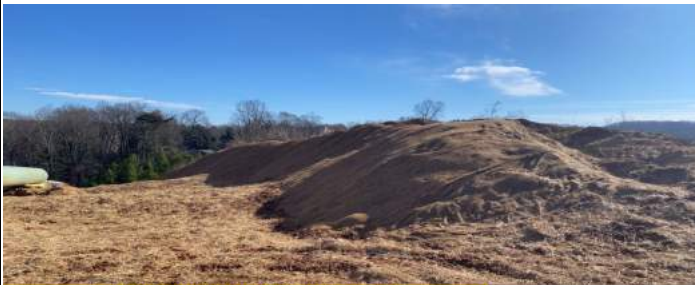
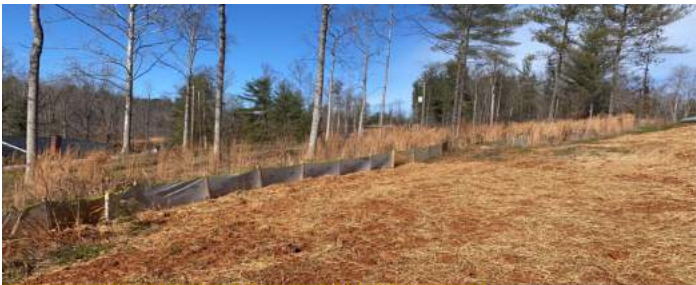
GPS Location	3	GPS Location	4		
Field Station#	13986+00	Field Station#	14002+50		
Pic 3 Desc.	Spoil pile has been stabilized with erosion control blanket.		Pic 4 Desc.	Contractor replaced P1 silt fence per punch list item.

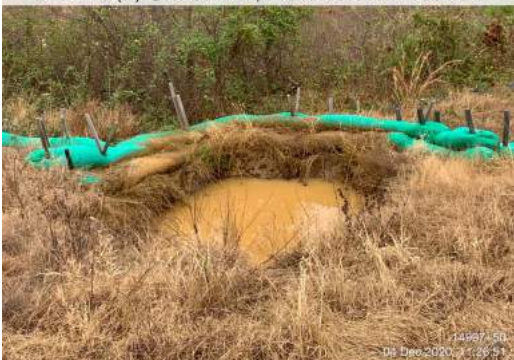
GPS Location	0	GPS Location	0		
Field Station#	14997+50	Field Station#	14993+00		
Pic 3 Desc.	CFS requires maintenance		Pic 4 Desc.	Waterbar end treatment requires maintenance; needs holes repaired and sediment removed

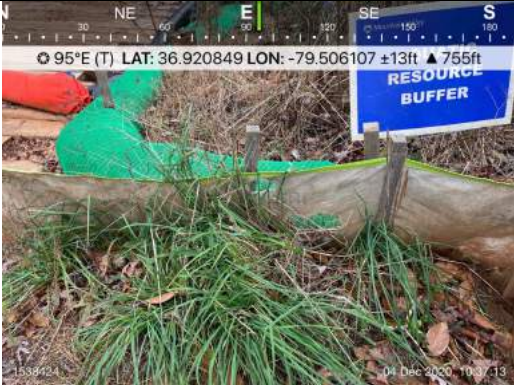
GPS Location	See photo		GPS Location	See photo	
Field Station#	15384+24		Field Station#	15384+24	
Pic 1 Desc.	Buffer zone P1 is damaged and needs to be replaced.		Pic 2 Desc.	Environmental crew has corrected this issue.

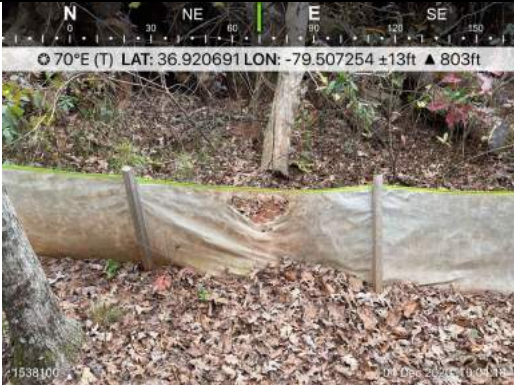
GPS Location	See photo		GPS Location	See photo	
Field Station#	15381+00		Field Station#	15381+00	
Pic 3 Desc.	P1 has been damaged and needs to be replaced.		Pic 4 Desc.	Environmental crew has corrected this issue.
