Visual Site Inspection Report

Project Name H-600 Pipeline Spread G		AFE 124300137	Spread H-600 Pipeline Spread G
Contractor Precision		Report # 20019	
Inspector Len Kruizenga		Date/Time 2/15/2021 8:48 AM	
Permit # TBD	Inspection Type VA SWPP	Station Begin	12005+00
State VA	Inspection Area Full	Station End	12005+00
County Giles	Ground Wet	Temperature (°F)	33.00
Municipality N/A	Weather Cloudy	Rain Gauge (in)	2.00
Rain Accumulation Time (days)			3.00

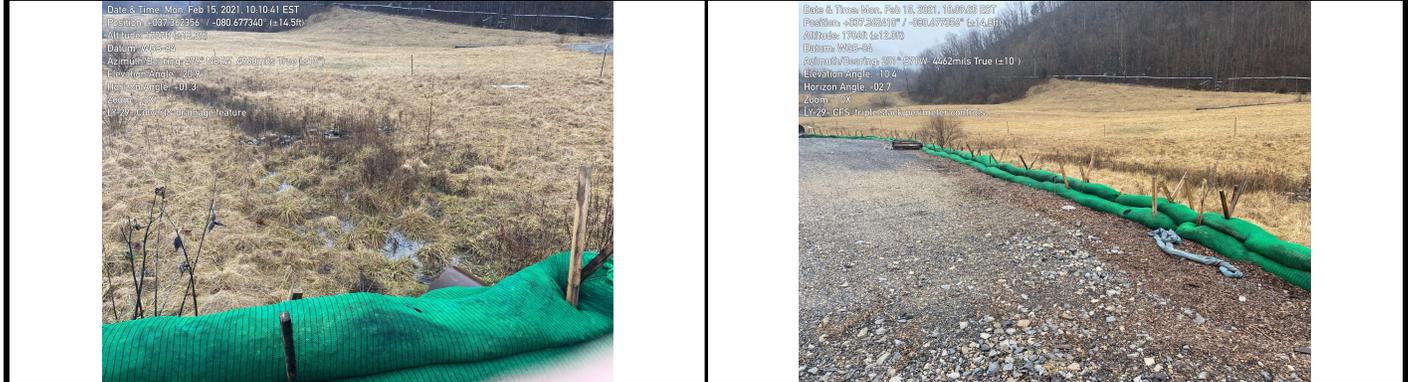
GPS Location	See photo GPS	GPS Location	See photo GPS
Field Station#	12005+00	Field Station#	12005+00
Pic 1 Desc.	LY29- Culvert and drainage feature.	Pic 2 Desc.	LY29- CFS triple stack perimeter controls are in acceptable condition.

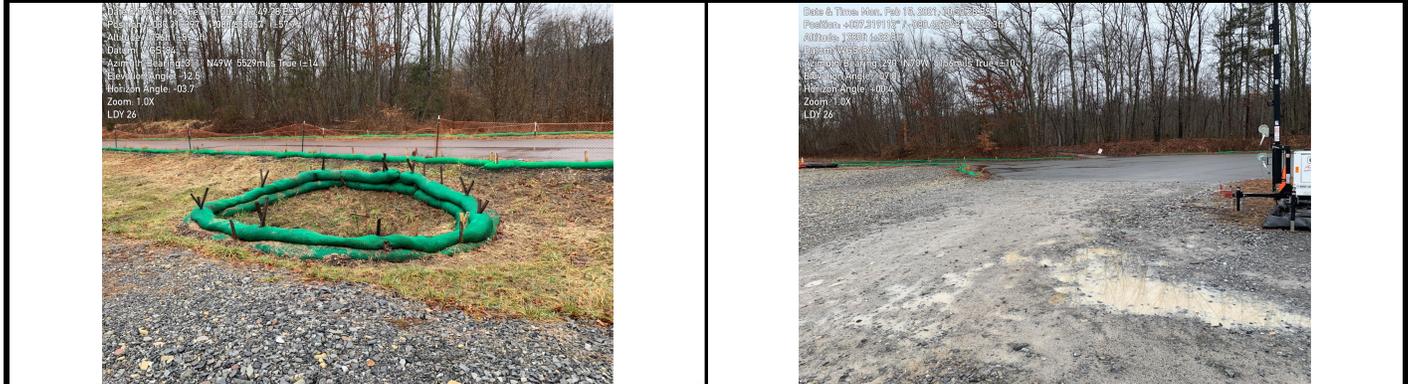
GPS Location	See photo for GPS location.	GPS Location	See photo for GPS location.
Field Station#	12005+00	Field Station#	12005+00
Pic 1 Desc.	Triple stack cfs in place around drainage.	Pic 2 Desc.	RCE in place at LDY 26 entrance.

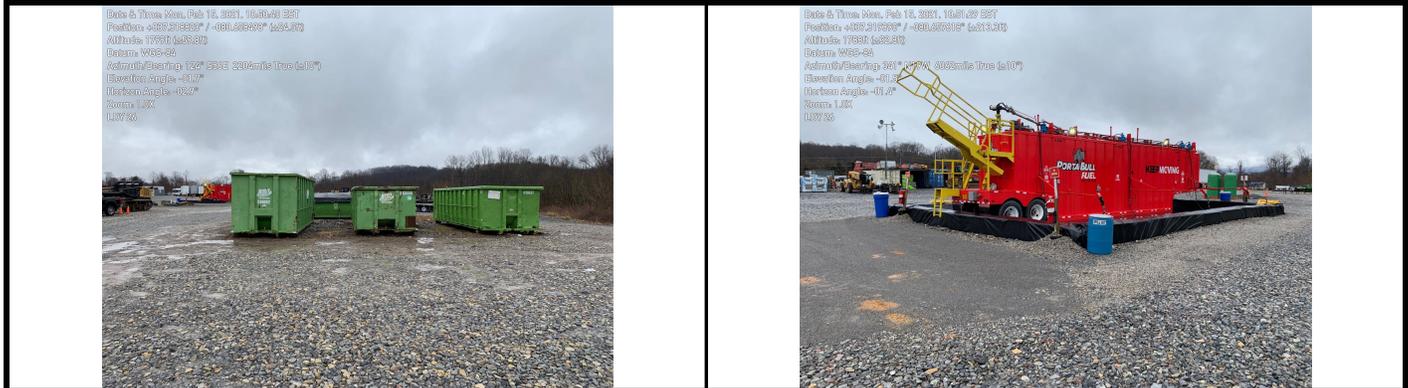
GPS Location	See photo for GPS location.	GPS Location	See photo for GPS location.
Field Station#	12005+00	Field Station#	12005+00
Pic 3 Desc.	Dumpsters being utilized for trash management.	Pic 4 Desc.	Secondary containment in place under fuel cell.

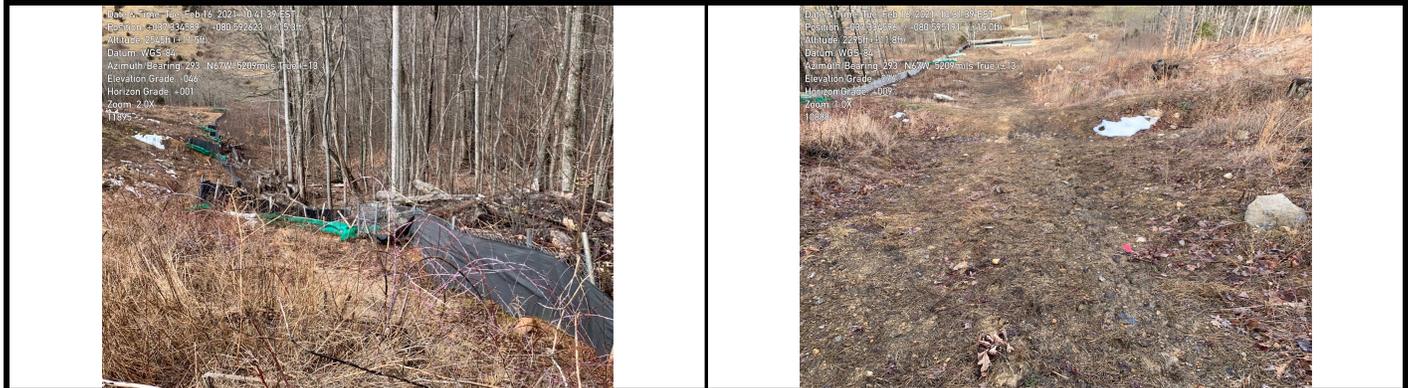
Arrived at LDY 26 for morning meeting
 Performed SWPPP for MP 205 - MP 207
 damaged ECD's observed during inspection
 ROW conditions are stable and showing minimal signs of erosion
 Damaged ECDs added to the punch list
 Observed tree felling crew from 10930+00 ~
 Leak discovered @ LDY 28, crews cleaned and contained leak. Added secondary containment

Pic 3 Desc.	Damaged ROW	Pic 4 Desc.	Beginning of rill erosion
--------------------	-------------	--------------------	---------------------------

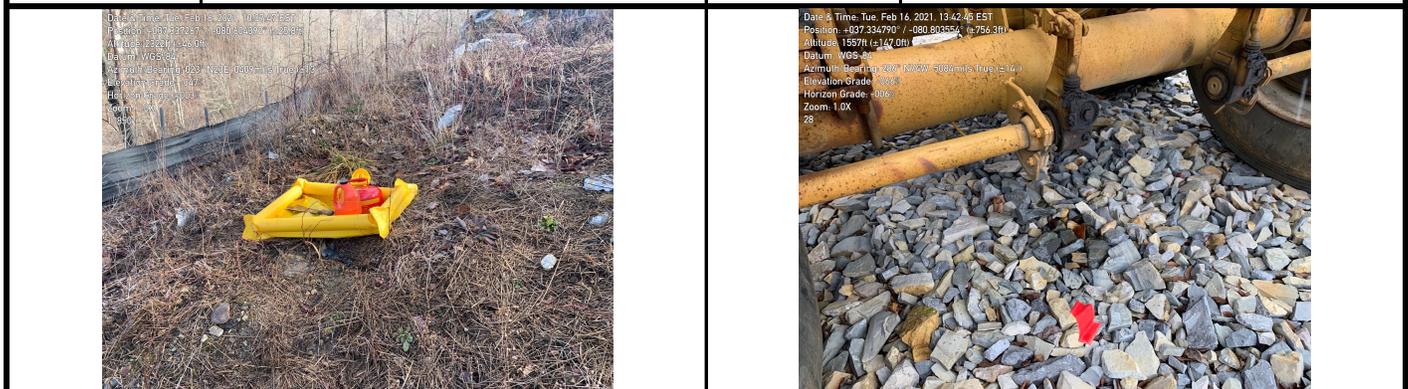
Pic 5 Desc.	Secondary containment	Pic 6 Desc.	Leak found at LDY 28
--------------------	-----------------------	--------------------	----------------------
