# Visual Site Inspection Report

<b>Project Name</b> H-600 Pipeline Spread G		<b>AFE</b> 124300137	<b>Spread</b> H-600 Pipeline Spread G
<b>Contractor</b> Precision		<b>Report #</b> 20262	
<b>Inspector</b> Chris Burns		<b>Date/Time</b> 2/22/2021 8:10 AM	
<b>Permit #</b> TBD	<b>Inspection Type</b> VA SWPP	<b>Station Begin</b>	11023+80
<b>State</b> VA	<b>Inspection Area</b> Partial	<b>Station End</b>	11064+53
<b>County</b> Giles	<b>Ground</b> Wet	<b>Temperature (°F)</b>	45.00
<b>Municipality</b> N/A	<b>Weather</b> Light Rain	<b>Rain Gauge (in)</b>	0.00
			<b>Rain Accumulation Time (days)</b> 1.00

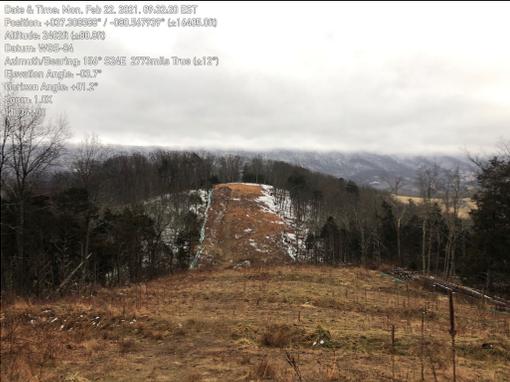
<p>Date &amp; Time: Mon, Feb 22, 2021, 09:30:30 EST  Position: +037.308369° / -080.547797° (+1648.0m)  Altitude: 2468ft (+750.8m)  Datum: WGS-84  Azimuth/Bearing: 106° 33'45" 3730mils True (+12°)  Elevation Angle: -43.2°  Horizon Angle: +07.2°  Zoom: 1.00  11034+00</p>		<p><b>GPS Location</b> 1</p> <p><b>Field Station#</b> 11025+50</p> <p><b>Pic 1 Desc.</b> S-IJ18 and controls.</p>		<p><b>GPS Location</b> 2</p> <p><b>Field Station#</b> 11034+00</p> <p><b>Pic 2 Desc.</b> Section of RoW showing conditions and controls.</p>

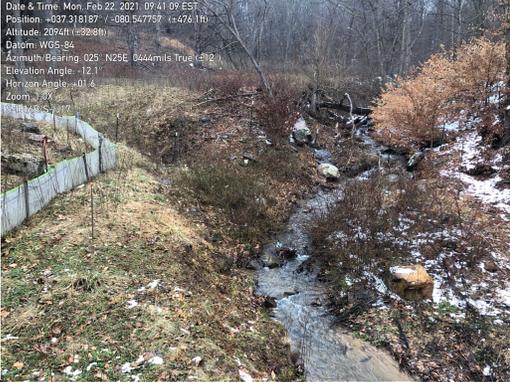
<p>Date &amp; Time: Mon, Feb 22, 2021, 09:41:09 EST  Position: +037.318187° / -080.547752° (+1476.1m)  Altitude: 2594ft (+790.4m)  Datum: WGS-84  Azimuth/Bearing: 025° N25E 8644mils True (+12°)  Elevation Angle: -12.1°  Horizon Angle: +01.4°  Zoom: 1.00  11050+10</p>		<p><b>GPS Location</b> 3</p> <p><b>Field Station#</b> 11049+00</p> <p><b>Pic 3 Desc.</b> Section of RoW showing conditions and controls.</p>		<p><b>GPS Location</b> 4</p> <p><b>Field Station#</b> 11050+10</p> <p><b>Pic 4 Desc.</b> S-IJ16B/S-IJ17 and controls.</p>

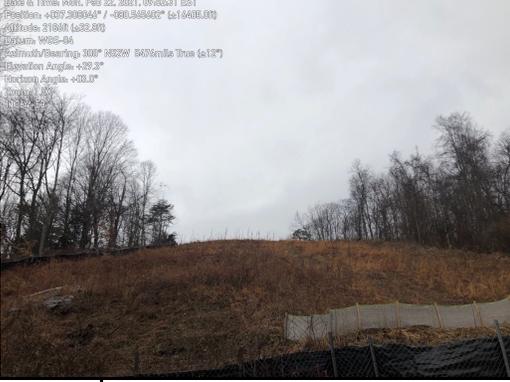
<p>Date &amp; Time: Mon, Feb 22, 2021, 09:48:31 EST  Position: +037.308349° / -080.544978° (+1648.0m)  Altitude: 2166ft (+659.7m)  Datum: WGS-84  Azimuth/Bearing: 300° N32W 5600mils True (+12°)  Elevation Angle: +32.2°  Horizon Angle: +03.2°  Zoom: 1.00</p>		<p><b>GPS Location</b> 5</p> <p><b>Field Station#</b> 11057+00</p> <p><b>Pic 5 Desc.</b> Section of RoW showing conditions and controls.</p>		<p><b>GPS Location</b> 6</p> <p><b>Field Station#</b> 11064+53</p> <p><b>Pic 6 Desc.</b> Section of RoW showing conditions and controls.</p>

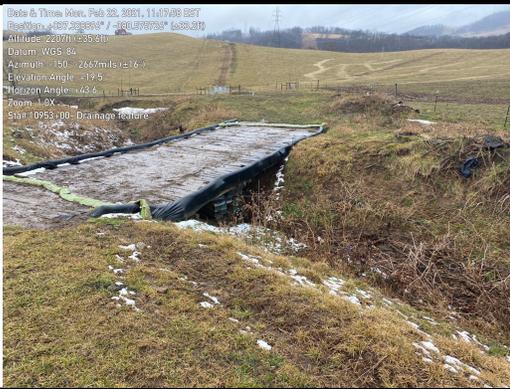
<b>Pic 5 Desc.</b>	Stream S- E24, bridge slippery, ECD's are in acceptable condition.	<b>Pic 6 Desc.</b>	Bridge over drainage feature.

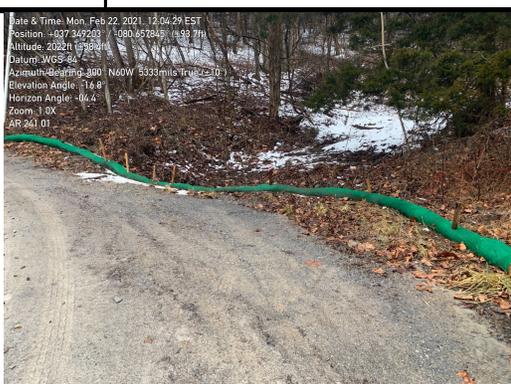
<b>Field Station#</b>	10696+00	<b>Field Station#</b>	10695+00	<b>Pic 5 Desc.</b>	RCE in place at Buffalo Anklets Road.	<b>Pic 6 Desc.</b>	CFS replaced. Was a communication item last inspection.

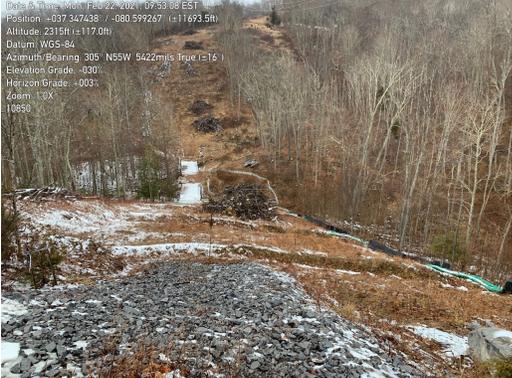
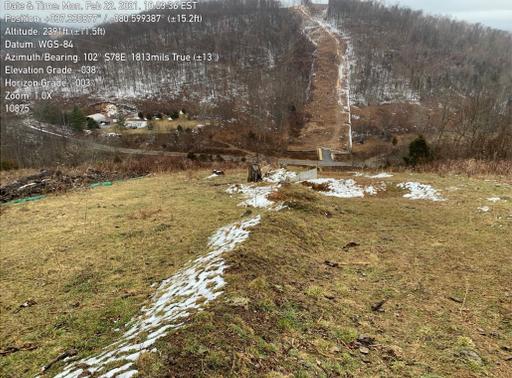
<b>GPS Location</b>	See picture above for GPS coordinates	<b>GPS Location</b>	See picture above for GPS coordinates	
<b>Field Station#</b>	10850+00	<b>Field Station#</b>	10875+00	
<b>Pic 1 Desc.</b>	ECD's and row conditions	<b>Pic 2 Desc.</b>	ECD's and row conditions

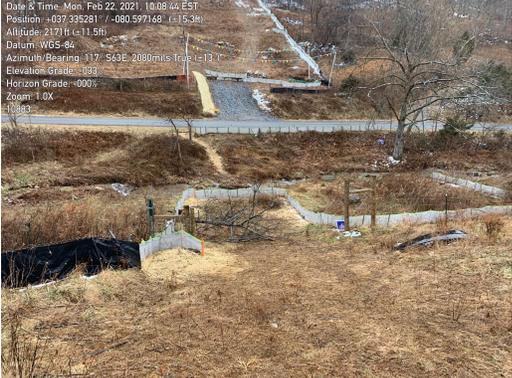
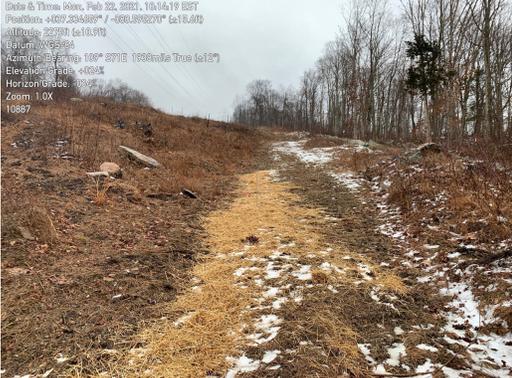
<b>GPS Location</b>	See picture above for GPS coordinates	<b>GPS Location</b>	See picture above for GPS coordinates	
<b>Field Station#</b>	10883+00	<b>Field Station#</b>	10887+00	
<b>Pic 3 Desc.</b>	ECD's and row conditions	<b>Pic 4 Desc.</b>	ECD's and row conditions

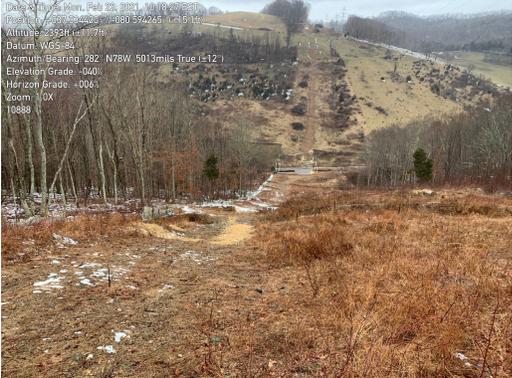
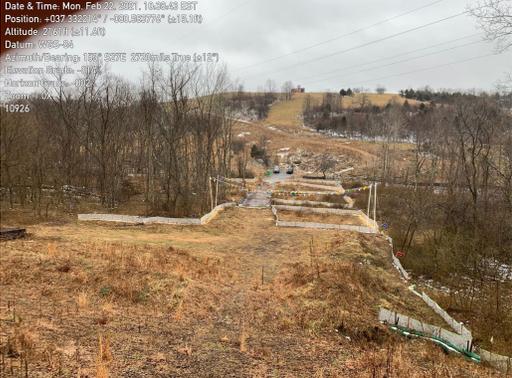
<b>GPS Location</b>	See picture above for GPS coordinates	<b>GPS Location</b>	See picture above for GPS coordinates	
<b>Field Station#</b>	10888+00	<b>Field Station#</b>	10926+00	
<b>Pic 5 Desc.</b>	ECD's and row conditions	<b>Pic 6 Desc.</b>	ECD's and row conditions

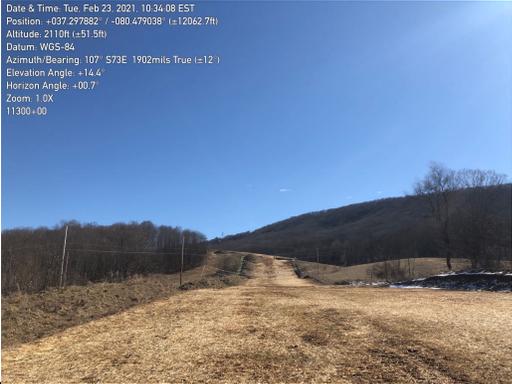
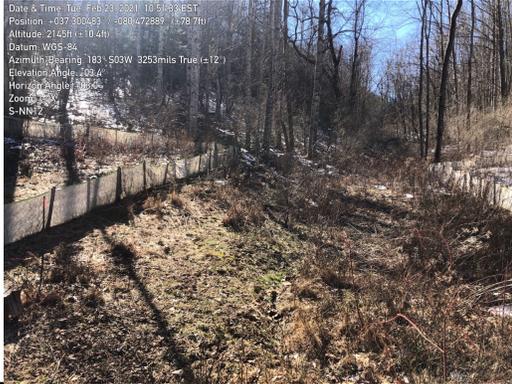
<b>GPS Location</b> 3		<b>GPS Location</b> 4			
<b>Field Station#</b> 11300+00		<b>Field Station#</b> 11327+85			
<b>Pic 3 Desc.</b> Section of RoW showing conditions and controls.		<b>Pic 4 Desc.</b> S-NN12 and controls.

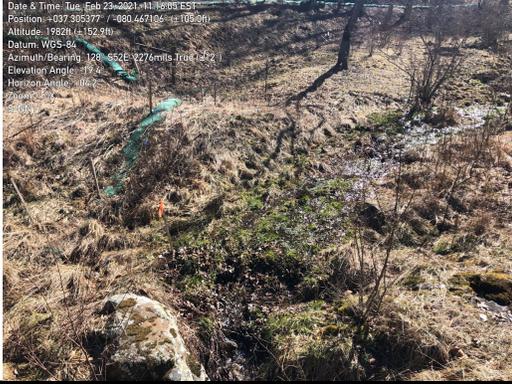
<p>Date &amp; Time: Tue, Feb 23, 2021, 11:16:05 EST Position: +037.309277 / -080.467106 (+109.6ft) Altitude: 1982ft (+60.2ft) Datum: WGS-84 Azimuth/Bearing: 128.552E 2276mils True (+12.1) Elevation Angle: +17.4 Horizon Angle: +00.4</p>		
<b>GPS Location</b> 5		<b>GPS Location</b> 6			
<b>Field Station#</b> 11350+00		<b>Field Station#</b> 11352+97			
<b>Pic 5 Desc.</b> Section of RoW showing conditions and controls.		<b>Pic 6 Desc.</b> S-NN11.

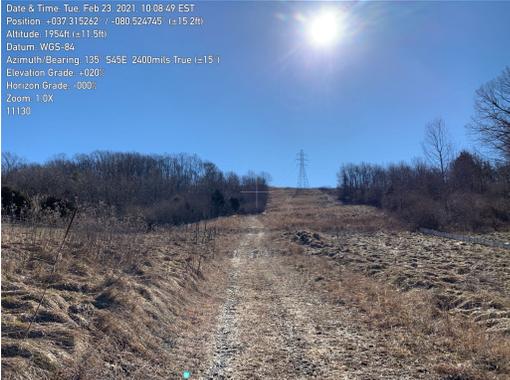
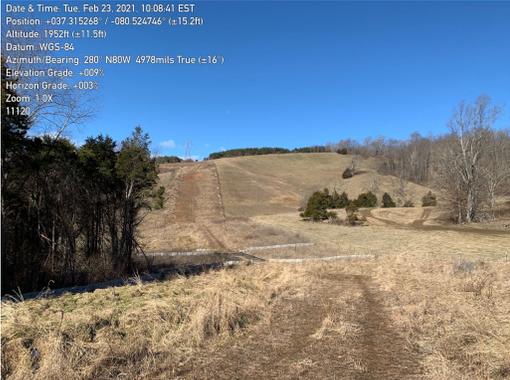
<b>GPS Location</b>	See picture above for GPS coordinates	<b>GPS Location</b>	See picture above for GPS coordinates	
<b>Field Station#</b>	111130+00	<b>Field Station#</b>	11120+00	
<b>Pic 3 Desc.</b>	ECD's and row conditions	<b>Pic 4 Desc.</b>	ECD's and row conditions

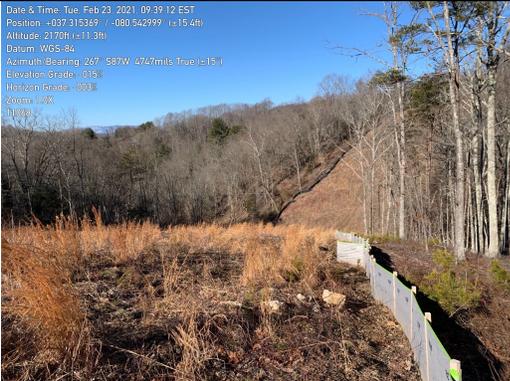
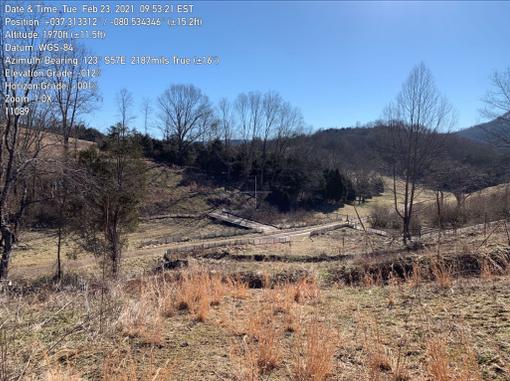
<b>Field Station#</b>	11068+00	<b>Field Station#</b>	11089+00	
<b>Pic 5 Desc.</b>	ECD's and row conditions	<b>Pic 6 Desc.</b>	ECD's and row conditions

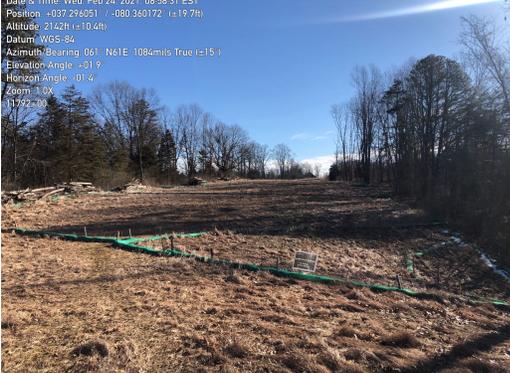
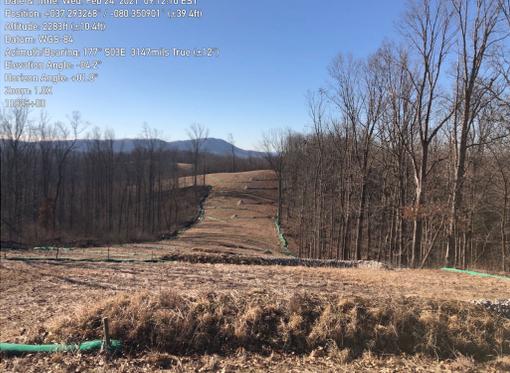
<b>GPS Location</b> 1		<b>GPS Location</b> 2					
<b>Field Station#</b> 11792+00		<b>Field Station#</b> 11825+00					
<b>Pic 1 Desc.</b> Section of restored RoW showing conditions and controls.		<b>Pic 2 Desc.</b> Section of restored RoW showing conditions and controls.

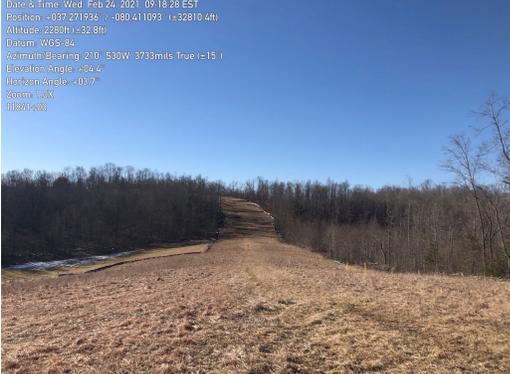
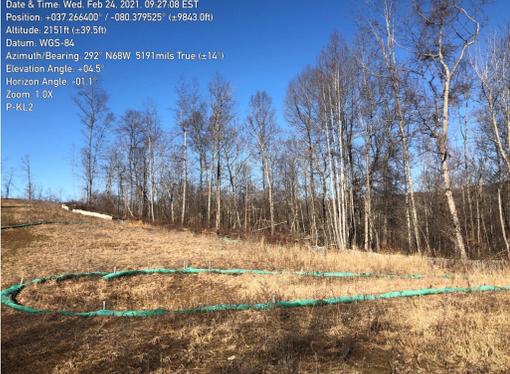
<b>GPS Location</b> 3		<b>GPS Location</b> 4					
<b>Field Station#</b> 11841+00		<b>Field Station#</b> 11863+65					
<b>Pic 3 Desc.</b> Section of restored RoW showing conditions and controls.		<b>Pic 4 Desc.</b> P-KL2 and controls.

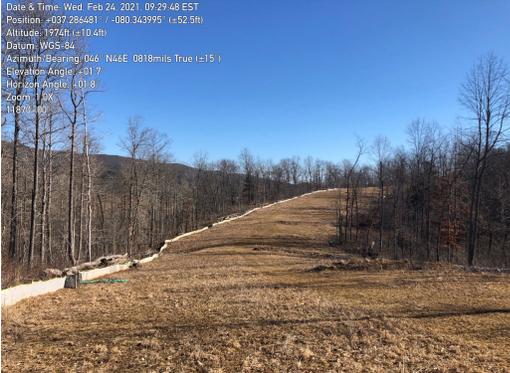
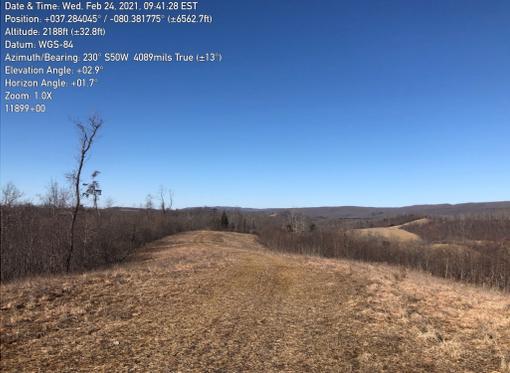
<b>GPS Location</b> 5		<b>GPS Location</b> 6					
<b>Field Station#</b> 11870+00		<b>Field Station#</b> 11899+00					
<b>Pic 5 Desc.</b> Section of restored RoW showing conditions and controls.		<b>Pic 6 Desc.</b> Section of restored RoW showing conditions and controls.

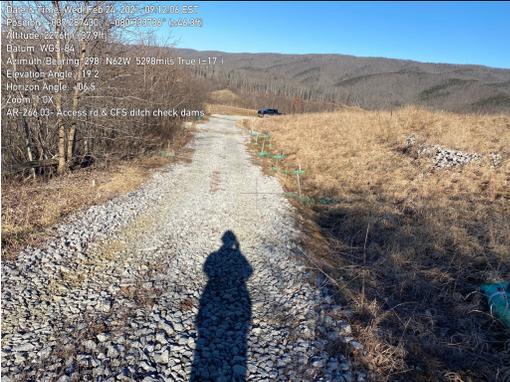
<p>Date &amp; Time: Wed, Feb 24, 2021 09:16:39 EST Position: +0301287038 / +080332805 (x=49.3ft) Altitude: 2289ft (+27.0ft) Datum: WGS-84 Azimuth/Bearing: 578° N62W 5298mils True (±17.1°) Elevation Angle: +19.2° Horizon Angle: +04.5° Zoom: 1.0X Sta# 11900.00- Access rd &amp; CFS ditch check dams.</p>

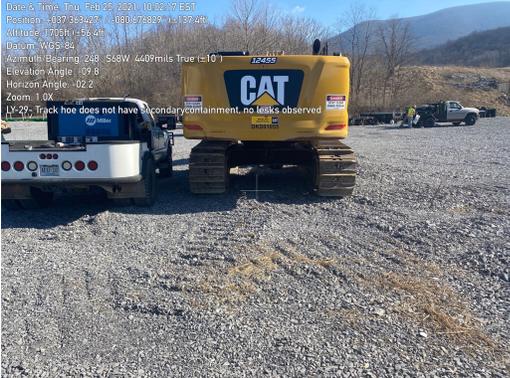
<p><small>Date &amp; Time: Thu, Feb 25, 2021, 10:02:17 EST Position: +037.363827, -080.676307, 1515910ft Altitude: 1795ft (+31.0ft) Datum: WGS-84 Azimuth/Bearing: 248.548W, 440.9mils True (+10°) Elevation Angle: -09.8° Horizon Angle: -02.2° Zoom: 1.0X LY-29- Track hoe does not have secondary containment, no leaks observed</small></p>

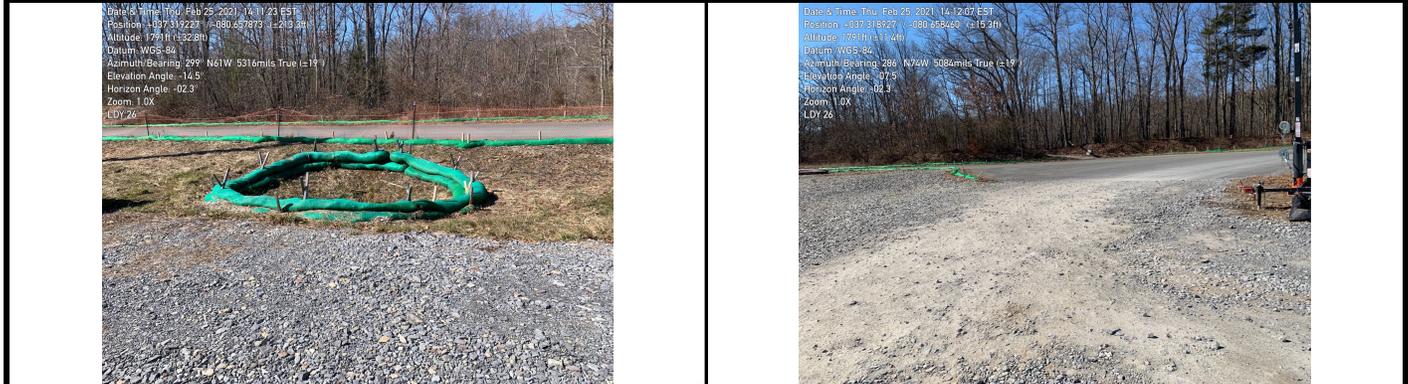
<b>GPS Location</b>	See photo for GPS location.	<b>GPS Location</b>	See photo for GPS location.
<b>Field Station#</b>	12005+00	<b>Field Station#</b>	12005+00
<b>Pic 1 Desc.</b>	Triple stack compost filter sock in place around drainage.	<b>Pic 2 Desc.</b>	RCE in place at LDY 26 entrance.

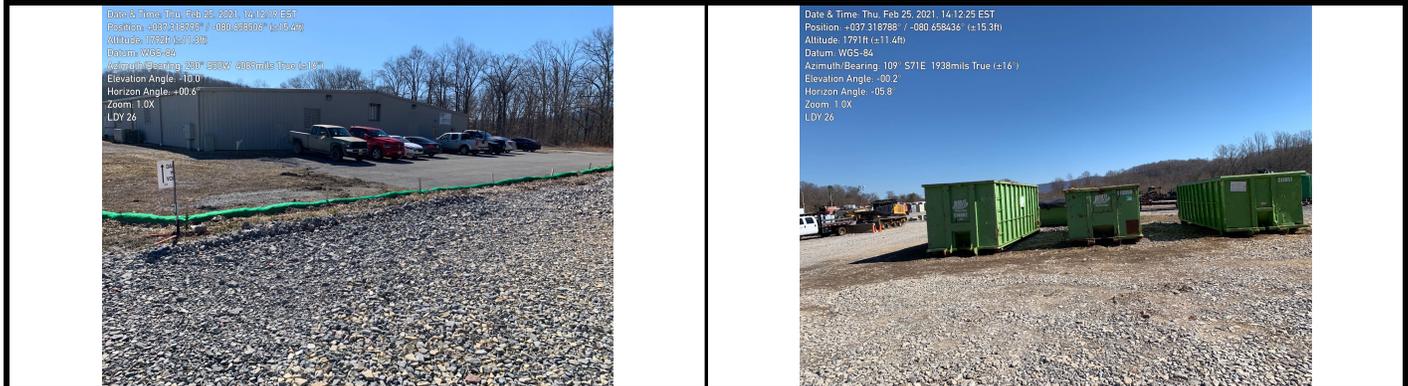
<b>GPS Location</b>	See photo for GPS location.	<b>GPS Location</b>	See photo for GPS location.
<b>Field Station#</b>	12005+00	<b>Field Station#</b>	12005+00
<b>Pic 3 Desc.</b>	18 inch compost filter sock in place along LOD.	<b>Pic 4 Desc.</b>	Dumpsters being utilized for trash management.

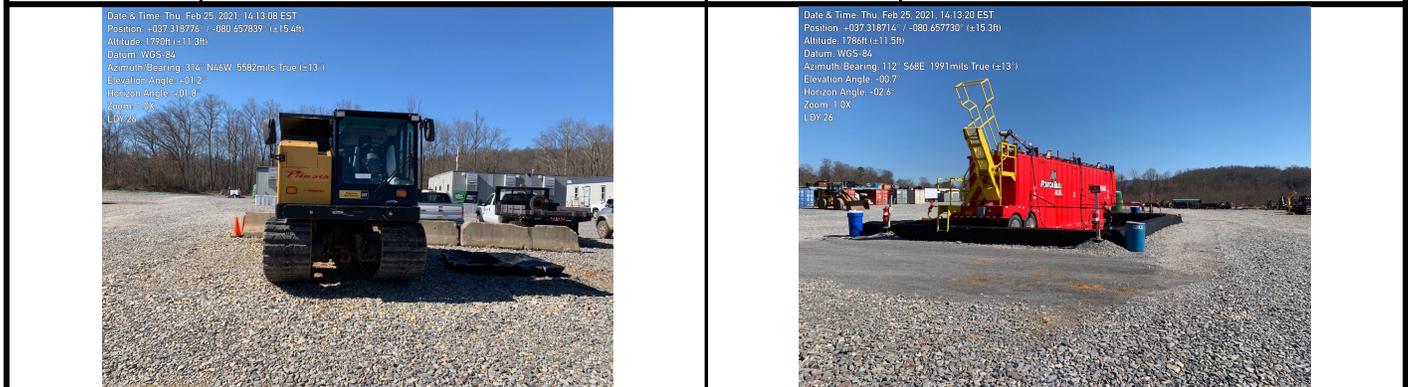
<b>GPS Location</b>	See photo for GPS location.	<b>GPS Location</b>	See photo for GPS location.
<b>Field Station#</b>	12005+00	<b>Field Station#</b>	12005+00
<b>Pic 5 Desc.</b>	Checked staged equipment for leaks.	<b>Pic 6 Desc.</b>	Secondary containment in place under fuel cell.
