Visual Site Inspection Report

Project Name H-600 Pipeline Spread G		AFE 124300137	Spread H-600 Pipeline Spread G
Contractor Precision		Report # 19808	
Inspector Rob Robertson		Date/Time 2/8/2021 11:53 AM	
Permit # TBD	Inspection Type VA SWPP	Station Begin	11600+01
State VA	Inspection Area Full	Station End	11670+00
County Montgomery	Ground Frozen	Temperature (°F)	22.00
Municipality N/A	Weather Sunny	Rain Gauge (in)	0.00
			Rain Accumulation Time (days) 1.00

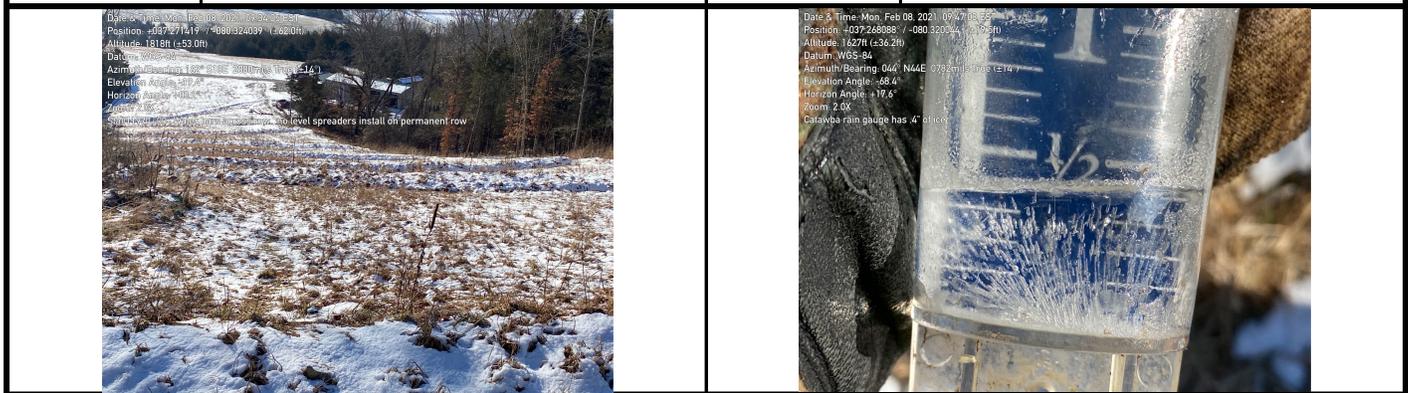
GPS Location	See photo GPS	GPS Location	See photo GPS
Field Station#	11970+00	Field Station#	11989+00
Pic 5 Desc.	Water bars crossing entire row, no level spreaders installed on permanent row, in this area.	Pic 6 Desc.	Catawba rain gauge reading- .4" of ice.

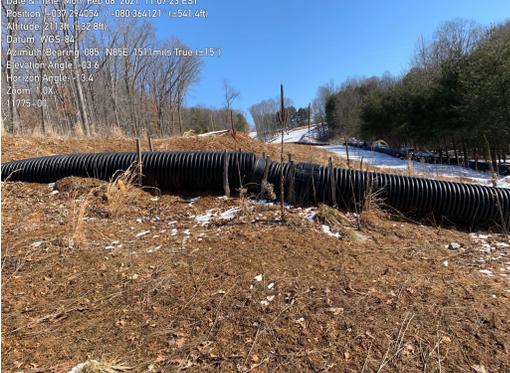
Conducted VA SWPPP inspection from MP 221 to MP 223.8.
 Since last inspection Precision Pipeline has conducted ECD maintenance and ECD upgrades where needed.
 No forward progress has been completed due to FERC shut down.
 ROW has been stabilized using seed, mulch, and minor vegetation growth.
 Deficiencies located at station numbers;
 11768+00 and 11770+00 - reattach super silt fabric to chain link fencing.
 11775+00 - reattach clean water drainage pipe.

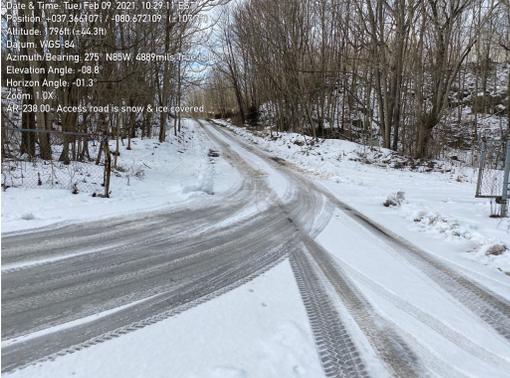
<p>Date & Time: Tue, Feb 09, 2021, 10:29:11 EST Position: +3373443.07 / +869.872109 / +1109.1171 Altitude: 1794ft (+662.3ft) Datum: WGS-84 Azimuth/Bearing: 275° N65W 4889mils True (+20°) Elevation Angle: -08.8° Horizon Angle: -01.3° Zoom: 1.0X LY29- AR-238.00- Access road is snow & ice covered.</p>

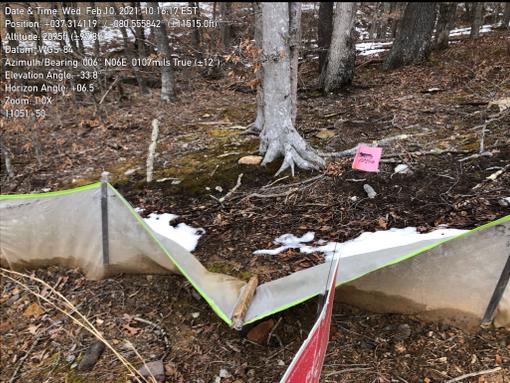
GPS Location 5		GPS Location 6			
Field Station# 11055+00		Field Station# 11051+50			
Pic 5 Desc. Section of RoW showing conditions and controls.		Pic 6 Desc. Minor wildlife damage to controls.

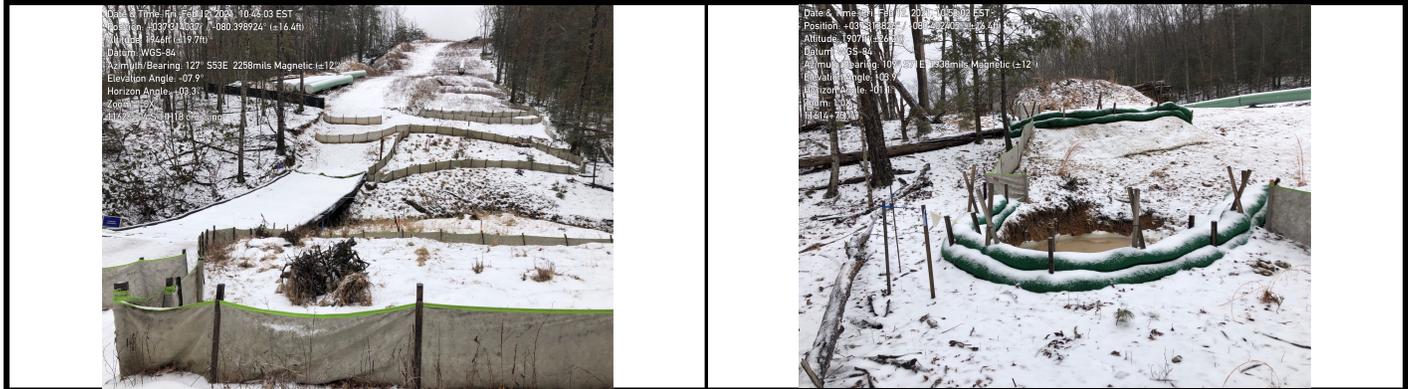
GPS Location	On photo	GPS Location	On photo
Field Station#	11626+04	Field Station#	11614+75
Pic 5 Desc.	The S-HH18 crossing is currently stable with adequate ECDs in place.	Pic 6 Desc.	Perimeter ECDs are in place and functional.

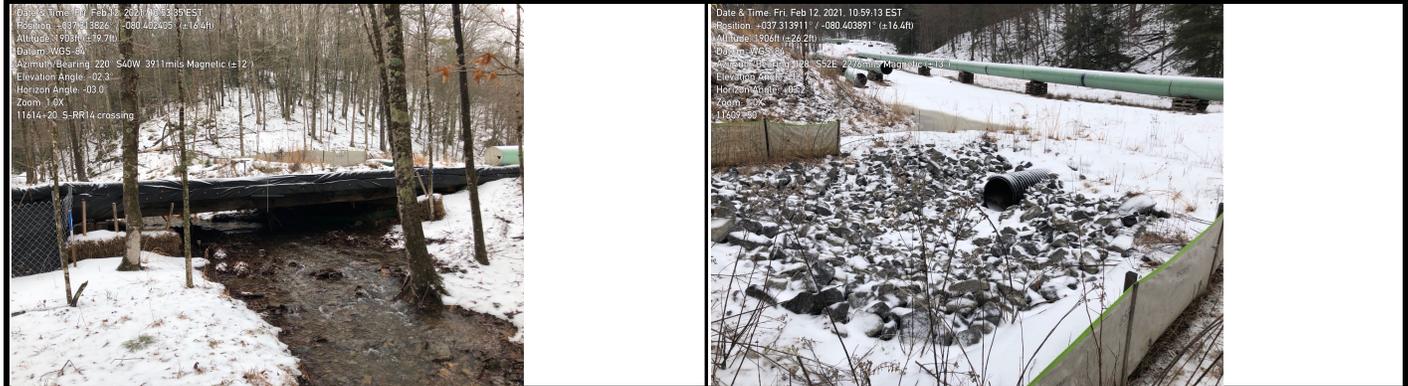
GPS Location	On photo	GPS Location	On photo
Field Station#	11614+20	Field Station#	11609+50
Pic 7 Desc.	The S-RR14 crossing is stable with no impact discovered. ECDs are in place.	Pic 8 Desc.	The outlet and sump are in acceptable condition.

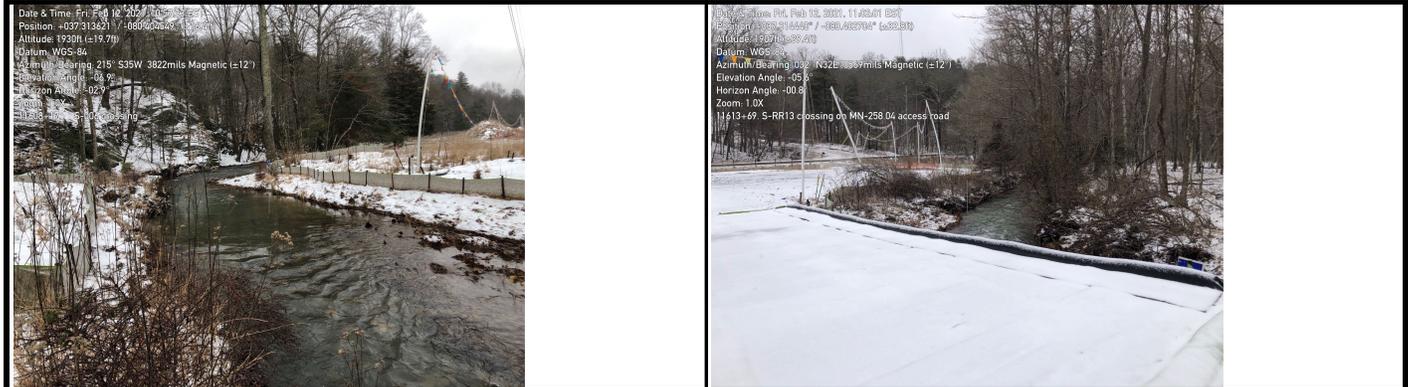
GPS Location	On photo	GPS Location	On photo
Field Station#	11608+17	Field Station#	11613+69
Pic 9 Desc.	The S-006 crossing is stable.	Pic 10 Desc.	The S-RR13 crossing at access road MN-258.04 is stable.
