# Visual Site Inspection Report

<b>Project Name</b> H-600 Pipeline Spread G		<b>AFE</b> 124300137	<b>Spread</b> H-600 Pipeline Spread G
<b>Contractor</b> Precision		<b>Report #</b> 20845	
<b>Inspector</b> Chris Burns		<b>Date/Time</b> 3/8/2021 12:39 PM	
<b>Permit #</b> TBD	<b>Inspection Type</b> VA SWPP	<b>Station Begin</b>	11788+52
<b>State</b> VA	<b>Inspection Area</b> Partial	<b>Station End</b>	11899+99
<b>County</b> Montgomery	<b>Ground</b> Dry	<b>Temperature (°F)</b>	55.00
<b>Municipality</b> N/A	<b>Weather</b> Sunny	<b>Rain Gauge (in)</b>	0.00
			<b>Rain Accumulation Time (days)</b> 1.00

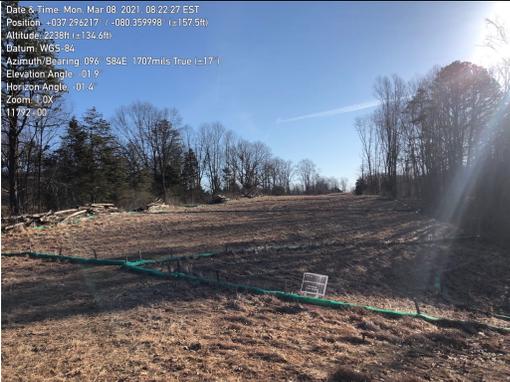
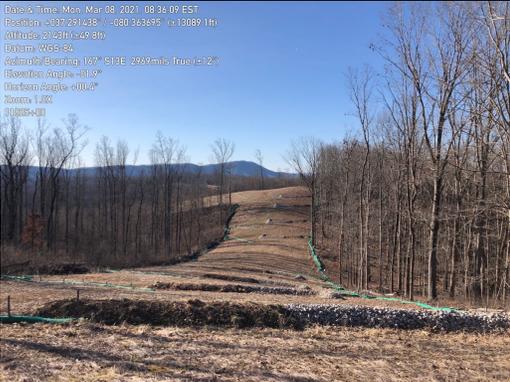
<b>GPS Location</b> 1		<b>GPS Location</b> 2			
<b>Field Station#</b> 11792+00		<b>Field Station#</b> 11825+00			
<b>Pic 1 Desc.</b> Section of restored RoW showing conditions and controls.		<b>Pic 2 Desc.</b> Section of restored RoW showing conditions and controls.

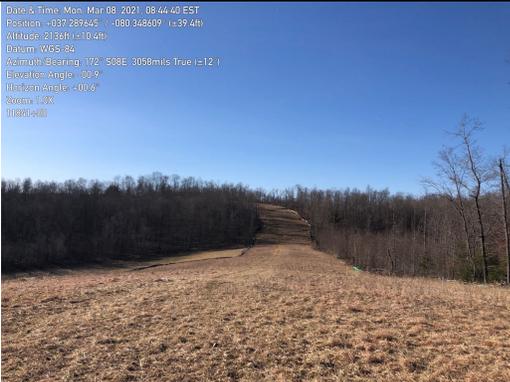
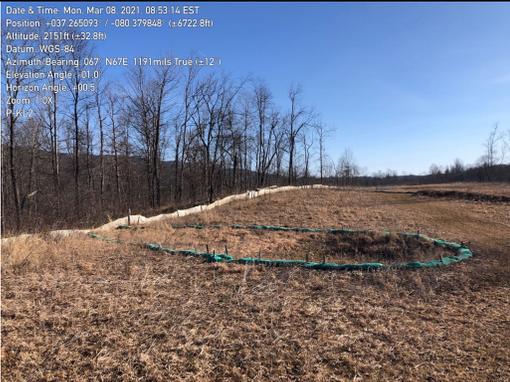
<b>GPS Location</b> 3		<b>GPS Location</b> 4			
<b>Field Station#</b> 11841+00		<b>Field Station#</b> 11863+65			
<b>Pic 3 Desc.</b> Section of restored RoW showing conditions and controls.		<b>Pic 4 Desc.</b> P-KL2 and controls.

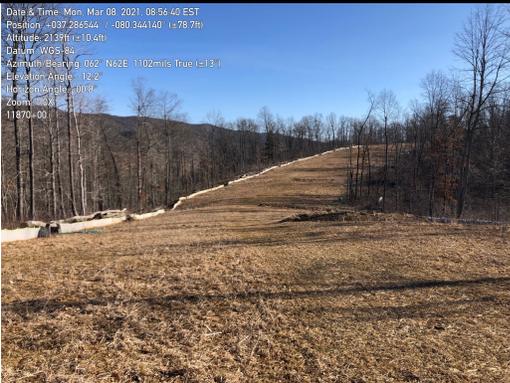
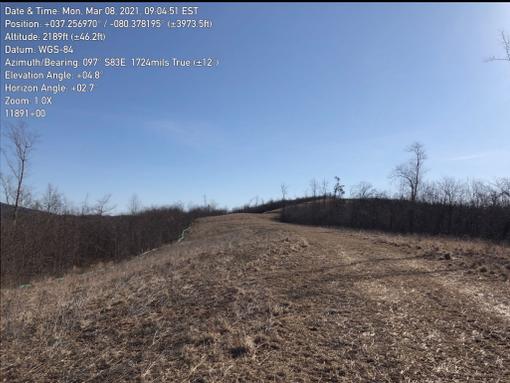
<b>GPS Location</b> 5		<b>GPS Location</b> 6			
<b>Field Station#</b> 11870+00		<b>Field Station#</b> 11891+00			
<b>Pic 5 Desc.</b> Section of restored RoW showing conditions and controls.		<b>Pic 6 Desc.</b> Section of restored RoW showing conditions and controls.

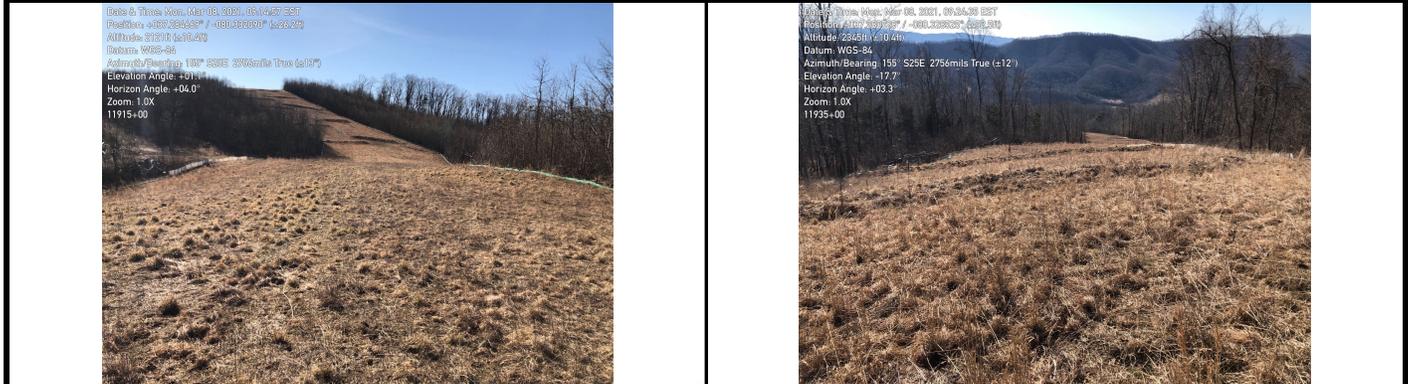
<b>GPS Location</b>	See photo GPS	<b>GPS Location</b>	See photo GPS
<b>Field Station#</b>	11915+00	<b>Field Station#</b>	11935+00
<b>Pic 1 Desc.</b>	Row vegetation and ECD's	<b>Pic 2 Desc.</b>	Row, vegetation and water bars.

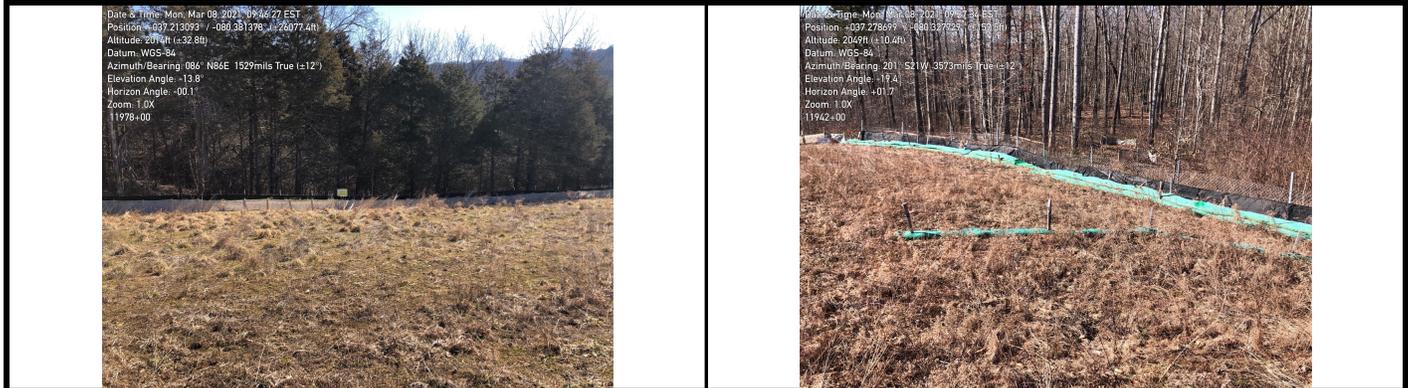
<b>GPS Location</b>	See photo GPS	<b>GPS Location</b>	See photo GPS
<b>Field Station#</b>	11978+00	<b>Field Station#</b>	11942+00
<b>Pic 3 Desc.</b>	Karst ECD's	<b>Pic 4 Desc.</b>	Karst ECD's

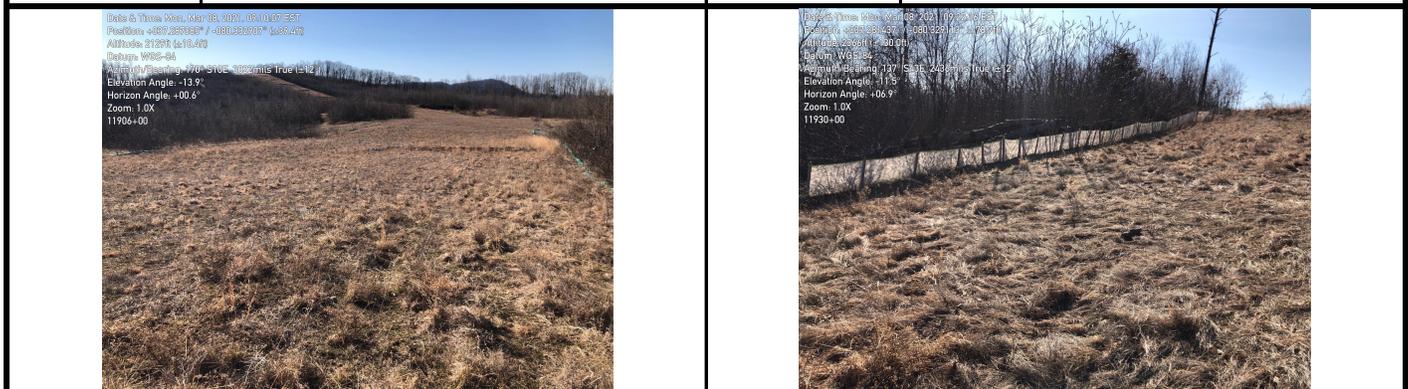
<b>GPS Location</b>	See photo GPS	<b>GPS Location</b>	See photo GPS
<b>Field Station#</b>	11906+00	<b>Field Station#</b>	11930+00
<b>Pic 5 Desc.</b>	Row vegetation and level spreaders.	<b>Pic 6 Desc.</b>	P1 silt fence perimeter controls.

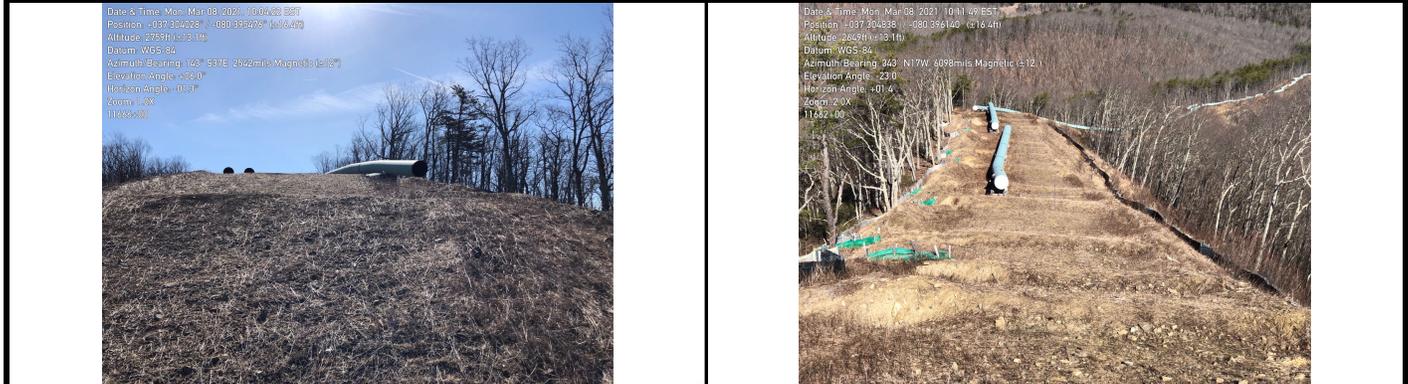
<b>GPS Location</b>	On photo	<b>GPS Location</b>	On photo
<b>Field Station#</b>	11666+00	<b>Field Station#</b>	11662+00
<b>Pic 1 Desc.</b>	The ROW is stable. Perimeter controls are in place. Slope breakers are in place and effective.	<b>Pic 2 Desc.</b>	Slope breakers functioning properly. Perimeter controls in place.

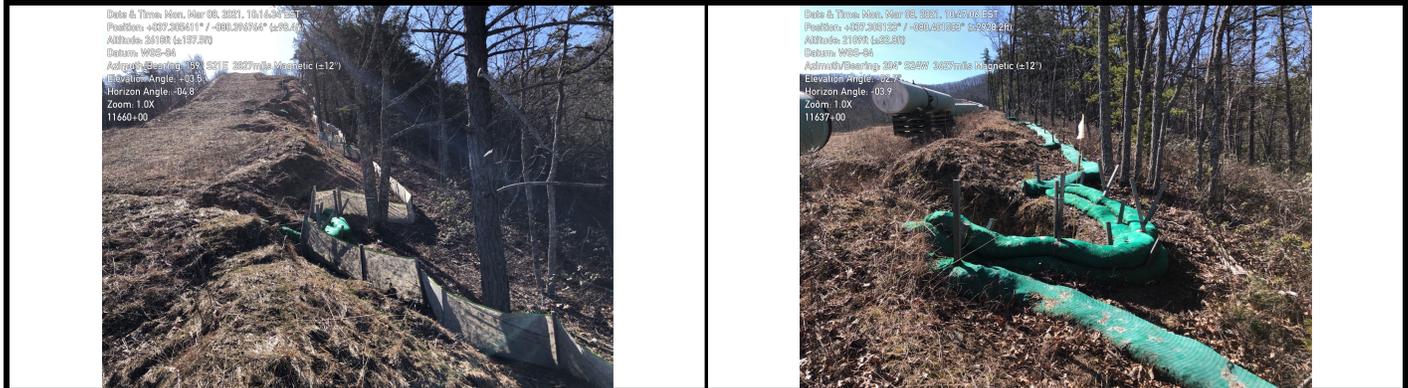
<b>GPS Location</b>	On photo	<b>GPS Location</b>	On photo
<b>Field Station#</b>	11660+00	<b>Field Station#</b>	11637+00
<b>Pic 3 Desc.</b>	Perimeter ECDs are in place and functional.	<b>Pic 4 Desc.</b>	ROW stable. Perimeter ECDs in place.

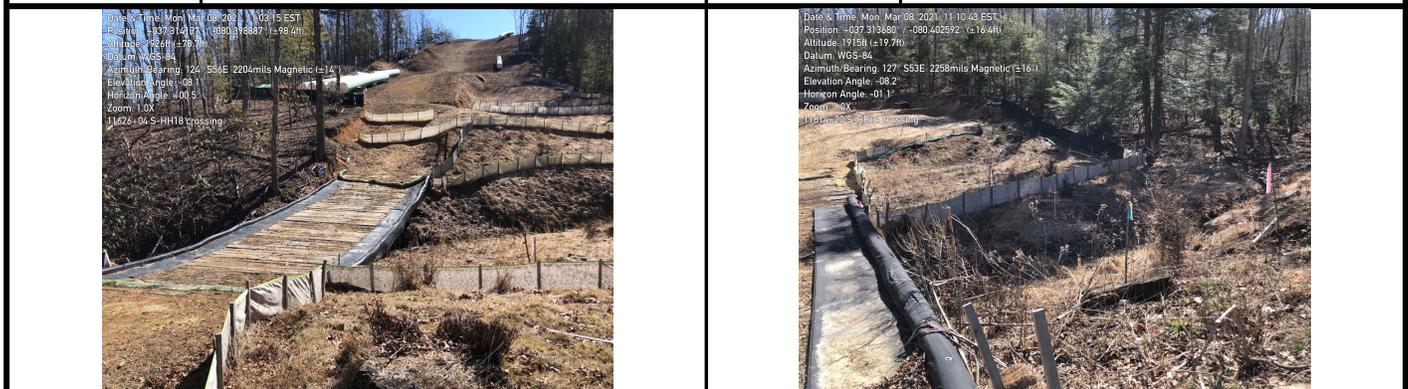
<b>GPS Location</b>	On photo	<b>GPS Location</b>	On photo
<b>Field Station#</b>	11626+04	<b>Field Station#</b>	11614+20
<b>Pic 5 Desc.</b>	The S-HH18 crossing is stable.	<b>Pic 6 Desc.</b>	The S-RR14 crossing is stable.

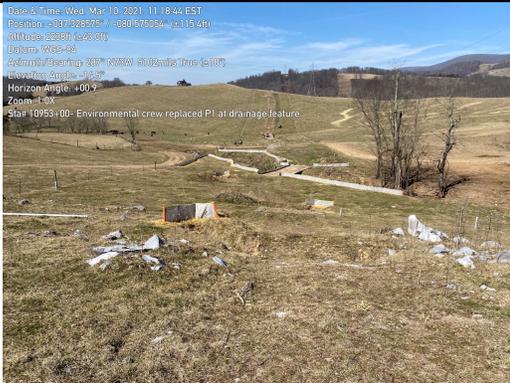
<p>Date &amp; Time: Wed Mar 10 2021 11:18:44 EST Position: 4337223263, -889546697 (+88.2ft) Altitude: 2381ft (+72.6m) Datum: WGS-84 Azimuth Bearing: 207 N20W 5102mils True (+18) Elevation Angle: -11.5 Horizon Angle: +00.3 Zoom: 1.0X Star: 10956+00 - Environmental crew replaced PI at drainage feature</p>

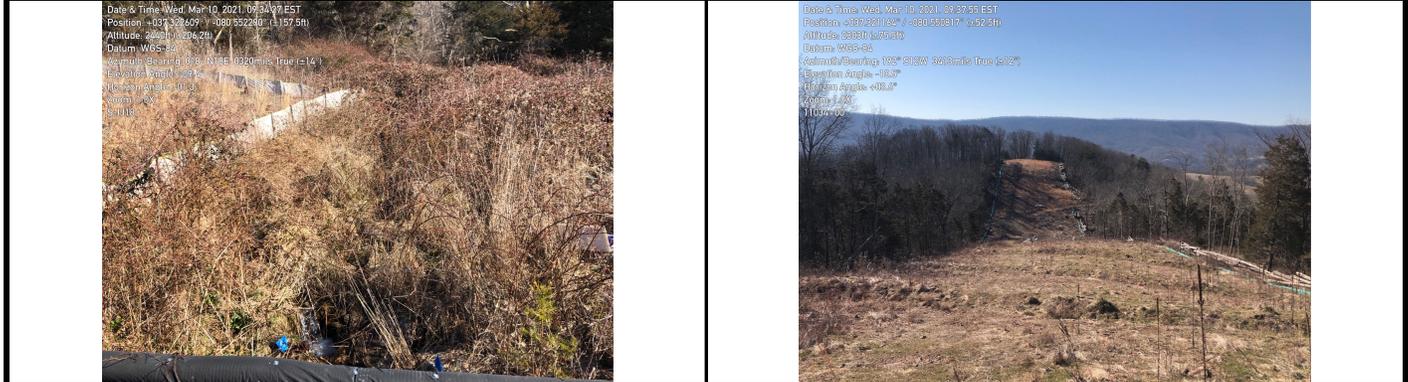
<b>GPS Location</b>	1	<b>GPS Location</b>	2
<b>Field Station#</b>	11025+50	<b>Field Station#</b>	11034+00
<b>Pic 1 Desc.</b>	S-IJ18 and controls.	<b>Pic 2 Desc.</b>	Section of RoW showing conditions and controls.

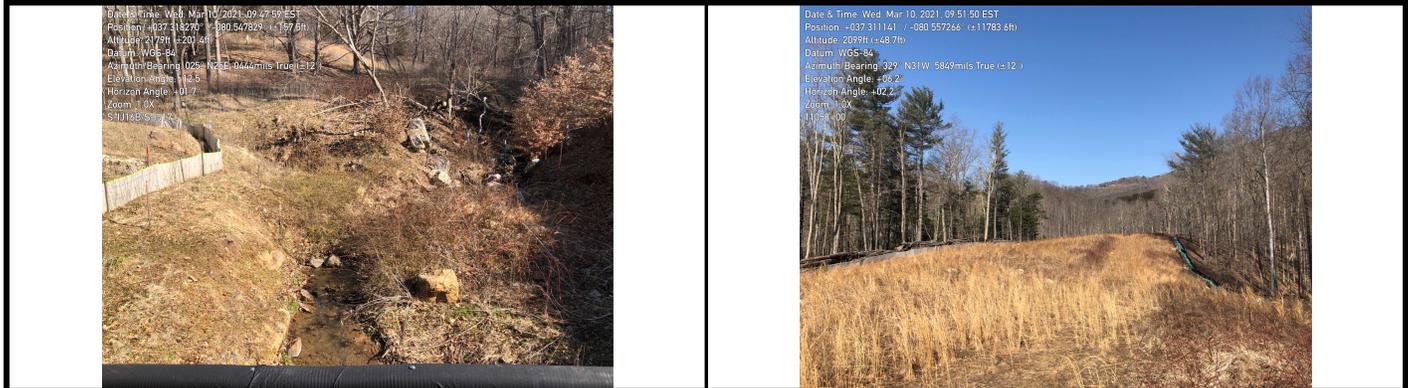
<b>GPS Location</b>	3	<b>GPS Location</b>	4
<b>Field Station#</b>	11050+10	<b>Field Station#</b>	11058+00
<b>Pic 3 Desc.</b>	S-IJ16B/S-IJ17 and controls.	<b>Pic 4 Desc.</b>	Section of RoW showing conditions and controls.

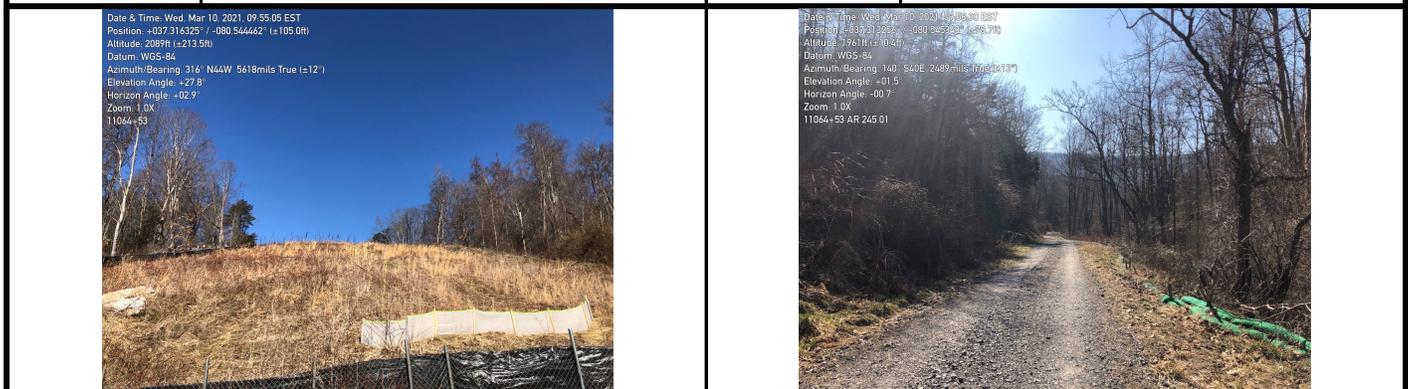
<b>GPS Location</b>	5	<b>GPS Location</b>	6
<b>Field Station#</b>	11064+53	<b>Field Station#</b>	11064+53
<b>Pic 5 Desc.</b>	Section of RoW showing conditions and controls.	<b>Pic 6 Desc.</b>	AR 245.01 conditions and controls.

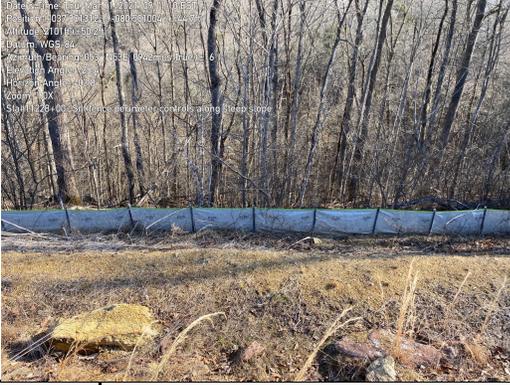
<p><small>Date &amp; Time: Thu, Mar 11, 2021, 09:15:21 EST Position: +037.301598 / -080.502624 (+121.2ft) Altitude: 2063ft (+223.2ft) Datum: WGS-84 Azimuth/Bearing: 021° S85E 3022mils True (+16°) Elevation Angle: -28.3° Horizon Angle: +00.7° Zoom: 1.0X Sta# 11228+00- Silt fence perimeter controls along steep slope.</small></p>

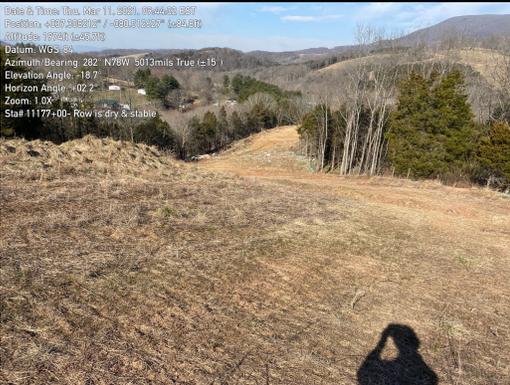
<p><small>Date &amp; Time: Thu, Mar 11, 2021, 09:42:05 EST Position: +037.308811 / -080.510307 (+24.4ft) Altitude: 1929ft (+35.7ft) Datum: WGS-84 Azimuth/Bearing: 282° N78W 5013mils True (+15°) Elevation Angle: -18.7° Horizon Angle: +02.2° Zoom: 1.0X Sta# 11177+00- Row is dry &amp; stable.</small></p>

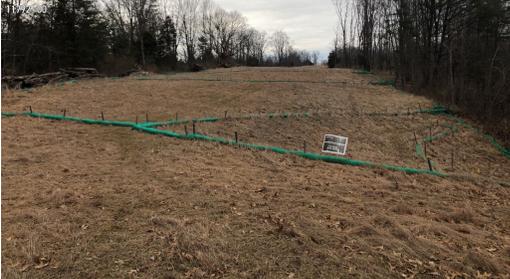
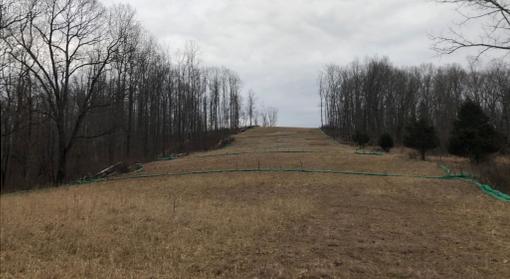
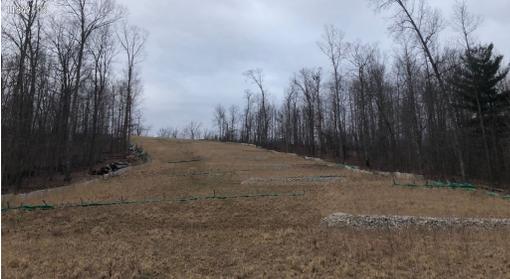
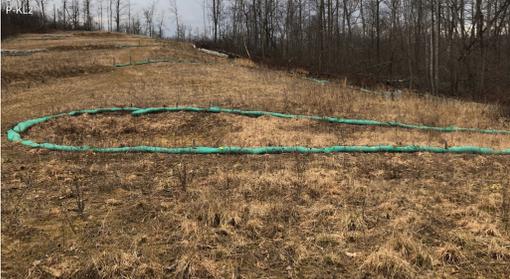
GPS Location 1		GPS Location 2		GPS Location 3		GPS Location 4	
Field Station# 11792+00		Field Station# 11818+00		Field Station# 11849+00		Field Station# 11863+65	
Pic 1 Desc. Section of restored RoW showing conditions and controls.		Pic 2 Desc. Section of restored RoW showing conditions and controls.		Pic 3 Desc. Section of restored RoW showing conditions and controls.		Pic 4 Desc. P-KL2 and controls.

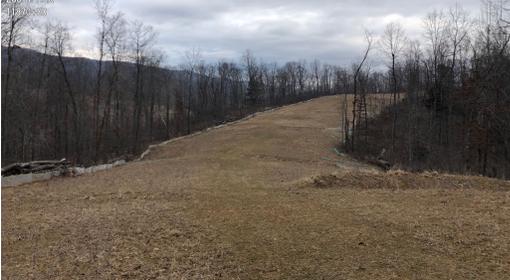
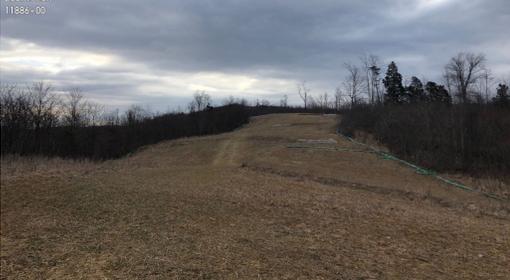
GPS Location 5		GPS Location 6	
Field Station# 11870+00		Field Station# 11886+00		Field Station# 11870+00		Field Station# 11886+00	
Pic 5 Desc. Section of restored RoW showing conditions and controls.		Pic 6 Desc. Section of restored RoW showing conditions and controls.		Pic 5 Desc. Section of restored RoW showing conditions and controls.		Pic 6 Desc. Section of restored RoW showing conditions and controls.

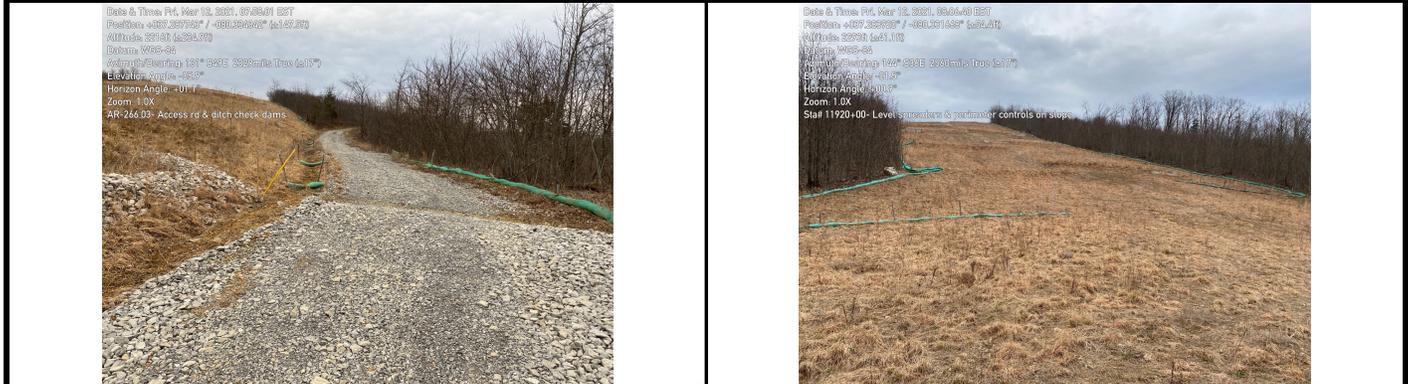
<b>GPS Location</b>	See photo GPS	<b>GPS Location</b>	See photo GPS
<b>Field Station#</b>	11900+00	<b>Field Station#</b>	11920+00
<b>Pic 1 Desc.</b>	AR-266.03- Access road and CFS ditch check dams.	<b>Pic 2 Desc.</b>	Level spreaders and perimeter controls on slope.

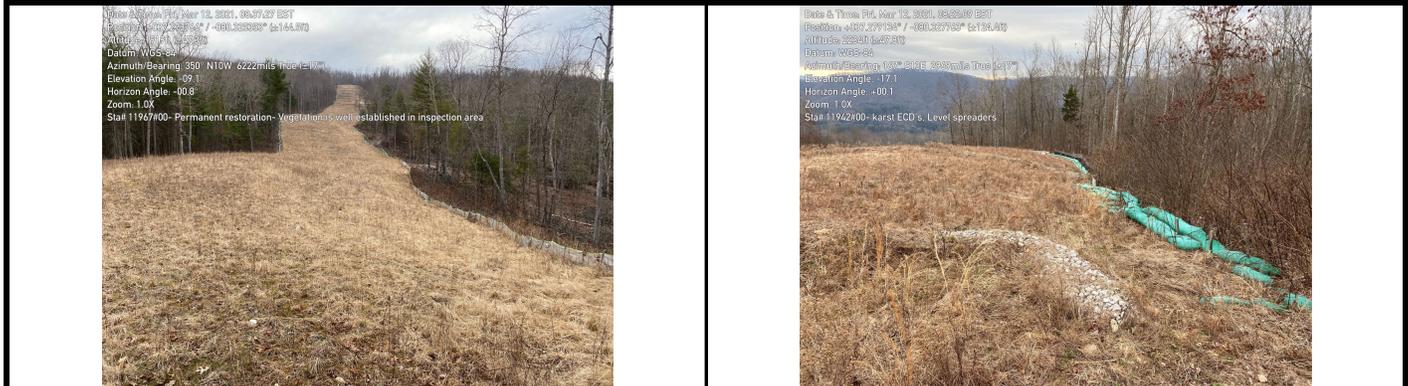
<b>GPS Location</b>	See photo GPS	<b>GPS Location</b>	See photo GPS
<b>Field Station#</b>	11967+00	<b>Field Station#</b>	11942+00
<b>Pic 3 Desc.</b>	Permanent restoration- vegetation is very well established.	<b>Pic 4 Desc.</b>	Karst ECD's and level spreaders.

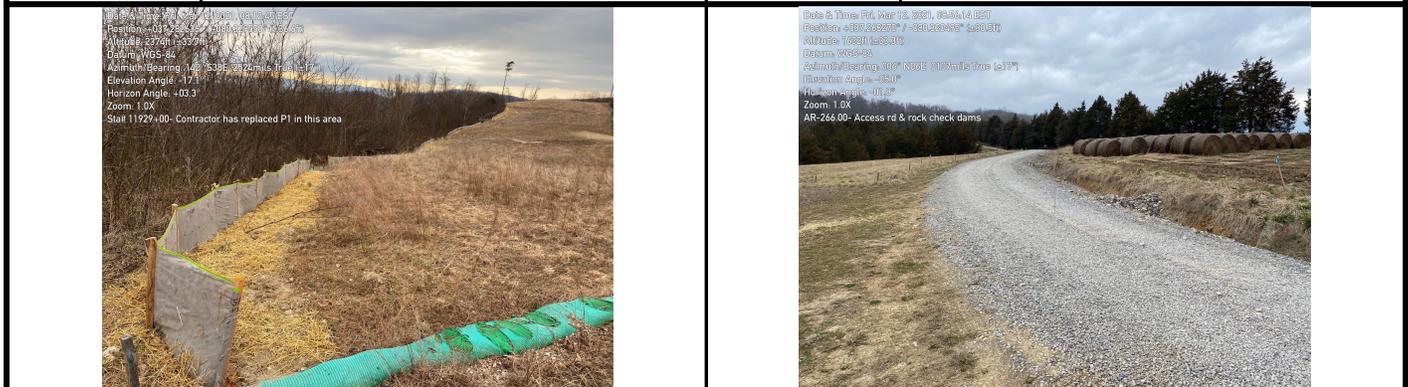
<b>GPS Location</b>	See photo GPS	<b>GPS Location</b>	See photo GPS
<b>Field Station#</b>	11929+00	<b>Field Station#</b>	11988+00
<b>Pic 5 Desc.</b>	The contractor has replaced P1 perimeter controls.	<b>Pic 6 Desc.</b>	AR-266.00- Access road and rock check dams in bar ditch.

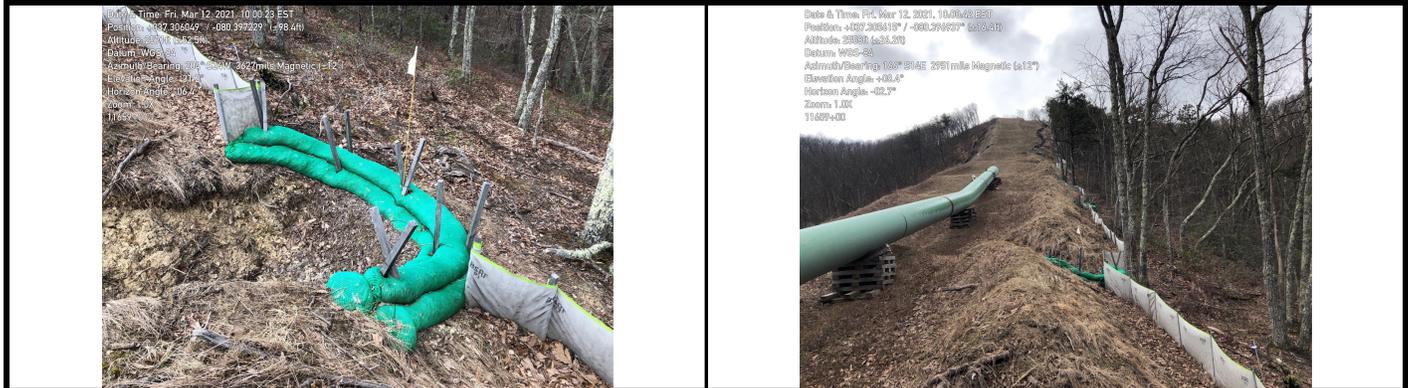
<b>GPS Location</b>	On photo	<b>GPS Location</b>	On photo
<b>Field Station#</b>	11659+00	<b>Field Station#</b>	11659+00
<b>Pic 3 Desc.</b>	Perimeter controls are in place. No erosion has occurred.	<b>Pic 4 Desc.</b>	Perimeter controls are in place. ROW stable.

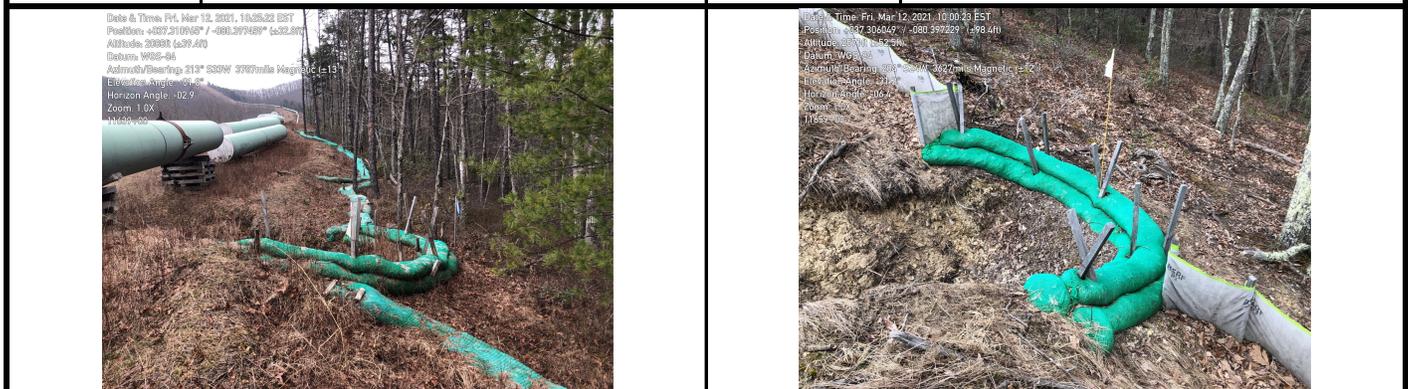
<b>GPS Location</b>	On photo	<b>GPS Location</b>	On photo
<b>Field Station#</b>	11639+00	<b>Field Station#</b>	11659+00
<b>Pic 5 Desc.</b>	Perimeter controls are in place.	<b>Pic 6 Desc.</b>	Perimeter controls are in place.
