Visual Site Inspection Report

Project Name H-600 Pipeline Spread H		AFE 124300138	Spread H-600 Pipeline Spread H
Contractor Precision		Report # 19370	
Inspector John Brcic		Date/Time 1/25/2021 11:05 AM	
Permit # TBD	Inspection Type VA SWPP	Station Begin 12119+17	
State VA	Inspection Area Partial	Station End 12284+75	
County Montgomery	Ground Damp	Temperature (°F) 37.00	
Municipality N/A	Weather Light Rain	Rain Gauge (in) 0.00	
			Rain Accumulation Time (days) 3.00

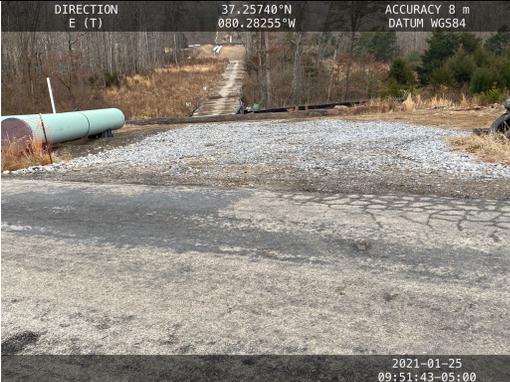
GPS Location	See photo		GPS Location	See photo	
Field Station#	12119+17		Field Station#	12121+33	
Pic 1 Desc.	Flatwoods Road crossing and RCE in satisfactory condition.		Pic 2 Desc.	Stream S-C33, facing north, upstream

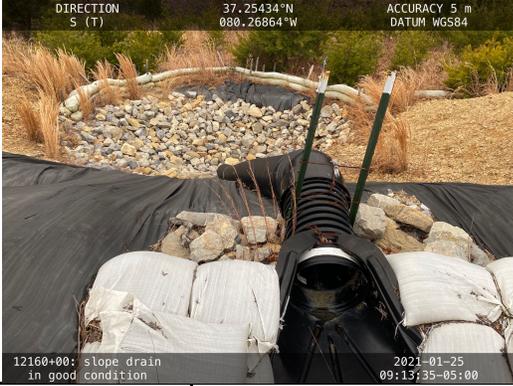
<p>DIRECTION S (T) 37.25434°N 080.26864°W ACCURACY 5 m DATUM WGS84 12160+00: slope drain in good condition 2021-01-25 09:13:35-05:00</p>	
GPS Location	See photo	GPS Location	See photo
Field Station#	12158+00	Field Station#	12160+00
Pic 7 Desc.	Clean water diversion channel stable, ECDs in good condition.	Pic 8 Desc.	Side slope drain in good repair.

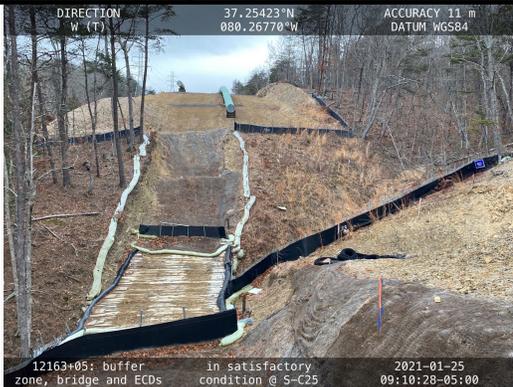
<p>DIRECTION W (T) 37.25423°N 080.26776°W ACCURACY 11 m DATUM WGS84 12163+05: buffer zone, bridge and ECDs in satisfactory condition @ S-C25 2021-01-25 09:10:28-05:00</p>

Field Station#	12163+05	Field Station#	12166+47
Pic 9 Desc.	The bridge, buffer zone and ECDs are in satisfactory condition at stream S-C25.	Pic 10 Desc.	Bridge, buffer zone and ECDs are in good repair at stream S-C24.

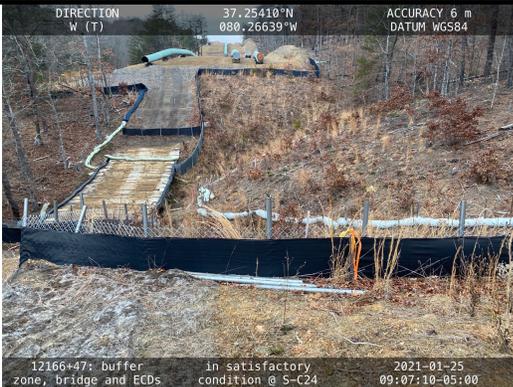
<p>DIRECTION W (T) 37.25410°N 080.26639°W ACCURACY 6 m DATUM WGS84 12166+47: buffer zone, bridge and ECDs in satisfactory condition @ S-C24 2021-01-25 09:07:10-05:00</p>	
GPS Location	See photo	GPS Location	See photo

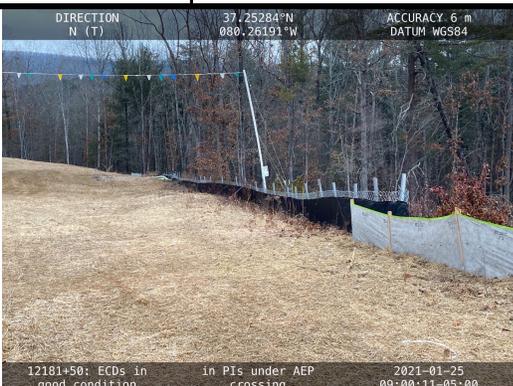
<p>DIRECTION N (T) 37.25284°N 080.26191°W ACCURACY 6 m DATUM WGS84 12181+50: ECDs in good condition in PIs under AEP crossing 2021-01-25 09:00:11-05:00</p>	
GPS Location	See photo	GPS Location	See photo
Field Station#	12179+00	Field Station#	12181+50
Pic 11 Desc.	ROW stable	Pic 12 Desc.	ECDs in satisfactory condition in PIs under the AEP crossing.

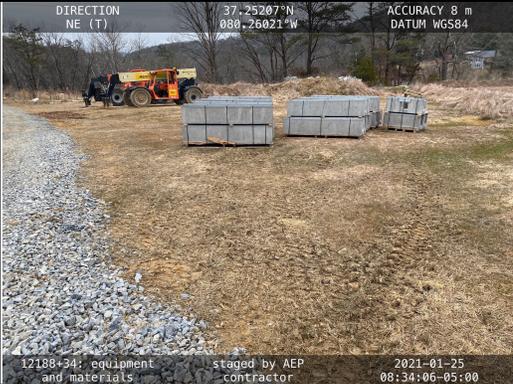
GPS Location	See photo	GPS Location	See photo
Field Station#	12188+34	Field Station#	12190+70
Pic 13 Desc.	The AEP contractor has equipment and materials staged next to where access road MVP-MN-274 crosses the ROW.	Pic 14 Desc.	Outdated 18" CFS was replaced on the coming in side road bank of Bradshaw Road today.

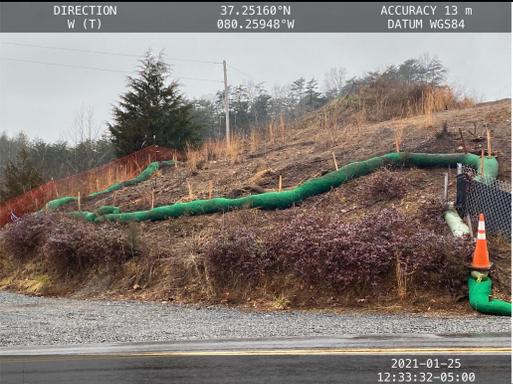
Station 12119+17 to 12284+75.....Activity since last SWPPP inspection. Outdated 18 inch CFS was replaced on the road bank on the coming in side of Bradshaw Road.

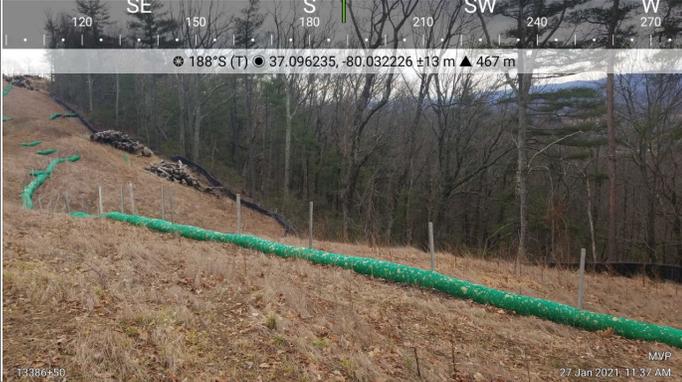
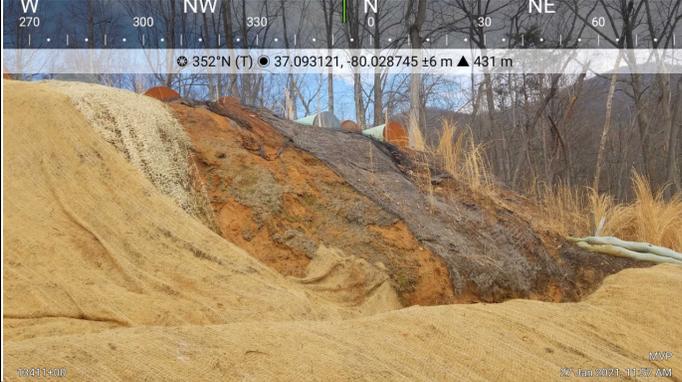
GPS Location See Above	GPS Location See Above
Field Station# 13386+50	Field Station# 13411+00
Pic 13 Desc. ROW Overview. ECDs are functional and ROW is stable.	Pic 14 Desc. Internal 72 hour punchlist item: Stabilize loose soils on slope.

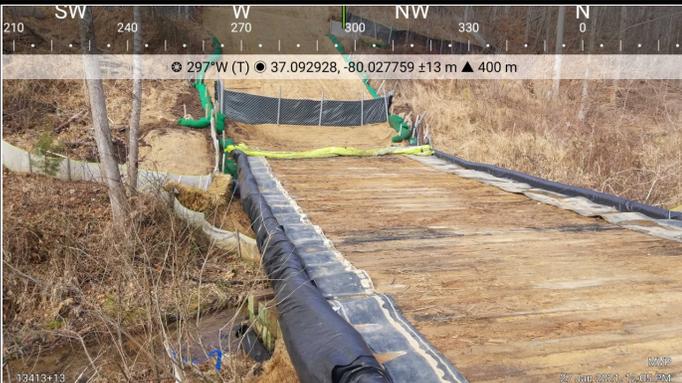
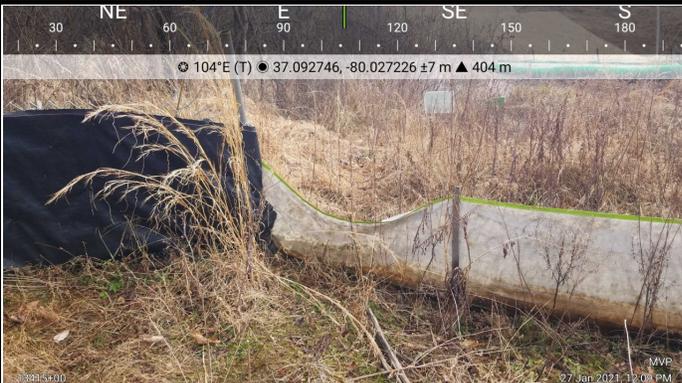
GPS Location See Above	GPS Location See Above
Field Station# 13413+13	Field Station# 13415+00
Pic 15 Desc. Overview of Waterbody S-IJ1. ECDs are functional and ROW is stable.	Pic 16 Desc. Internal 72 hour punchlist item: Repair P1 silt fence.

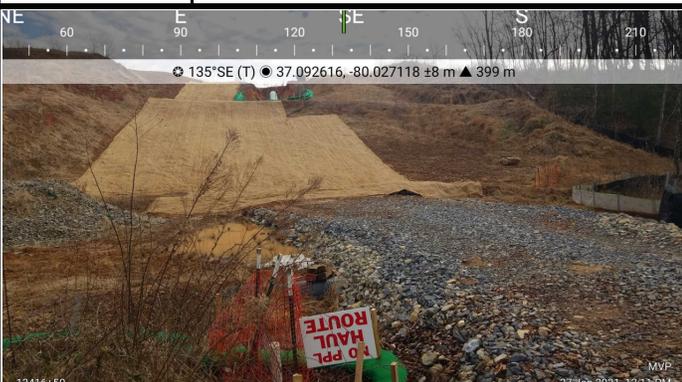
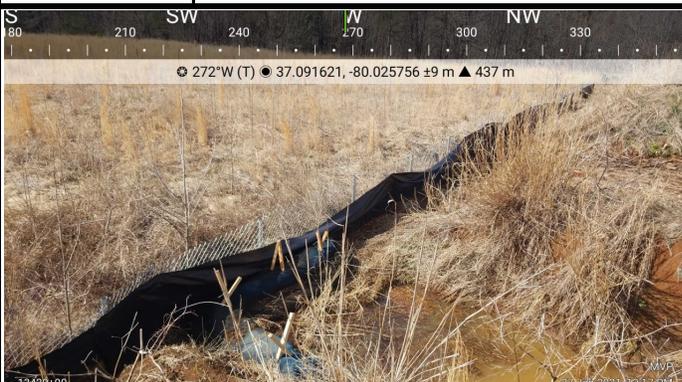
GPS Location See Above	GPS Location See Above
Field Station# 13416+50	Field Station# 13420+00
Pic 17 Desc. ROW Overview. ECDs are functional and ROW is stable.	Pic 18 Desc. Internal 72 hour punchlist item: Repair super silt fence.

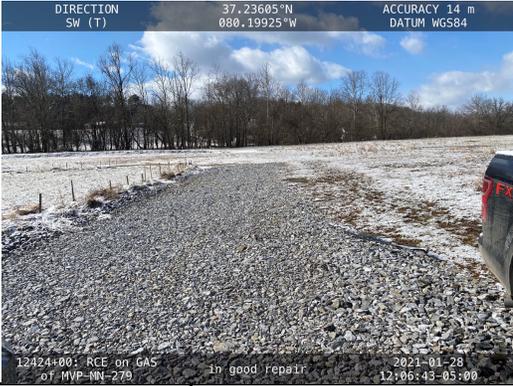
<p>DIRECTION SW (T) 37.23605°N 080.19925°W ACCURACY 14 m DATUM WGS84 12424+00: RCE on GAS in good repair 2021-01-28 12:06:43-05:00</p>
