Visual Site Inspection Report

Project Name H-600 Pipeline Spread H		AFE 124300138	Spread H-600 Pipeline Spread H
Contractor Precision		Report # 19600	
Inspector Dawn McCullough		Date/Time 2/1/2021 2:54 PM	
Permit # TBD	Inspection Type VA SWPP	Station Begin 13141+65	
State VA	Inspection Area Partial	Station End 13316+21	
County Franklin	Ground Frozen	Temperature (°F) 37.00	
Municipality N/A	Weather Cloudy	Rain Gauge (in) 0.60	
			Rain Accumulation Time (days) 1.00

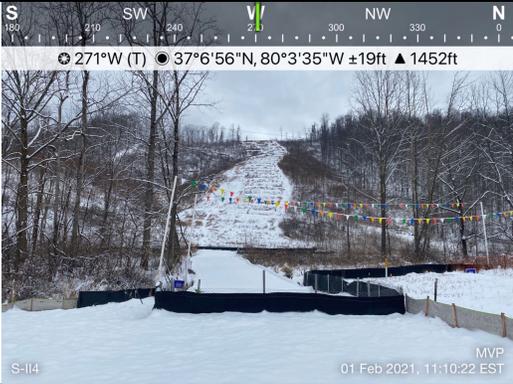
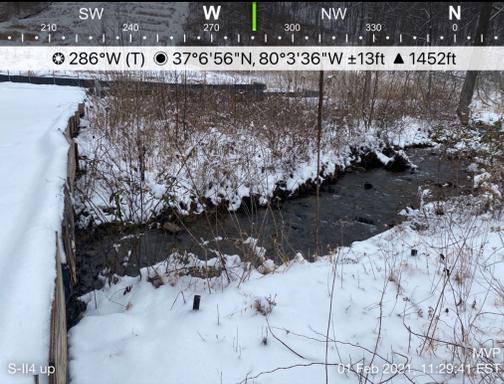
GPS Location	See photo for coordinates.
Field Station#	13261+00	GPS Location	See photo for coordinates.	Pic 7 Desc.	Perimeter controls in acceptable condition along S-II4, ROW stable and snow covered.
Pic 8 Desc.		Pic 8 Desc.	S-II4, upstream, no environmental concerns noted at stream crossing.

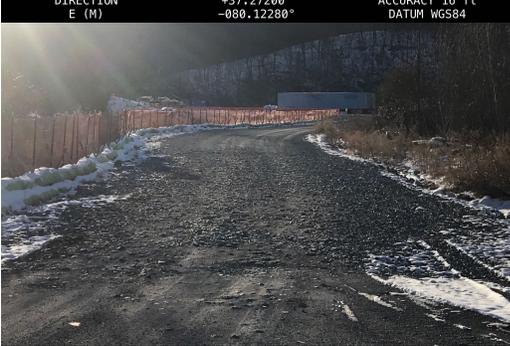
<p>DIRECTION E (M) +37.27200° -080.12280° ACCURACY 16 ft DATUM WGS84</p> <p>MVP-LY-049_020321 Condition of rock entrance 2021-02-03 08:30:20-05:00</p>

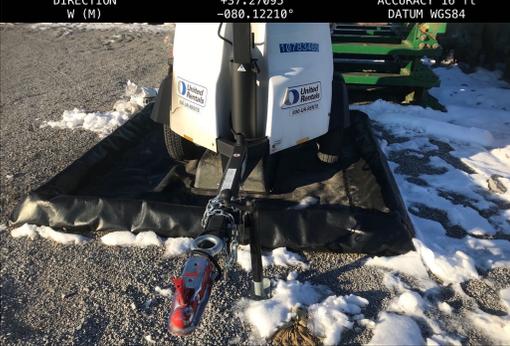
<p>DIRECTION W (M) +37.27095° -080.12210° ACCURACY 16 ft DATUM WGS84</p> <p>MVP-LY-049_020321 Condition of containment 2021-02-03 08:32:09-05:00</p>			
GPS Location MVP-LY-049 See photo for gps data		GPS Location MVP-LY-049 See photo for gps data			
Field Station# +0		Field Station# +0			
Pic 1 Desc. Condition of rock entrance on center drive. No sediment on stone. Looking SE.		Pic 2 Desc. Condition of containment under light plant. Free of snow. Looking W.

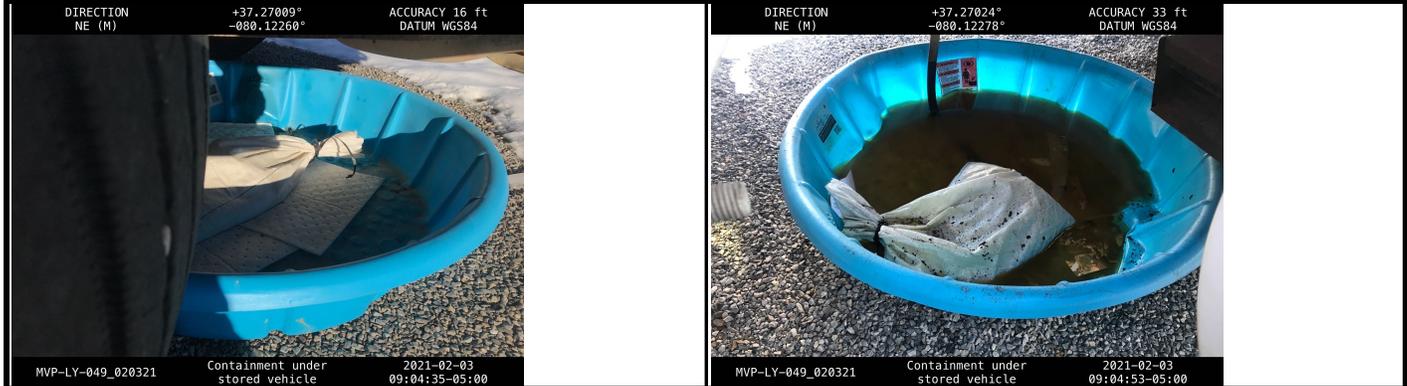
GPS Location MVP-LY-049 See photo for gps data	GPS Location MVP-LY-049 See photo for gps data
Field Station# +0	Field Station# +0
Pic 7 Desc. Condition of containment under stored vehicle. Looking NE.	Pic 8 Desc. Condition of containment under stored vehicle. Looking NE.

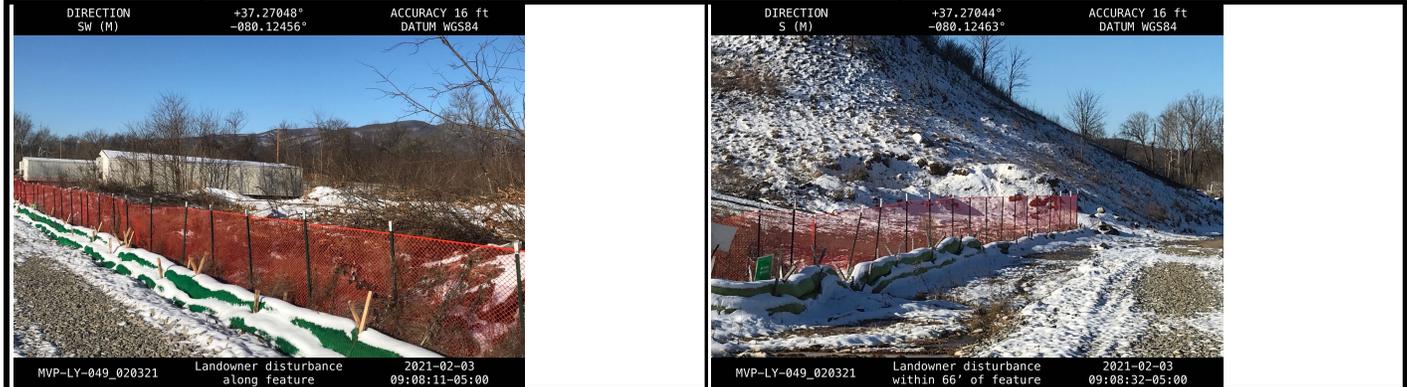
GPS Location MVP-LY-049 See photo for gps data	GPS Location MVP-LY-049 See photo for gps data
Field Station# +0	Field Station# +0
Pic 9 Desc. Landowner soil disturbance along north edge of feature W-CV21A. Looking NW.	Pic 10 Desc. Landowner disturbance within 66' and 120' west of feature W-CV21B. Areas not stabilized. No impacts. Looking W.

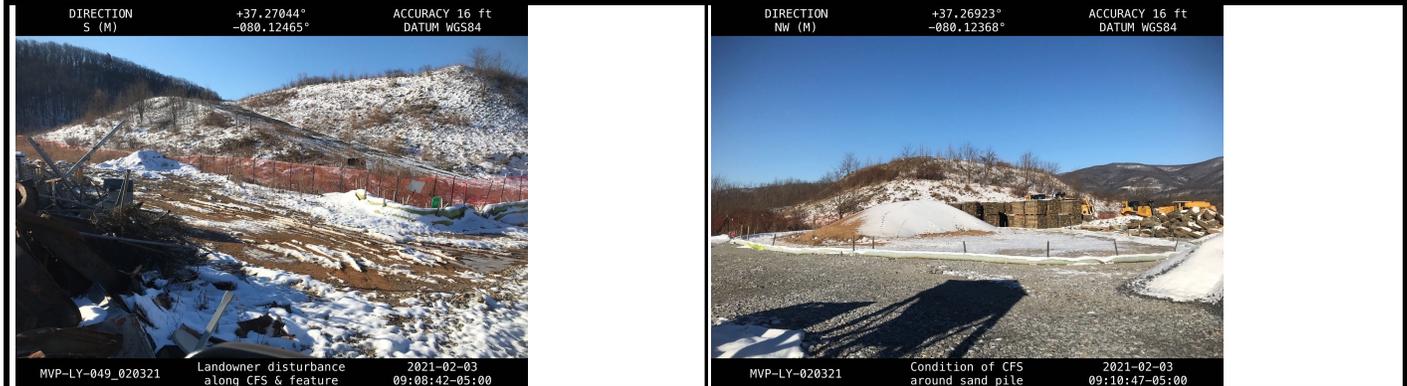
GPS Location MVP-LY-049 See photo for gps data	GPS Location MVP-LY-049 See photo for gps data
Field Station# +0	Field Station# +0
Pic 11 Desc. Landowner disturbance along CFS and feature W-CV21B. Area not stabilized. No impacts to feature. Looking S.	Pic 12 Desc. Condition of compost filter sock around sand pile. Looking NW.

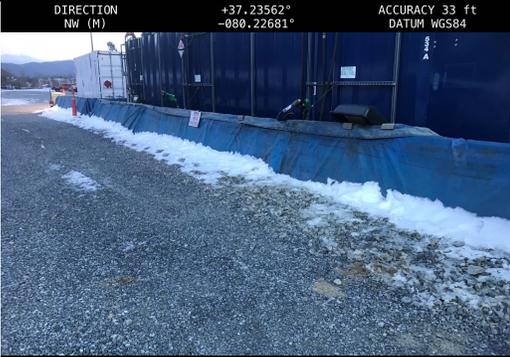
<p>DIRECTION NW (M) +37.23562° -080.22681° ACCURACY 33 ft DATUM WGS84</p> <p>MVP-PY-006_020321 No fuel spills south of tanks 2021-02-03 07:26:15-05:00</p>

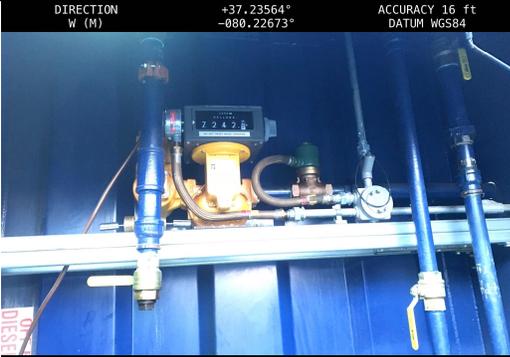
<p>DIRECTION W (M) +37.23564° -080.22673° ACCURACY 16 ft DATUM WGS84</p> <p>MVP-PY-006_020321 No leaky internal fittings 2021-02-03 07:27:23-05:00</p>

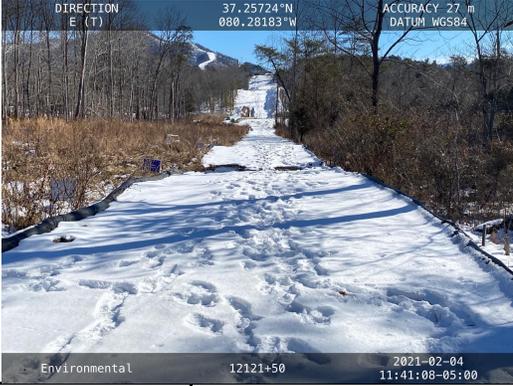
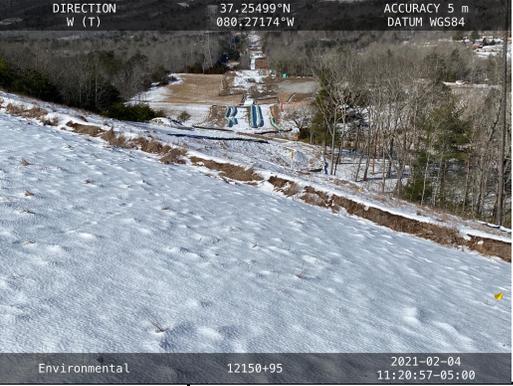
GPS Location	See photo	GPS Location	See photo
Field Station#	12121+50	Field Station#	12150+95
Pic 7 Desc.	Bridge and ECDs crossing multiple streams and wetlands covered with snow and ice	Pic 8 Desc.	Stabilized ROW covered with snow and ice

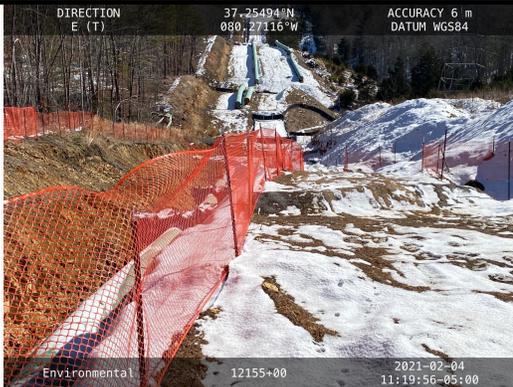
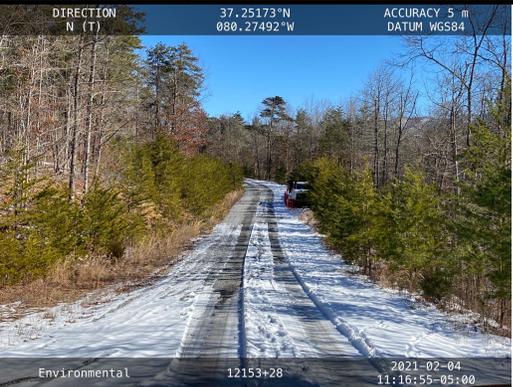
GPS Location	See photo	GPS Location	See photo
Field Station#	12155+00	Field Station#	12153+28
Pic 9 Desc.	Stabilized ROW with a thin layer of ice and snow coverage	Pic 10 Desc.	Access Road MVP-MN-273 in acceptable condition

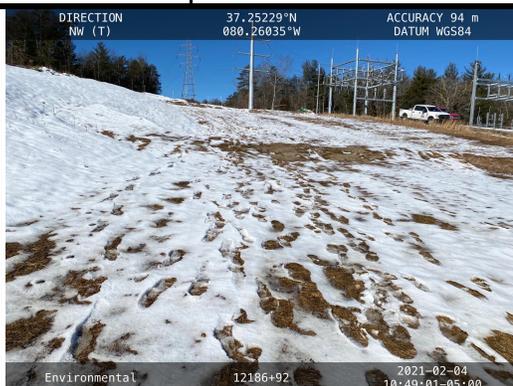
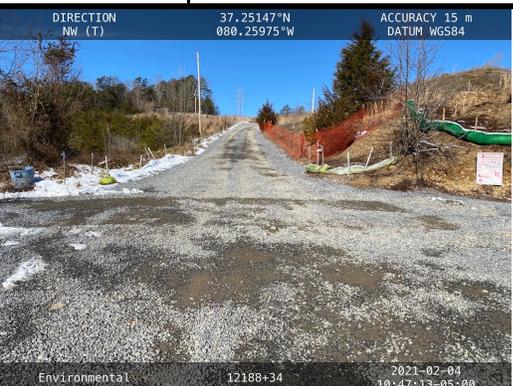
GPS Location	See photo	GPS Location	See photo
Field Station#	12186+92	Field Station#	12188+34
Pic 11 Desc.	Stabilized ROW with thin layer of ice and snow	Pic 12 Desc.	Access Road MVP-MN-274 in acceptable condition

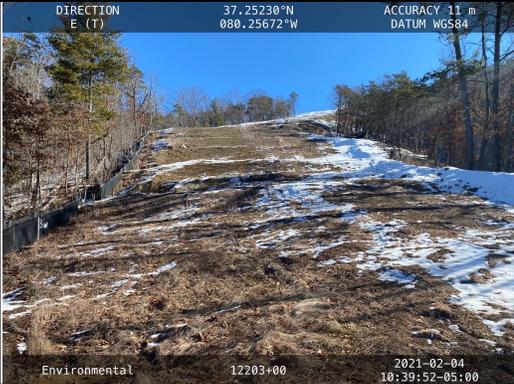
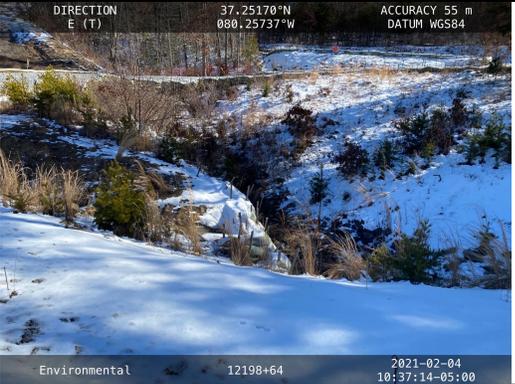
GPS Location	See photo	GPS Location	See photo
Field Station#	12203+00	Field Station#	12198+64
Pic 13 Desc.	Stabilized ROW in acceptable condition	Pic 14 Desc.	S-OO11 on the East side of the railroad tracks in acceptable condition

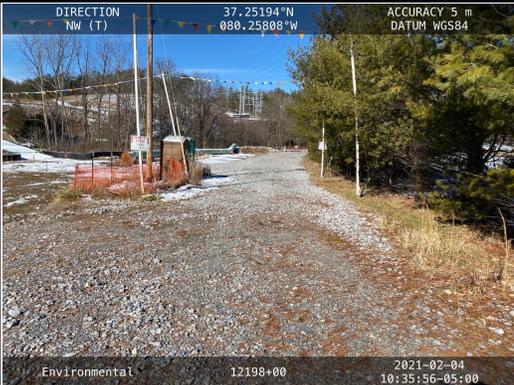
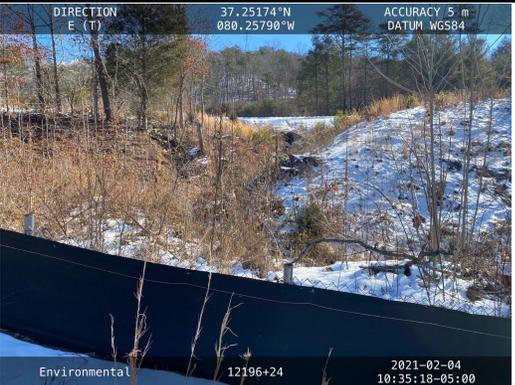
GPS Location	See photo	GPS Location	See photo
Field Station#	12198+00	Field Station#	12196+24
Pic 15 Desc.	Access Road MVP-MN-275 in acceptable condition	Pic 16 Desc.	S-OO11 on the West side of the railroad tracks in acceptable condition

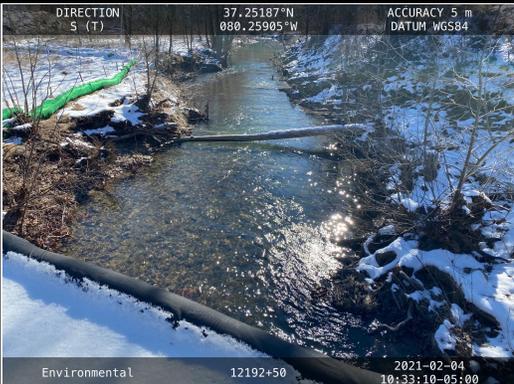
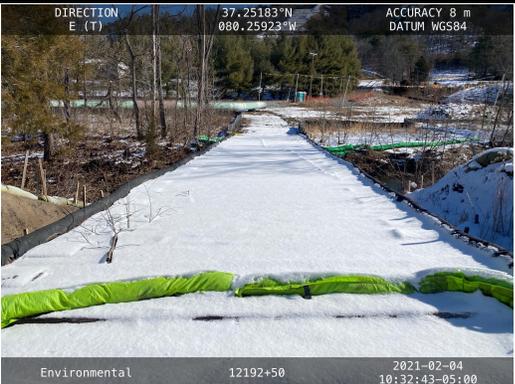
GPS Location	See photo	GPS Location	See photo
Field Station#	12192+50	Field Station#	12192+50
Pic 17 Desc.	S-C21 down stream with no signs of impact	Pic 18 Desc.	Bridge and ECDs crossing S-C21 in acceptable condition

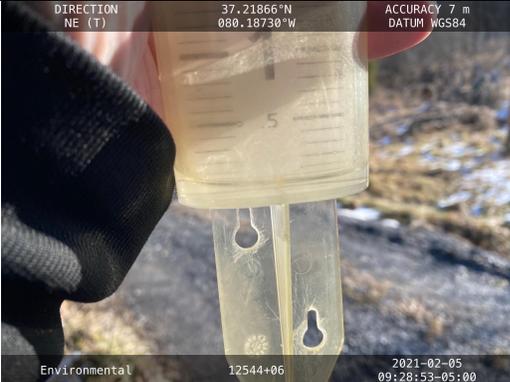
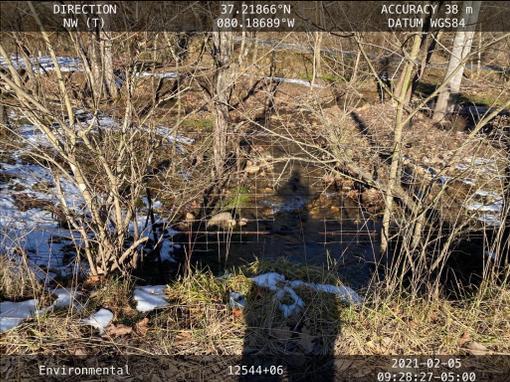
GPS Location	See photo		GPS Location	See photo	
Field Station#	12544+06		Field Station#	12544+06	
Pic 1 Desc.	Yellow finch rain gauge accumulation with 0.1"		Pic 2 Desc.	S-KL32 Down stream from yellow finch in acceptable condition

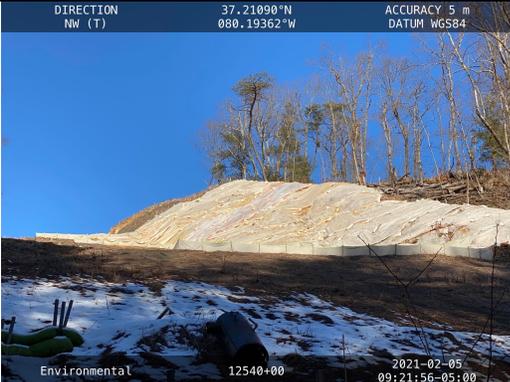
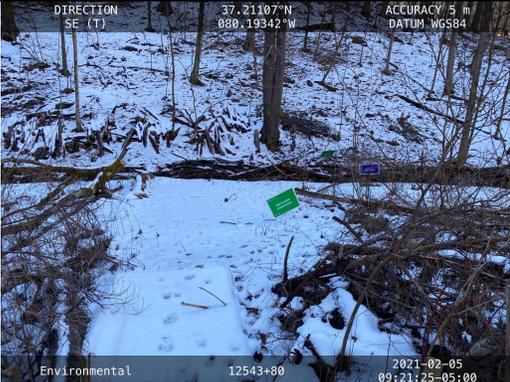
GPS Location	See photo		GPS Location	See photo	
Field Station#	12540+00		Field Station#	12543+80	
Pic 3 Desc.	Plastic used for stabilization in acceptable condition		Pic 4 Desc.	S-EF20a crossing in acceptable condition with no signs of impact

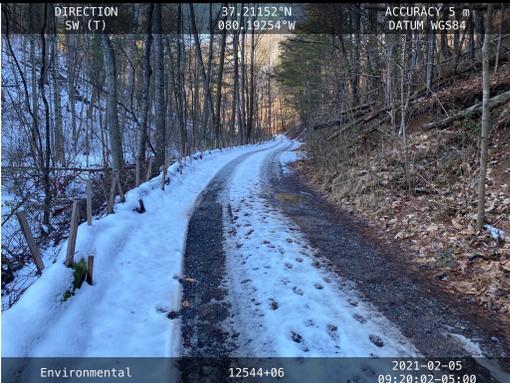
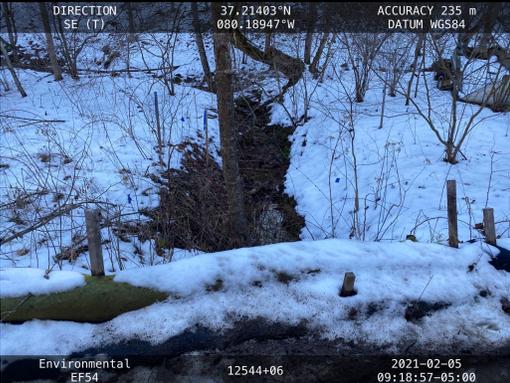
GPS Location	See photo		GPS Location	See photo	
Field Station#	12544+06		Field Station#	12544+06	
Pic 5 Desc.	Yellow finch road in acceptable condition with thin layer of snow		Pic 6 Desc.	S-EF54 down stream in acceptable condition with no signs of impact

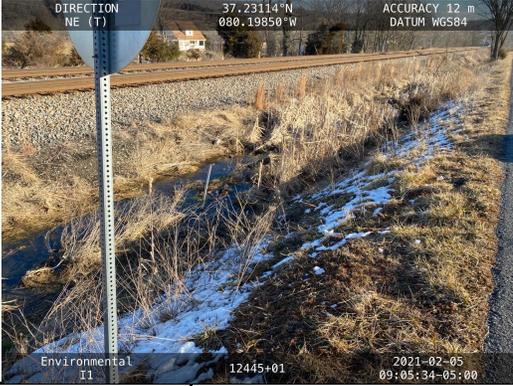
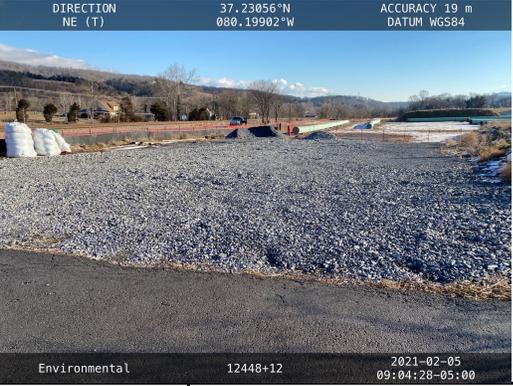
GPS Location	See photo	GPS Location	See photo		
Field Station#	12445+01	Field Station#	12448+12		
Pic 7 Desc.	S-11 crossing in acceptable condition with no sign of impact	Pic 8 Desc.	RCE in acceptable condition

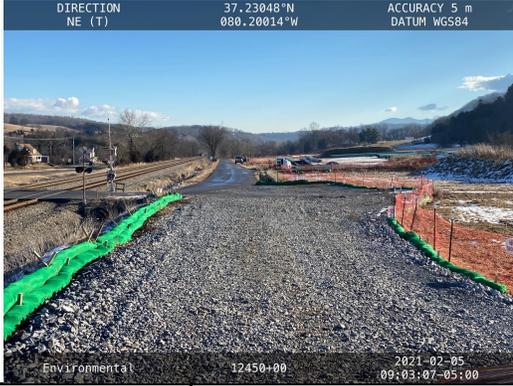
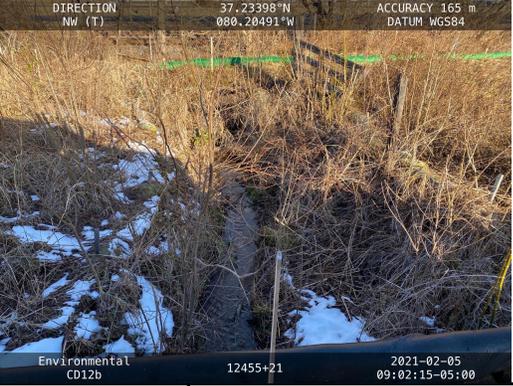
GPS Location	See photo	GPS Location	See photo		
Field Station#	12450+00	Field Station#	12455+21		
Pic 9 Desc.	RCE in acceptable condition	Pic 10 Desc.	S-CD12b down stream with no signs of impact

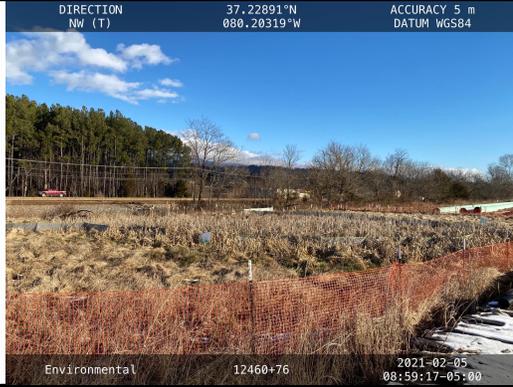
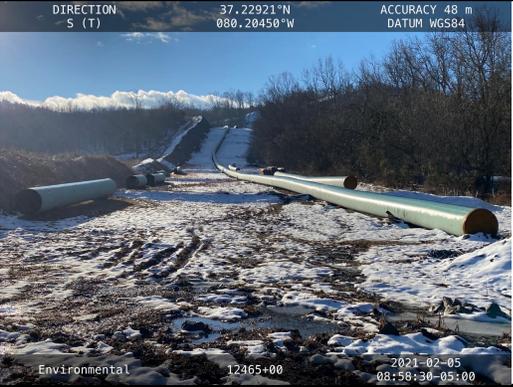
GPS Location	See photo	GPS Location	See photo		
Field Station#	12460+76	Field Station#	12465+00		
Pic 11 Desc.	Wetland W-KL58 in acceptable condition	Pic 12 Desc.	Stabilized ROW in acceptable condition with thin layer of snow
