# Visual Site Inspection Report

<b>Project Name</b> H-600 Pipeline Spread H		<b>AFE</b> 124300138	<b>Spread</b> H-600 Pipeline Spread H
<b>Contractor</b> Precision		<b>Report #</b> 20563	
<b>Inspector</b> John Brcic		<b>Date/Time</b> 3/1/2021 1:48 PM	
<b>Permit #</b> TBD	<b>Inspection Type</b> VA SWPP	<b>Station Begin</b> 12443+75	
<b>State</b> VA	<b>Inspection Area</b> Partial	<b>Station End</b> 12544+06	
<b>County</b> Montgomery	<b>Ground</b> Wet	<b>Temperature (°F)</b> 50.00	
<b>Municipality</b> N/A	<b>Weather</b> Light Rain	<b>Rain Gauge (in)</b> 1.20	
<b>Rain Accumulation Time (days)</b>			3.00

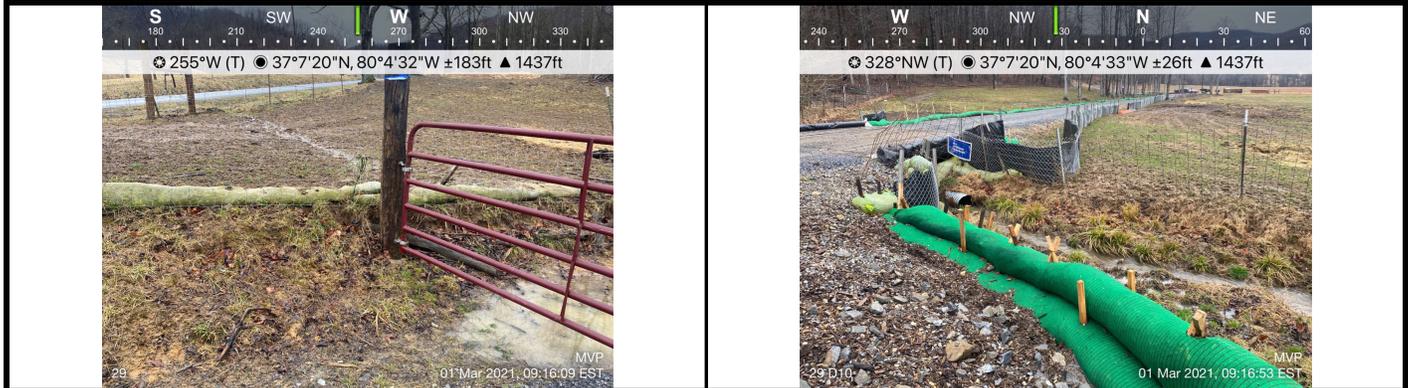
<b>Pic 1 Desc.</b>	MVP-FR-292, RCE and access road in acceptable condition.	<b>Pic 2 Desc.</b>	No waterbar flowing out of S-D14 across MVP-FR-292.
--------------------	--	--------------------	---

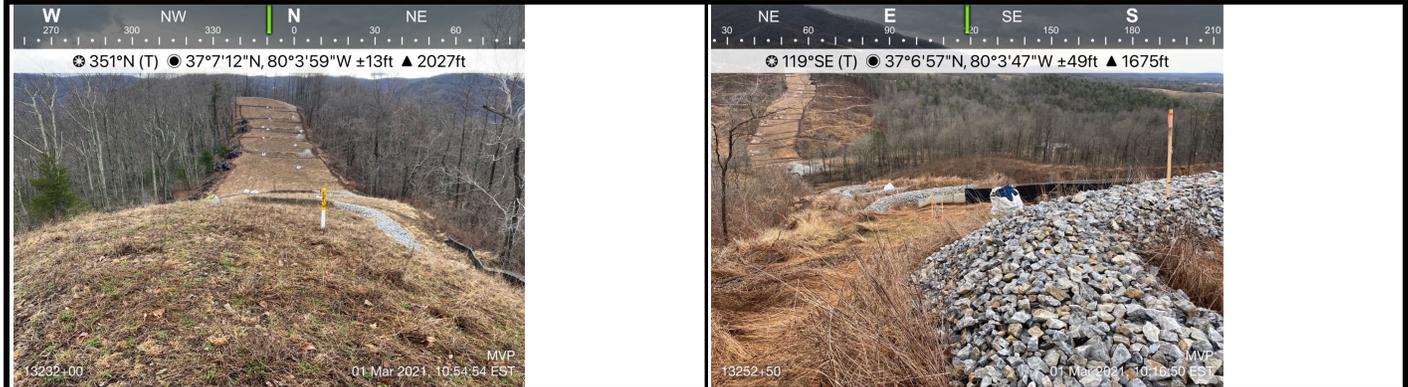
<b>GPS Location</b>	See photo for coordinates.	<b>GPS Location</b>	See photo for coordinates.
<b>Field Station#</b>	13232+00	<b>Field Station#</b>	13252+50
<b>Pic 9 Desc.</b>	ROW stable, no issues noted with level spreaders or permanent waterbar berms, mostly dead or dormant vegetation noted.	<b>Pic 10 Desc.</b>	ROW stable, no issues noted with level spreaders or permanent waterbar berms, P1 silt fence slowly accumulating sediment.

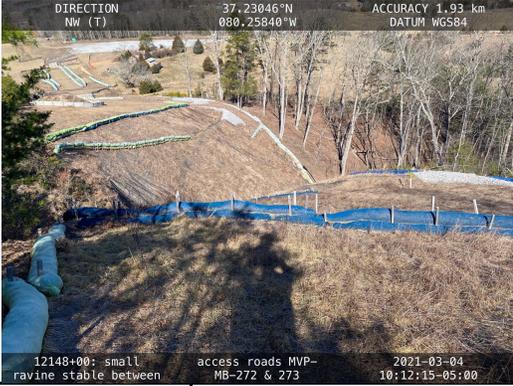
<p>DIRECTION NW (T) 37.23046°N 080.25840°W ACCURACY 1.93 km DATUM WGS84</p> <p>12148+00: small ravine stable between access roads MVP-MN-272 &amp; 273 2021-03-04 10:12:15-05:00</p>

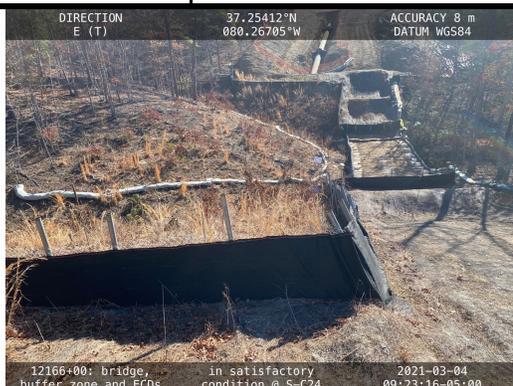
<p>DIRECTION E (T) 37.25412°N 080.26705°W ACCURACY 8 m DATUM WGS84</p> <p>12166+00: bridge, buffer zone and ECDs in satisfactory condition @ S-C24 2021-03-04 09:23:16-05:00</p>

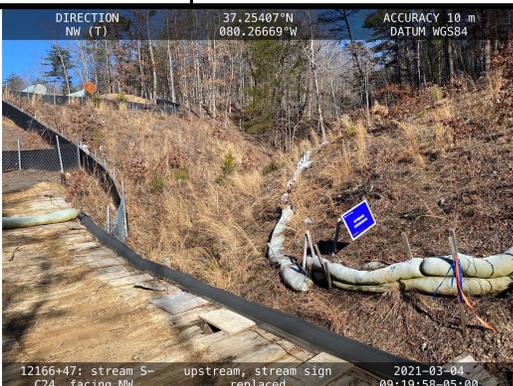
<p>DIRECTION NW (T) 37.25407°N 080.26669°W ACCURACY 10 m DATUM WGS84</p> <p>12166+47: stream S-C24, facing NW, upstream, stream sign replaced 2021-03-04 09:19:58-05:00</p>	
<b>GPS Location</b>	See photo	<b>GPS Location</b>	See photo
<b>Field Station#</b>	12166+00	<b>Field Station#</b>	12166+47
<b>Pic 11 Desc.</b>	Bridge, buffer zone and ECDs in satisfactory condition at stream S-C24.	<b>Pic 12 Desc.</b>	Stream S-C24, facing northwest, upstream. One stream sign replaced.

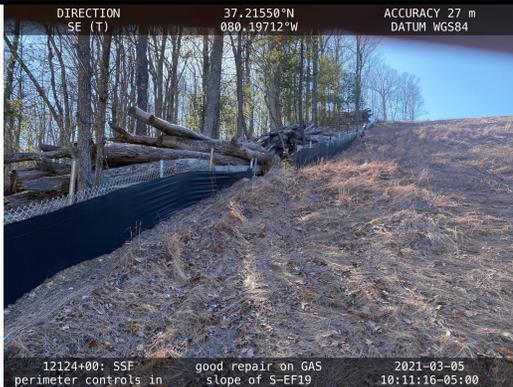
<p>DIRECTION SE (T) 37.21550°N 080.19712°W ACCURACY 27 m DATUM WGS84 12124+00: SSF perimeter controls in good repair on GAS slope of S-EF19 2021-03-05 10:11:16-05:00</p>
