# Visual Site Inspection Report

<b>Project Name</b> H-600 Pipeline Spread H		<b>AFE</b> 124300138	<b>Spread</b> H-600 Pipeline Spread H
<b>Contractor</b> Precision		<b>Report #</b> 21095	
<b>Inspector</b> John Brcic		<b>Date/Time</b> 3/15/2021 12:34 PM	
<b>Permit #</b> TBD	<b>Inspection Type</b> VA SWPP	<b>Station Begin</b> 12284+75	
<b>State</b> VA	<b>Inspection Area</b> Partial	<b>Station End</b> 12443+75	
<b>County</b> Montgomery	<b>Ground</b> Dry	<b>Temperature (°F)</b> 48.00	
<b>Municipality</b> N/A	<b>Weather</b> Cloudy	<b>Rain Gauge (in)</b> 0.00	
<b>Rain Accumulation Time (days)</b>			3.00

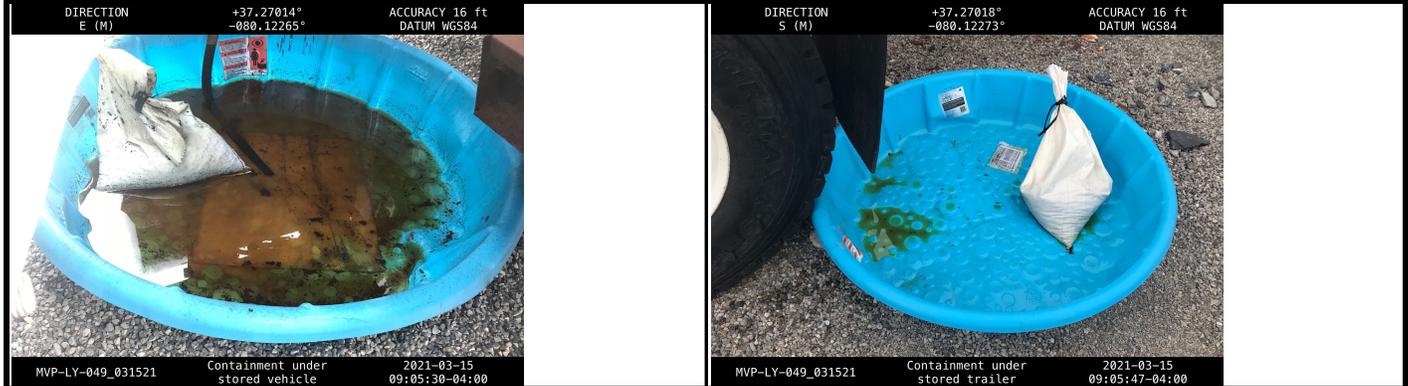
<b>Pic 7 Desc.</b> Condition of containment under stored vehicle. Looking E.	<b>Pic 8 Desc.</b> Condition of containment under stored trailer. Looking S.
--	--

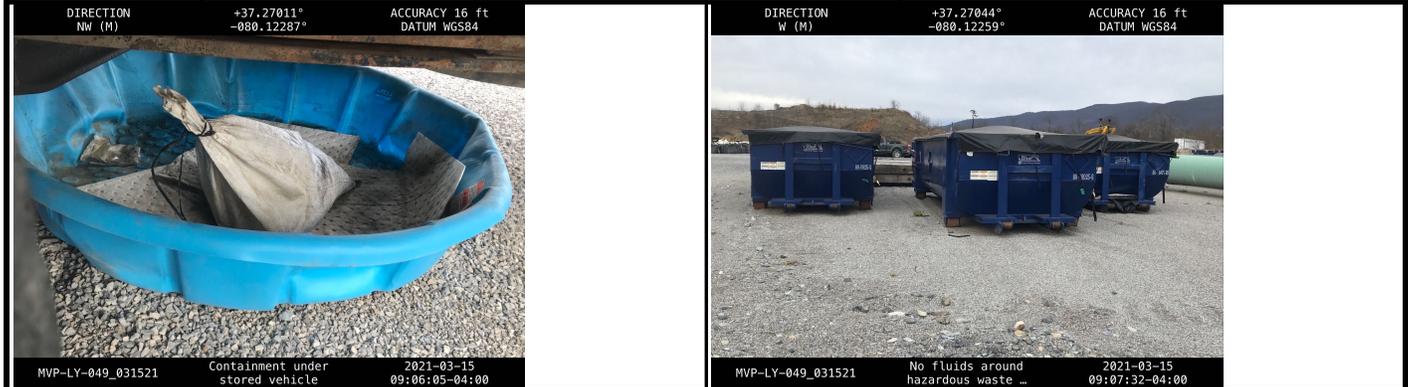
<b>Pic 9 Desc.</b> Condition of containment under stored vehicle. Looking NW.	<b>Pic 10 Desc.</b> No fluids or deposits around hazardous waste dumpsters. Looking W.
---	--

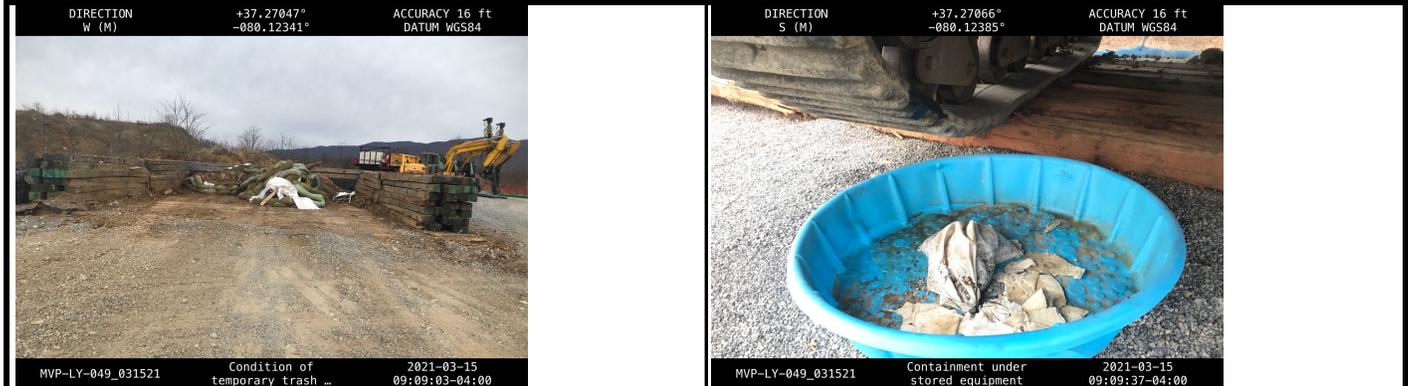
<b>Pic 11 Desc.</b> Condition of temporary trash transfer pit. Trash inside of boundary pit. Looking W.	<b>Pic 12 Desc.</b> Condition of containment under stored equipment. Looking S.
---	---

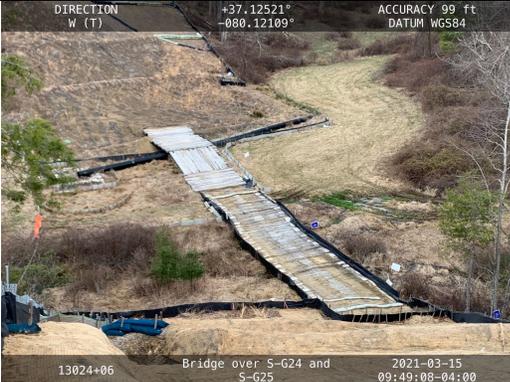
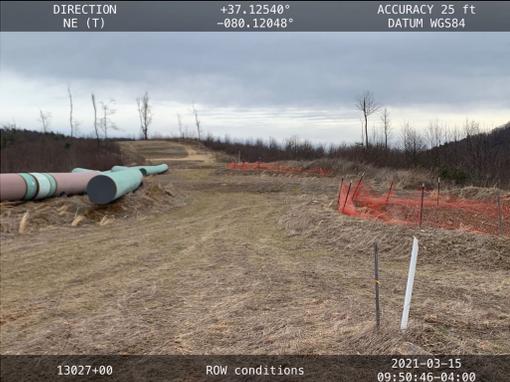
<b>GPS Location</b>	See photo for gps location data.		<b>GPS Location</b>	See photo for gps location data.	
<b>Field Station#</b>	13024+06		<b>Field Station#</b>	13027+00	
<b>Pic 1 Desc.</b>	Photo shows the bridge over streams S-G24 and S-G25.		<b>Pic 2 Desc.</b>	Photo shows the ROW condition from about 13027+00 to 13030+00.

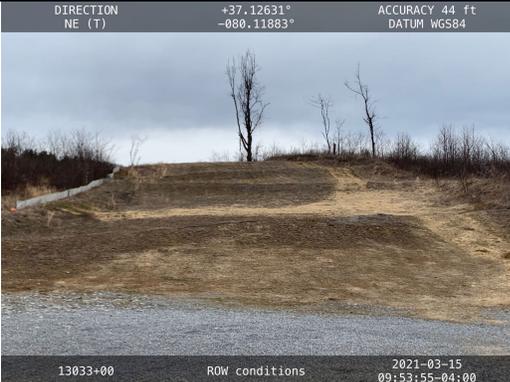
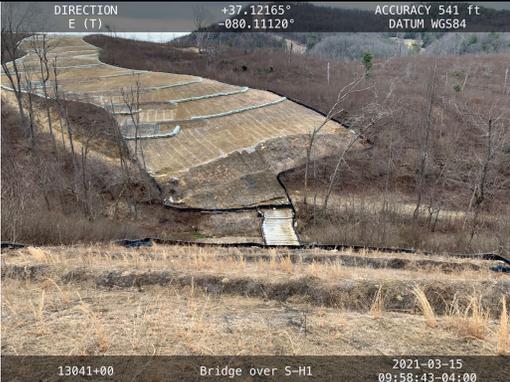
<b>GPS Location</b>	See photo for gps location data.		<b>GPS Location</b>	See photo for gps location data.	
<b>Field Station#</b>	13033+00		<b>Field Station#</b>	13041+00	
<b>Pic 3 Desc.</b>	Photo shows the ROW condition from about 13033+00 to 13036+00.		<b>Pic 4 Desc.</b>	Photo shows the bridge over stream S-H1.

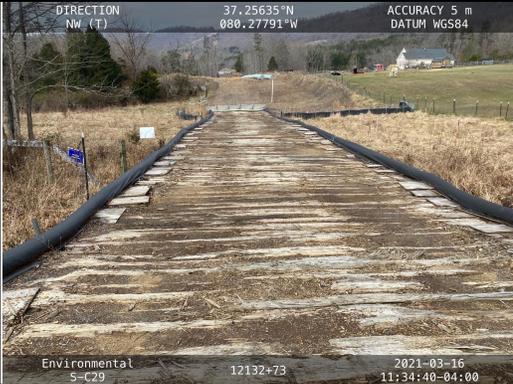
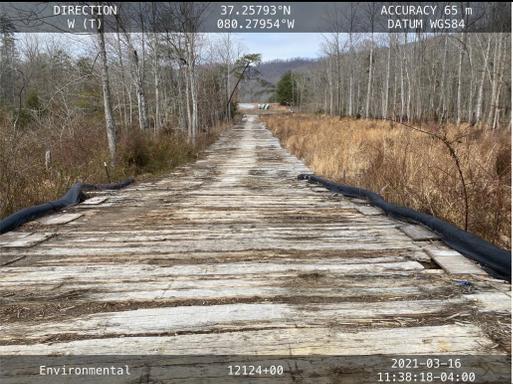
<b>GPS Location</b>	See photo	<b>GPS Location</b>	See photo
<b>Field Station#</b>	12132+73	<b>Field Station#</b>	12124+00
<b>Pic 13 Desc.</b>	Bridge and ECDs crossing stream S-C29 in acceptable condition	<b>Pic 14 Desc.</b>	Bridge and ECDs crossing multiple streams in acceptable condition

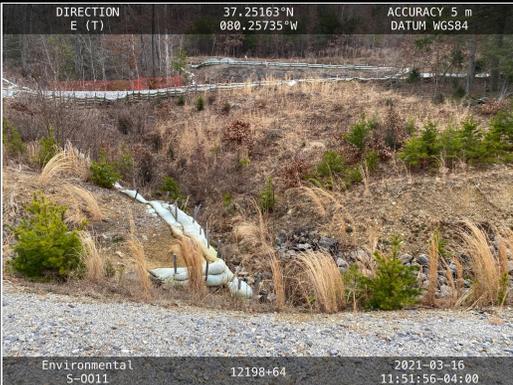
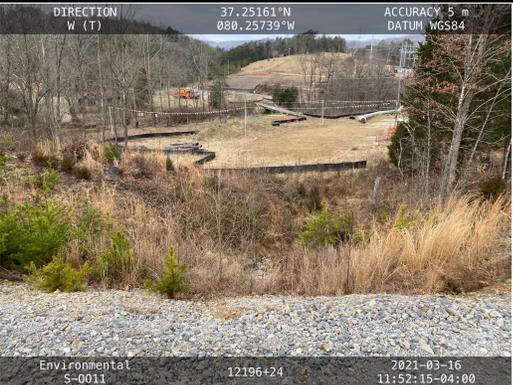
<b>GPS Location</b>	See photo	<b>GPS Location</b>	See photo
<b>Field Station#</b>	12198+64	<b>Field Station#</b>	12196+24
<b>Pic 15 Desc.</b>	Stream crossing S-0011 on the east side of the railroad tracks in acceptable condition	<b>Pic 16 Desc.</b>	Stream crossing S-0011 in acceptable condition

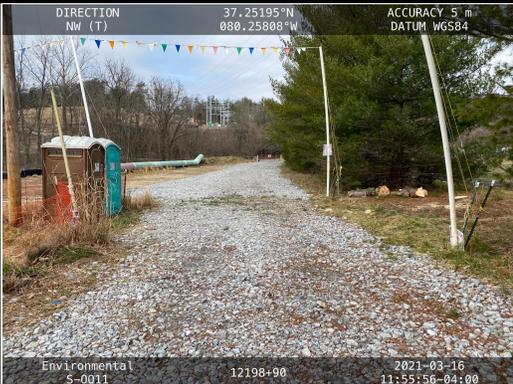
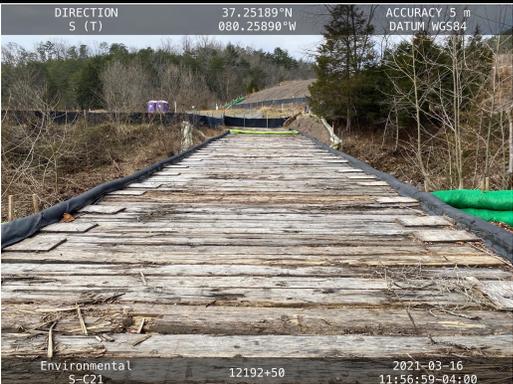
<b>GPS Location</b>	See photo	<b>GPS Location</b>	See photo
<b>Field Station#</b>	12198+90	<b>Field Station#</b>	12192+50
<b>Pic 17 Desc.</b>	Access Road MVP-MN-275 in acceptable condition	<b>Pic 18 Desc.</b>	Bridge and ECDs crossing stream S-C21 in acceptable condition

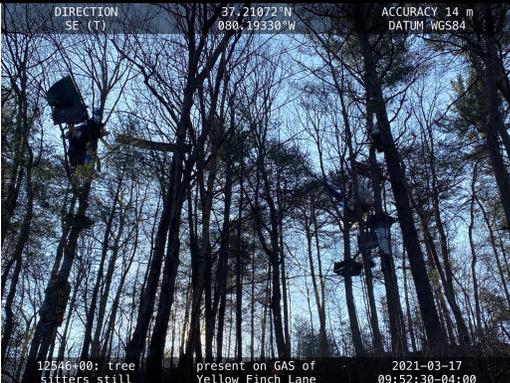
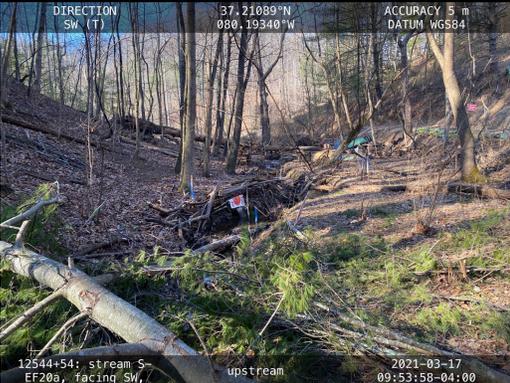
GPS Location		See photo		GPS Location	
Field Station#		12546+00		Field Station#	
Pic 5 Desc.		Tree sitters are still present in the tree stands on the going away side of Yellow Finch Lane.		Pic 6 Desc.

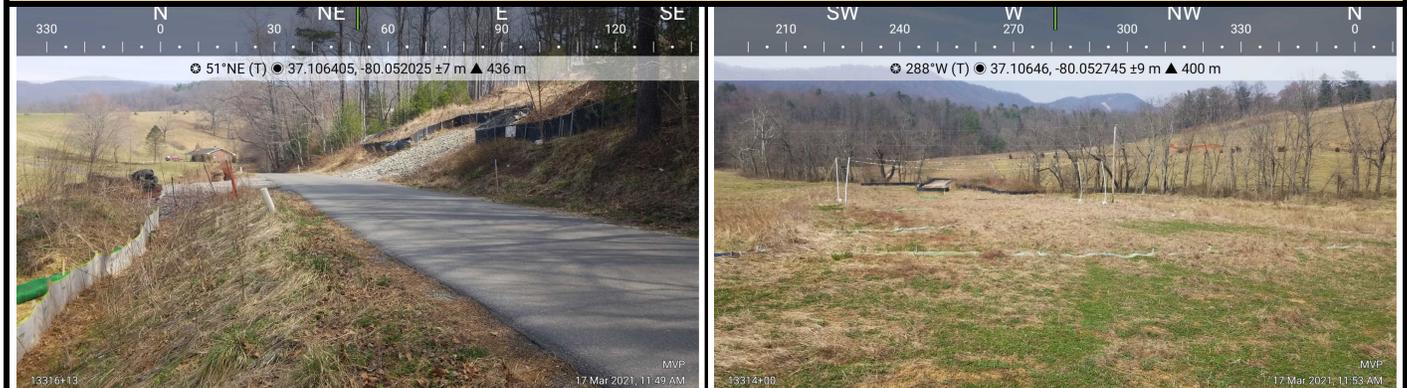
<b>GPS Location</b>	See photo for coordinates.	<b>GPS Location</b>	See photo for coordinates.
<b>Field Station#</b>	13316+13	<b>Field Station#</b>	13314+00
<b>Pic 1 Desc.</b>	Wades Gap road crossing, road clean, RCEs in acceptable condition.	<b>Pic 2 Desc.</b>	Vegetative cover noted across LOD.

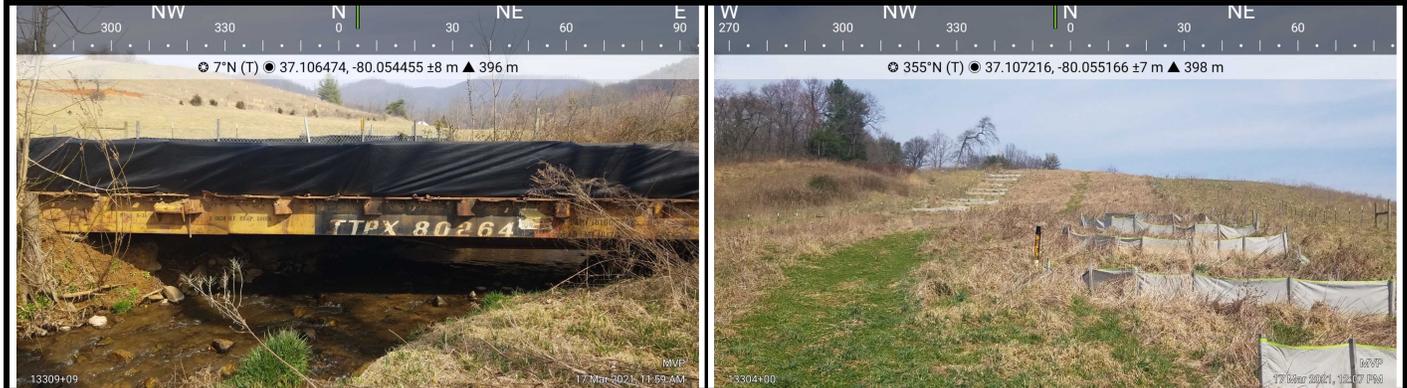
<b>GPS Location</b>	See photo for coordinates.	<b>GPS Location</b>	See photo for coordinates.
<b>Field Station#</b>	13309+09	<b>Field Station#</b>	13304+00
<b>Pic 3 Desc.</b>	S-GH7, downstream of equipment bridge, no changes noted at crossing, bridge in good condition.	<b>Pic 4 Desc.</b>	Vegetative cover noted across LOD, ATV trail evident.

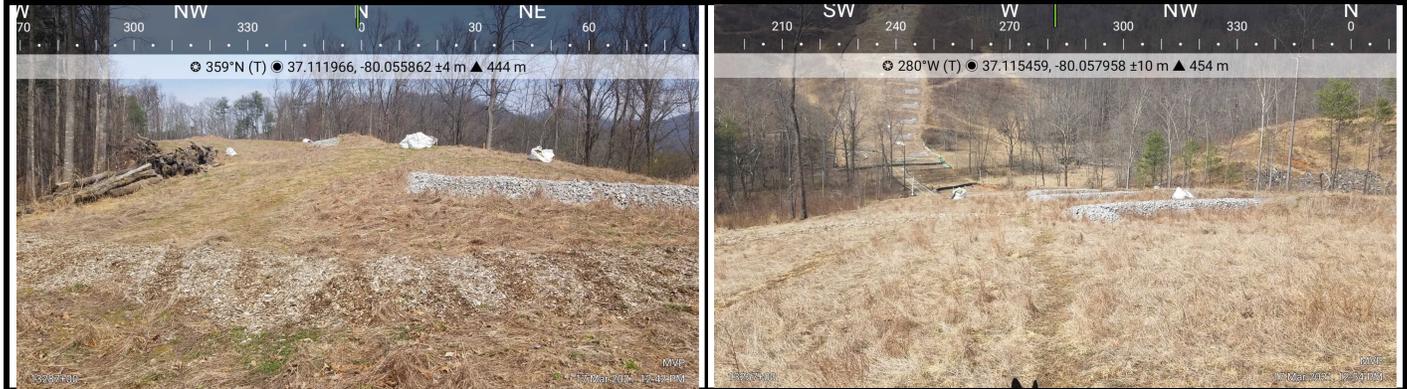
<b>GPS Location</b>	See photo for coordinates.	<b>GPS Location</b>	See photo for coordinates.
<b>Field Station#</b>	13287+00	<b>Field Station#</b>	13267+00
<b>Pic 5 Desc.</b>	ROW stable with vegetative cover noted across LOD.	<b>Pic 6 Desc.</b>	ROW stable with vegetative cover noted across LOD.

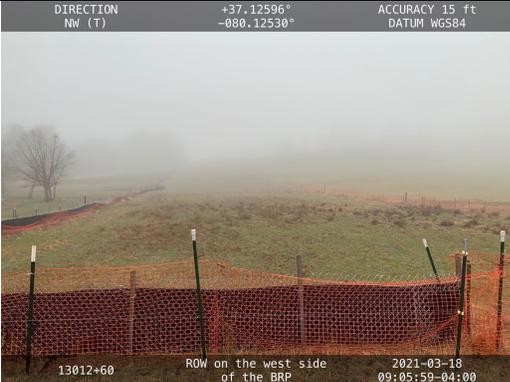
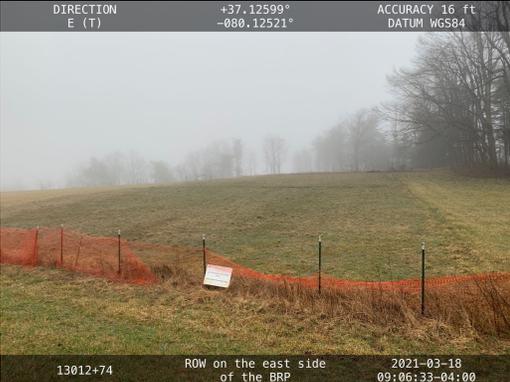
<b>GPS Location</b>	See photo for gps location data.		<b>GPS Location</b>	See photo for gps location data.	
<b>Field Station#</b>	13012+60		<b>Field Station#</b>	13012+74	
<b>Pic 1 Desc.</b>	Photo shows the ROW condition from on the west side of the BRP.		<b>Pic 2 Desc.</b>	Photo shows the ROW condition on the east side of the BRP.

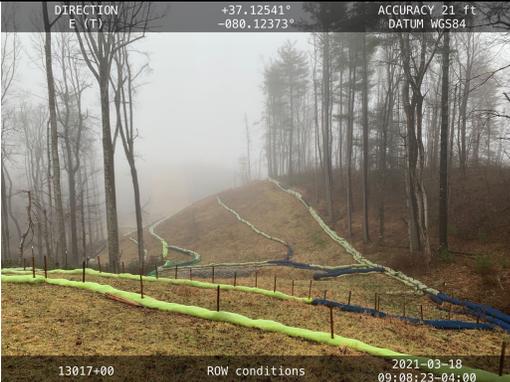
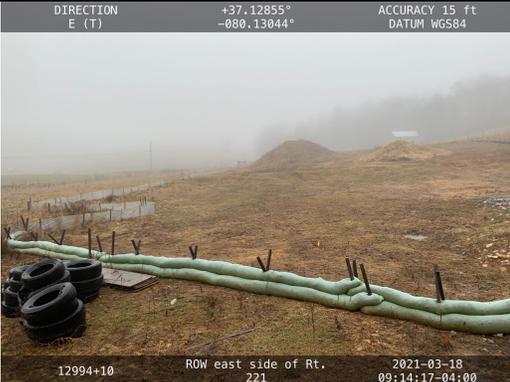
<b>GPS Location</b>	See photo for gps location data.		<b>GPS Location</b>	See photo for gps location data.	
<b>Field Station#</b>	13017+00		<b>Field Station#</b>	12994+10	
<b>Pic 3 Desc.</b>	Photo shows the ROW condition from about 13017+00 to 13021+00.		<b>Pic 4 Desc.</b>	Photo shows the ROW condition on the east side of Rt. 221.

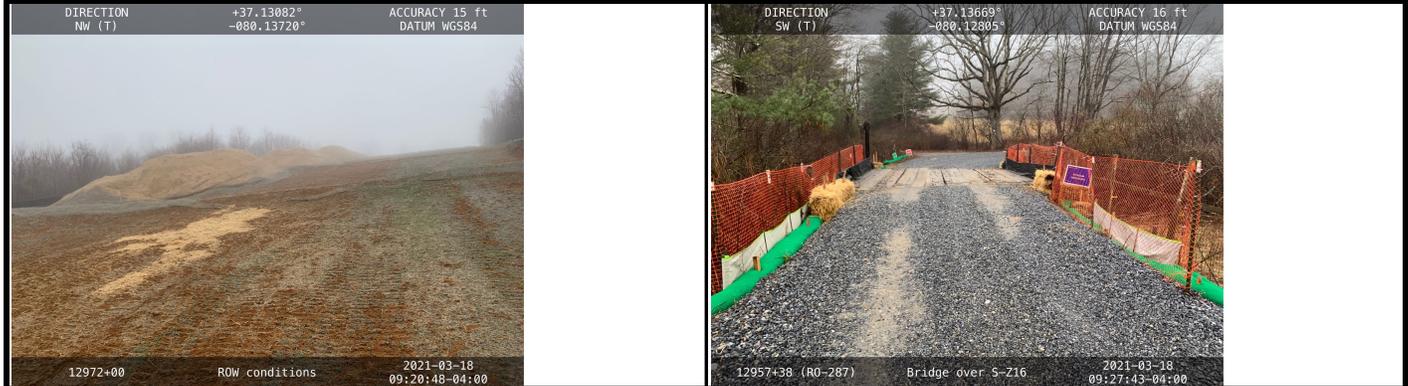
<b>GPS Location</b>	See photo for gps location data.	<b>GPS Location</b>	See photo for gps location data.
<b>Field Station#</b>	12972+00	<b>Field Station#</b>	12957+38
<b>Pic 7 Desc.</b>	Photo shows the ROW condition from about 12969+00 to 12972+00.	<b>Pic 8 Desc.</b>	Photo shows the bridge over stream S-Z16 on access road RO-287.

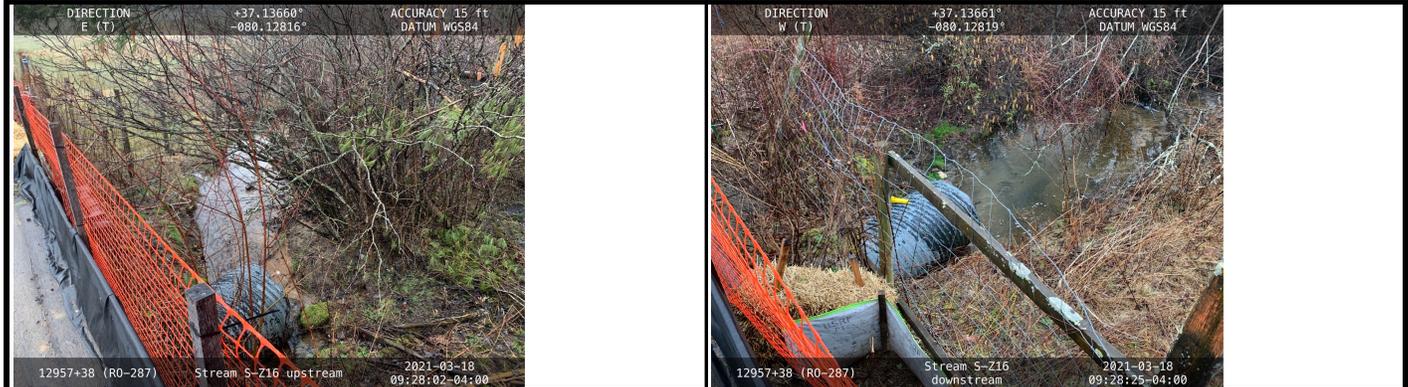
<b>GPS Location</b>	See photo for gps location data.	<b>GPS Location</b>	See photo for gps location data.
<b>Field Station#</b>	12957+38	<b>Field Station#</b>	12957+38
<b>Pic 9 Desc.</b>	Photo shows stream S-Z16 upstream of access road RO-287.	<b>Pic 10 Desc.</b>	Photo shows stream S-Z16 downstream of RO-287.

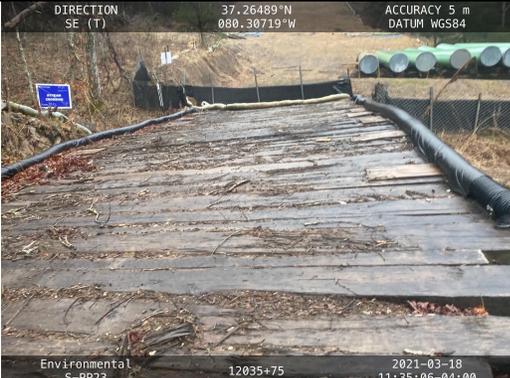
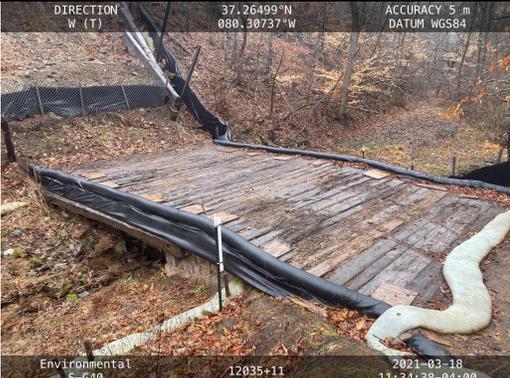
<b>GPS Location</b>	See photo	<b>GPS Location</b>	See photo		
<b>Field Station#</b>	12035+75	<b>Field Station#</b>	12035+11		
<b>Pic 3 Desc.</b>	S-PP23 bridge and ECDs in acceptable condition	<b>Pic 4 Desc.</b>	Bridge and ECDs at stream crossing S-G40 in acceptable condition

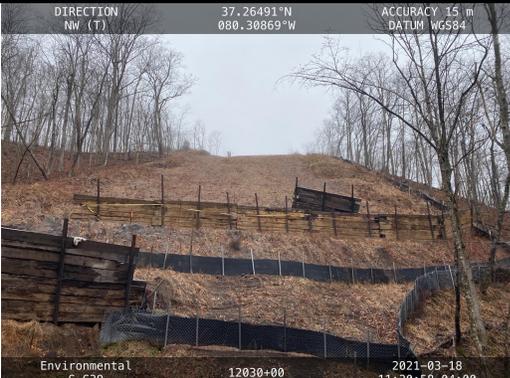
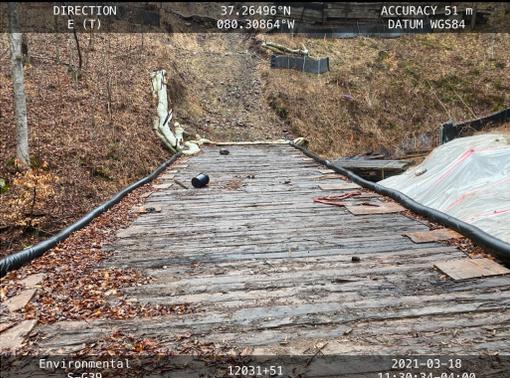
<b>GPS Location</b>	See photo	<b>GPS Location</b>	See photo		
<b>Field Station#</b>	12030+00	<b>Field Station#</b>	12031+51		
<b>Pic 5 Desc.</b>	Stabilized slope in acceptable condition	<b>Pic 6 Desc.</b>	Bridge and ECDs at stream crossing S-G39 in acceptable condition

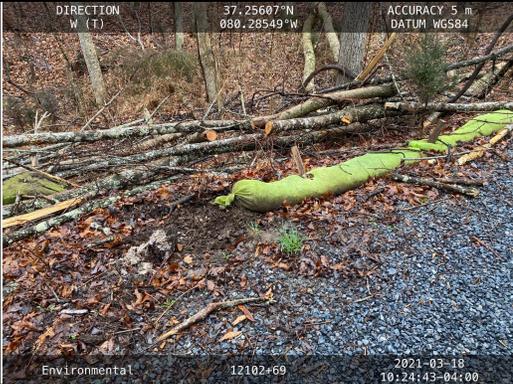
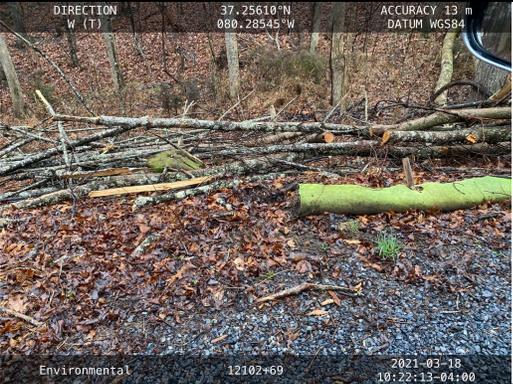
<p>DIRECTION W (T) 37.25610°N 080.28545°W ACCURACY 13 m DATUM WGS84 Environmental 12102+69 2021-03-18 10:22:13-04:00</p>			
<b>GPS Location</b>	See photo		<b>GPS Location</b>	See photo	
<b>Field Station#</b>	12102+69		<b>Field Station#</b>	12102+69	
<b>Pic 13 Desc.</b>	CFS along access road MVP-MN-270.01 damages repaired		<b>Pic 14 Desc.</b>	CFS along access road MVP-MN-270.01 needs repaired.

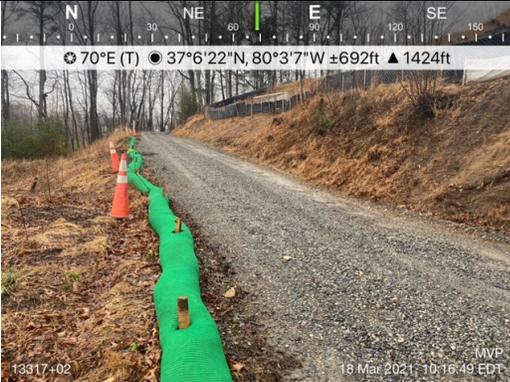
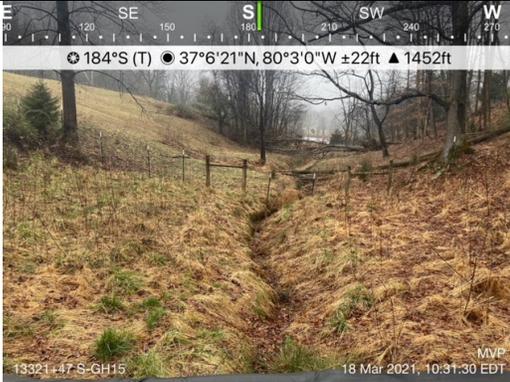
<b>GPS Location</b> See Above		<b>GPS Location</b> See Above			
<b>Field Station#</b> 13317+02		<b>Field Station#</b> 13321+47			
<b>Pic 1 Desc.</b> Overview of private road crossing ROW. ECDs are functional and ROW is stable.		<b>Pic 2 Desc.</b> Waterbody S-GH15 (downstream). ECDs are functional and ROW is stable.

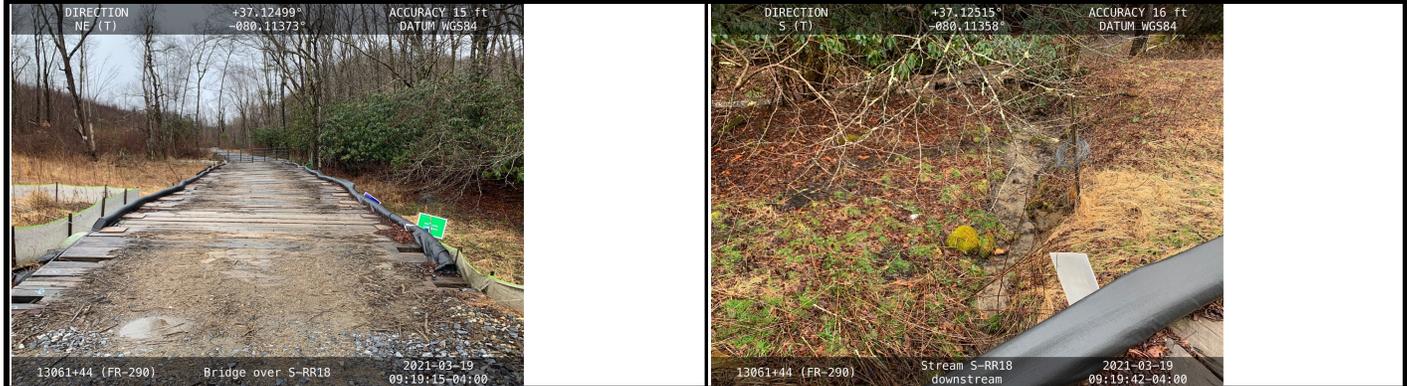
<b>GPS Location</b> See photo for gps location data.	<b>GPS Location</b> See photo for gps location data.
<b>Field Station#</b> 13061+44	<b>Field Station#</b> 13061+44
<b>Pic 7 Desc.</b> Photo shows the bridge over stream S-RR18 on FR-290.	<b>Pic 8 Desc.</b> Photo shows stream S-RR18 downstream from FR-290.

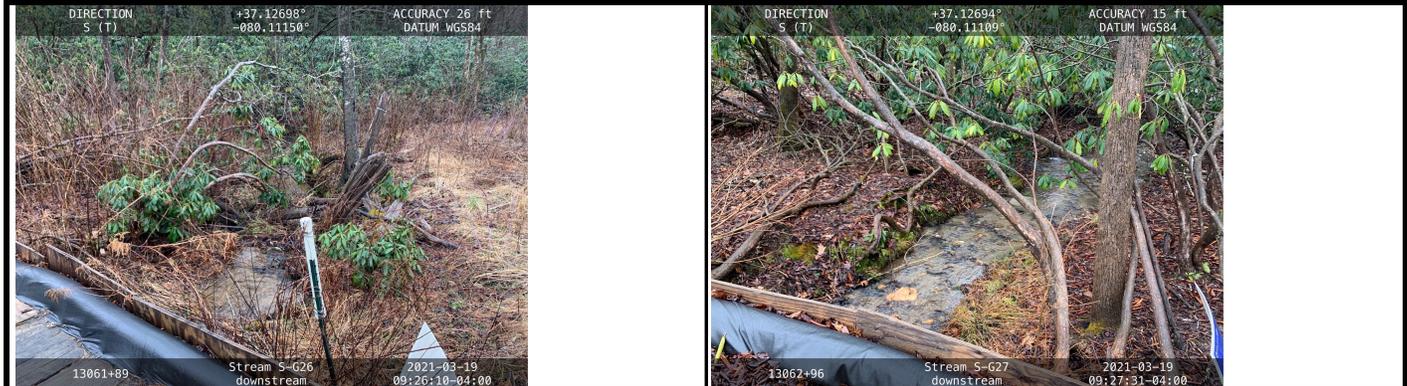
<b>GPS Location</b> See photo for gps location data.	<b>GPS Location</b> See photo for gps location data.
<b>Field Station#</b> 13061+89	<b>Field Station#</b> 13062+96
<b>Pic 11 Desc.</b> Photo shows stream S-G26 downstream from the ROW.	<b>Pic 12 Desc.</b> Photo shows stream S-G27 downstream from the ROW.
