Visual Site Inspection Report

Project Name	H-600 Pipeline Spread H	AFE	124300138	Spread	H-600 Pipeline Spread H
Contractor	Precision			Report #	20859
Inspector	John Brcic			Date/Time	3/8/2021 1:22 PM
Permit #	TBD	Inspection Type	VA SWPP	Station Begin	12005+00
State	VA	Inspection Area	Partial	Station End	12119+17
County	Montgomery	Ground	Dry	Temperature (°F)	55.00
Municipality	N/A	Weather	Sunny	Rain Gauge (in)	0.00
				Rain Accumulation Time (days)	1.00

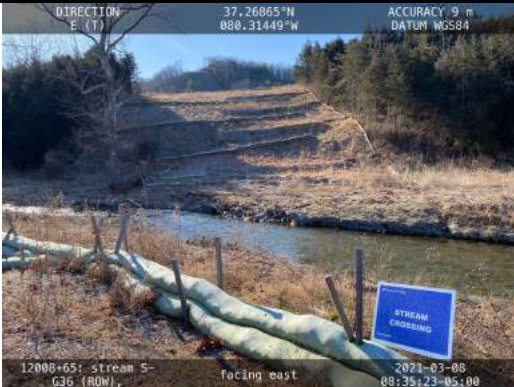
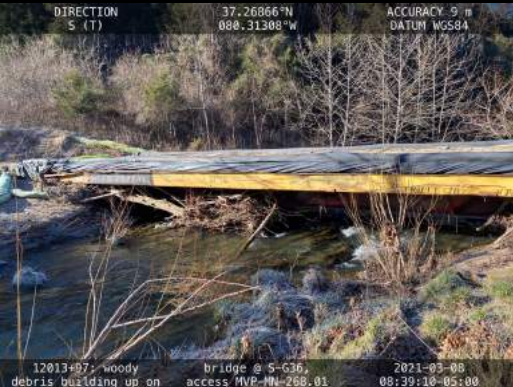
GPS Location	See photo		GPS Location	See photo	
Field Station#	12008+65		Field Station#	12013+97	
Pic 1 Desc.	Stream S-G36 (ROW), facing east		Pic 2 Desc.	Woody debris building up against upstream side of bridge at stream S-G36 on access road MVP-MN-268.01.

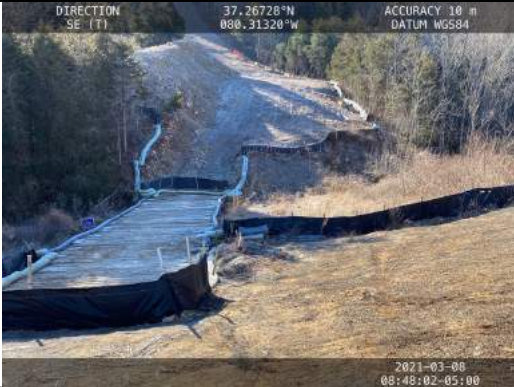
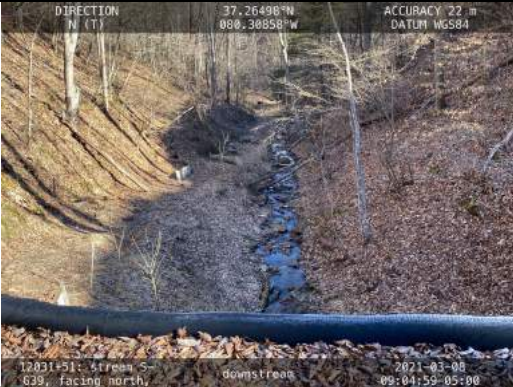
GPS Location	See photo		GPS Location	See photo	
Field Station#	12015+84		Field Station#	12031+51	
Pic 3 Desc.	Bridge, buffer zone and ECDs in satisfactory condition at stream S-G36.		Pic 4 Desc.	Stream S-G39, facing north, downstream

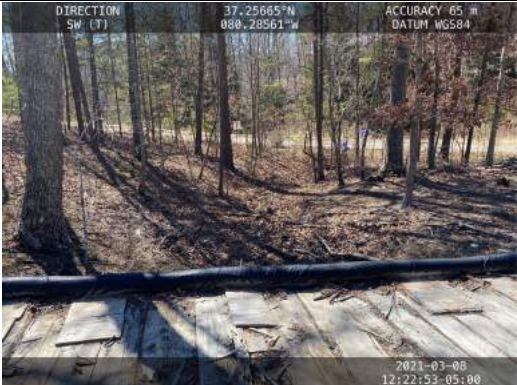
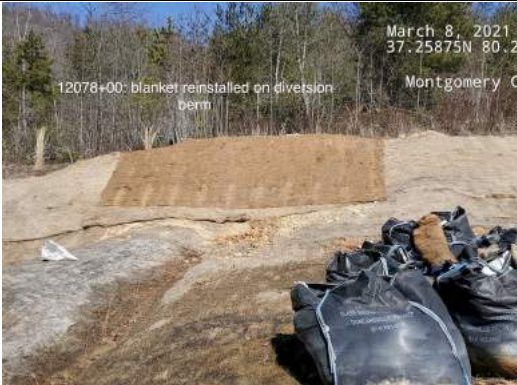
GPS Location	See photo		GPS Location	See photo	
Field Station#	12112+13		Field Station#	12078+00	
Pic 17 Desc.	Stream S-F16, facing southwest, downstream		Pic 18 Desc.	Blanket was reinstalled on this diversion berm where it had slipped down.

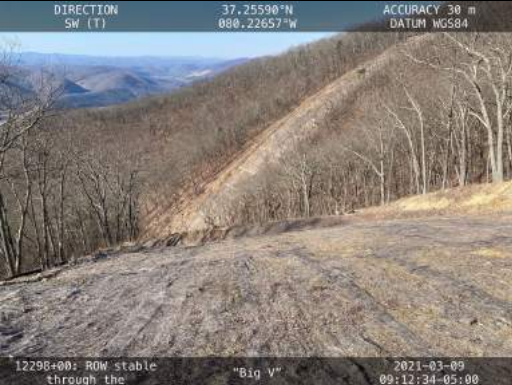
GPS Location	See photo		GPS Location	See photo	
Field Station#	12284+75		Field Station#	12298+00	
Pic 1 Desc.	ROW crossing on access road MVP-MN-276.03 in satisfactory condition.		Pic 2 Desc.	ROW stable through the "Big V".

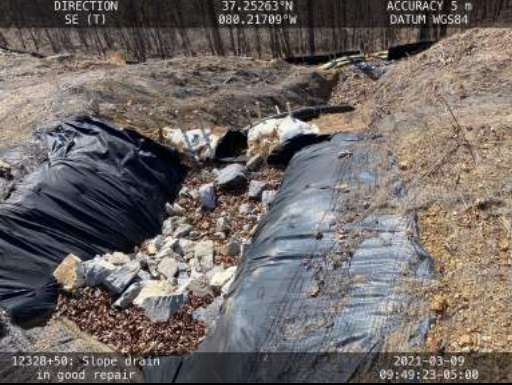
GPS Location	See photo		GPS Location	See photo	
Field Station#	12328+00		Field Station#	12328+50	
Pic 5 Desc.	ROW stable		Pic 6 Desc.	Slope drain in good repair.

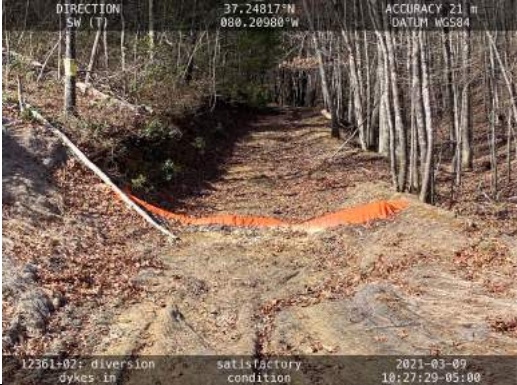
GPS Location	See photo		GPS Location	See photo	
Field Station#	12361+02		Field Station#	12374+16	
Pic 7 Desc.	Silt dyke on unused access road is in satisfactory condition.		Pic 8 Desc.	Stream S-0016, facing southwest, downstream

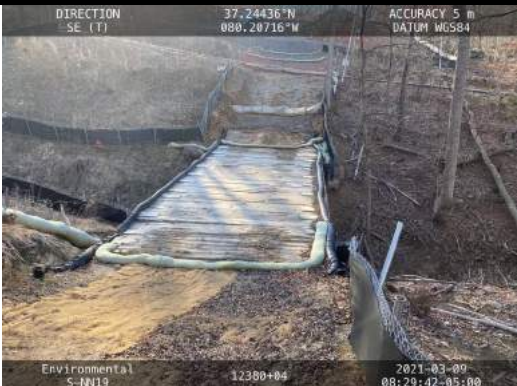
GPS Location	See photo		GPS Location	See photo	
Field Station#	12380+04		Field Station#	12380+04	
Pic 9 Desc.	Stream S-NN19, facing southwest, downstream		Pic 10 Desc.	Bridge, buffer zone and ECDs in satisfactory condition at stream S-NN19.

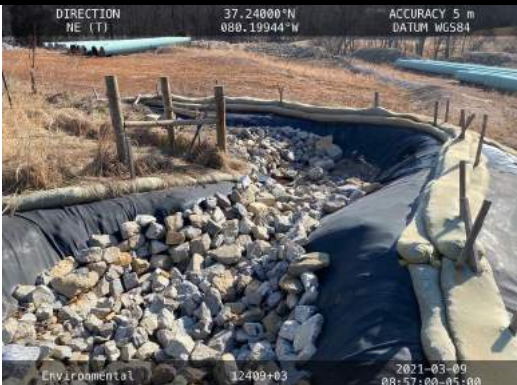
GPS Location	See photo		GPS Location	See photo	
Field Station#	12380+04		Field Station#	12409+03	
Pic 11 Desc.	Stream S-NN19, facing east, upstream		Pic 12 Desc.	Clean water diversion pipe inlet is free of sediment and in good condition.

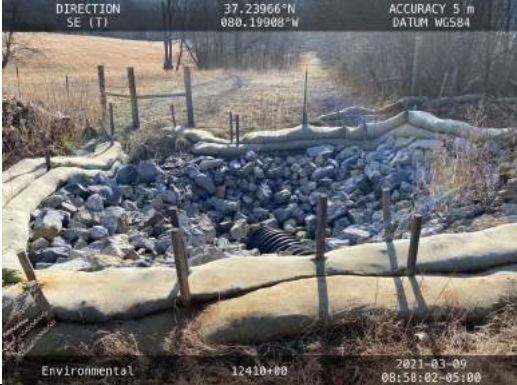
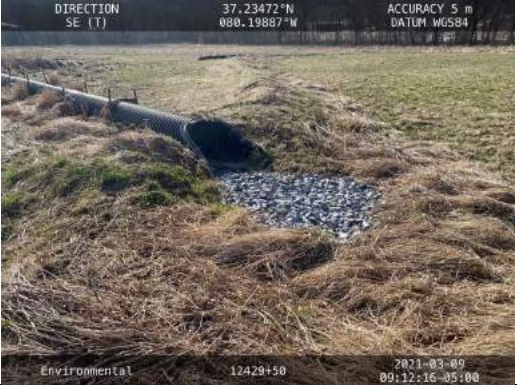
GPS Location	See photo		GPS Location	See photo	
Field Station#	12410+00		Field Station#	12429+50	
Pic 13 Desc.	Clean water diversion pipe outlet plunge pool is free of sediment and in good condition.		Pic 14 Desc.	Clean water diversion pipe inlet in satisfactory condition.

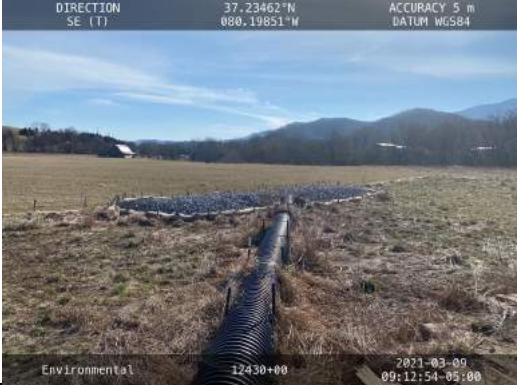
GPS Location	See photo		GPS Location	See photo	
Field Station#	12430+00		Field Station#	12435+16	
Pic 15 Desc.	Clean water diversion pipe outlet in good condition.		Pic 16 Desc.	Stream S-NN16, Roanoke River, facing southwest towards Lafayette Road.

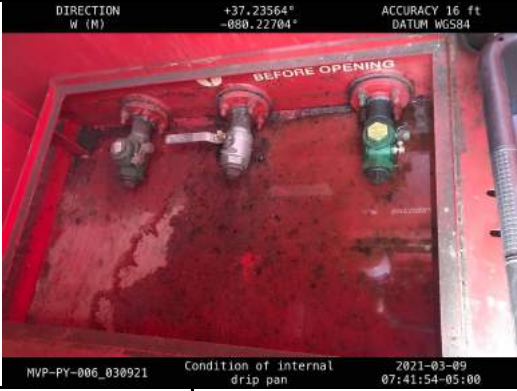
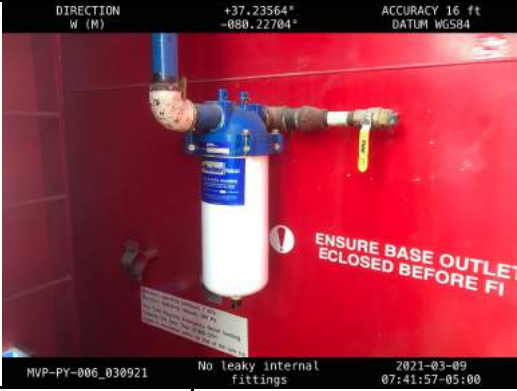
GPS Location	MVP-PY-006 See photo for gps data		GPS Location	MVP-PY-006 See photo for gps data	
Field Station#	+0		Field Station#	+0	
Pic 7 Desc.	Off Road Fuel unit condition of internal drip pan. Looking W.		Pic 8 Desc.	Off Road Fuel unit no leaky internal fittings. Looking W.

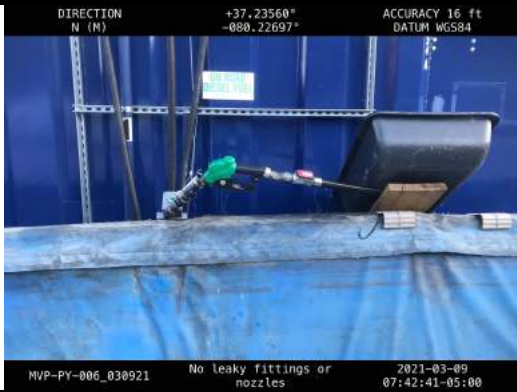
GPS Location	MVP-PY-006 See photo for gps data		GPS Location	MVP-PY-006 See photo for gps data	
Field Station#	+0		Field Station#	+0	
Pic 9 Desc.	Blue Bulk Fuel tanks no leaky fittings or nozzles. Looking N.		Pic 10 Desc.	No fluids or deposits around hazardous waste dumpsters. Looking S.

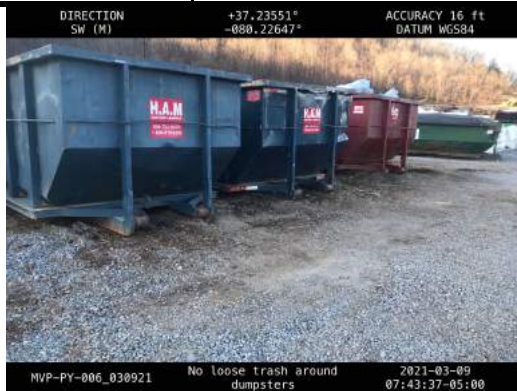
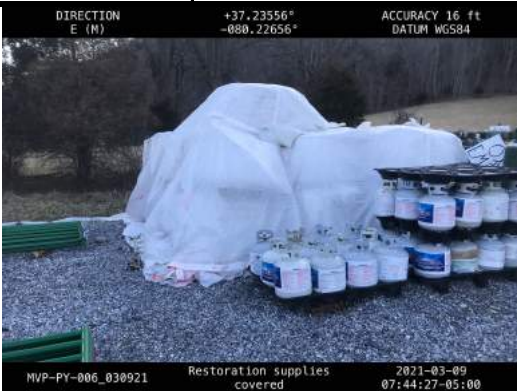
GPS Location	MVP-PY-006 See photo for gps data		GPS Location	MVP-PY-006 See photo for gps data	
Field Station#	+0		Field Station#	+0	
Pic 11 Desc.	No loose trash around dumpsters or in the yard. Looking SW.		Pic 12 Desc.	Restoration supplies covered and protected from the weather. Looking E.

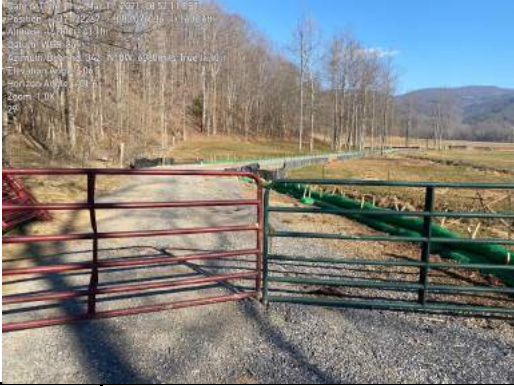
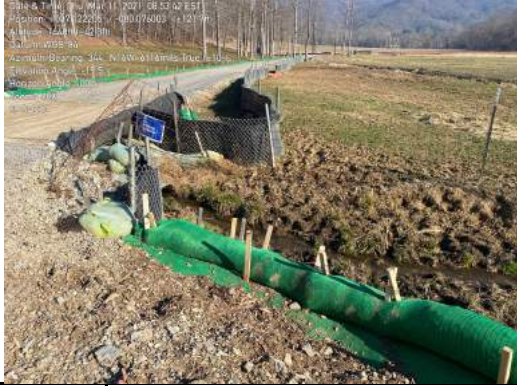
GPS Location	See photo for coordinates.		GPS Location	See photo for coordinates.	
Field Station#	13190+00		Field Station#	13190+00	
Pic 1 Desc.	MVP-MLV-AR-29, access road in acceptable condition.		Pic 2 Desc.	S-D10, downstream of air bridge on MVP-MLV-AR-29, typical cattle disturbance noted along banks.

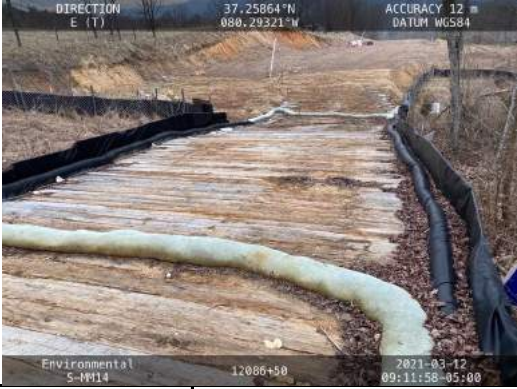
GPS Location	See photo		GPS Location	See photo	
Field Station#	12086+50		Field Station#	12086+50	
Pic 13 Desc.	Bridge and ECDs in satisfactory condition at stream S-MM14.		Pic 14 Desc.	Stream S-MM14, facing southeast, downstream

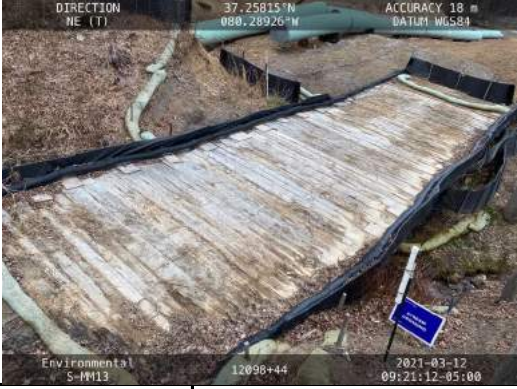
GPS Location	See photo		GPS Location	See photo	
Field Station#	12098+44		Field Station#	12101+57	
Pic 15 Desc.	Bridge and ECDs in satisfactory condition at stream S-MM13.		Pic 16 Desc.	Stream S-MM11, facing south, downstream

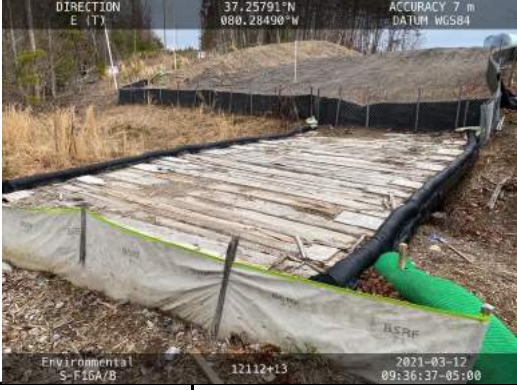
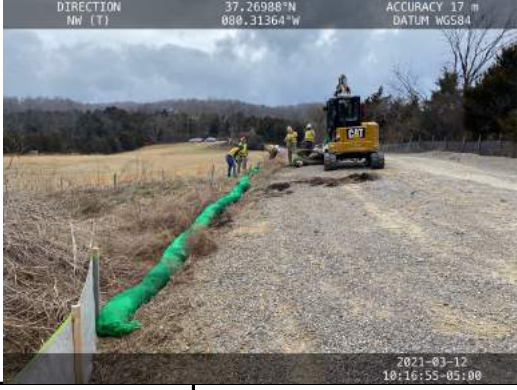
GPS Location	See photo		GPS Location	See photo	
Field Station#	12112+13		Field Station#	12013+97	
Pic 17 Desc.	Bridge and ECDs in satisfactory condition at stream S-F16.		Pic 18 Desc.	An environmental crew replaced old CFS along access road MVP-MN-268.

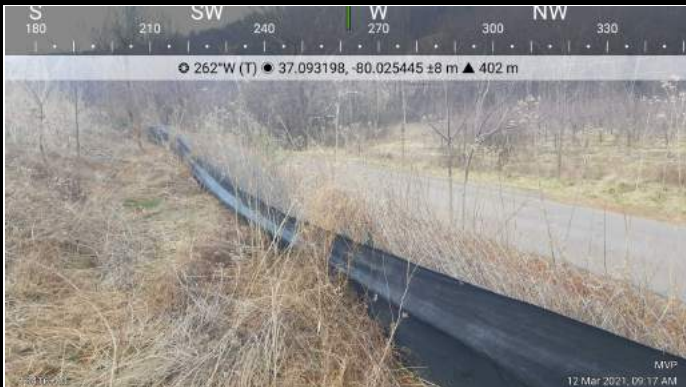
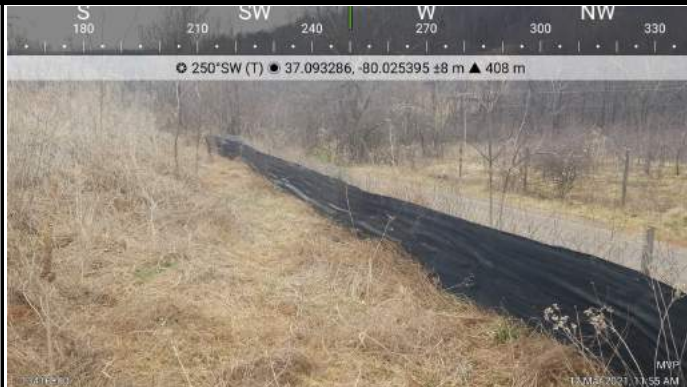
GPS Location	See Above		GPS Location	See Above	
Field Station#	13416+00		Field Station#	13416+00	
Pic 17 Desc.	Punchlist item: Repair super silt fence.		Pic 18 Desc.	Punchlist item: Super silt fence repaired.
