Visual Site Inspection Report

Project Name H-600 Pipeline Spread I		AFE 124300139	Spread H-600 Pipeline Spread I
Contractor Precision		Report # 19351	
Inspector John White		Date/Time 1/25/2021 9:47 AM	
Permit # TBD	Inspection Type VA SWPP	Station Begin 15584+23	
State VA	Inspection Area Full	Station End 15647+03	
County Pittsylvania	Ground Damp	Temperature (°F) 39.00	
Municipality Chatham	Weather Cloudy	Rain Gauge (in) 0.00	
Rain Accumulation Time (days)			6.00

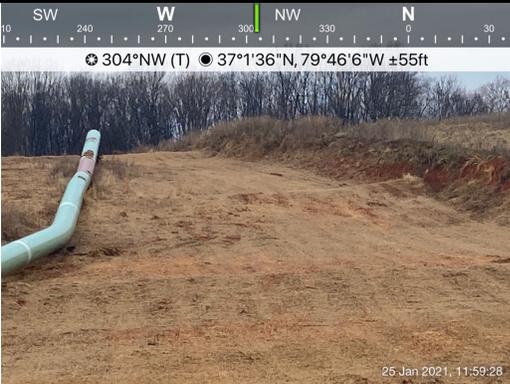
<p>GPS Location: 0 Field Station#: 14450+00 Pic 1 Desc.: Approximately 14450+00. Overview of ROW.</p>

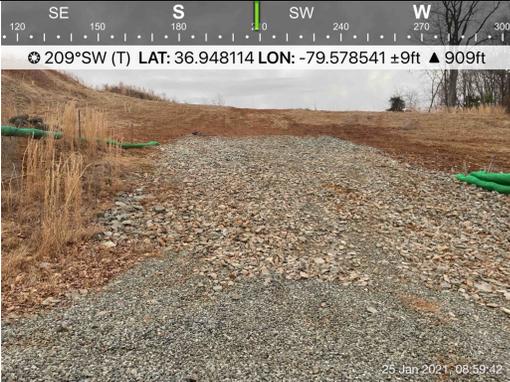
GPS Location		See photo		GPS Location	
Field Station#		15142+66		Field Station#	
Pic 1 Desc.		RCE at Rockcreek in good condition.		Pic 2 Desc.

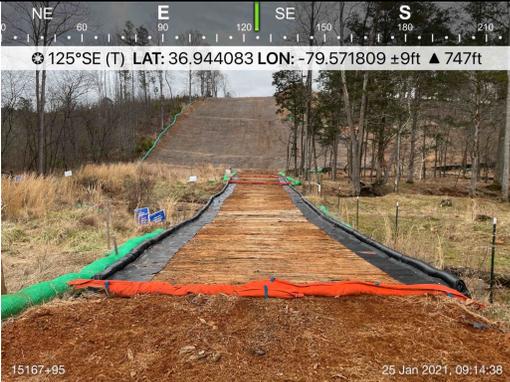
GPS Location		See photo		GPS Location	
Field Station#		15167+95		Field Station#	
Pic 3 Desc.		Equipment bridge ECDs in place at this stream crossing.		Pic 4 Desc.

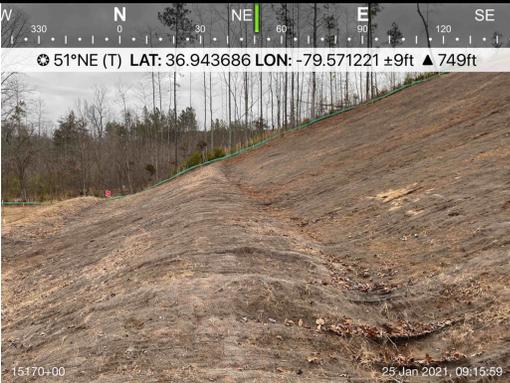
GPS Location		See photo		GPS Location	
Field Station#		15170+00		Field Station#	
Pic 5 Desc.		Temporary waterbars in good condition.		Pic 6 Desc.	
				Pic 6 Desc.	
				Permanent waterbars in good condition and functioning.

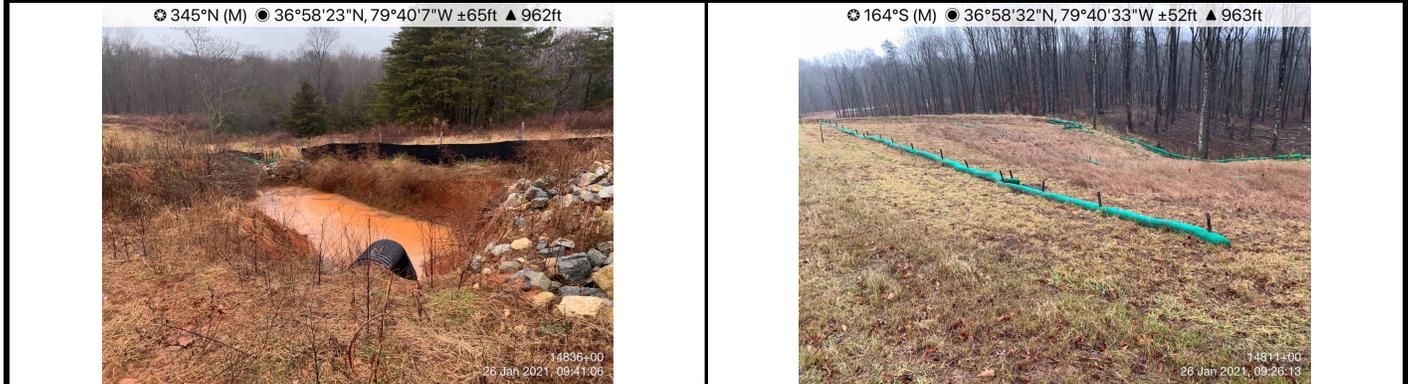
GPS Location	0	GPS Location	0
Field Station#	14836+00	Field Station#	14811+00
Pic 1 Desc.	Sump pit in acceptable condition	Pic 2 Desc.	Permanent vegetative stabilization in acceptable condition

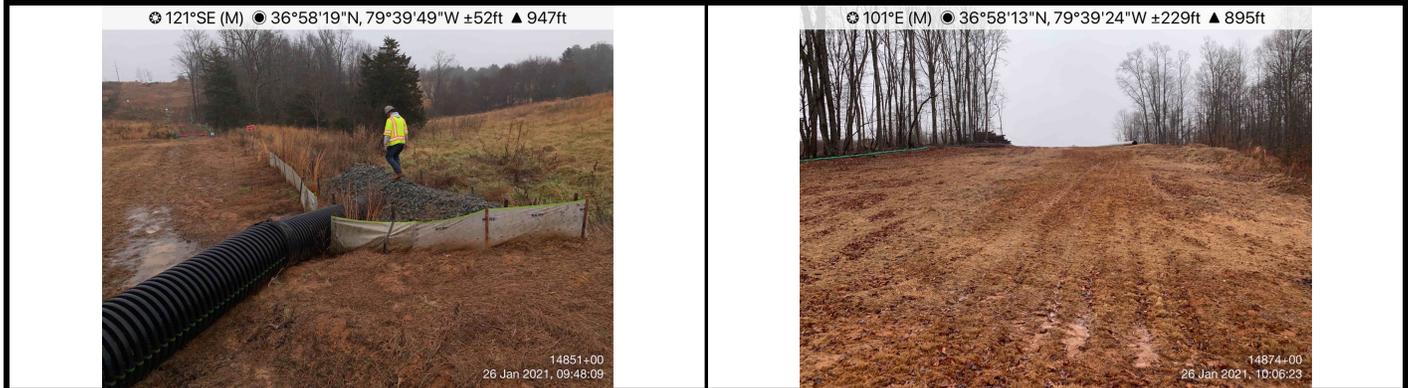
GPS Location	0	GPS Location	0
Field Station#	14851+00	Field Station#	14874+00
Pic 3 Desc.	Clean water diversion pipe in acceptable condition	Pic 4 Desc.	Temporary vegetative stabilization in acceptable condition

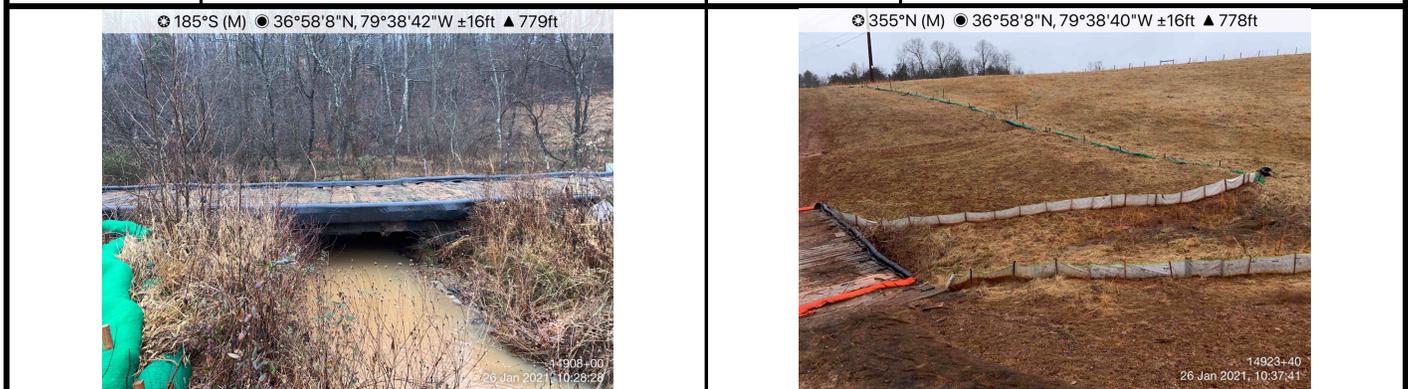
GPS Location	0	GPS Location	0
Field Station#	14908+00	Field Station#	14923+40
Pic 5 Desc.	Equipment bridge in acceptable condition	Pic 6 Desc.	P1 silt fence in acceptable condition

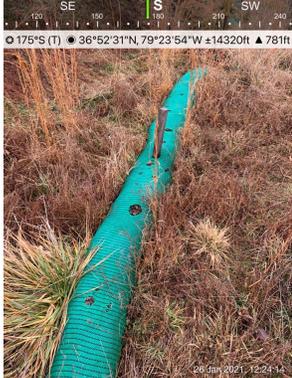
GPS Location	O	GPS Location	O		
Field Station#	15772+00	Field Station#	15764+30		
Pic 1 Desc.	Observing CFS that requires maintenance		Pic 2 Desc.	Observing p1 that requires maintenance

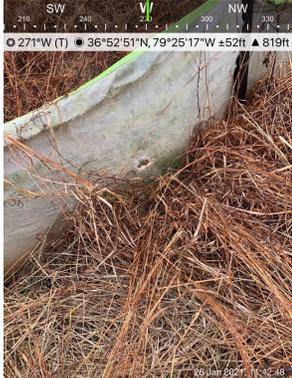
GPS Location	O	GPS Location	O		
Field Station#	15693+60	Field Station#	15753+00		
Pic 3 Desc.	Observing p1 that requires. This location was damaged by wildlife (deer trail)		Pic 4 Desc.	Observing p1 that requires maintenance

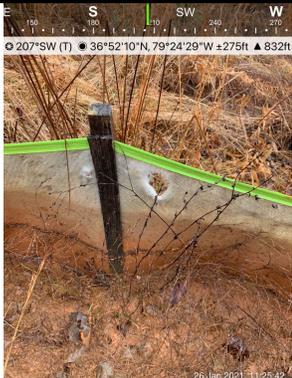
GPS Location	O	GPS Location	O		
Field Station#	15753+00	Field Station#	15744+59		
Pic 5 Desc.	Observing p1 that requires maintenance		Pic 6 Desc.	Observing CFS that requires maintenance

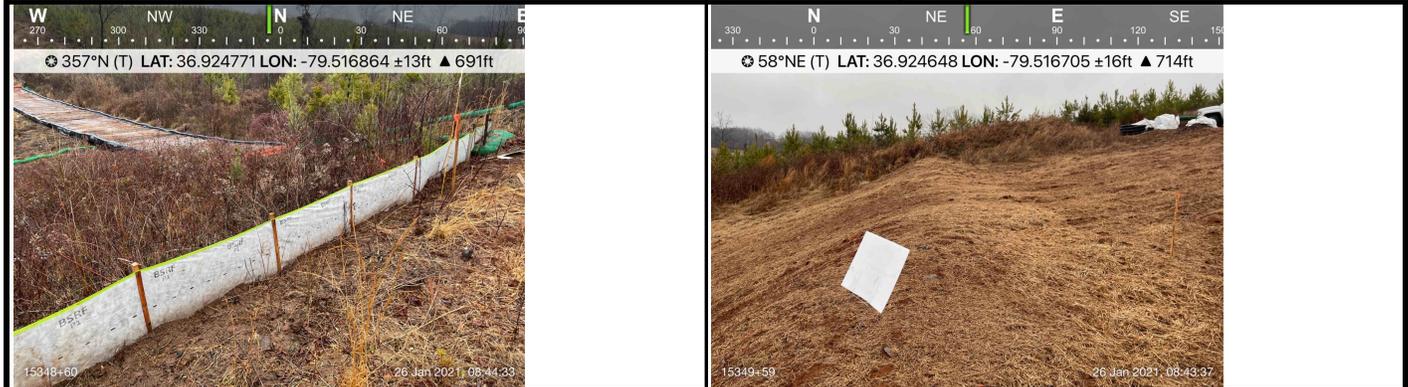
GPS Location	See photo	GPS Location	See photo
Field Station#	15348+60	Field Station#	15349+59
Pic 9 Desc.	P1 is in good condition at all stream and wetland buffers.	Pic 10 Desc.	Waterbars are in good condition and functioning as intended.

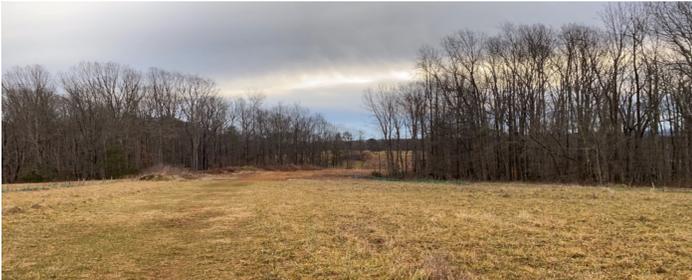
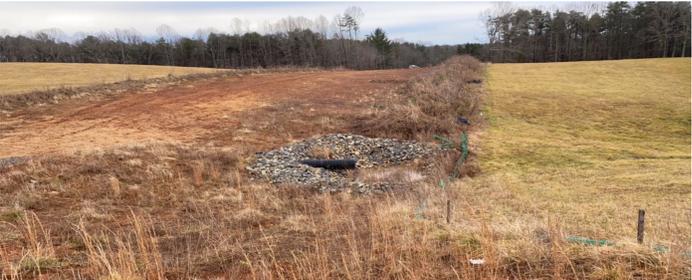
GPS Location	3		GPS Location	4	
Field Station#	14120+00		Field Station#	14132+00	
Pic 3 Desc.	Stabilized ROW shifting from final to temporary area. No erosion issues observed.		Pic 4 Desc.	Plunge pool performing intended function.

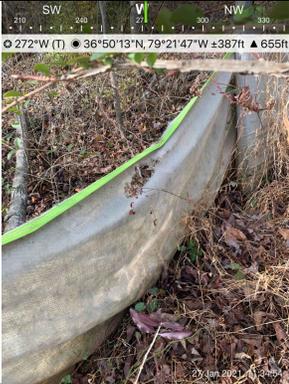
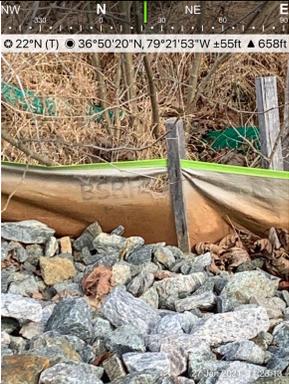
GPS Location	O
GPS Location	O	GPS Location	O	Field Station#	15941+50
Field Station#	15941+50	Field Station#	15934+00	Pic 1 Desc.	Observing p1 that requires maintenance
Pic 1 Desc.	Observing p1 that requires maintenance	Pic 2 Desc.	Observing p1 that requires

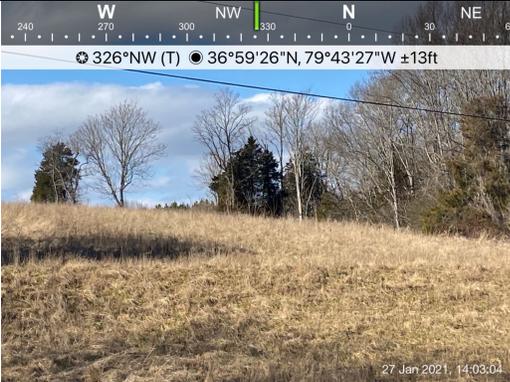
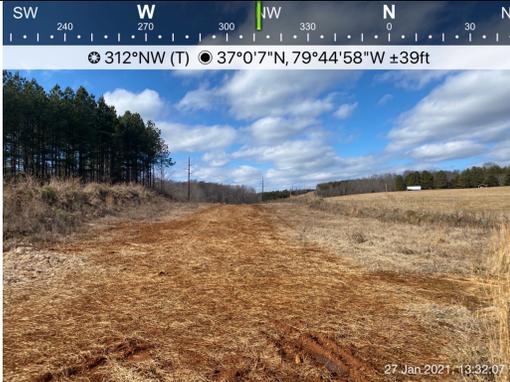
GPS Location	0	GPS Location	0
Field Station#	14647+00	Field Station#	14558+00
Pic 1 Desc.	Approximately 14647+00. Overview of ROW.	Pic 2 Desc.	Approximately 14558+00. Overview of ROW.

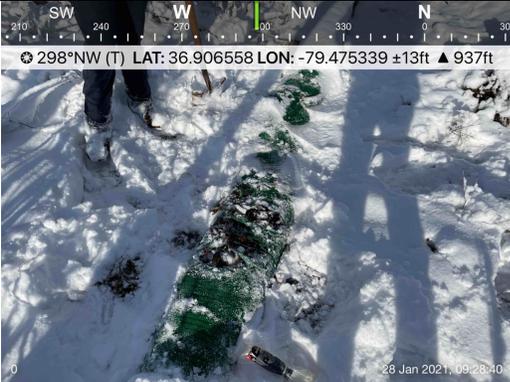
GPS Location	See photo	GPS Location	See photo
Field Station#	15496+06	Field Station#	15496+06
Pic 1 Desc.	CFS has been damaged by 3rd party.	Pic 2 Desc.	Environmental crew has corrected this issue.

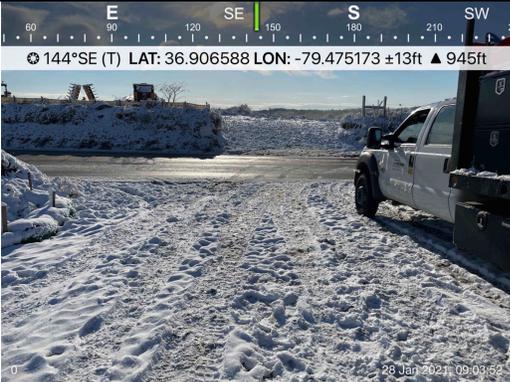
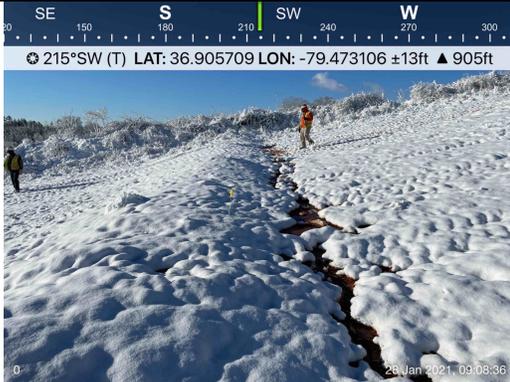
GPS Location	See photo	GPS Location	See photo
Field Station#	15496+70	Field Station#	15502+00
Pic 3 Desc.	RCEs are in good condition at all road crossings.	Pic 4 Desc.	Waterbars are functioning as intended.

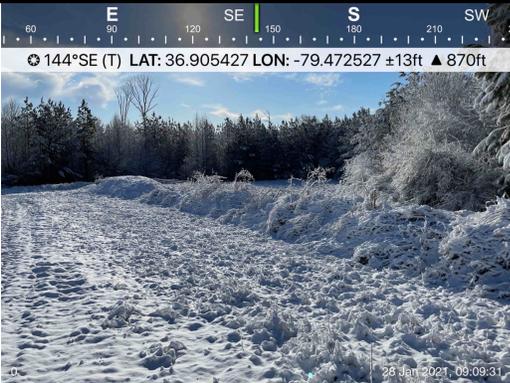
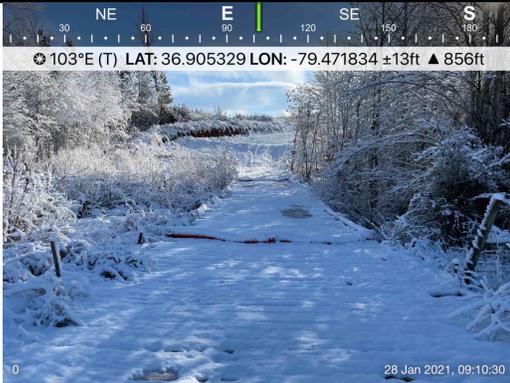
GPS Location	See photo	GPS Location	See photo
Field Station#	15506+00	Field Station#	15507+00
Pic 5 Desc.	Stockpiles remain stabilized.	Pic 6 Desc.	Equipment bridge ECDs are in place and functioning.

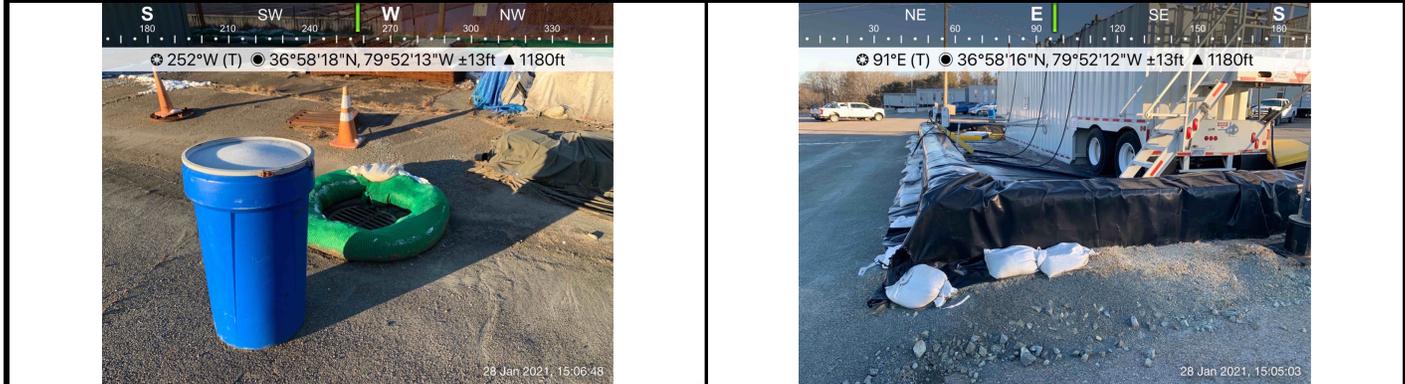
GPS Location	000000000000	GPS Location	000000000000
Field Station#	0000+00	Field Station#	0000+00
Pic 1 Desc.	Inlet protection for parking lot drain on north end of paved yard in good condition.	Pic 2 Desc.	Secondary containment structure for fuel cell in acceptable condition.

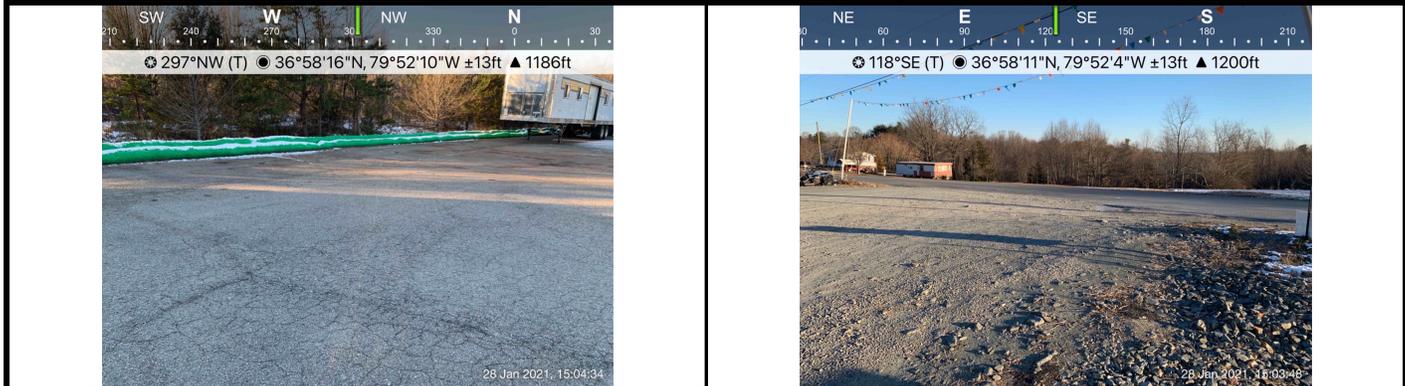
GPS Location	000000000000	GPS Location	000000000000
Field Station#	0000+00	Field Station#	0000+00
Pic 3 Desc.	Perimeter ECD's on south end of paved yard in good condition.	Pic 4 Desc.	RCE at gravel yard in good condition.

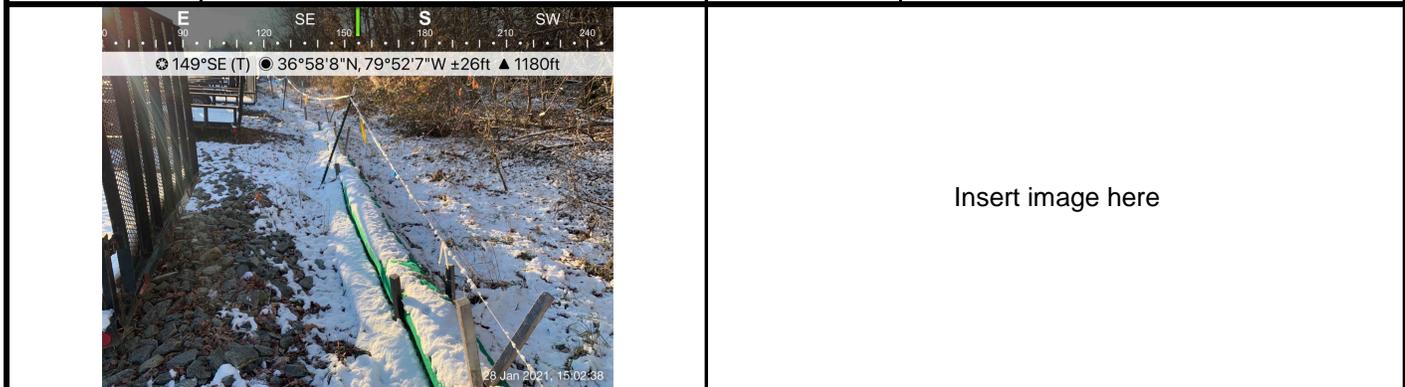
GPS Location	000000000000	GPS Location	
Field Station#	0000+00	Field Station#	
Pic 5 Desc.	Perimeter ECD's on west side of gravel yard near employee parking area in good condition.	Pic 6 Desc.

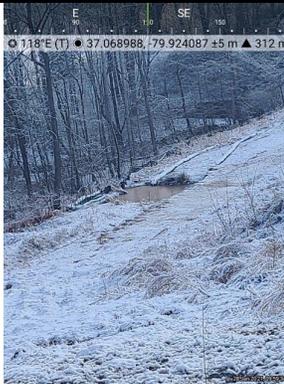
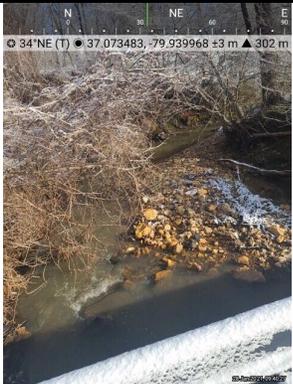
GPS Location	00000		GPS Location	000000	
Field Station#	13815+12		Field Station#	13755+49	
Pic 1 Desc.	The EI monitored plunge pool and ECDs , no environmental issues were observed at the time of inspection.		Pic 2 Desc.	Stream observation photo facing downstream, no issues observed at time of inspection.

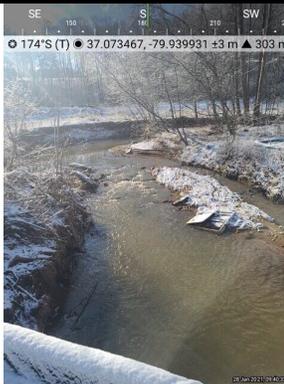
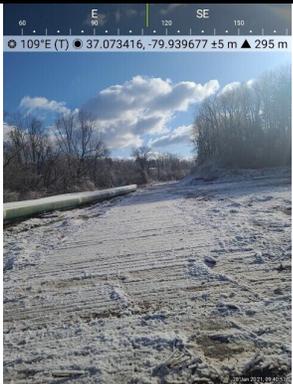
GPS Location	00000		GPS Location	00000	
Field Station#	13755+49		Field Station#	13756+00	
Pic 3 Desc.	Stream observation by the EI facing upstream, no environmental issues observed at time of inspection.		Pic 4 Desc.	Monitored row conditions after overnight snow/rain event, no issues observed at the time of inspection.

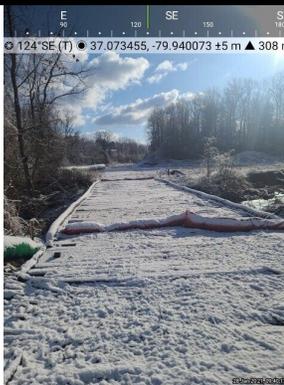
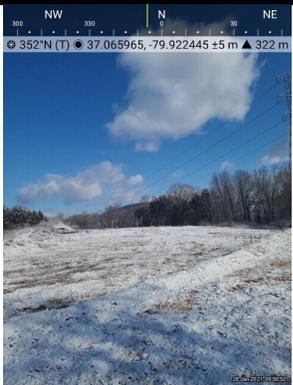
GPS Location	00000		GPS Location	0000	
Field Station#	13755+49		Field Station#	13826+05	
Pic 5 Desc.	Monitored equipment bridge and protection.		Pic 6 Desc.	Row photo showing snow after rain/snow events overnight.

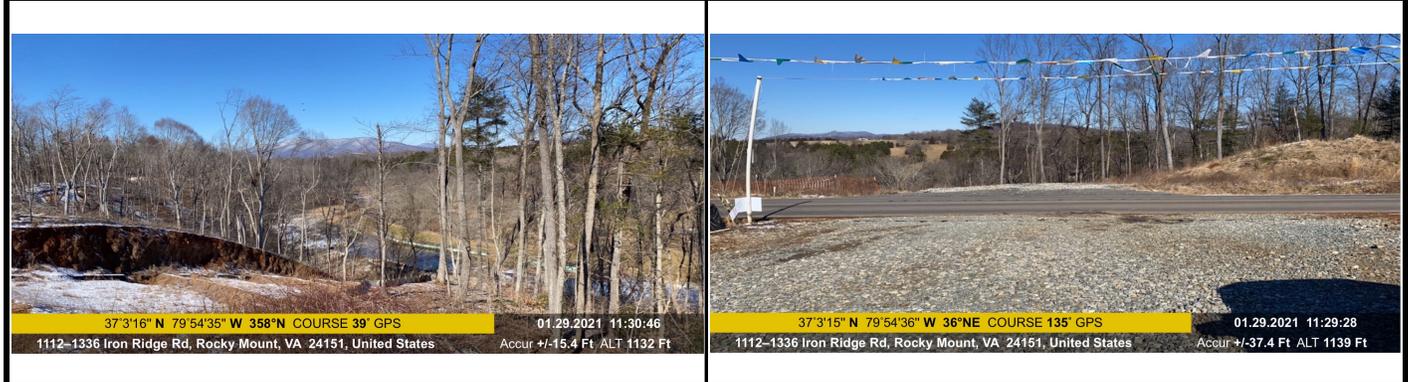
GPS Location	1	GPS Location	2
Field Station#	13890+00	Field Station#	13892+45
Pic 1 Desc.	Water bars and sumps down slope are functional. ROW is stabilized. No issues observed.	Pic 2 Desc.	RCE at Iron Ridge Rd in good condition.

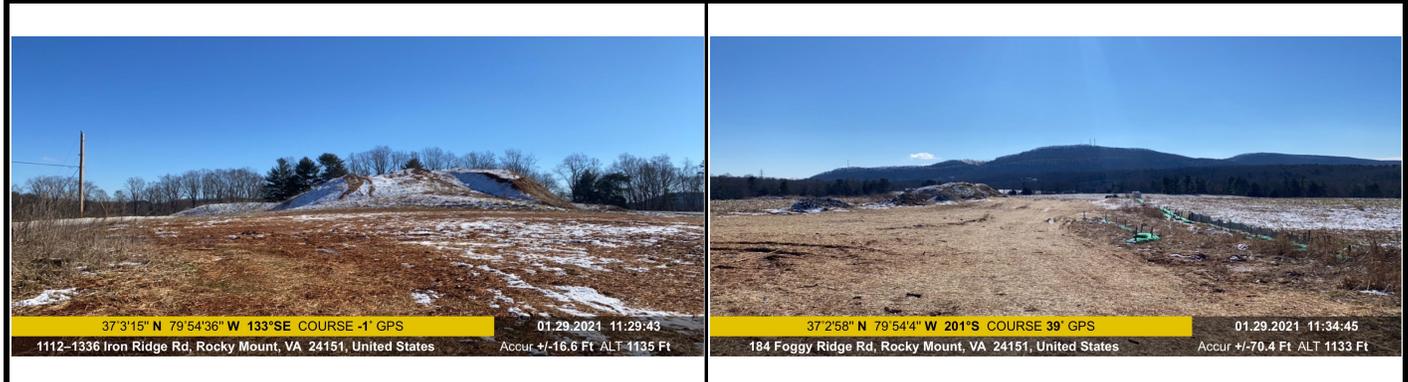
GPS Location	3	GPS Location	4
Field Station#	13894+00	Field Station#	13939+50
Pic 3 Desc.	Spoil pile CIS Iron Ridge Rd stabilized. No issues identified.	Pic 4 Desc.	MVP-FR-305 stabilized with perimeter controls in place and functional at intersection with ROW.

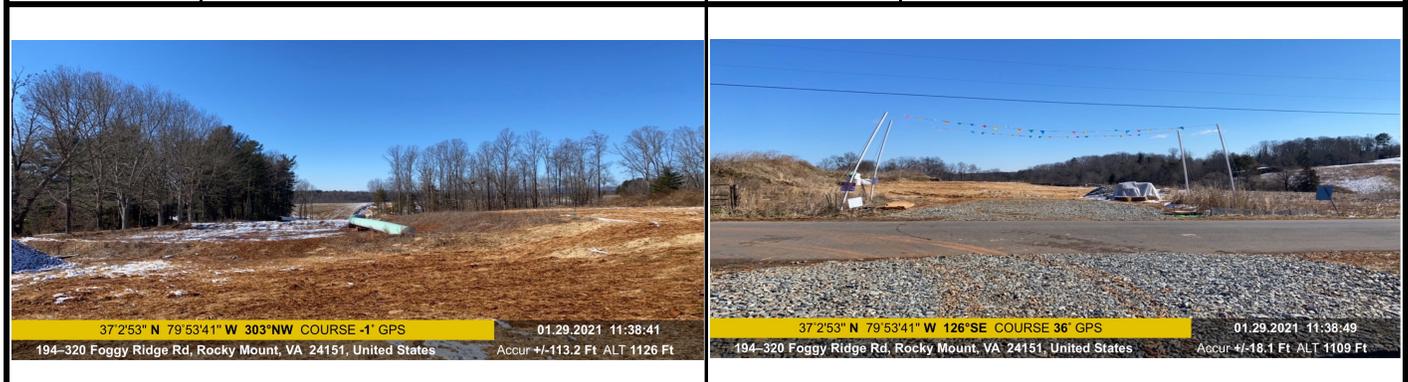
GPS Location	5	GPS Location	6
Field Station#	13955+00	Field Station#	13958+31
Pic 5 Desc.	ROW in two-toned area stabilized with temporary seeding/straw mulch. No environmental issues observed.	Pic 6 Desc.	RCE at Foggy Ridge Rd in good condition

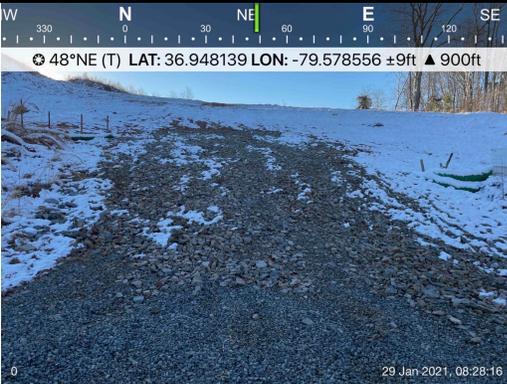
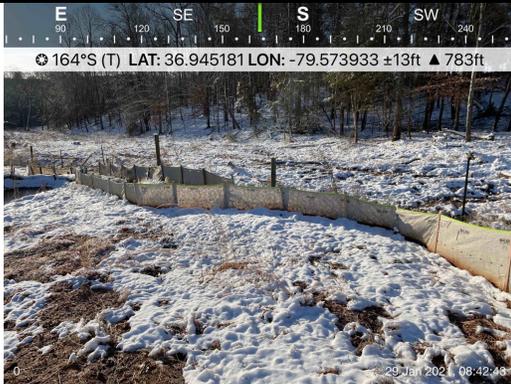
GPS Location	See photo		GPS Location	See photo	
Field Station#	15142+66		Field Station#	15160+00	
Pic 1 Desc.	RCE at Rockcreek Rd. is in good condition.		Pic 2 Desc.	P1 is in good condition around all streams and drainages.

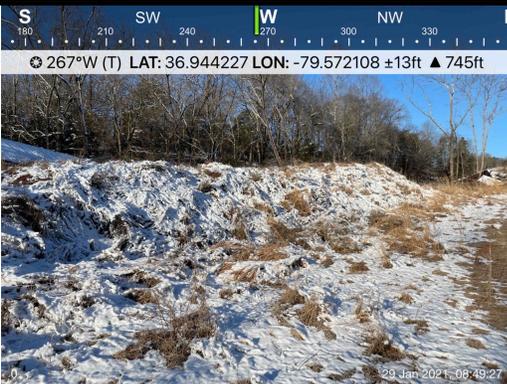
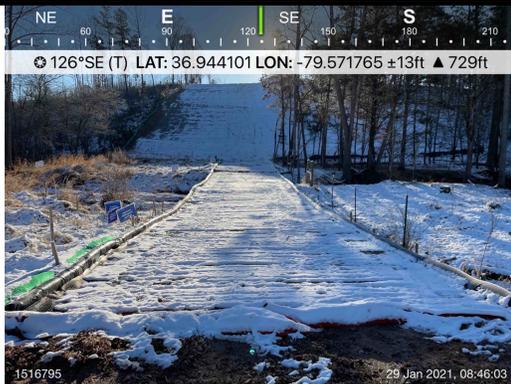
GPS Location	See photo		GPS Location	See photo	
Field Station#	15166+00		Field Station#	15167+95	
Pic 3 Desc.	Stockpiles remain stabilized.		Pic 4 Desc.	Equipment bridge ECDs are in place and functioning.

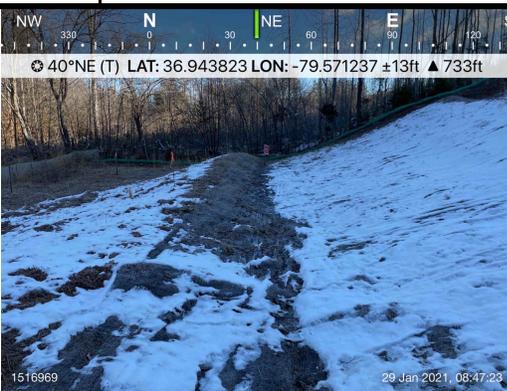
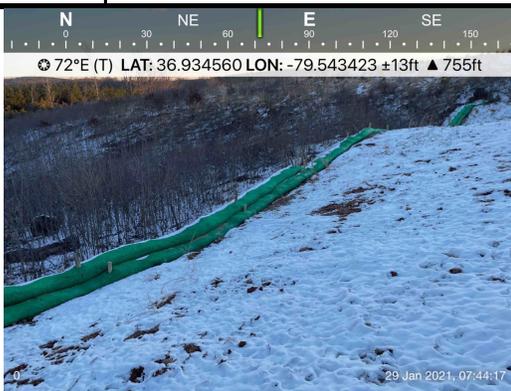
GPS Location	See photo		GPS Location	See photo	
Field Station#	15169+69		Field Station#	15260+00	
Pic 5 Desc.	Temporary and permanent waterbars are in good condition throughout this section of ROW.		Pic 6 Desc.	Perimeter CFS is in good condition and functioning as intended.

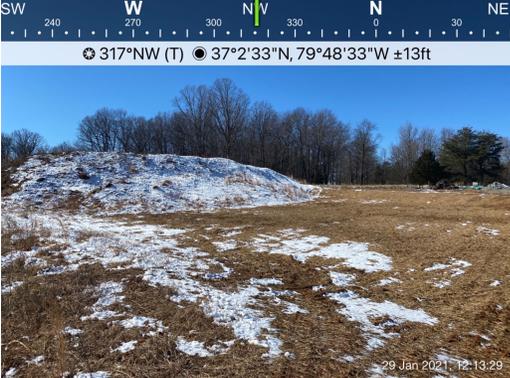
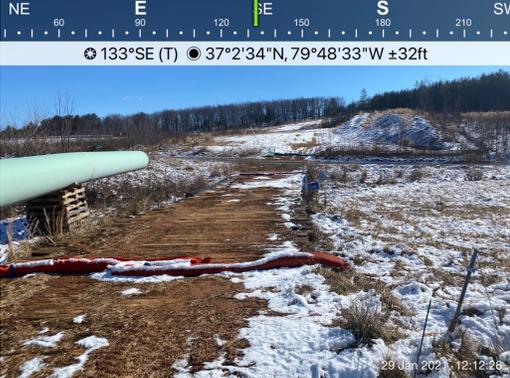
GPS Location	0	GPS Location	0		
Field Station#	14313+00	Field Station#	14314+79		
Pic 1 Desc.	Approximately 14313+00. Overview of ROW.		Pic 2 Desc.	Approximately 14314+79. Overview of stream crossing, equipment bridge and ECDs at stream S-GG4.
