Visual Site Inspection Report

Project Name H-600 Pipeline Spread I		AFE 124300139	Spread H-600 Pipeline Spread I
Contractor Precision		Report # 19583	
Inspector Justin Burch		Date/Time 2/1/2021 11:38 AM	
Permit # TBD	Inspection Type VA SWPP	Station Begin 14802+19	
State VA	Inspection Area Full	Station End 14928+52	
County Franklin	Ground Frozen	Temperature (°F) 45.00	
Municipality N/A	Weather Cloudy	Rain Gauge (in) 0.90	
Rain Accumulation Time (days)			6.00

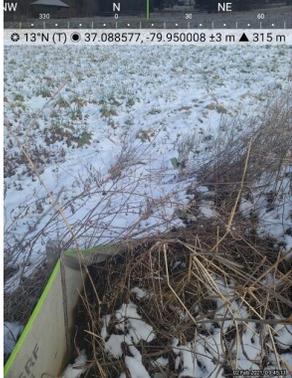
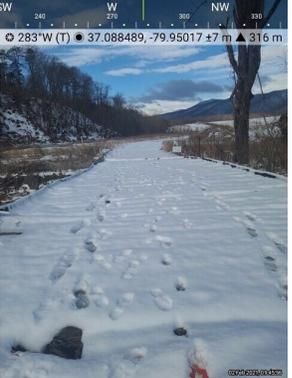
GPS Location	0000	GPS Location	00000	
Field Station#	13679+30	Field Station#	13678+71	
Pic 1 Desc.	P1 requires maintenance due to being weathered and stakes broke. Documented and sent in to be added to the punch list.	Pic 2 Desc.	Equipment bridge monitored by the EI , showing snow covered and no environmental issues observed.

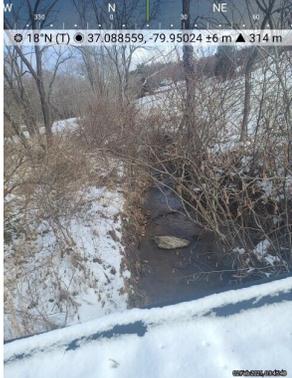
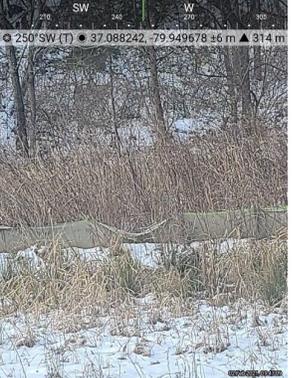
GPS Location	0000	GPS Location	00000	
Field Station#	13678+71	Field Station#	13681+10	
Pic 3 Desc.	Stream observation photo facing downstream during row inspection today.	Pic 4 Desc.	P1 requires maintenance, documented and sent in to be added to the punch list.

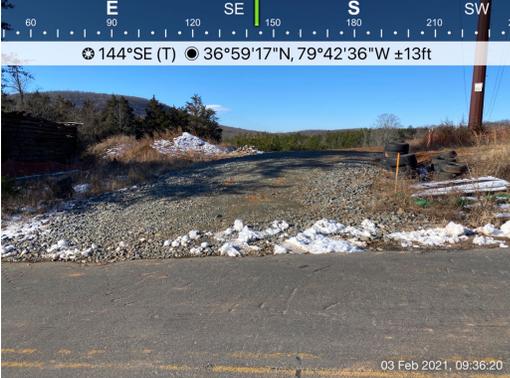
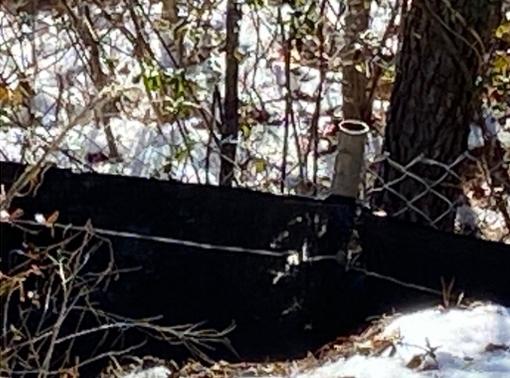
GPS Location 0		GPS Location 0			
Field Station# 14694+50		Field Station# 14688+90			
Pic 1 Desc. Approximately 14694+50. Overview of road crossing and RCE.		Pic 2 Desc. Approximately 14688+90. SSF requires maintenance.

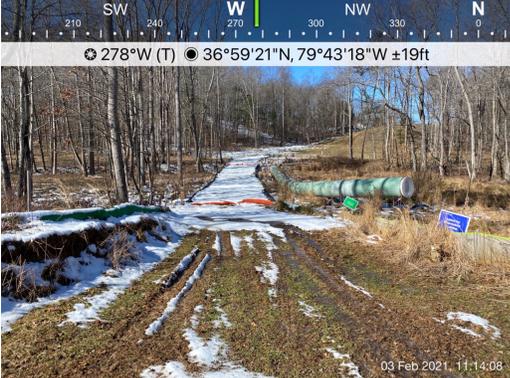
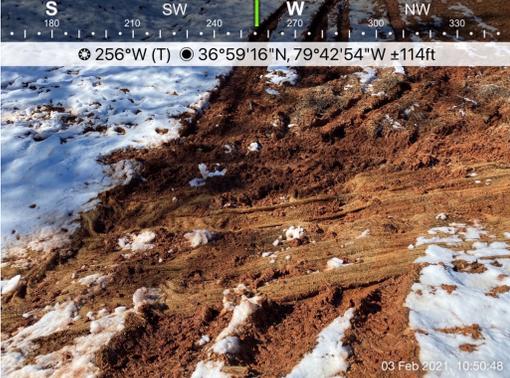
GPS Location 0		GPS Location 0			
Field Station# 14656+93		Field Station# 14679+00			
Pic 3 Desc. Approximately 14656+93. Overview of stream crossing, equipment bridge and ECDs at stream S-H38.		Pic 4 Desc. Approximately 14679+00. Erosion control blanket requires maintenance. Appears to be damaged by third party.

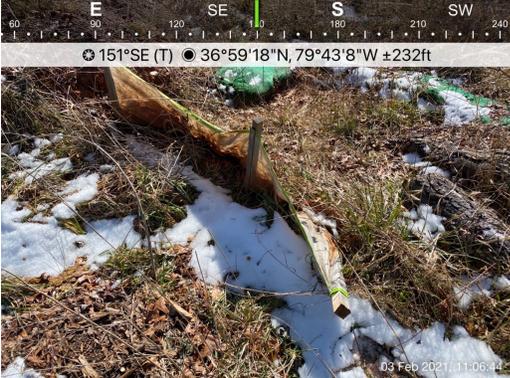
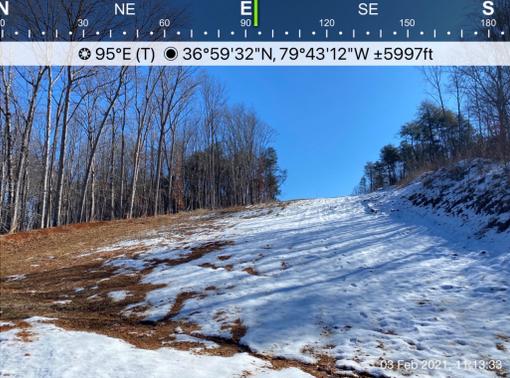
GPS Location 0		GPS Location 0			
Field Station# 14667+50		Field Station# 14661+00			
Pic 5 Desc. Approximately 14667+50. P-1 requires maintenance. Appears to have been damaged by wildlife.		Pic 6 Desc. Approximately 14661+00. Overview of ROW.

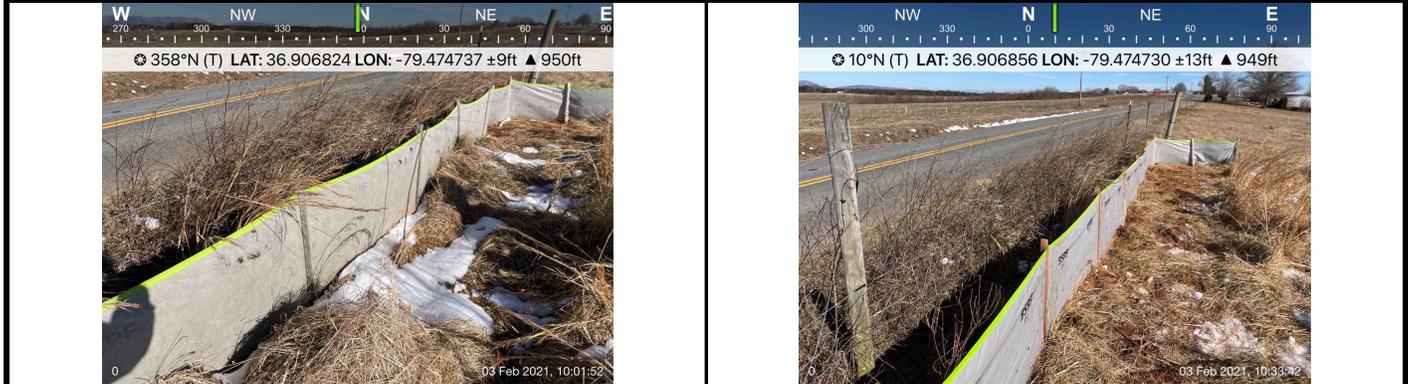
GPS Location	See photo	GPS Location	See photo
Field Station#	15496+70	Field Station#	15496+70
Pic 1 Desc.	P1 is degraded and needs to be replaced.	Pic 2 Desc.	Environmental crew has corrected this issue

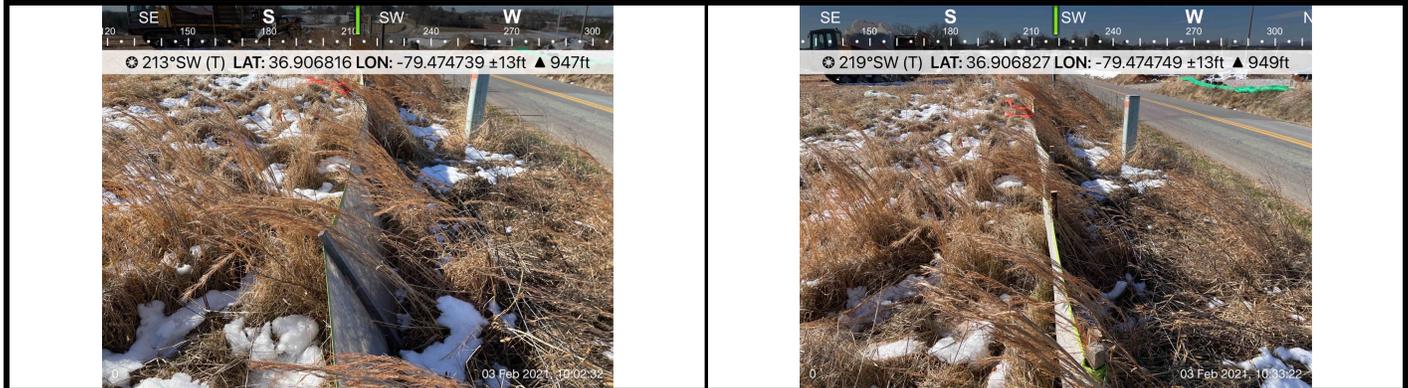
GPS Location	See photo	GPS Location	See photo
Field Station#	15496+70	Field Station#	15496+70
Pic 3 Desc.	P1 needs to be restaked.	Pic 4 Desc.	Environmental crew has corrected this issue.

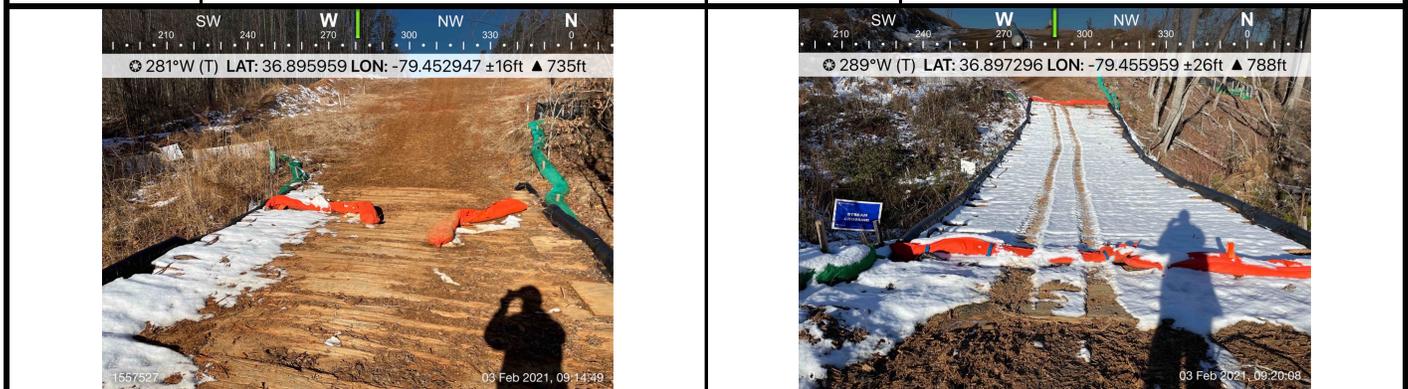
GPS Location	See photo	GPS Location	See photo
Field Station#	15573+54	Field Station#	15562+68
Pic 5 Desc.	3rd party has displaced multiple waddles.	Pic 6 Desc.	3rd party has driven over multiple equipment bridge waddles.

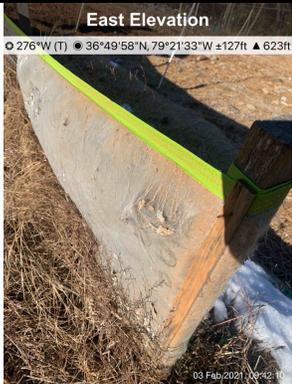
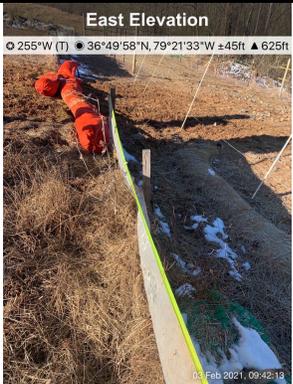
GPS Location	O		GPS Location	O	
Field Station#	15964+59		Field Station#	15964+59	
Pic 1 Desc.	Observing p1 that requires maintenance		Pic 2 Desc.	Observing p1 that requires maintenance

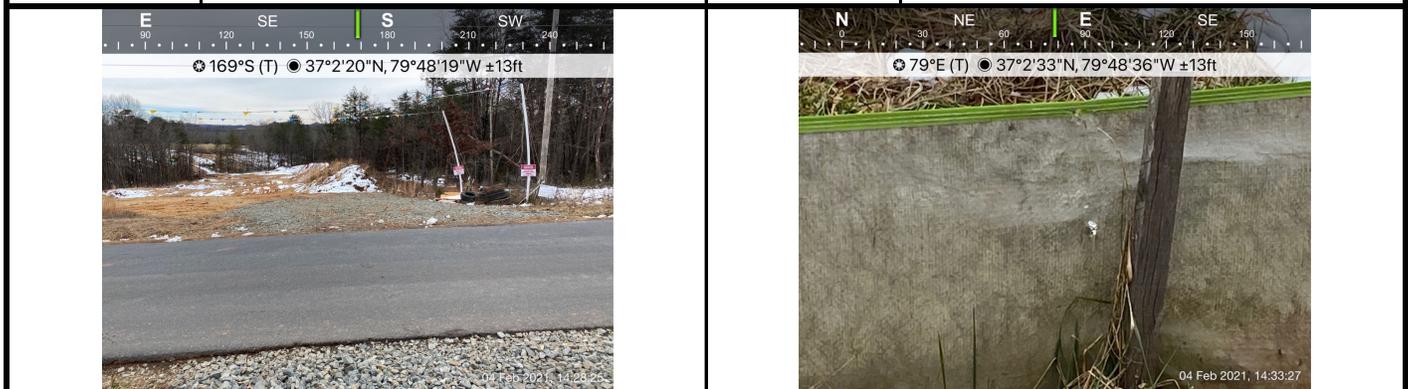
GPS Location	0	GPS Location	0
Field Station#	14333+50	Field Station#	14311+80
Pic 5 Desc.	Approximately 14333+50. Overview of road crossing and RCE.	Pic 6 Desc.	Approximately 14311+80. P-1 requires maintenance.

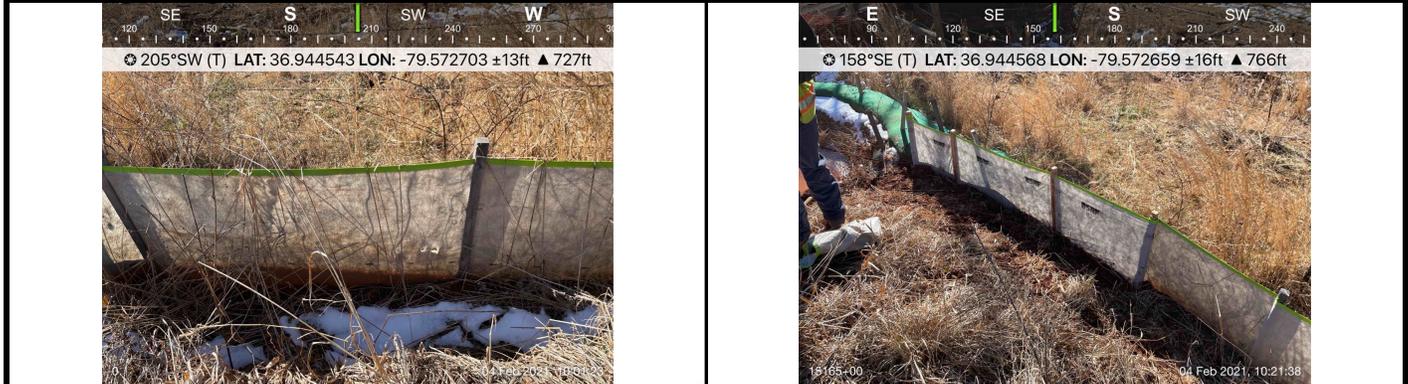
GPS Location	See photo	GPS Location	See photo
Field Station#	15165+00	Field Station#	15165+00
Pic 1 Desc.	P1 is degraded and needs to be replaced.	Pic 2 Desc.	Environmental crew has corrected this issue

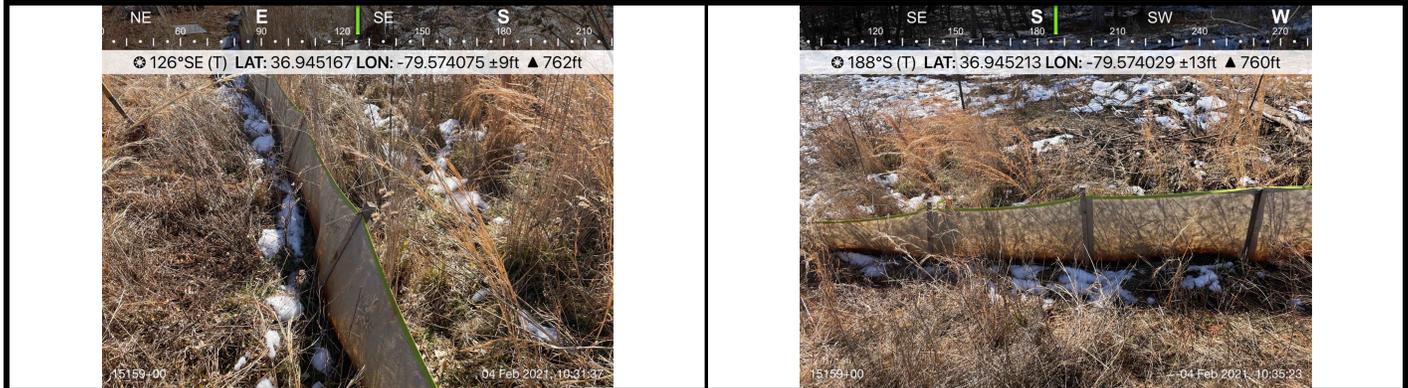
GPS Location	See photo	GPS Location	See photo
Field Station#	15159+00	Field Station#	15159+00
Pic 3 Desc.	P1 needs to be restaked.	Pic 4 Desc.	Environmental crew has corrected this issue.
