Visual Site Inspection Report

Project Name H-600 Pipeline Spread I		AFE 124300139	Spread H-600 Pipeline Spread I
Contractor Precision		Report # 19801	
Inspector Justin Burch		Date/Time 2/8/2021 9:14 AM	
Permit # TBD	Inspection Type VA SWPP	Station Begin 14928+52	
State VA	Inspection Area Full	Station End 15063+95	
County Franklin/Pittsylvania	Ground Frozen	Temperature (°F) 48.00	
Municipality Chatham	Weather Sunny	Rain Gauge (in) 0.60	
Rain Accumulation Time (days)			6.00

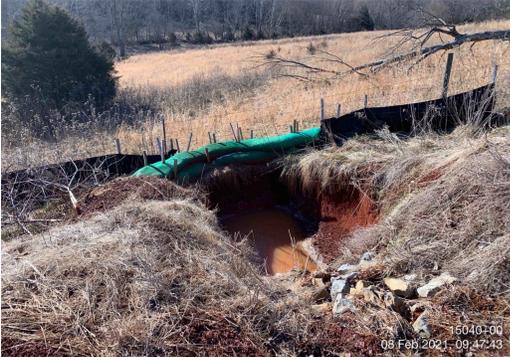
<p>186°S (M) ● 36°58'10"N, 79°36'8"W ±74960ft ▲ 921ft 14975+50 08 Feb 2021, 10:28:26</p>				
GPS Location		0		GPS Location		0	
Field Station#		15040+00		Field Station#		14975+50	
Pic 1 Desc.		Waterbar end treatment in acceptable condition		Pic 2 Desc.		Plunge pool in acceptable condition

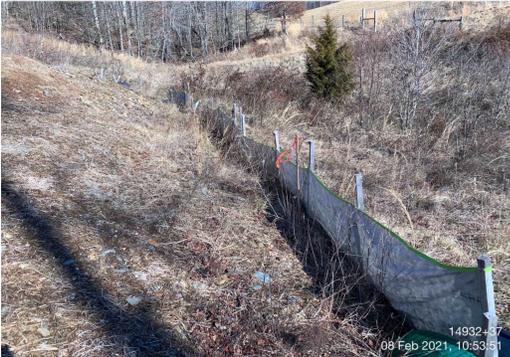
GPS Location		0		GPS Location		0	
Field Station#		14932+37		Field Station#		14929+50	
Pic 5 Desc.		P1 silt fence in acceptable condition		Pic 6 Desc.		perimeter CFS at MVP=ATWS-378 is missing stakes and fabric is deteriorated in multiple location from 14929+00 to 14931+00

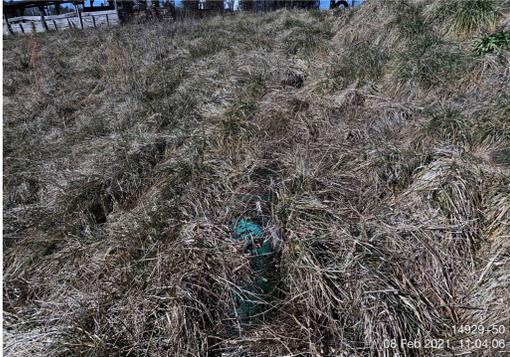
- The EI performed a SWPPP inspection from 14928+52 to 15063+85 (Ramsey Memorial Road to Armstrong Road). The contractor had an environmental crew foreman and straw foreman walk with the EI on his inspection. One issue was submitted for the punch list which was perimeter CFS missing stakes and CFS fabric deteriorated in multiple location at MVP-ATWS-378. Other ECDs inspected were in compliance at the time of inspection.

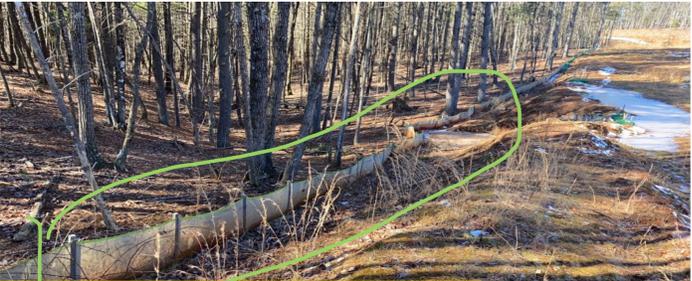
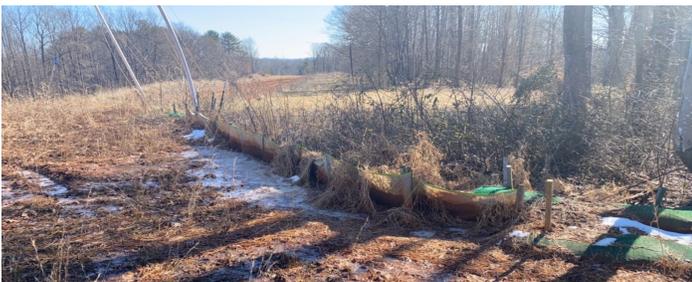
GPS Location	1	GPS Location	2
Field Station#	14062+17	Field Station#	14076+00
Pic 1 Desc.	Contractor staging stabilization materials at Bonbrook Mill RC2	Pic 2 Desc.	Routine maintenance. Replace row of P1 silt fence which has reached effective lifespan.

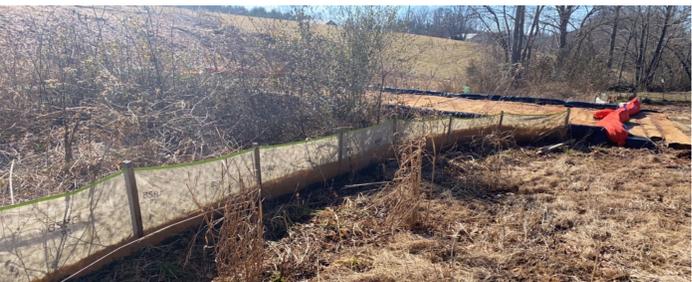
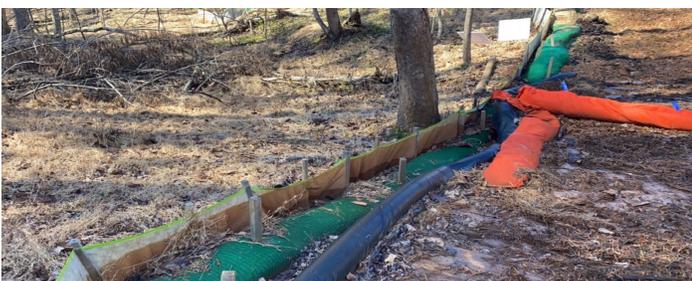
GPS Location	3	GPS Location	4
Field Station#	14083+50	Field Station#	14126+50
Pic 3 Desc.	Routine maintenance. Replace row of P1 silt fence which has reached effective lifespan.	Pic 4 Desc.	Routine maintenance. Replace row of P1 silt fence which has reached effective lifespan. Holes in base of fabric.

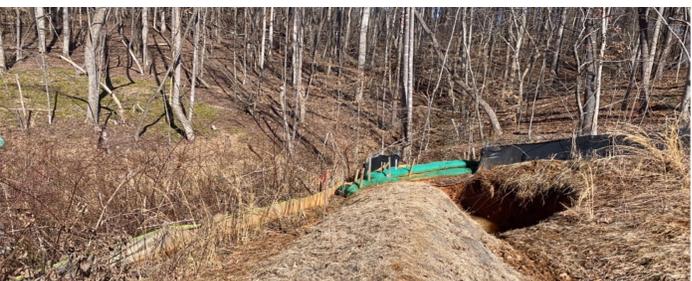
GPS Location	5	GPS Location	6
Field Station#	14141+25	Field Station#	14142+00
Pic 5 Desc.	Routine maintenance. Replace row of P1 silt fence which has reached effective lifespan.	Pic 6 Desc.	Routine maintenance. Replace row of P1 silt fence which has reached effective lifespan.

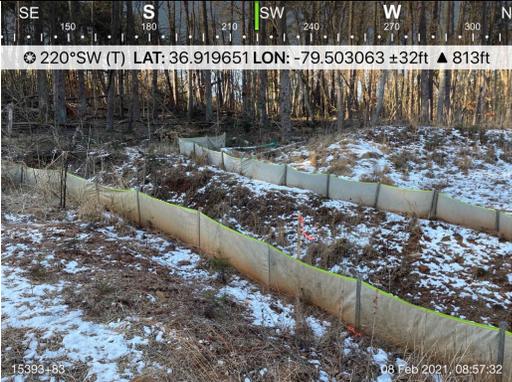
GPS Location See photo		GPS Location See photo			
Field Station# 15393+83		Field Station# 15393+83			
Pic 1 Desc. P1 is degraded and needs to be replaced.		Pic 2 Desc. Environmental crew has corrected this issue.

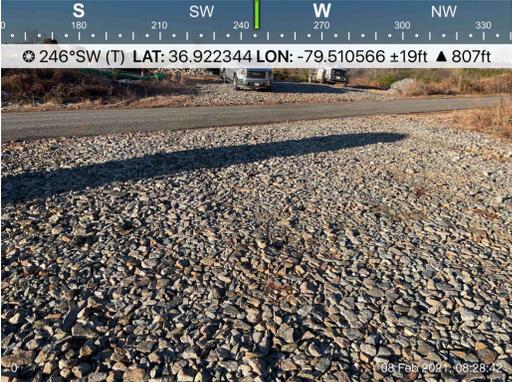
GPS Location See photo		GPS Location See photo			
Field Station# 15370+62		Field Station# 15375+00			
Pic 3 Desc. RCEs are in good condition at all road crossings.		Pic 4 Desc. CFS is in good condition throughout this section.

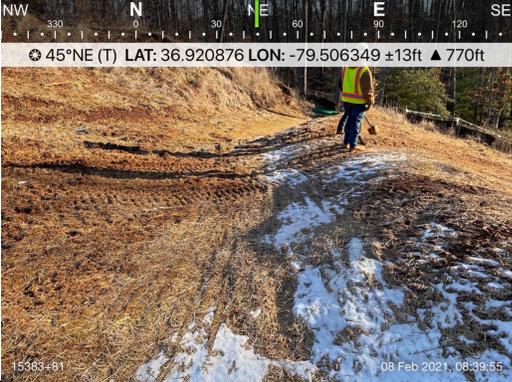
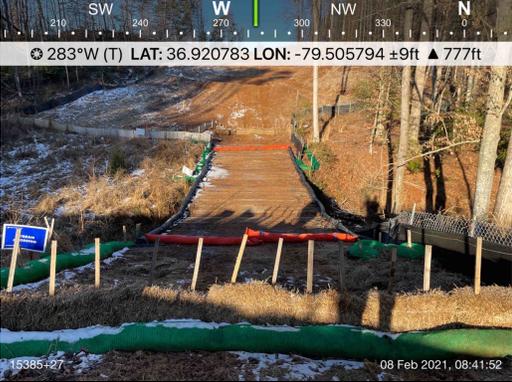
GPS Location See photo		GPS Location See photo			
Field Station# 15383+81		Field Station# 15385+27			
Pic 5 Desc. Temporary waterbars and end treatments are in good condition.		Pic 6 Desc. Equipment bridge ECDs are in place and functioning.

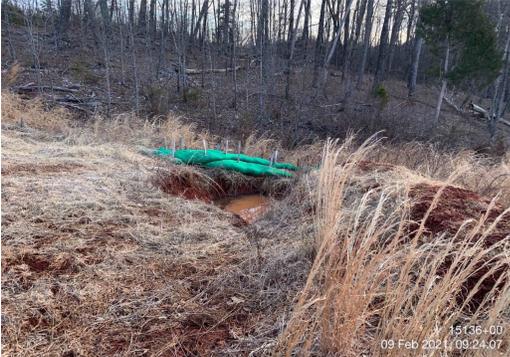
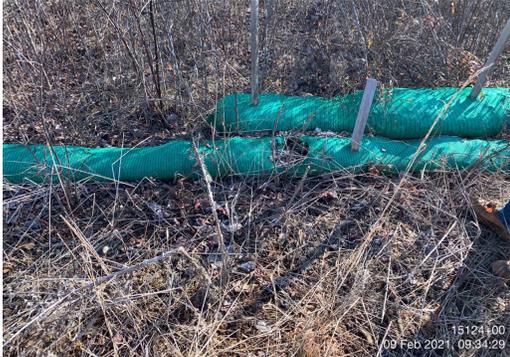
<p>15124+00 09 Feb 2021 09:34:29</p>	
GPS Location	0	GPS Location	0
Field Station#	15136+00	Field Station#	15124+00
Pic 1 Desc.	Waterbar end treatment in acceptable condition	Pic 2 Desc.	CFS damaged by wildlife
<p>200°S (M) 36°57'8"N, 79°34'49"W ±13ft ▲ 870ft</p>

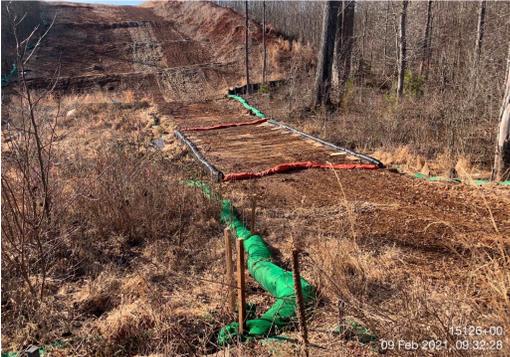
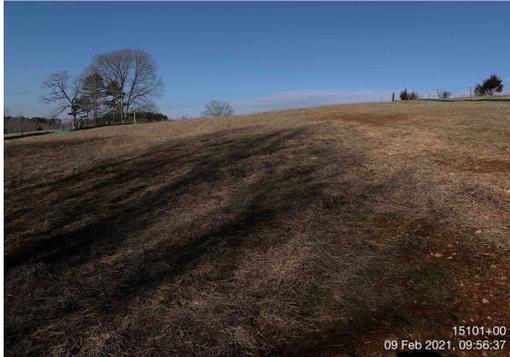
<p>15101+00 09 Feb 2021 09:56:37</p>	
GPS Location	0	GPS Location	0
Field Station#	15126+00	Field Station#	15101+00
Pic 3 Desc.	Equipment bridge in acceptable condition	Pic 4 Desc.	Permanent vegetative stabilization in acceptable condition
<p>28°NE (M) 36°57'44"N, 79°35'21"W ±13ft ▲ 900ft</p>

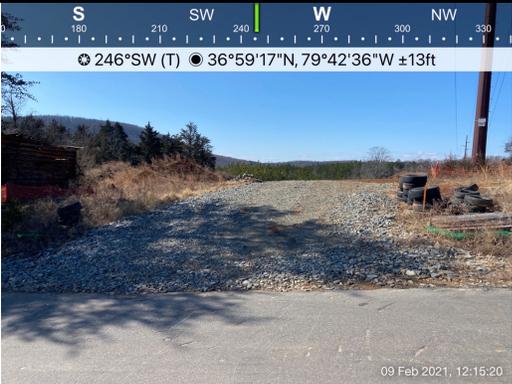
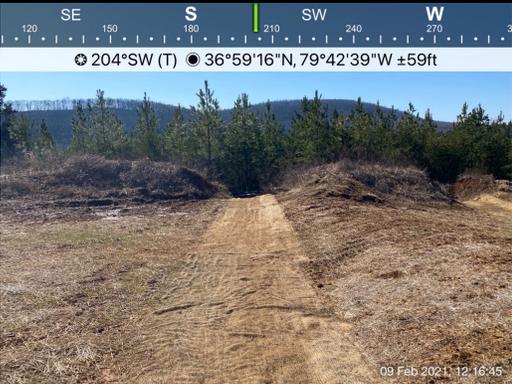
GPS Location	0	GPS Location	0	
Field Station#	14694+50	Field Station#	14691+00	
Pic 1 Desc.	Approximately 14694+50. Overview of road crossing and RCE.		Pic 2 Desc.	Approximately 14691+00. Overview of ROW.

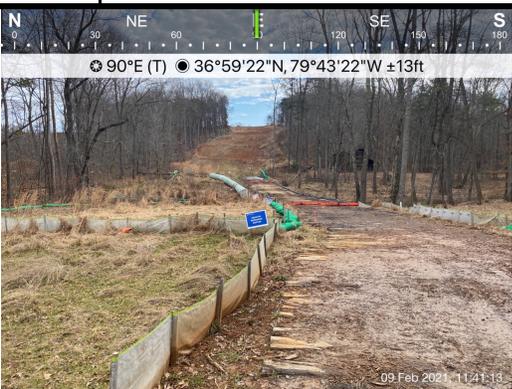
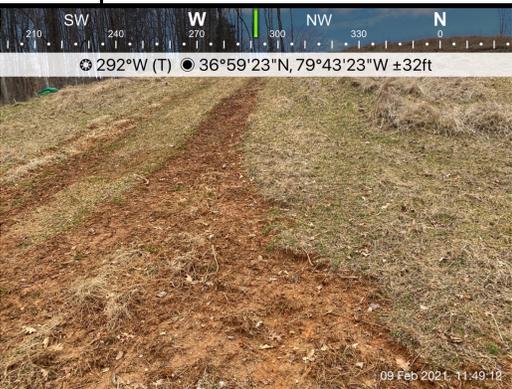
GPS Location	0	GPS Location	0	
Field Station#	14656+94	Field Station#	14653+75	
Pic 5 Desc.	Approximately 14656+94. Overview of stream crossing, equipment bridge and ECDs at stream S-H38.		Pic 6 Desc.	Approximately 14653+75. Repair erosion, seed and stabilize.

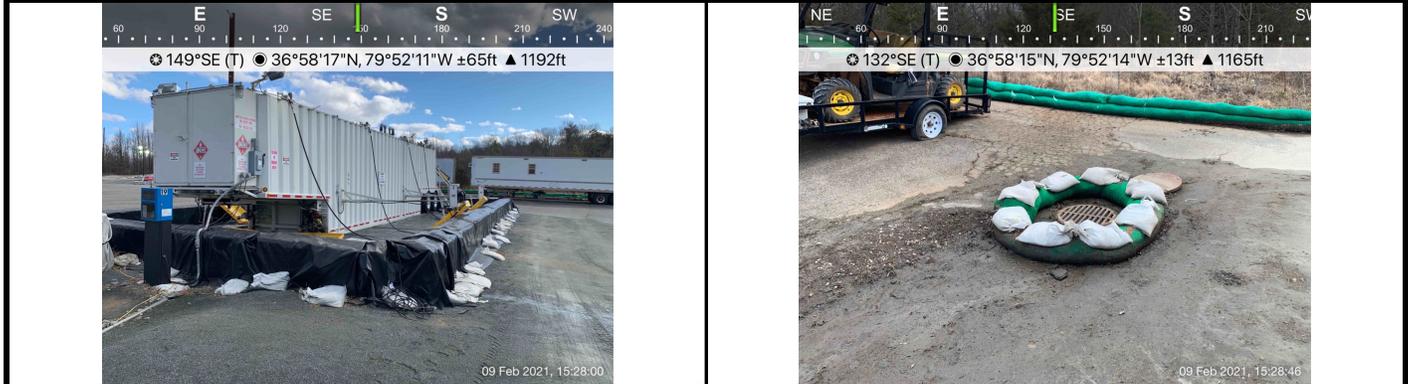
GPS Location 000000000000	GPS Location 000000000000
Field Station# 0000+00	Field Station# 0000+00
Pic 1 Desc. secondary containment structure for fuel cell at MVP-LY-046 in good condition.	Pic 2 Desc. Inlet protection for catch basin on south end of MVP-LY-046 in acceptable condition.

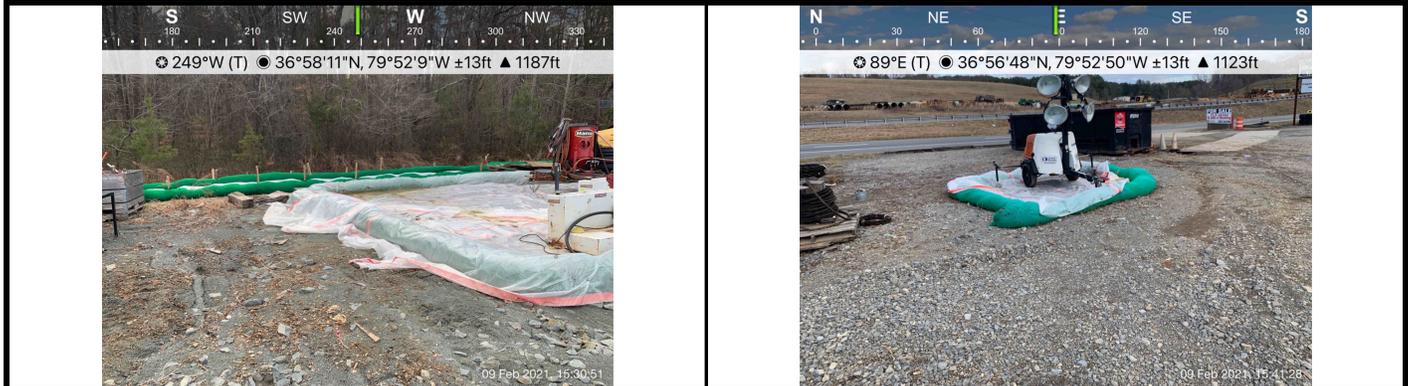
GPS Location 000000000000	GPS Location 000000000000
Field Station# 0000+00	Field Station# 0000+00
Pic 3 Desc. Secondary containment structure for and perimeter ECD's in good condition on northwest corner of MVP-LY-045	Pic 4 Desc. secondary containment liner need maintenance near entrance to MVP-LY-032

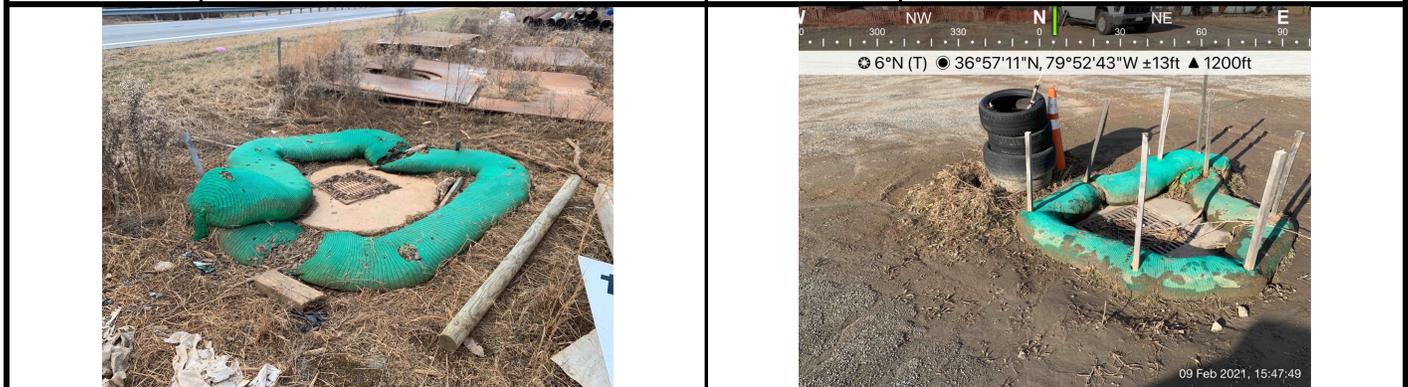
GPS Location 000000000000	GPS Location 000000000000
Field Station# 0000+00	Field Station# 0000+00
Pic 5 Desc. Inlet protection for catch basin at MVP-LY-033 requires maintenance.	Pic 6 Desc. Inlet protection for catch basin at MVP-ANC-006 requires maintenance.

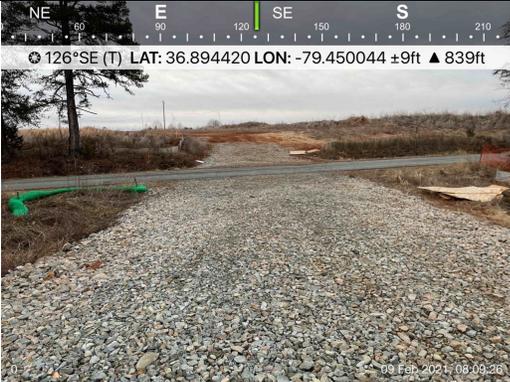
GPS Location See photo		GPS Location See photo			
Field Station# 15584+23		Field Station# 15574+47			
Pic 1 Desc. RCEs are in good condition at all road crossings.		Pic 2 Desc. P1 is degraded and needs to be replaced.

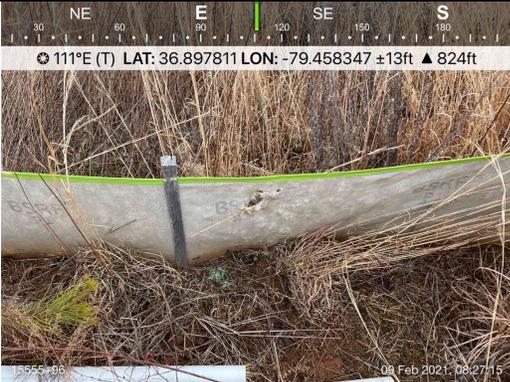
GPS Location See photo		GPS Location See photo			
Field Station# 15555+96		Field Station# 15555+96			
Pic 3 Desc. P1 is damaged and needs to be replaced.		Pic 4 Desc. Environmental crew has corrected this issue

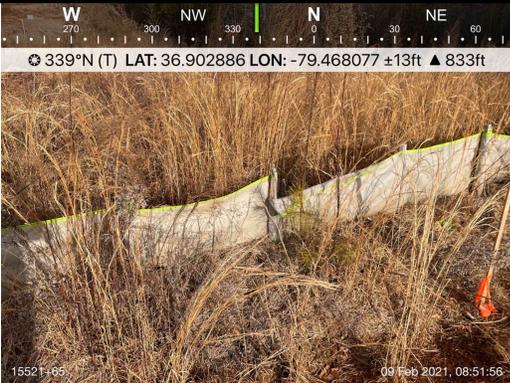
GPS Location See photo		GPS Location See photo			
Field Station# 15521+65		Field Station# 15521+65			
Pic 5 Desc. P1 is damaged and needs to be replaced.		Pic 6 Desc. Environmental crew has corrected this issue.

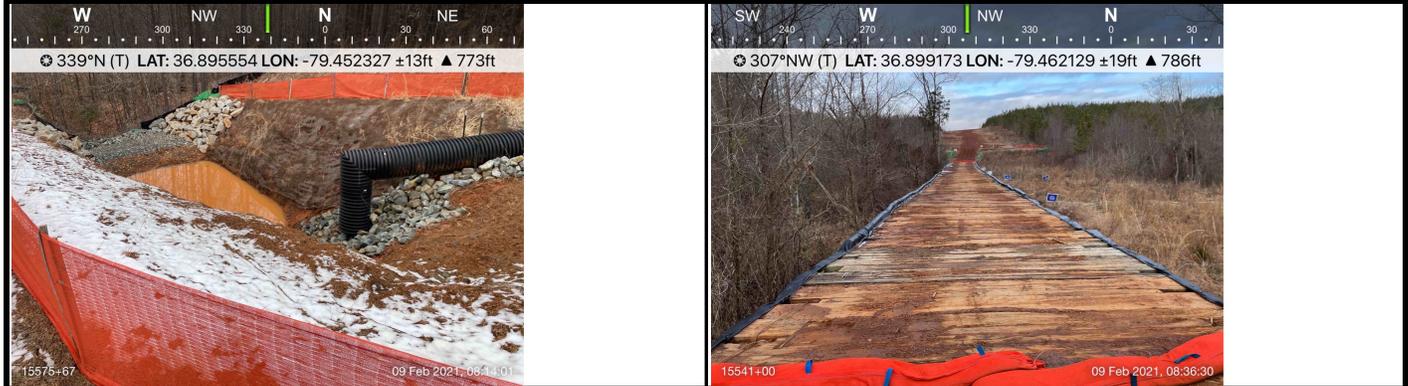
GPS Location	See photo	GPS Location	See photo
Field Station#	15575+67	Field Station#	15541+00
Pic 7 Desc.	Slope drain is in good condition and functioning.	Pic 8 Desc.	Equipment bridge ECDs are in place and functioning.

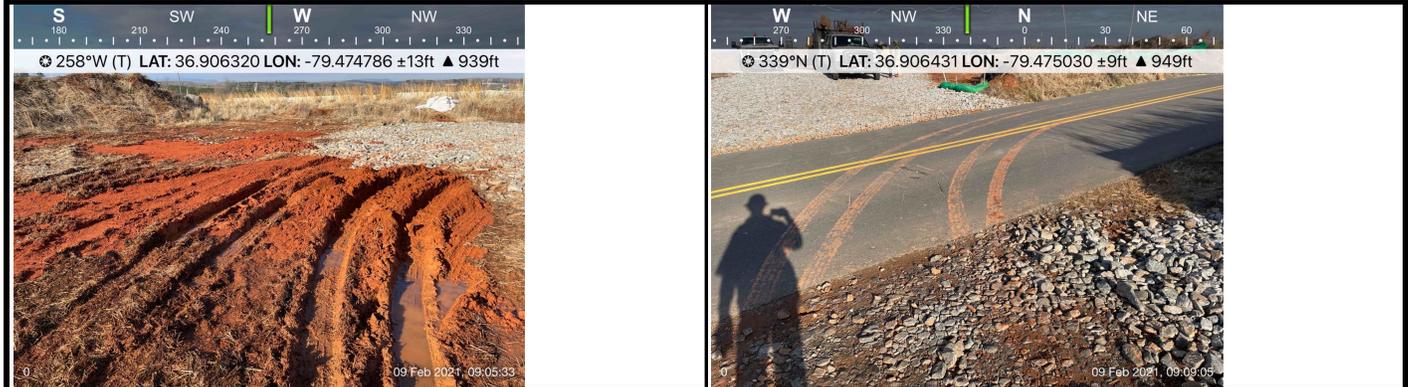
GPS Location	See photo	GPS Location	See photo
Field Station#	15496+70	Field Station#	15496+70
Pic 9 Desc.	3rd party continues to dump material and track onto Climax Rd.	Pic 10 Desc.	3rd party tracking onto Climax Rd.

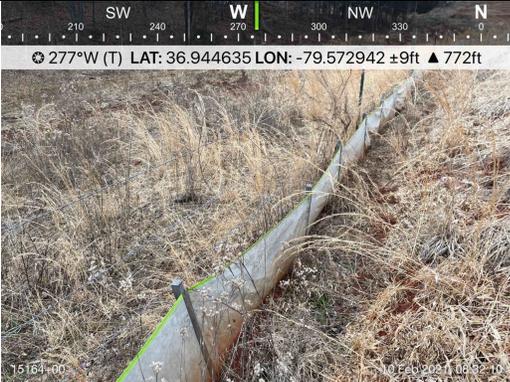
GPS Location See photo		GPS Location See photo			
Field Station# 15164+00		Field Station# 15164+00			
Pic 1 Desc. P1 is degraded and needs to be replaced.		Pic 2 Desc. Environmental crew has corrected this issue.

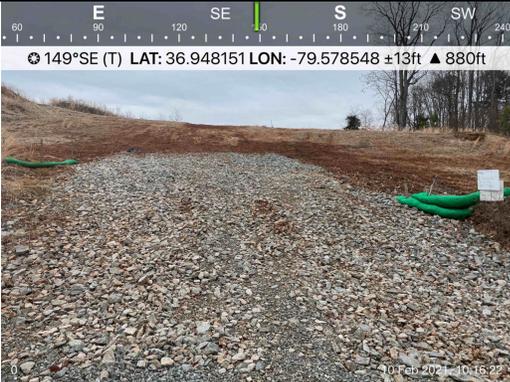
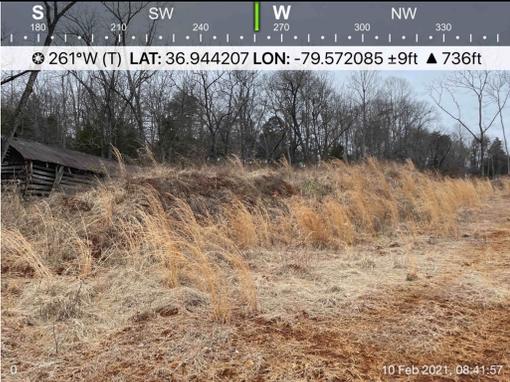
GPS Location See photo		GPS Location See photo			
Field Station# 15142+66		Field Station# 15166+00			
Pic 3 Desc. RCE at Rockcreek Road is in good condition.		Pic 4 Desc. Stockpiles remain stabilized.

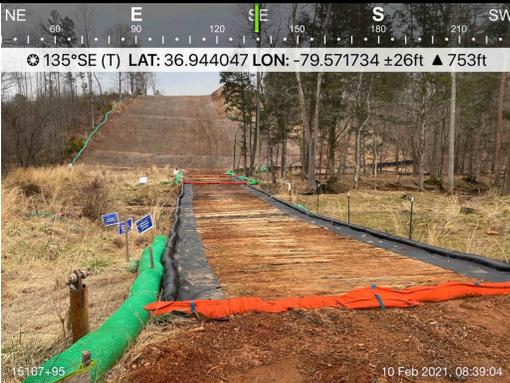
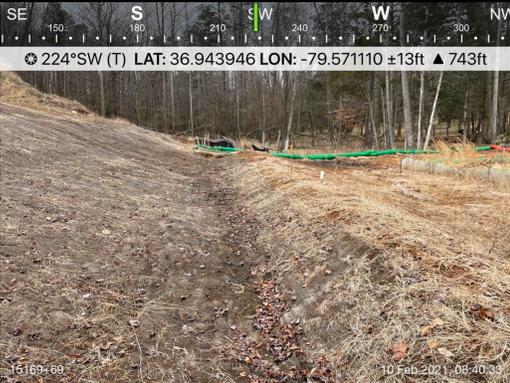
GPS Location See photo		GPS Location See photo			
Field Station# 15167+95		Field Station# 15169+69			
Pic 5 Desc. Equipment bridge ECDs are in place at S-C7 stream crossing.		Pic 6 Desc. Temporary waterbars are functioning as intended.

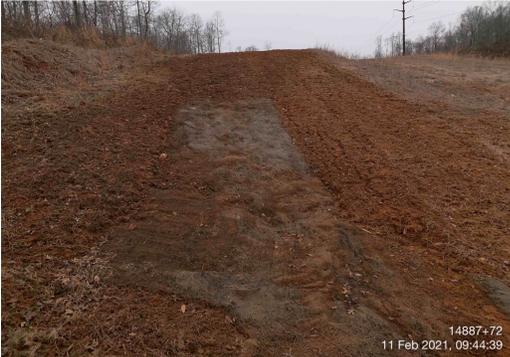
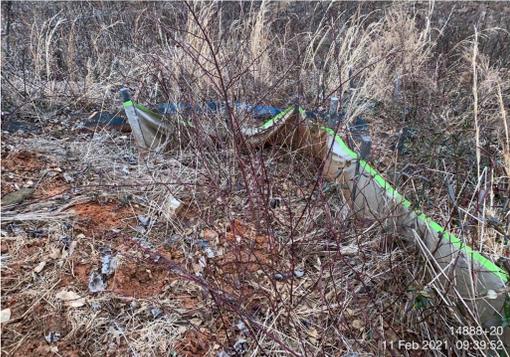
GPS Location	0	GPS Location	0
Field Station#	14887+72	Field Station#	14888+20
Pic 3 Desc.	Erosion is developing under existing Curlex	Pic 4 Desc.	P1 silt fence requiring replacement at stream buffer of S-AB8
Ⓞ 42°NE (M) ● 36°58'10"N, 79°38'51"W ±29ft ▲ 828ft

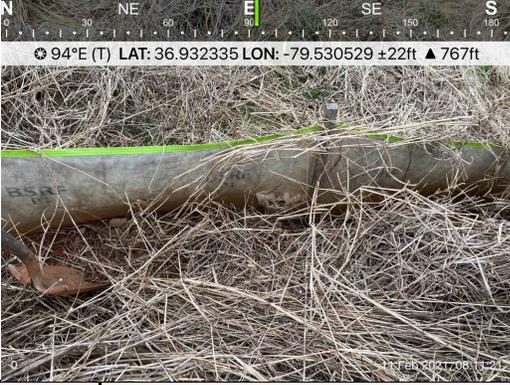
GPS Location See photo		GPS Location See photo			
Field Station# 15300+00		Field Station# 15300+00			
Pic 1 Desc. P1 is damaged and needs to be replaced.		Pic 2 Desc. Environmental crew has corrected this issue.

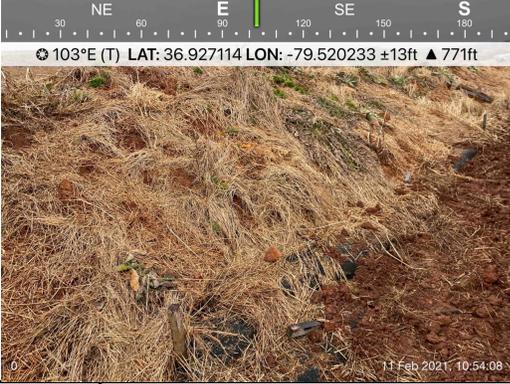
GPS Location See photo		GPS Location See photo			
Field Station# 15338+00		Field Station# 15338+00			
Pic 3 Desc. CFS is degraded and needs to be replaced.		Pic 4 Desc. Environmental crew has replaced CFS with P1.

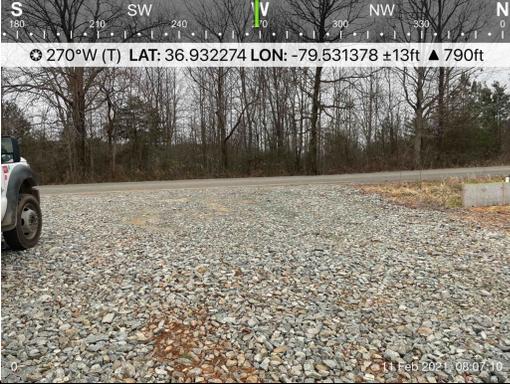
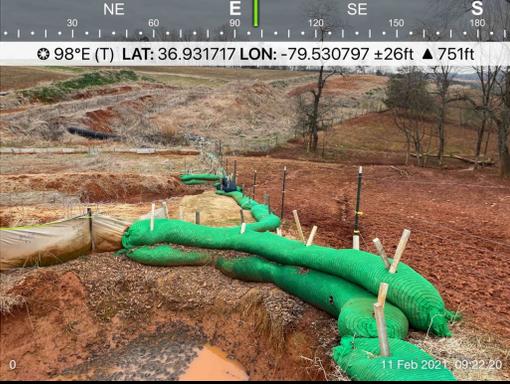
GPS Location See photo		GPS Location See photo			
Field Station# 15296+00		Field Station# 15298+24			
Pic 5 Desc. RCEs are in good condition at all road crossings.		Pic 6 Desc. Waterbar end treatments are functioning as intended.
