Visual Site Inspection Report

Project Name H-600 Pipeline Spread I		AFE 124300139	Spread H-600 Pipeline Spread I
Contractor Precision		Report # 20532	
Inspector Justin Burch		Date/Time 3/1/2021 8:52 AM	
Permit # TBD	Inspection Type VA SWPP	Station Begin 14802+19	
State VA	Inspection Area Full	Station End 14928+52	
County Franklin	Ground Wet	Temperature (°F) 53.00	
Municipality N/A	Weather Light Rain	Rain Gauge (in) 1.00	
			Rain Accumulation Time (days) 6.00

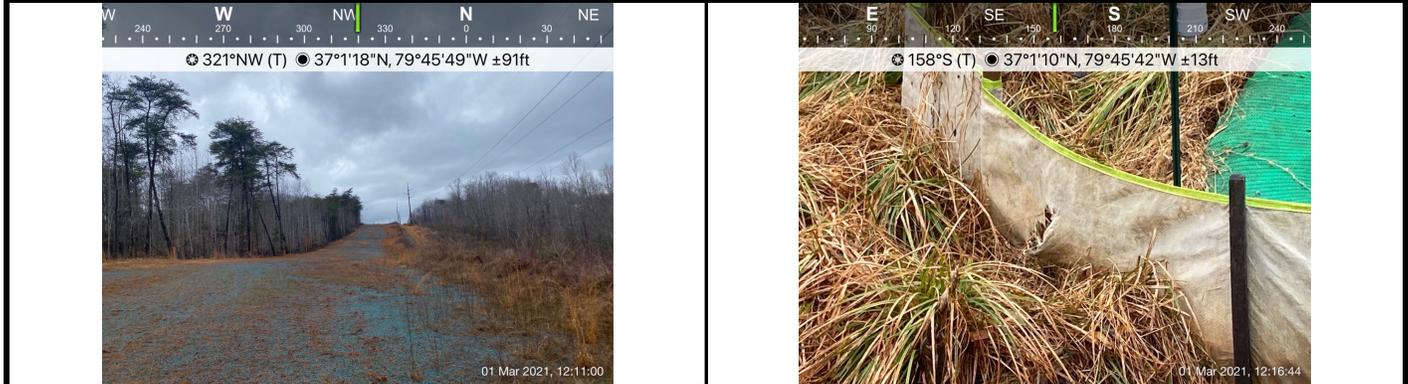
GPS Location	0	GPS Location	0
Field Station#	14475+00	Field Station#	14486+75
Pic 1 Desc.	Approximately 14475+00. Overview of ROW.	Pic 2 Desc.	Approximately 14486+75. P-1 requires maintenance. Appears to have been damaged by livestock or wildlife.

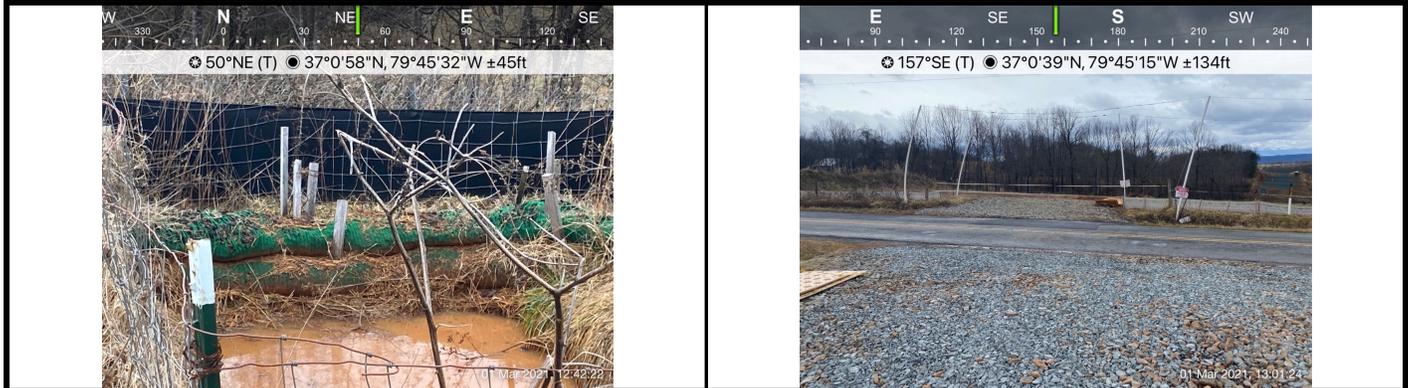
GPS Location	0	GPS Location	0
Field Station#	14501+65	Field Station#	14524+50
Pic 3 Desc.	Approximately 14501+65. CFS requires maintenance.	Pic 4 Desc.	Approximately 14524+50. Overview of road crossing and RCEs.

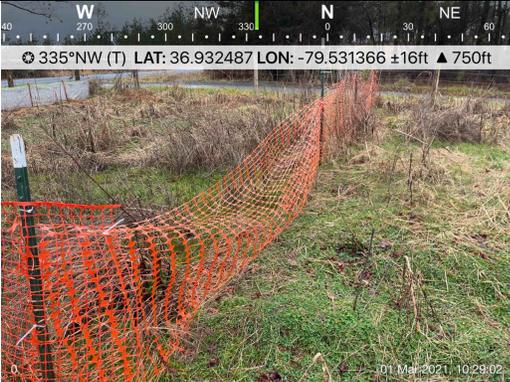
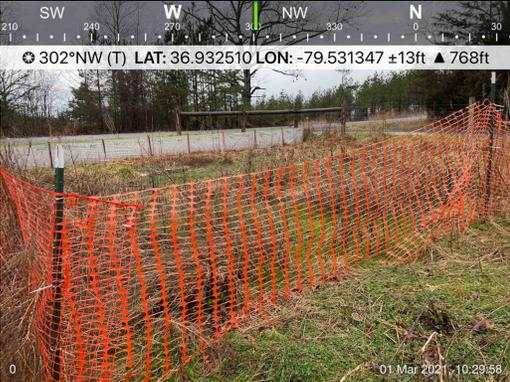
GPS Location	See photo		GPS Location	See photo	
Field Station#	15296+50		Field Station#	15296+50	
Pic 1 Desc.	Safety fence is damaged and needs to be repaired.		Pic 2 Desc.	Environmental crew has corrected this issue.

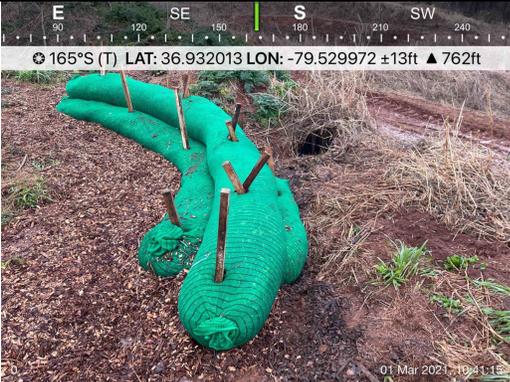
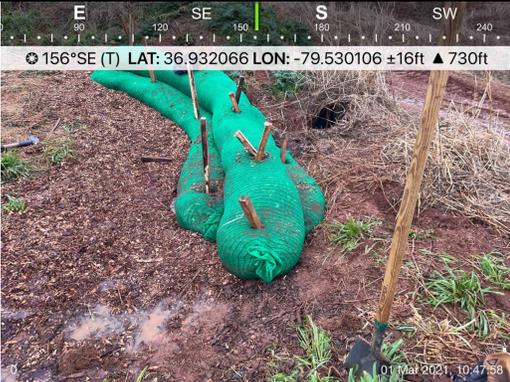
GPS Location	See photo		GPS Location	See photo	
Field Station#	15300+00		Field Station#	15300+00	
Pic 3 Desc.	CWD needs to be keyed in to prevent runoff from going around the ECD.		Pic 4 Desc.	Environmental crew has corrected this issue.

- EI began inspection at Oxford Rd.
- RCEs are in good condition throughout this section.
- CWD inlet at 15300+00 needs to be keyed into topsoil berm. Environmental crew has corrected this issue.
- CWD outlet is undermined at 15301+00. Environmental crew has corrected this issue.
- Rills between the topsoil berm and perimeter P1 at 15335+00 need to be stabilized. Environmental crew has corrected this issue.
- Safety fence is damaged and needs to be repaired in multiple areas. Environmental crew has corrected this issue.
- P1 is in good condition throughout this area.
- Equipment bridge ECDs are in place at all stream and wetland crossings.
- Slip repair at 15338+00 is in good condition after recent rain event.

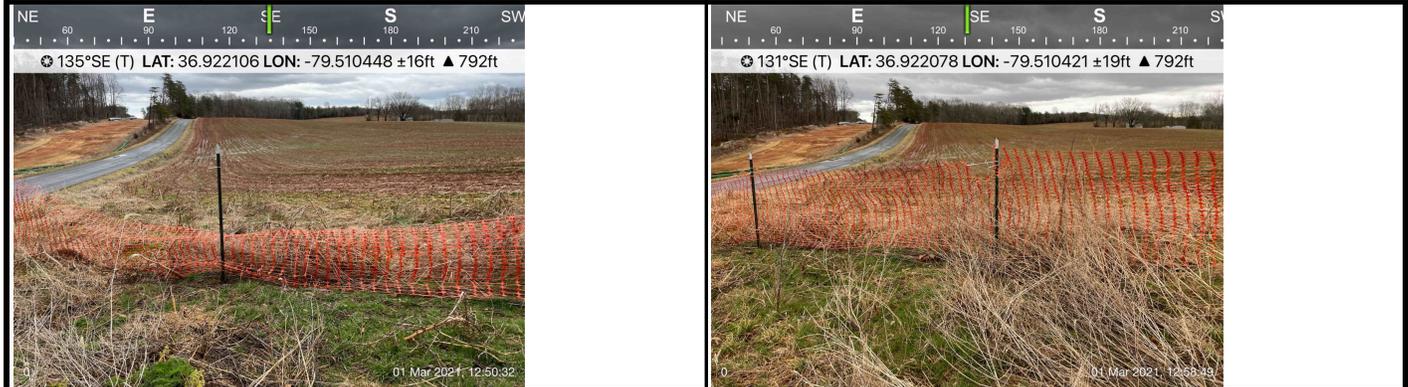
GPS Location	See photo	GPS Location	See photo
Field Station#	15370+00	Field Station#	15370+00
Pic 9 Desc.	Safety fence is damaged and needs to be repaired.	Pic 10 Desc.	Environmental crew has corrected this issue.

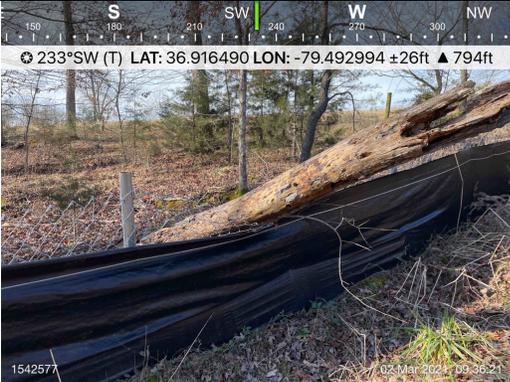
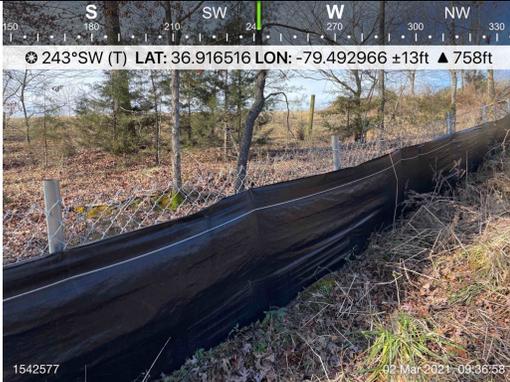
GPS Location See photo		GPS Location See photo			
Field Station# 15425+77		Field Station# 15425+77			
Pic 1 Desc. Tree has fallen across SSF and needs to be removed.		Pic 2 Desc. Environmental crew has corrected this issue.

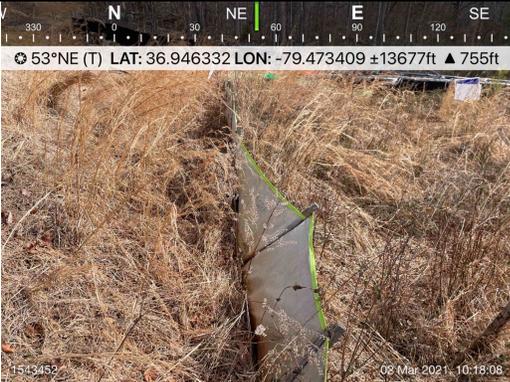
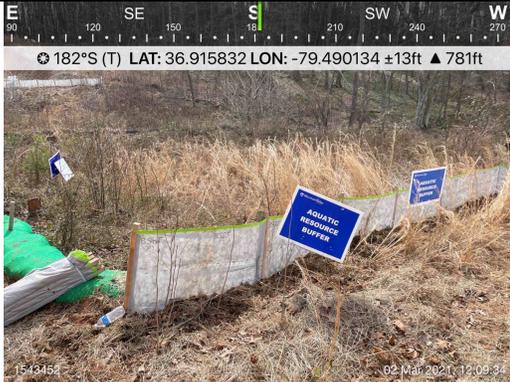
GPS Location See photo		GPS Location See photo			
Field Station# 15434+52		Field Station# 15434+52			
Pic 3 Desc. P1 is degraded and needs to be replaced.		Pic 4 Desc. Environmental crew has corrected this issue.

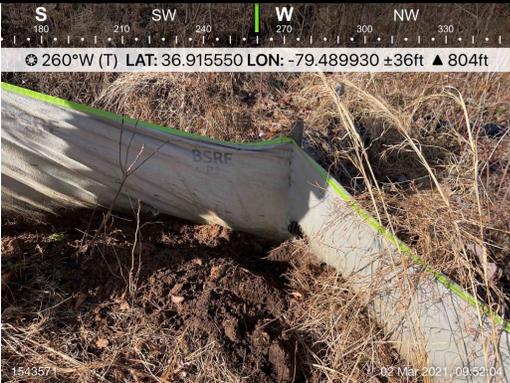
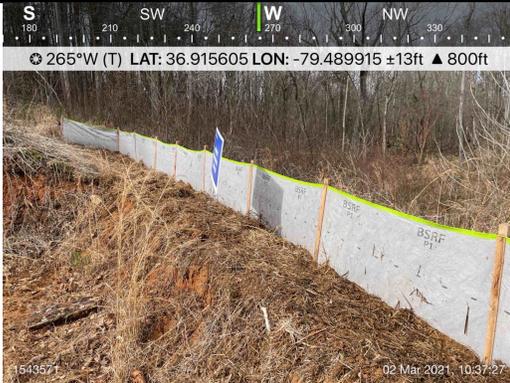
GPS Location See photo		GPS Location See photo			
Field Station# 15435+71		Field Station# 15435+71			
Pic 5 Desc. P1 is degraded and needs to be replaced.		Pic 6 Desc. Environmental crew has corrected this issue.

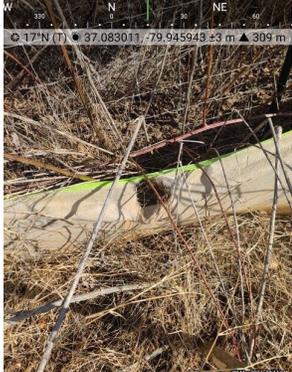
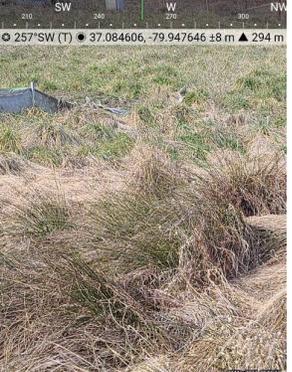
GPS Location	00000	GPS Location	00000		
Field Station#	13704+49	Field Station#	13695+22		
Pic 1 Desc.	P1 requires maintenance on row edge , weathered and torn .		Pic 2 Desc.	P1 requires maintenance at wetland area , documented and added to the punch list.

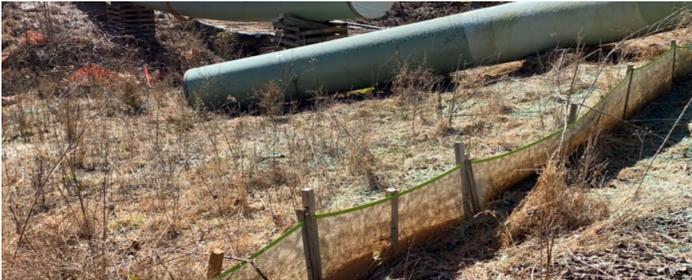
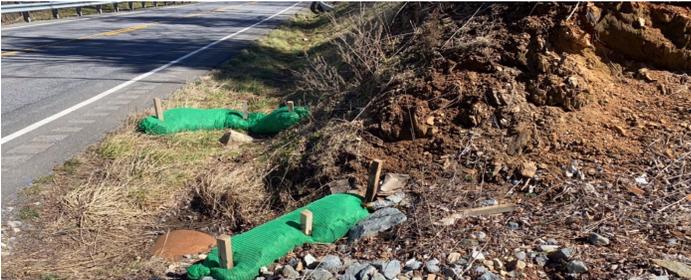
GPS Location 3			GPS Location 4		
Field Station# 14213+50			Field Station# 14209+85		
Pic 3 Desc. Routine maintenance. Replace panel of P1 silt fence with holes in base of fabric.			Pic 4 Desc. Contractor replaced CFS check dams per punch list item

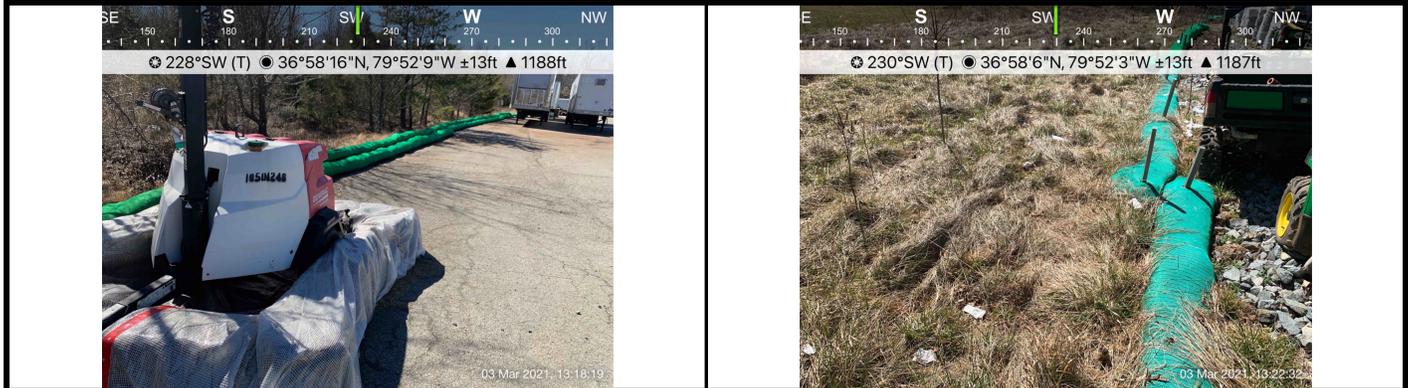
GPS Location	000000000000	GPS Location	000000000000
Field Station#	0000+00	Field Station#	0000+00
Pic 3 Desc.	Secondary containment structure for light plant and perimeter ECD's on south end of MVP-LY-046 in good condition	Pic 4 Desc.	Housekeeping issue along perimeter ECD's on south end of MVP-LY-045.

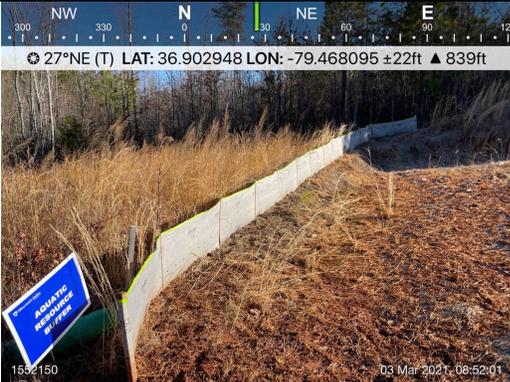
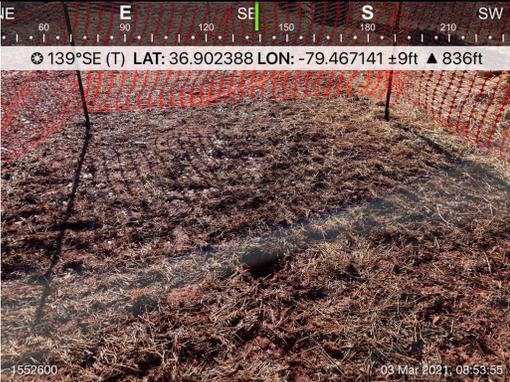
GPS Location See photo		GPS Location See photo			
Field Station# 15521+50		Field Station# 15526+00			
Pic 3 Desc. P1 is in good condition at all stream and wetland buffers.		Pic 4 Desc. Small sink hole at this location will continue to be monitored.

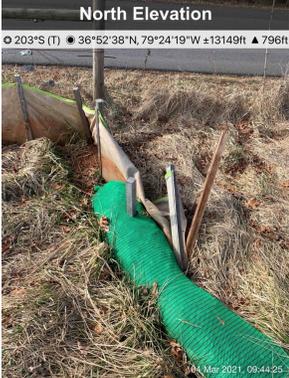
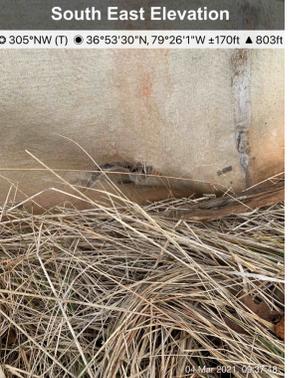
GPS Location	O	GPS Location	O		
Field Station#	15646+00	Field Station#	15637+50		
Pic 1 Desc.	Observing p1 that requires maintenance		Pic 2 Desc.	Observing p1 that requires maintenance

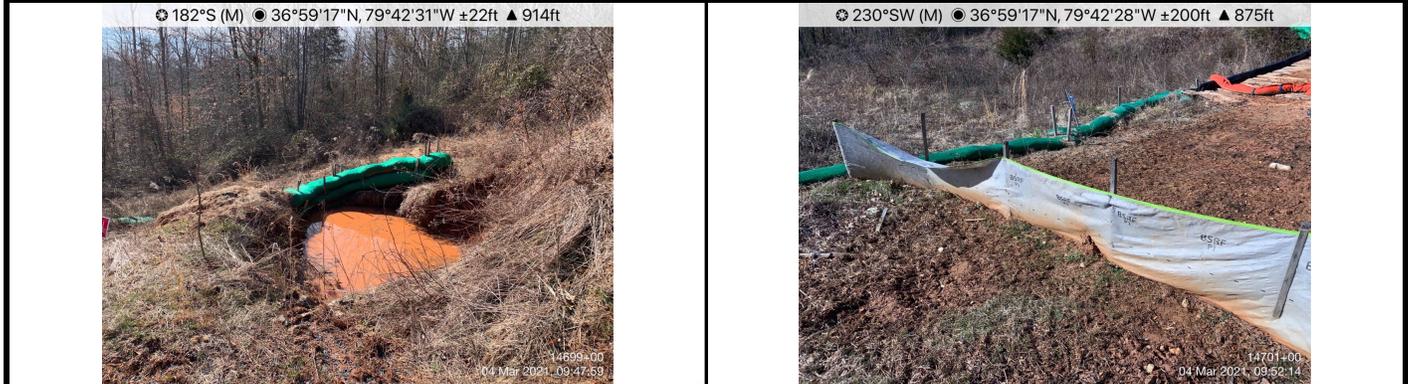
GPS Location	0	GPS Location	0
Field Station#	14699+00	Field Station#	14701+00
Pic 1 Desc.	Waterbar end treatment in acceptable condition	Pic 2 Desc.	P1 silt fence detached from stake and a hole in it

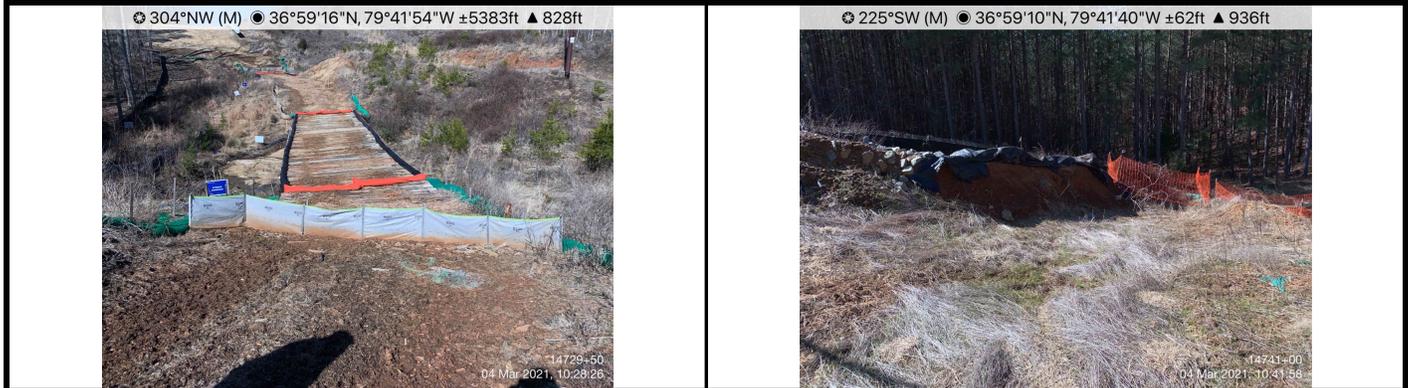
GPS Location	0	GPS Location	0
Field Station#	14729+50	Field Station#	14741+00
Pic 3 Desc.	P1 silt fence in acceptable condition	Pic 4 Desc.	Berm around plunge pool lacking stabilization

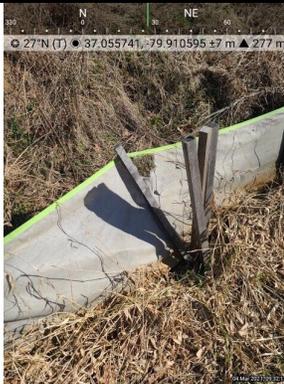
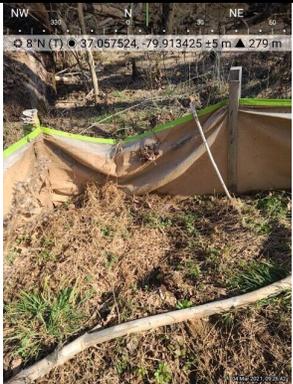
GPS Location	00000		GPS Location	00000	
Field Station#	1388+00		Field Station#	13876+20	
Pic 1 Desc.	P1 requires maintenance due to being weathered and torn. Documented and sent in to be added to the punch list.		Pic 2 Desc.	P1 requires maintenance, documented and sent in to be added to the punch list.

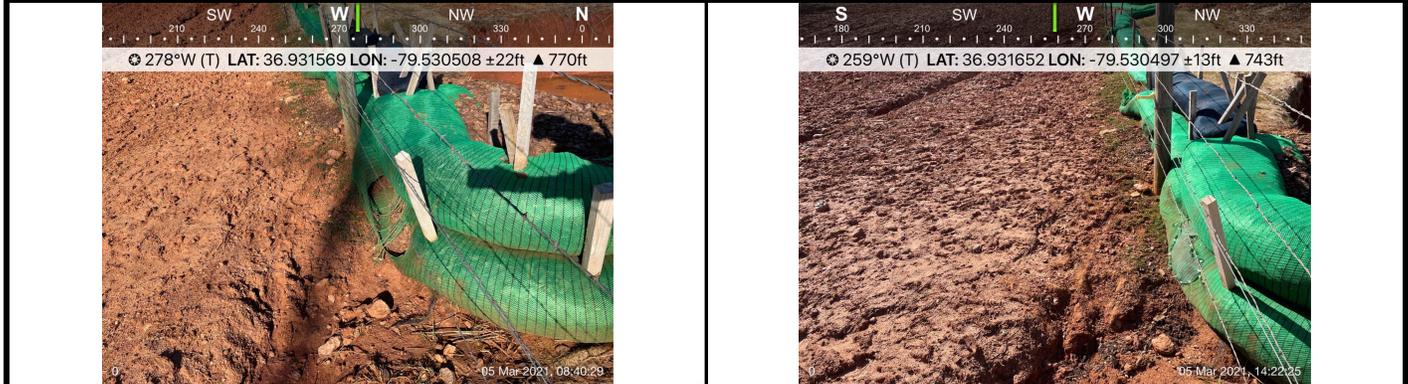
GPS Location	See photo	GPS Location	See photo
Field Station#	15299+00	Field Station#	15299+00
Pic 1 Desc.	CFS end treatment is damaged and needs to be repaired.	Pic 2 Desc.	Environmental crew has corrected this issue.

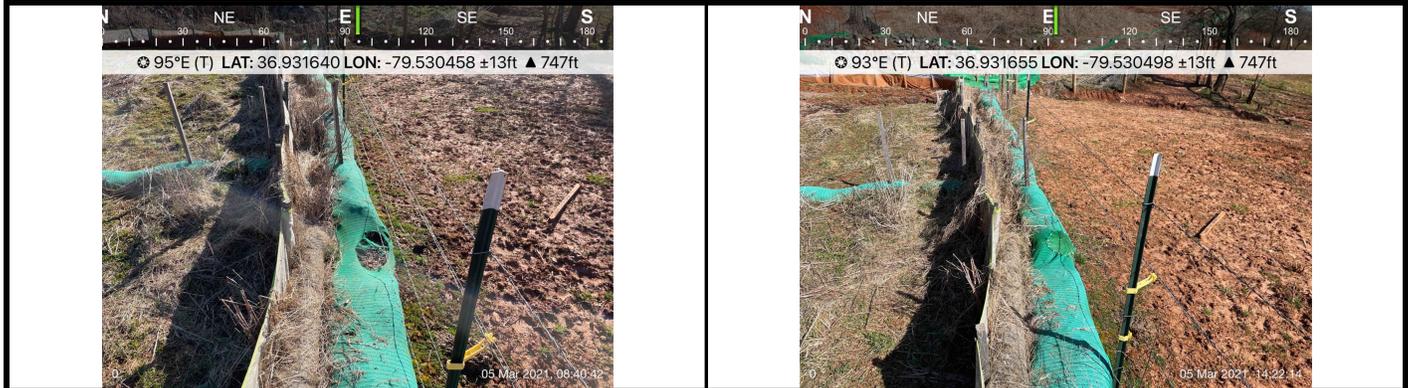
GPS Location	See photo	GPS Location	See photo
Field Station#	15299+50	Field Station#	15299+50
Pic 3 Desc.	Perimeter CFS is damaged and needs to be repaired.	Pic 4 Desc.	Environmental crew has corrected this issue.

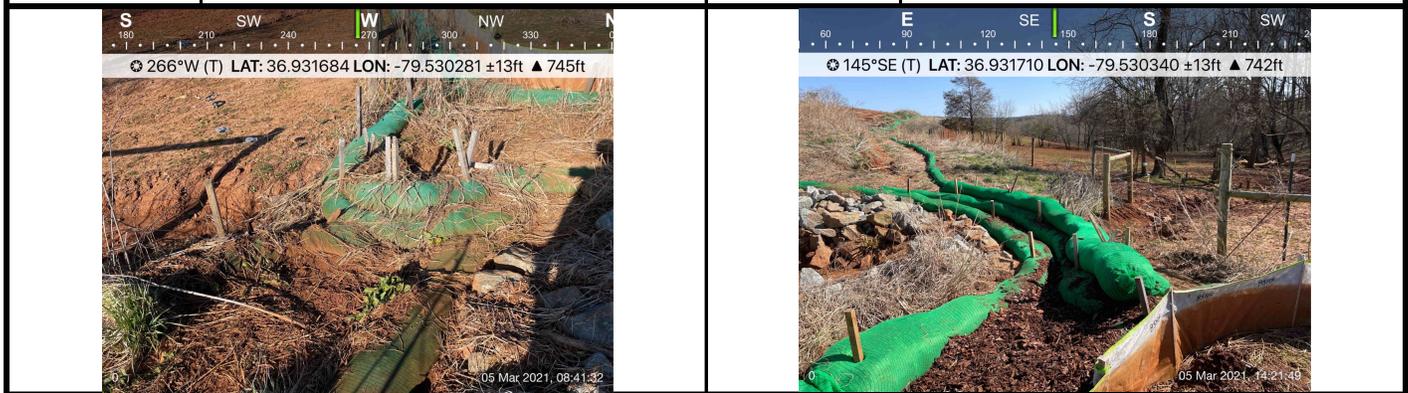
GPS Location	See photo	GPS Location	See photo
Field Station#	15299+75	Field Station#	15299+75
Pic 5 Desc.	Drainage outlet is degraded and needs to be replaced.	Pic 6 Desc.	Environmental crew has corrected this issue.

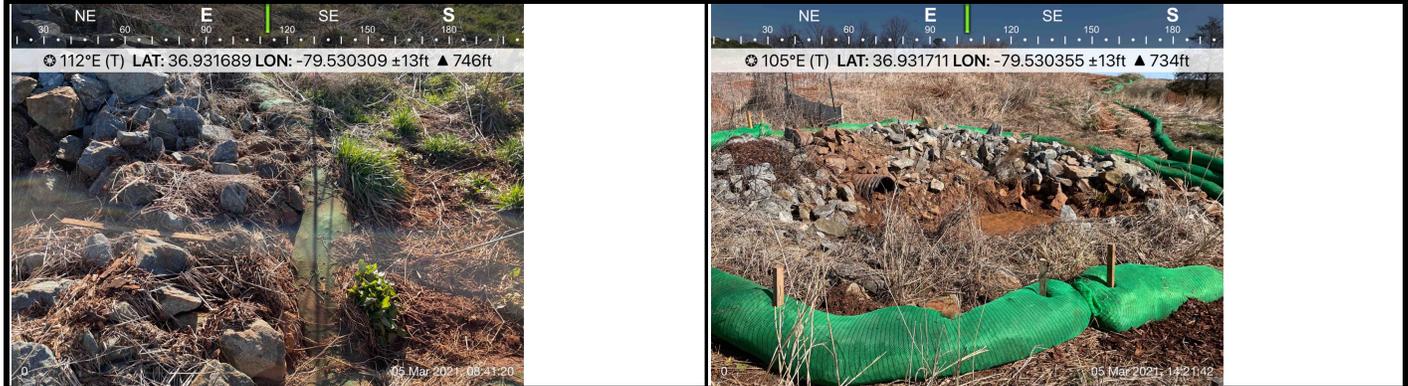
GPS Location	See photo	GPS Location	See photo
Field Station#	15300+00	Field Station#	15300+00
Pic 7 Desc.	Plunge pool CFS is degraded and needs to be replaced.	Pic 8 Desc.	Environmental crew has corrected this issue.

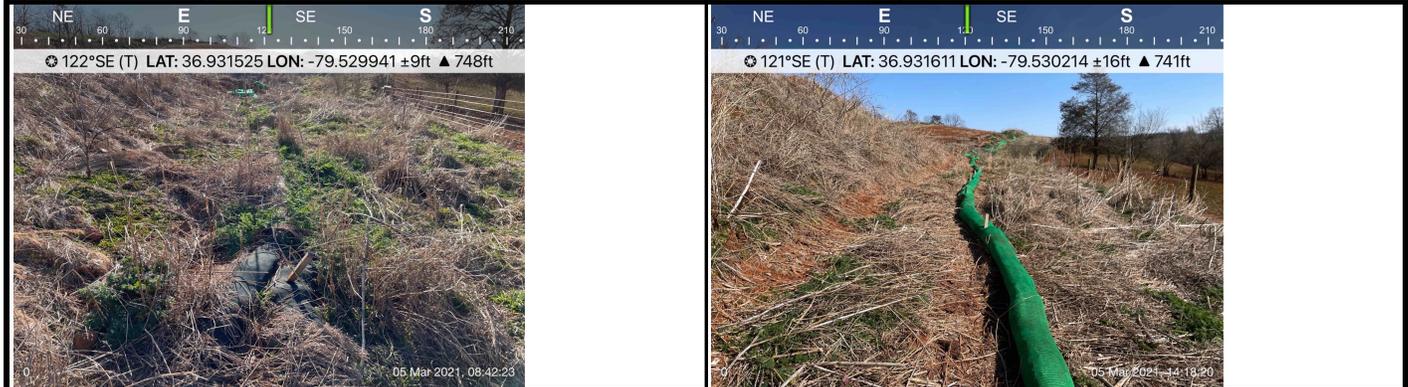
GPS Location	See photo	GPS Location	See photo
Field Station#	15300+00	Field Station#	15300+00
Pic 9 Desc.	Perimeter CFS needs to be replaced from 15300+00-15308+00.	Pic 10 Desc.	Environmental crew has corrected this issue.

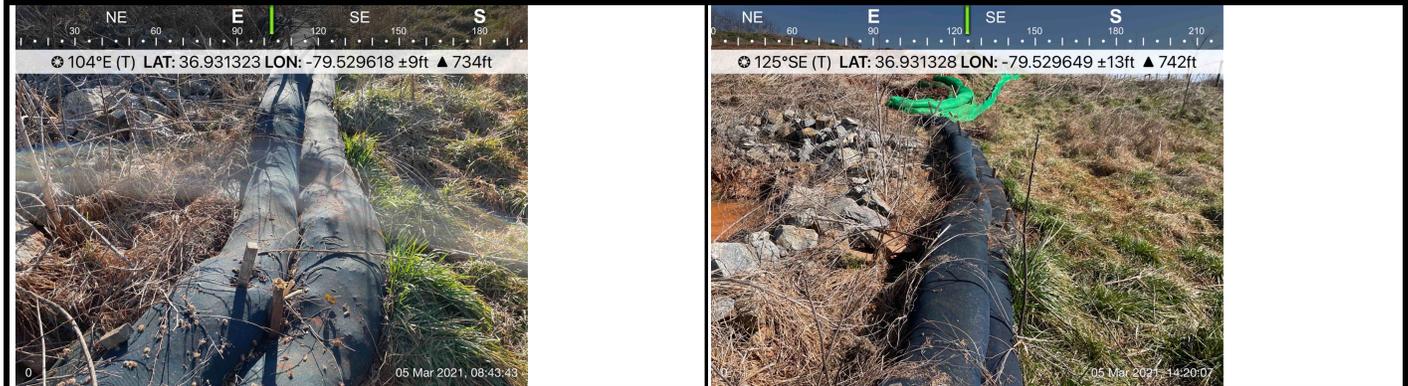
GPS Location	See photo	GPS Location	See photo
Field Station#	15303+00	Field Station#	15303+00
Pic 11 Desc.	CWD outlet CFS needs to be restaked.	Pic 12 Desc.	Environmental crew has corrected this issue.

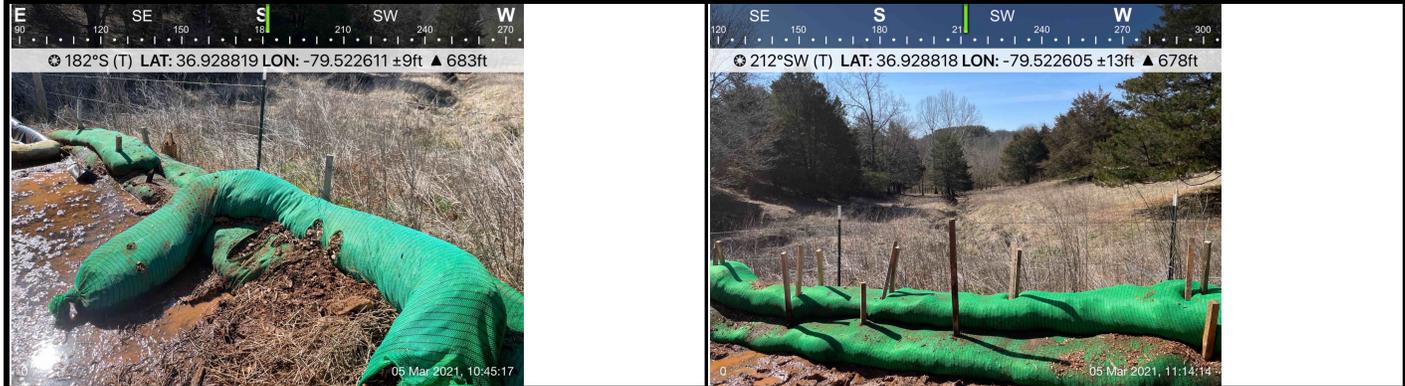
GPS Location	See photo	GPS Location	See photo
Field Station#	15326+00	Field Station#	15326+00
Pic 13 Desc.	CFS is damaged and needs to be replaced.	Pic 14 Desc.	Environmental crew has corrected this issue.
