# Visual Site Inspection Report

<b>Project Name</b> H-600 Pipeline Spread I		<b>AFE</b> 124300139	<b>Spread</b> H-600 Pipeline Spread I
<b>Contractor</b> Precision		<b>Report #</b> 21606	
<b>Inspector</b> Ben Davenport		<b>Date/Time</b> 3/29/2021 9:41 AM	
<b>Permit #</b> TBD	<b>Inspection Type</b> VA SWPP	<b>Station Begin</b> 13958+31	
<b>State</b> VA	<b>Inspection Area</b> Partial	<b>Station End</b> 14062+17	
<b>County</b> Franklin	<b>Ground</b> Muddy	<b>Temperature (°F)</b> 60.00	
<b>Municipality</b> N/A	<b>Weather</b> Sunny	<b>Rain Gauge (in)</b> 0.50	
			<b>Rain Accumulation Time (days)</b> 1.00

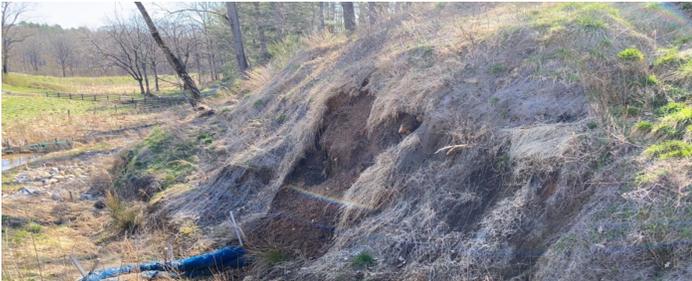
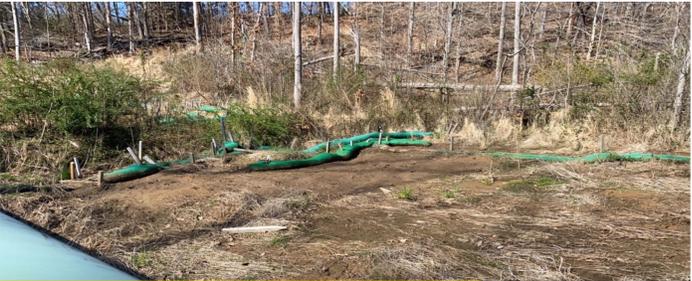
<small>37°36' N 79°53'11" W 116°SE COURSE 215' GPS</small> <small>Rocky Mount, VA 24151, United States</small>		<small>03.29.2021 10:13:06</small> <small>Accur +/-18.4 Ft ALT 1008 Ft</small>		<small>37°31'2" N 79°53'4" W 287°W COURSE 220' GPS</small> <small>Rocky Mount, VA 24151, United States</small>	
<small>03.29.2021 11:00:41</small> <small>Accur +/-76.6 Ft ALT 1136 Ft</small>					
<b>GPS Location</b>	1	<b>GPS Location</b>	2		
<b>Field Station#</b>	14990+00	<b>Field Station#</b>	13999+00		
<b>Pic 1 Desc.</b>	Routine maintenance. Repair and stabilize minor slip of fill slope		<b>Pic 2 Desc.</b>	Discussed plan to correct issues surround ECDs in resource buffer GAS S-KL36

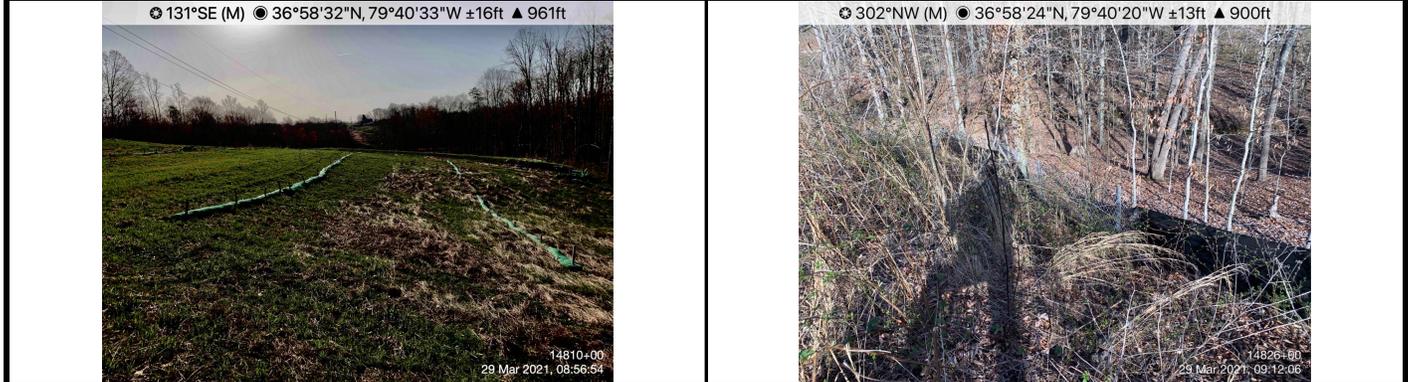
<b>GPS Location</b>	0	<b>GPS Location</b>	0
<b>Field Station#</b>	14810+00	<b>Field Station#</b>	14826+00
<b>Pic 1 Desc.</b>	Permanent vegetative stabilization in acceptable condition	<b>Pic 2 Desc.</b>	Super silt fence fabric is detached from the wire fence

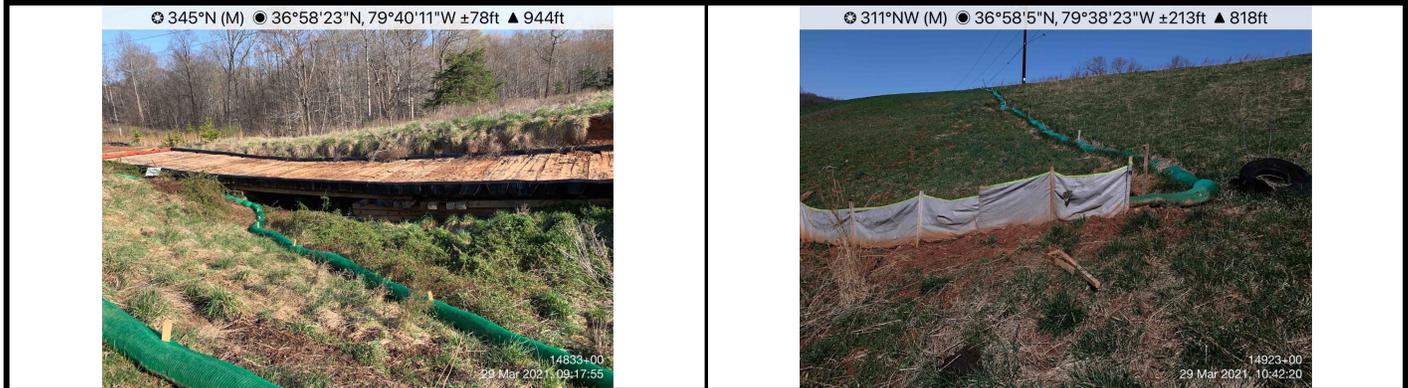
<b>GPS Location</b>	0	<b>GPS Location</b>	0
<b>Field Station#</b>	14833+00	<b>Field Station#</b>	14923+00
<b>Pic 3 Desc.</b>	Equipment bridge in acceptable condition	<b>Pic 4 Desc.</b>	Holes in P1 silt fence (2 panels)

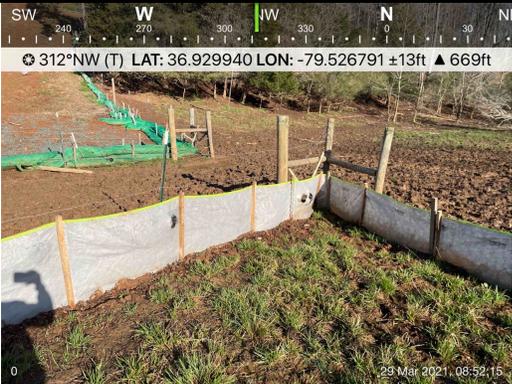
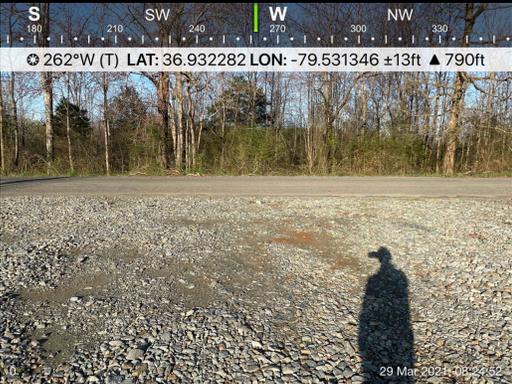
- EI began inspection at Oxford Rd.
- RCEs are in good condition at all road crossings.
- CWD is in good condition and functioning at 15299+00.
- P1 is damaged and needs to be replaced around wetland buffer at 15311+78.
- Equipment bridge ECDs are in place and functioning.
- Previously repaired diversion berm and CWD inlet are in good condition at 15338+00.
- Waterbars are in good condition and functioning.
- Area remains temporarily stabilized.

<b>GPS Location</b>	See photo	<b>GPS Location</b>	See photo		
<b>Field Station#</b>	15311+78	<b>Field Station#</b>	15296+00		
<b>Pic 1 Desc.</b>	P1 is damaged around wetland buffer and needs to be replaced.	<b>Pic 2 Desc.</b>	RCEs are in good condition at all road crossings.

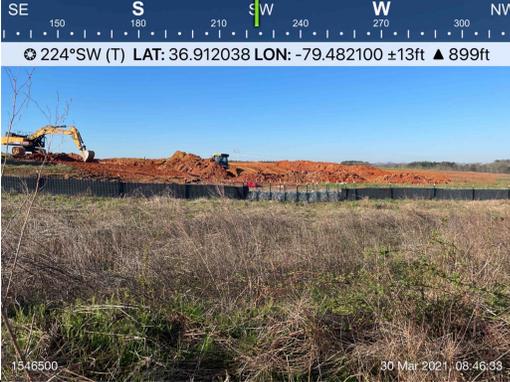
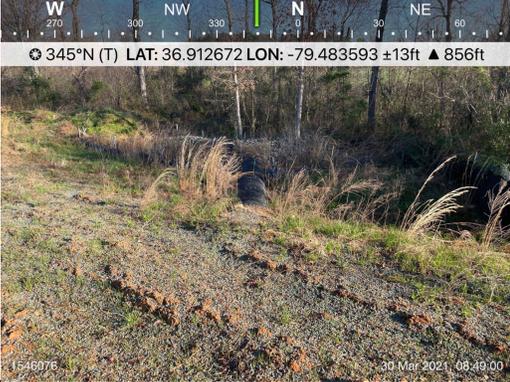
<b>GPS Location</b> See photo		<b>GPS Location</b> See photo			
<b>Field Station#</b> 15465+00		<b>Field Station#</b> 15460+76			
<b>Pic 3 Desc.</b> 3rd party disturbance up slope from rock outlet will continue to be monitored during rain events.		<b>Pic 4 Desc.</b> CWDs are in good condition and functioning.

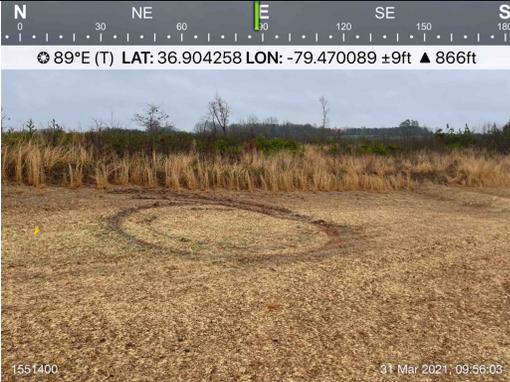
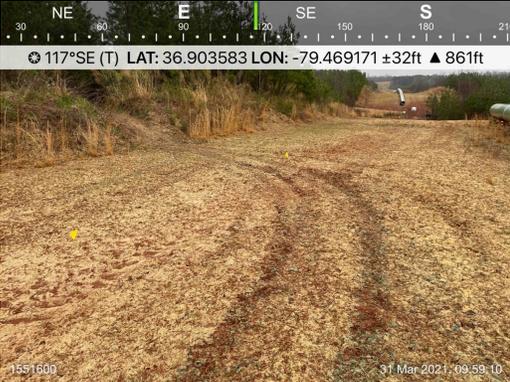
<b>GPS Location</b> See photo		<b>GPS Location</b> See photo			
<b>Field Station#</b> 15514+00		<b>Field Station#</b> 15516+00			
<b>Pic 1 Desc.</b> 3rd party ATV use disturbing temporary stabilization.		<b>Pic 2 Desc.</b> 3rd party ATV use disturbing temporary stabilization.

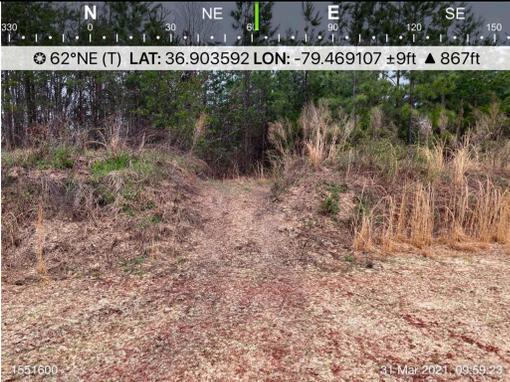
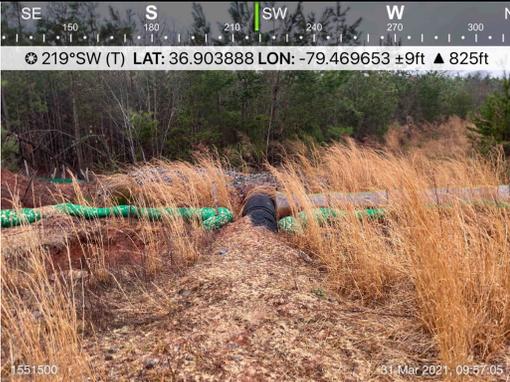
<b>GPS Location</b> See photo		<b>GPS Location</b> See photo			
<b>Field Station#</b> 15516+00		<b>Field Station#</b> 15515+00			
<b>Pic 3 Desc.</b> 3rd party ATV use disturbing temporary stabilization.		<b>Pic 4 Desc.</b> CWDs are in good condition and functioning as intended.

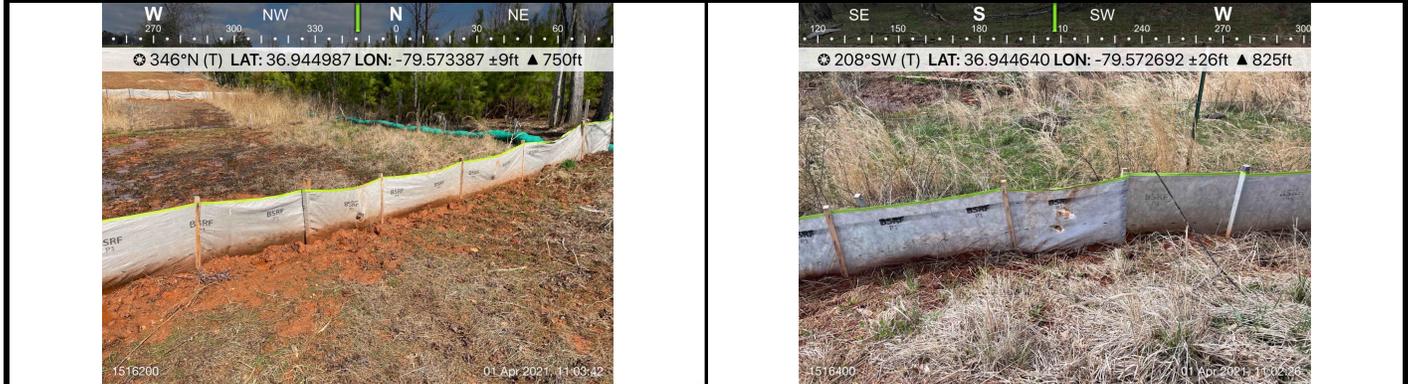
<b>GPS Location</b>	See photo	<b>GPS Location</b>	See photo
<b>Field Station#</b>	15162+00	<b>Field Station#</b>	15164+00
<b>Pic 1 Desc.</b>	P1 has been damaged by livestock and needs to be replaced.	<b>Pic 2 Desc.</b>	P1 has been damaged by livestock and needs to be replaced.

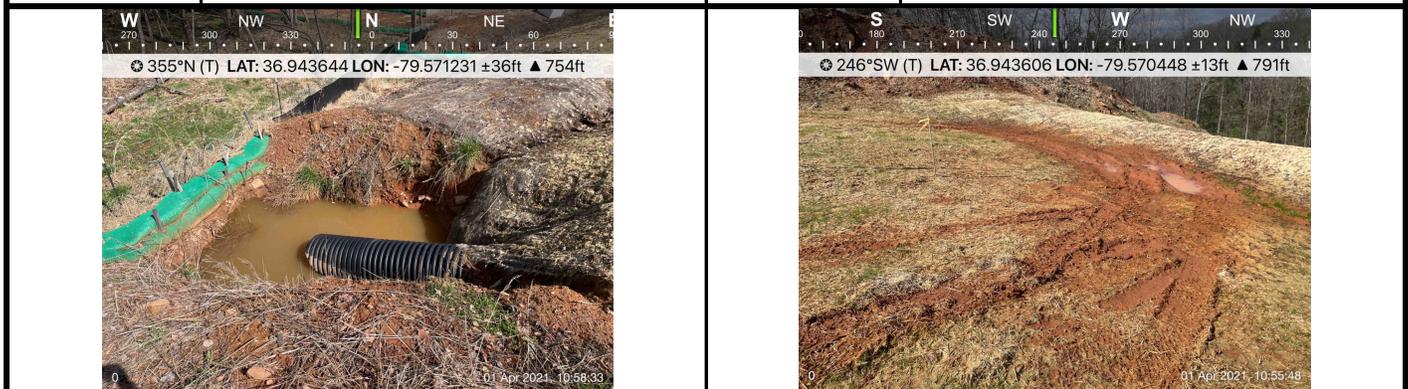
<b>GPS Location</b>	See photo	<b>GPS Location</b>	See photo
<b>Field Station#</b>	15170+00	<b>Field Station#</b>	15171+00
<b>Pic 5 Desc.</b>	Slope drain is in good condition and functioning.	<b>Pic 6 Desc.</b>	Unauthorized ATV use by 3rd party has disturbed some areas of temporary stabilization.

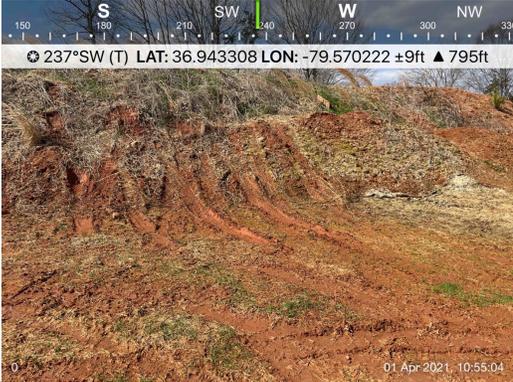
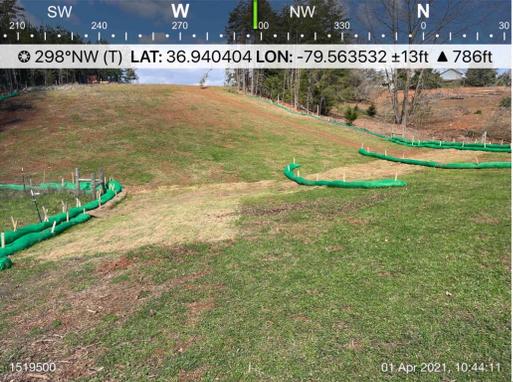
<b>GPS Location</b>	See photo		<b>GPS Location</b>	See photo	
<b>Field Station#</b>	15171+00		<b>Field Station#</b>	15195+00	
<b>Pic 7 Desc.</b>	Unauthorized ATV use by 3rd party has disturbed some areas of temporary stabilization.		<b>Pic 8 Desc.</b>	Drainage ECDs are in good condition and functioning.

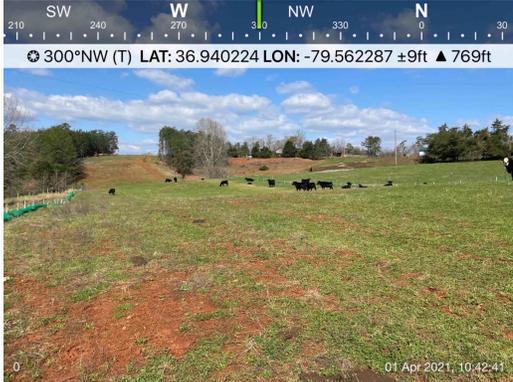
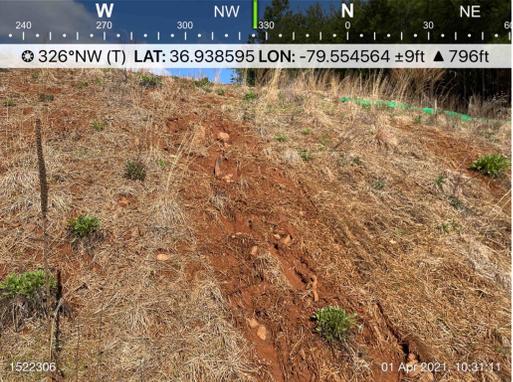
<b>GPS Location</b>	See photo		<b>GPS Location</b>	See photo	
<b>Field Station#</b>	15196+00		<b>Field Station#</b>	15223+06	
<b>Pic 9 Desc.</b>	Cows present on ROW.		<b>Pic 10 Desc.</b>	Rill erosion needs to be regraded and stabilized.

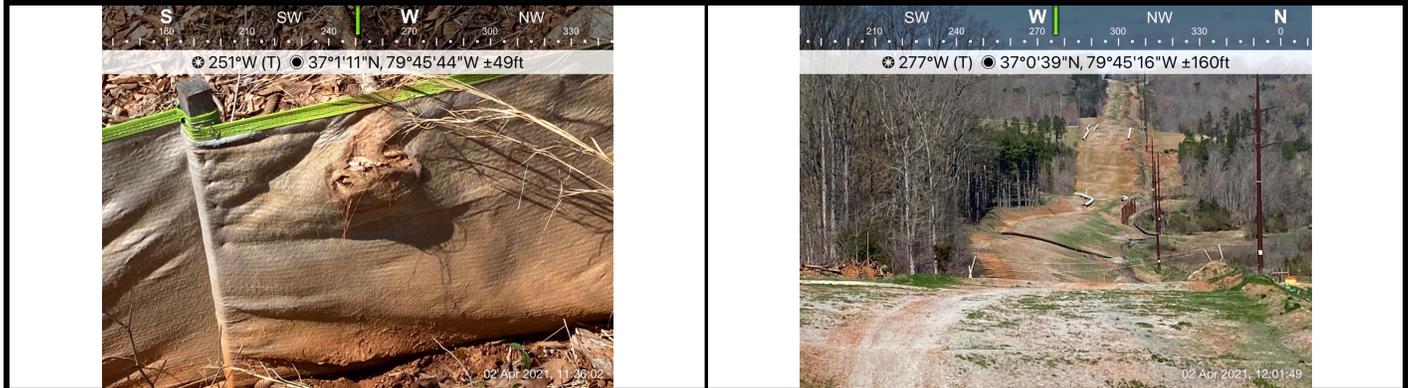
<b>GPS Location</b>	0	<b>GPS Location</b>	0
<b>Field Station#</b>	14485+25	<b>Field Station#</b>	14510+00
<b>Pic 3 Desc.</b>	Approximately 14485+25. P-1 damaged by livestock.	<b>Pic 4 Desc.</b>	Approximately 14510+00. Overview of ROW.

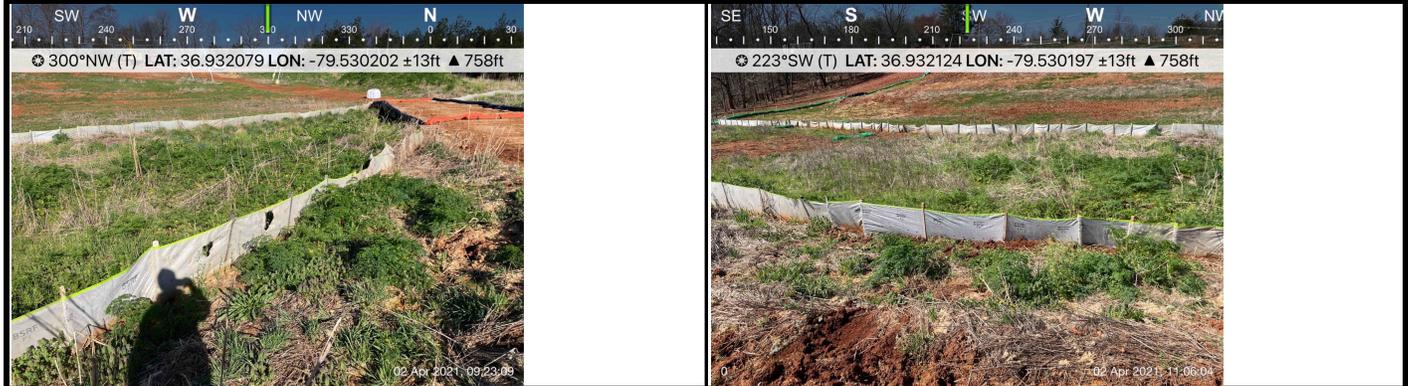
<b>GPS Location</b>	See photo	<b>GPS Location</b>	See photo
<b>Field Station#</b>	15299+75	<b>Field Station#</b>	15299+75
<b>Pic 7 Desc.</b>	P1 has been damaged by livestock and needs to be replaced.	<b>Pic 8 Desc.</b>	Environmental crew has corrected this issue.
