Visual Site Inspection Report

Project Name H-600 Pipeline Spread G		AFE 124300137	Spread H-600 Pipeline Spread G
Contractor Precision		Report # 19361	
Inspector Chris Burns		Date/Time 1/25/2021 12:30 PM	
Permit # TBD	Inspection Type VA SWPP	Station Begin 11023+80	
State VA	Inspection Area Partial	Station End 11064+53	
County Giles	Ground Wet	Temperature (°F) 39.00	
Municipality N/A	Weather Heavy Rain	Rain Gauge (in) 0.10	
			Rain Accumulation Time (days) 1.00

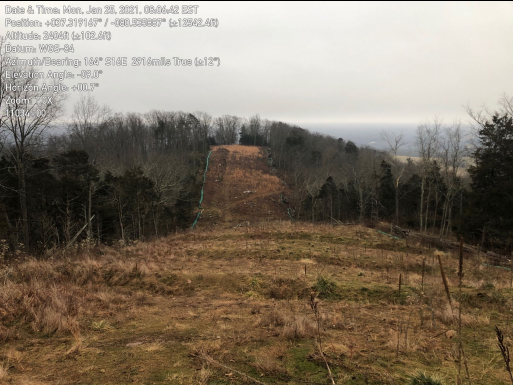
GPS Location 1		GPS Location 2			
Field Station# 11025+50		Field Station# 11034+00			
Pic 1 Desc. S-IJ18 and controls.		Pic 2 Desc. Section of RoW showing conditions and controls.

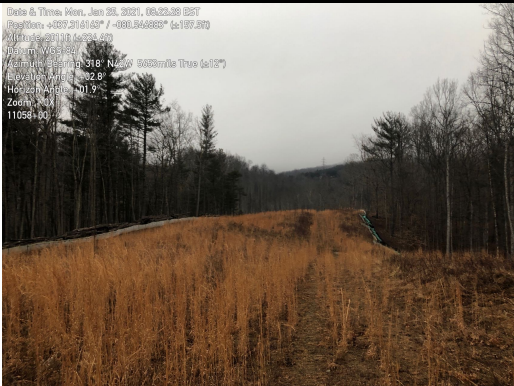
GPS Location 3		GPS Location 4			
Field Station# 11049+00		Field Station# 11050+10			
Pic 3 Desc. Section of RoW showing conditions and controls.		Pic 4 Desc. S-IJ16B/S-IJ17 and controls.

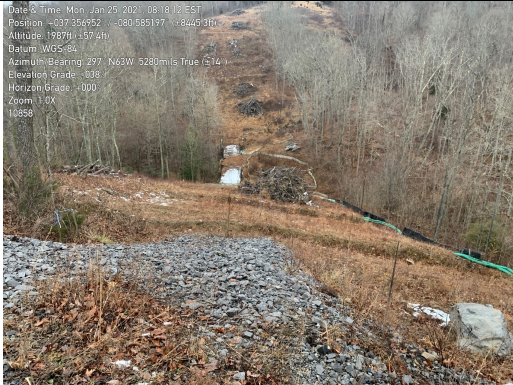
<p>Date & Time: Mon, Jan 25, 2021, 08:18:12 EST Position: +37.34932° / -80.55177° (+44.93 mi) Altitude: 198 ft (+1.57 mi) Datum: WGS-84 Azimuth/Bearing: 297° N63W 5280mils True (+14) Elevation Grade: -038 Horizon Grade: -000 Zoom: 1.0X 10858</p>		<p>GPS Location See picture above for GPS coordinates</p> <p>Field Station# 10833+00</p> <p>Pic 1 Desc. .2" of rain recorded</p>		<p>GPS Location See picture above for GPS coordinates</p> <p>Field Station# 10850+00</p> <p>Pic 2 Desc. ECD's and row conditions</p>

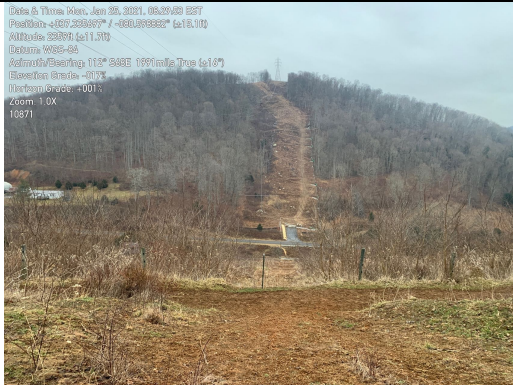
<p>Date & Time: Mon, Jan 25, 2021, 08:39:49 EST Position: +37.34932° / -80.55177° (+44.93 mi) Altitude: 285 ft (+1.10) Datum: WGS-84 Azimuth/Bearing: 113° 28' 55" 180mils True (+17) Elevation Grade: -010X Horizon Grade: -001X Zoom: 1.0X 10871</p>		<p>GPS Location See picture above for GPS coordinates</p> <p>Field Station# 10864+00</p> <p>Pic 3 Desc. ECD's and row conditions</p>		<p>GPS Location See picture above for GPS coordinates</p> <p>Field Station# 10871+00</p> <p>Pic 4 Desc. ECD's and row conditions</p>

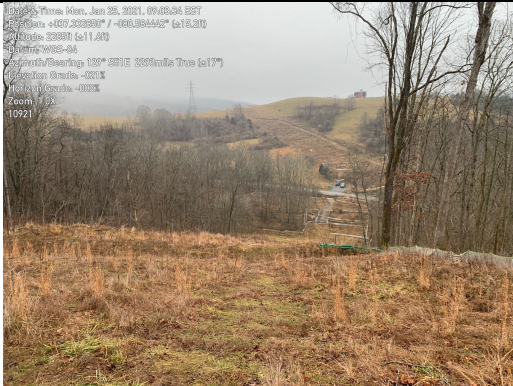
<p>Date & Time: Mon, Jan 25, 2021, 08:40:24 EST Position: +37.34932° / -80.55177° (+44.93 mi) Altitude: 288 ft (+1.07) Datum: WGS-84 Azimuth/Bearing: 123° 28' 55" 230mils True (+17) Elevation Grade: -021X Horizon Grade: -000X Zoom: 1.0X 10921</p>		<p>GPS Location See picture above for GPS coordinates</p> <p>Field Station# 10883+00</p> <p>Pic 5 Desc. ECD's and row conditions</p>		<p>GPS Location See picture above for GPS coordinates</p> <p>Field Station# 10921+00</p> <p>Pic 6 Desc. ECD's and row conditions</p>

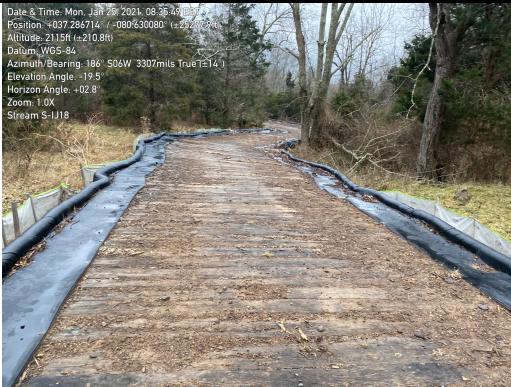
<p><small>Date & Time Mon, Jan 25, 2021, 08:36:49 EST Position: +037.225714° / +080.630880° (+57.2) Altitude: 2115ft (+210.8m) Datum: WGS-84 Azimuth/Bearing: 186.506W 3307mils True (+1.4) Elevation Angle: -19.5 Horizon Angle: +02.8 Zoom: 1.0X Stream: S-IJ18</small></p>

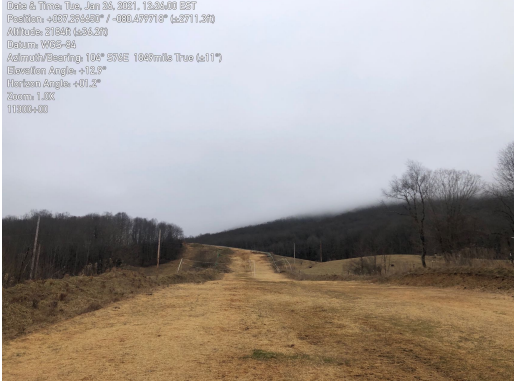
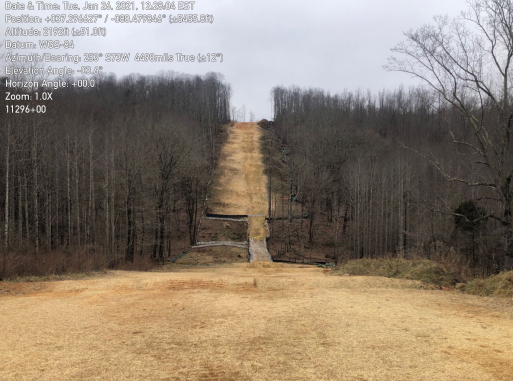
GPS Location 1		GPS Location 2			
Field Station# 11300+00		Field Station# 11296+00			
Pic 1 Desc. Section of RoW showing conditions and controls.		Pic 2 Desc. Section of RoW showing conditions and controls.

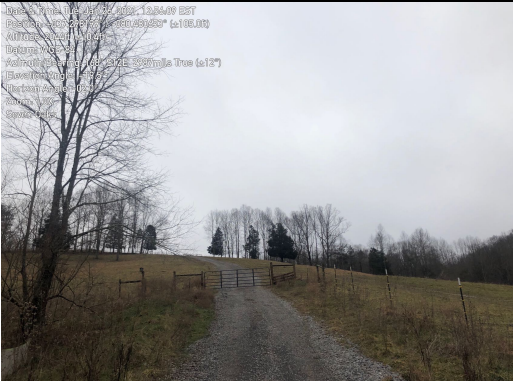
GPS Location 3		GPS Location 4			
Field Station# 11292+80		Field Station# 11298+00			
Pic 3 Desc. S-MM18 and controls.		Pic 4 Desc. AR 234 conditions.

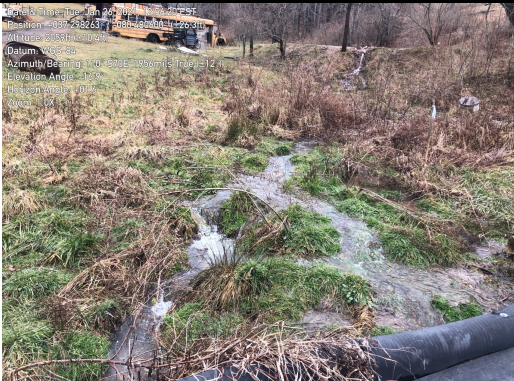
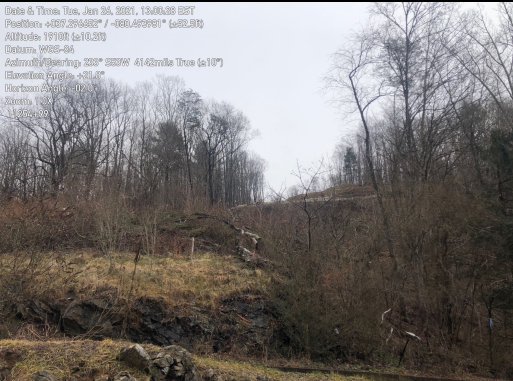
GPS Location 5		GPS Location 6			
Field Station# 11298+50		Field Station# 11254+99			
Pic 5 Desc. S-MM17/W-MM10 conditions.		Pic 6 Desc. Section of RoW showing conditions and controls.

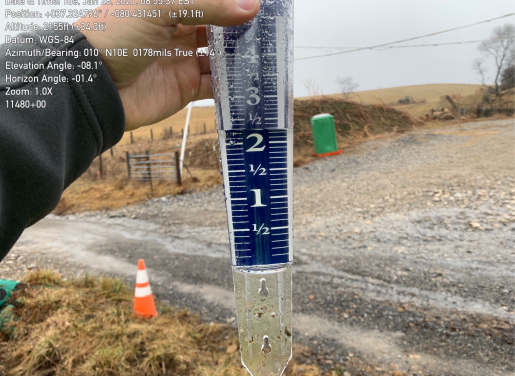
<p><small>Date & Time: Tue, Jan 26, 2021, 08:55:37 EST Position: +037.253697° / -080.431451° (+19.17) Altitude: 2355 (+43.00) Datum: WGS-84 Azimuth/Bearing: 010° N10E 0178mils True (+1.6°) Elevation Angle: -08.1° Horizon Angle: -01.4° Zoom: 1.0X 11480+00</small></p>			
GPS Location See photo for GPS location.	GPS Location See photo for GPS location.			
Field Station# 11475+50	Field Station# 11480+00			
Pic 1 Desc. Sloughing on two-tone. Replace ECB.	Pic 2 Desc. Rain gauge at Stevers Gap Road reads 2.25 inches.

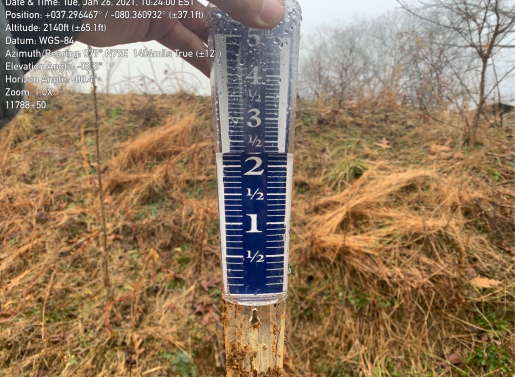
Conducted VA SWPPP inspection from MP 215 to MP 218.3.
 Since last inspection Precision Pipeline has conducted ECD maintenance and ECD upgrades where needed.
 No forward progress has been completed due to FERC shut down.
 Right of way has been stabilized using seed, mulch, and natural vegetation.
 Deficiencies located at station numbers;
 11475+50 - Sloughing on two-tone. Re-stabilize with new ECB
 11492+50 - undermined CFS end treatment.
 11512+58 - Hole and broken stake in priority one silt fence.

<p><small>Date & Time: Tue, Jan 26, 2021, 10:24:00 EST Position: +037.246467° / -080.369732° (+37.17) Altitude: 2140 (+25.11) Datum: WGS-84 Azimuth/Bearing: 070° N79E 1600mils True (+1.2°) Elevation Angle: -03.5° Horizon Angle: -00.0° Zoom: 1.0X 11788+50</small></p>			
GPS Location See photo for GPS location.	GPS Location See photo for GPS location.			
Field Station# 11512+58	Field Station# 11788+50

Pic 5 Desc. Priority one silt fence has broken stakes and holes.	Pic 6 Desc. Rain gauge at Mount Tabor Road reads 2.25 inches.

E&S BMPs	Compliance Level	Corrective Action	Corrective Time Frame	Date Repaired
Broad-Based Dip	Acceptable			
Cleanwater Diversion Berm	Acceptable			
Cleanwater Diversion Pipe	Acceptable			
Compost Filter Sock	Communication	Repair undermining	24 Hours	
Equipment Bridge	Acceptable			
Erosion Control Blanket	Communication	Replace ECB	48 Hours	
Rock Construction Entrance	Acceptable			
Silt Fence (Filter Fabric Fence)	Communication	Replace fence.	24 Hours	
Sensitive Resource Buffer	Acceptable

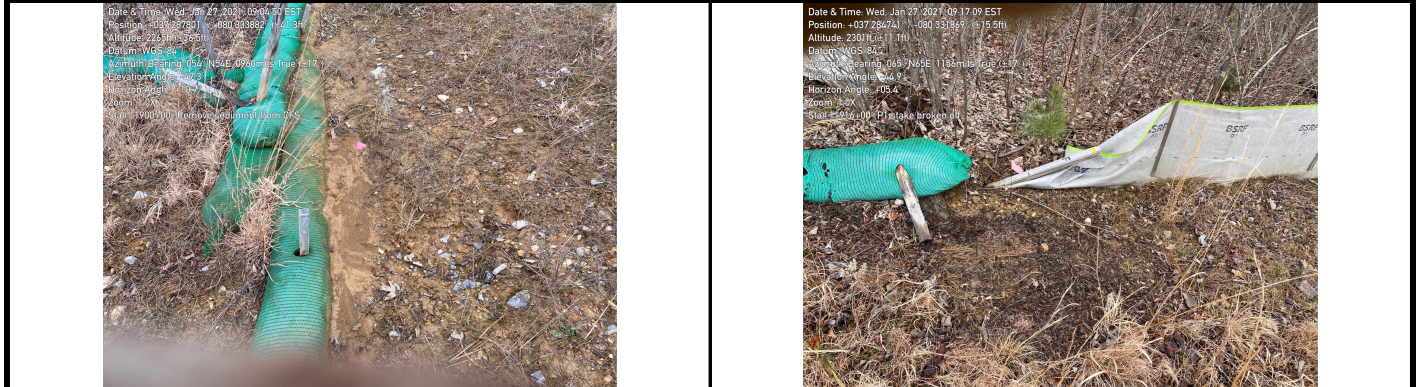
GPS Location	See photo GPS	GPS Location	See photo GPS
Field Station#	11900+00	Field Station#	11916+00
Pic 1 Desc.	Remove sediment buildup, contractor notified and items added to the punch list.	Pic 2 Desc.	Wooden stake broken, P1 down, contractor notified and items added to the punch list.

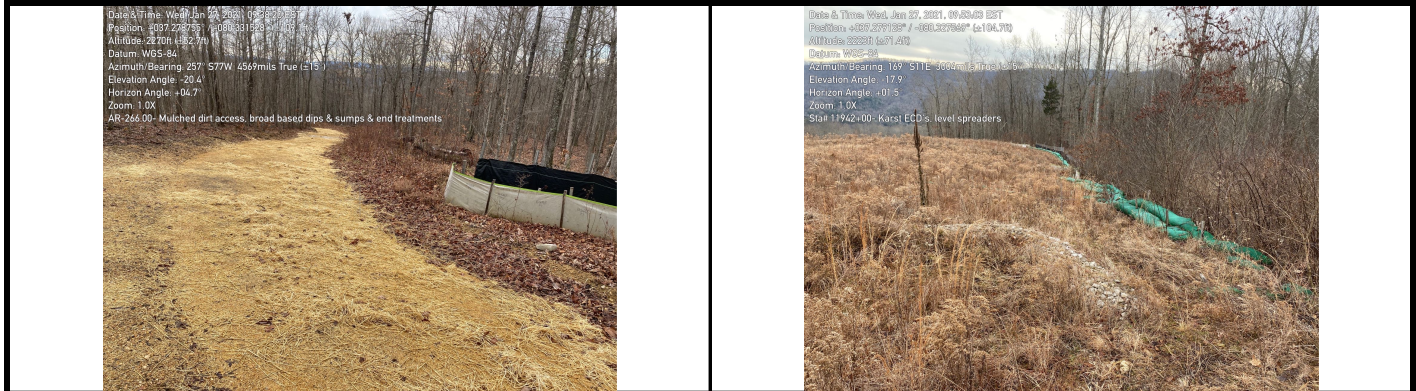
GPS Location	See photo GPS	GPS Location	See photo GPS
Field Station#	11930+00	Field Station#	11942+00
Pic 3 Desc.	AR-266.00- Mulched access road, broad based dips, controls.	Pic 4 Desc.	Karst ECD's.

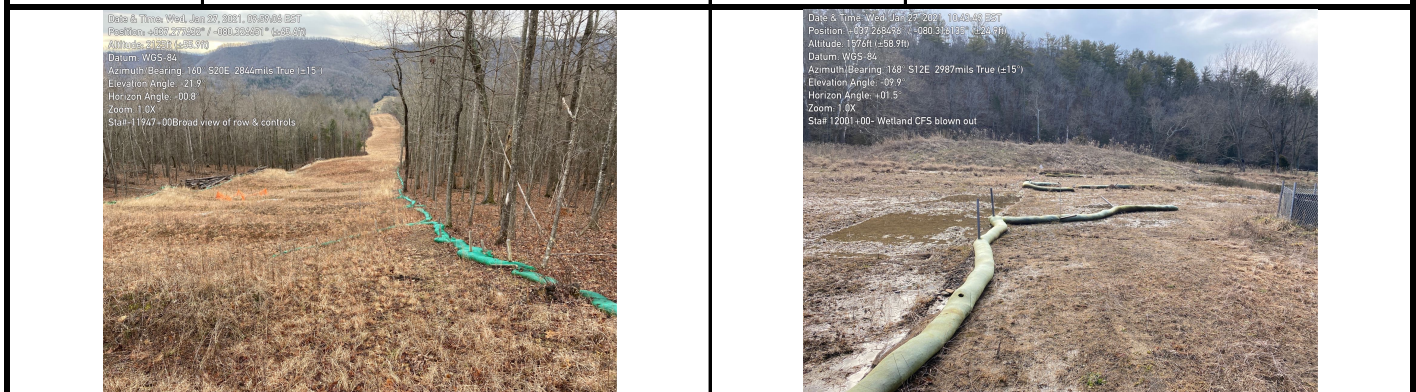
GPS Location	See photo GPS	GPS Location	See photo GPS
Field Station#	11947+00	Field Station#	12001+00
Pic 5 Desc.	Broad view of the row and controls.	Pic 6 Desc.	CFS blown out in wetlands, contractor notified and items added to the punch list.

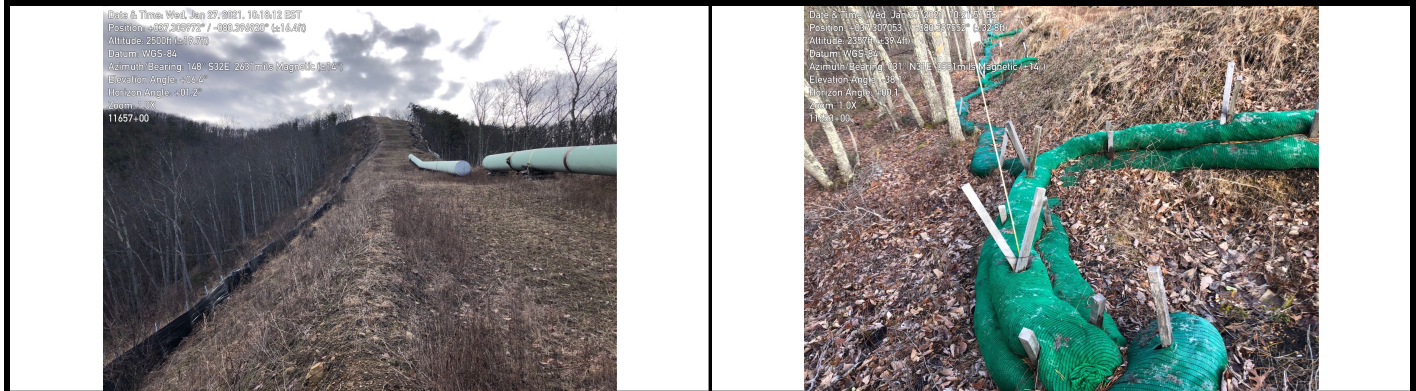
GPS Location	On photo	GPS Location	On photo
Field Station#	11657+00	Field Station#	11653+00
Pic 3 Desc.	Perimeter controls in place. Slope breakers functional. Surface stable.	Pic 4 Desc.	End treatments are working as designed.

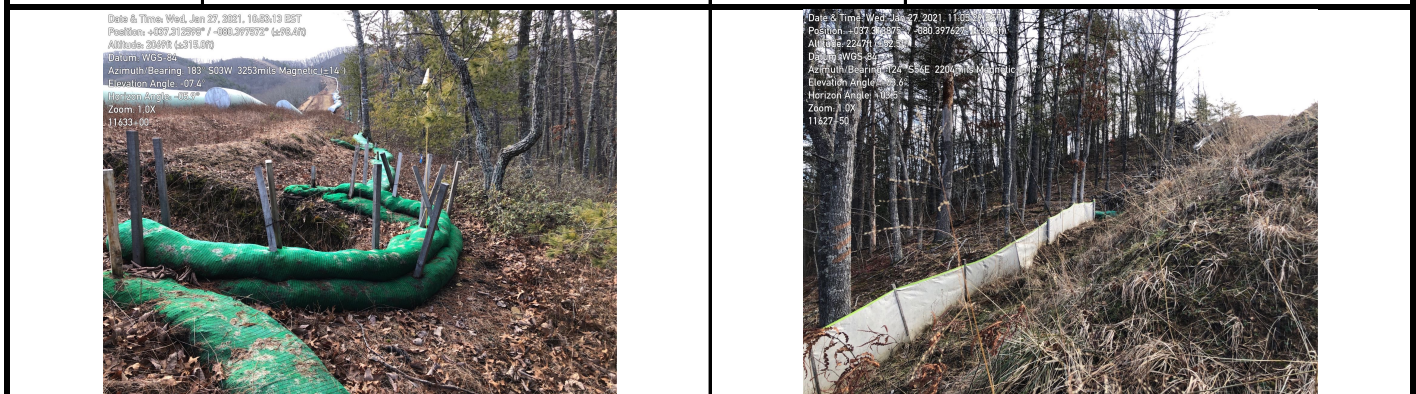
GPS Location	On photo	GPS Location	On photo
Field Station#	11633+00	Field Station#	11627+50
Pic 5 Desc.	End treatments are in place and functional.	Pic 6 Desc.	Perimeter controls are in place and functional.

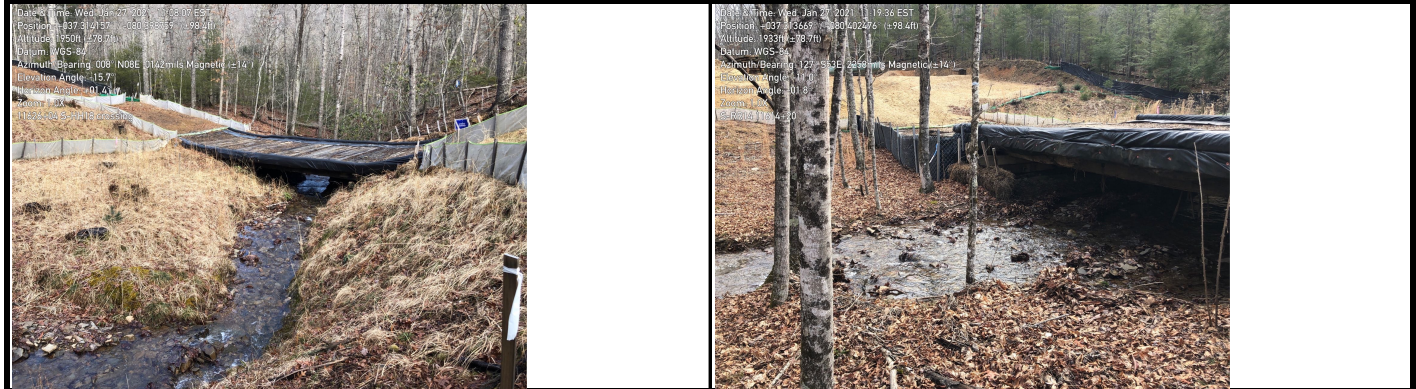
GPS Location	On photo	GPS Location	On photo
Field Station#	11626+04	Field Station#	11614+20
Pic 7 Desc.	S-HH18 buffer stable. ECDS in place. No apparent impact to resource.	Pic 8 Desc.	S-RR14 crossing buffer stable. ECDs in place. No impact at resource.

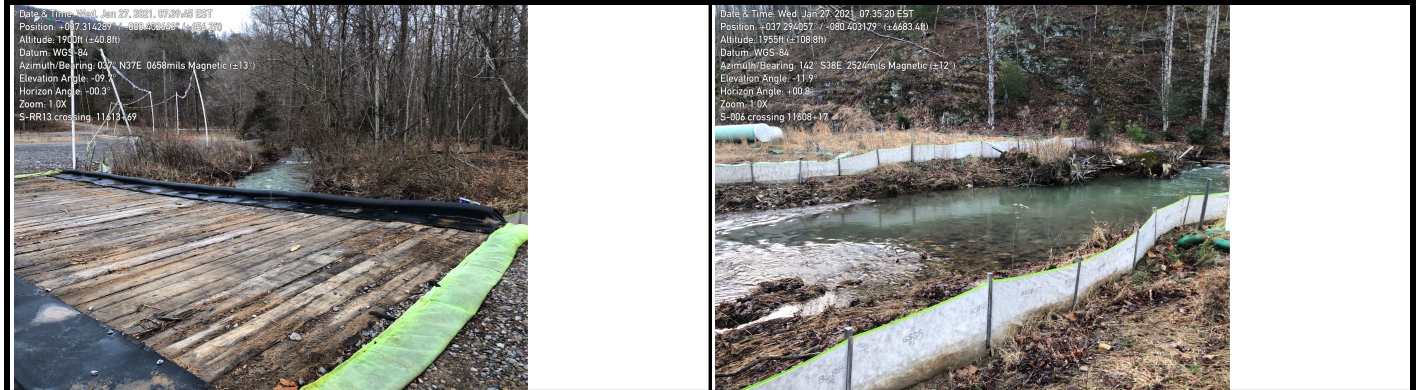
GPS Location	On photo	GPS Location	On photo
Field Station#	11613+69	Field Station#	11698+17
Pic 9 Desc.	S-RR13 crossing stable at access MN-258.04.	Pic 10 Desc.	S-006 crossing stable. ECDs in place. No impact to resource.

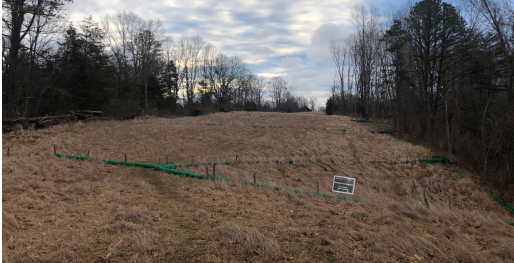
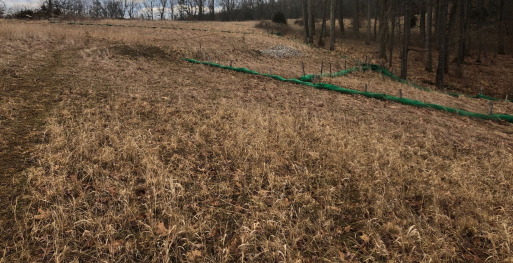
GPS Location 1		GPS Location 2			
Field Station# 11792+00		Field Station# 11812+00			
Pic 1 Desc. Section of restored RoW showing conditions and controls.		Pic 2 Desc. Section of restored RoW showing conditions and controls.

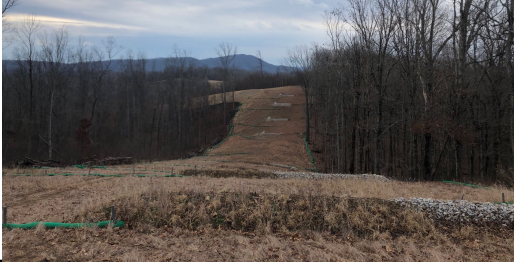
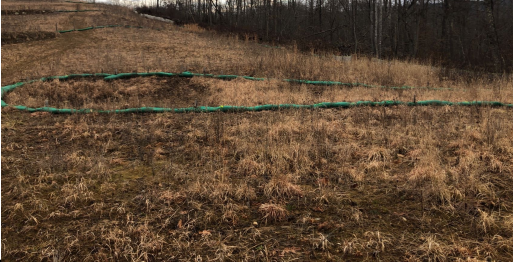
GPS Location 3		GPS Location 4			
Field Station# 11825+00		Field Station# 11863+65			
Pic 3 Desc. Section of restored RoW showing conditions and controls.		Pic 4 Desc. P-KL2 and controls.

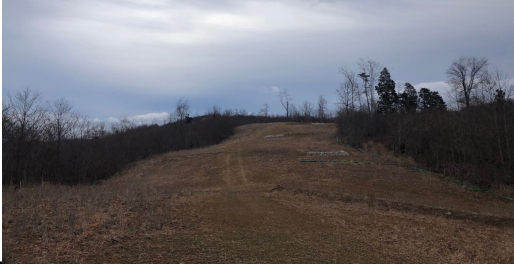
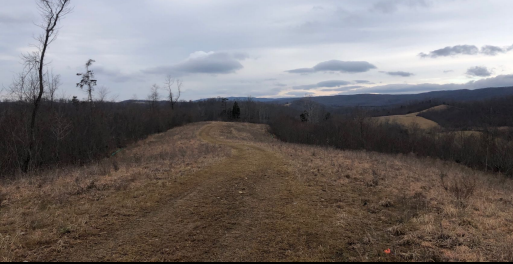
GPS Location 5		GPS Location 6			
Field Station# 11886+00		Field Station# 11899+50			
Pic 5 Desc. Section of restored RoW showing conditions and controls.		Pic 6 Desc. Section of restored RoW showing conditions and controls.

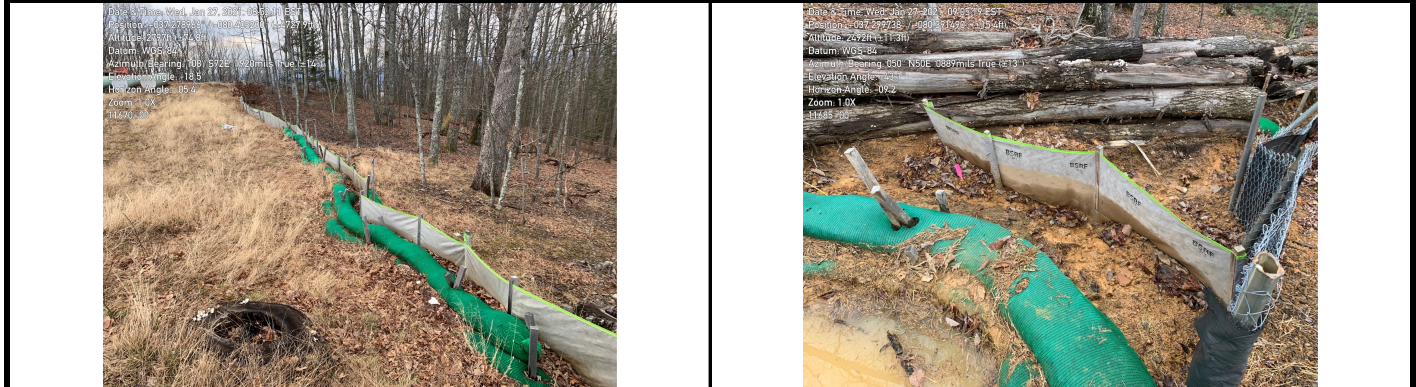
GPS Location	See photo for GPS location.	GPS Location	See photo for GPS location.
Field Station#	11670+00	Field Station#	11685+00
Pic 1 Desc.	Triple stack compost filter sock and priority one silt fence in place along LOD.	Pic 2 Desc.	Undermined priority one silt fence.

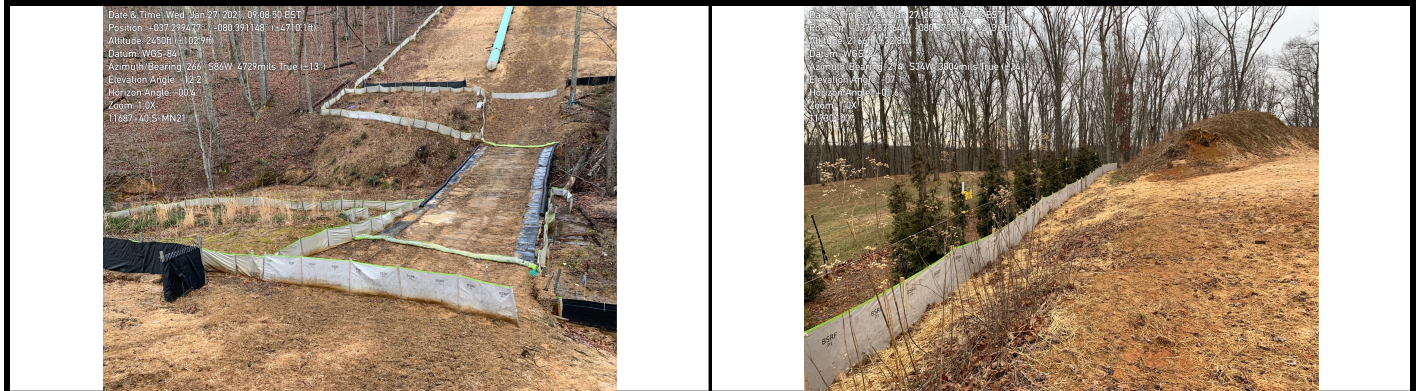
GPS Location	See photo for GPS location.	GPS Location	See photo for GPS location.
Field Station#	11687+40	Field Station#	11730+00
Pic 3 Desc.	Sensitive resource buffer in place at stream S-MN21.	Pic 4 Desc.	Priority one silt fence replace.

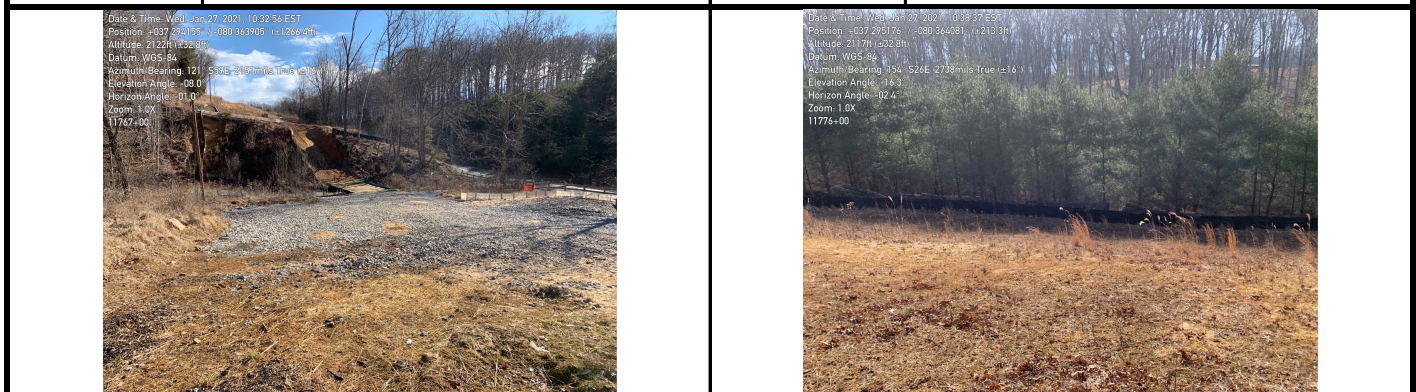
GPS Location	See photo for GPS location.	GPS Location	See photo for GPS location.
Field Station#	11767+00	Field Station#	11776+00
Pic 5 Desc.	RCE in place at Main Line Valve 26.	Pic 6 Desc.	Reinforced super silt fence in place along LOD.

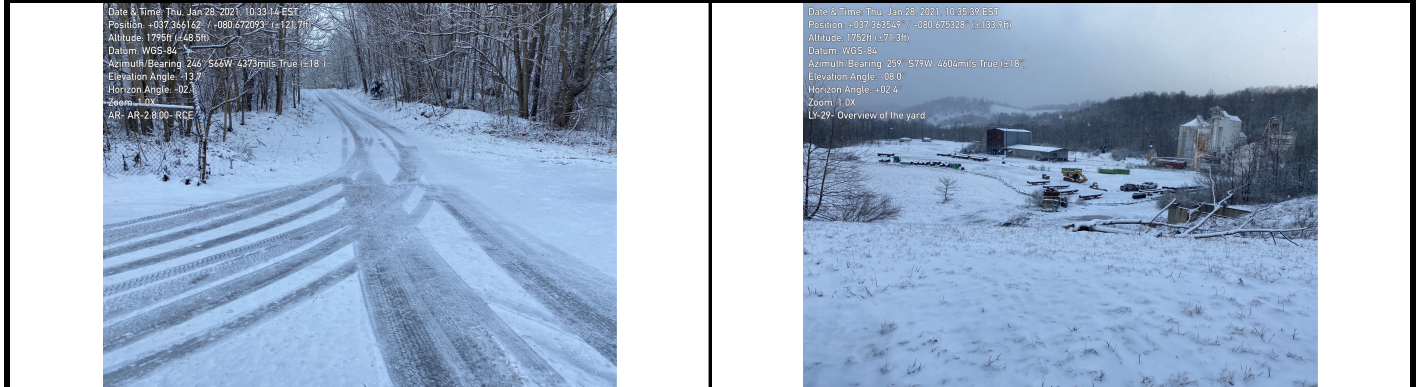
GPS Location	See photo GPS	GPS Location	See photo GPS
Field Station#	12005+00	Field Station#	12005+00
Pic 1 Desc.	AR-238.00- Access road and RCE	Pic 2 Desc.	LY29- Overview of the yard

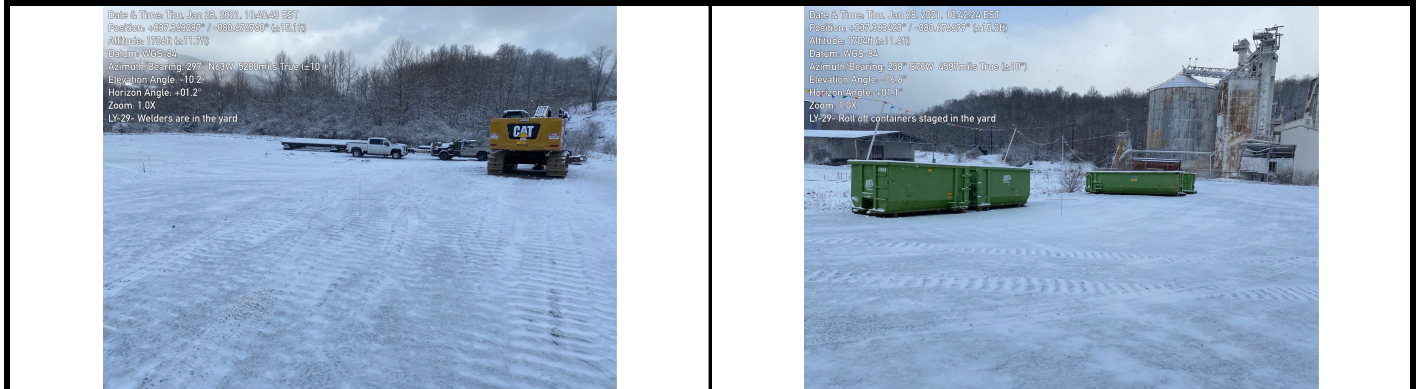
GPS Location	See photo GPS	GPS Location	See photo GPS
Field Station#	12005+00	Field Station#	12005+00
Pic 3 Desc.	LY29- Track hoe, welders rig	Pic 4 Desc.	LY29- Roll off containers brought in to the yard.

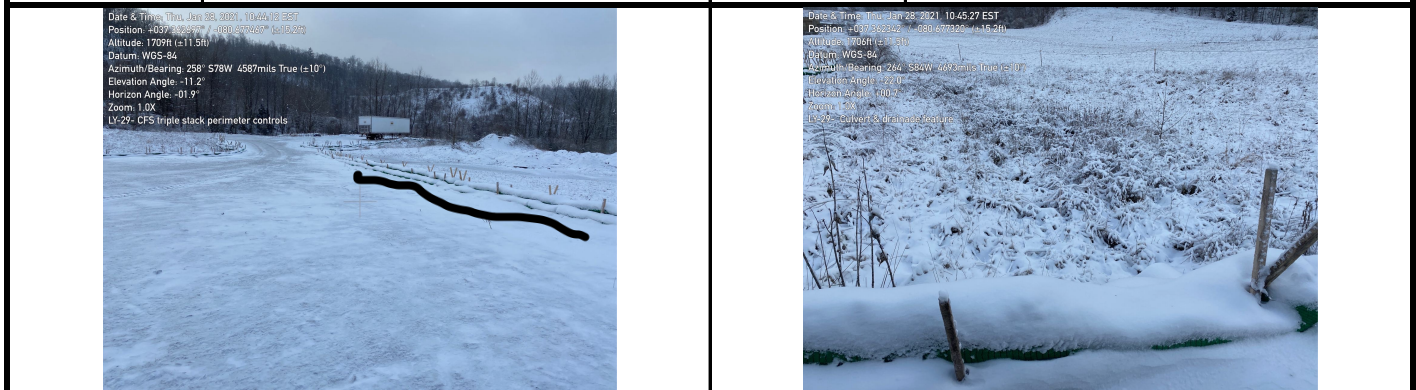
GPS Location	See photo GPS	GPS Location	See photo GPS
Field Station#	12005+00	Field Station#	12005+00
Pic 5 Desc.	CFS triple stack perimeter controls	Pic 6 Desc.	LY29- Culvert and drainage feature.
