# Visual Site Inspection Report

<b>Project Name</b> H-600 Pipeline Spread G		<b>AFE</b> 124300137	<b>Spread</b> H-600 Pipeline Spread G
<b>Contractor</b> Precision		<b>Report #</b> 20551	
<b>Inspector</b> Len Kruizenga		<b>Date/Time</b> 3/1/2021 2:34 PM	
<b>Permit #</b> TBD	<b>Inspection Type</b> VA SWPP	<b>Station Begin</b> 11254+99	
<b>State</b> VA	<b>Inspection Area</b> Full	<b>Station End</b> 11158+27	
<b>County</b> Giles	<b>Ground</b> Muddy	<b>Temperature (°F)</b> 51.00	
<b>Municipality</b> N/A	<b>Weather</b> Light Rain	<b>Rain Gauge (in)</b> 1.95	
<b>Rain Accumulation Time (days)</b>			3.00

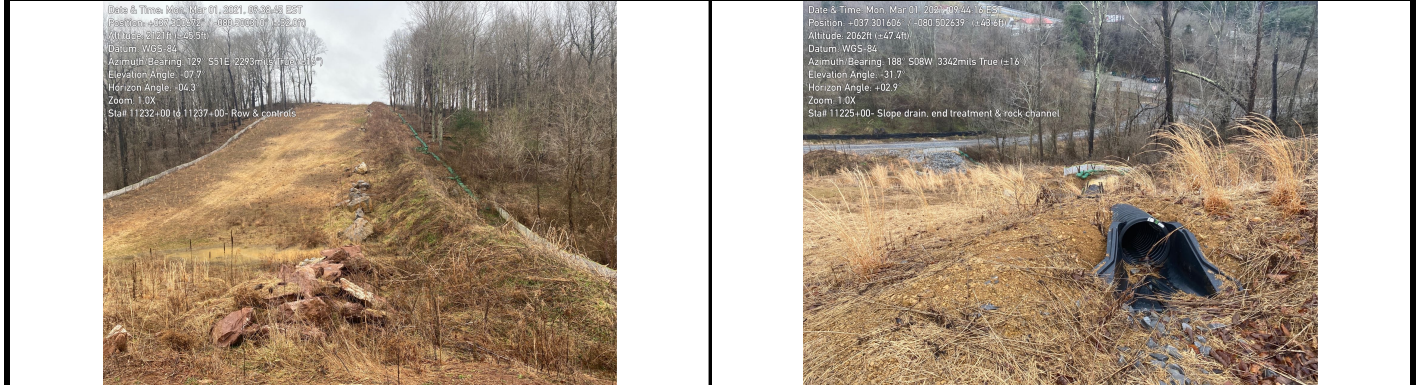
<b>GPS Location</b>	See photo GPS	<b>GPS Location</b>	See photo
<b>Field Station#</b>	11232+00	<b>Field Station#</b>	11225+00
<b>Pic 1 Desc.</b>	Row and controls	<b>Pic 2 Desc.</b>	Slope drain inlet and rock channel.

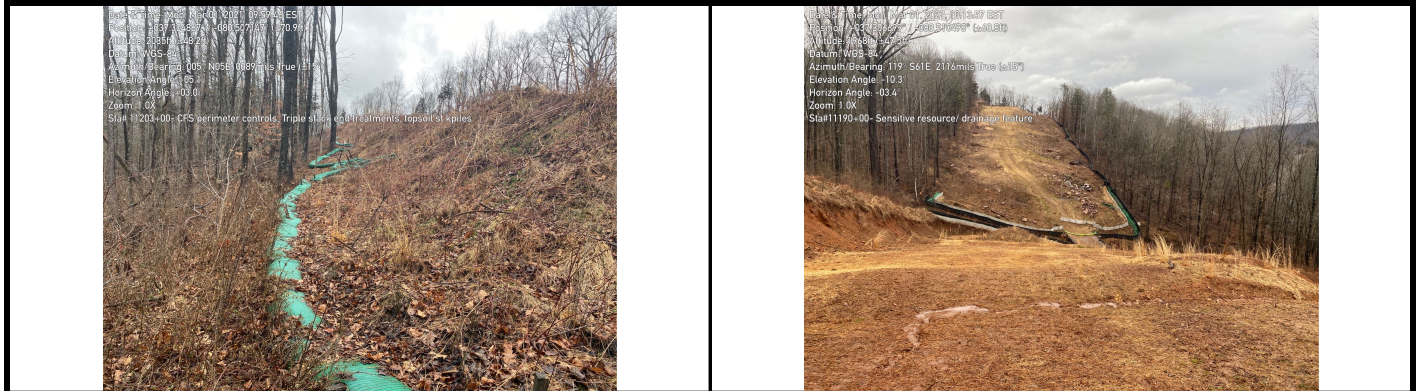
<b>GPS Location</b>	See photo GPS	<b>GPS Location</b>	See photo GPS
<b>Field Station#</b>	11203+00	<b>Field Station#</b>	11190+00
<b>Pic 3 Desc.</b>	CFS perimeter controls and end treatments, topsoil stockpiles	<b>Pic 4 Desc.</b>	Sensitive resource/ drainage feature and ECD's.

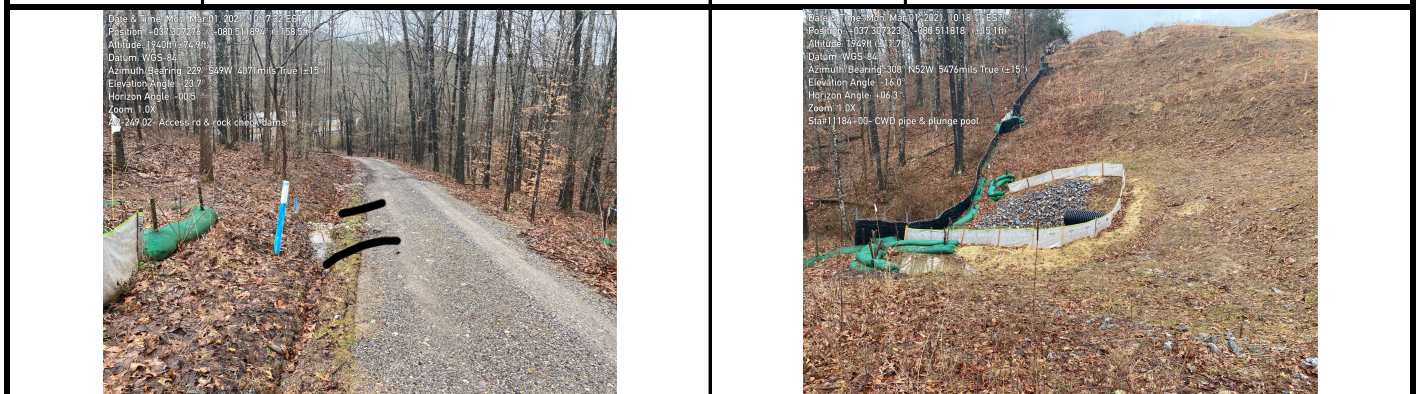
<b>GPS Location</b>	See photo GPS	<b>GPS Location</b>	See photo GPS
<b>Field Station#</b>	11184+50	<b>Field Station#</b>	11184+00
<b>Pic 5 Desc.</b>	AR-249.02- Access road and rock check dams.	<b>Pic 6 Desc.</b>	CWD pipe and plunge pool

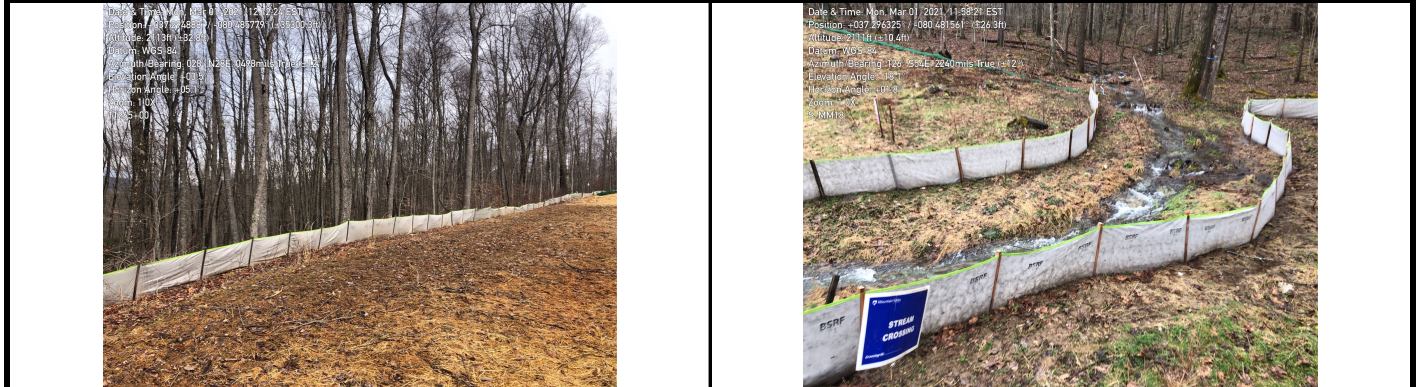
<b>GPS Location</b>	1	<b>GPS Location</b>	2
<b>Field Station#</b>	11265+00	<b>Field Station#</b>	11292+80
<b>Pic 1 Desc.</b>	Perimeter controls functional.	<b>Pic 2 Desc.</b>	S-MM18 and controls.

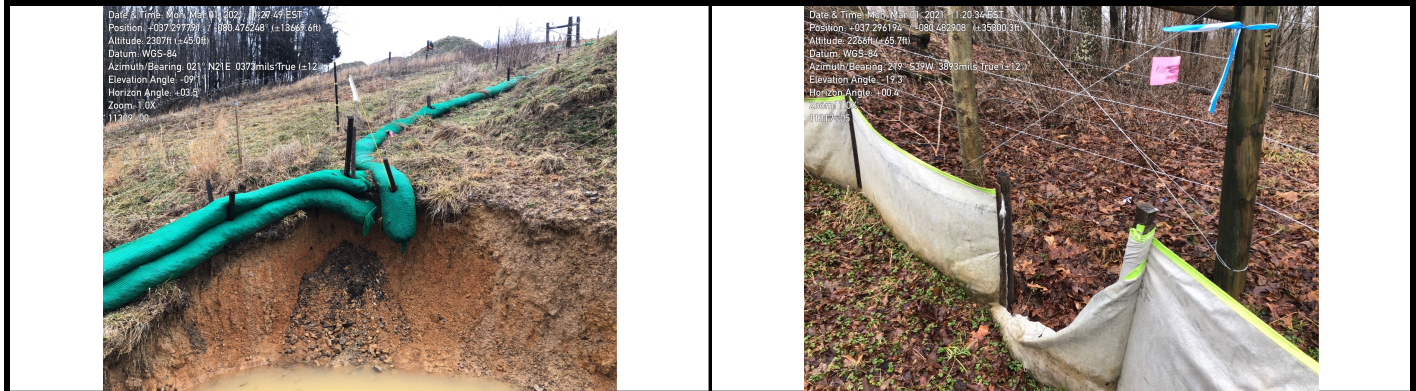
<b>GPS Location</b>	3	<b>GPS Location</b>	4
<b>Field Station#</b>	11309+00	<b>Field Station#</b>	11317+05
<b>Pic 3 Desc.</b>	End treatment falling into sump.	<b>Pic 4 Desc.</b>	Wildlife/livestock damage to P-1.

E&S BMPs	Compliance Level	Corrective Action	Corrective Time Frame	Date Repaired
Cleanwater Diversion Berm	Acceptable			
Cleanwater Diversion Pipe	Acceptable			
Compost Filter Sock	Acceptable			
Housekeeping	Acceptable			
Sensitive Resource Buffer	Acceptable			
Silt Fence (Filter Fabric Fence)	Communication	Repair damaged silt fence	24 Hours	
Silt Fence (Reinforced Filter Fabric Fence)	Problem Area			
Vegetative Stabilization (Temporary)	Acceptable			
Waterbar End Treatment	Communication	Repair end treatment	24 Hours

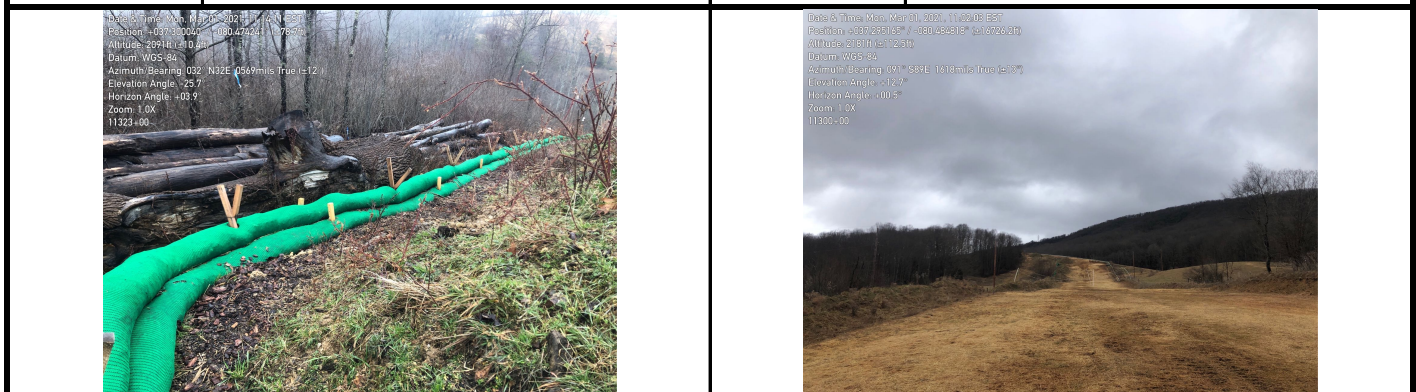
<b>GPS Location</b>	5	<b>GPS Location</b>	6
<b>Field Station#</b>	11323+00	<b>Field Station#</b>	11300+00
<b>Pic 5 Desc.</b>	Perimeter controls functional.	<b>Pic 6 Desc.</b>	Section of RoW showing conditions and controls.

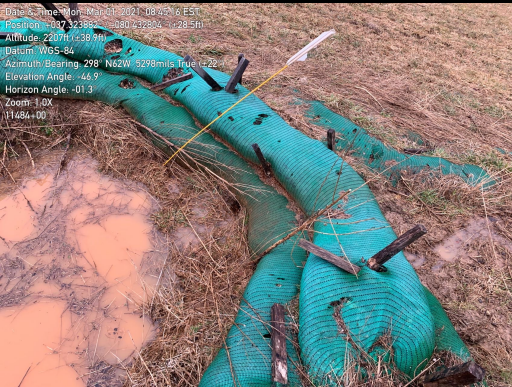
<p><small>Date &amp; Time: Mon, Mar 01, 2021, 08:44:02 EST Position: +037.326147 / -080.426841 (±19.4ft) Altitude: 2200ft (±68.0ft) Datum: WGS-84 Azimuth/Bearing: 29° N22W 529mils True (±2°) Elevation Angle: +6.9° Horizon Angle: -01.3° Zoom: 1.0X 11484+00</small></p>			
<b>GPS Location</b>	See photo for GPS location.	<b>GPS Location</b>	See photo for GPS location.	
<b>Field Station#</b>	11474+00	<b>Field Station#</b>	11484+00	
<b>Pic 1 Desc.</b>	Two-tone stabilized with ECB and slope drains in place.	<b>Pic 2 Desc.</b>	Waterbar end treatment in undermined.

E&S BMPs	Compliance Level	Corrective Action	Corrective Time Frame	Date Repaired
Cleanwater Diversion Berm	Acceptable			
Broad-Based Dip	Acceptable			
Cleanwater Diversion Pipe	Acceptable			
Compost Filter Sock	Communication	Repair undermined end treatment	Addressed	3/1/2021
Equipment Bridge	Acceptable			
Housekeeping	Acceptable			
Plunge Pool	Acceptable			
Rock Construction Entrance	Acceptable			
Sensitive Resource Buffer	Acceptable

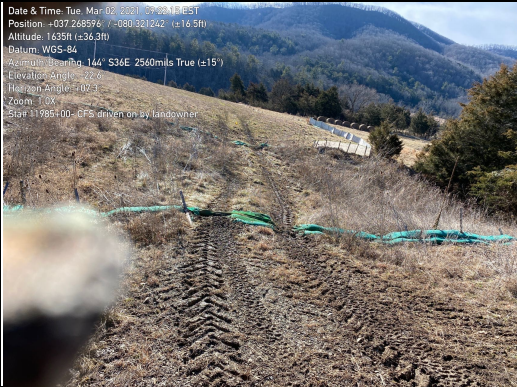
<b>Pic 7 Desc.</b>	CFS damaged by the landowner at drainage feature.	<b>Pic 8 Desc.</b>	Contractor making repairs to controls damaged by the landowner.
--------------------	---	--------------------	---

SWPPP inspection area: Sta# 11899+99 to 12005+00. MP-225.3 to 227.3  
 At the beginning of my inspection walk the row was frozen as overnight temperature dropped below 30 degrees.  
 The row is stable with very good vegetation.  
 Perimeter controls are in acceptable condition.  
 Water bars and level spreaders are in good condition.  
 Karst ECD's are in acceptable condition.  
 Wetland ECD's are in acceptable condition.  
 AR-266.03 and AR-266.00 are maintained in acceptable condition.  
 Sta#11985+00- The CFS protecting the drainage feature has been damaged by the landowner running over it with a tractor. The contractor has been notified and made repairs same day.
