# Visual Site Inspection Report

<b>Project Name</b> H-600 Pipeline Spread G		<b>AFE</b> 124300137	<b>Spread</b> H-600 Pipeline Spread G
<b>Contractor</b> Precision		<b>Report #</b> 21081	
<b>Inspector</b> Len Kruizenga		<b>Date/Time</b> 3/15/2021 8:39 AM	
<b>Permit #</b> TBD	<b>Inspection Type</b> VA SWPP	<b>Station Begin</b>	12005+00
<b>State</b> VA	<b>Inspection Area</b> Full	<b>Station End</b>	12005+00
<b>County</b> Giles	<b>Ground</b> Dry	<b>Temperature (°F)</b>	45.00
<b>Municipality</b> N/A	<b>Weather</b> Cloudy	<b>Rain Gauge (in)</b>	0.00
			<b>Rain Accumulation Time (days)</b> 1.00

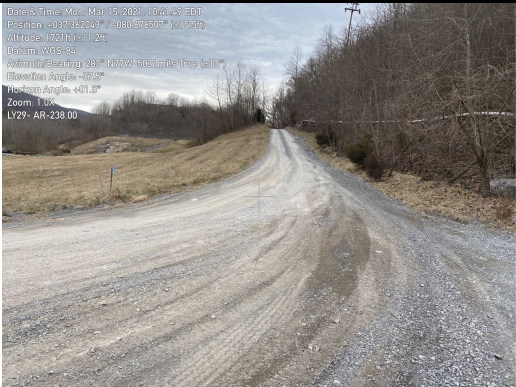
<p>Date &amp; Time Mon, Mar 15, 2021, 10:40:44 EDT  Position: +38.932234° / +80.57754° (-10.00)  Altitude: 1621 ft (495.27)  Datum: WGS-84  Azimuth Bearing: 311° N29W 452mils True (±0.1°)  Elevation Angle: 22.4°  Horizon Angle: +0.0°  Zoom: 1.0X  LY29- Culvert &amp; drainage feature</p>

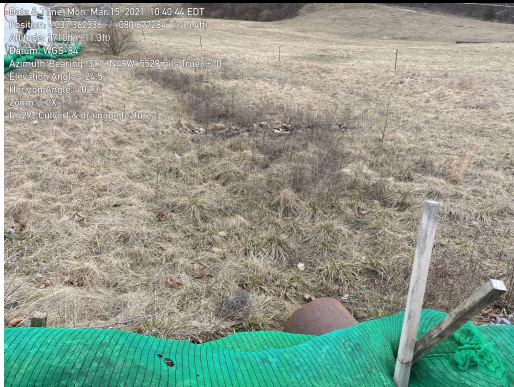
<b>GPS Location</b>	See photo GPS		<b>GPS Location</b>	See photo GPS	
<b>Field Station#</b>	12005+00		<b>Field Station#</b>	12005+00	
<b>Pic 1 Desc.</b>	AR-238.00- Access road serving LY29		<b>Pic 2 Desc.</b>	Culvert and drainage feature	
<p>Date &amp; Time Wed, Mar 10, 2021, 11:59:40 EDT  Position: +38.933357° / +80.57138° (-10.00)  Altitude: 1626 ft (494.82)  Datum: WGS-84  Azimuth Bearing: 235° S39W 424mils True (±0.1°)  Elevation Angle: +12.4°  Horizon Angle: +0.0°  Zoom: 1.0X  LY29- CFS triple stack perimeter controls</p>	 		<p>Date &amp; Time Wed, Mar 10, 2021, 11:59:46 EDT  Position: +38.933357° / +80.57138° (-10.00)  Altitude: 1710 ft (521.33)  Datum: WGS-84  Azimuth Bearing: 235° S39W 530mils True (±0.1°)  Elevation Angle: -15.2°  Horizon Angle: +0.0°  Zoom: 1.0X  LY29- Waste containers</p>

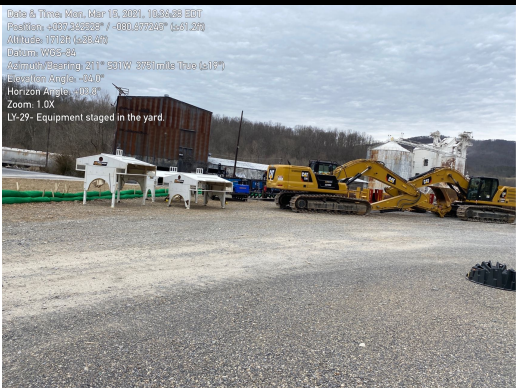
<p>Date &amp; Time Wed, Mar 10, 2021, 11:59:52 EDT  Position: +38.933357° / +80.57138° (-10.00)  Altitude: 1750 ft (533.21)  Datum: WGS-84  Azimuth Bearing: 201° S42W 441mils True (±0.1°)  Elevation Angle: +11.2°  Horizon Angle: +0.0°  Zoom: 1.0X  LY29- overview of the yard</p>

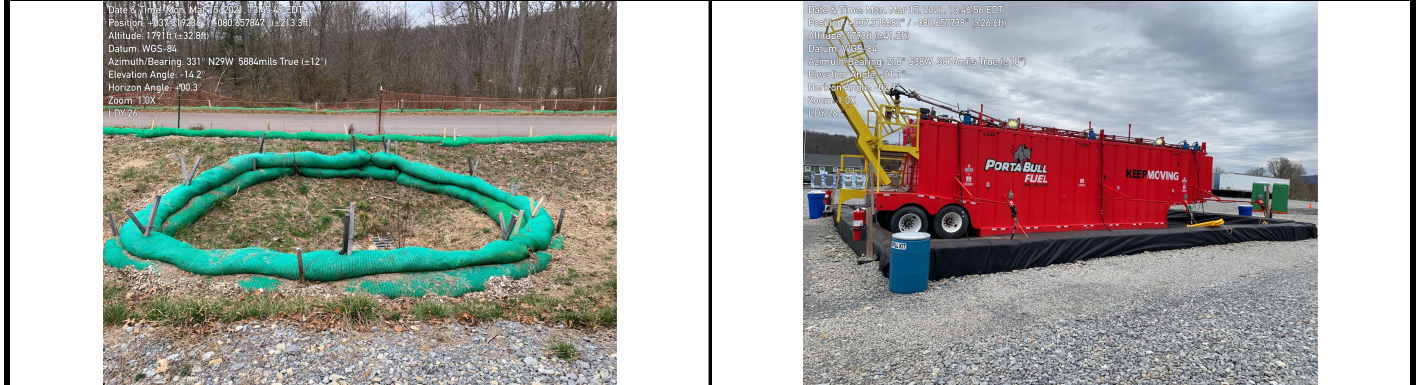
<b>GPS Location</b>	See photo for GPS location.	<b>GPS Location</b>	See photo for GPS location.
<b>Field Station#</b>	12005+00	<b>Field Station#</b>	12005+00
<b>Pic 1 Desc.</b>	Triple stack compost filter sock in place around drainage feature.	<b>Pic 2 Desc.</b>	Secondary containment in place under fuel cell.

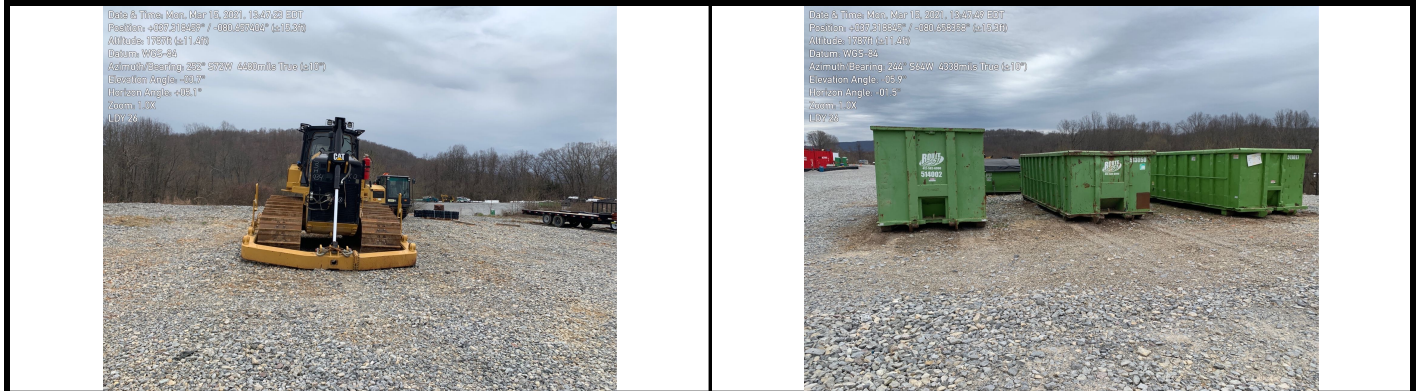
<b>GPS Location</b>	See photo for GPS location.	<b>GPS Location</b>	See photo for GPS location.
<b>Field Station#</b>	12005+00	<b>Field Station#</b>	12005+00
<b>Pic 3 Desc.</b>	Checked staged equipment for leaks.	<b>Pic 4 Desc.</b>	Dumpsters being utilized for trash management.

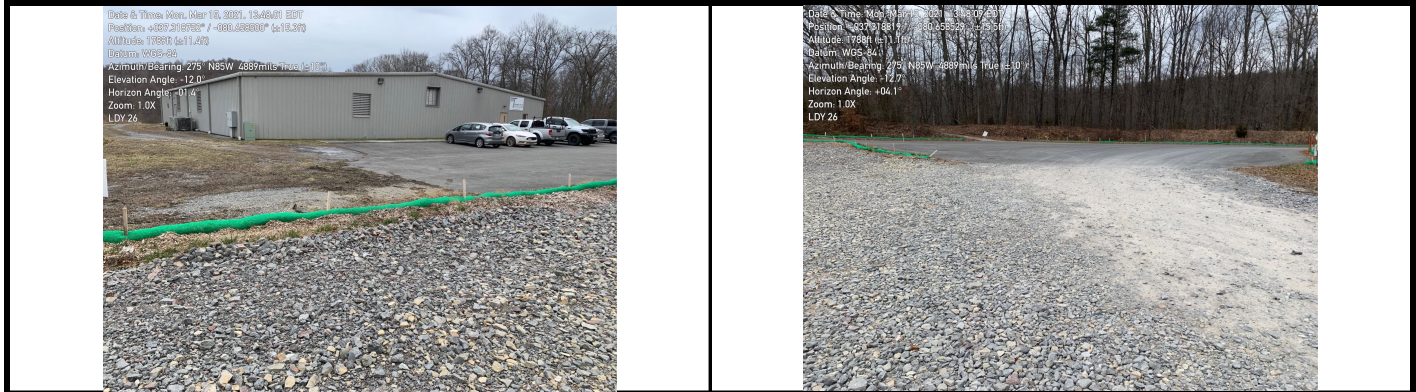
<b>GPS Location</b>	See photo for GPS location.	<b>GPS Location</b>	See photo for GPS location.
<b>Field Station#</b>	12005+00	<b>Field Station#</b>	12005+00
<b>Pic 5 Desc.</b>	18 inch compost filter sock in place along LOD.	<b>Pic 6 Desc.</b>	RCE in place at entrance of LDY 26.

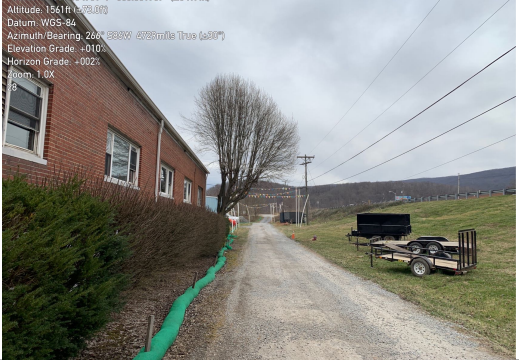
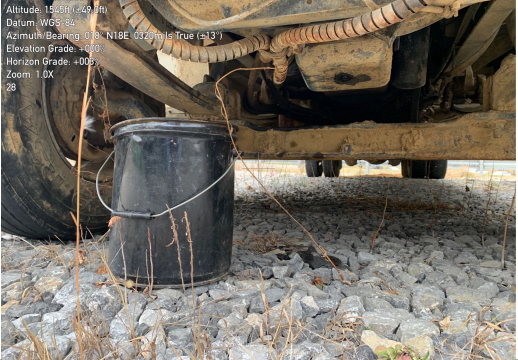
Arrived at LDY 26 for morning meeting  
 Performed SWPPP for LDY 28  
 No damaged ECD's observed during inspection  
 ROW conditions are stable and showing minimal signs of erosion  
 No items added to the punch list  
 Leak discovered due to improper placement of secondary containment, had crews clean spill and upgrade secondary containment

<b>GPS Location</b>	See picture above for GPS coordinates	<b>GPS Location</b>	See picture above for GPS coordinates	
<b>Field Station#</b>	12005+00	<b>Field Station#</b>	12005+00	
<b>Pic 3 Desc.</b>	ECD's and row conditions	<b>Pic 4 Desc.</b>	Improperly placed secondary containment

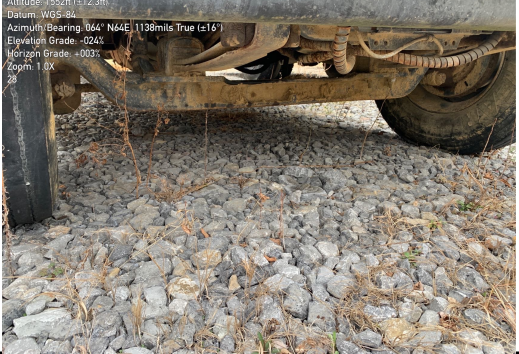
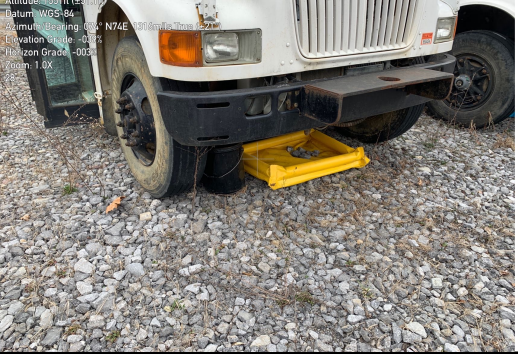
<b>GPS Location</b>	See picture above for GPS coordinates	<b>GPS Location</b>	See picture above for GPS coordinates	
<b>Field Station#</b>	12005+00	<b>Field Station#</b>	12005+00	
<b>Pic 5 Desc.</b>	Spill cleaned	<b>Pic 6 Desc.</b>	Larger secondary containment installed

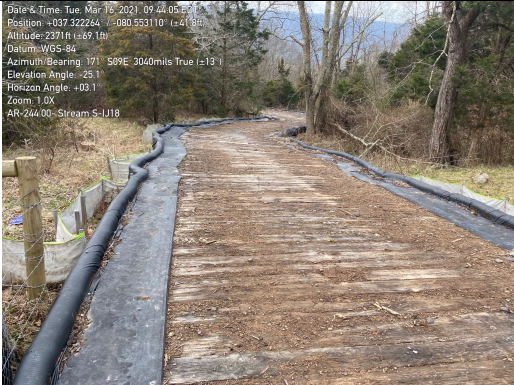
<p>Date &amp; Time: Tue, Mar 16, 2021 09:24:05 EDT  Position: +037.322264 / -080.533110 (+41.8m)  Altitude: 2271ft (+69.1m)  Datum: WGS-84  Azimuth/Bearing: 171.509E 304.0mils True (+13.1)  Elevation Angle: +25.1  Horizon Angle: +03.1  Zoom: 1.0X  Sta# 11024+00 - Stream S- IJ18</p>

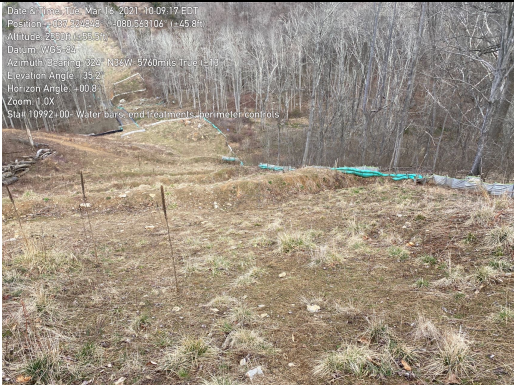
<p>Date &amp; Time: Tue, Mar 16, 2021 10:09:12 EDT  Position: +037.325283 / -080.533104 (+45.8m)  Altitude: 2331ft (+71.3m)  Datum: WGS-84  Azimuth/Bearing: 122.4183W 374.0mils True (+13.1)  Elevation Angle: +35.2  Horizon Angle: +00.8  Zoom: 1.0X  Sta# 10992+00 - Water bars, end treatments, perimeter controls</p>

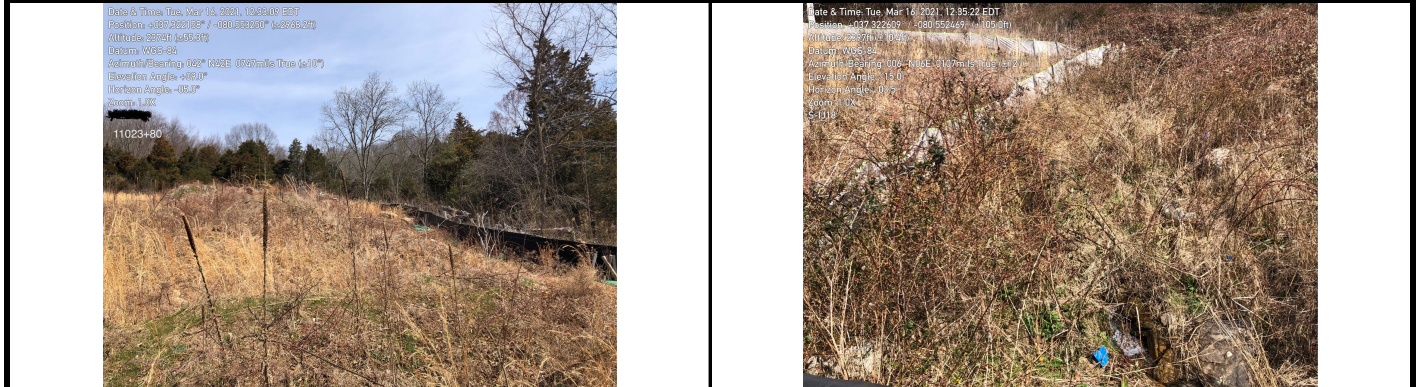
<b>GPS Location</b>	1	<b>GPS Location</b>	2
<b>Field Station#</b>	11023+80	<b>Field Station#</b>	11025+50
<b>Pic 1 Desc.</b>	Section of RoW showing conditions and controls.	<b>Pic 2 Desc.</b>	S-IJ18.

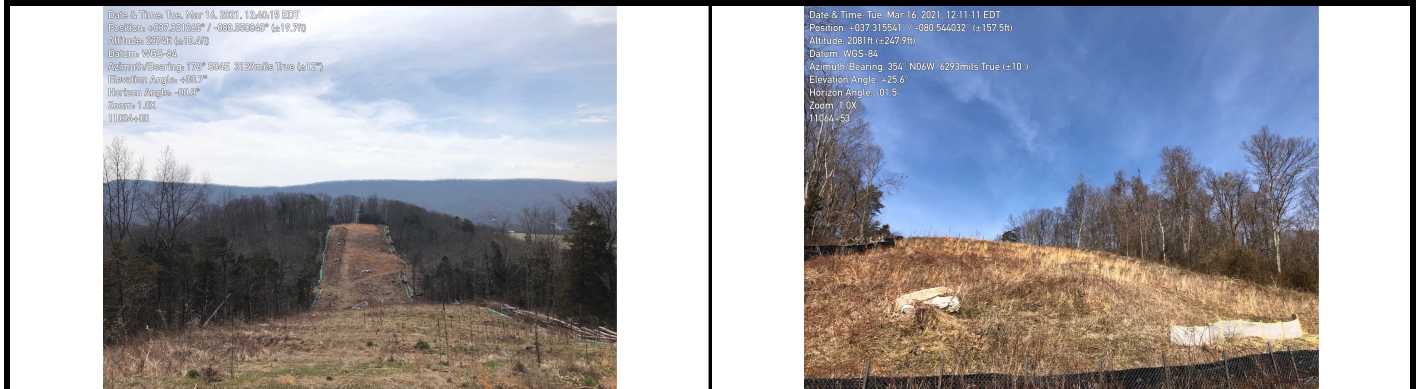
<b>GPS Location</b>	3	<b>GPS Location</b>	4
<b>Field Station#</b>	11034+00	<b>Field Station#</b>	11064+53
<b>Pic 3 Desc.</b>	Section of RoW showing conditions and controls.	<b>Pic 4 Desc.</b>	Section of RoW showing conditions and controls.

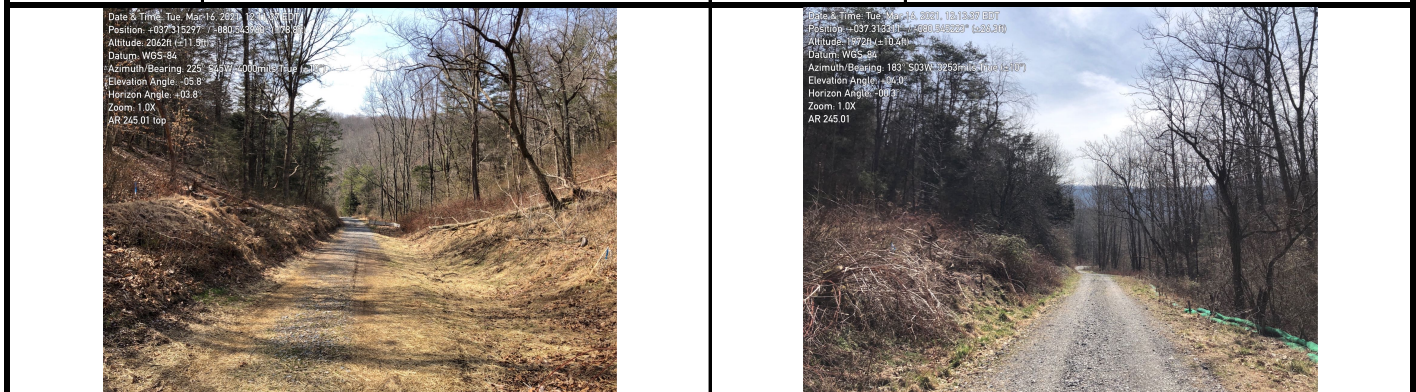
<b>GPS Location</b>	5	<b>GPS Location</b>	6
<b>Field Station#</b>	11064+53	<b>Field Station#</b>	11064+53
<b>Pic 5 Desc.</b>	Top of AR 245.01.	<b>Pic 6 Desc.</b>	Middle of AR 245.01.

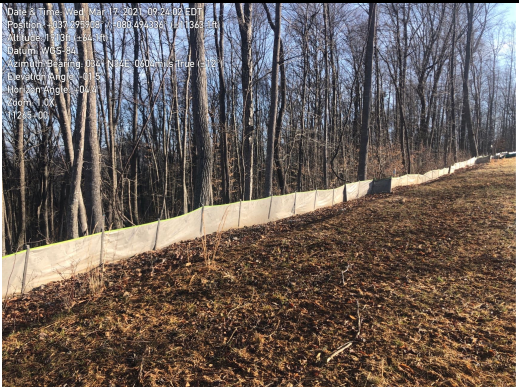
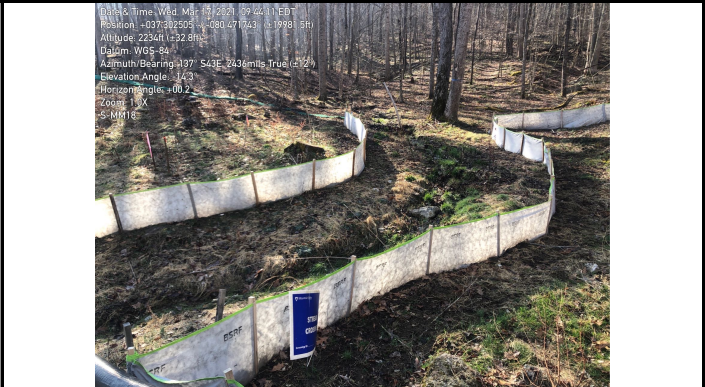
GPS Location	1	GPS Location	2		
Field Station#	11265+00	Field Station#	11292+80		
Pic 1 Desc.	Perimeter controls functional.		Pic 2 Desc.	S-MM18 and controls.

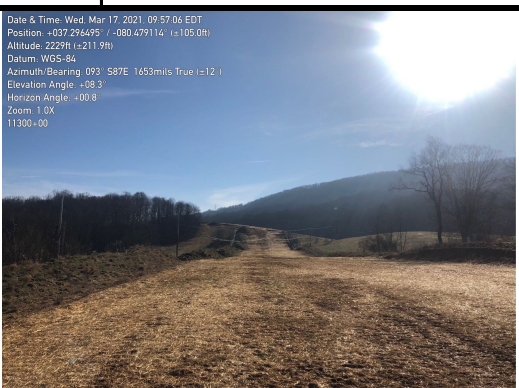
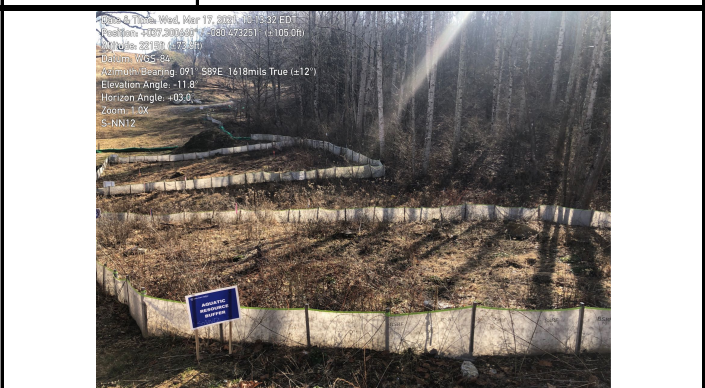
GPS Location	3	GPS Location	4		
Field Station#	11300+00	Field Station#	11327+85		
Pic 3 Desc.	Section of RoW showing conditions and controls.		Pic 4 Desc.	S-NN12 and controls.

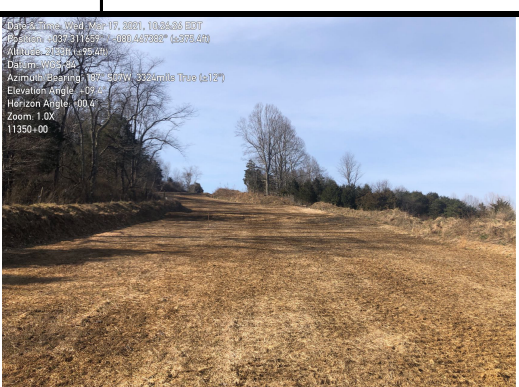
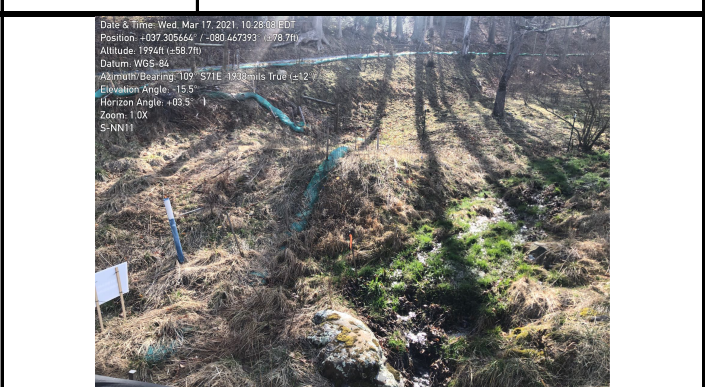
GPS Location	5	GPS Location	6		
Field Station#	11350+00	Field Station#	11352+97		
Pic 5 Desc.	Section of RoW showing conditions and controls.		Pic 6 Desc.	S-NN11 and controls.

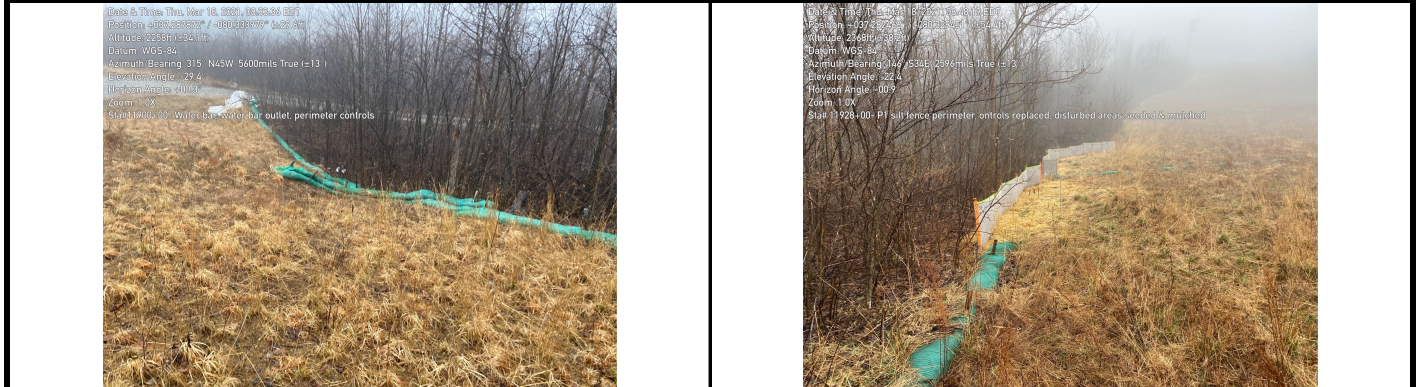
<b>GPS Location</b>	See photo GPS	<b>GPS Location</b>	See photo GPS
<b>Field Station#</b>	11900+00	<b>Field Station#</b>	11928+00
<b>Pic 1 Desc.</b>	Water bar and water bar outlet, perimeter controls.	<b>Pic 2 Desc.</b>	P1 silt fence perimeter controls replaced, disturbed area seeded, mulched.

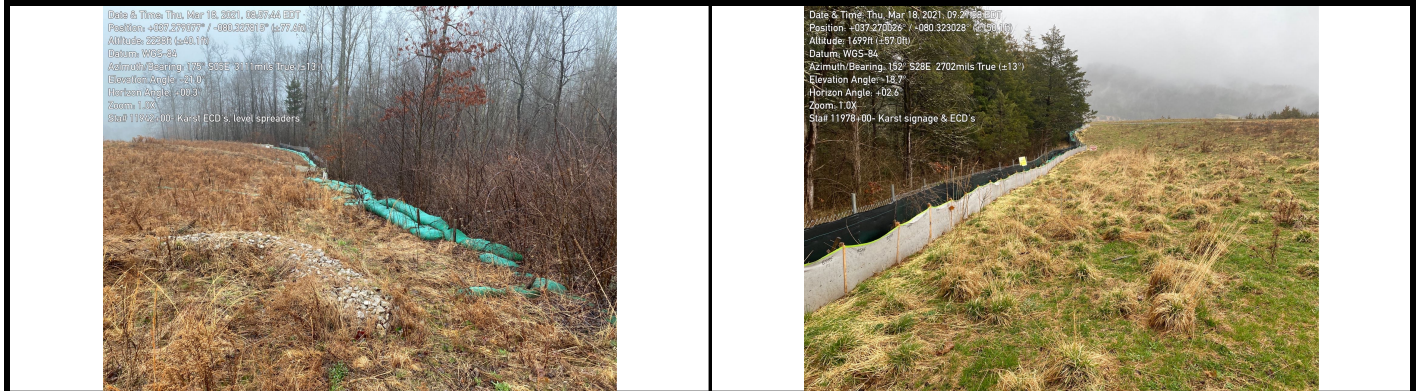
<b>GPS Location</b>	See photo GPS	<b>GPS Location</b>	See photo GPS
<b>Field Station#</b>	11942+00	<b>Field Station#</b>	11978+00
<b>Pic 3 Desc.</b>	Karst ECD's & level spreaders.	<b>Pic 4 Desc.</b>	Karst ECD's and signage.

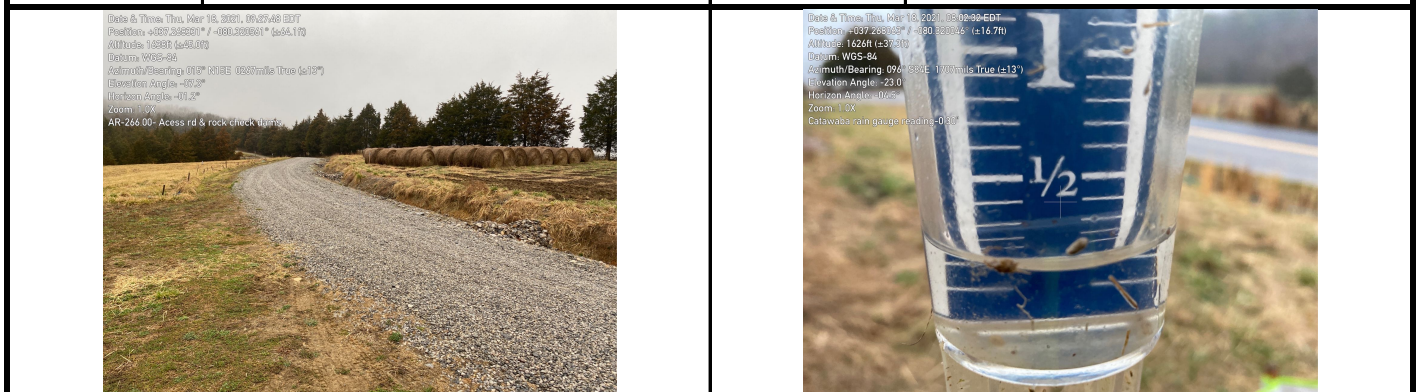
<b>GPS Location</b>	See photo GPS	<b>GPS Location</b>	See photo GPS
<b>Field Station#</b>	11989+00	<b>Field Station#</b>	11989+00
<b>Pic 5 Desc.</b>	AR-266.00- Access road and rock check dams.	<b>Pic 6 Desc.</b>	Catawba rain gauge reading-0.30"

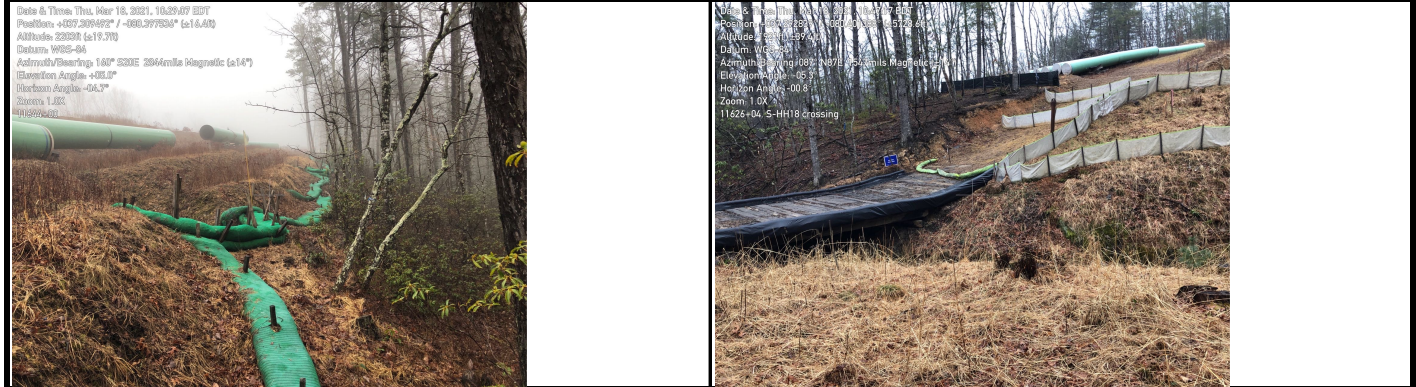
<b>GPS Location</b>	On photo	<b>GPS Location</b>	On photo
<b>Field Station#</b>	11644+00	<b>Field Station#</b>	11626+04
<b>Pic 7 Desc.</b>	Perimeter controls are in place.	<b>Pic 8 Desc.</b>	S-HH18 crossing stable with controls in place

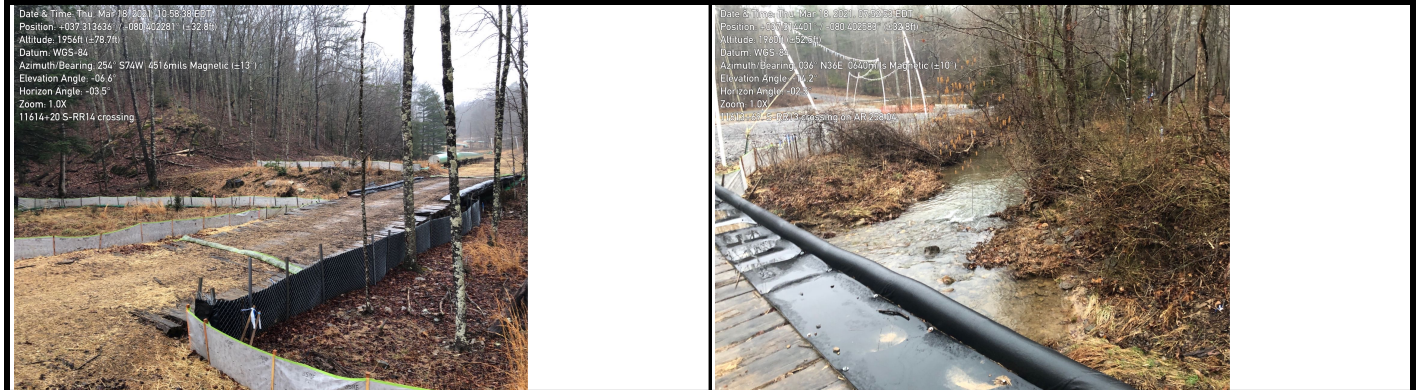
<b>GPS Location</b>	On photo	<b>GPS Location</b>	On photo
<b>Field Station#</b>	11614+20	<b>Field Station#</b>	11613+69
<b>Pic 9 Desc.</b>	S-RR14 crossing stable with adequate ECDs in place	<b>Pic 10 Desc.</b>	S-RR13 crossing stable

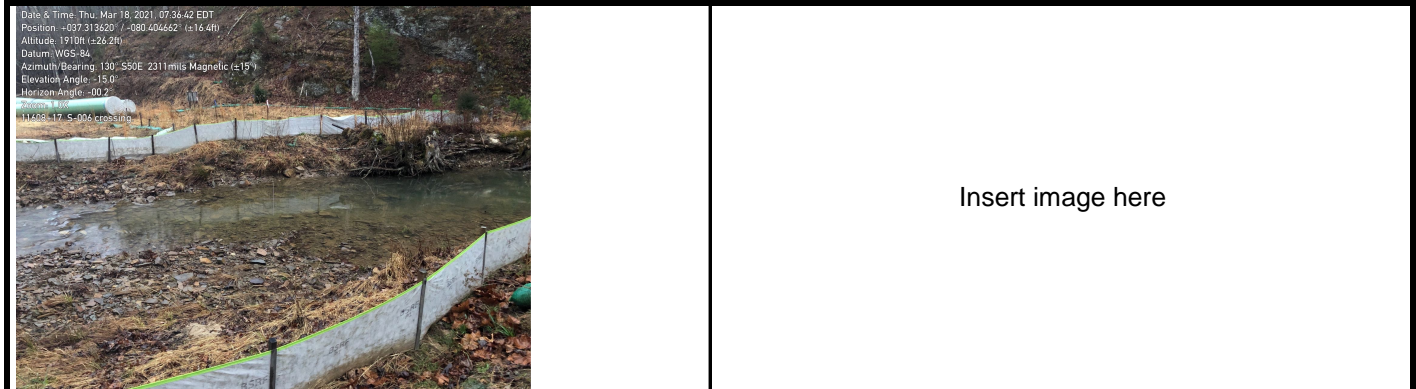
<b>GPS Location</b>	On photo	<b>GPS Location</b>	
<b>Field Station#</b>	11608+17	<b>Field Station#</b>	
<b>Pic 11 Desc.</b>	S-006 crossing currently stable with adequate ECDs in place.	<b>Pic 12 Desc.</b>
