Visual Site Inspection Report

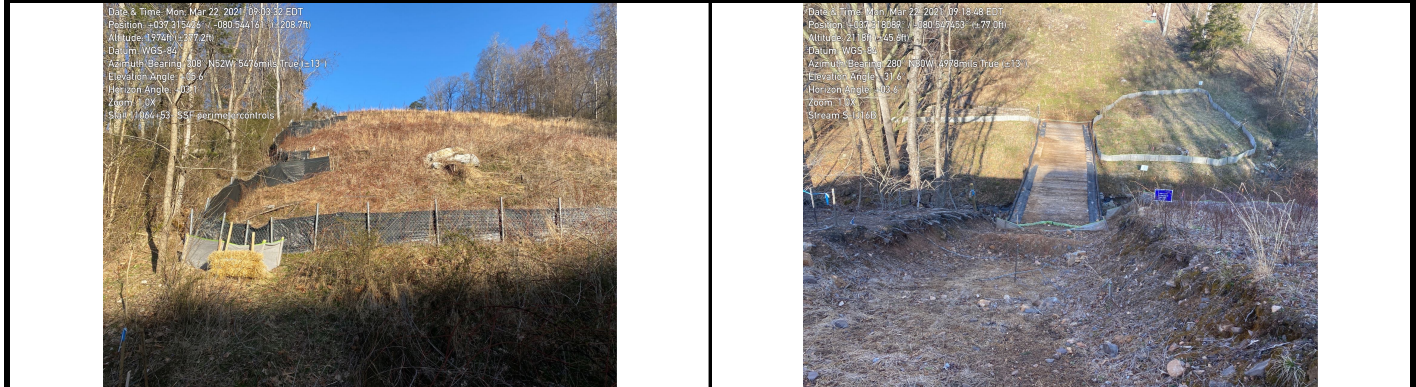
GPS Location	See photo GPS	GPS Location	See photo GPS
Field Station#	11064+53	Field Station#	11049+50
Pic 1 Desc.	SSF perimeter controls.	Pic 2 Desc.	Stream S- IJ16

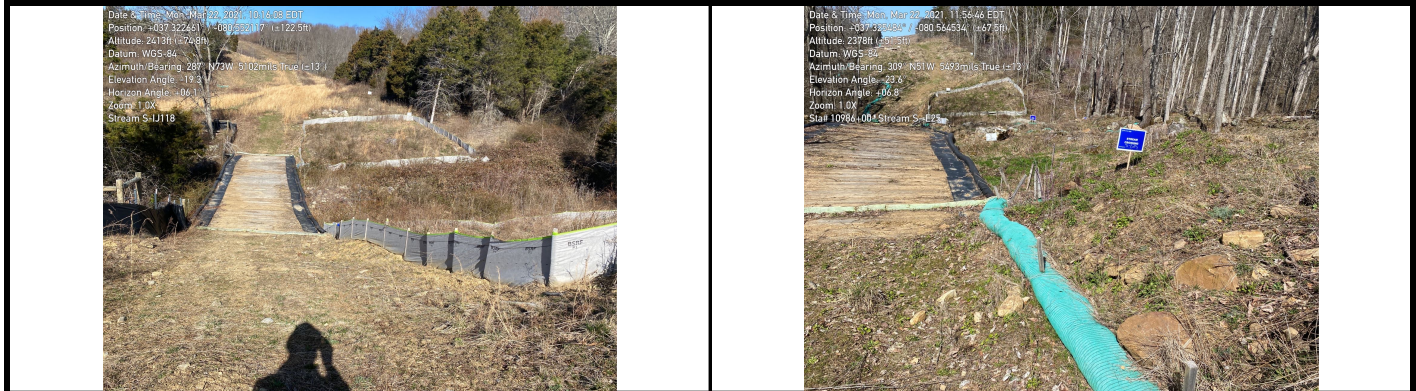
GPS Location	See photo GPS	GPS Location	See photo GPS
Field Station#	11025+00	Field Station#	10986+00
Pic 3 Desc.	Stream S- IJ18	Pic 4 Desc.	Stream S- E25

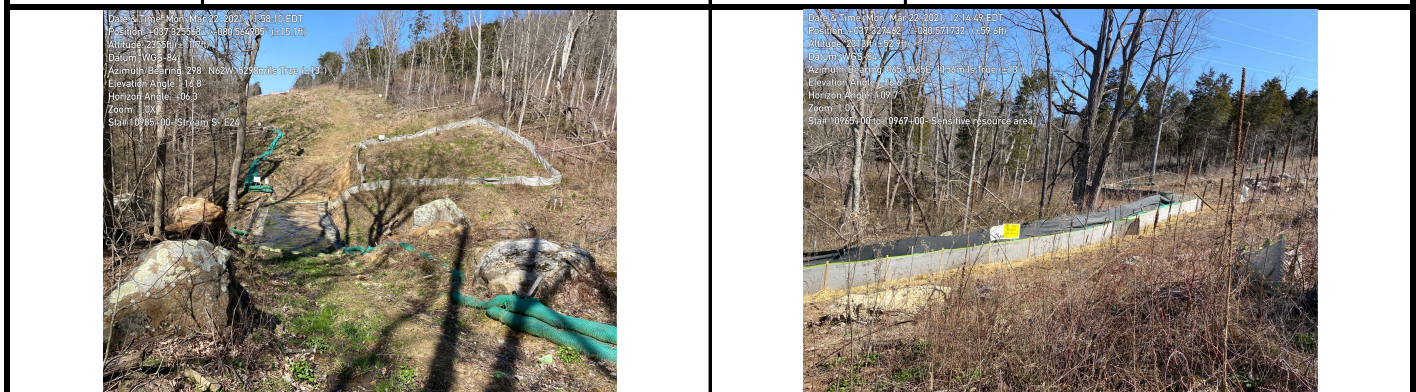
GPS Location	See photo GPS	GPS Location	See photo GPS
Field Station#	10985+00	Field Station#	10965+00
Pic 5 Desc.	Stream S- E24	Pic 6 Desc.	Sensitive resource area ECD's.

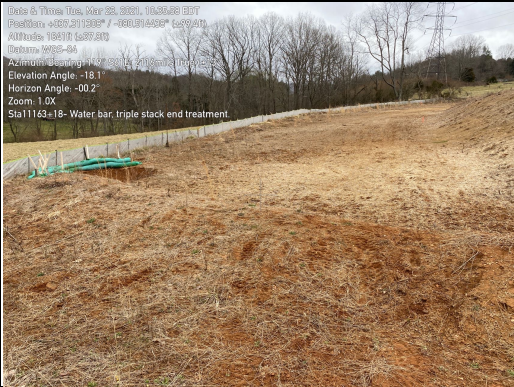
GPS Location	See photo GPS	GPS Location	See photo GPS
Field Station#	11163+18	Field Station#	11184+00
Pic 7 Desc.	Water bar and triple stack end treatment.	Pic 8 Desc.	CWD pipe and plunge pool.

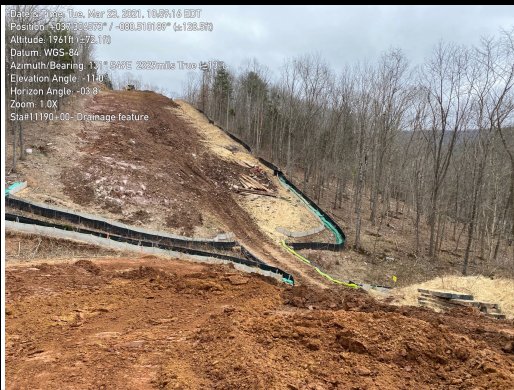
GPS Location	See photo GPS	GPS Location	See photo GPS
Field Station#	11190+00	Field Station#	11195+00
Pic 9 Desc.	Drainage feature and ECD's.	Pic 10 Desc.	SSF and CFS perimeter controls

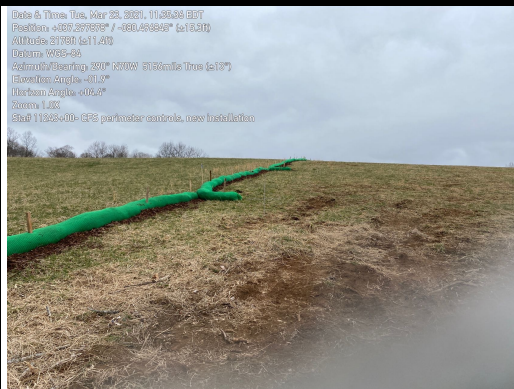
GPS Location	See photo GPS	GPS Location	See photo GPS
Field Station#	11243+00	Field Station#	11227+00
Pic 11 Desc.	CFS perimeter controls, new installation.	Pic 12 Desc.	Winding Way access road - SSF fabric detached from chain link, item added to the punch list.

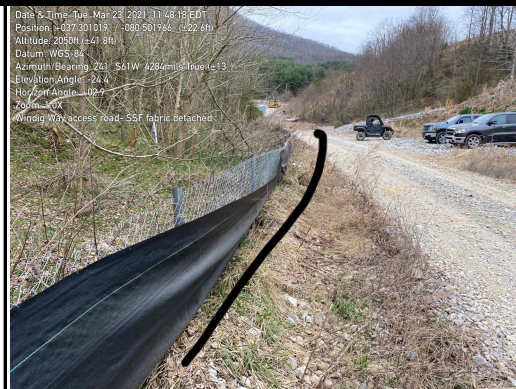
SWPPP inspection area: Sta#11064+53 to 11254+99. MP-209.5 to 213
 The row is dry and in stable condition, row from sta# 11064+53 to 11158+00 has temporary stabilization, row from sta# 11158+00 to 11254+99 is being graded.
 Perimeter controls, silt fence, CFS, SSF are in acceptable condition.
 CWD pipe and plunge pool are in acceptable condition.
 Sensitive resource area/drainage feature and ECD's are in acceptable condition.
 Karst ECD's are in acceptable condition.
 Access roads- 245.01, 249.00, 249.01, 249.02 are in acceptable condition. Winding Way SSF fabric is detached from chain link, item added to the punch list.

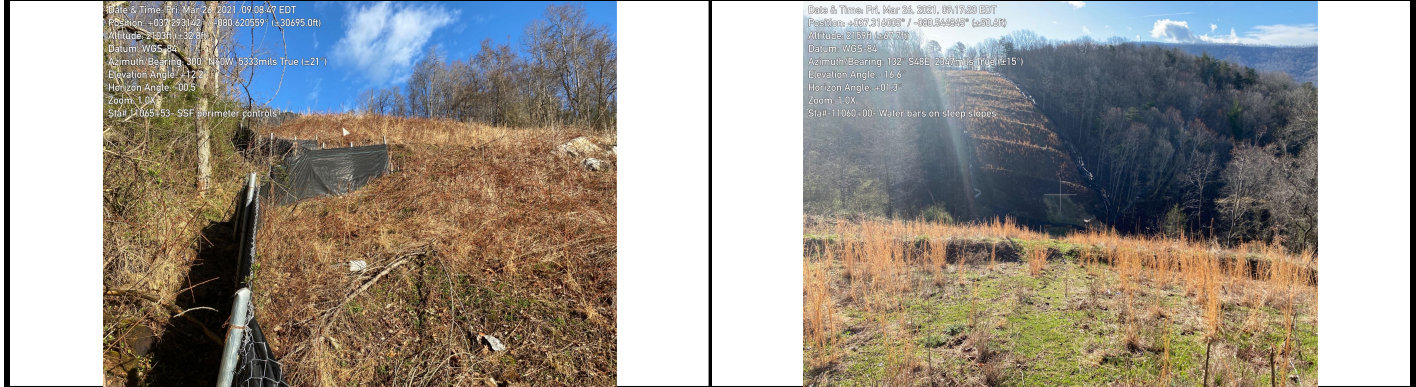
GPS Location	See photo GPS	GPS Location	See photo GPS
Field Station#	11064+53	Field Station#	11060+00
Pic 1 Desc.	SSF perimeter controls.	Pic 2 Desc.	Water bars on steep slope.

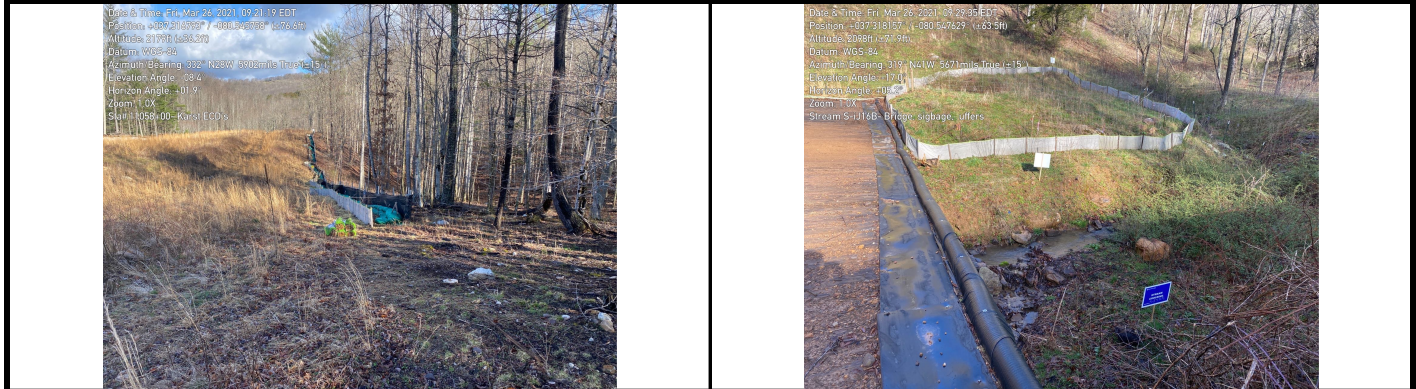
GPS Location	See photo GPS	GPS Location	See photo
Field Station#	11058+00	Field Station#	11049+50
Pic 3 Desc.	Karst ECD's	Pic 4 Desc.	Stream S-IJ16B- Bridge, buffers, signage.

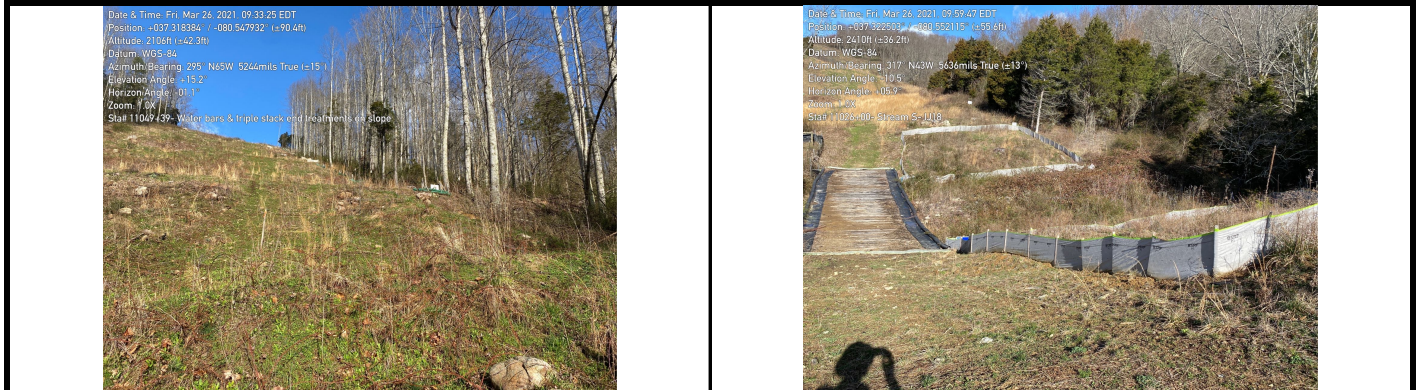
GPS Location	See photo GPS	GPS Location	See photo GPS
Field Station#	11049+39	Field Station#	11026+00
Pic 5 Desc.	Water bars & triple stack end treatments on steep slope.	Pic 6 Desc.	Stream S-IJ18- Bridge, buffers
