Visual Site Inspection Report

| Project Name H-600 Pipeline Spread G | | AFE 124300137 | Spread H-600 Pipeline Spread G |
| Permit # TBD | Inspection Type VA SWPP | Station Begin 11064+55 | |

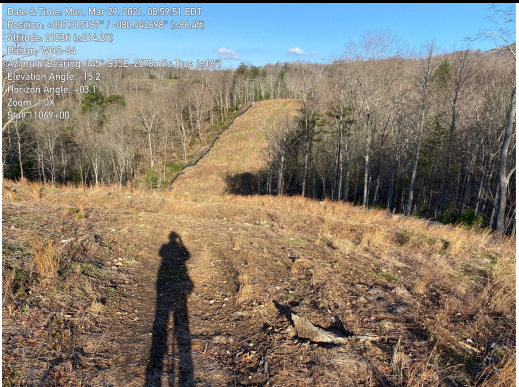
| AFE | 124300137 | Date/Time | 3/29/2021 7:38 AM | Report # | |
|---|---|---|---|---|--|
| Field Station# | 11069+00 | Field Station# | 11075+64 | | |

| AFE | 124300137 | Date/Time | 3/29/2021 7:38 AM | Report # | |
|---|---|---|---|---|--|
| Pic 1 Desc. | Row vegetation | Pic 2 Desc. | CFS perimeter controls | | |

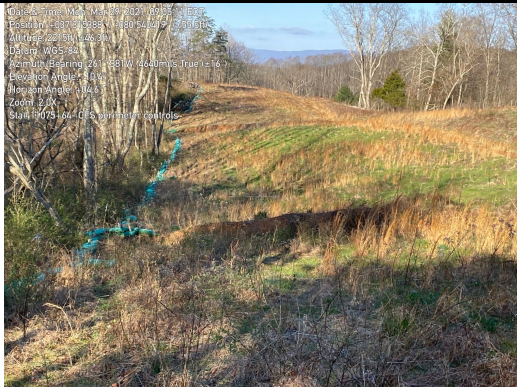
| AFE | 124300137 | Date/Time | 3/29/2021 7:38 AM | Report # | |
|---|---|---|---|---|--|
| <p>Date & Time: Mon, Mar 29, 2021, 08:59:51 EDT Position: -080.312637, -080.532397, 4563.0ft Altitude: 5183ft (=5183ft) Datum: WGS-84 Azimuth Bearing: 125.535E, 206mils True (=125) Elevation Angle: -15.2 Horizon Angle: +03.1 Zoom: 2.0X Station: 11069+00</p> | | | <p>Date & Time: Mon, Mar 29, 2021, 09:01:52 EDT Position: -080.312637, -080.532397, 4563.0ft Altitude: 5183ft (=5183ft) Datum: WGS-84 Azimuth Bearing: 261.881W, 4640mils True (=16) Elevation Angle: -14.4 Horizon Angle: +03.3 Zoom: 2.0X Station: 11075+00 - CFS perimeter controls</p> | | |

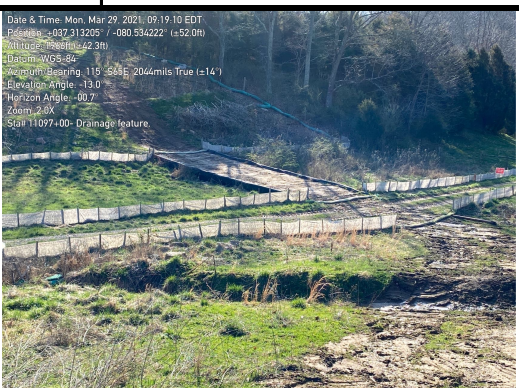
| AFE | 124300137 | Date/Time | 3/29/2021 7:38 AM | Report # | |
|---|---|---|---|---|--|
| Field Station# | 11097+00 | Field Station# | 11108+00 | | |

| AFE | 124300137 | Date/Time | 3/29/2021 7:38 AM | Report # | |
|---|---|---|---|---|--|
| Pic 3 Desc. | Drainage feature | Pic 4 Desc. | Forward controls crew replacing ECD's | | |

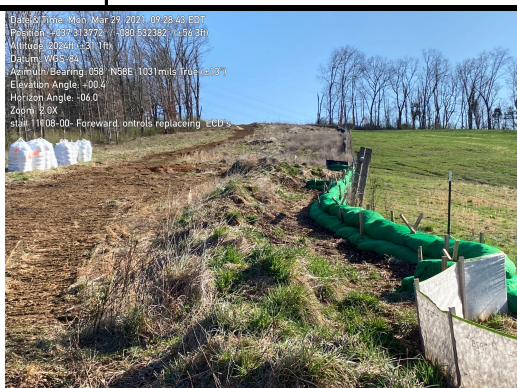
| AFE | 124300137 | Date/Time | 3/29/2021 7:38 AM | Report # | |
|---|---|---|---|---|--|
| <p>Date & Time: Mon, Mar 29, 2021, 09:19:10 EDT Position: -080.313205, -080.534222, 4552.0ft Altitude: 4626ft (=4626ft) Datum: WGS-84 Azimuth Bearing: 119.535E, 206mils True (=14) Elevation Angle: -13.0 Horizon Angle: -00.7 Zoom: 2.0X Station: 11097+00- Drainage feature.</p> | | | <p>Date & Time: Mon, Mar 29, 2021, 09:28:00 EDT Position: -080.313772, -080.532382, 4586.3ft Altitude: 5026ft (=5026ft) Datum: WGS-84 Azimuth Bearing: 89E, NSBE, 1031mils True (=89) Elevation Angle: -00.4 Horizon Angle: -06.0 Zoom: 2.0X Station: 11108+00- Forward controls replacing ECD's</p> | | |

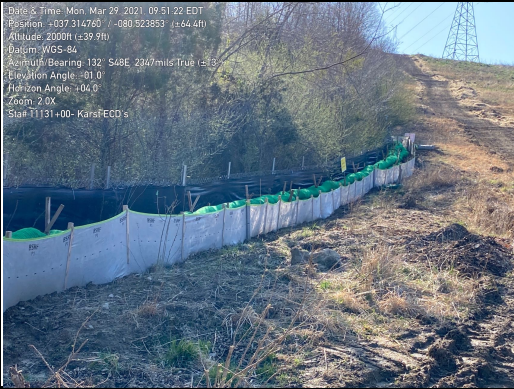
| Field Station# | 11131+00 |

| Pic 7 Desc. | Karst ECD's. |

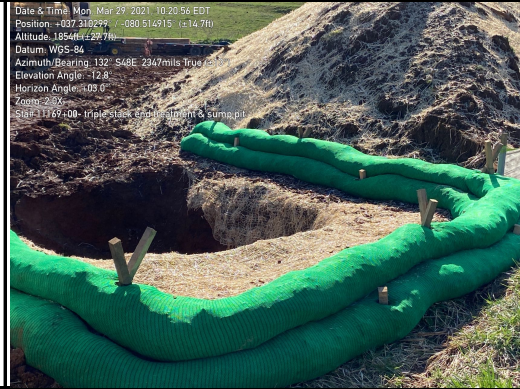
| Field Station# | 11169+00 |

| Pic 8 Desc. | CFS triple stack end treatment and sump pit. |

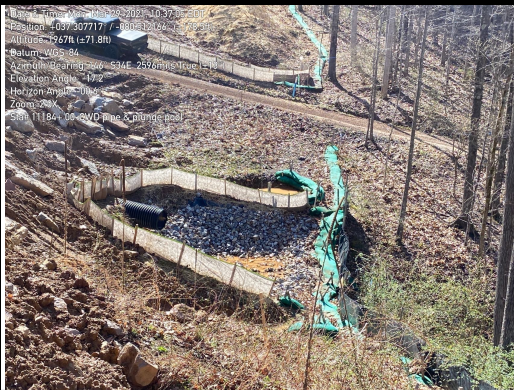
| Field Station# | 11184+00 |

| Pic 9 Desc. | CWD pipe and plunge pool. |

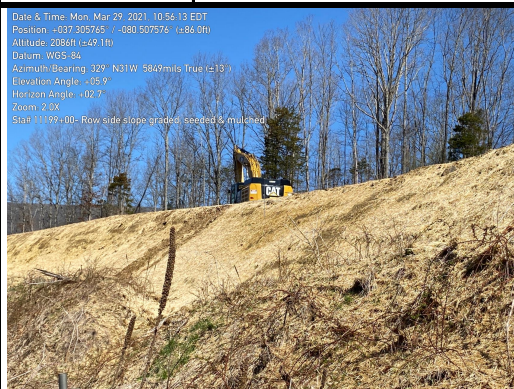
| Field Station# | 11199+00 |

| Pic 11 Desc. | Row side slope graded, seeded, mulched. |

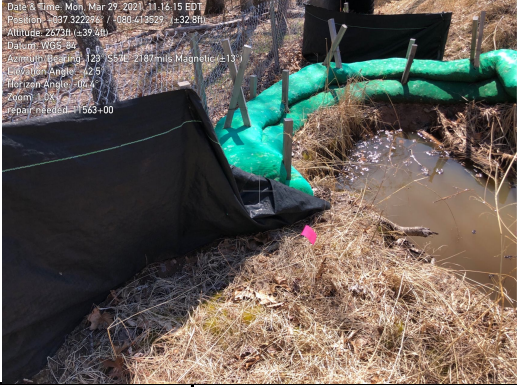
| Pic 7 Desc. | Broken stake to be replaced | Pic 8 Desc. | Broken stake |

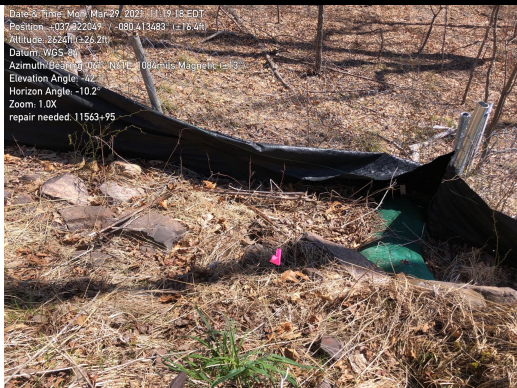
| Pic 9 Desc. | Re-attach fabric | Pic 10 Desc. | Re-attach fabric to chain link. |

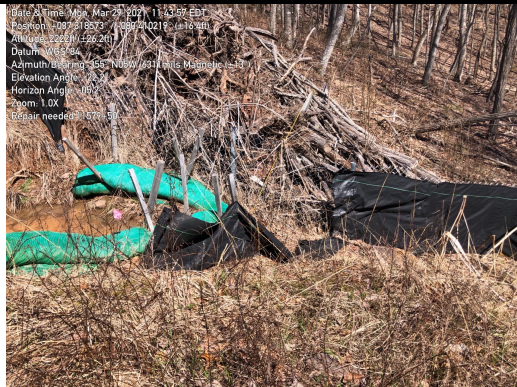
| Pic 11 Desc. | Repair ripped fabric | Pic 12 Desc. | ECD needed to check runoff behind windrow pile |

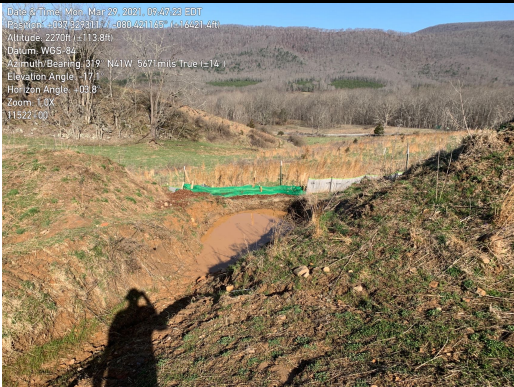
| AFE | 124300137 | Date/Time | 3/29/2021 8:14 PM | Report # | | |
|---|---|---|---|---|---|--|
| Pic 1 Desc. | Triple stack compost filter sock end treatment replaced. | | Pic 2 Desc. | I'm proper installation of triple stack CFS. | | |

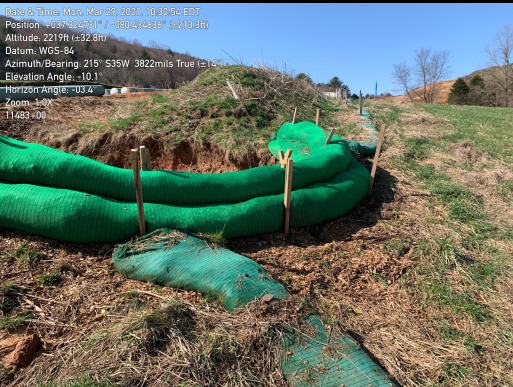
| E&S BMPs | Compliance Level | Corrective Action | Corrective Time Frame | Date Repaired |
|---|---|---|---|---|
| Compost Filter Sock | Communication | Improper installation | Addressed | 3/30/2021 |

Conducted VA SWPPP inspection from MP 213.1 (Sta # 11254+99) to MP 218.3 (Sta # 11524+16).
 Since last inspection ECD upgrades and replacement have been conducted throughout area.
 Crews are still working on upgrades and replacement of ECDs.
 Forced excavation crew and two environmental crews currently working in area.
 Improper installation of triple stack CFS. Informed foreman's of improper installation and provided proper spec for CFS staking.
 Crew began repairing items.

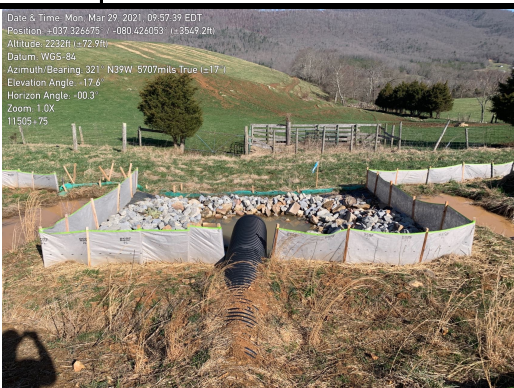
| AFE | 124300137 | Date/Time | 3/29/2021 8:14 PM | Report # | | |
|---|---|---|---|---|---|--|
| Pic 3 Desc. | Clean water drainage pipe and plunge pool in place. | | Pic 4 Desc. | Clean water drainage pipe inlet and berm in place. Clean water currently entering pipe. | | |

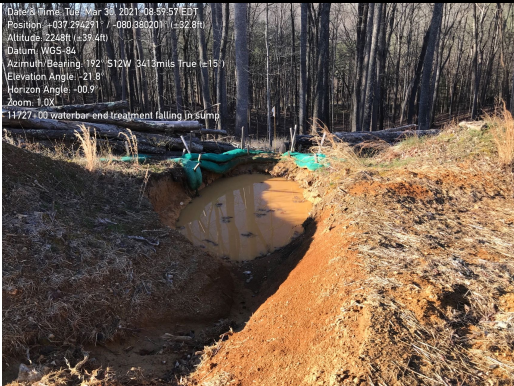
VA SWPPP inspection MP 221.02 to MP 223.37
 Maintenance items identified and added to punch list.
 -11725+50-CFS falling into sump.
 -11734+00-super siltfence and end treatment in need of maintenance
 -11735+00-sump full of sediment.
 -11727+00-CFS falling into sump
 Communication was given to Precision on listed items.
 No impacts to sensitive resources observed.

| AFE 124300137 | | Date/Time 3/30/2021 11:36 AM | | Report # | | | |
|---|---|---|---|---|---|---|--|
| Pic 5 Desc. | CFS falling into sump. | Pic 6 Desc. | End treatment in good working condition | Pic 5 Desc. | End treatment in good working condition | | |

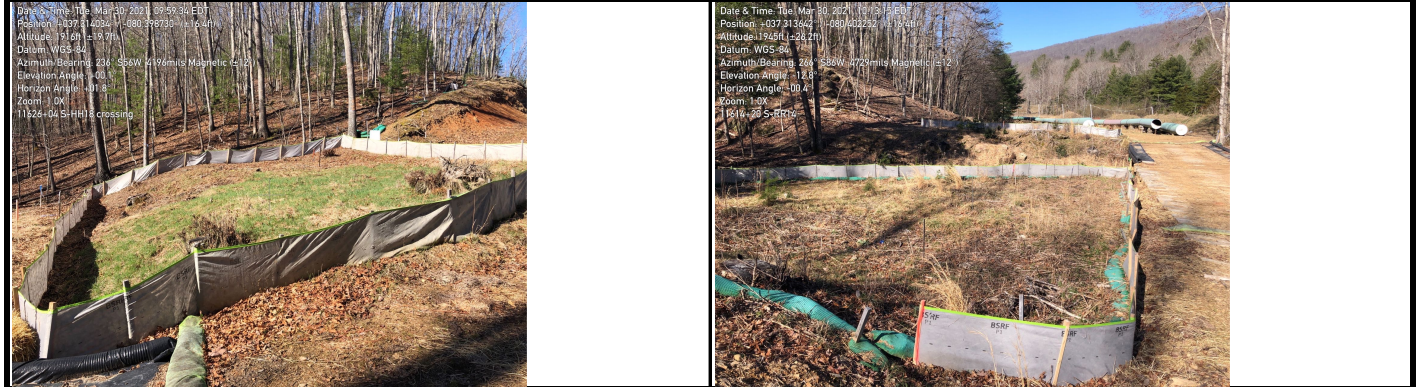
| Pic 7 Desc. | S-HH18 buffers and crossing are stable. | Pic 8 Desc. | S-RR14 buffers and crossing are stable. |

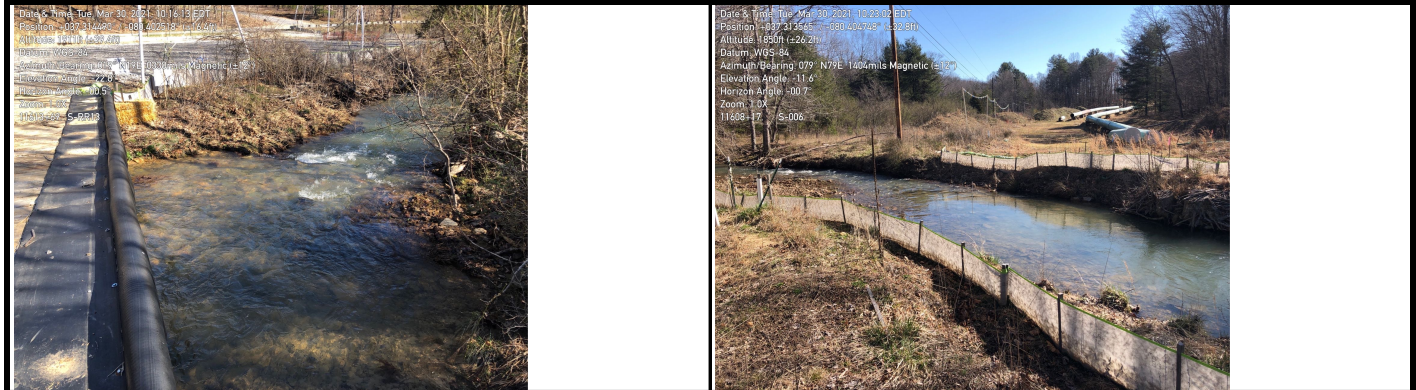
| Pic 9 Desc. | The S-RR13 crossing on MN-258.04 is stable. | Pic 10 Desc. | S-006 crossing and buffers are stable. |

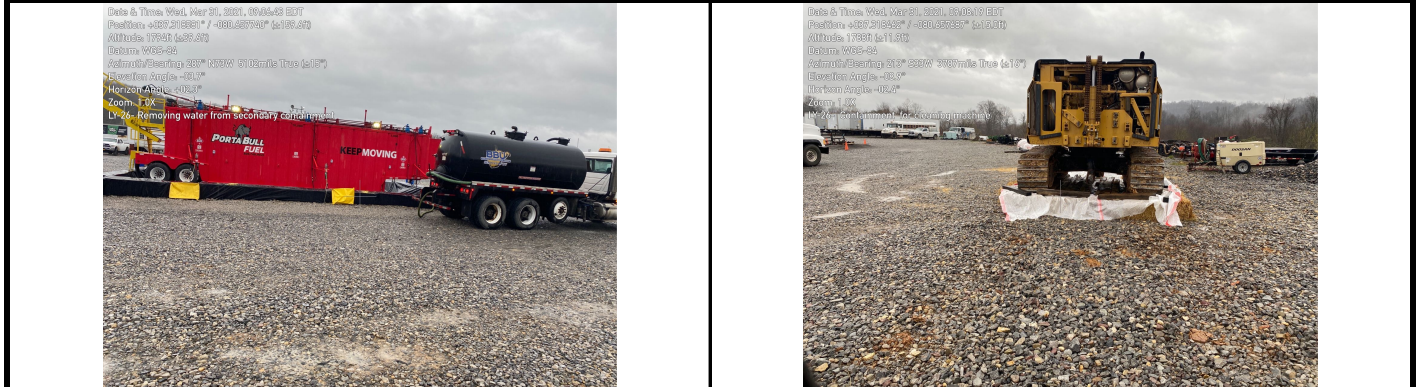
| Pic 1 Desc. | LY-26- Contractor pumping water from containment units | Pic 2 Desc. | Hoe in containment. |

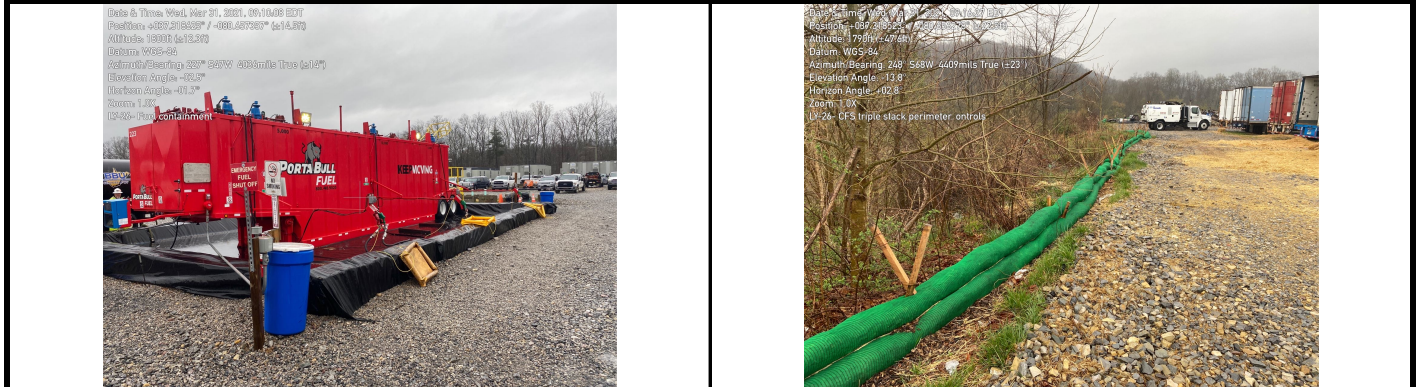
| Pic 3 Desc. | Fuel tank in containment. | Pic 4 Desc. | CFS triple stack perimeter controls. |

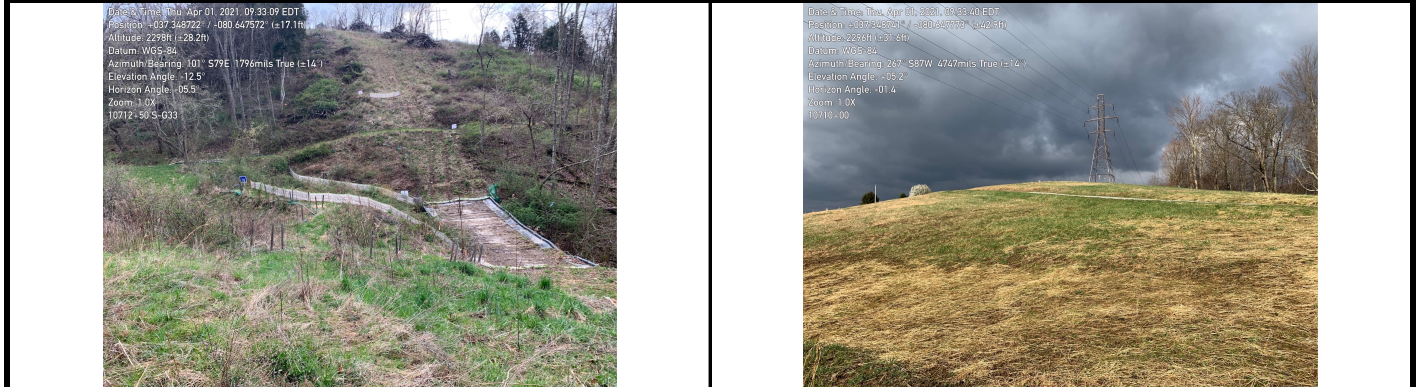
| Pic 1 Desc. Sensitive resource buffer in place at stream S-G33. | Pic 2 Desc. ROW stabilized with natural vegetation growth. |

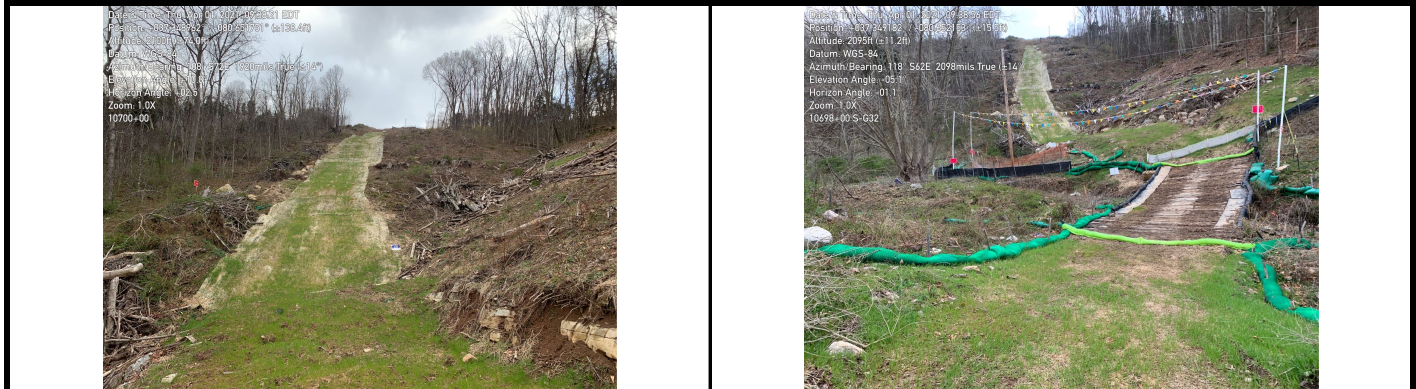
| Pic 3 Desc. Steep slope stabilized with ECB. | Pic 4 Desc. Sensitive resource buffer in place at stream S-G32. |

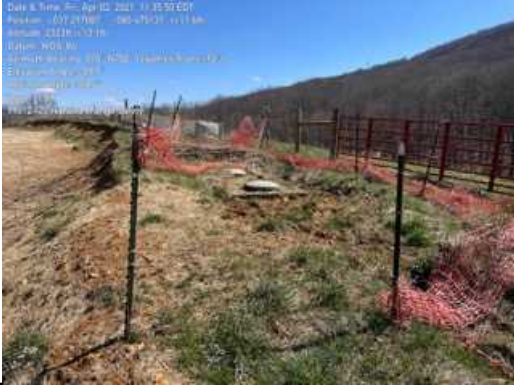
| AFE 124300137 | | Date/Time 4/2/2021 10:57 PM | | Report # | |
|---|--|---|--|---|--|
| Pic 3 Desc. safety fence in need of repair | | Pic 4 Desc. cfs needs sediment removed from equipment tracking | | | |
