Visual Site Inspection Report

Project Name H-600 Pipeline Spread H		AFE 124300138	Spread H-600 Pipeline Spread H
Contractor Precision		Report # 20048	
Inspector John Brcic		Date/Time 2/15/2021 3:58 PM	
Permit # TBD	Inspection Type VA SWPP	Station Begin 12284+75	
State VA	Inspection Area Partial	Station End 12443+75	
County Montgomery	Ground Wet	Temperature (°F) 35.00	
Municipality N/A	Weather Light Rain	Rain Gauge (in) 0.60	
Rain Accumulation Time (days)			3.00

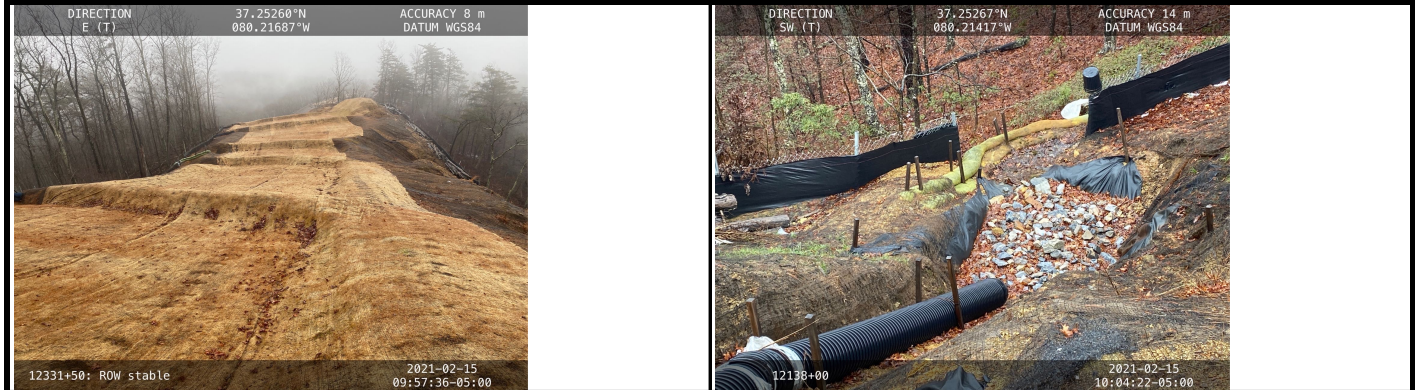
GPS Location	See photo	GPS Location	See photo
Field Station#	12331+00	Field Station#	12138+00
Pic 9 Desc.	ROW stable	Pic 10 Desc.	Slope drain in satisfactory condition.

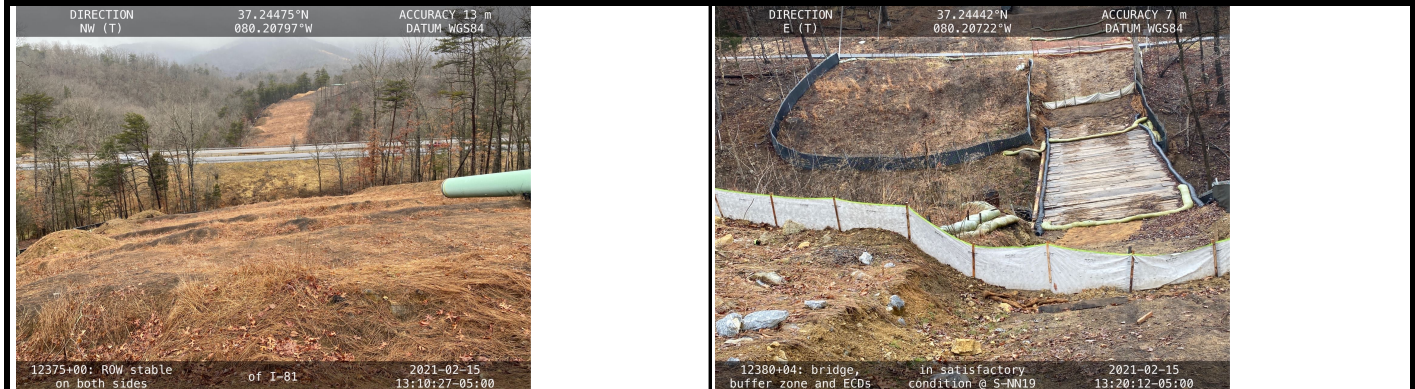
GPS Location	See photo	GPS Location	See photo
Field Station#	12375+00	Field Station#	12380+04
Pic 11 Desc.	ROW stable on both sides of I-81.	Pic 12 Desc.	Bridge, buffer zone and ECDs in satisfactory condition at stream S-NN19.

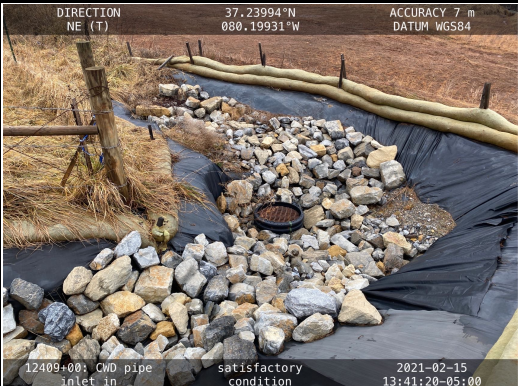
<p>DIRECTION NE (T) 37.23994°N 080.19931°W ACCURACY 7 m DATUM WGS84 12409+00; CWD pipe inlet in satisfactory condition 2021-02-15 13:41:20-05:00</p>

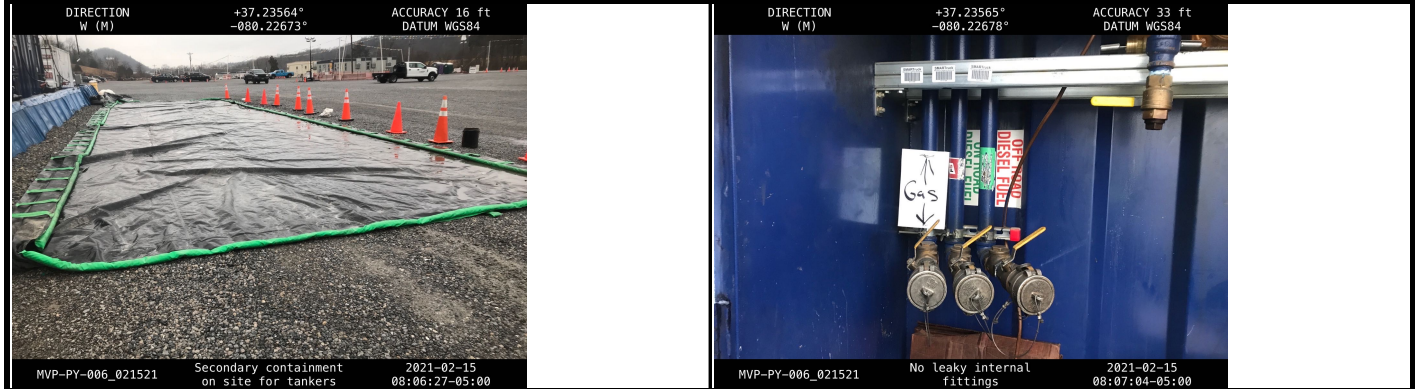
GPS Location MVP-PY-006 See photo for gps data	GPS Location MVP-PY-006 See photo for gps data
Field Station# +0	Field Station# +0
Pic 13 Desc. Secondary containment on site for tankers offloading fuel into Blue Bulk fuel tanks. Looking W.	Pic 14 Desc. Blue Bulk Fuel tanks no leaky internal fittings. Looking W.

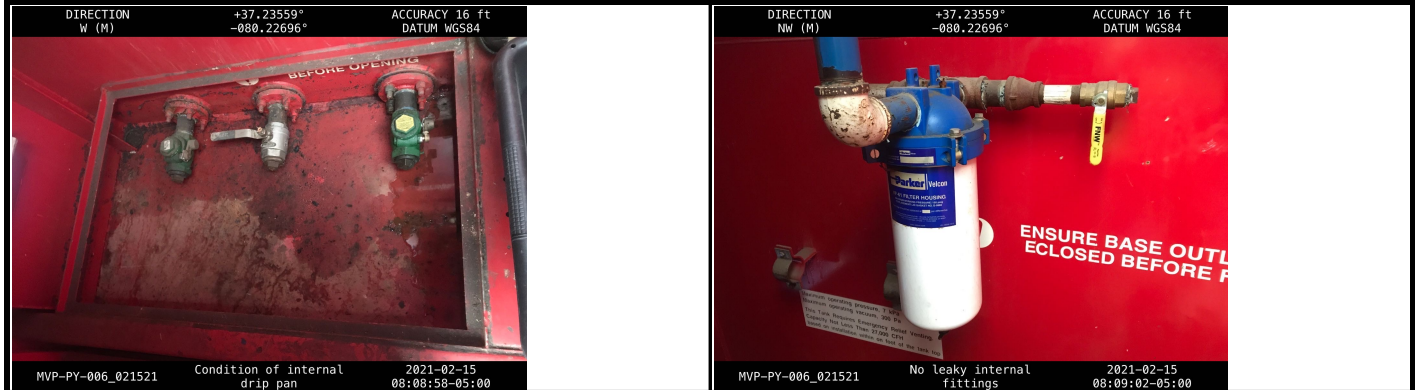
GPS Location MVP-PY-006 See photo for gps data	GPS Location MVP-PY-006 See photo for gps data
Field Station# +0	Field Station# +0
Pic 15 Desc. Off Road Fuel unit condition of internal drip pan. Looking W.	Pic 16 Desc. Off Road Fuel unit no leaky internal fittings. Looking W.

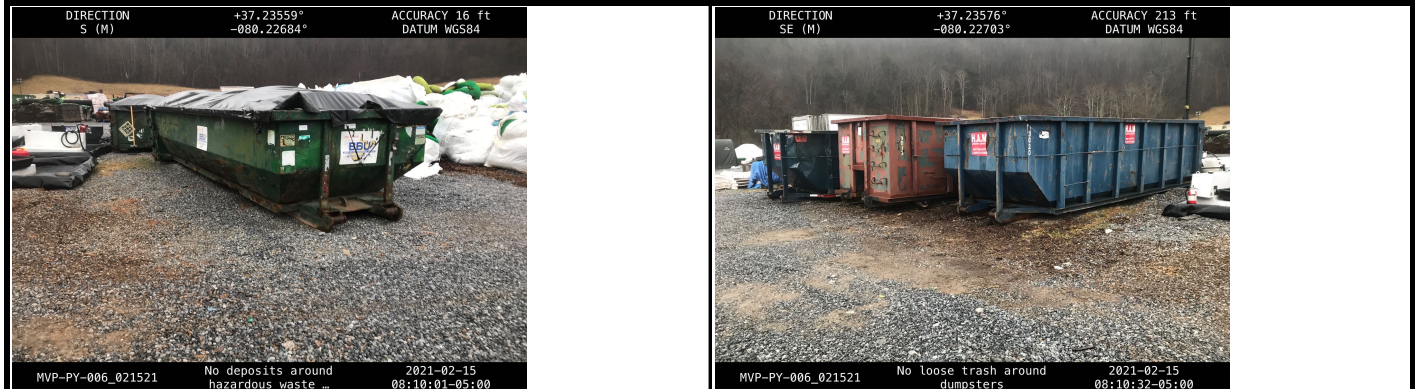
GPS Location MVP-PY-006 See photo for gps data	GPS Location MVP-PY-006 See photo for gps data
Field Station# +0	Field Station# +0
Pic 17 Desc. No deposits or fluids around hazardous waste dumpsters. Looking S.	Pic 18 Desc. No loose trash around dumpsters. Looking SE.

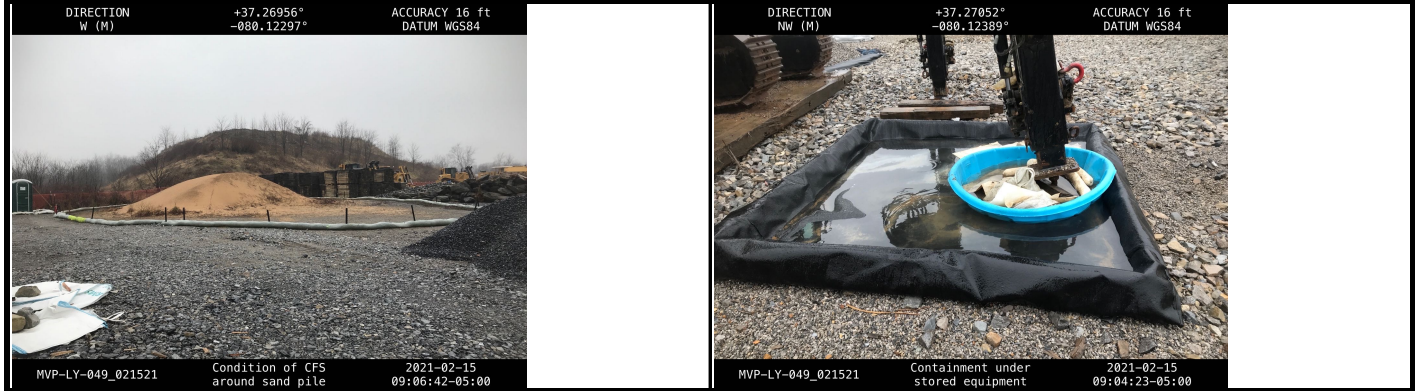
GPS Location MVP-LY-049 See photo for gps data	GPS Location MVP-LY-049 See photo for gps data
Field Station# +0	Field Station# +0
Pic 13 Desc. Condition of compost filter sock around sand pile. Looking W.	Pic 14 Desc. Condition of containment under stored equipment. Holding fluid and stormwater. Looking NW.

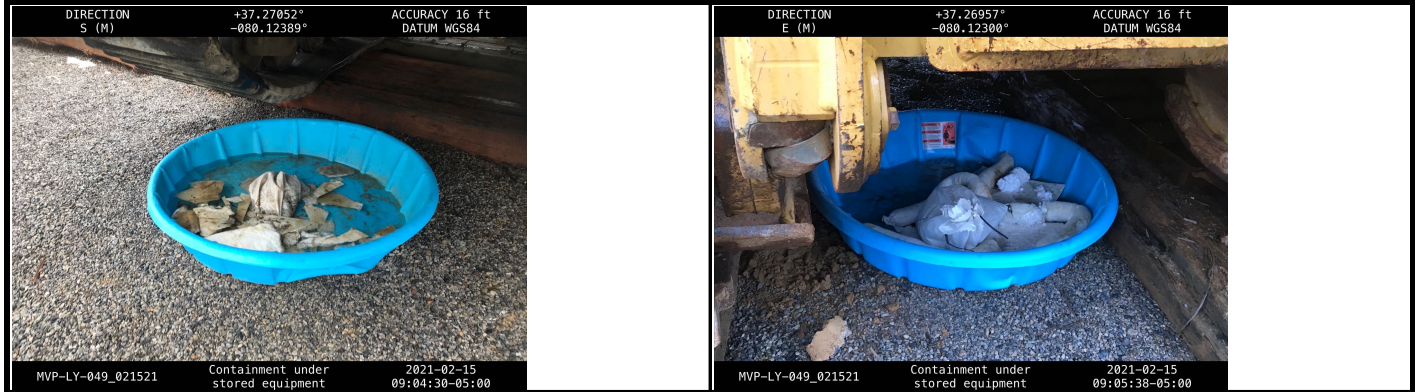
GPS Location MVP-LY-049 See photo for gps data	GPS Location MVP-LY-049 See photo for gps data
Field Station# +0	Field Station# +0
Pic 15 Desc. Condition of containment under stored equipment. Holding fluid and stormwater. Looking S.	Pic 16 Desc. Condition of containment under stored equipment. Holding some stormwater. Looking E.

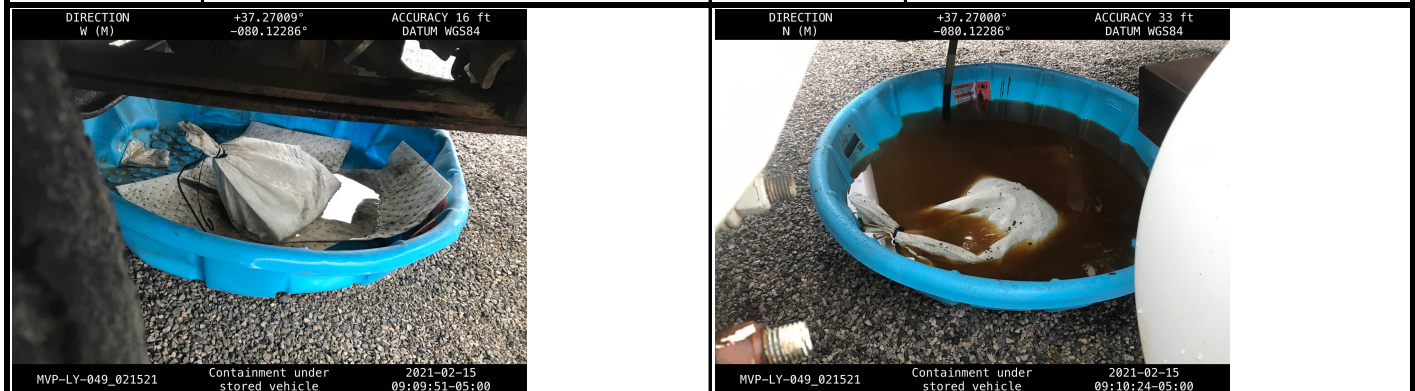
GPS Location MVP-LY-049 See photo for gps data	GPS Location MVP-LY-049 See photo for gps data
Field Station# +0	Field Station# +0
Pic 17 Desc. Condition of containment under stored vehicle. Looking NW.	Pic 18 Desc. Condition of containment under stored vehicle. Holding fluid and stormwater. Looking N.

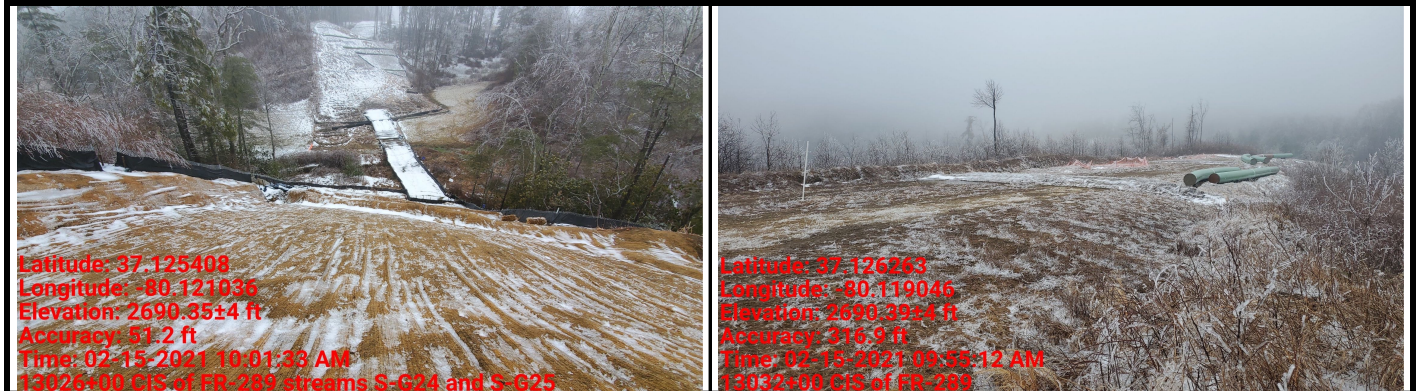
GPS Location	See pic for GPS location	GPS Location	See pic for GPS location
Field Station#	13026+00	Field Station#	13032+00
Pic 3 Desc.	Streams S-G24 and S-G25 from the GAS.	Pic 4 Desc.	Current ROW conditions on the CIS of FR-289.

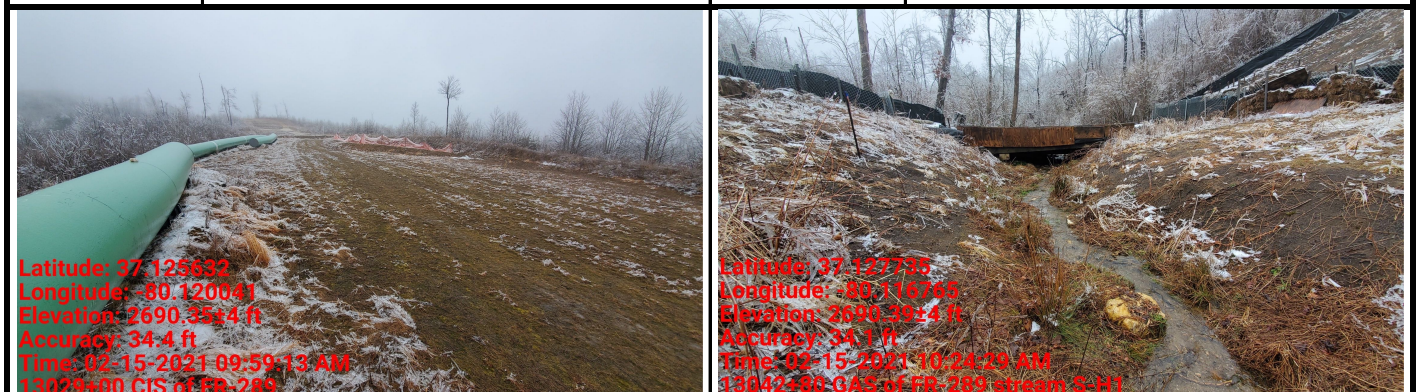
GPS Location	See pic for GPS location	GPS Location	See pic for GPS location
Field Station#	13029+00	Field Station#	13042+80
Pic 5 Desc.	Current ROW conditions on the CIS of FR-289.	Pic 6 Desc.	Stream S-H1 from the upstream side of the ROW.

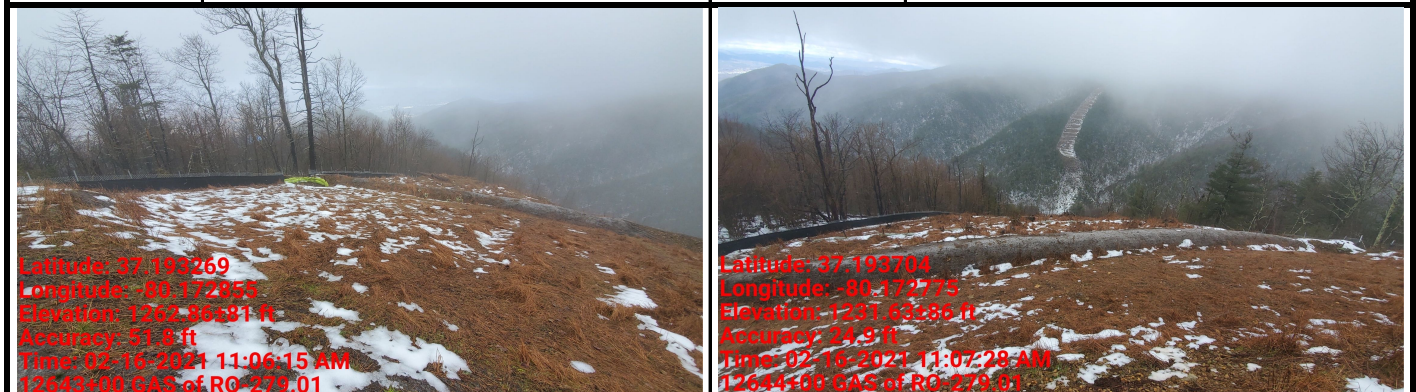
GPS Location	See pic for GPS location	GPS Location	See pic for GPS location
Field Station#	12643+00	Field Station#	12644+00
Pic 5 Desc.	Current ROW conditions on the GAS of RO-279.01.	Pic 6 Desc.	Current ROW conditions on the GAS of RO-279.01.

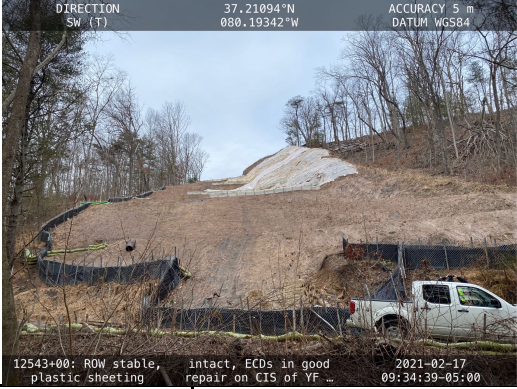
<p>DIRECTION SW (T) 37.21094°N 080.19342°W ACCURACY 5 m DATUM WGS84</p> <p>12543+00: ROW stable, plastic sheeting intact, ECDs in good repair on CIS of YF ... 2021-02-17 09:34:39-05:00</p>		  <p>DIRECTION S (T) 37.21180°N 080.19558°W ACCURACY 10 m DATUM WGS84</p> <p>12535+00: fill slope stable 2021-02-17 09:42:43-05:00</p>	
GPS Location	See photo	GPS Location	See photo
Field Station#	12543+00	Field Station#	12535+00
Pic 7 Desc.	ROW stable, plastic sheeting intact, and ECDs in satisfactory condition on the coming in side of Yellow Finch Lane.	Pic 8 Desc.	Fill slope stable.
  <p>DIRECTION N (T) 37.21233°N 080.19624°W ACCURACY 11 m DATUM WGS84</p> <p>12534+00: CWD pipe outlet in good repair Rick discolored but no sediment deposits 2021-02-17 09:46:24-05:00</p>		  <p>DIRECTION N (T) 37.21292°N 080.19694°W ACCURACY 5 m DATUM WGS84</p> <p>2021-02-17 09:49:34-05:00</p>

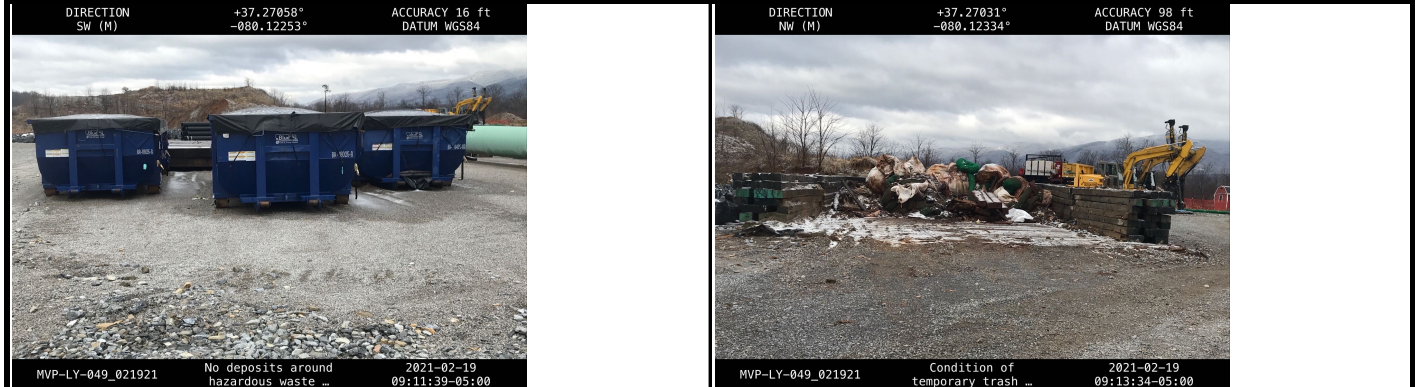
GPS Location MVP-LY-049 See photo for gps data	GPS Location MVP-LY-049 See photo for gps data
Field Station# +0	Field Station# +0
Pic 7 Desc. No deposits or fluids around hazardous waste dumpsters. Looking NW.	Pic 8 Desc. Condition of of temporary trash transfer pit. Debris inside boundary of pit. Looking NW.

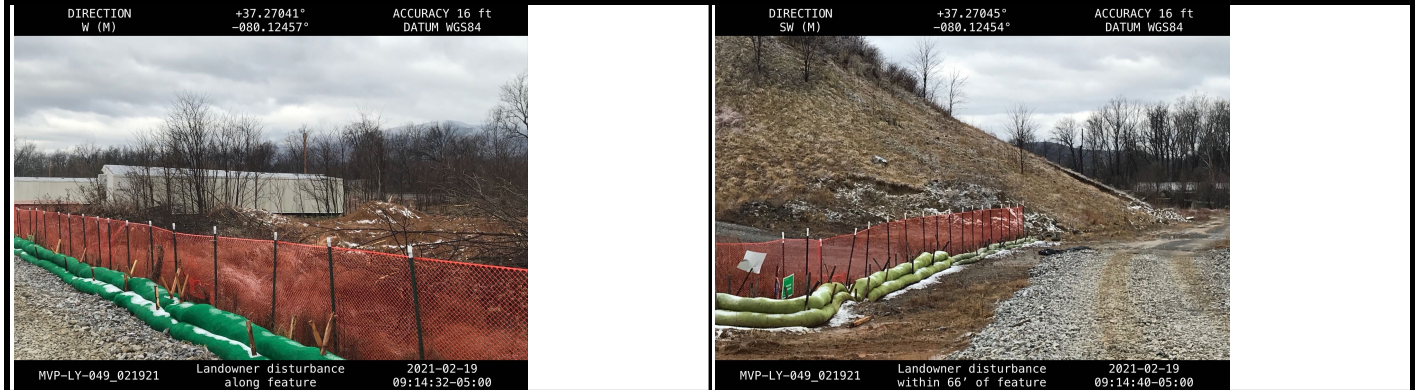
GPS Location MVP-LY-049 See photo for gps data	GPS Location MVP-LY-049 See photo for gps data
Field Station# +0	Field Station# +0
Pic 9 Desc. Landowner soil disturbance along north edge of feature W-CV21A. Looking W.	Pic 10 Desc. Landowner soil disturbance within 66' and 120' west of feature W-CV21B. Areas not stabilized. Looking SW.

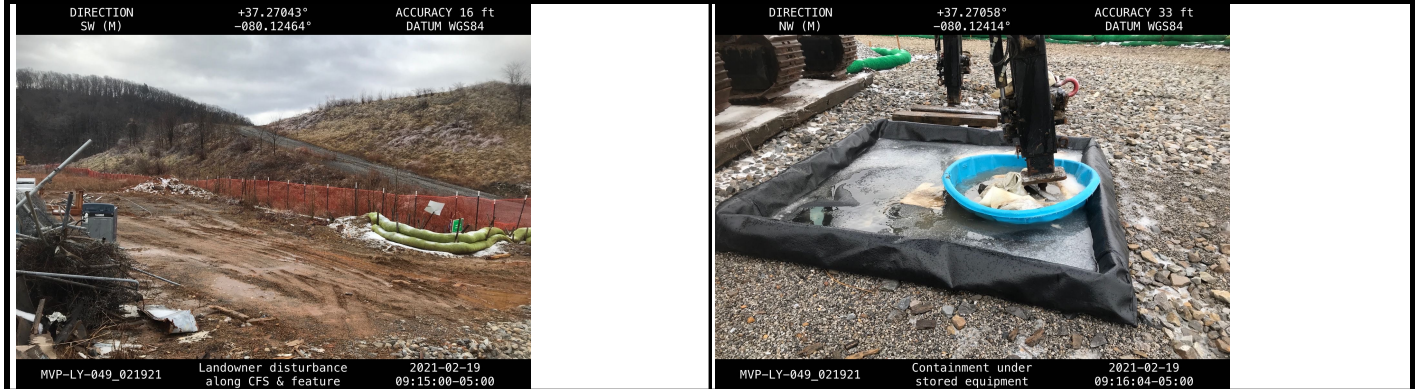
GPS Location MVP-LY-049 See photo for gps data	GPS Location MVP-LY-049 See photo for gps data
Field Station# +0	Field Station# +0
Pic 11 Desc. Landowner soil disturbance along compost filter sock and feature W-CV21B. Area not stabilized. Looking SW.	Pic 12 Desc. Condition of containment under stored equipment. Containment holding fluid, stormwater and ice. Looking NW.

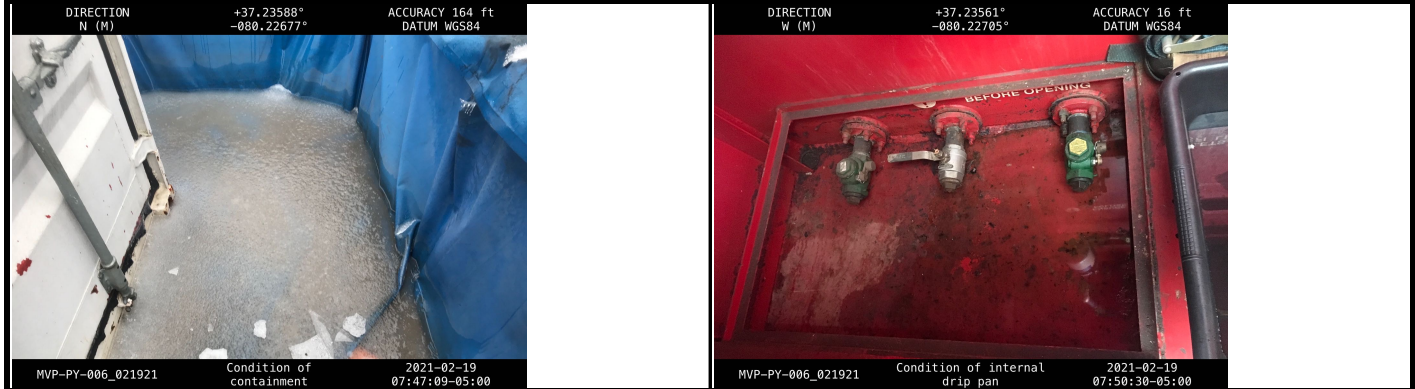
GPS Location MVP-PY-006 See photo for gps data	GPS Location MVP-PY-006 See photo for gps data
Field Station# +0	Field Station# +0
Pic 13 Desc. Off Road Fuel unit containment holding stormwater and ice. Looking N.	Pic 14 Desc. Off Road Fuel unit condition of internal drip pan. Looking W.

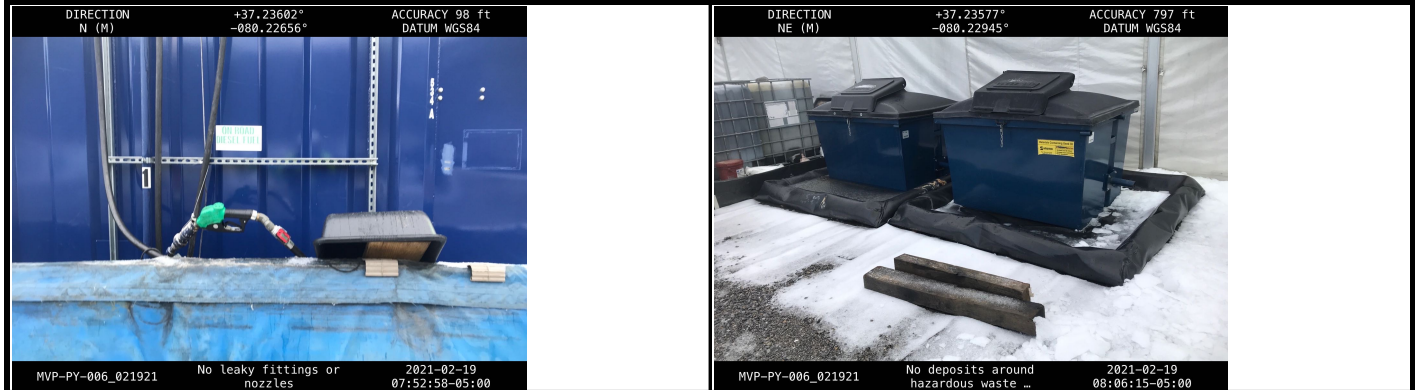
GPS Location MVP-PY-006 See photo for gps data	GPS Location MVP-PY-006 See photo for gps data
Field Station# +0	Field Station# +0
Pic 15 Desc. Blue Bulk Fuel tanks no leaky fittings or nozzles. Looking N.	Pic 16 Desc. No deposits or fluids around hazardous waste waste dumpsters west of mechanics building. Looking NE.

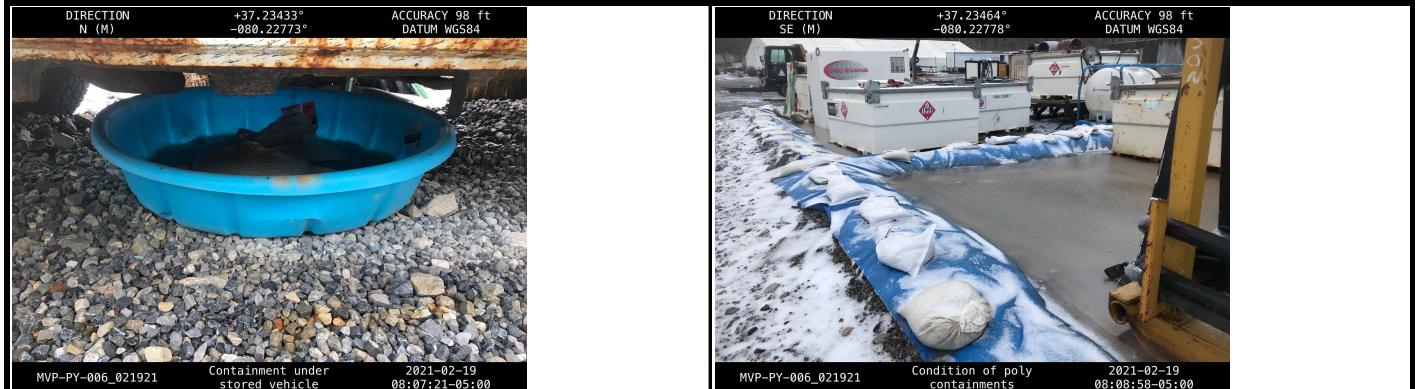
GPS Location MVP-PY-006 See photo for gps data	GPS Location MVP-PY-006 See photo for gps data
Field Station# +0	Field Station# +0
Pic 17 Desc. Condition of containment under stored vehicle. Looking N.	Pic 18 Desc. Condition of poly lined containments. Holding stormwater and ice. Looking SE.
