Visual Site Inspection Report

Project Name H-600 Pipeline Spread H		AFE 124300138	Spread H-600 Pipeline Spread H
Contractor Precision		Report # 20247	
Inspector John Brcic		Date/Time 2/20/2021 1:37 PM	
Permit # TBD	Inspection Type VA SWPP	Station Begin 12284+75	
State VA	Inspection Area Partial	Station End 12443+75	
County Montgomery	Ground Frozen	Temperature (°F) 30.00	
Municipality N/A	Weather Sunny	Rain Gauge (in) 0.00	
			Rain Accumulation Time (days) 1.00

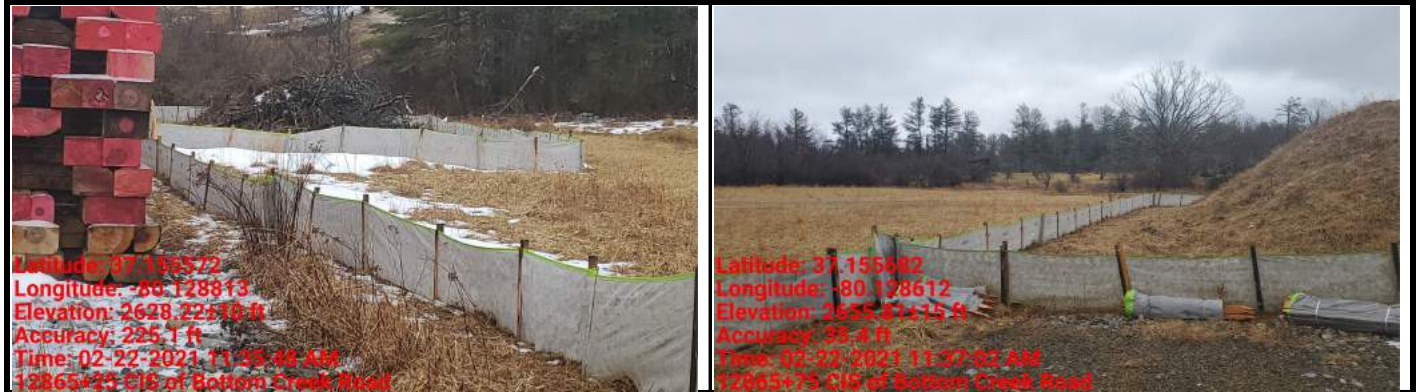
GPS Location	See pic for GPS location	GPS Location	See pic for GPS location
Field Station#	12865+25	Field Station#	12865+75
Pic 15 Desc.	P1 silt fence perimeter on the CIS of Bottom Creek Road.	Pic 16 Desc.	P1 silt fence recently replaced around topsoil pile.

P1 silt fence replaced where deteriorating around the topsoil pile on Bottom Creek Road.

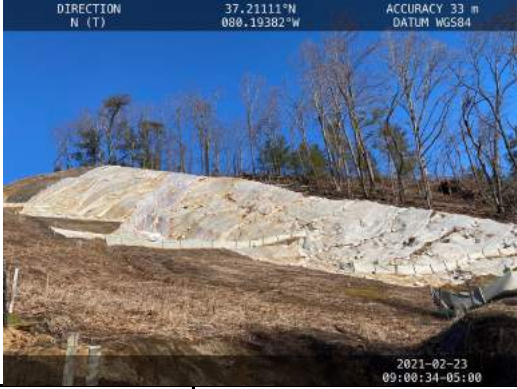
<p>DIRECTION N (T) 37.21111°N 088.19382°W ACCURACY 33 m DATUM WGS84</p> <p>2021-02-23 09:00:34-05:00</p>	
GPS Location	See photo	GPS Location	See photo
Field Station#	12543+00	Field Station#	12543+00
Pic 7 Desc.	The slope on the coming in side of Yellow Finch Lane is stable, ECDs in satisfactory condition.	Pic 8 Desc.	Plastic sheeting nearest to Yellow Finch Lane is intact and secure.

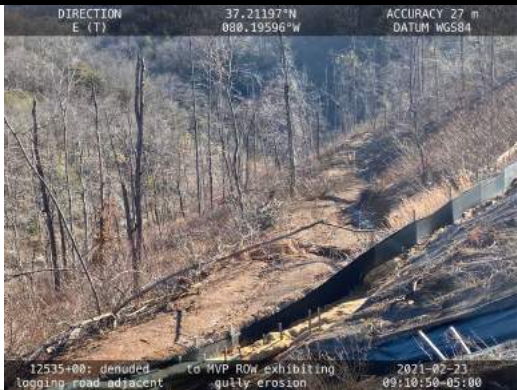
<p>DIRECTION E (T) 37.21197°N 088.19596°W ACCURACY 27 m DATUM WGS84</p> <p>12535+00: denuded logging road adjacent to MVP ROW exhibiting gully erosion 2021-02-23 09:10:50-05:00</p>

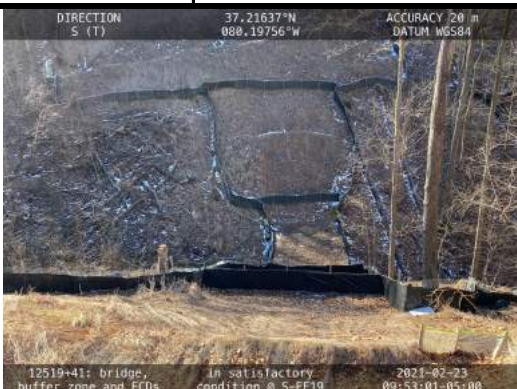
<p>DIRECTION S (T) 37.21637°N 088.19756°W ACCURACY 26 m DATUM WGS84</p> <p>12519+41: bridge, buffer zone and ECDs in satisfactory condition @ S-EF19 2021-02-23 09:53:01-05:00</p>	
GPS Location	See photo	GPS Location	See photo
Field Station#	12519+41	Field Station#	12519+41
Pic 11 Desc.	Stream S-EF19, facing east, upstream	Pic 12 Desc.	Bridge, buffer zone and ECDs in satisfactory condition at stream S-EF19.

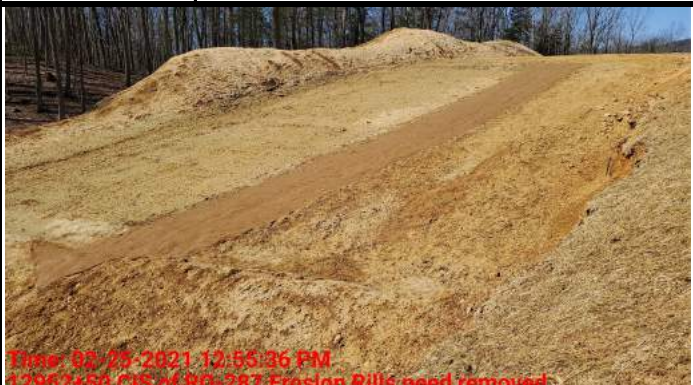
<p>Time: 02-23-2021 12:55:36 PM 12962+50 CIS of RO-287 Erosion Rills need removed</p>			
GPS Location	See pic for GPS location		GPS Location	See pic for GPS location	
Field Station#	12952+50		Field Station#	12952+50	
Pic 11 Desc.	Current ROW conditions on the CIS of RO-287.		Pic 12 Desc.	Erosion rills near the top of the slope on the CIS of RO- *Repaired*

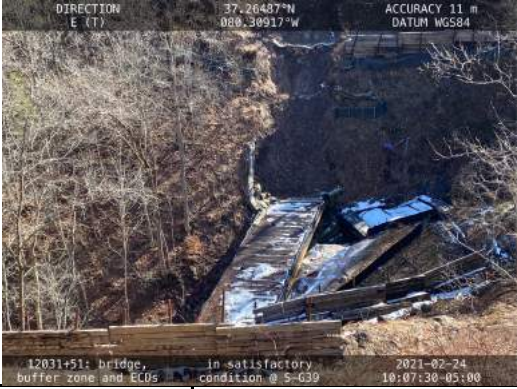
<p>DIRECTION E (T) 37.26487°N 088.38917°W ACCURACY 11 m DATUM WGS84 12031+51: bridge, buffer zone and ECDs in satisfactory condition @ S-G39 2021-02-24 10:07:38-05:00</p>

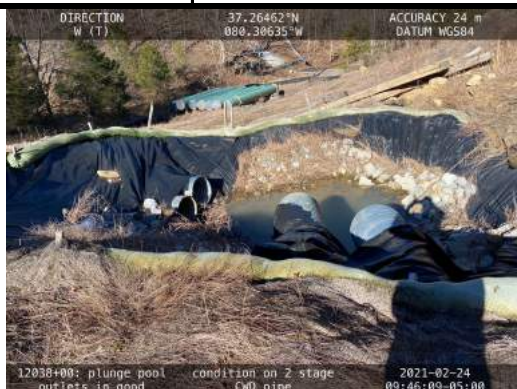
<p>DIRECTION W (T) 37.26462°N 088.38635°W ACCURACY 24 m DATUM WGS84 12038+00: plunge pool outlets in good condition on 2 stage CWD pipe 2021-02-24 09:46:09-05:00</p>

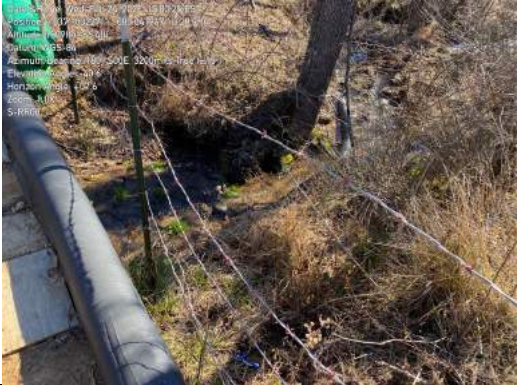
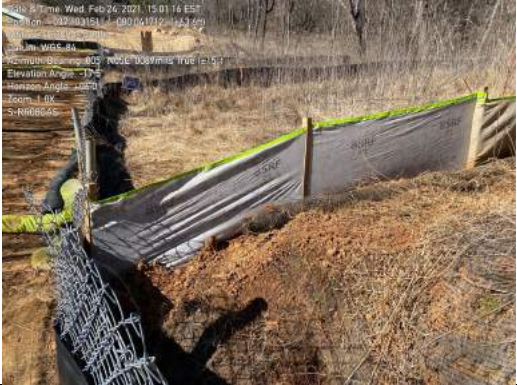
GPS Location	See photo for coordinates.	GPS Location	See photo for coordinates.
Field Station#	13348+46	Field Station#	13349+00
Pic 13 Desc.	S-RR08, downstream, no environmental concerns noted at stream crossing.	Pic 14 Desc.	Priority one silt fence was repaired on 2-23-21.

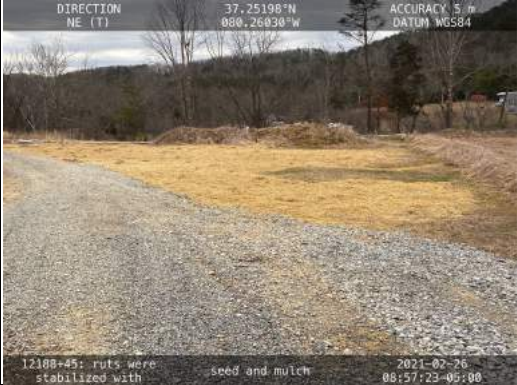
<p>DIRECTION NE (T) 37.25198°N 880.26030°W ACCURACY 5 m DATUM WGS84 12188+45: ruts were stabilized with seed and mulch 2021-02-26 08:57:23-09:00</p>
