Visual Site Inspection Report

Project Name H-600 Pipeline Spread H		AFE 124300138	Spread H-600 Pipeline Spread H
Contractor Precision		Report # 19823	
Inspector Jason Nielsen		Date/Time 2/8/2021 4:11 PM	
Permit # TBD	Inspection Type VA SWPP	Station Begin	12005+00
State VA	Inspection Area Partial	Station End	12119+17
County Montgomery	Ground Wet	Temperature (°F)	40.00
Municipality N/A	Weather Sunny	Rain Gauge (in)	0.30
			Rain Accumulation Time (days) 1.00

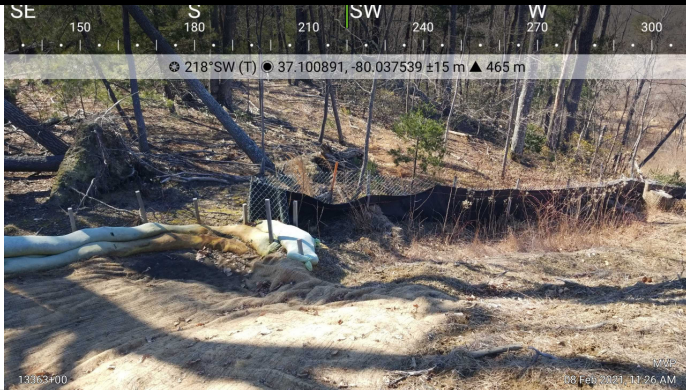
GPS Location	See Above	GPS Location	See Above
Field Station#	13363+00	Field Station#	13358+64
Pic 9 Desc.	Punchlist item: Repair super silt fence.	Pic 10 Desc.	Overview of Waterbody S-RR11. ECDs are functional and ROW is stable.

E&S BMPs	Compliance Level	Corrective Action	Corrective Time Frame	Date Repaired
Compost Filter Sock	Acceptable			
Silt Fence (Filter Fabric Fence)	Acceptable			
Silt Fence (Reinforce Filter Fence)	Communication	ST 13363+00 repair super silt fence		
Sump Pit	Acceptable			
Waterbar	Acceptable			
Waterbar End Treatment	Acceptable			
Equipment Bridge	Acceptable			
Cleanwater Diversion Pipe	Acceptable			
Rock Construction Entrance	Acceptable

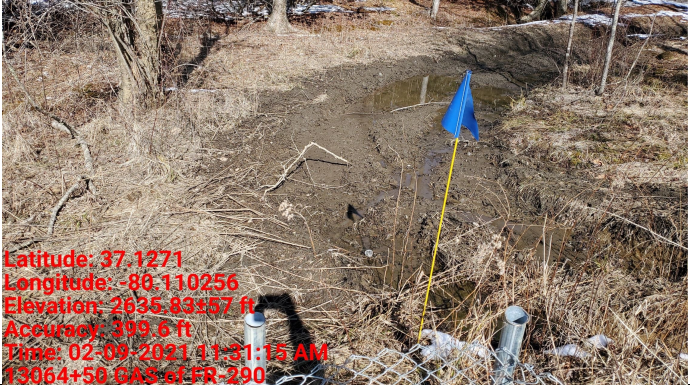
<p>Latitude: 37.1271 Longitude: -80.110256 Elevation: 2635.83±57 ft Accuracy: 399.6 ft Time: 02-09-2021 11:31:15 AM 13064+50 GAS of FR-290</p>	
GPS Location	See pic for GPS location	GPS Location	See pic for GPS location
Field Station#	13064+50	Field Station#	13064+50
Pic 7 Desc.	SSF damaged by landowner driving over it.	Pic 8 Desc.	Mud hole beyond the LOD where landowner has driven through and over the SSF.

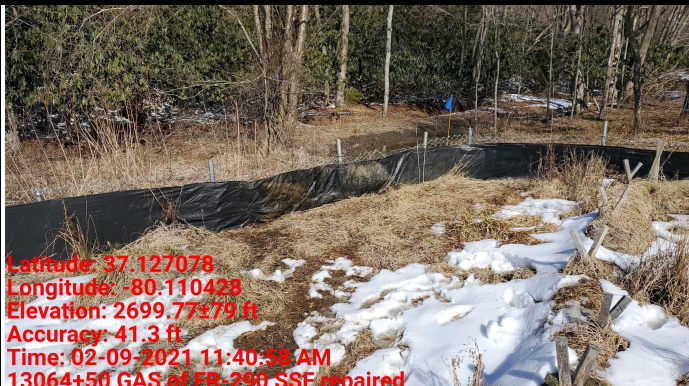
<p>Latitude: 37.127078 Longitude: -80.110428 Elevation: 2699.77±79 ft Accuracy: 41.3 ft Time: 02-09-2021 11:40:58 AM 13064+50 GAS of FR-290 SSF repaired</p>		  <p>Latitude: 37.126988 Longitude: -80.111195 Elevation: 2692.16±43 ft Accuracy: 48.2 ft Time: 02-09-2021 12:49:08 PM 13063+00 GAS of FR-290 stream S-G27</p>	
GPS Location	See pic for GPS location	GPS Location	See pic for GPS location

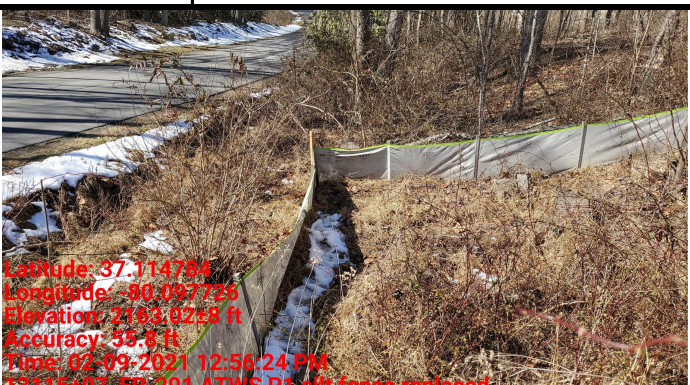
<p>Latitude: 37.114784 Longitude: -80.097725 Elevation: 2163.02±8 ft Accuracy: 55.0 ft Time: 02-09-2021 12:56:24 PM 13115+97 FR-291 ATWS Pt silt fence replaced</p>	
GPS Location	See pic for GPS location	GPS Location	See pic for GPS location
Field Station#	13062+00	Field Station#	13115+97
Pic 11 Desc.	Stream S-G26 on the GAS of FR-290.	Pic 12 Desc.	P1 silt fence replaced where damaged by fallen tree limb.

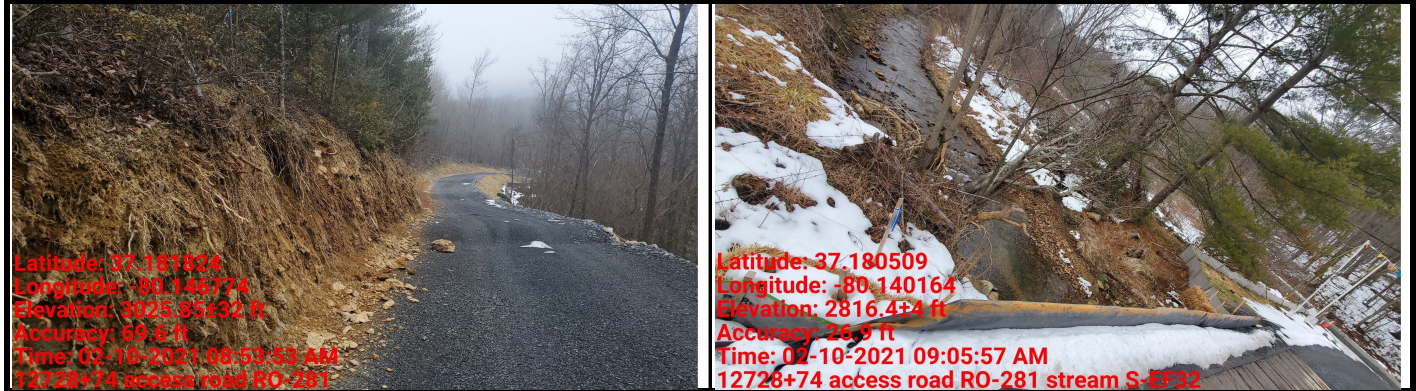
GPS Location	See pic for GPS location	GPS Location	See pic for GPS location
Field Station#	12728+74	Field Station#	12728+74
Pic 7 Desc.	Cut bank along RO-281 with small rocks falling from the freezing and thawing of the material. No significant issues observed.	Pic 8 Desc.	No impacts observed at stream S-EF32.

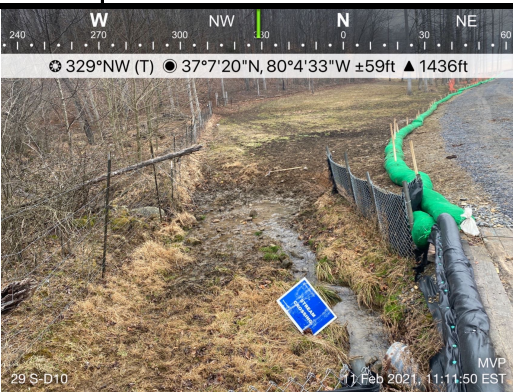
<p>GPS: 329°NW (T) 37°7'20"N, 80°4'33"W ±59ft ▲1436ft 11 Feb 2021, 11:11:50 EST</p>			
GPS Location	See photo for coordinates.		GPS Location	See photo for coordinates.	
Field Station#	13189+00		Field Station#	13190+00	
Pic 3 Desc.	MVP-FR-292.01, access road in acceptable condition, banks stabilized and broad based dips and rock lined channel outlets acceptable.		Pic 4 Desc.	S-D10, upstream of equipment air bridge, typical cattle disturbance noted along banks and in stream bed.

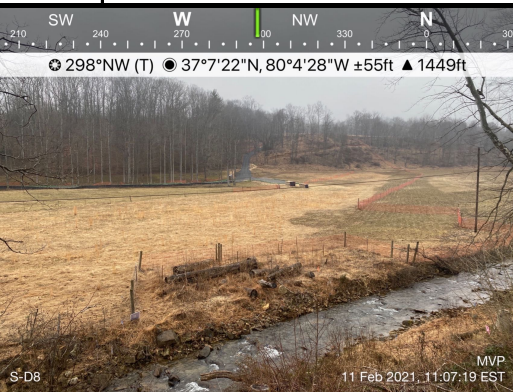
<p>GPS: 298°NW (T) 37°7'22"N, 80°4'28"W ±55ft ▲1449ft 11 Feb 2021, 11:07:19 EST</p>			
GPS Location	See photo for coordinates.		GPS Location	See photo for coordinates.	
Field Station#	13190+00		Field Station#	13197+00	
Pic 5 Desc.	S-D10, downstream of equipment air bridge, typical cattle disturbance noted along banks and in stream bed.		Pic 6 Desc.	S-D8, no ground disturbance in this section of ROW, some exclusion fence knocked down.

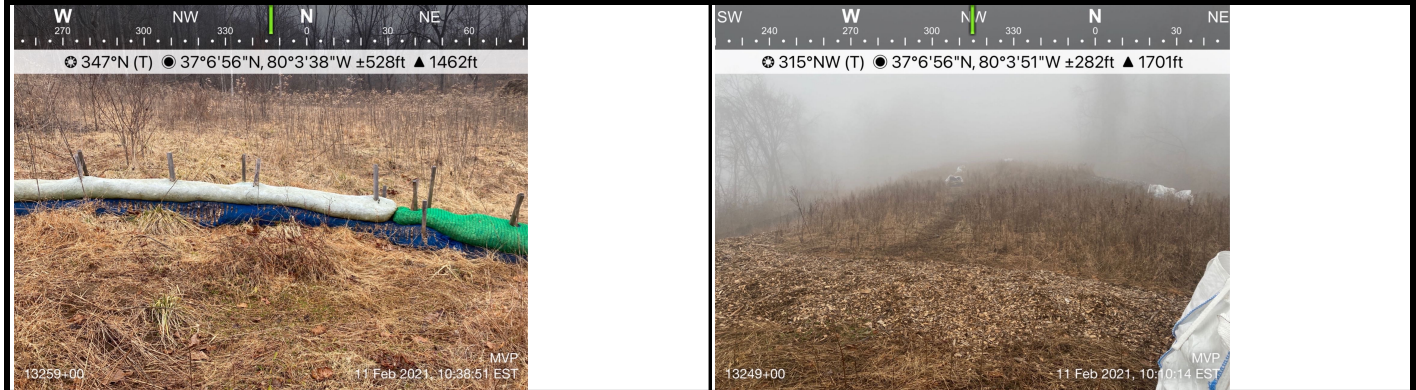
GPS Location	See photo for coordinates.	GPS Location	See photo for coordinates.
Field Station#	13259+00	Field Station#	13249+00
Pic 9 Desc.	Compost filter sock deteriorating on CIS of S-II4.	Pic 10 Desc.	ROW stable with good vegetative cover across LOD.
