Visual Site Inspection Report

Project Name H-600 Pipeline Spread H		AFE 124300138	Spread H-600 Pipeline Spread H
Contractor Precision		Report # 21607	
Inspector Logan Box		Date/Time 3/29/2021 3:36 PM	
Permit # TBD	Inspection Type VA SWPP	Station Begin 13525+99	
State VA	Inspection Area Partial	Station End 13670+00	
County Franklin	Ground Damp	Temperature (°F) 61.00	
Municipality N/A	Weather Sunny	Rain Gauge (in) 0.50	
			Rain Accumulation Time (days) 2.00

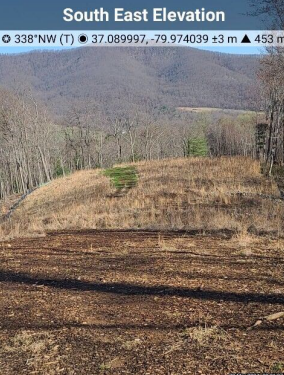
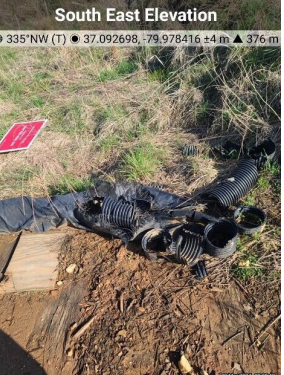
Throughout today's inspections the EI noticed the splash protection on one of the equipment bridges was damaged from wildlife activities. Documented and sent in to be added to the punch list as well as the contractor that was traveling row was aware and was going to make repairs today .

<p>South East Elevation 335°NW (T) ● 37.092698, -79.978416 ±4 m ▲ 376 m</p>	
GPS Location	00000		GPS Location	00000	
Field Station#	13610+00		Field Station#	13565+30	
Pic 3 Desc.	Row photo showing vegetation, some areas with little growth at this time, will continue to monitor.		Pic 4 Desc.	Splash protection on equipment bridge requires maintenance due to wildlife damage, documented and added to the punch list.

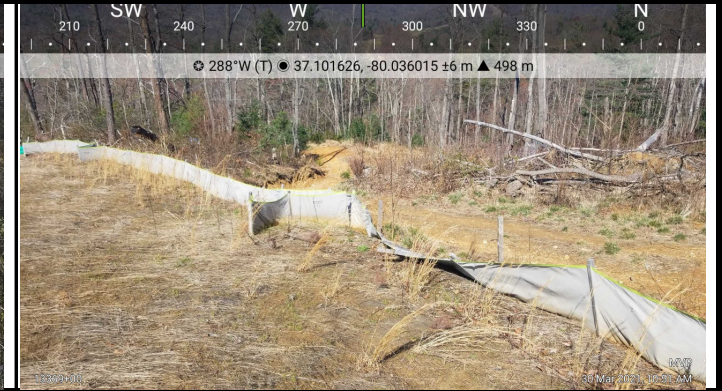
GPS Location	See Above
Field Station#	13369+00
Pic 14 Desc.	Punchlist item: Repair P1 silt fence.

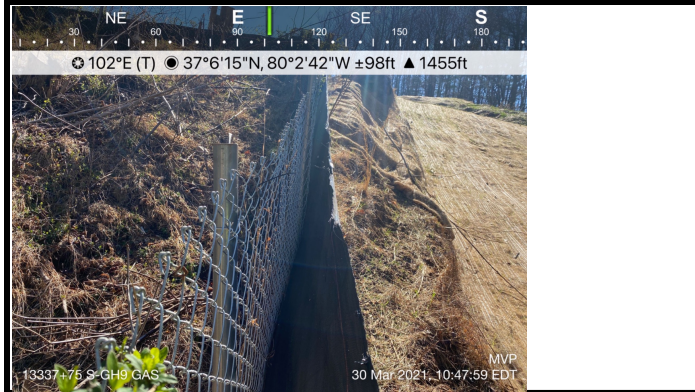
GPS Location	See Above
Field Station#	13337+75
Pic 15 Desc.	Punchlist item: Repair super silt fence.

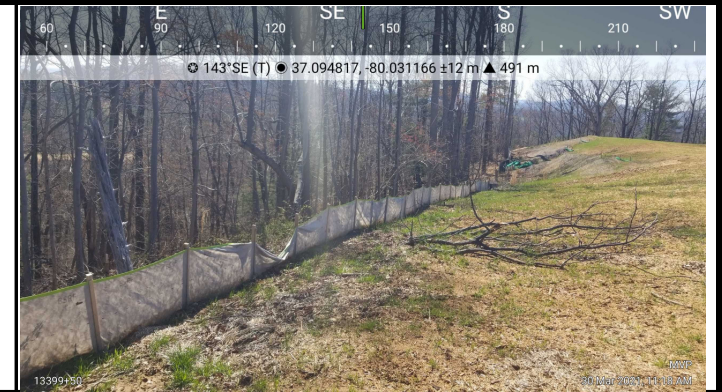
GPS Location	See Above
Field Station#	13399+50
Pic 16 Desc.	Punchlist item: Repair P1 silt fence.

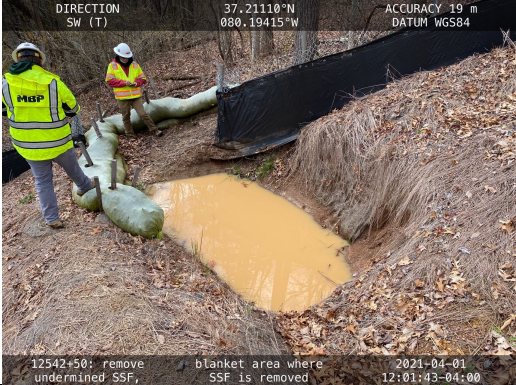
GPS Location	See photo	GPS Location	See photo
Field Station#	12543+00	Field Station#	12542+50
Pic 7 Desc.	The slope and stockpiles are stable, ECDs in satisfactory condition on coming in side of Yellow Finch Lane.	Pic 8 Desc.	MBP inspectors created an action item of SSF that was undermined by water entering the ROW.
