# Visual Site Inspection Report

<b>Project Name</b>	H-600 Pipeline Spread H	<b>AFE</b>	124300138	<b>Spread</b>	H-600 Pipeline Spread H
<b>Contractor</b>	Precision			<b>Report #</b>	22418
<b>Inspector</b>	Logan Box			<b>Date/Time</b>	4/19/2021 3:18 PM
<b>Permit #</b>	TBD	<b>Inspection Type</b>	VA SWPP	<b>Station Begin</b>	13415+51
<b>State</b>	VA	<b>Inspection Area</b>	Partial	<b>Station End</b>	13525+99
<b>County</b>	Franklin	<b>Ground</b>	Wet	<b>Temperature (°F)</b>	64.00
<b>Municipality</b>	N/A	<b>Weather</b>	Light Rain	<b>Rain Gauge (in)</b>	0.30
				<b>Rain Accumulation Time (days)</b>	1.00

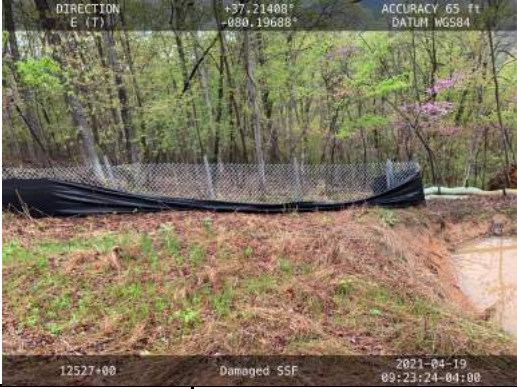
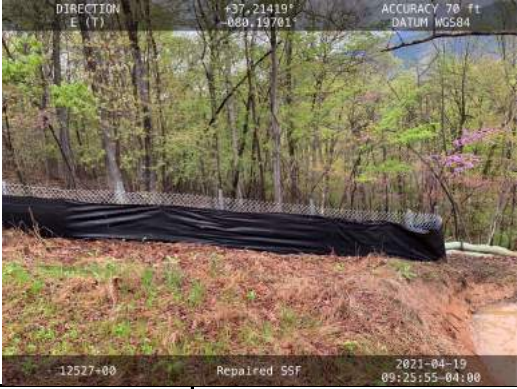
<b>GPS Location</b>	See photo for gps location data.		<b>GPS Location</b>	See photo for gps location data.	
<b>Field Station#</b>	12527+00		<b>Field Station#</b>	12527+00	
<b>Pic 7 Desc.</b>	Photo shows the damaged SSF.		<b>Pic 8 Desc.</b>	Photo shows repaired SSF.

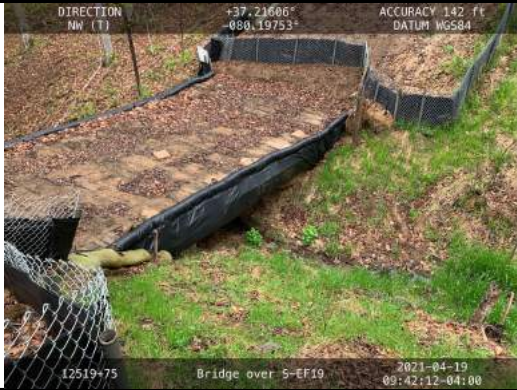
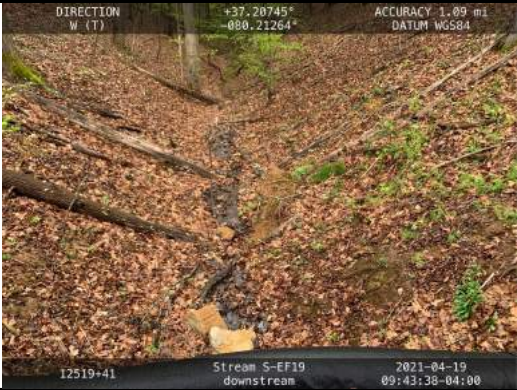
<b>GPS Location</b>	See photo for gps location data.		<b>GPS Location</b>	See photo for gps location data.	
<b>Field Station#</b>	12519+75		<b>Field Station#</b>	12519+41	
<b>Pic 9 Desc.</b>	Photo shows the bridge over stream S-EF19.		<b>Pic 10 Desc.</b>	Photo shows stream S-EF32 downstream from the bridge.

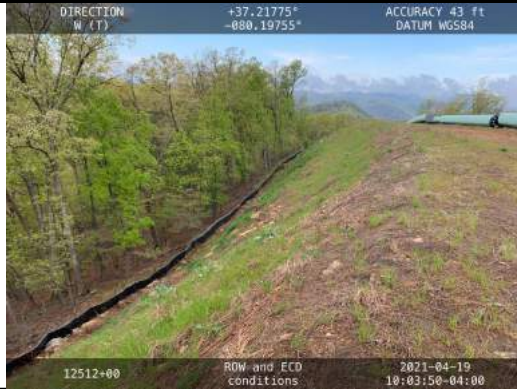
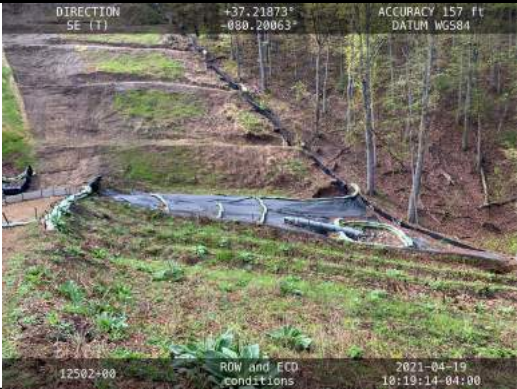
<b>GPS Location</b>	See photo for gps location data.		<b>GPS Location</b>	See photo for gps location data.	
<b>Field Station#</b>	12512+00		<b>Field Station#</b>	12502+00	
<b>Pic 11 Desc.</b>	Photo shows the ROW and ECD conditions from about 12511+00 to 12513+00.		<b>Pic 12 Desc.</b>	Photo shows the ROW and ECD conditions from about 12502+00 to 12505+00.

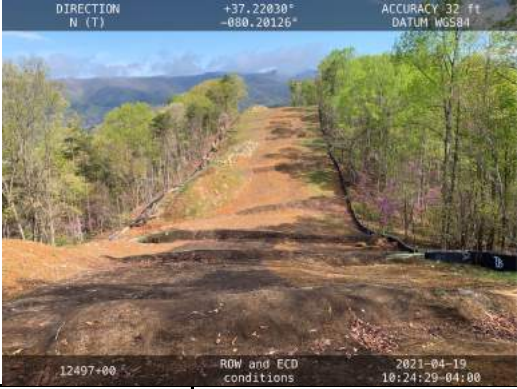
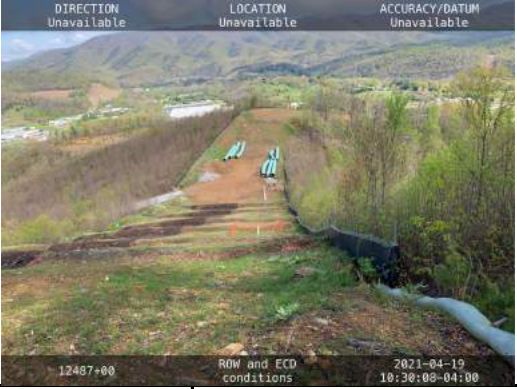
<b>GPS Location</b>	See photo for gps location data.		<b>GPS Location</b>	See photo for gps location data.	
<b>Field Station#</b>	12497+00		<b>Field Station#</b>	12487+00	
<b>Pic 13 Desc.</b>	Photo shows the ROW and ECD conditions from about 12493+00 to 12497+00.		<b>Pic 14 Desc.</b>	Photo shows the ROW and ECD conditions from about 12485+00 to 12487+00.

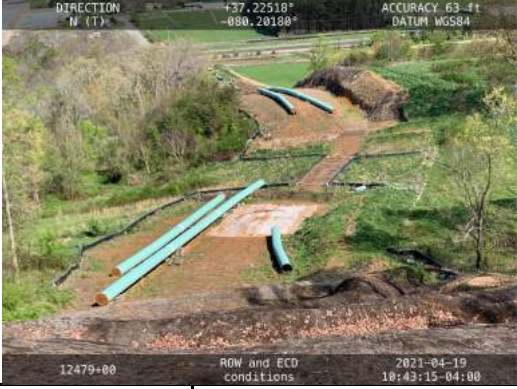
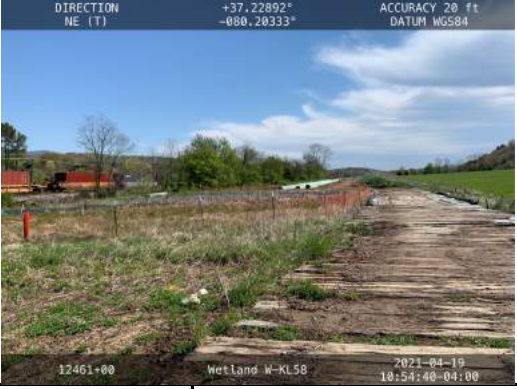
<b>GPS Location</b>	See photo for gps location data.		<b>GPS Location</b>	See photo for gps location data.	
<b>Field Station#</b>	12479+00		<b>Field Station#</b>	12461+00	
<b>Pic 15 Desc.</b>	Photo shows the ROW and ECD conditions from about 12475+00 to 12479+00.		<b>Pic 16 Desc.</b>	Photo shows wetland W-KL58.

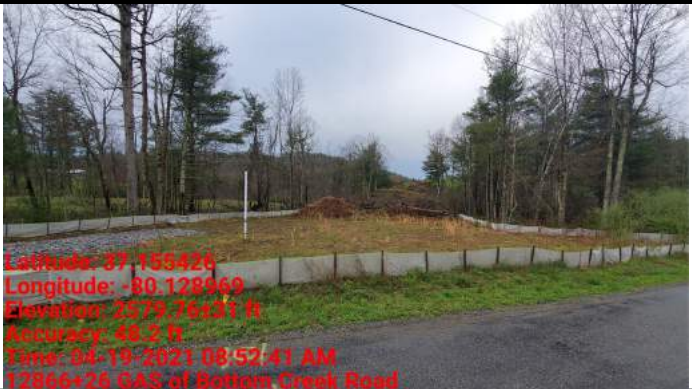
<p>Latitude: 37.155426 Longitude: -80.128969 Elevation: 2579.76±31 ft Accuracy: 44.2 ft Time: 04-19-2021 08:52:41 AM 12866+26 GAS of Bottom Creek Road</p>

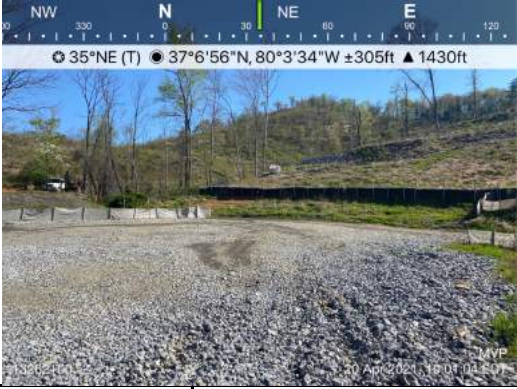
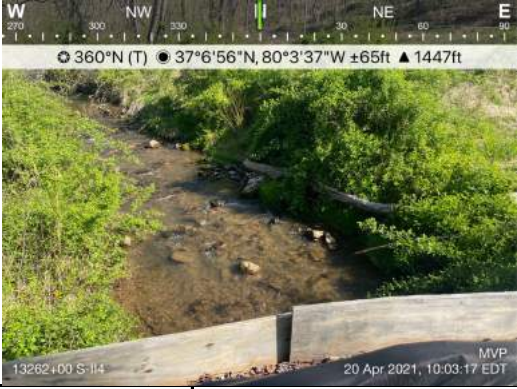
<b>GPS Location</b>	See photo for coordinates.		<b>GPS Location</b>	See photo for coordinates.	
<b>Field Station#</b>	13262+00		<b>Field Station#</b>	13262+60	
<b>Pic 7 Desc.</b>	MVP-FR-293.01, Flanders Road, RCE in acceptable condition.		<b>Pic 8 Desc.</b>	S-II4, upstream, banks well vegetated, no observable turbidity.

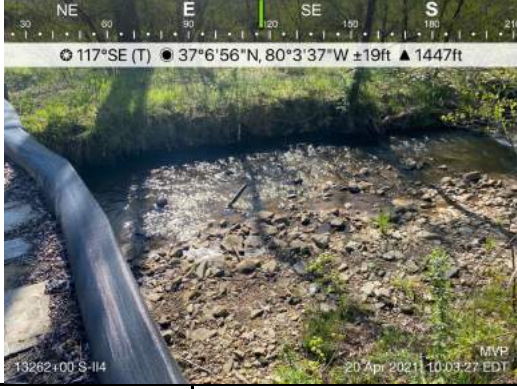
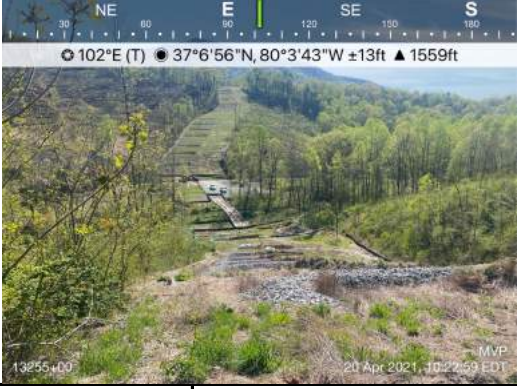
<b>GPS Location</b>	See photo for coordinates.		<b>GPS Location</b>	See photo for coordinates.	
<b>Field Station#</b>	13262+00		<b>Field Station#</b>	13255+00	
<b>Pic 9 Desc.</b>	S-II4, downstream, bed and banks stable with no changes noted.		<b>Pic 10 Desc.</b>	ROW stable with vegetative cover across LOD.

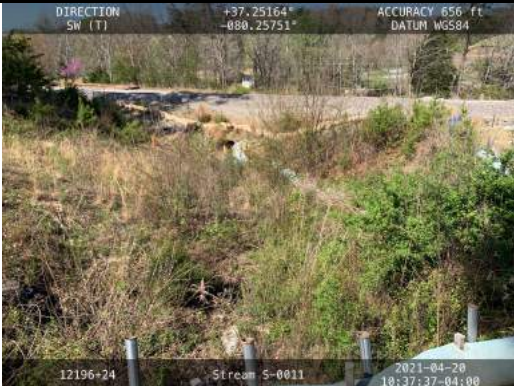
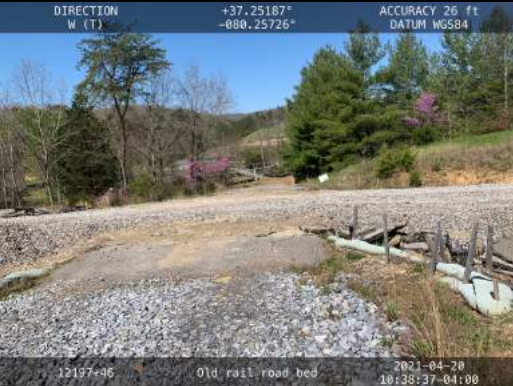
<b>GPS Location</b>	See photo for gps location data.		<b>GPS Location</b>	See photo for gps location data.	
<b>Field Station#</b>	1219+24		<b>Field Station#</b>	12197+46	
<b>Pic 5 Desc.</b>	Photo shows stream S-0011.		<b>Pic 6 Desc.</b>	Photo shows the former railroad bed. Rails were recently removed.

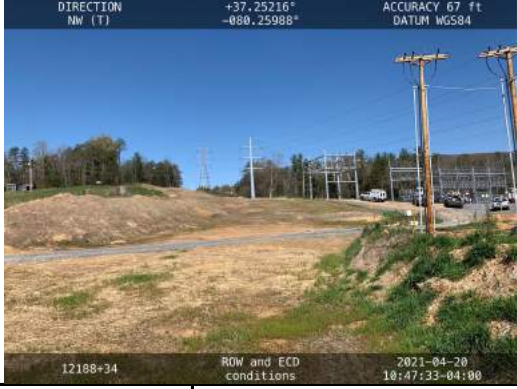
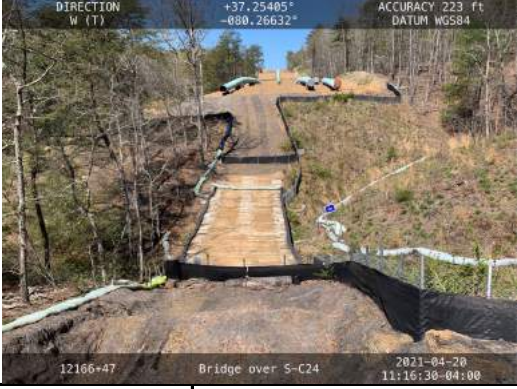
<b>GPS Location</b>	See photo for gps location data.		<b>GPS Location</b>	See photo for gps location data.	
<b>Field Station#</b>	12188+34		<b>Field Station#</b>	12166+47	
<b>Pic 9 Desc.</b>	Photo shows the ROW and ECD conditions.		<b>Pic 10 Desc.</b>	Photo shows the bridge over stream S-C24.

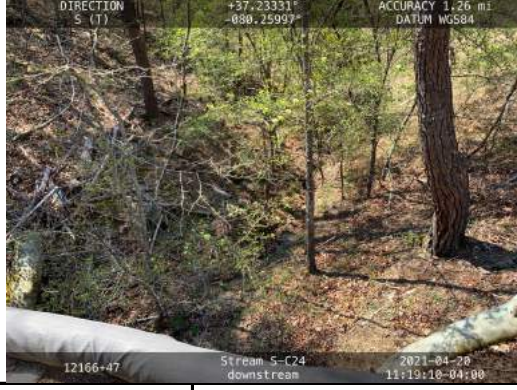
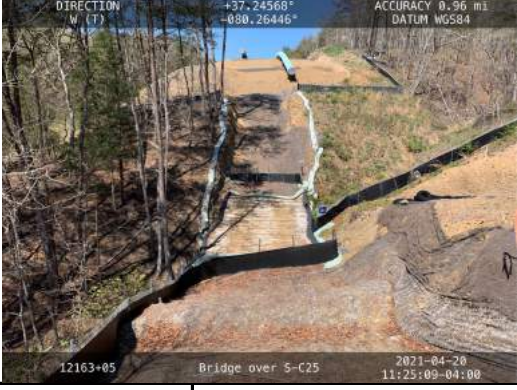
<b>GPS Location</b>	See photo for gps location data.		<b>GPS Location</b>	See photo for gps location data.	
<b>Field Station#</b>	12166+47		<b>Field Station#</b>	12163+05	
<b>Pic 11 Desc.</b>	Photo shows stream S-C24 downstream from the bridge.		<b>Pic 12 Desc.</b>	Photo shows the bridge over stream S-C25.

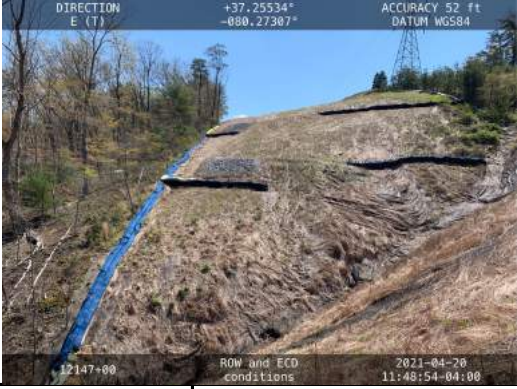
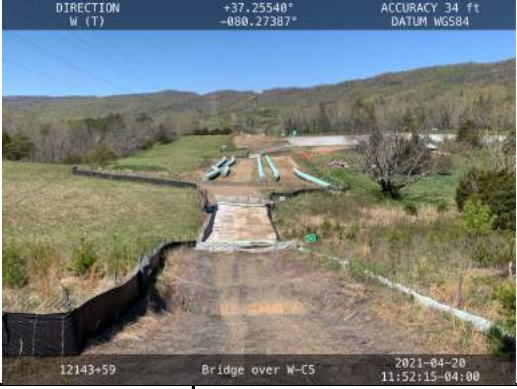
<b>GPS Location</b>	See photo for gps location data.		<b>GPS Location</b>	See photo for gps location data.	
<b>Field Station#</b>	12147+00		<b>Field Station#</b>	12143+59	
<b>Pic 15 Desc.</b>	Photo shows the ROW and ECD conditions.		<b>Pic 16 Desc.</b>	Photo shows the bridge over wetland W-C5.

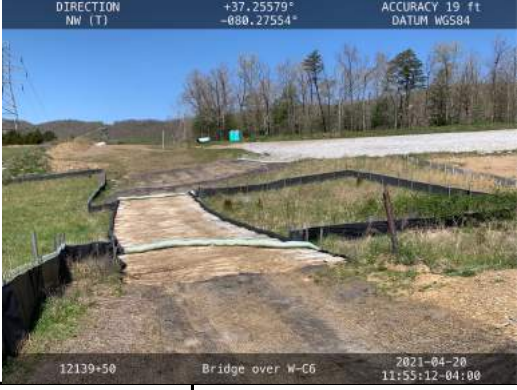
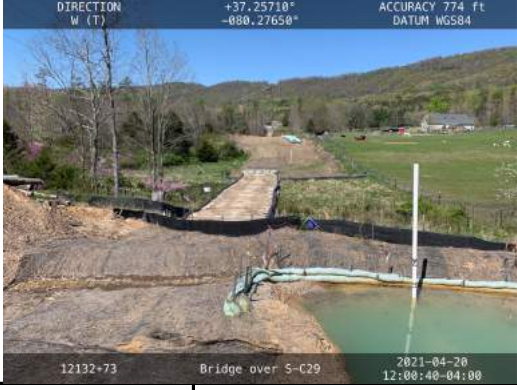
<b>GPS Location</b>	See photo for gps location data.		<b>GPS Location</b>	See photo for gps location data.	
<b>Field Station#</b>	12139+50		<b>Field Station#</b>	12132+73	
<b>Pic 17 Desc.</b>	Photo shows the bridge over wetland W-C6.		<b>Pic 18 Desc.</b>	Photo shows the bridge over stream S-C29.

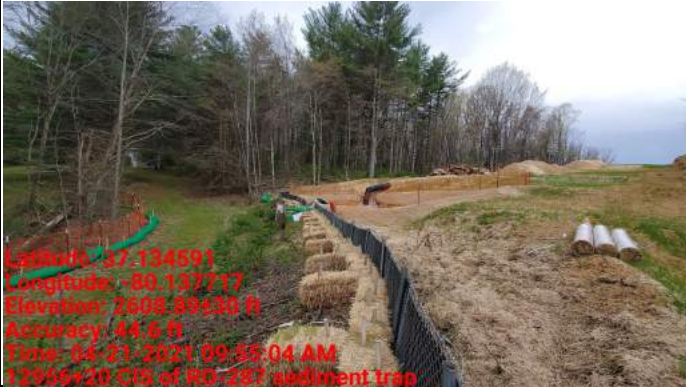
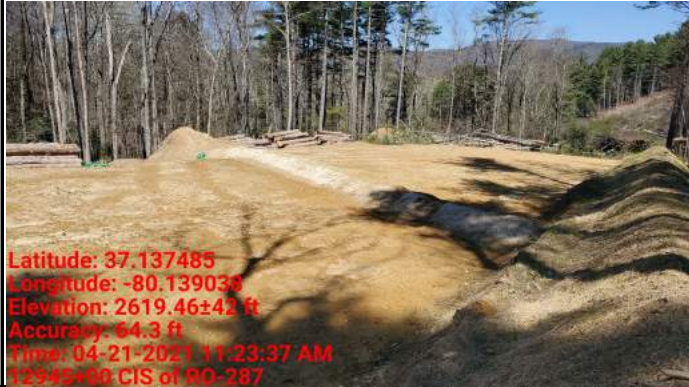
Latitude: 37.134591 Longitude: -80.137717 Elevation: 2608.89±30 ft Accuracy: 44.6 ft Time: 04-21-2021 09:52:04 AM 12956+20 CIS of RO-287 sediment trap			Latitude: 37.137485 Longitude: -80.139039 Elevation: 2619.46±42 ft Accuracy: 64.3 ft Time: 04-21-2021 11:23:37 AM 12945+00 CIS of RO-287

<b>GPS Location</b>	See pic for GPS location		<b>GPS Location</b>	See pic for GPS location	
<b>Field Station#</b>	12956+20		<b>Field Station#</b>	12945+00	
<b>Pic 15 Desc.</b>	Sediment trap on the CIS of RO-287.		<b>Pic 16 Desc.</b>	Current ROW conditions on the GAS of Stream S-IJ43.

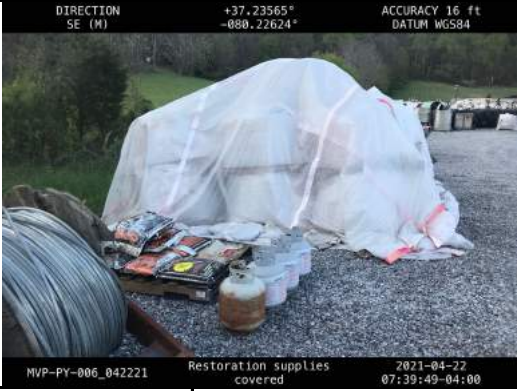
<p>DIRECTION SE (M) +37.23565° -080.22624° ACCURACY 16 ft DATUM WGS84</p> <p>MVP-PY-006_042221 Restoration supplies covered 2021-04-22 07:39:49-04:00</p>			
<b>GPS Location</b>	MVP-PY-006 See photo for gps data		<b>GPS Location</b>	MVP-PY-006 See photo for gps data	
<b>Field Station#</b>	+0		<b>Field Station#</b>	+0	
<b>Pic 7 Desc.</b>	Condition of containment under light plant. Free of stormwater. Looking SE.		<b>Pic 8 Desc.</b>	Restoration supplies covered and protected from the weather. Looking SE.	
  <p>DIRECTION SW (M) +37.23575° -080.22674° ACCURACY 16 ft DATUM WGS84</p> <p>MVP-PY-006_042221 Secondary containment on site for tankers 2021-04-22 07:42:51-04:00</p>

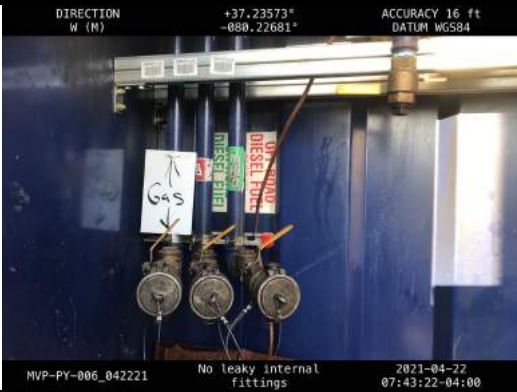
<p>DIRECTION W (M) +37.23573° -080.22681° ACCURACY 16 ft DATUM WGS84</p> <p>MVP-PY-006_042221 No leaky internal fittings 2021-04-22 07:43:22-04:00</p>

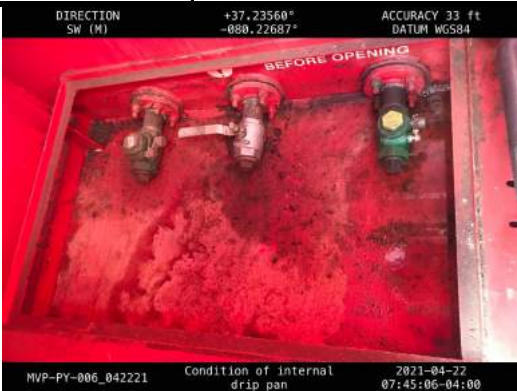
<p>DIRECTION SW (M) +37.23560° -080.22687° ACCURACY 33 ft DATUM WGS84</p> <p>MVP-PY-006_042221 Condition of internal drip pan 2021-04-22 07:45:06-04:00</p>			
<b>GPS Location</b>	MVP-PY-006 See photo for gps data		<b>GPS Location</b>	MVP-PY-006 See photo for gps data	
<b>Field Station#</b>	+0		<b>Field Station#</b>	+0	
<b>Pic 11 Desc.</b>	Off Road Fuel unit no leaky internal fittings. Looking NW.		<b>Pic 12 Desc.</b>	Off Road Fuel unit condition of internal drip pan. Looking SW.

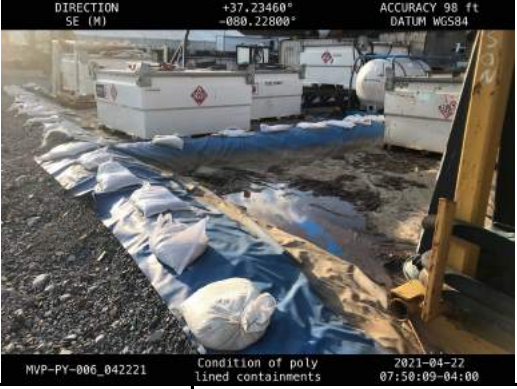
<b>GPS Location</b>	MVP-PY-006 See photo for gps data		<b>GPS Location</b>	MVP-PY-006 See photo for gps data	
<b>Field Station#</b>	+0		<b>Field Station#</b>	+0	
<b>Pic 15 Desc.</b>	No loose trash around dumpsters or in the yard. Looking SE.		<b>Pic 16 Desc.</b>	Condition of poly lined rock berm containments. Hold small amount of stormwater. Looking SE.

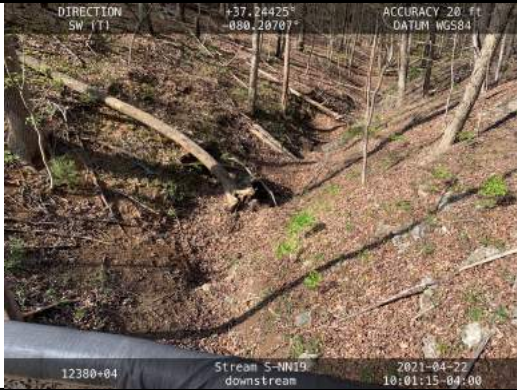
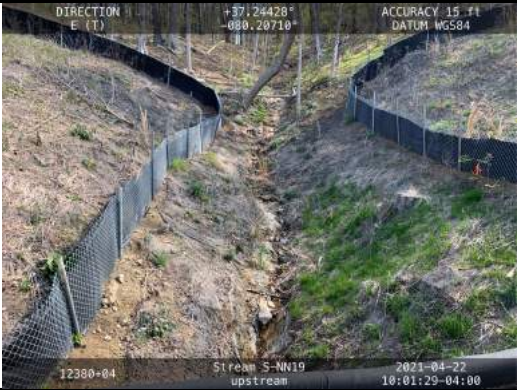
<b>GPS Location</b>	See photo for gps location data.		<b>GPS Location</b>	See photo for gps location data.	
<b>Field Station#</b>	12380+04		<b>Field Station#</b>	12380+04	
<b>Pic 9 Desc.</b>	Photo shows stream S-NN19 downstream from the bridge.		<b>Pic 10 Desc.</b>	Photo shows stream S-NN19 upstream.

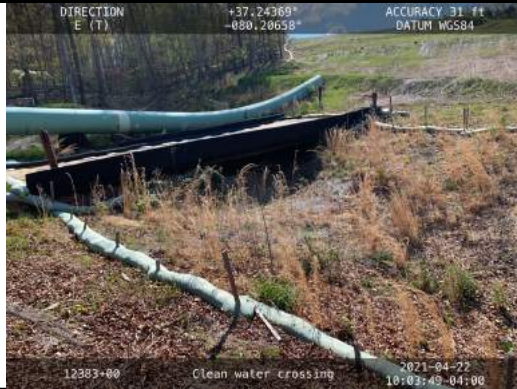
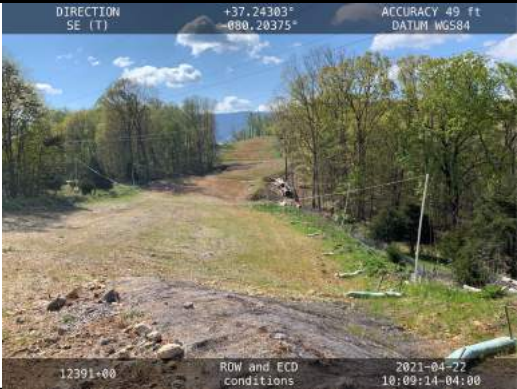
<b>GPS Location</b>	See photo for gps location data.		<b>GPS Location</b>	See photo for gps location data.	
<b>Field Station#</b>	12383+00		<b>Field Station#</b>	12391+00	
<b>Pic 11 Desc.</b>	Photo shows the clean water crossing.		<b>Pic 12 Desc.</b>	Photo shows the ROW and ECD conditions.

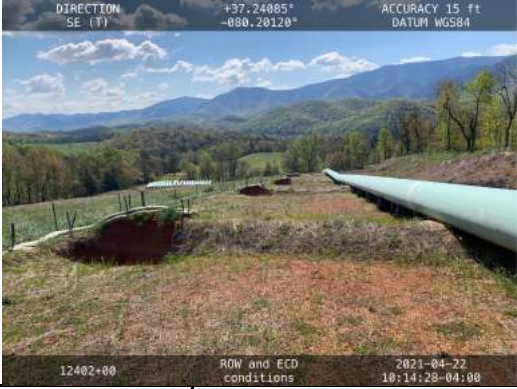
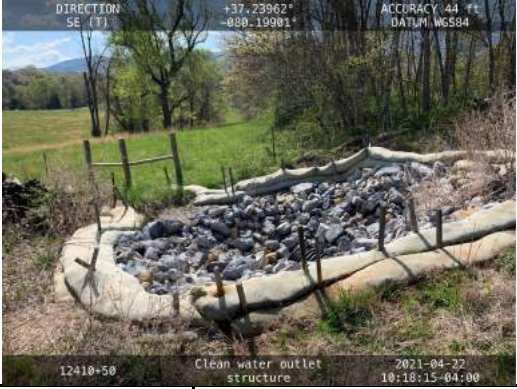
<b>GPS Location</b>	See photo for gps location data.		<b>GPS Location</b>	See photo for gps location data.	
<b>Field Station#</b>	12402+00		<b>Field Station#</b>	12410+50	
<b>Pic 13 Desc.</b>	Photo shows the ROW and ECD conditions.		<b>Pic 14 Desc.</b>	Photo shows the clean water outlet structure.

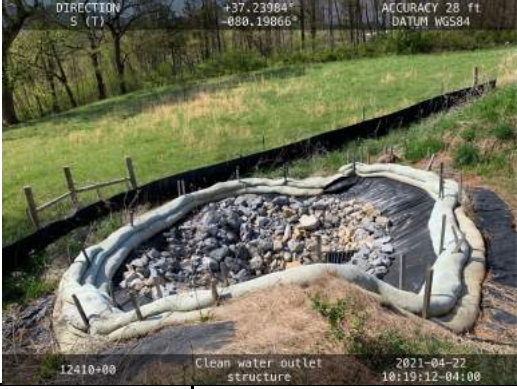
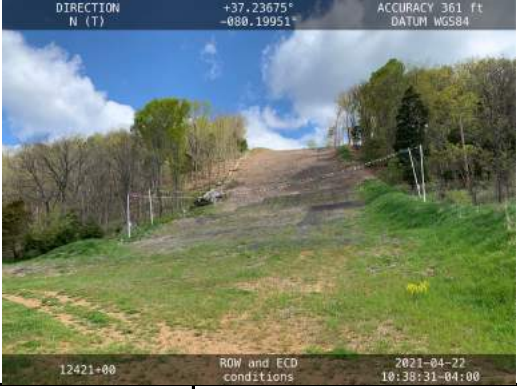
<b>GPS Location</b>	See photo for gps location data.		<b>GPS Location</b>	See photo for gps location data.	
<b>Field Station#</b>	12410+00		<b>Field Station#</b>	12421+00	
<b>Pic 15 Desc.</b>	Photo shows the clean water outlet structure.		<b>Pic 16 Desc.</b>	Photo shows the ROW and ECD conditions.

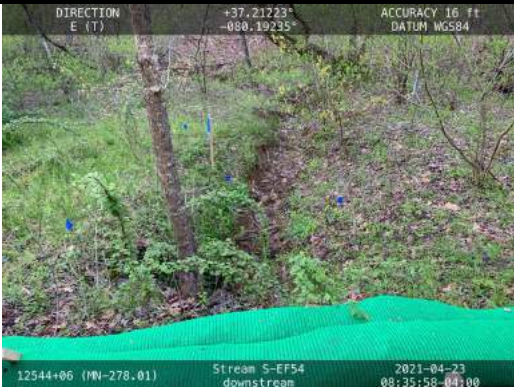
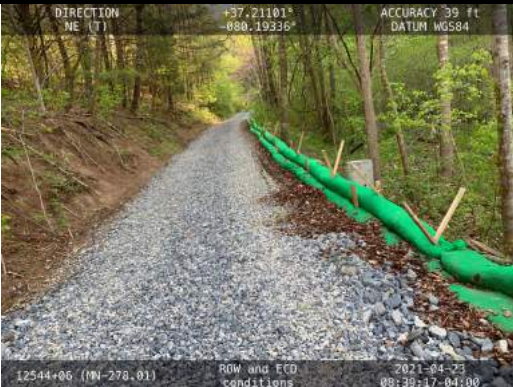
<b>GPS Location</b>	See photo for gps location data.		<b>GPS Location</b>	See photo for gps location data.	
<b>Field Station#</b>	12544+06		<b>Field Station#</b>	12544+06	
<b>Pic 3 Desc.</b>	Photo shows stream S-EF54 downstream from the access road.		<b>Pic 4 Desc.</b>	Photo shows the access road and ECD conditions.

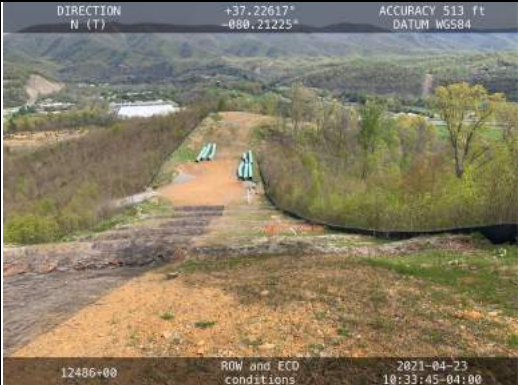
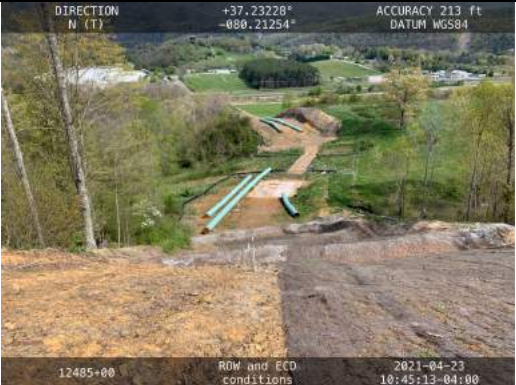
<b>GPS Location</b>	See photo for gps location data.		<b>GPS Location</b>	See photo for gps location data.	
<b>Field Station#</b>	12486+00		<b>Field Station#</b>	12485+00	
<b>Pic 13 Desc.</b>	Photo shows the ROW and ECD conditions.		<b>Pic 14 Desc.</b>	Photo shows the ROW and ECD conditions.
