Visual Site Inspection Report

| Project Name | H-600 Pipeline Spread H | AFE | 124300138 | Spread | H-600 Pipeline Spread H |
| Permit # | TBD | Inspection Type | VA SWPP | Station Begin | 12942+00 |

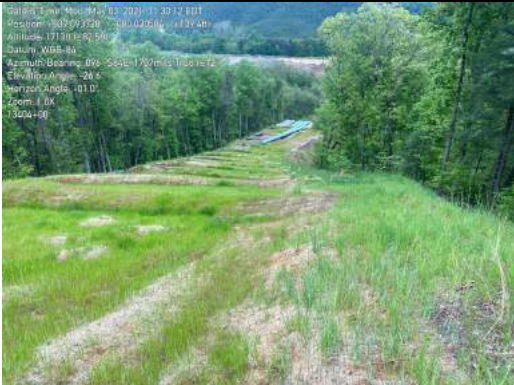
| Pic 1 Desc. | ATWS-1351 workspace stabilized with vegetation establishing. | | Pic 2 Desc. | S-IJ1, downstream, no ROW impacts, banks well vegetated, slight turbidity noted. | |

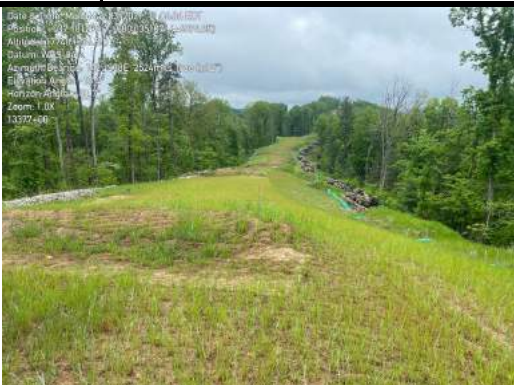
| Pic 3 Desc. | ROW stable with vegetation establishing across LOD, waterbars functioning acceptably. | | Pic 4 Desc. | ROW stable, sparse vegetation noted in travel lane with the exception of the newly stabilized area. | |

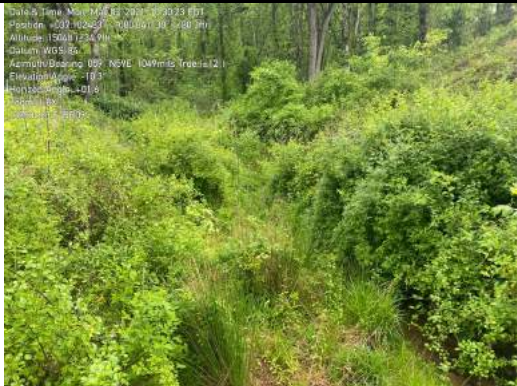
| Pic 7 Desc. | S-RR11, upstream, no ROW impacts noted, ECDs functioning acceptably along stream buffer. | | Pic 8 Desc. | S-RR11, downstream, no ROW impacts noted, slight turbidity noted in stream. | |

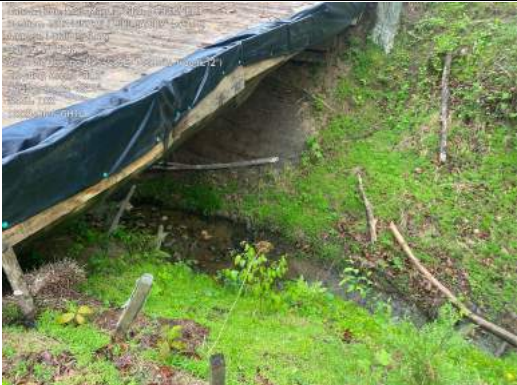
| Pic 15 Desc. | S-GH9, upstream, no ROW releases noted, slight turbidity noted in stream, banks well vegetated. | | Pic 16 Desc. | S-GH11, downstream of equipment bridge looking upstream, banks stabilized with erosion control blanket, small log in stream. | |

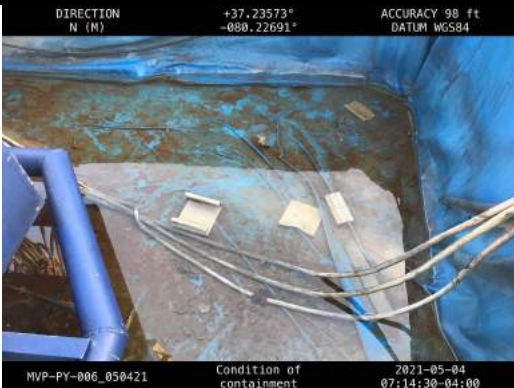
| Pic 3 Desc. | Condition of containment under light plant. Free of stormwater. Looking SE. | | Pic 4 Desc. | No fuel spills south of the Blue Bulk fuel tank. Looking NW. | |

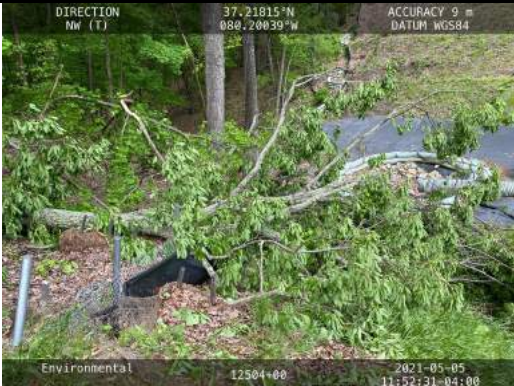
| Pic 3 Desc. | Fabric pulled away from chain link | | Pic 4 Desc. | Stabilized slope in acceptable condition | |

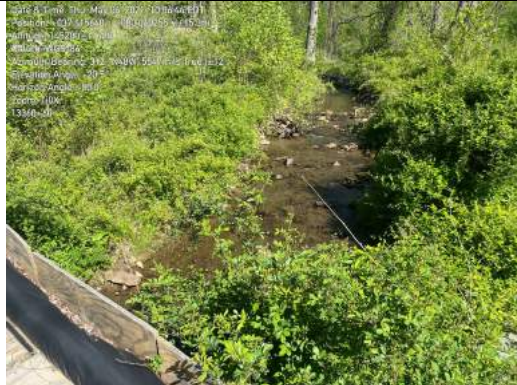
| Pic 9 Desc. | Slip appeared to be stable, no notable changes, vegetation establishing. | | Pic 10 Desc. | Perimeter controls below slip in acceptable condition. | |

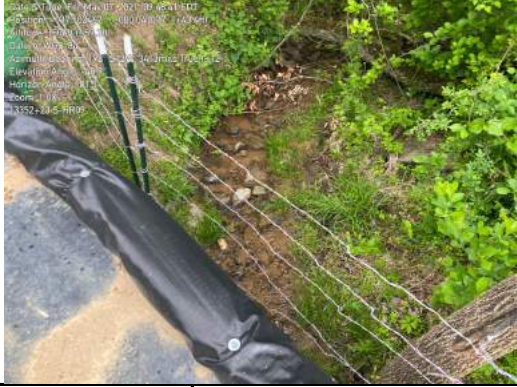
| Pic 7 Desc. | S-RR11, downstream, some livestock disturbance noted along banks and stream bed, no ROW impacts, water clear. | | Pic 8 Desc. | ROW stable with vegetation establishing across LOD; sparse in travel lane. | |
