Visual Site Inspection Report

Project Name H-600 Pipeline Spread I		AFE 124300139	Spread H-600 Pipeline Spread I
Contractor Precision		Report # 20027	
Inspector Justin Burch		Date/Time 2/15/2021 11:07 AM	
Permit # TBD	Inspection Type VA SWPP	Station Begin 15063+85	
State VA	Inspection Area Full	Station End 15142+66	
County Pittsylvania	Ground Wet	Temperature (°F) 38.00	
Municipality Chatham	Weather Light Rain	Rain Gauge (in) 0.30	
			Rain Accumulation Time (days) 6.00

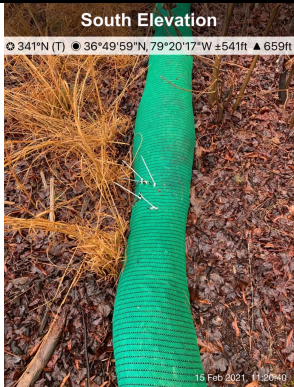
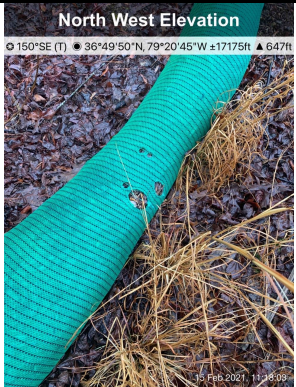
GPS Location	O
GPS Location	O	GPS Location	O	Field Station#	20+00
Field Station#	20+00	Field Station#	20+00	Pic 1 Desc.	Observing cfs that received maintenance
Pic 1 Desc.		Pic 2 Desc.		Pic 2 Desc.	Observing cfs that required maintenance

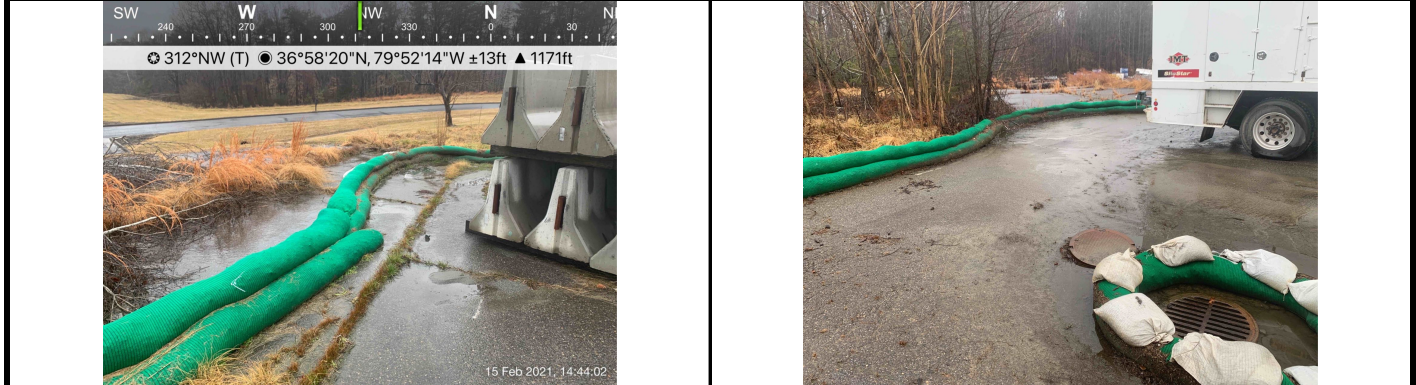
GPS Location	000000000000	GPS Location	000000000000
Field Station#	0000+00	Field Station#	0000+00
Pic 1 Desc.	Perimeter ECD's on northwest corner of MVP-LY-046 in acceptable condition.	Pic 2 Desc.	Perimeter ECD's on southwest corner and inlet protection for catch basin at MVP-LY-056 in good condition.

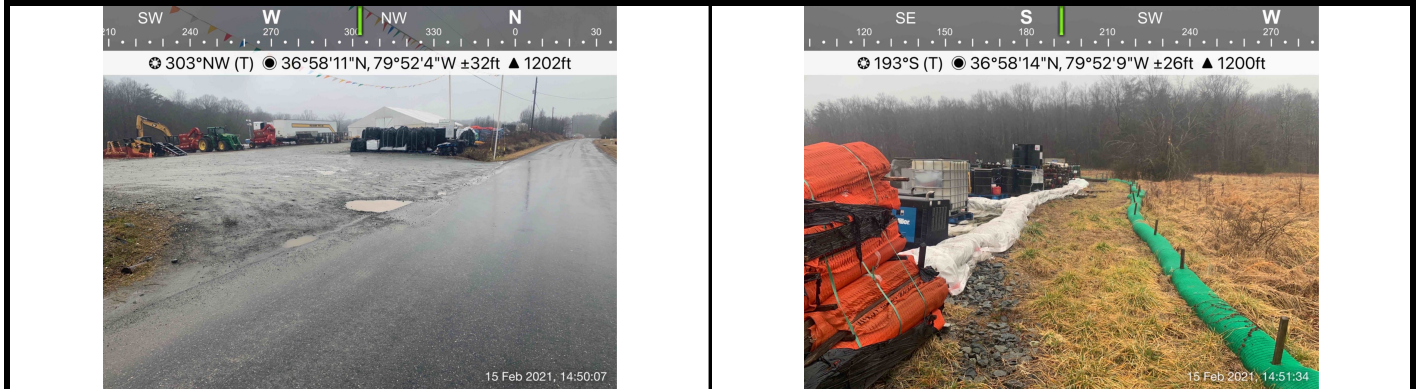
GPS Location	000000000000	GPS Location	000000000000
Field Station#	0000+00	Field Station#	0000+00
Pic 3 Desc.	RCE at MBP-LY-045 in good condition.	Pic 4 Desc.	Perimeter ECD's and secondary containment structure on north end of MVP-LY-045 in acceptable condition.

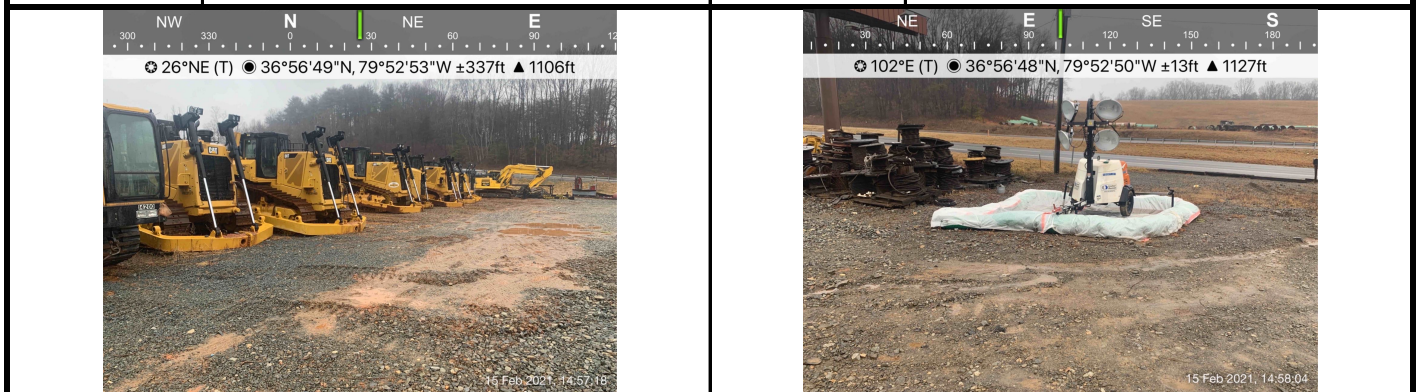
GPS Location	000000000000	GPS Location	000000000000
Field Station#	0000+00	Field Station#	0000+00
Pic 5 Desc.	Equipment at MVP-LY-032 no leaks found at time of inspection.	Pic 6 Desc.	Secondary containment structure for light plant at entrance of MVP-LY-032 liner issue from previous inspection addressed by contractor.

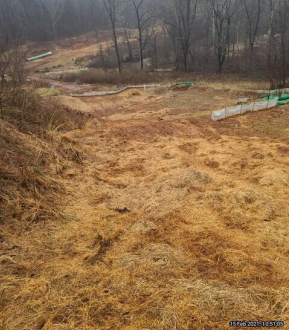
GPS Location	00000	GPS Location	00000
Field Station#	13830+00	Field Station#	13783+90	Pic 1 Desc.	Row photo showing saturated row conditions as light rain events continue.	Pic 2 Desc.	EI monitored row conditions , checking ECDs and stabilization on hill sides above stream crossing, o environmental issues observed at the time of inspection
	<p data-bbox="365 789 527 810">South West Elevation</p> <p data-bbox="305 814 592 835">☉ 51°NE (T) ● 37.06989, -79.933037 ±6 m ▲ 299 m</p>  		<p data-bbox="1063 789 1226 810">North West Elevation</p> <p data-bbox="1003 814 1291 835">☉ 164°SE (T) ● 37.065918, -79.922213 ±3 m ▲ 316 m</p>

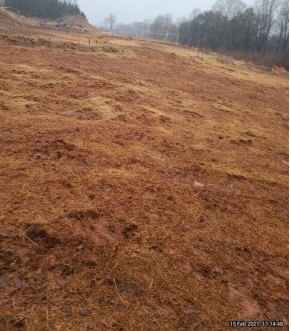
GPS Location	00000	GPS Location	00000
Field Station#	13786+23	Field Station#	13826+87	Pic 5 Desc.	Row photo up hill from stream crossing showing stabilization, no environmental issues observed at the time of inspection.	Pic 6 Desc.	Row photo taken by the EI showing saturated conditions.

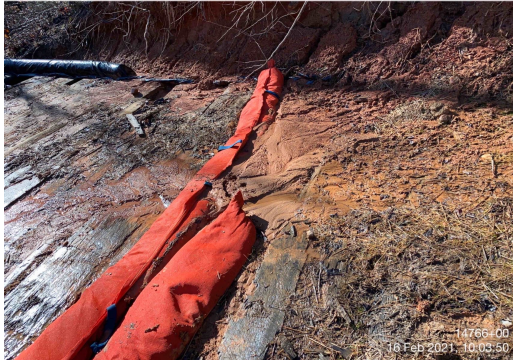
<p>14766+00 16 Feb 2021, 10:03:50</p>	
GPS Location	0	GPS Location	0
Field Station#	14724+70	Field Station#	14766+00
Pic 3 Desc.	P1 silt fence damaged by a fallen tree	Pic 4 Desc.	Sediment on equipment bridge
<p>174°S (M) 36°58'41"N, 79°40'53"W ±3070ft ▲ 859ft</p>

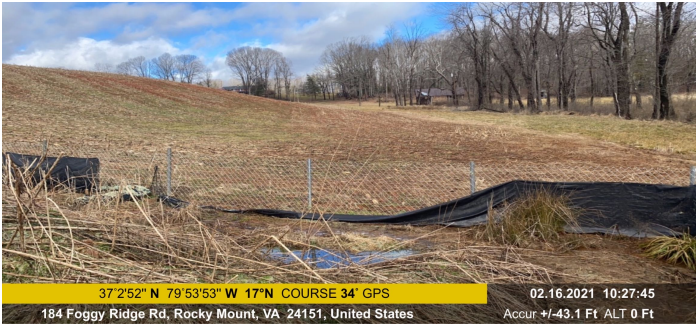
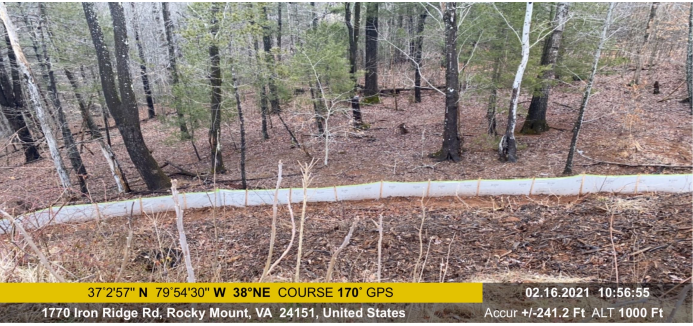
GPS Location	1	GPS Location	2
Field Station#	13948+50	Field Station#	13892+00
Pic 1 Desc.	Routine maintenance. SSF down along perimeter. Reattach geotech to fencing.	Pic 2 Desc.	Contractor replaced P1 silt fence per punch list item

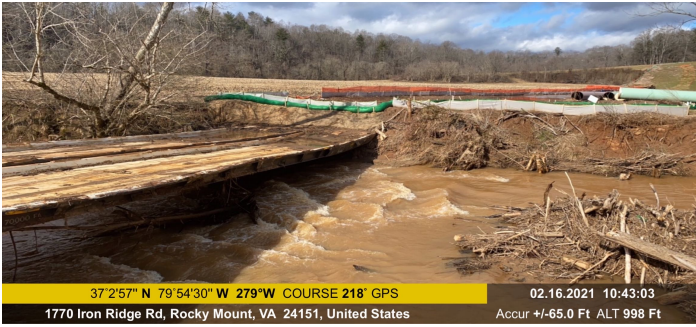
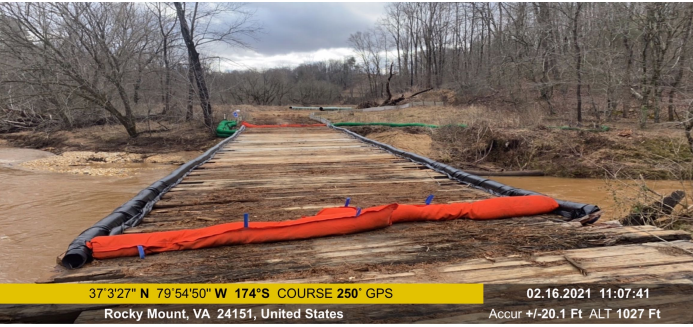
GPS Location	3	GPS Location	4
Field Station#	13916+12	Field Station#	13875+73
Pic 3 Desc.	View of equipment bridge and surrounding ECDs at S-II2	Pic 4 Desc.	Equipment bridge and surrounding ECDs in place and functional at S-CD6

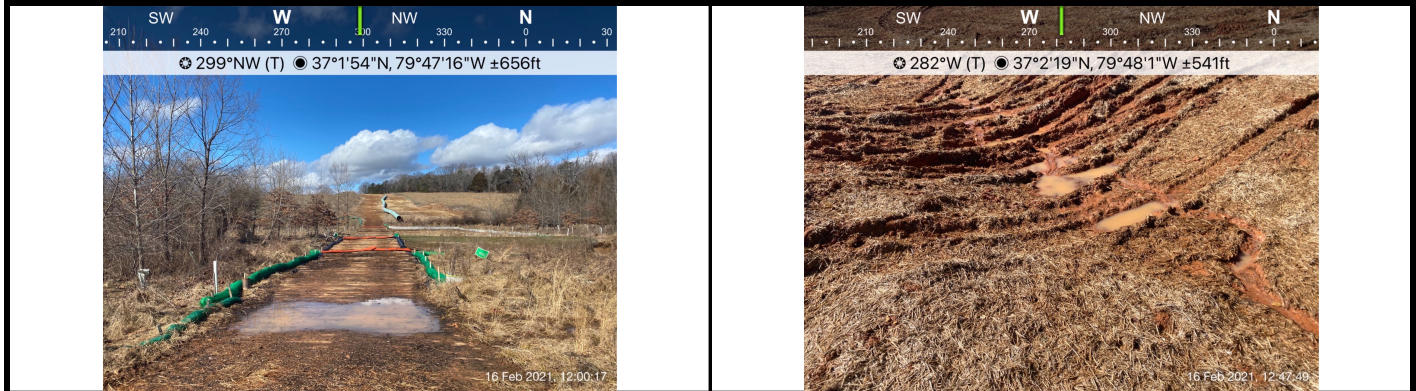
GPS Location	0	GPS Location	0
Field Station#	14391+53	Field Station#	14350+50
Pic 3 Desc.	Approximately 14391+53. Overview of stream crossing, equipment bridge and ECDs at stream S-A41.	Pic 4 Desc.	Approximately 14350+50. ROW and water bar damaged by third party.

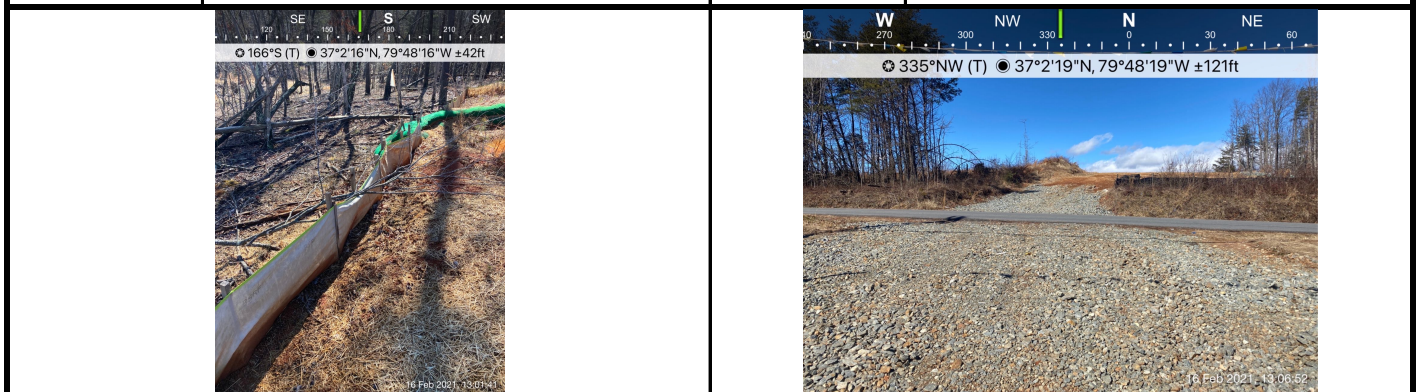
GPS Location	0	GPS Location	0
Field Station#	14338+00	Field Station#	14333+00
Pic 5 Desc.	Approximately 14338+00. P-1 silt fence requires maintenance.	Pic 6 Desc.	Approximately 14333+00. Overview of road crossing and RCES.

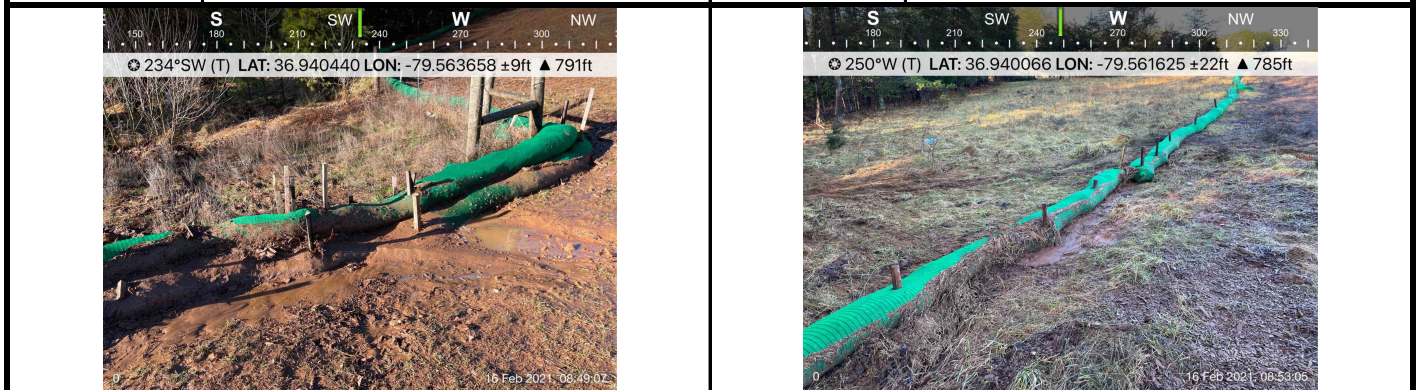
GPS Location	See photo	GPS Location	See photo
Field Station#	15195+00	Field Station#	15202+00
Pic 5 Desc.	CFS requires maintenance.	Pic 6 Desc.	CFS requires maintenance.

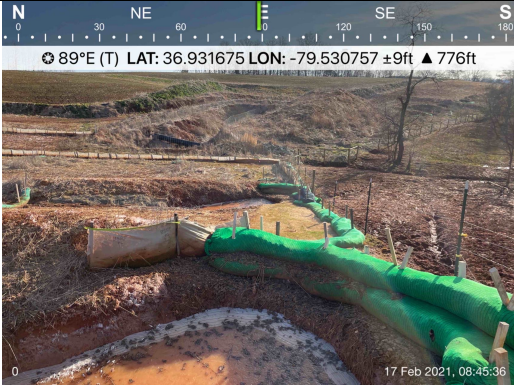
GPS Location	See photo	GPS Location	See photo
Field Station#	15299+00	Field Station#	15311+00
Pic 1 Desc.	Waterbar end treatments are in good condition and functioning.	Pic 2 Desc.	Perimeter P1 is in good condition.

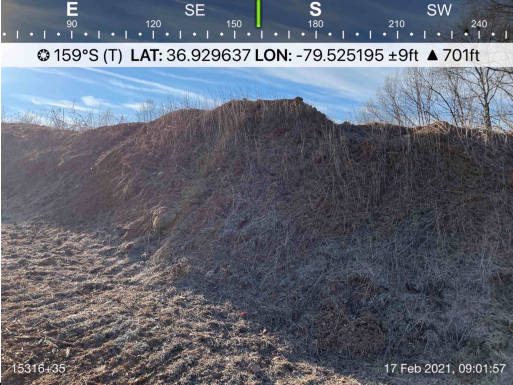
GPS Location	See photo	GPS Location	See photo
Field Station#	15313+00	Field Station#	15316+35
Pic 3 Desc.	Equipment bridge ECDs are in place.	Pic 4 Desc.	Stockpiles remain stabilized.

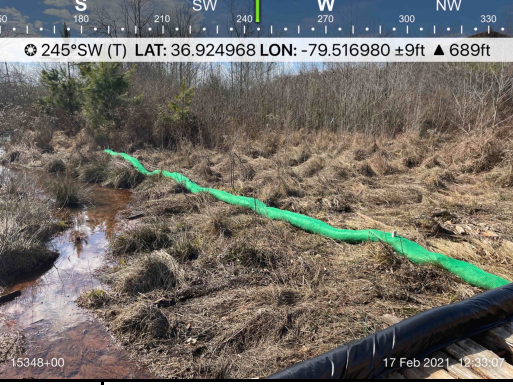
GPS Location	See photo	GPS Location	See photo
Field Station#	15323+24	Field Station#	15348+00
Pic 5 Desc.	RCEs are in good condition at all road crossings.	Pic 6 Desc.	CFS is in good condition at all stream and wetland buffers.

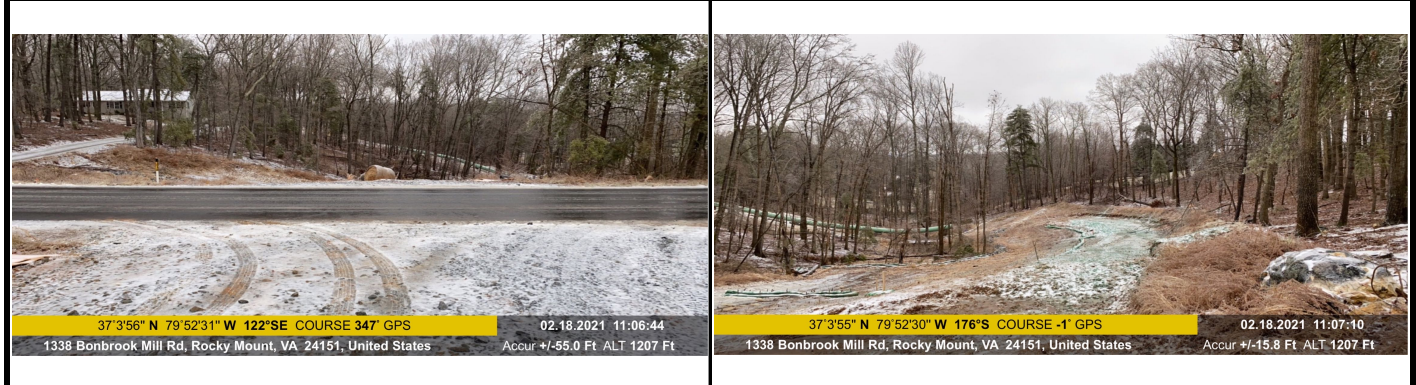
GPS Location	1	GPS Location	2
Field Station#	14062+17	Field Station#	14064+00
Pic 1 Desc.	RCE at Bonbrook Mill RC2 in good condition; frozen ground conditions observed	Pic 2 Desc.	Frozen ground conditions observed during inspection; no issues identified

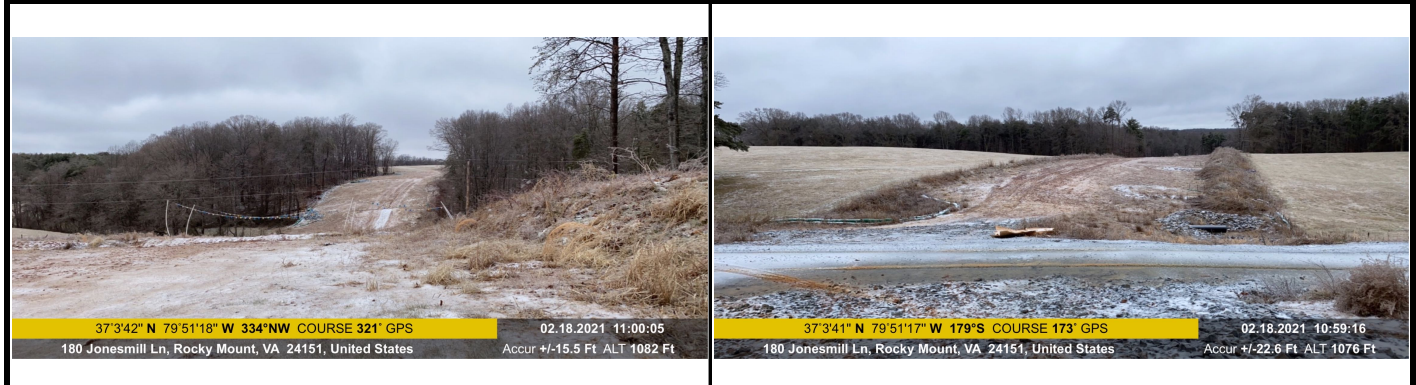
GPS Location	3	GPS Location	4
Field Station#	14127+00	Field Station#	14131+28
Pic 3 Desc.	Frozen ground conditions observed during inspection; no issues identified	Pic 4 Desc.	RCE at Jonesmill Rd in good condition; frozen ground conditions observed

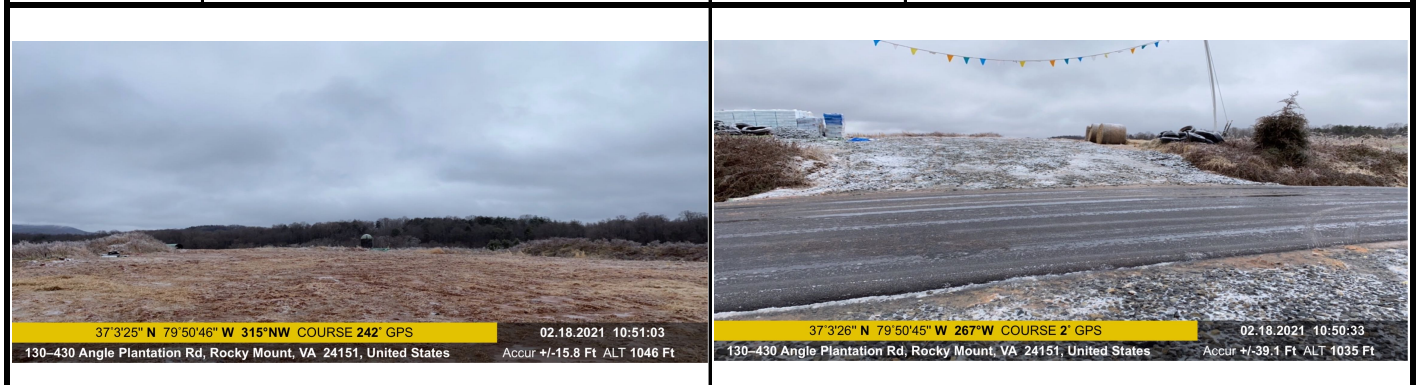
GPS Location	5	GPS Location	6
Field Station#	14168+00	Field Station#	14171+36
Pic 5 Desc.	Frozen ground conditions observed during inspection; no issues identified	Pic 6 Desc.	RCE at Angle Plantation Rd in good condition; frozen ground conditions observed

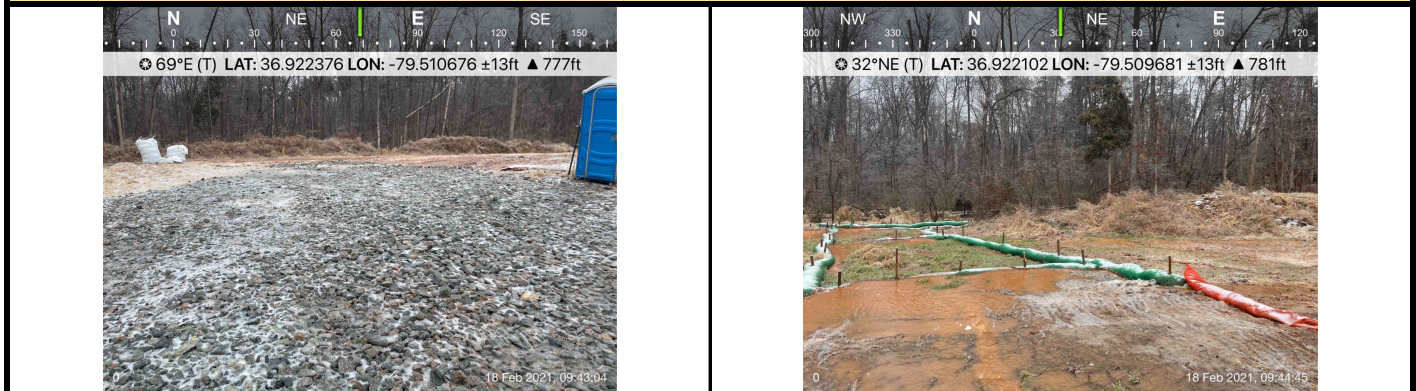
GPS Location	See photo	GPS Location	See photo
Field Station#	15370+62	Field Station#	15375+00
Pic 1 Desc.	RCEs are in good condition at all road crossings.	Pic 2 Desc.	CFS is functioning throughout this section.

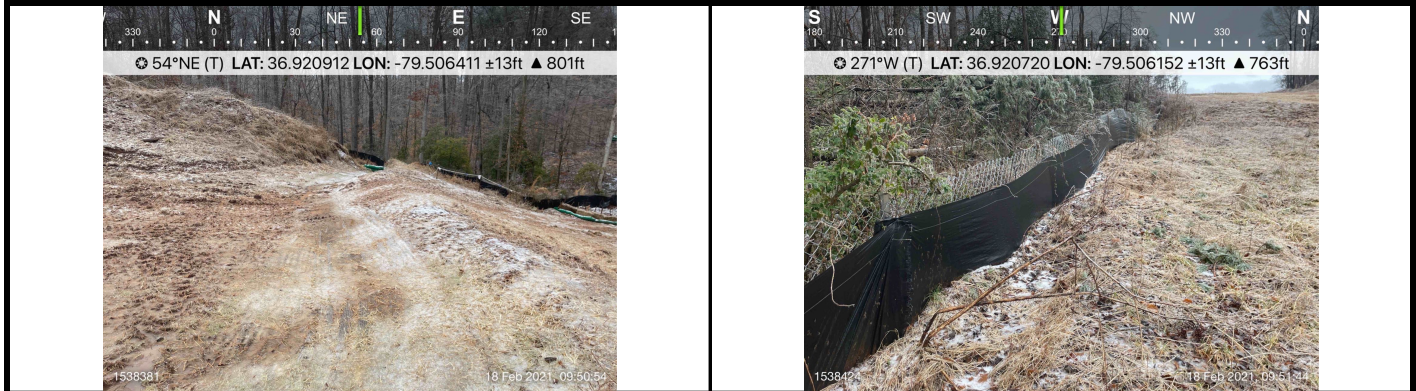
GPS Location	See photo	GPS Location	See photo
Field Station#	15383+81	Field Station#	15384+24
Pic 3 Desc.	Waterbars are functioning as intended.	Pic 4 Desc.	SSF is in good condition.

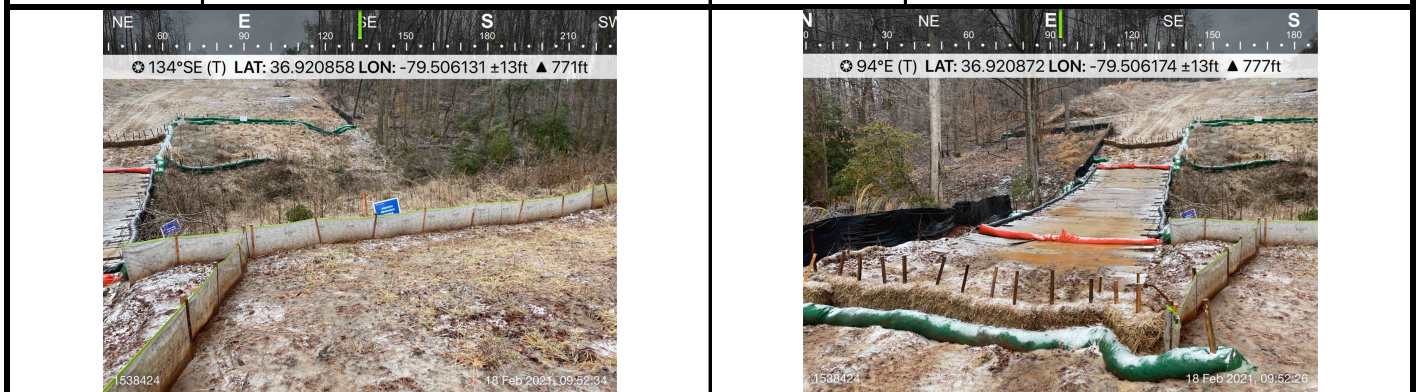
GPS Location	See photo	GPS Location	See photo
Field Station#	15384+24	Field Station#	15384+24
Pic 5 Desc.	P1 is in place and functioning at stream and wetland buffers.	Pic 6 Desc.	Equipment bridge ECDs are in place and functioning.

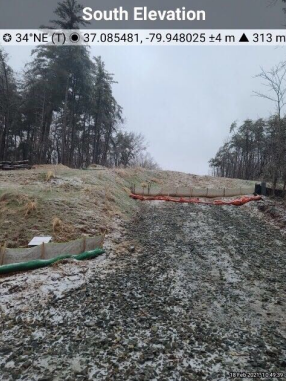
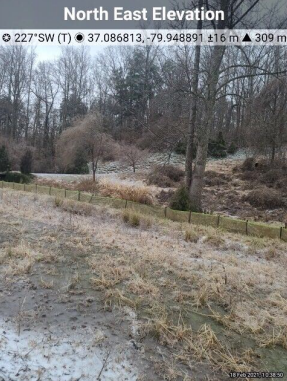
GPS Location		0000		GPS Location		00000	
Field Station#		13748+20		Field Station#		13683+67	
Pic 1 Desc.		Photo taken from road crossing during sleet events, monitored ECDs and RCE .		Pic 2 Desc.		EI observed ECDs on row edge, no environmental issues observed at the time of inspection.

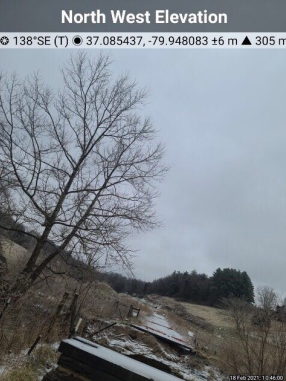
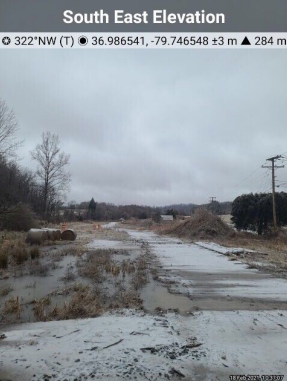
GPS Location		00000		GPS Location		00000	
Field Station#		13692+64		Field Station#		13687+61	
Pic 3 Desc.		Monitored stream crossing where equipment mats were removed during maintenance.		Pic 4 Desc.		Row photo showing ice on row , row conditions were saturated at time of inspection.

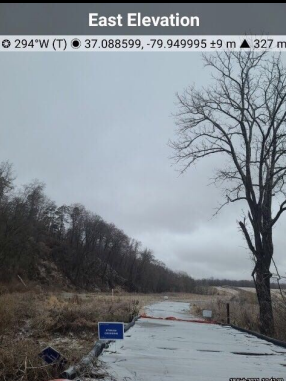
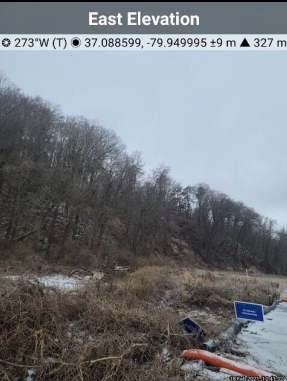
GPS Location		00000		GPS Location		00000	
Field Station#		13678+71		Field Station#		13678+71	
Pic 5 Desc.		Photo showing ice in equipment bridge during row inspection today.no environmental issues observed.		Pic 6 Desc.		Stream observation photo facing downstream during routine inspection today.

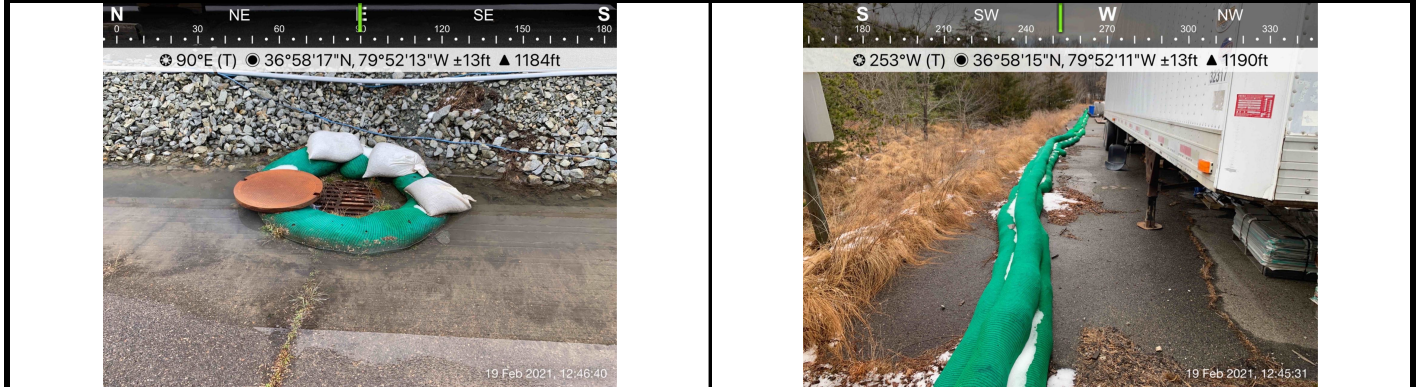
GPS Location 000000000000	GPS Location 000000000000
Field Station# 0000+00	Field Station# 0000+00
Pic 1 Desc. Inlet protection for catch basin near storage building at MVP- LY-046 in good condition.	Pic 2 Desc. Perimeter ECD's on south end of MVP-LY-046 in good condition

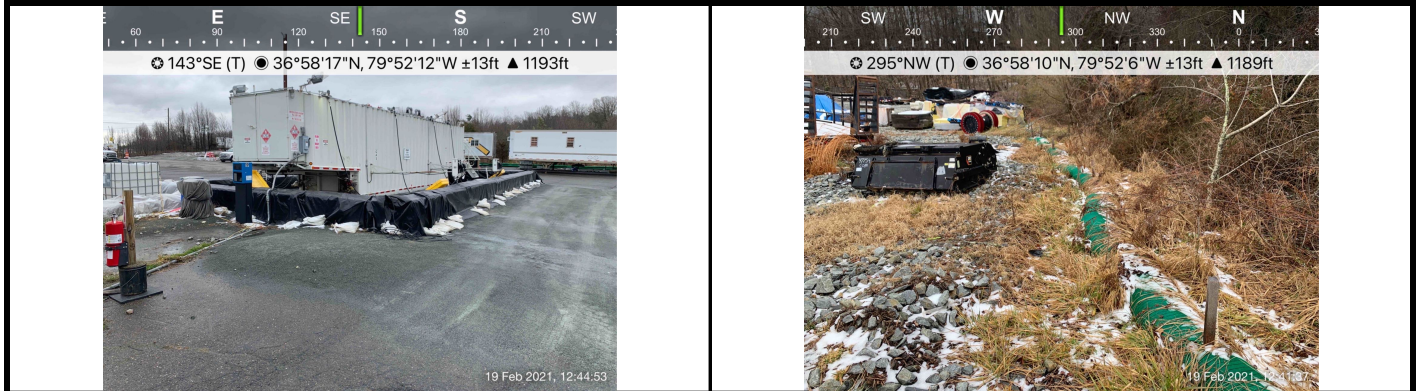
GPS Location 000000000000	GPS Location 000000000000
Field Station# 0000+00	Field Station# 0000+00
Pic 3 Desc. Secondary containment structure for fuel cell at MVP-LY-46 in good condition.	Pic 4 Desc. Perimeter ECD's on west side of MVP-LY-045 in good condition

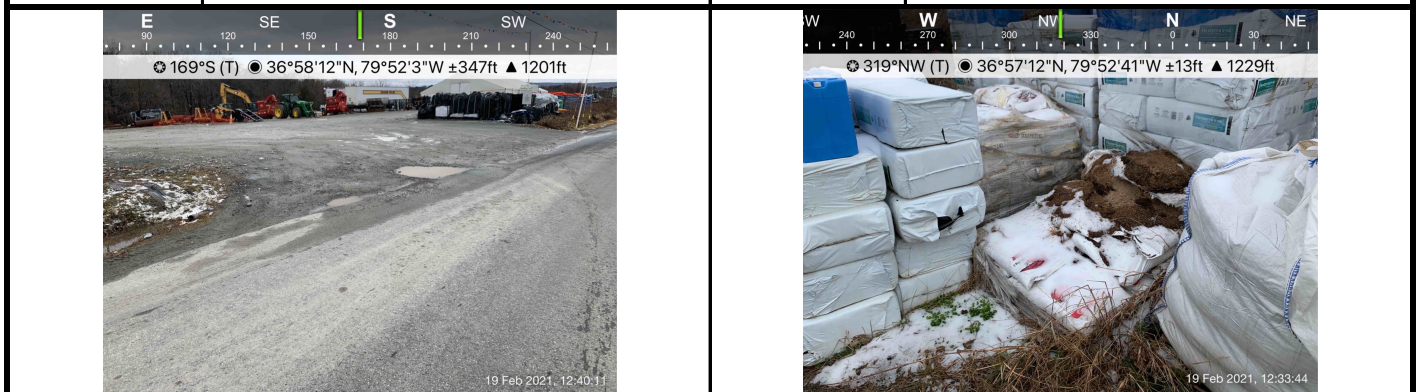
GPS Location 000000000000	GPS Location 000000000000
Field Station# 0000+00	Field Station# 0000+00
Pic 5 Desc. RCE at MVP-LY-045 in good condition.	Pic 6 Desc. Fertilizer at MVP-ANC-006 needs covered.

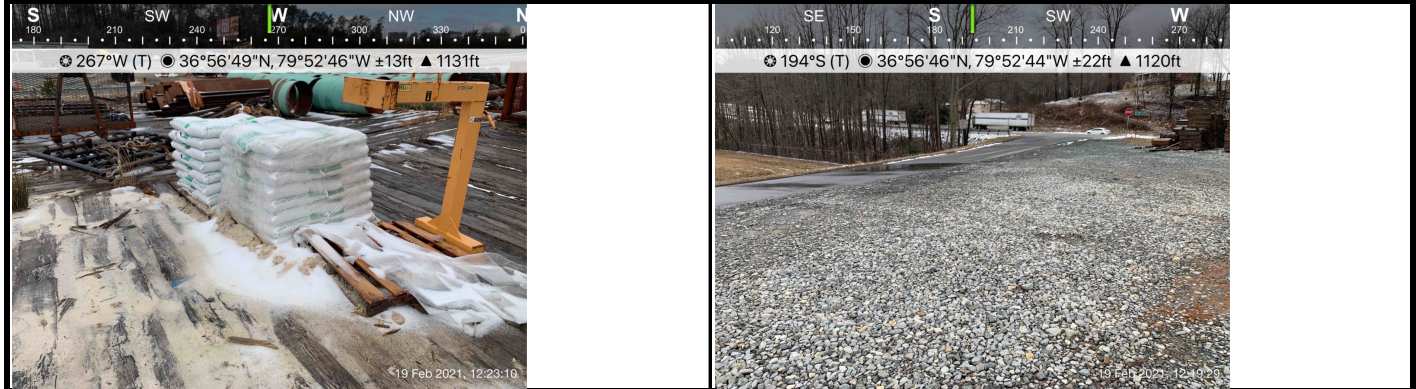
GPS Location	000000000000	GPS Location	000000000000
Field Station#	0000+00	Field Station#	0000+00
Pic 7 Desc.	Fertilizer needs covered at MVP-LY-033	Pic 8 Desc.	RCE at MVP-LY-033 was in good condition

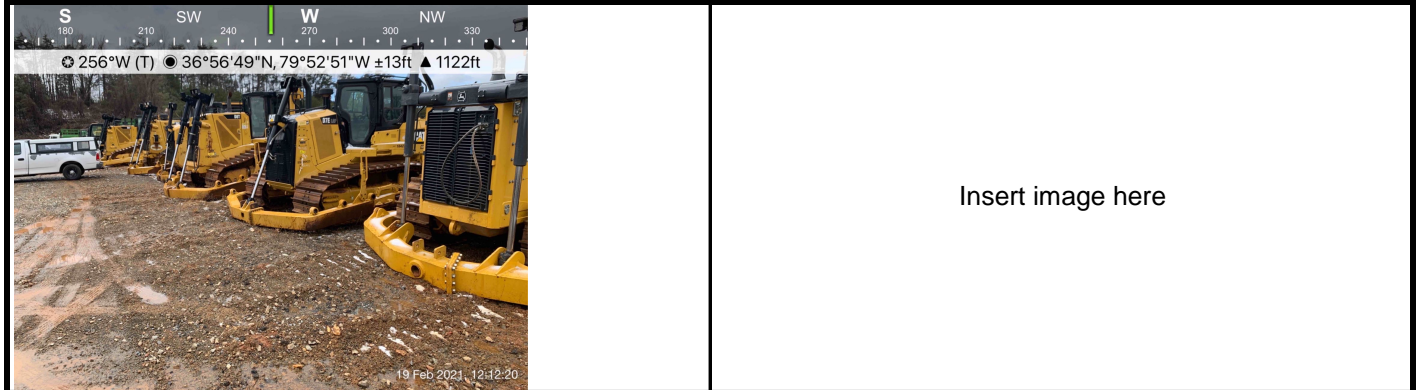
GPS Location	000000000000	GPS Location	000000000000
Field Station#	0000+00	Field Station#	0000+00
Pic 9 Desc.	No equipment oil leaks were found at time of inspection at MVP-LY-032	Pic 10 Desc.

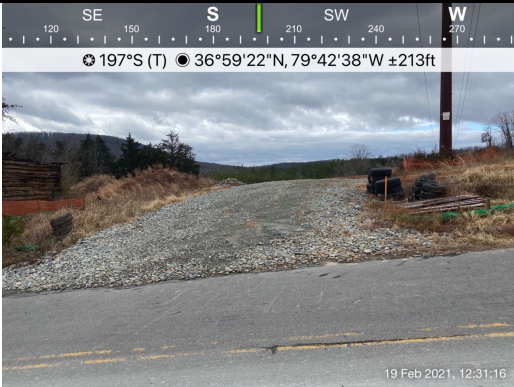
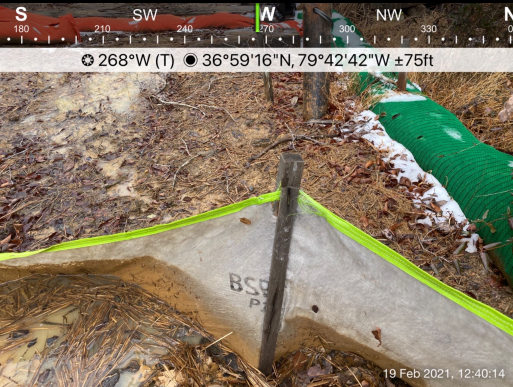
GPS Location 0		GPS Location 0			
Field Station# 14694+00		Field Station# 14689+50			
Pic 1 Desc. Approximately 14694+00. Overview of road crossing and RCE.		Pic 2 Desc. Approximately 14689+50. P-1 requires maintenance.

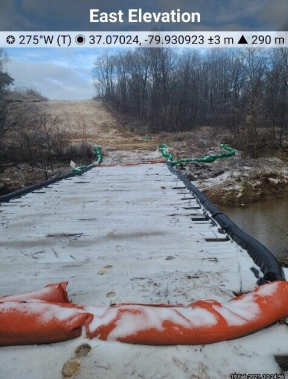
<p>East Elevation <small>275°W (T) • 37.07024, -79.930923 ±3 m ▲ 290 m</small></p>	
GPS Location	00000		GPS Location	00000	
Field Station#	13805+69		Field Station#	13790+47	
Pic 1 Desc.	Stream observation photo facing downstream, no issues observed at time of inspection.		Pic 2 Desc.	The EI monitored equipment bridges and ECDs while checking row conditions throughout.

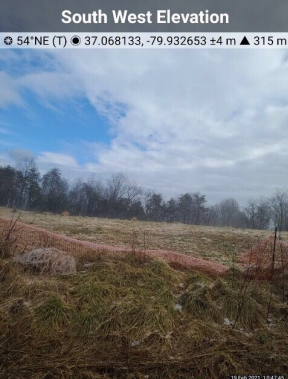
<p>South West Elevation <small>54°NE (T) • 37.068133, -79.932653 ±4 m ▲ 315 m</small></p>	
GPS Location	00000		GPS Location	00000	
Field Station#	13805+69		Field Station#	13784+35	
Pic 3 Desc.	Stream observation photo facing upstream during routine inspection today, no issues observed at time of inspection.		Pic 4 Desc.	EI noticed safety fence was down after recent ice event , documented and sent in to be added to the punch list.

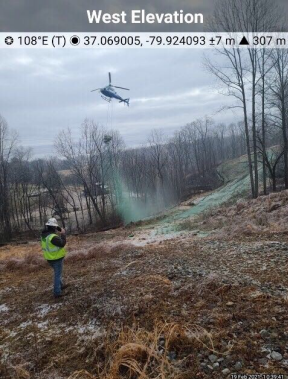
<p>West Elevation <small>108°E (T) • 37.069005, -79.924093 ±7 m ▲ 307 m</small></p>	
GPS Location	000000		GPS Location	00000	
Field Station#	13087+48		Field Station#	13814+23	
Pic 5 Desc.	Row photo showing ice on row , over head power ribbon was down, talked with the contractor and they were aware and will be replacing it today.		Pic 6 Desc.	While traveling row during routine inspection today the EI monitored the seeding contractor hydro seeding the row with a helicopter, no environmental issues observed at the time of
