Visual Site Inspection Report

Project Name H-600 Pipeline Spread I		AFE 124300139	Spread H-600 Pipeline Spread I
Contractor Precision		Report # 20252	
Inspector Ben Davenport		Date/Time 2/21/2021 1:12 PM	
Permit # TBD	Inspection Type VA SWPP	Station Begin 13853+45	
State VA	Inspection Area Partial	Station End 14311+57	
County Franklin	Ground Muddy	Temperature (°F) 40.00	
Municipality N/A	Weather Sunny	Rain Gauge (in) 0.00	
Rain Accumulation Time (days)			0.00

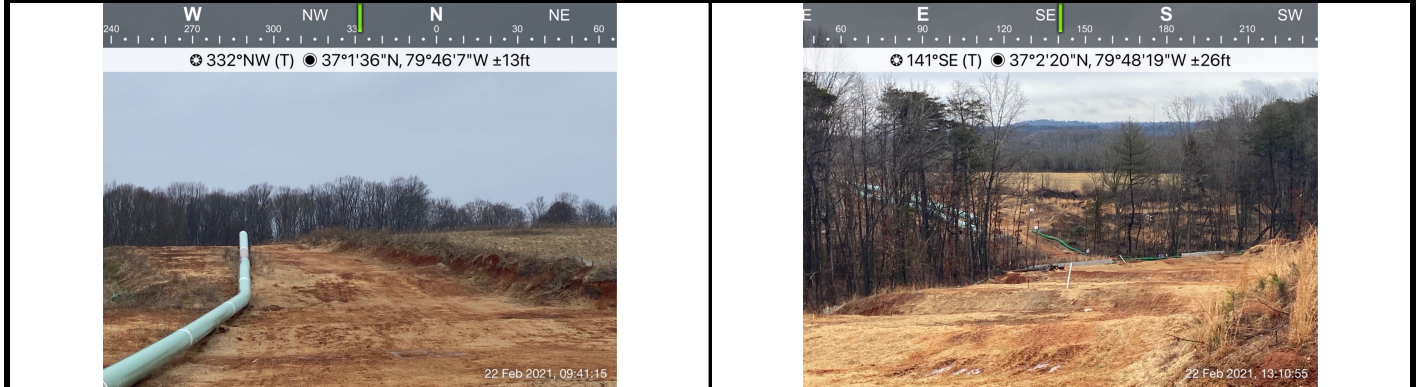
GPS Location	0	GPS Location	0
Field Station#	14451+00	Field Station#	14337+00
Pic 1 Desc.	Approximately 14451+00. Overview of ROW.	Pic 2 Desc.	Approximately 14337+00. Overview of SW ROW.

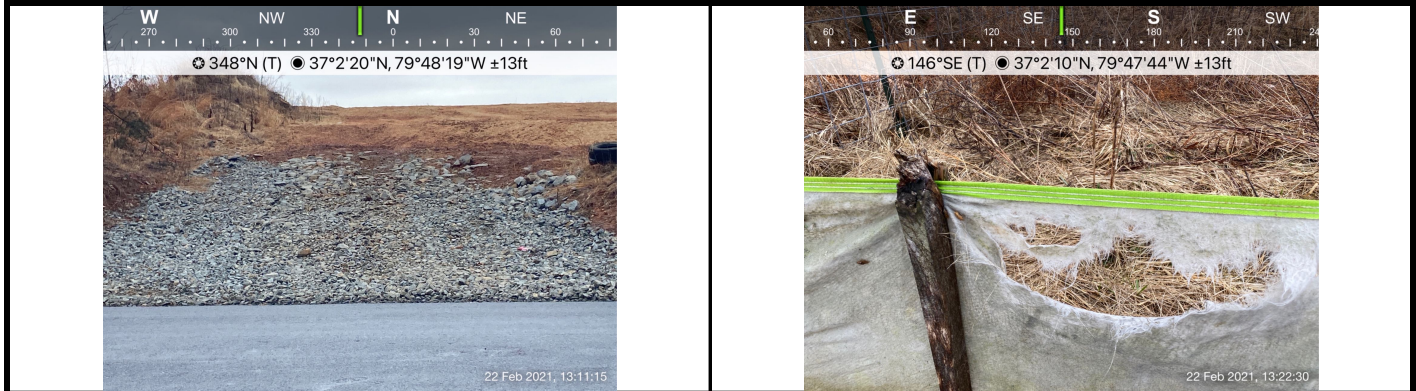
GPS Location	0	GPS Location	0
Field Station#	14333+00	Field Station#	14364+36
Pic 3 Desc.	Approximately 14333+00. Overview of road crossing and RCE.	Pic 4 Desc.	Approximately 14364+36. P-1 damaged by livestock and wildlife in this area.

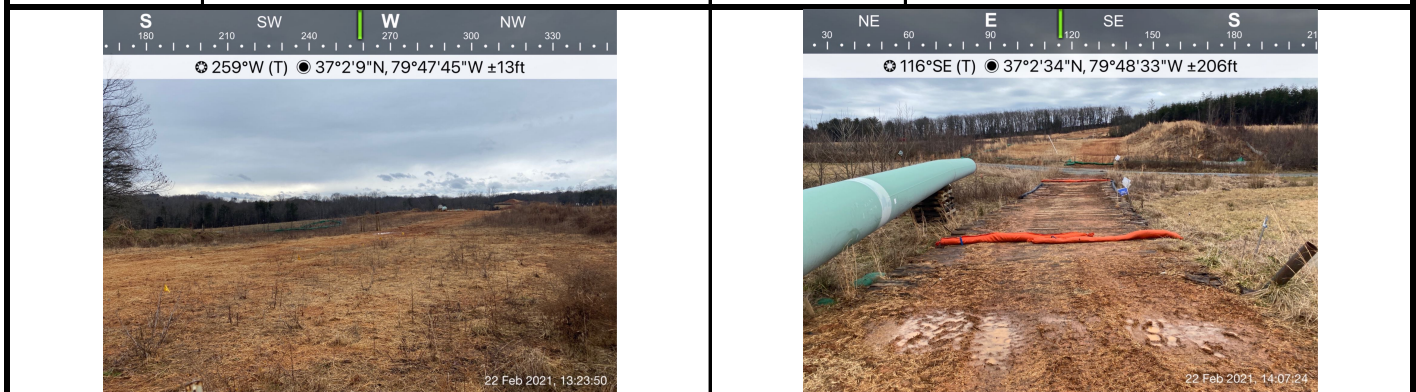
GPS Location	0	GPS Location	0
Field Station#	14361+00	Field Station#	14314+79
Pic 5 Desc.	Approximately 14361+00. Overview of ROW.	Pic 6 Desc.	Approximately 14314+79. Overview of stream crossing, equipment bridge and ECDs at stream S-GG4.

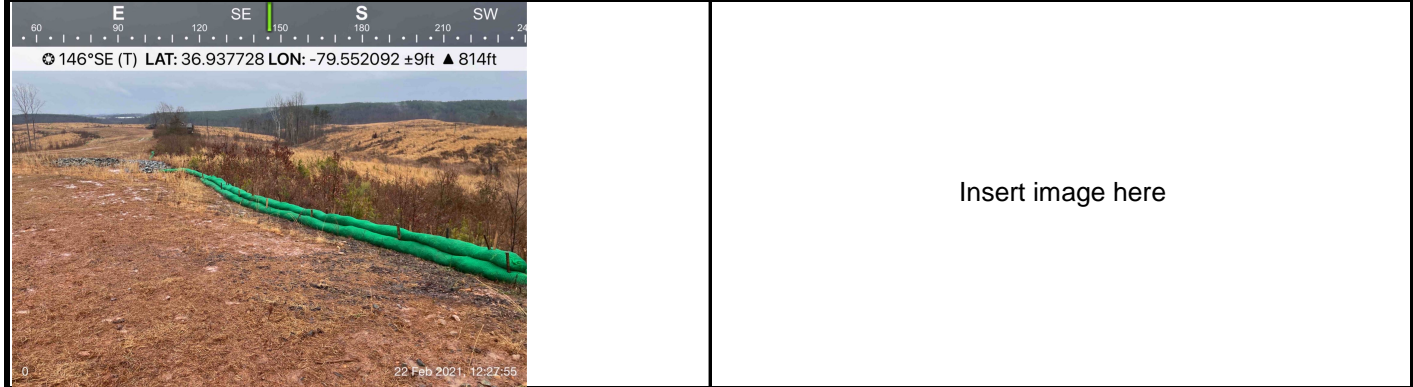
Pic 7 Desc.	Perimeter CFS is in good condition.	Pic 8 Desc.	
--------------------	-------------------------------------	--------------------	--

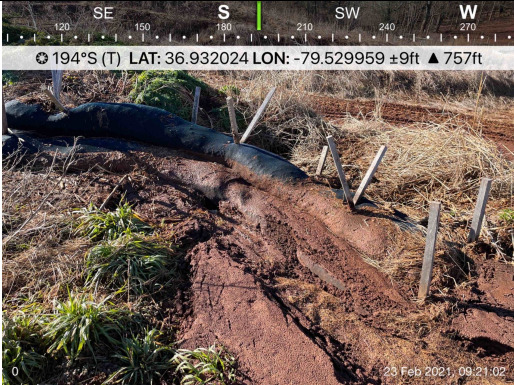
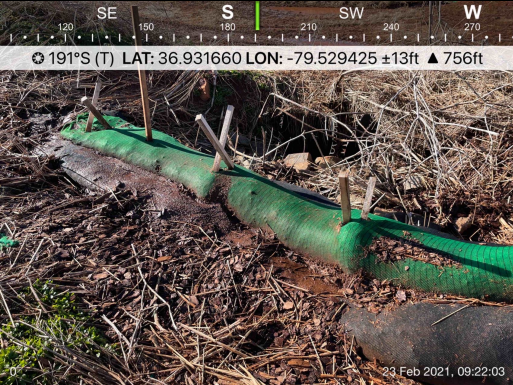
GPS Location See photo		GPS Location See photo			
Field Station# 15301+00		Field Station# 15302+00			
Pic 1 Desc. CWD inlet requires maintenance.		Pic 2 Desc. CWD inlet requires maintenance.

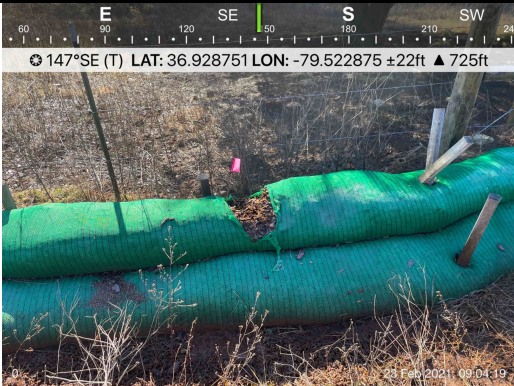
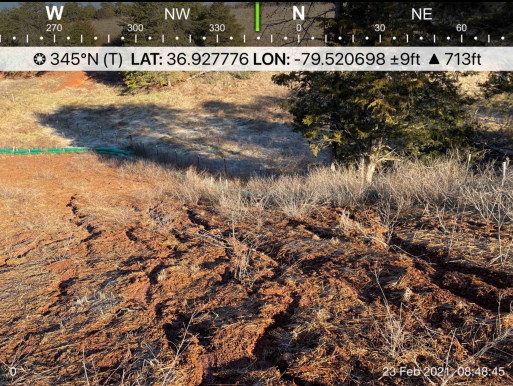
GPS Location See photo		GPS Location See photo			
Field Station# 15325+00		Field Station# 15333+00			
Pic 5 Desc. CFS needs to be repaired.		Pic 6 Desc. Rills on this slope need to be regraded and stabilized.

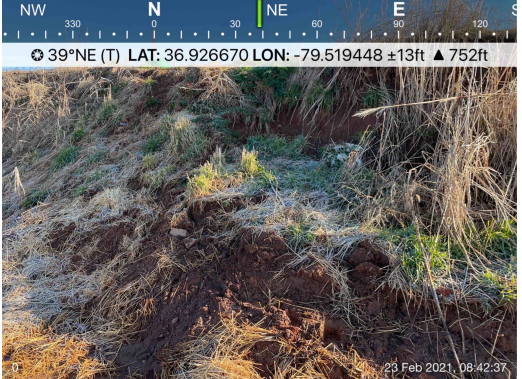
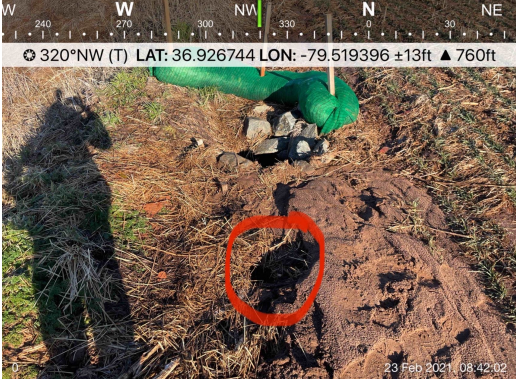
GPS Location	See photo	GPS Location	See photo	
Field Station#	15383+00	Field Station#	15338+00	
Pic 7 Desc.	Cut lope/Topsoil berm has slipped from erosion around CWD inlet.		Pic 8 Desc.	Hole in berm where water has concentrated and caused the slip.

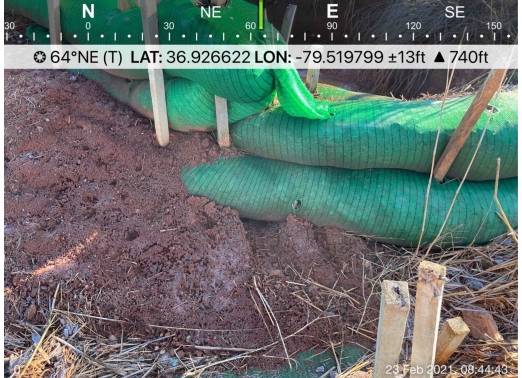
GPS Location	See photo	GPS Location	See photo	
Field Station#	15338+00	Field Station#	15338+50	
Pic 9 Desc.	End treatment is undermined and needs to be keyed in.		Pic 10 Desc.	End treatment is undermined and needs to be keyed in.

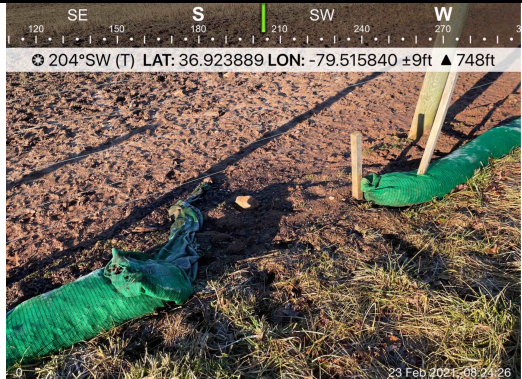
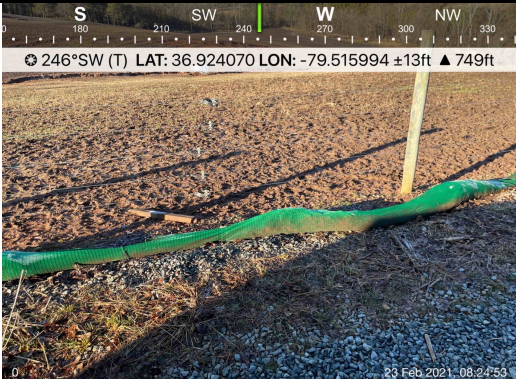
GPS Location	See photo	GPS Location	See photo	
Field Station#	15353+00	Field Station#	15353+00	
Pic 11 Desc.	CFS needs to be repaired along MVP-PI-332.		Pic 12 Desc.	CFS needs to be repaired along MVP-PI-332.

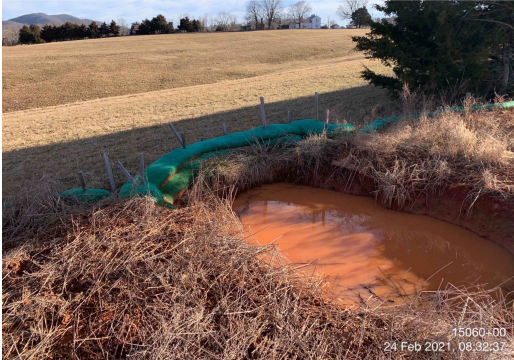
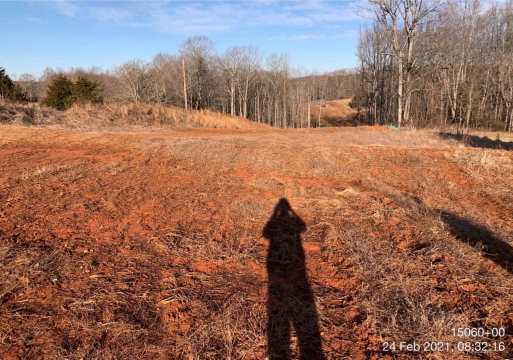
GPS Location 0			GPS Location 0		
Field Station# 15060+00			Field Station# 15060+00		
Pic 1 Desc. Waterbar end treatment in acceptable condition			Pic 2 Desc. Waterbar in acceptable condition

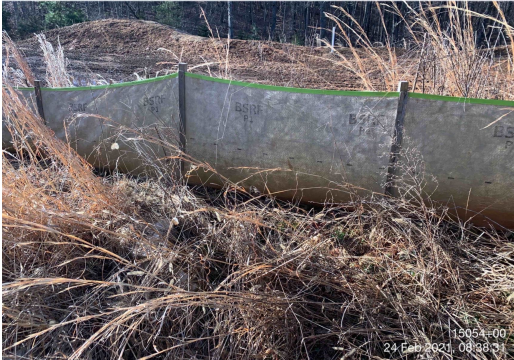
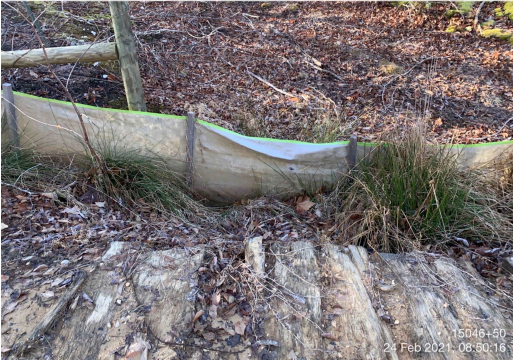
GPS Location 0			GPS Location 0		
Field Station# 15054+00			Field Station# 15046+50		
Pic 3 Desc. Hole in P1 silt fence			Pic 4 Desc. Hole in P1 silt fence

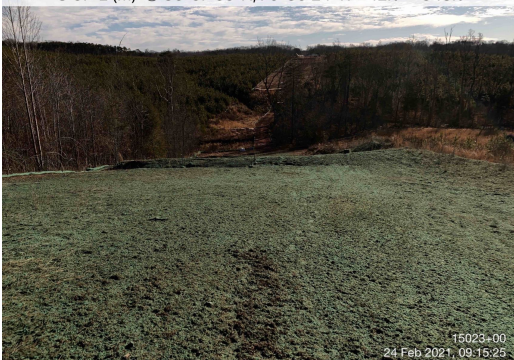
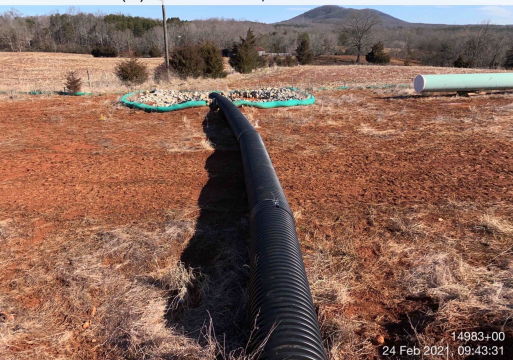
GPS Location 0			GPS Location 0		
Field Station# 15023+00			Field Station# 14983+00		
Pic 5 Desc. Temporary vegetative stabilization in acceptable condition			Pic 6 Desc. Clean water diversion pipe in acceptable condition

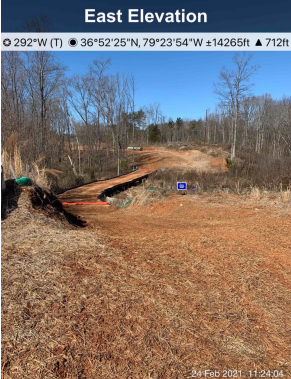
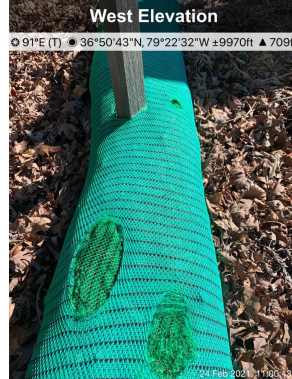
GPS Location	O		GPS Location	O	
Field Station#	15852+88		Field Station#	15862+30	
Pic 1 Desc.	Observing temporary stabilization, signage, buffer, equipment crossing and ECD's		Pic 2 Desc.	Observing CFS that received maintenance

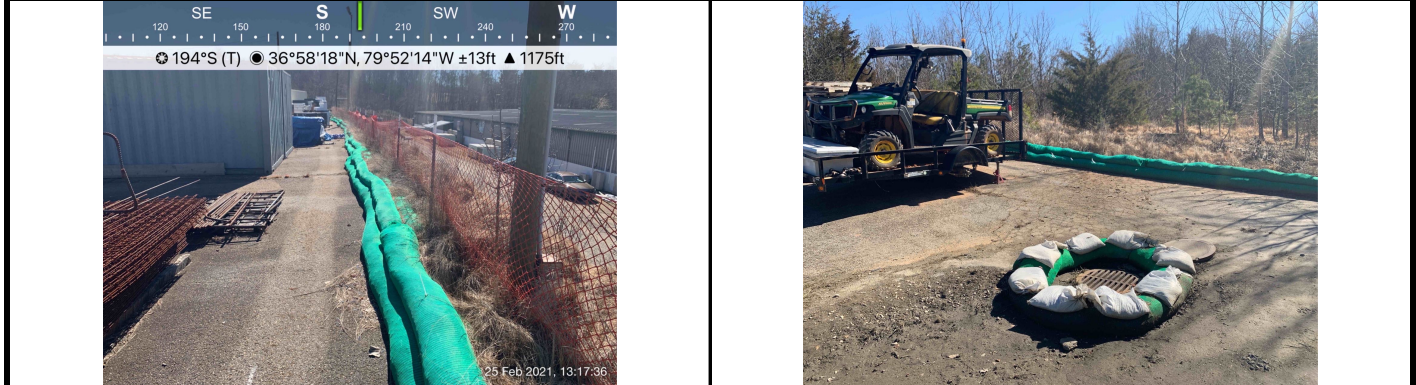
GPS Location	000000000000	GPS Location	000000000000
Field Station#	0000+00	Field Station#	0000+00
Pic 1 Desc.	Perimeter ECD's on west side of MVP-LY-046 in good condition.	Pic 2 Desc.	Perimeter ECD's and inlet protection for catch basin at the south end of MVP-LY-046 in good condition.

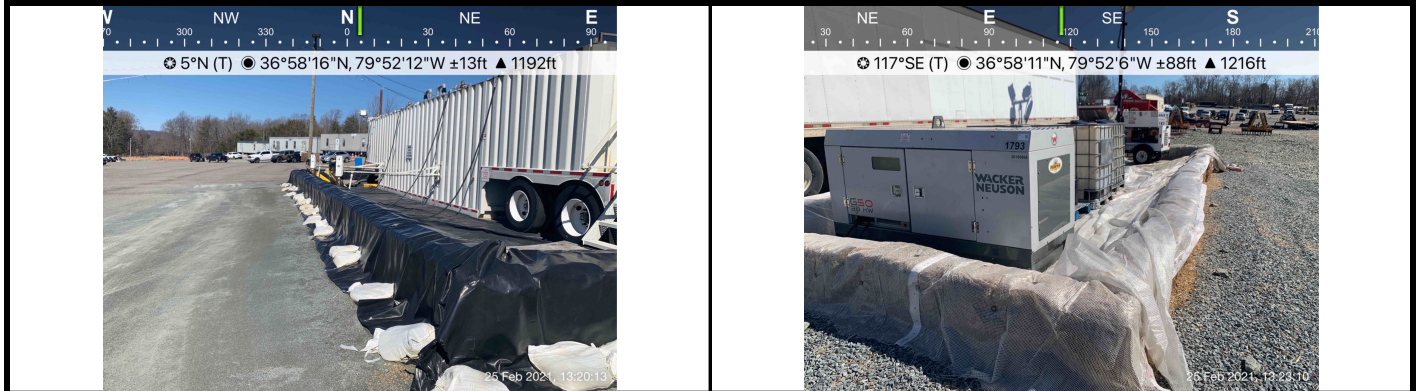
GPS Location	000000000000	GPS Location	000000000000
Field Station#	0000+00	Field Station#	0000+00
Pic 3 Desc.	Secondary containment structure for fuel cell in at MVP-LY-046 in good condition.	Pic 4 Desc.	Secondary containment structure at MVP-LY-045 near office building in good condition.

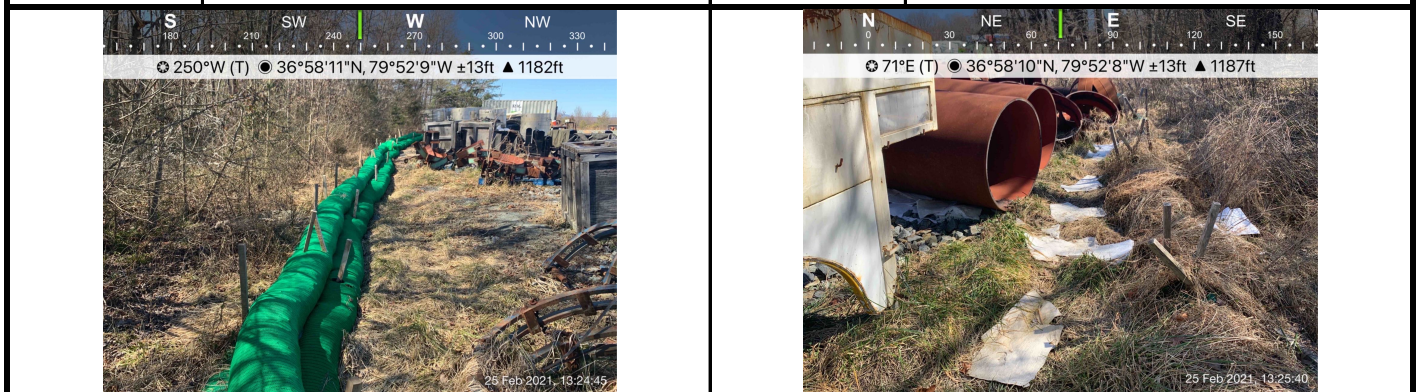
GPS Location	000000000000	GPS Location	000000000000
Field Station#	0000+00	Field Station#	0000+00
Pic 5 Desc.	Perimeter ECD's on west side of MVP-LY-046 in good condition.	Pic 6 Desc.	Housekeeping issue at MVP-LY-046 on west perimeter near bare pipe-

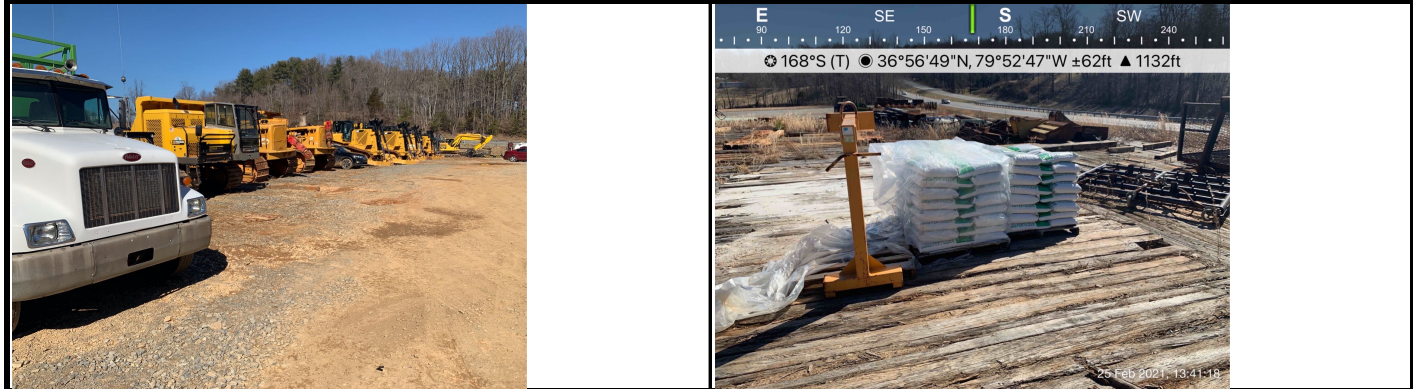
GPS Location	000000000000	GPS Location	000000000000
Field Station#	0000+00	Field Station#	0000+00
Pic 7 Desc.	All equipment inspected and no leaks observed at MVP-LY-032 (220 southbound)	Pic 8 Desc.	Cover to fertilizer bags blow off by high wind MVP-LY-033 (220 northbound) in good condition.

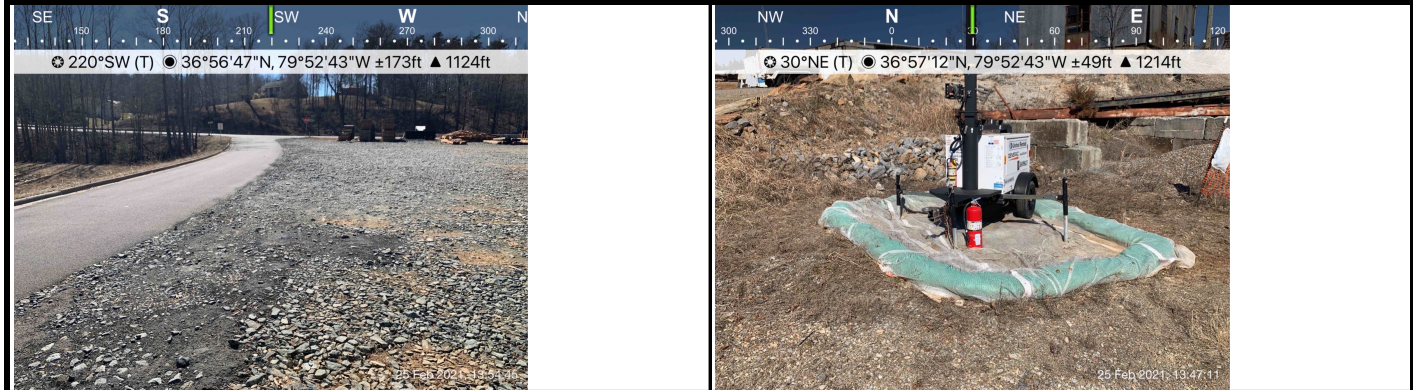
GPS Location	000000000000	GPS Location	000000000000
Field Station#	0000+00	Field Station#	0000+00
Pic 9 Desc.	RCE at yard MVP-LY-033 (220 northbound) in good condition.	Pic 10 Desc.	Secondary containment structure for light plant at yard MVP-ANC-006 (Sontag) needs liner replaced

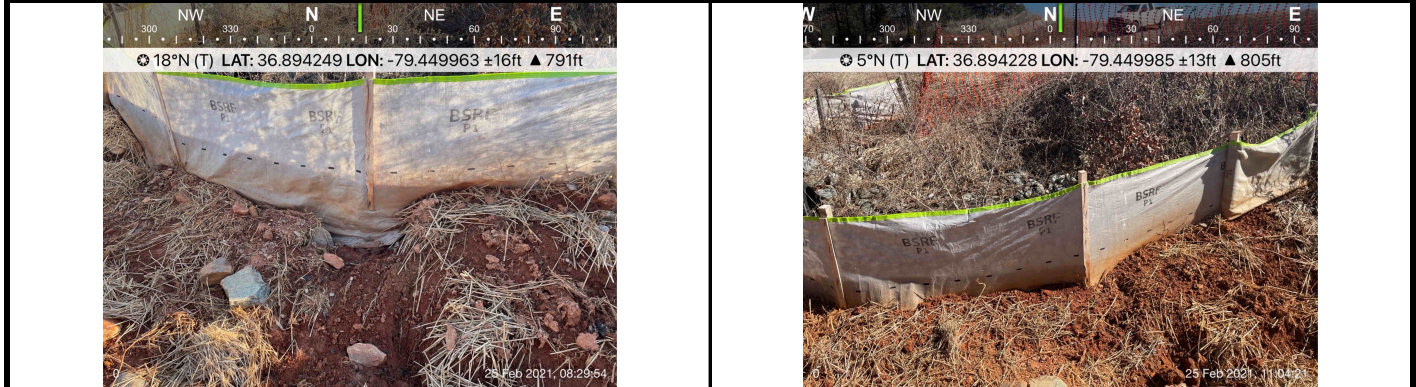
GPS Location	See photo	GPS Location	See photo
Field Station#	15584+00	Field Station#	15584+00
Pic 1 Desc.	P1 is undermined and needs to be keyed in.	Pic 2 Desc.	Environmental crew has corrected this issue.

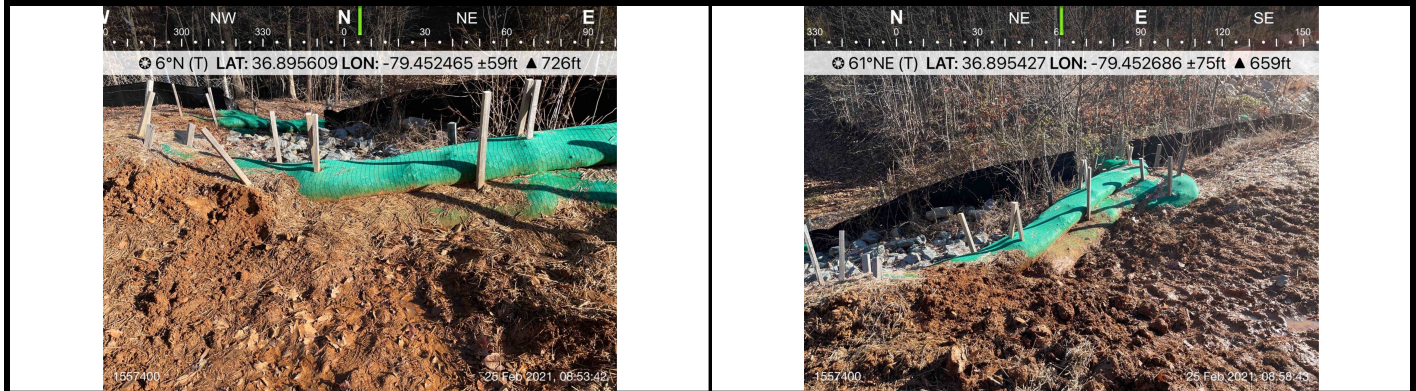
GPS Location	See photo	GPS Location	See photo
Field Station#	15574+00	Field Station#	15574+00
Pic 3 Desc.	CFS requires maintenance.	Pic 4 Desc.	Environmental crew has corrected this issue.

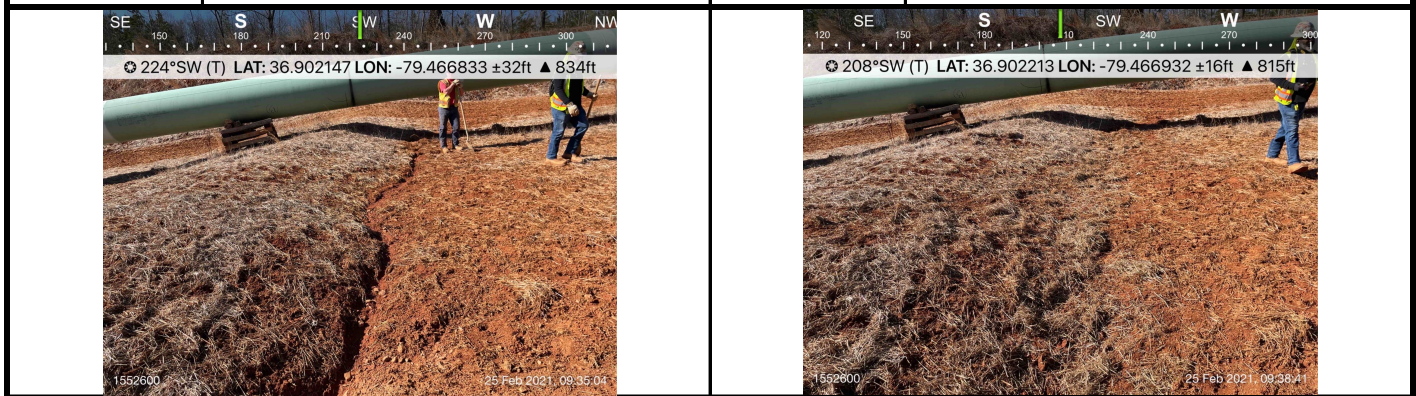
GPS Location	See photo	GPS Location	See photo
Field Station#	15526+00	Field Station#	15526+00
Pic 5 Desc.	Rill erosion needs to be regraded and stabilized.	Pic 6 Desc.	Environmental crew has corrected this issue.

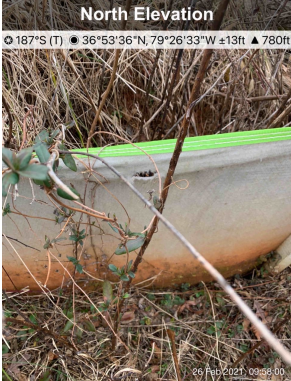
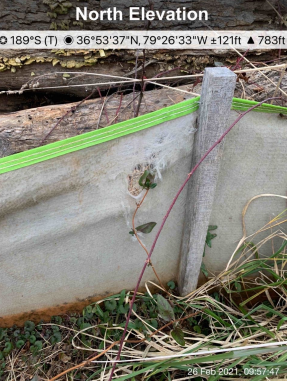
GPS Location	O
GPS Location	O	GPS Location	O	Field Station#	15607+10
Field Station#	15607+10	Field Station#	15607+00	Pic 1 Desc.	Observing p1 that requires maintenance
Pic 1 Desc.	Observing p1 that requires maintenance	Pic 2 Desc.	Observing p1 that requires maintenance

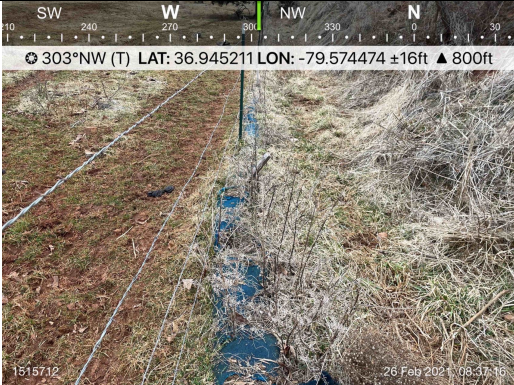
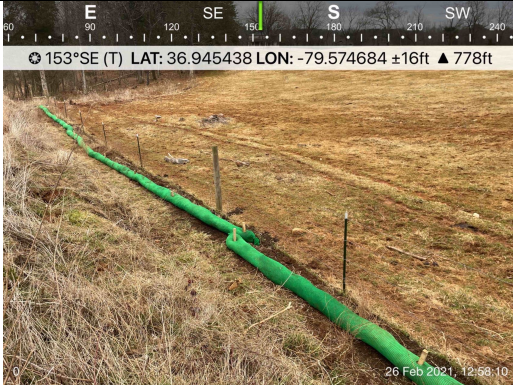
GPS Location See photo		GPS Location See photo			
Field Station# 15157+12		Field Station# 15157+12			
Pic 1 Desc. CFS is damaged and needs to be replaced.		Pic 2 Desc. Environmental crew has corrected this issue.

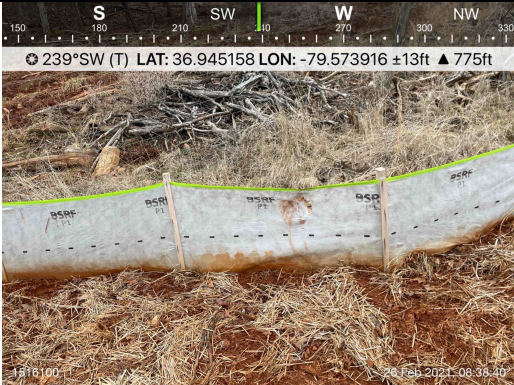
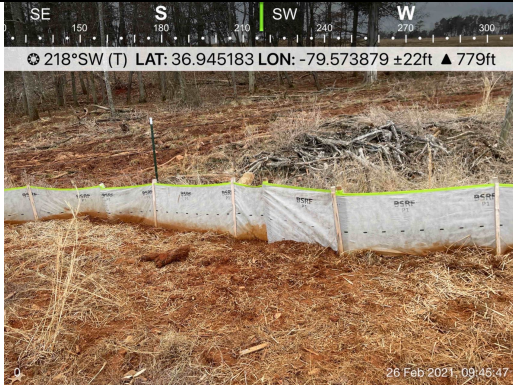
GPS Location See photo		GPS Location See photo			
Field Station# 15161+00		Field Station# 15161+00			
Pic 3 Desc. P1 is damaged and needs to be replaced.		Pic 4 Desc. Environmental crew has corrected this issue.

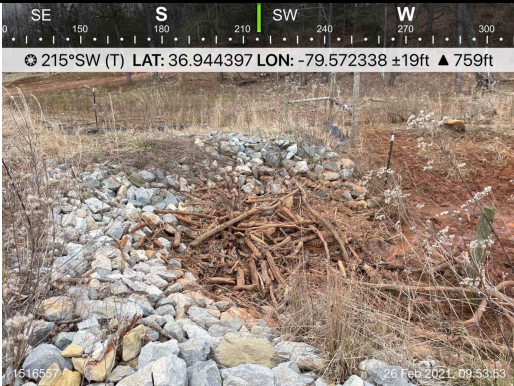
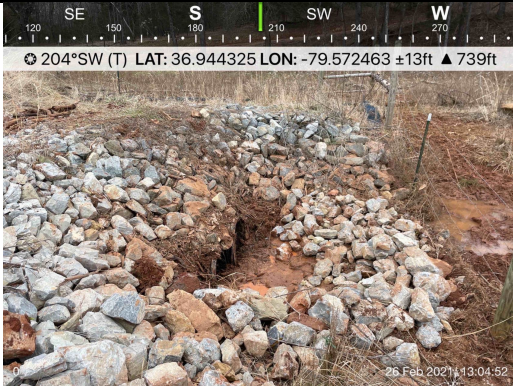
GPS Location See photo		GPS Location See photo			
Field Station# 15165+57		Field Station# 15165+57			
Pic 5 Desc. Debris needs to be removed from CWD inlet.		Pic 6 Desc. Environmental crew has corrected this issue.
