Visual Site Inspection Report

Project Name H-600 Pipeline Spread I		AFE 124300139	Spread H-600 Pipeline Spread I
Contractor Precision		Report # 21078	
Inspector Ben Davenport		Date/Time 3/15/2021 8:07 AM	
Permit # TBD	Inspection Type VA SWPP	Station Begin 14171+36	
State VA	Inspection Area Partial	Station End 14358+11	
County Franklin	Ground Dry	Temperature (°F) 50.00	
Municipality N/A	Weather Cloudy	Rain Gauge (in) 0.00	
Rain Accumulation Time (days)			0.00

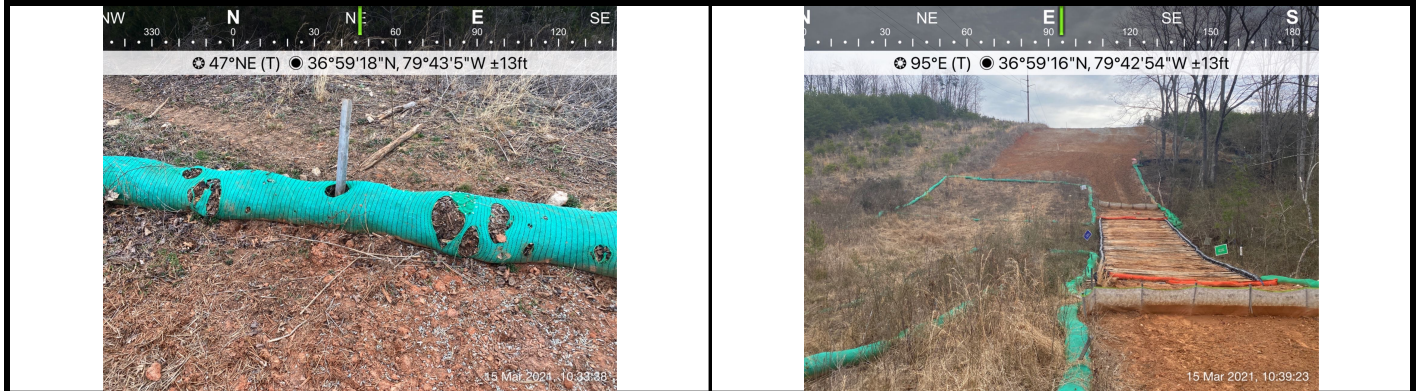
GPS Location 0	GPS Location 0
Field Station# 14652+00	Field Station# 14656+90
Pic 1 Desc. Approximately 14652+00. Overview of ROW.	Pic 2 Desc. Approximately 14656+90. Overview of stream crossing, equipment bridge and ECDs at stream S-H38.

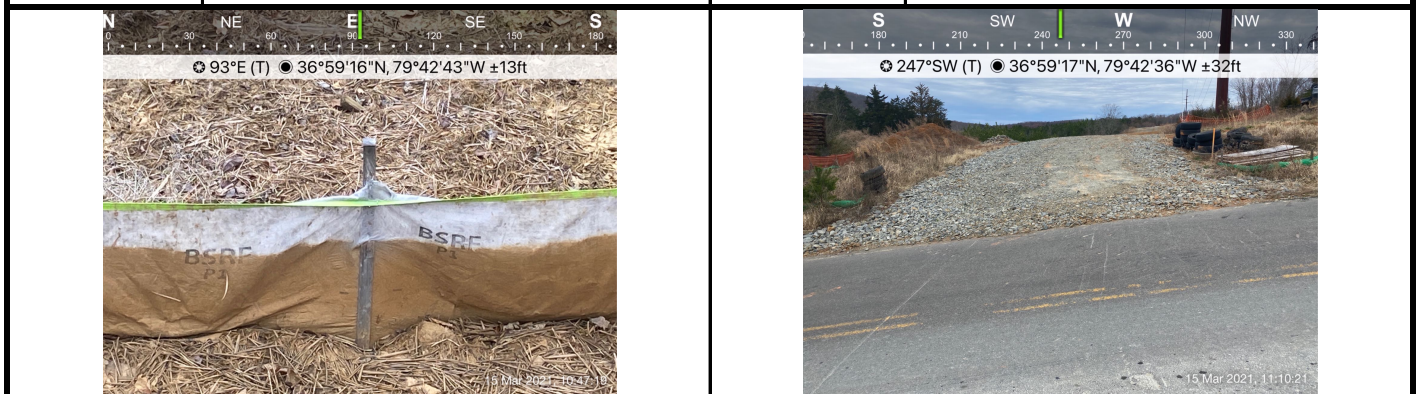
GPS Location 0	GPS Location 0
Field Station# 14668+60	Field Station# 14680+50
Pic 3 Desc. Approximately 14668+60. CFS damaged by livestock.	Pic 4 Desc. Approximately 14680+50. Overview of stream crossing, equipment bridge and ECDs at stream S-H36.

E&S BMPs	Compliance Level	Corrective Action	Corrective Time Frame	Date Repaired
3rd Party Damages	Communication	Repair livestock damage to CFS		
Compost Filter Sock	Communication	Repair livestock damage		
Equipment Bridge	Acceptable			
Sensitive Resource Buffer	Acceptable			
Sensitive Resource Signage	Acceptable			
Rock Construction Entrance	Acceptable			
Silt Fence (Filter Fabric Fence)	Communication	Repair/replace P-1		
Silt Fence (Reinforce Filter Fence)	Acceptable

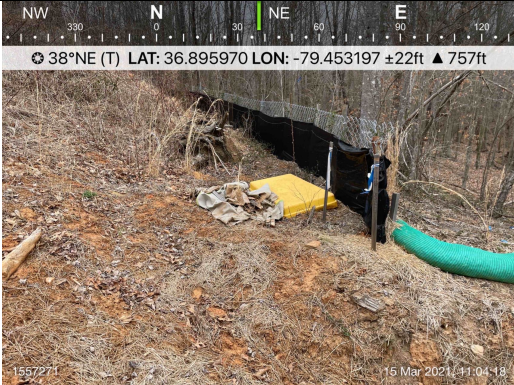
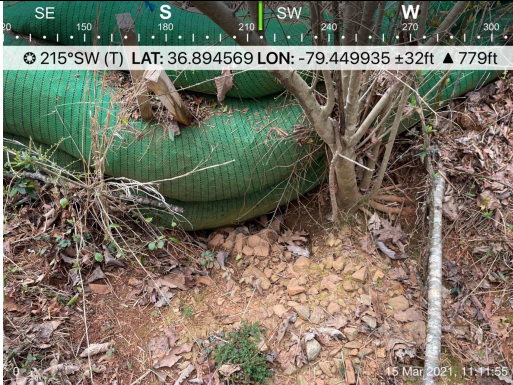
<p>GPS Location See photo</p> <p>Field Station# 15572+71</p> <p>Pic 1 Desc. Trash needs to be removed from the ROW.</p>		<p>GPS Location See photo</p> <p>Field Station# 15584+00</p> <p>Pic 2 Desc. CFS is undermined and needs to be keyed in.</p>

E&S BMPs	Compliance Level	Corrective Action	Corrective Time Frame	Date Repaired
Compost Filter Sock	Communication	CFS is undermined and needs to be		
Housekeeping	Communication	Trash needs to be removed from RC

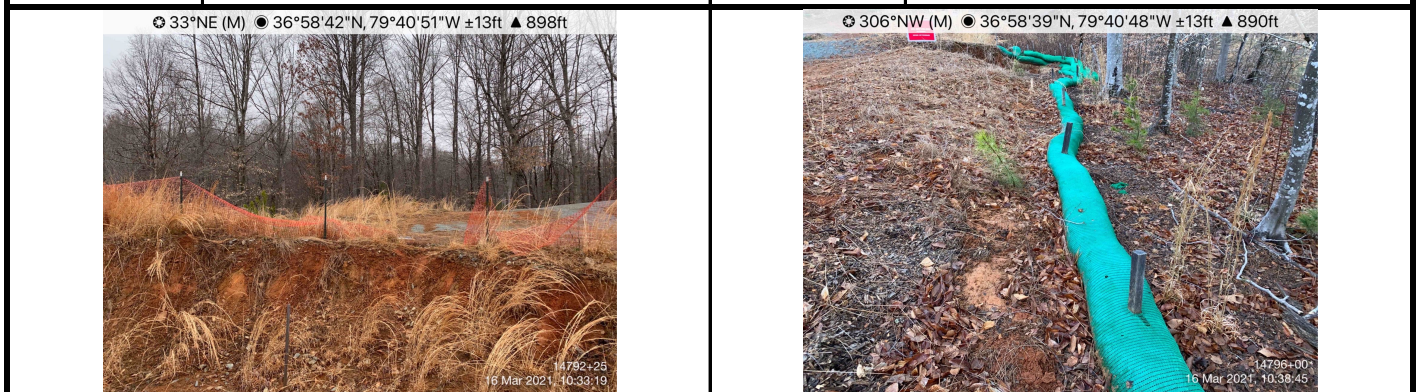
GPS Location	0	GPS Location	0
Field Station#	14792+25	Field Station#	14796+00
Pic 5 Desc.	Safety fence is down and requiring maintenance	Pic 6 Desc.	Perimeter CFS in acceptable condition

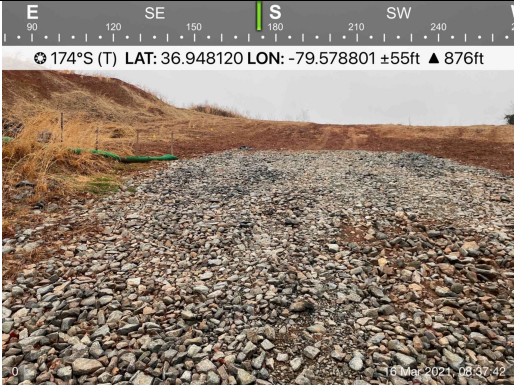
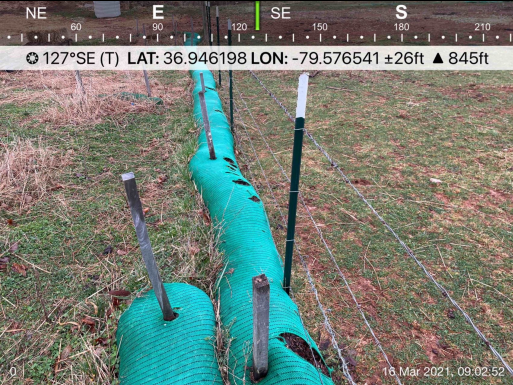
GPS Location See photo		GPS Location See photo			
Field Station# 1514+66		Field Station# 15152+84			
Pic 1 Desc. RCE is in good condition at Rockcreek Rd.		Pic 2 Desc. CFS is damaged and needs to be repaired.

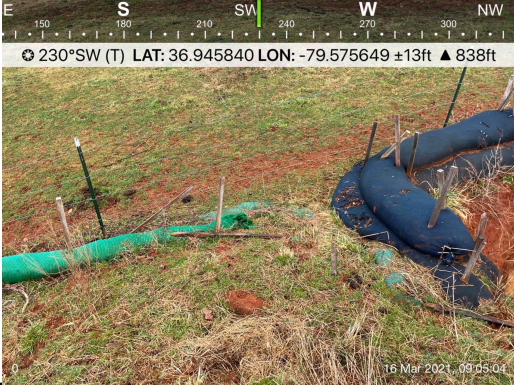
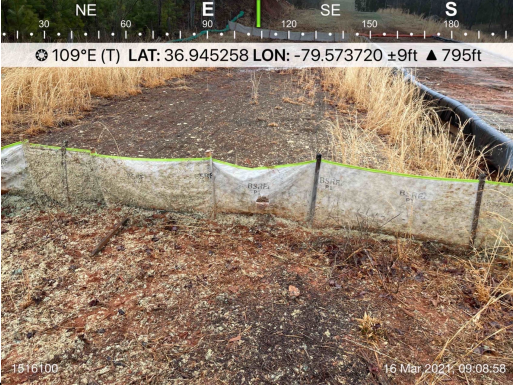
GPS Location See photo		GPS Location See photo			
Field Station# 15155+00		Field Station# 15161+00			
Pic 3 Desc. CFS is damaged and needs to be replaced.		Pic 4 Desc. P1 is damaged and needs to be replaced.

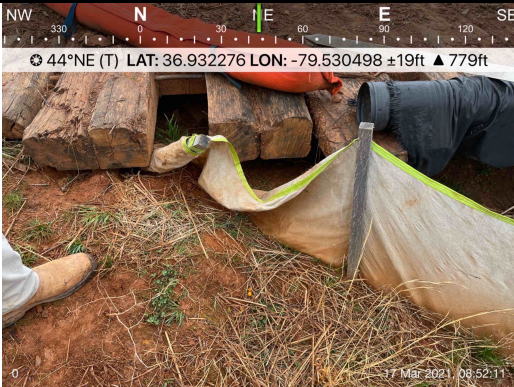
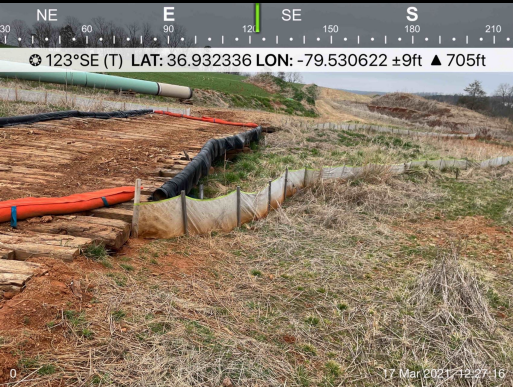
GPS Location	See photo	GPS Location	See photo		
Field Station#	15299+00	Field Station#	15299+00		
Pic 1 Desc.	P1 is damaged and needs to be repaired.	Pic 2 Desc.	Environmental crew has corrected this issue.

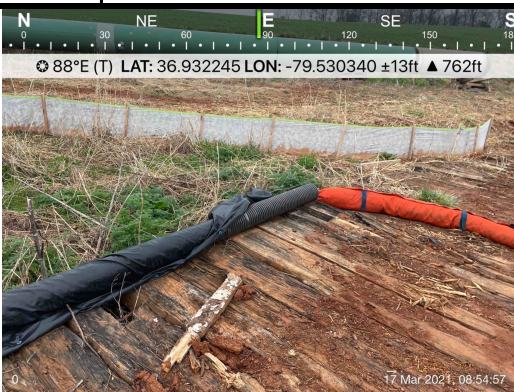
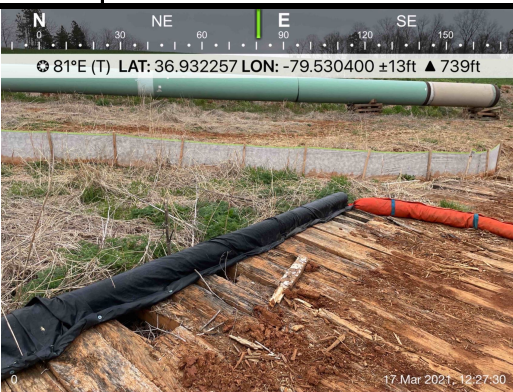
GPS Location	See photo	GPS Location	See photo		
Field Station#	15299+50	Field Station#	15299+50		
Pic 3 Desc.	Sideboard fabric needs to be reattached.	Pic 4 Desc.	Environmental crew has corrected this issue.

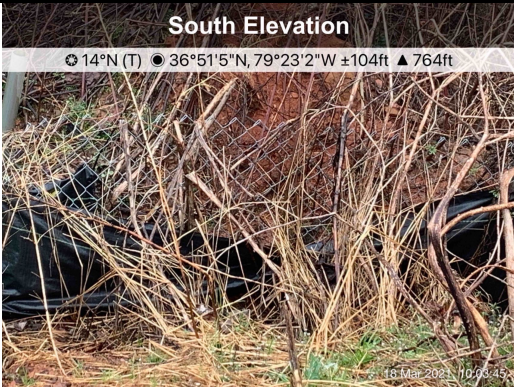
GPS Location	O		GPS Location	O	
Field Station#	15858+00		Field Station#	15858+00	
Pic 1 Desc.	Observing SSF that required maintenance		Pic 2 Desc.	Observing the Contractor performing ECD maintenance.

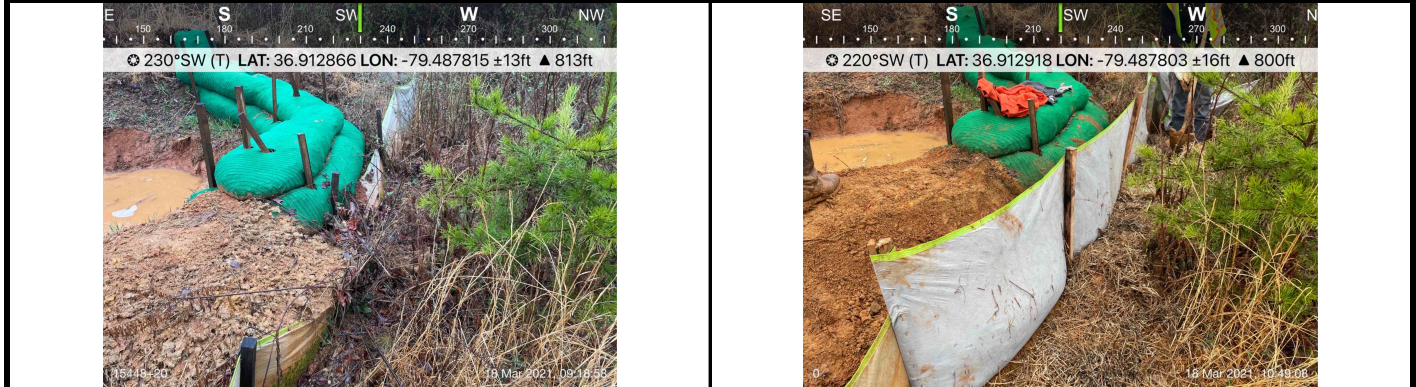
GPS Location	See photo	GPS Location	See photo
Field Station#	15448+20	Field Station#	15448+20
Pic 1 Desc.	P1 is damaged and needs to be replaced.	Pic 2 Desc.	Environmental crew has corrected this issue.

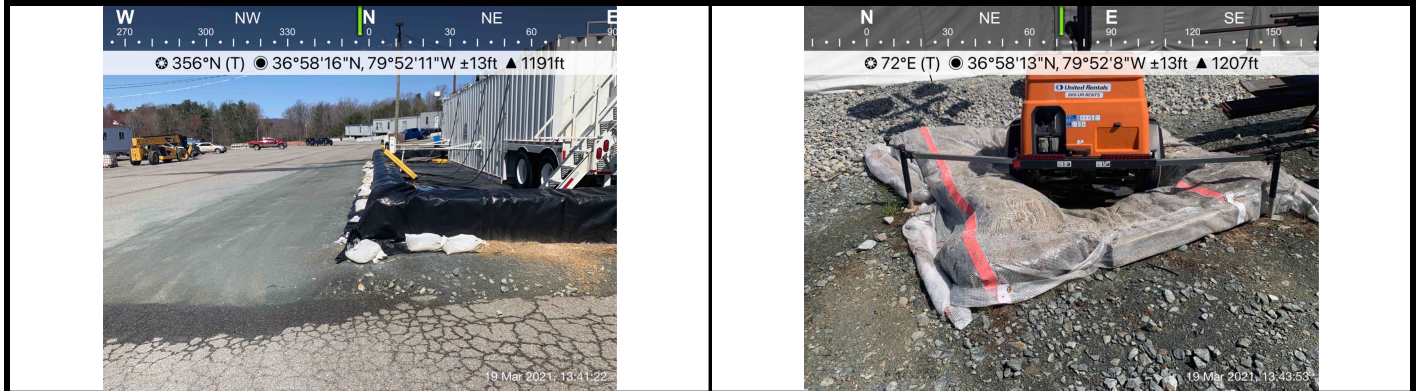
GPS Location	00000000000000	GPS Location	00000000000000
Field Station#	0000+00	Field Station#	0000+00
Pic 3 Desc.	Secondary containment structure for fuel cell at MVP-LY-046 in good condition.	Pic 4 Desc.	Secondary containment structure at MVP-LY-045 liner deteriorating needs replaced (addressed)

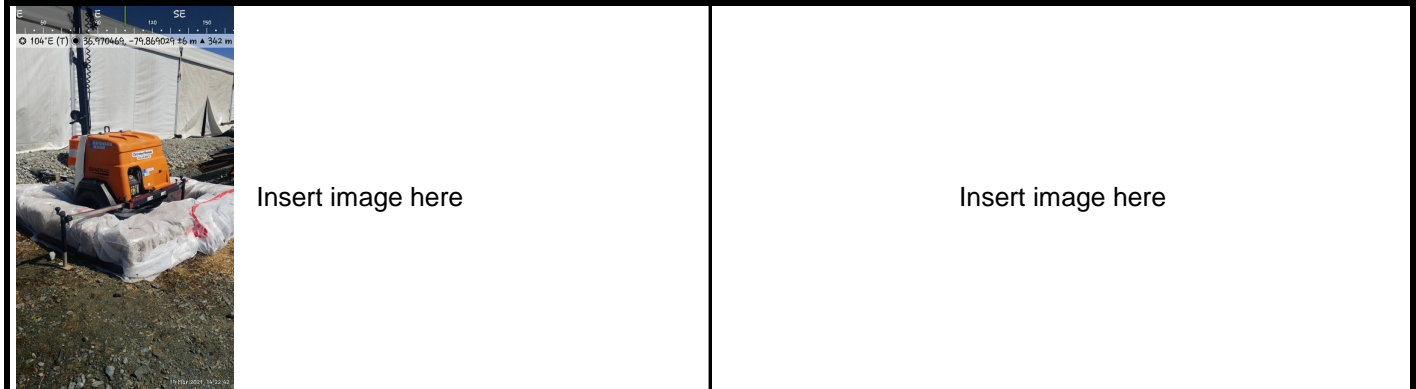
GPS Location	000000000000	GPS Location	
Field Station#	0000+00	Field Station#	
Pic 11 Desc.	Secondary containment structure liner issue at MVP-LY-045 addressed by contractor.	Pic 12 Desc.

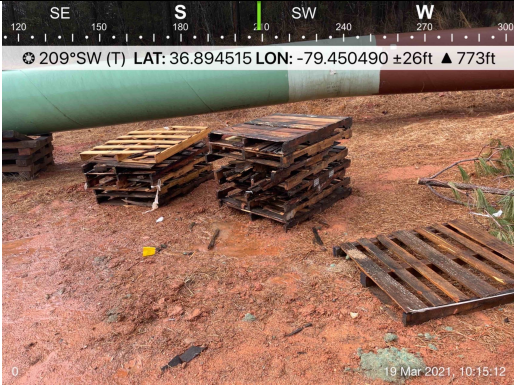
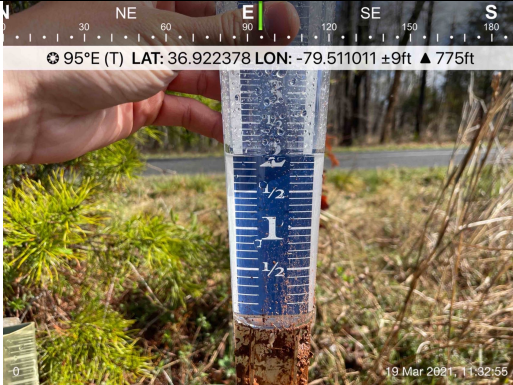
GPS Location See photo		GPS Location See photo			
Field Station# 15573+00		Field Station# 15370+62			
Pic 1 Desc. Trash left on ROW during stabilization needs to be removed.		Pic 2 Desc. Rain gauge reading 2.0" at Snowberry Rd.
