Visual Site Inspection Report

Project Name H-600 Pipeline Spread I		AFE 124300139	Spread H-600 Pipeline Spread I
Contractor Precision		Report # 20846	
Inspector Ben Davenport		Date/Time 3/8/2021 11:45 AM	
Permit # TBD	Inspection Type VA SWPP	Station Begin 14062+17	
State VA	Inspection Area Partial	Station End 14171+36	
County Franklin	Ground Dry	Temperature (°F) 61.00	
Municipality N/A	Weather Sunny	Rain Gauge (in) 0.00	
			Rain Accumulation Time (days) 0.00

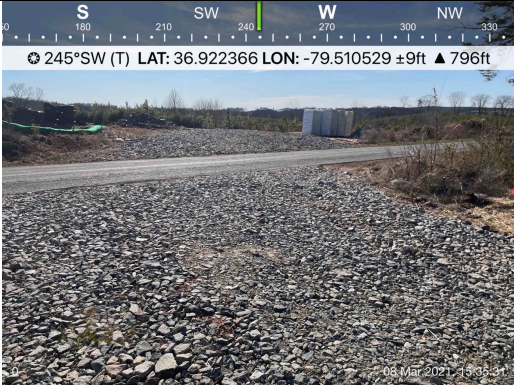
GPS Location See photo		GPS Location See photo			
Field Station# 15370+62		Field Station# 15384+24			
Pic 1 Desc. RCEs are in good condition at all road crossings.		Pic 2 Desc. Equipment bridge ECDs are in place and functioning.

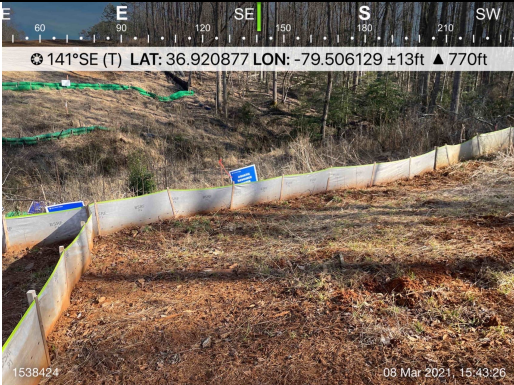
GPS Location See photo		GPS Location See photo			
Field Station# 15384+24		Field Station# 15385+27			
Pic 3 Desc. P1 is in good condition at all stream and wetland buffers.		Pic 4 Desc. CFS is in good condition throughout this section.

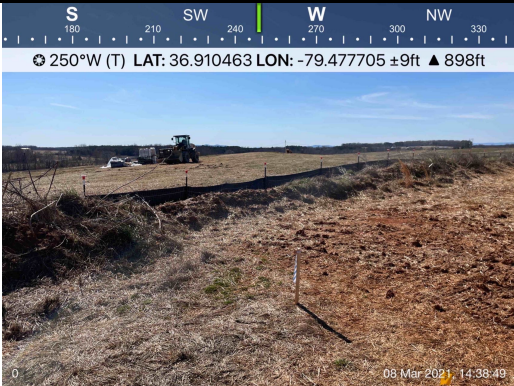
GPS Location See photo		GPS Location See photo			
Field Station# 15480+00		Field Station# 15470+00			
Pic 5 Desc. Diversion berm repair remains stabilized and in good condition.		Pic 6 Desc. MVP-PI-332.01 remains rutted due to 3rd party traffic.

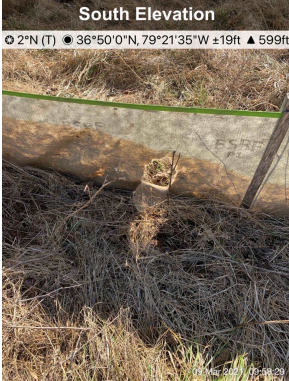
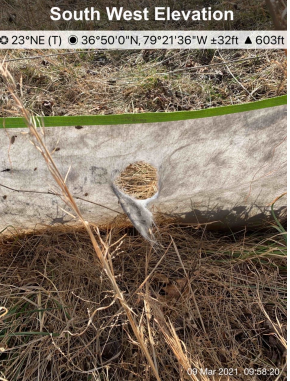
GPS Location	O	GPS Location	O		
Field Station#	15961+40	Field Station#	15961+40		
Pic 1 Desc.	Observing p1 that requires maintenance (damaged by livestock)		Pic 2 Desc.	Observing p1 that requires maintenance (damaged by livestock)

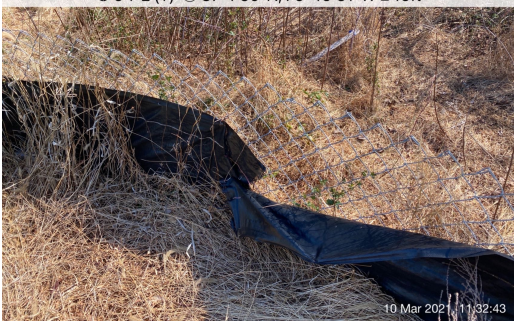
GPS Location	0	GPS Location	0		
Field Station#	14414+00	Field Station#	14314+24		
Pic 5 Desc.	Approximately 14414+00. SSF requires maintenance.		Pic 6 Desc.	Approximately 14314+24. P-1 requires maintenance. Damaged by wildlife.

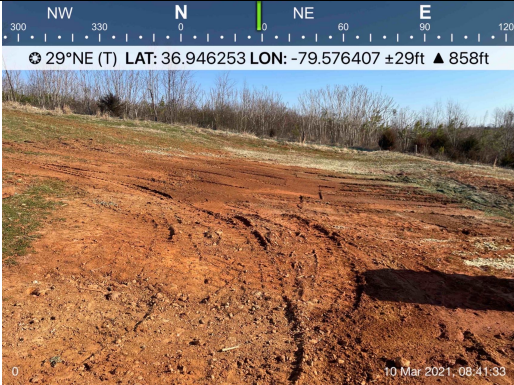
GPS Location See photo		GPS Location See photo			
Field Station# 15152+84		Field Station# 15159+00			
Pic 1 Desc. Area needs to be stabilized.		Pic 2 Desc. Trash needs to be removed from ROW.

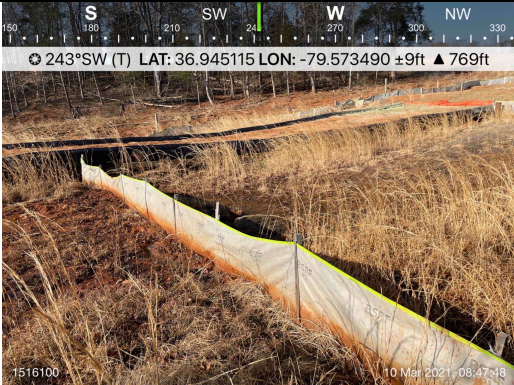
GPS Location See photo		GPS Location See photo			
Field Station# 15161+00		Field Station# 15167+96			
Pic 3 Desc. P1 is damaged and needs to be replaced.		Pic 4 Desc. Equipment bridge ECDs are in place and functioning.

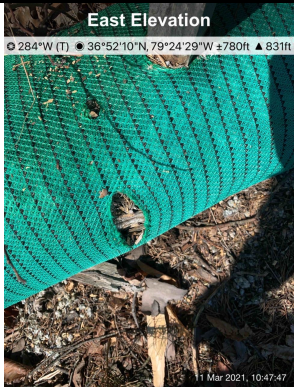
GPS Location	O		GPS Location	O	
Field Station#	15744+88		Field Station#	15744+88	
Pic 1 Desc.	Observing CFS that required maintenance		Pic 2 Desc.	Observing CFS that received maintenance

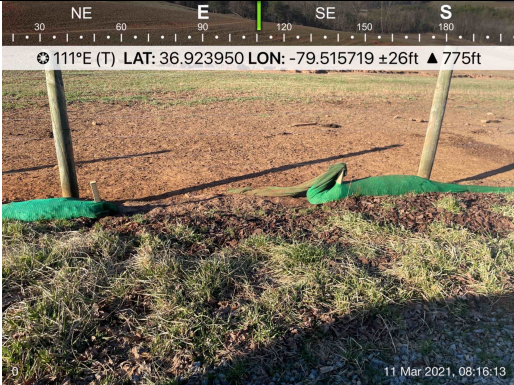
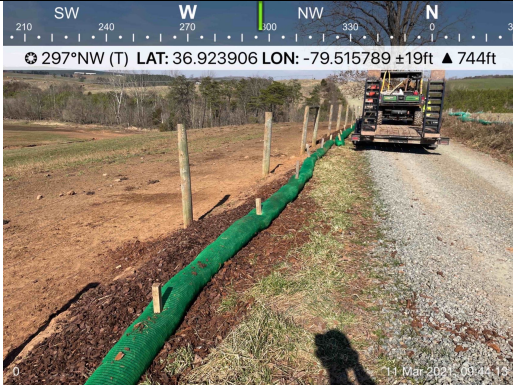
<p>297°NW (T) LAT: 36.923906 LON: -79.515789 ±19ft ▲ 744ft 11 Mar 2021, 08:14:11</p>		<p>GPS Location See photo</p> <p>Field Station# 15350+82</p> <p>Pic 1 Desc. CFS along MVP-PI-332 is damaged by livestock and needs to be replaced.</p>		<p>GPS Location See photo</p> <p>Field Station# 15350+82</p> <p>Pic 2 Desc. Environmental crew has corrected this issue.</p>

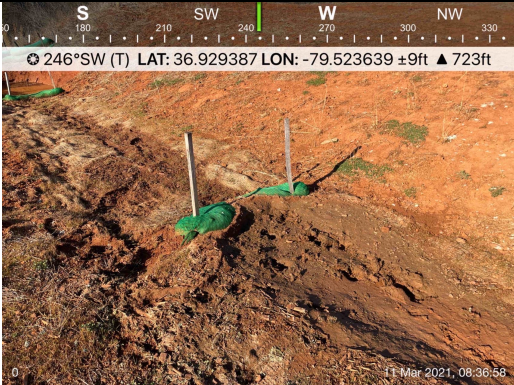
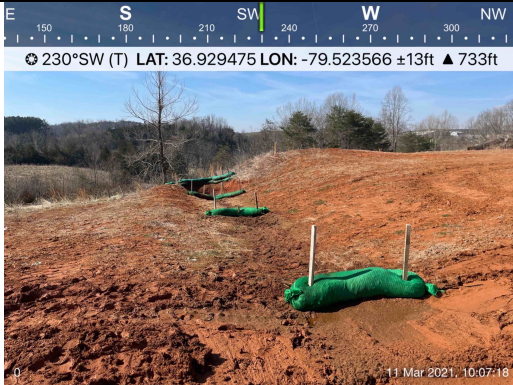
<p>230°SW (T) LAT: 36.929475 LON: -79.523566 ±13ft ▲ 733ft 11 Mar 2021, 10:07:18</p>		<p>GPS Location See photo</p> <p>Field Station# 15322+00</p> <p>Pic 3 Desc. Check dams are blocked by sediment and need to be replaced.</p>		<p>GPS Location See photo</p> <p>Field Station# 15322+00</p> <p>Pic 4 Desc. Environmental crew has corrected this issue.</p>
