# Visual Site Inspection Report

<b>Project Name</b> H-600 Pipeline Spread H		<b>AFE</b> 124300138	<b>Spread</b> H-600 Pipeline Spread H
<b>Contractor</b> Precision		<b>Report #</b> 20859	
<b>Inspector</b> John Brcic		<b>Date/Time</b> 3/8/2021 1:22 PM	
<b>Permit #</b> TBD	<b>Inspection Type</b> VA SWPP	<b>Station Begin</b>	12005+00
<b>State</b> VA	<b>Inspection Area</b> Partial	<b>Station End</b>	12119+17
<b>County</b> Montgomery	<b>Ground</b> Dry	<b>Temperature (°F)</b>	55.00
<b>Municipality</b> N/A	<b>Weather</b> Sunny	<b>Rain Gauge (in)</b>	0.00
			<b>Rain Accumulation Time (days)</b> 1.00

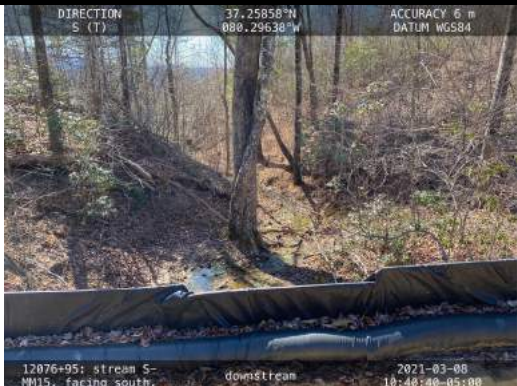
<p>DIRECTION S (T) 37.25858°N 888.29638°W ACCURACY 6 m DATUM WGS84 12076+95: stream S-MM15, facing south, downstream 2021-03-08 10:48:40-05:00</p>

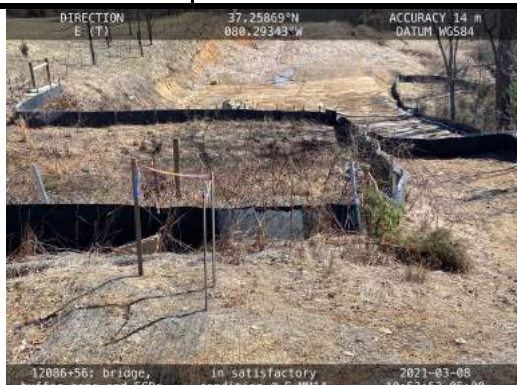
<p>DIRECTION E (T) 37.25869°N 888.29343°W ACCURACY 14 m DATUM WGS84 12086+56: bridge, buffer zone and ECDs in satisfactory condition @ S-MM14 2021-03-08 10:53:53-05:00</p>

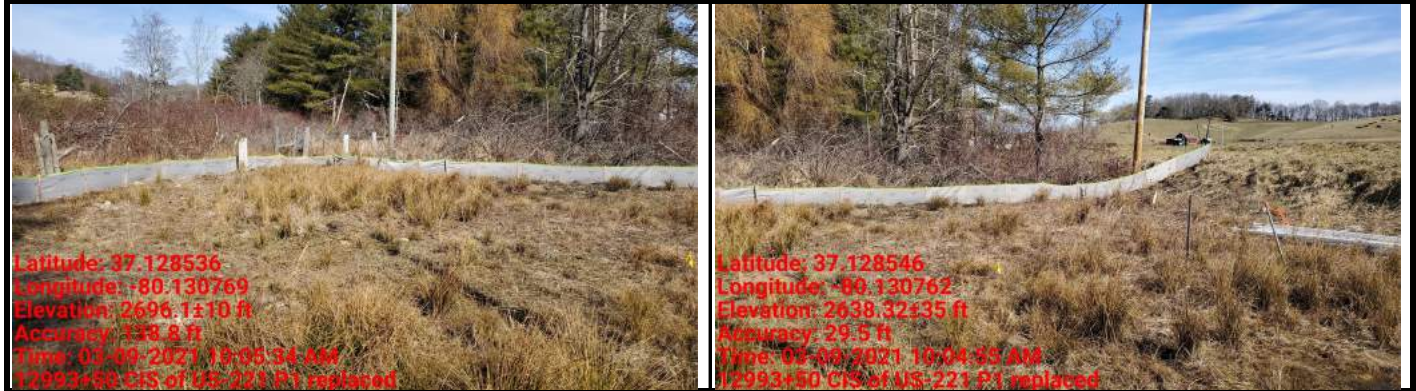
<b>GPS Location</b>	See pic for GPS location	<b>GPS Location</b>	See pic for GPS location
<b>Field Station#</b>	12993+50	<b>Field Station#</b>	12993+50
<b>Pic 7 Desc.</b>	P1 silt fence pushed over and needs maintenance. Replaced. 03/09/21	<b>Pic 8 Desc.</b>	P1 silt fence pushed over and needs maintenance. Replaced. 03/09/21

P1 silt fence replaced where deteriorating.

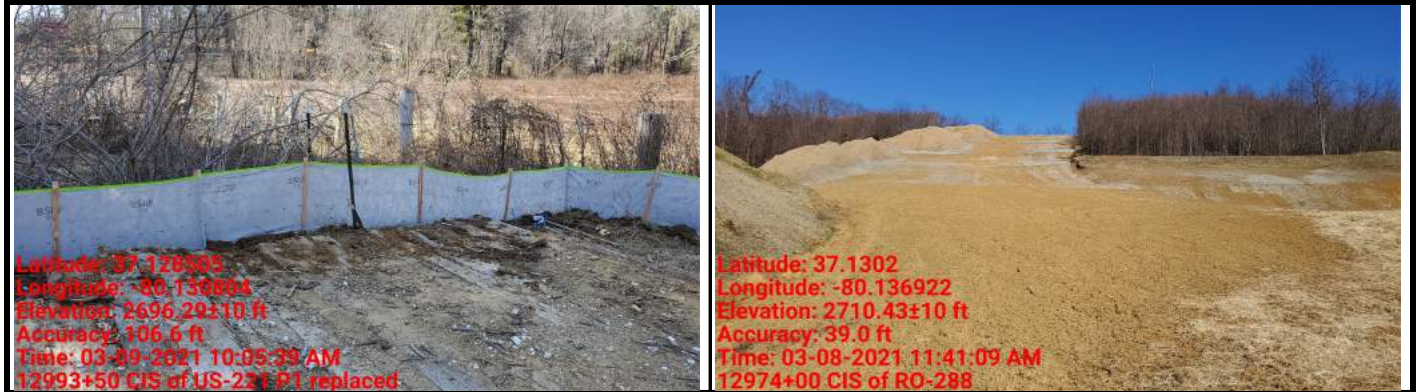
<b>GPS Location</b>	See pic for GPS location	<b>GPS Location</b>	See pic for GPS location
<b>Field Station#</b>	12993+50	<b>Field Station#</b>	12974+00
<b>Pic 9 Desc.</b>	Hole in P1 silt fence needs maintenance. Replaced. 03/09/21	<b>Pic 10 Desc.</b>	CIS of RO-288.

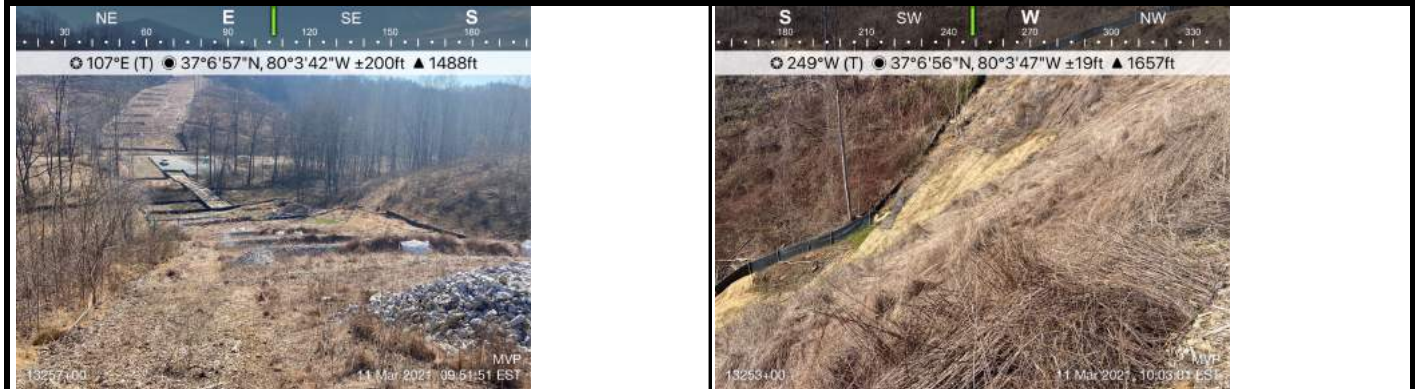
<b>GPS Location</b>	See photo for coordinates.	<b>GPS Location</b>	See photo for coordinates.
<b>Field Station#</b>	13257+00	<b>Field Station#</b>	13253+00
<b>Pic 11 Desc.</b>	ROW stable with acceptable vegetative cover across LOD.	<b>Pic 12 Desc.</b>	No changes noted at documented slip.

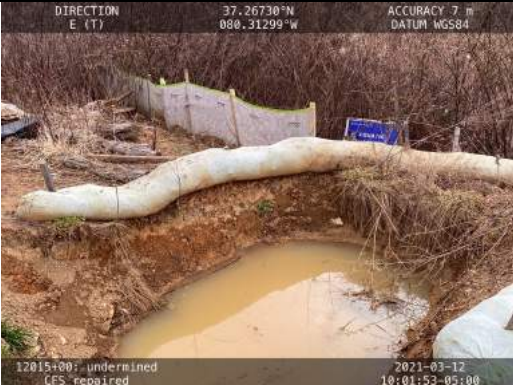
<p>DIRECTION E (T) 37.26730°N 080.31299°W ACCURACY 7 m DATUM WGS84 12015+00: undermined CFS repaired 2021-03-12 10:01:53-05:00</p>	
<b>GPS Location</b>	See photo	<b>GPS Location</b>	See photo
<b>Field Station#</b>	12015+84	<b>Field Station#</b>	12015+00
<b>Pic 3 Desc.</b>	The bridge, buffer zone and ECDs are in satisfactory condition at stream S-G38.	<b>Pic 4 Desc.</b>	Undermined CFS was repaired on this end treatment per MBP action item.

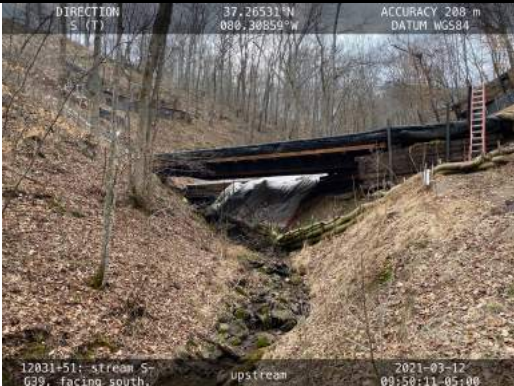
<p>DIRECTION S (T) 37.26531°N 080.30859°W ACCURACY 208 m DATUM WGS84 12031+51: stream S-G39, facing south, upstream 2021-03-12 09:50:11-05:00</p>		  <p>DIRECTION NE (T) 37.26584°N 080.30871°W ACCURACY 291 m DATUM WGS84 2021-03-12 09:49:07-05:00</p>	
<b>GPS Location</b>	See photo	<b>GPS Location</b>	See photo
<b>Field Station#</b>	12031+51	<b>Field Station#</b>	12031+51
<b>Pic 5 Desc.</b>	Stream S-G39, facing south, upstream	<b>Pic 6 Desc.</b>	Stream S-G39 at landowner's footbridge, immediately upstream of where S-G39 converges with S-G40.

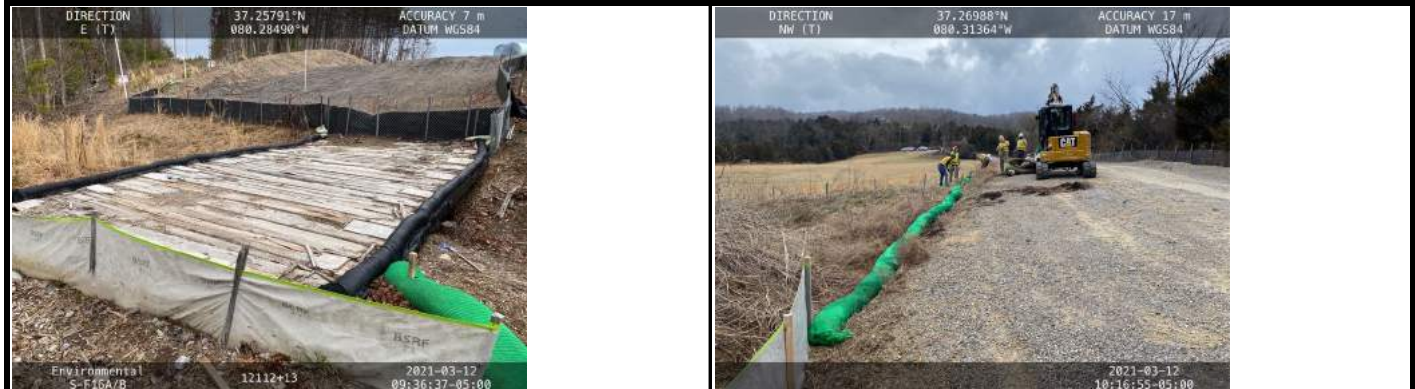
<b>GPS Location</b>	See photo	<b>GPS Location</b>	See photo
<b>Field Station#</b>	12112+13	<b>Field Station#</b>	12013+97
<b>Pic 17 Desc.</b>	Bridge and ECDs in satisfactory condition at stream S-F16.	<b>Pic 18 Desc.</b>	An environmental crew replaced old CFS along access road MVP-MN-268.
