Visual Site Inspection Report

Project Name	H-600 Pipeline Spread H	AFE	124300138	Spread	H-600 Pipeline Spread H
Contractor	Precision			Report #	24568
Inspector	Jason Nielsen			Date/Time	6/14/2021 7:14 PM
Permit #	TBD	Inspection Type	VA SWPP	Station Begin	12284+75
State	VA	Inspection Area	Partial	Station End	12443+75
County	Montgomery	Ground	Damp	Temperature (°F)	87.00
Municipality	N/A	Weather	Sunny	Rain Gauge (in)	1.00
				Rain Accumulation Time (days)	1.00

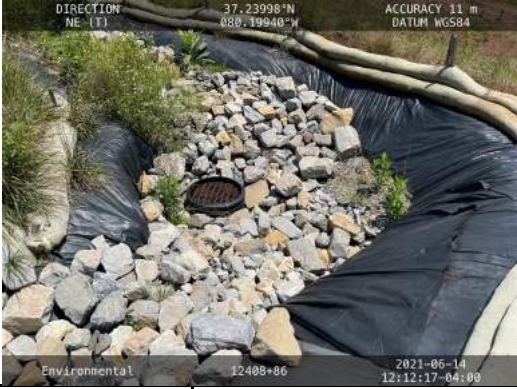
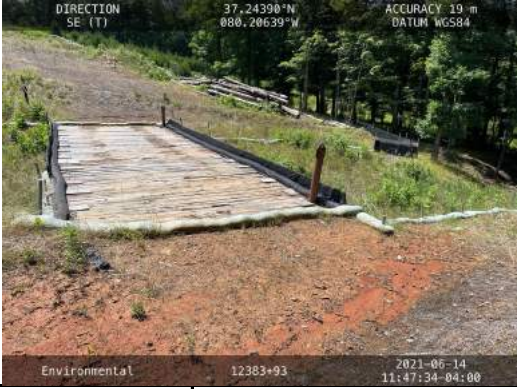
GPS Location	See photo		GPS Location	See photo	
Field Station#	12408+86		Field Station#	12383+93	
Pic 7 Desc.	Clean water crossing pipe inlet in acceptable condition		Pic 8 Desc.	Clean water crossing in acceptable condition

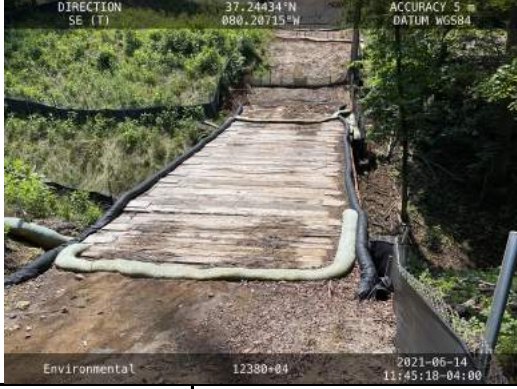
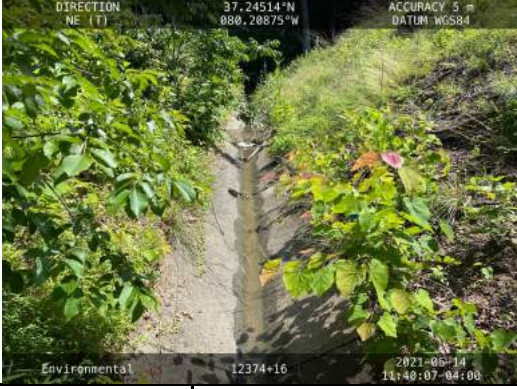
GPS Location	See photo		GPS Location	See photo	
Field Station#	12380+04		Field Station#	12374+16	
Pic 9 Desc.	Bridge and ECDs crossing stream S-NN19 in acceptable condition		Pic 10 Desc.	Stream crossing S-OO16 in acceptable condition

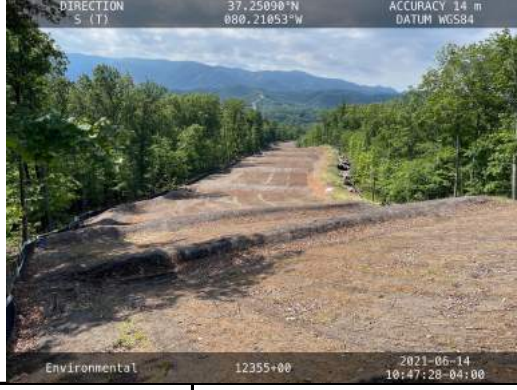
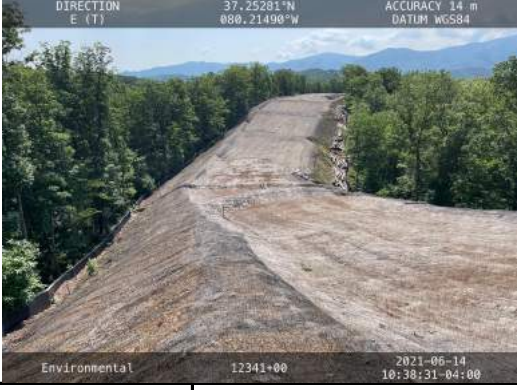
GPS Location	See photo		GPS Location	See photo	
Field Station#	12355+00		Field Station#	12341+00	
Pic 11 Desc.	Stabilized ROW In Acceptable condition		Pic 12 Desc.	Stabilized ROW in acceptable condition

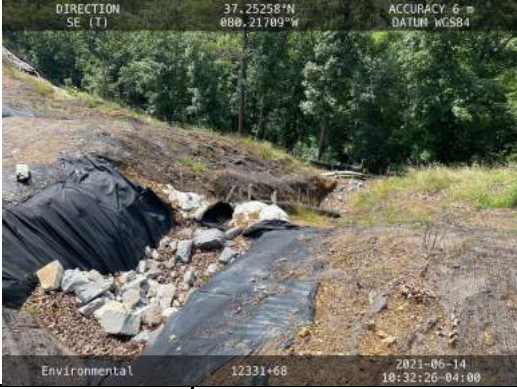
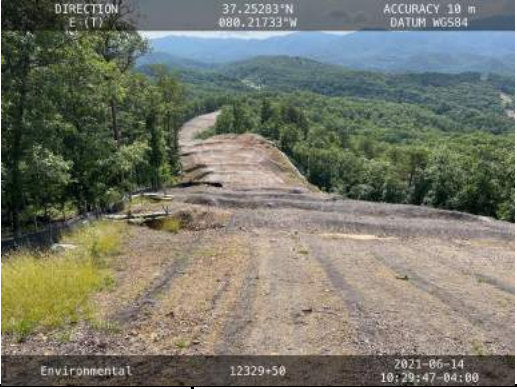
GPS Location	see photo		GPS Location	See photo	
Field Station#	12331+68		Field Station#	12329+50	
Pic 13 Desc.	Fill slope drain in acceptable condition		Pic 14 Desc.	Stabilized ROW in acceptable condition

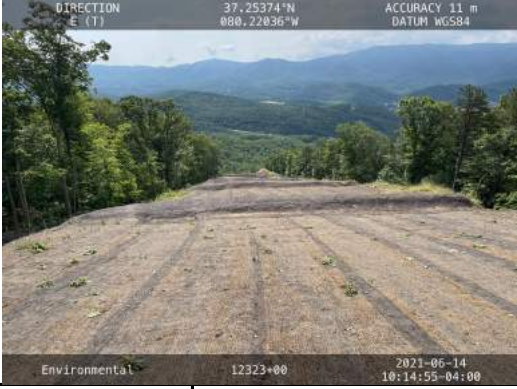
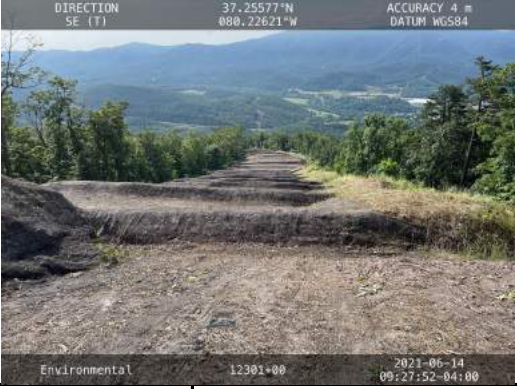
GPS Location	See photo		GPS Location	See photo	
Field Station#	12323+00		Field Station#	12301+00	
Pic 15 Desc.	Stabilized ROW In Acceptable condition		Pic 16 Desc.	Stabilized ROW In Acceptable condition

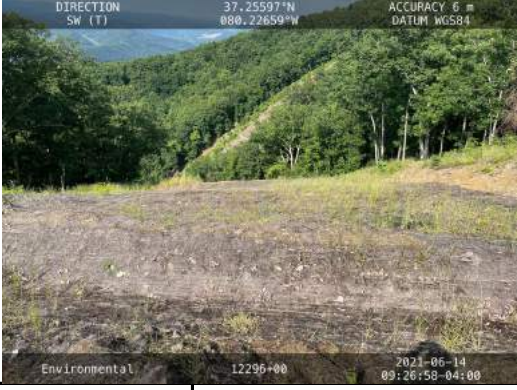
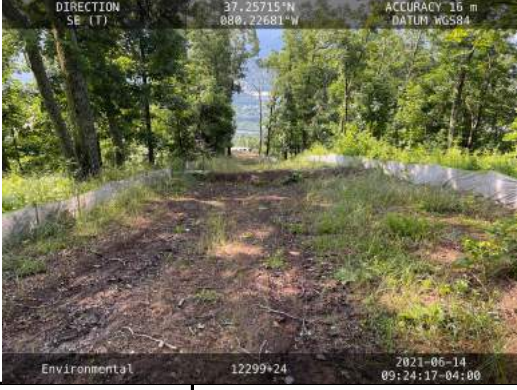
GPS Location	See photo		GPS Location	See photo	
Field Station#	12296+00		Field Station#	12299+24	
Pic 17 Desc.	Stabilized ROW in acceptable condition		Pic 18 Desc.	Stabilized access Road in acceptable condition

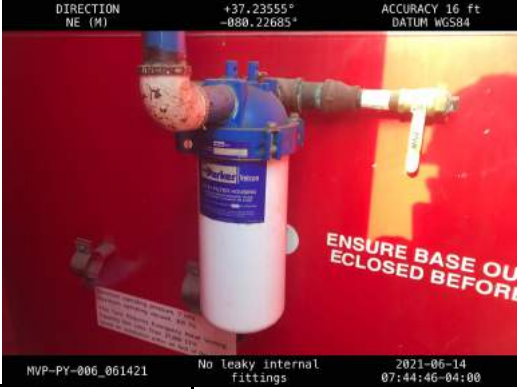
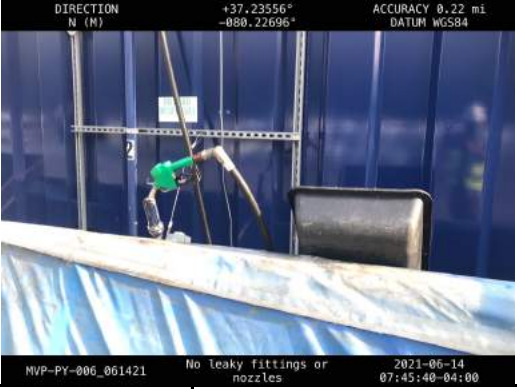
GPS Location	MVP-PY-006 See photo for gps data		GPS Location	MVP-PY-006 See photo for gps data	
Field Station#	+0		Field Station#	+0	
Pic 13 Desc.	Off Road Fuel unit no leaky internal fittings. Looking NW. Looking NW.		Pic 14 Desc.	Blue Bulk Fuel tanks no leaky fittings or nozzles. Looking N.

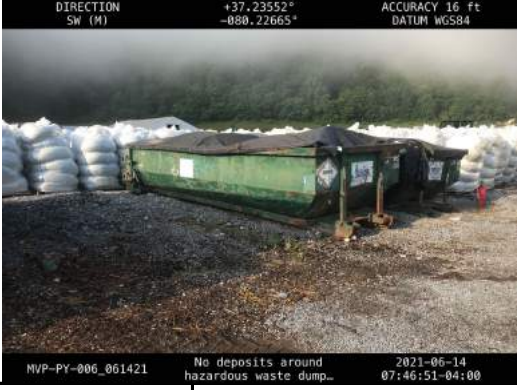
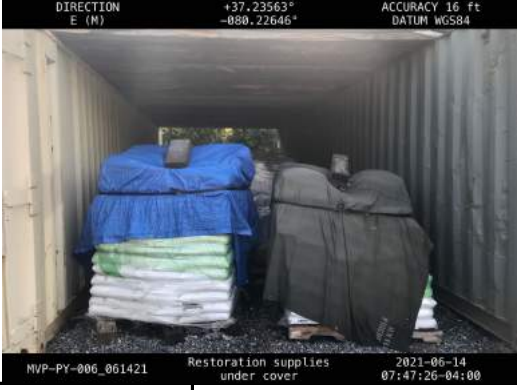
GPS Location	MVP-PY-006 See photo for gps data		GPS Location	MVP-PY-006 See photo for gps data	
Field Station#	+0		Field Station#	+0	
Pic 17 Desc.	No fluids or deposits around hazardous waste dumpsters. Looking SW.		Pic 18 Desc.	Rest supplies under cover. Looking E.

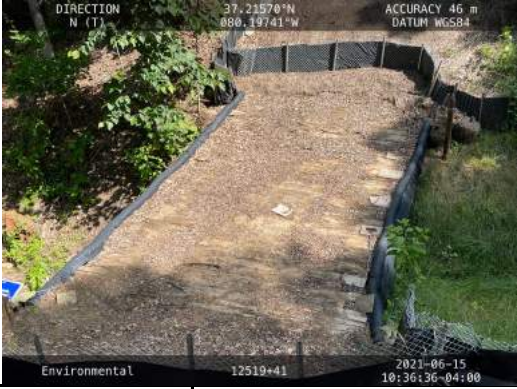
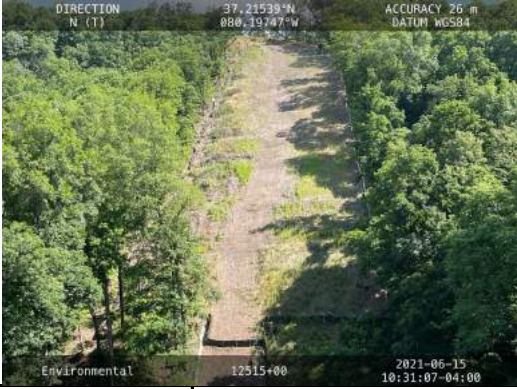
GPS Location	See photo		GPS Location	See photo	
Field Station#	12519+41		Field Station#	12515+00	
Pic 7 Desc.	Bridge and ECDs crossing stream S-EF19 in acceptable condition		Pic 8 Desc.	Stabilized slope in acceptable condition on the CIS of S-EF19

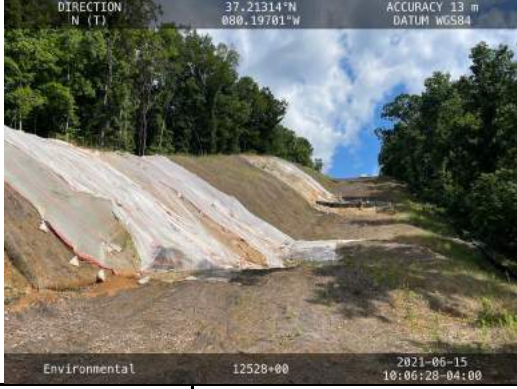
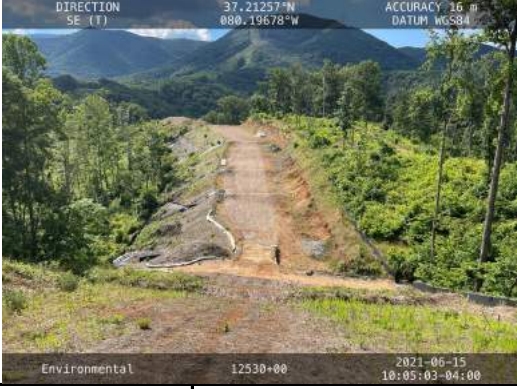
GPS Location	See photo		GPS Location	see photo	
Field Station#	12528+00		Field Station#	12530+00	
Pic 9 Desc.	Spoil pile stabilized with plastic covering in acceptable condition		Pic 10 Desc.	Stabilized ROW in acceptable condition

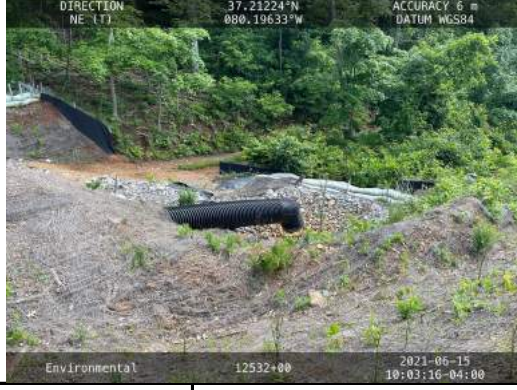
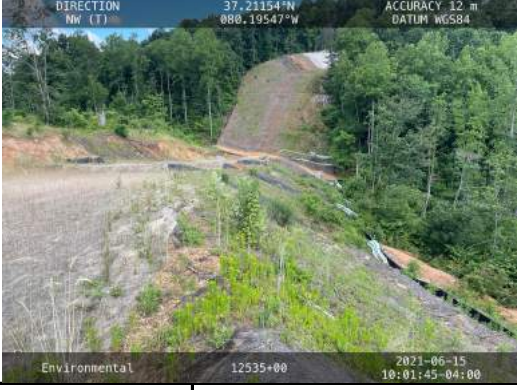
GPS Location	see photo		GPS Location	See photo	
Field Station#	12532+00		Field Station#	12535+00	
Pic 11 Desc.	Clean water crossing pipe outlet in acceptable condition		Pic 12 Desc.	Stabilized fill slope with fill slope drains in acceptable condition

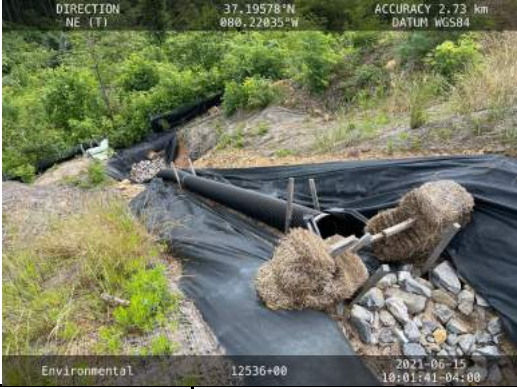
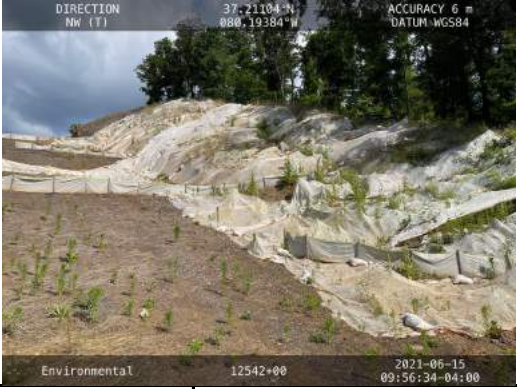
GPS Location	See photo		GPS Location	See photo	
Field Station#	12536+00		Field Station#	12542+00	
Pic 13 Desc.	Fill slope drain in acceptable condition		Pic 14 Desc.	Plastic covered spoil pile in acceptable condition

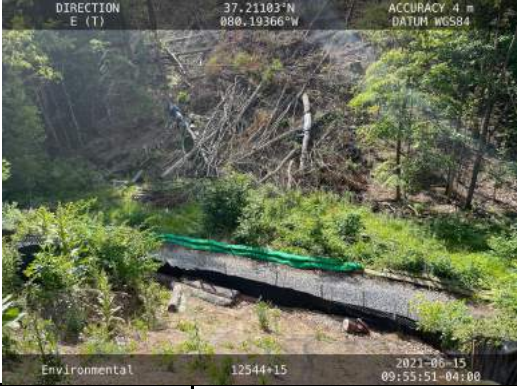
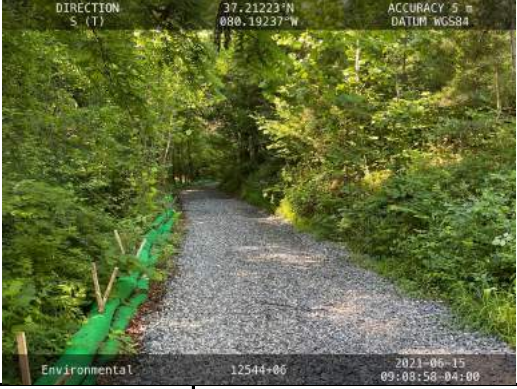
GPS Location	See photo		GPS Location	see photo	
Field Station#	12544+15		Field Station#	12544+06	
Pic 15 Desc.	Access Road MVP-MN-278.01 crossing in acceptable condition		Pic 16 Desc.	Access Road MVP-MN-278.01 in acceptable condition

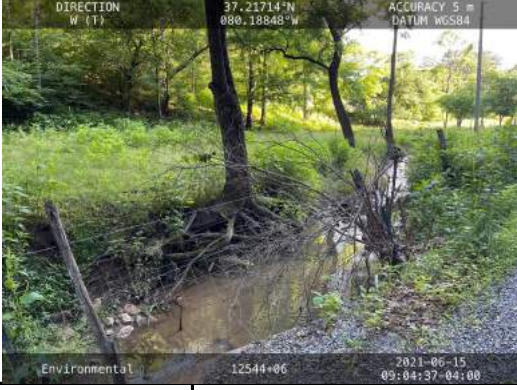
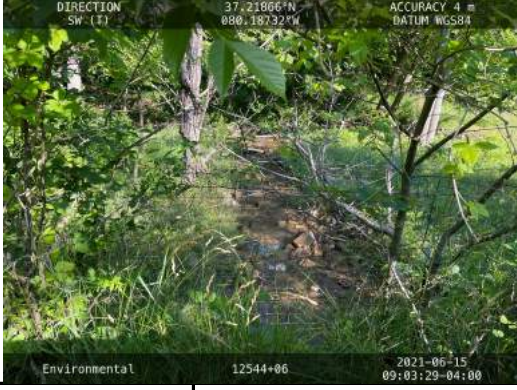
GPS Location	see photo		GPS Location	see photo	
Field Station#	12544+07		Field Station#	12544+06	
Pic 17 Desc.	Down stream of S-EF20b in acceptable condition		Pic 18 Desc.	Stream S-KL32 in acceptable condition

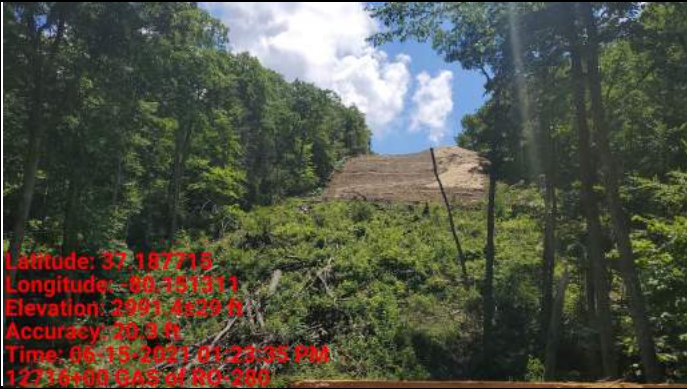
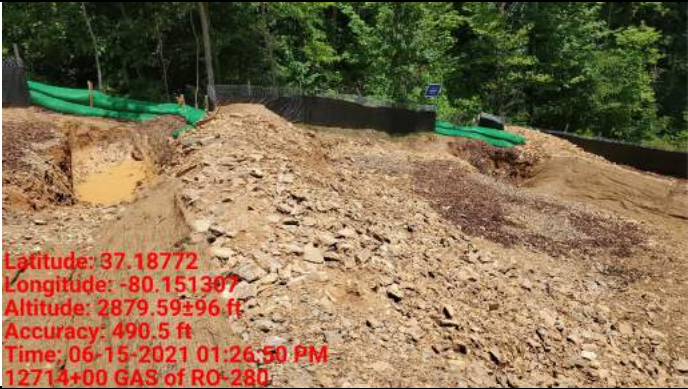
GPS Location	See pic for GPS location		GPS Location	See pic for GPS location	
Field Station#	12716+00		Field Station#	12714+00	
Pic 13 Desc.	Steep slope area on the GAS of streams S-Y13 and S-Y14.		Pic 14 Desc.	All observed waterbars, sumps and end treatments were in acceptable condition.

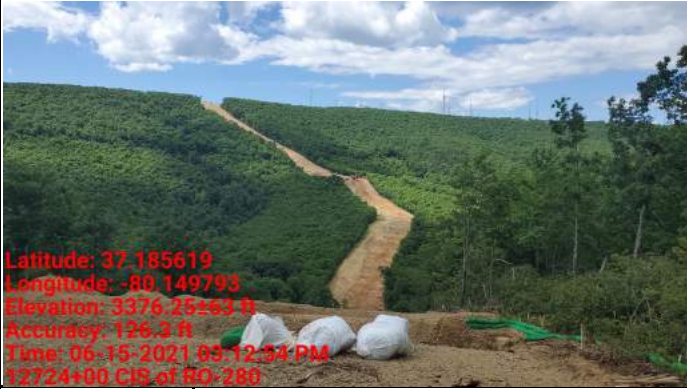
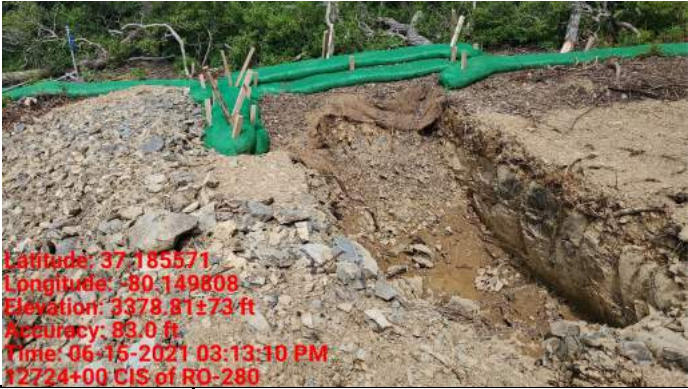
GPS Location	See pic for GPS location		GPS Location	See pic for GPS location	
Field Station#	12724+00		Field Station#	12724+00	
Pic 15 Desc.	View of the GAS of Honeysuckle and RO-280 from the CIS of RO-281.		Pic 16 Desc.	Waterbars, sumps and end treatments on the CIS of RO-280 remain in acceptable condition.

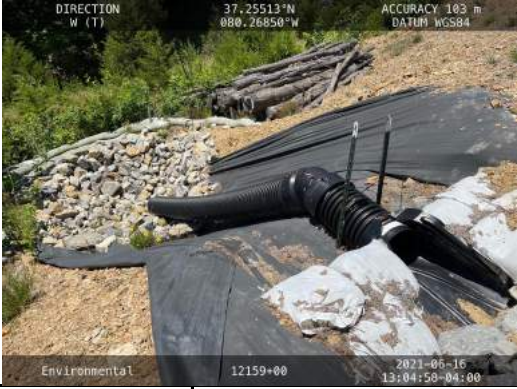
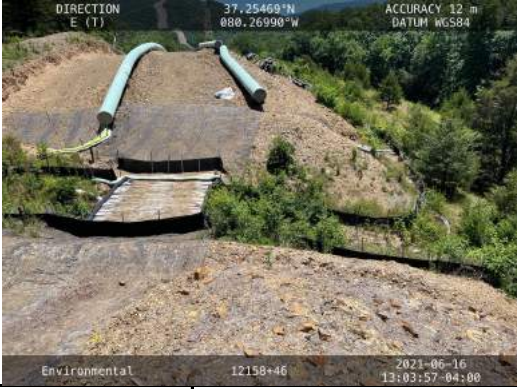
GPS Location	See photo		GPS Location	See photo	
Field Station#	12159+00		Field Station#	12158+46	
Pic 7 Desc.	Fill slope drain in acceptable condition		Pic 8 Desc.	Clean water crossing in acceptable condition

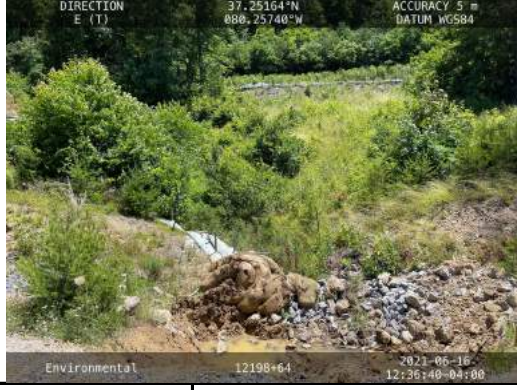
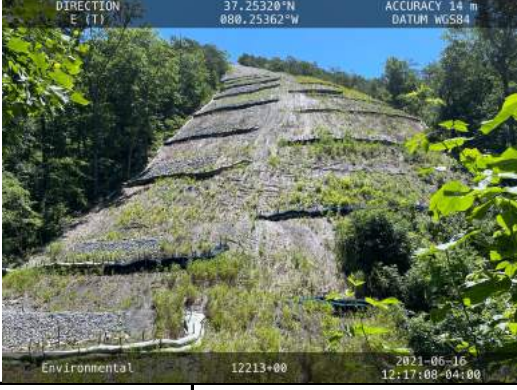
GPS Location	See photo		GPS Location	See photo	
Field Station#	12198+64		Field Station#	12213+00	
Pic 11 Desc.	S-OO11 stream crossing on the East side of the road in acceptable condition, other than the third part disturbance.		Pic 12 Desc.	Stabilized slope in acceptable condition

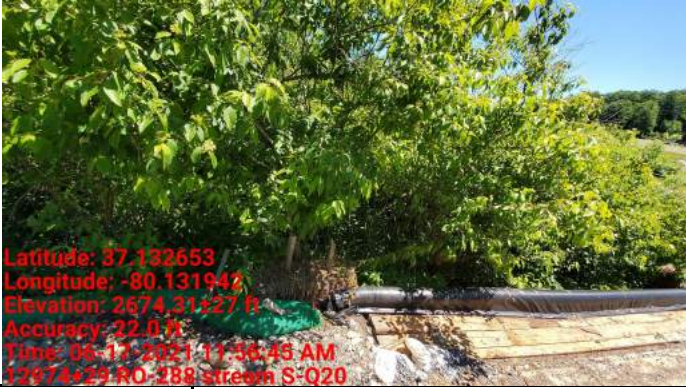
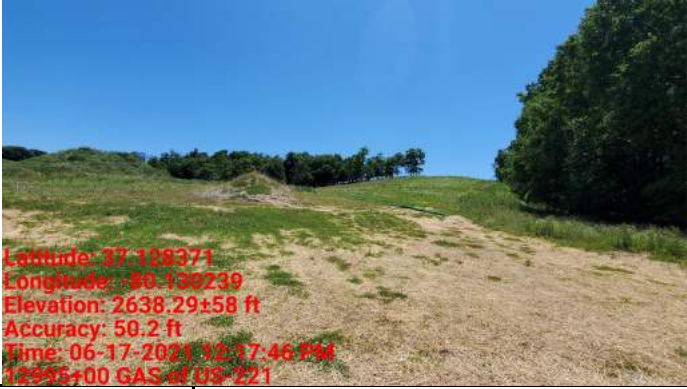
GPS Location	See pic for GPS location		GPS Location	See pic for GPS location	
Field Station#	12974+29		Field Station#	12995+00	
Pic 13 Desc.	Downstream side of stream S-Q20 on RO-287.		Pic 14 Desc.	GAS of the US-221 road crossing.

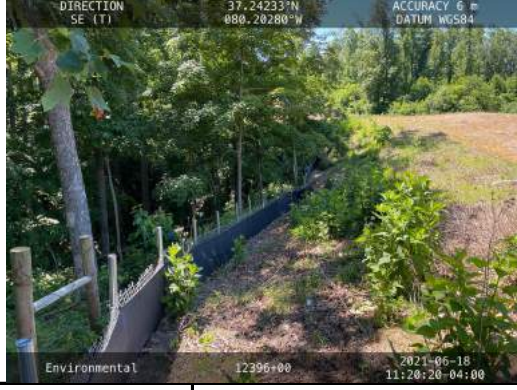
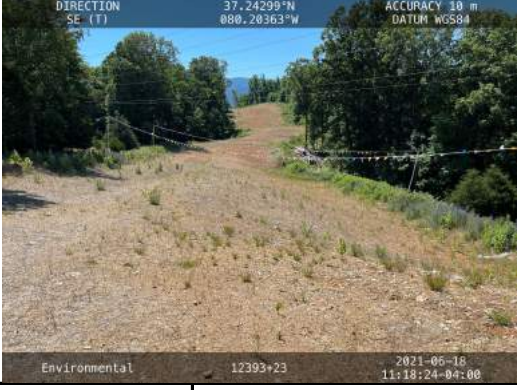
GPS Location	See photo		GPS Location	See photo	
Field Station#	12396+00		Field Station#	12393+23	
Pic 11 Desc.	SSF perimeter controls protecting off row karst features in acceptable condition		Pic 12 Desc.	Stabilized ROW in acceptable condition

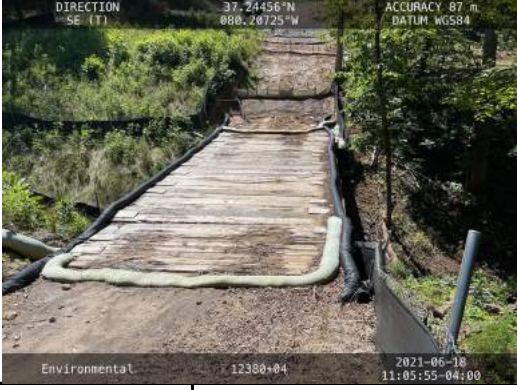
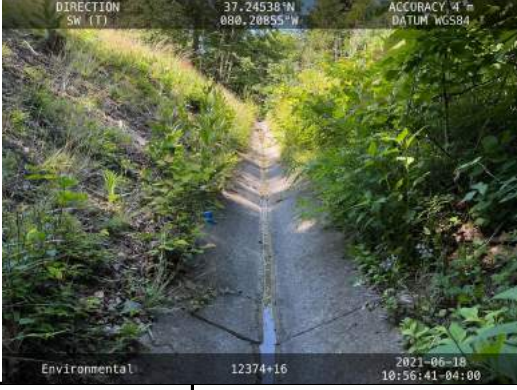
GPS Location	See photo		GPS Location	See photo	
Field Station#	12380+04		Field Station#	12374+16	
Pic 17 Desc.	Bridge and ECDs crossing stream S-NN19 in acceptable condition		Pic 18 Desc.	Stream crossing S-OO16 in acceptable condition
