Visual Site Inspection Report

Project Name	H-600 Pipeline Spread G	AFE	124300137	Spread	H-600 Pipeline Spread G
Contractor	Precision			Report #	26141
Inspector	Brian Shields			Date/Time	7/19/2021 8:38 AM
Permit #	TBD	Inspection Type	VA SWPP	Station Begin	10859+34
State	VA	Inspection Area	Full	Station End	11064+53
County	Giles	Ground	Dry	Temperature (°F)	82.00
Municipality	N/A	Weather	Sunny	Rain Gauge (in)	0.00
				Rain Accumulation Time (days)	1.00

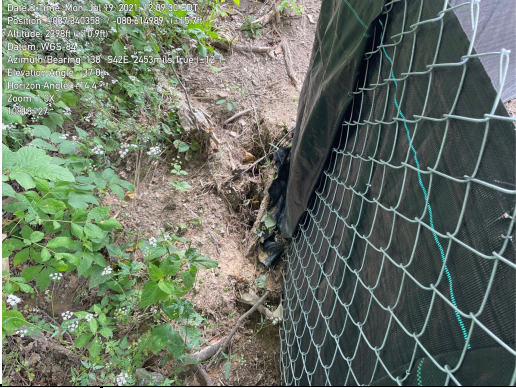
GPS Location	See photo	GPS Location	See photo		
Field Station#	10818+27	Field Station#	10774+15		
Pic 1 Desc.	Channeling behind supersilt fence	Pic 2 Desc.	Adjust CFS triple stack perimeter control

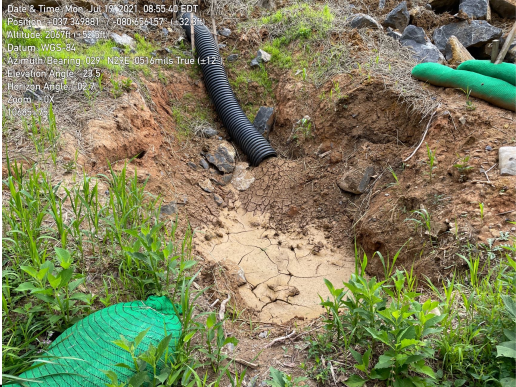
GPS Location	See photo	GPS Location	See photo		
Field Station#	10685+75	Field Station#	10695+77		
Pic 3 Desc.	Clean out end of slope drain	Pic 4 Desc.	Rain gauge measured 0.05"

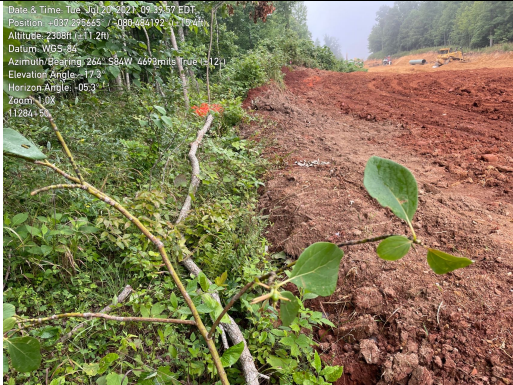
Date & Time: Tue, Jul 20, 2021, 08:53:57 EDT Position: +037.2463027, -080.4922831 (+15.6ft) Altitude: 11284 (+11.2ft) Datum: WGS-84 Azimuth/Bearing: 264° S40W 449mils True (+12.1°) Elevation Angle: -17.3° Horizon Angle: -02.3° Zoom: 1.0X 11284+50			Date & Time: Tue, Jul 20, 2021, 08:53:57 EDT Position: +037.2463027, -080.4922831 (+15.6ft) Altitude: 11433 (+11.2ft) Datum: WGS-84 Azimuth/Bearing: 264° S40W 449mils True (+12.1°) Elevation Angle: -17.3° Horizon Angle: -02.3° Zoom: 1.0X 11433+80			
GPS Location		See photo		GPS Location		See photo
Field Station#		11284+50		Field Station#		11433+80
Pic 1 Desc.		CWD berm taken out		Pic 2 Desc.		P1 undermined

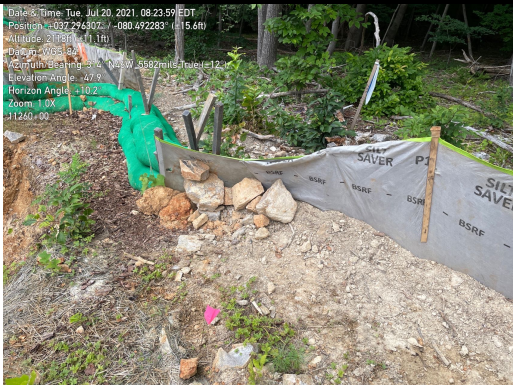
GPS Location		See photo		GPS Location		See photo
Field Station#		11260+00		Field Station#		11444+90
Pic 3 Desc.		P1 silt fence perimeter control damaged		Pic 4 Desc.		End treatment undermined

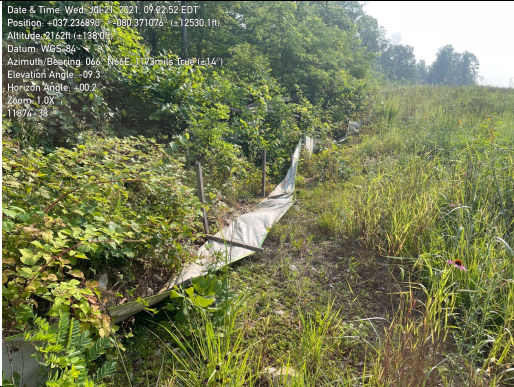
GPS Location	See photo	GPS Location	See photo		
Field Station#	11874+38	Field Station#	11878+00		
Pic 1 Desc.	Damaged P1	Pic 2 Desc.	Damaged P1		
<p>Date & Time: Wed, Jul 21, 2021, 09:24:31 EDT Position: +037.25785° / -080.342591° (+13720) Altitude: 2130ft (+26.2ft) Datum: WGS-84 Azimuth/Bearing: 002° N02E 503/mils True (+12°) Elevation Angle: -08.6 Horizon Angle: +02.2 Zoom: 1.0x 11876+25</p>

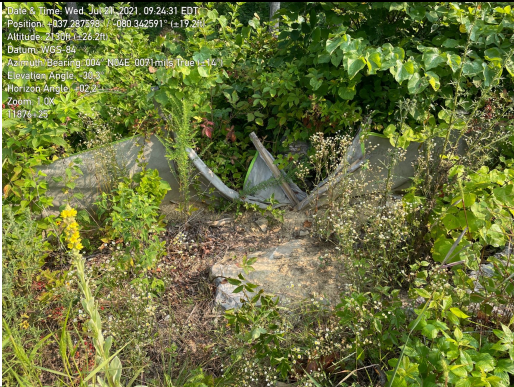
GPS Location	See photo	GPS Location	See photo		
Field Station#	11876+25	Field Station#	11788+84		
Pic 3 Desc.	Damaged P1	Pic 4 Desc.	RCE in place		
<p>Date & Time: Wed, Jul 21, 2021, 08:24:30 EDT Position: +037.259914° / -080.359061° (+19.4ft) Altitude: 2129ft (+59.0ft) Datum: WGS-84 Azimuth/Bearing: 042° N42E 072/mils True (+14°) Elevation Angle: +11.3 Horizon Angle: +00.4 Zoom: 1.0x 11794+50</p>

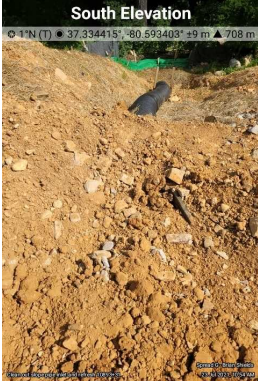
<p>South Elevation © 11°N (T) • 37.334415° -80.593403° ±9 m ▲ 708 m</p>							
GPS Location		1							
Field Station#		10893+31							
Pic 7 Desc.		sump maintenance needed							
<div style="text-align: center; height: 150px;">Insert image here</div>		<div style="text-align: center; height: 150px;">Insert image here</div>							
						GPS Location		1	
						Field Station#		10893+31	
						Pic 8 Desc.		Slope drain clogged and Rock inlets needs replaced	
GPS Location									
Field Station#									
Pic 9 Desc.									
<div style="text-align: center; height: 150px;">Insert image here</div>		<div style="text-align: center; height: 150px;">Insert image here</div>							
						GPS Location			
						Field Station#			
						Pic 10 Desc.			
GPS Location
