Visual Site Inspection Report

Project Name	H-600 Pipeline Spread H	AFE	124300138	Spread	H-600 Pipeline Spread H
Contractor	Precision			Report #	25087
Inspector	Logan Box			Date/Time	6/28/2021 3:55 PM
Permit #	TBD	Inspection Type	VA SWPP	Station Begin	13525+99
State	VA	Inspection Area	Partial	Station End	13670+00
County	Franklin	Ground	Dry	Temperature (°F)	90.00
Municipality	N/A	Weather	Sunny	Rain Gauge (in)	0.00
				Rain Accumulation Time (days)	0.00

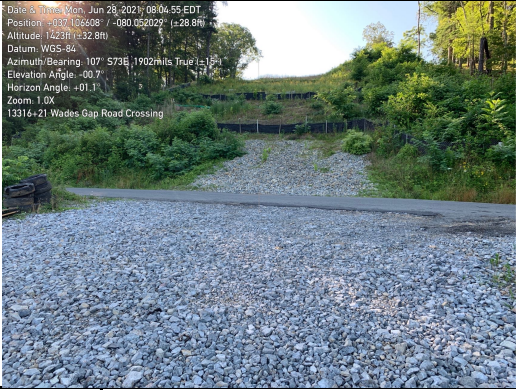
GPS Location	0	GPS Location	0		
Field Station#	13316+21	Field Station#	13314+00		
Pic 1 Desc.	Wades Gap Road Crossing in good condition, RCE in good condition and functioning properly		Pic 2 Desc.	ROW and ECDs in good condition, with good vegetation establishing across LOD.	
<p>Date & Time: Mon, Jun 28, 2021 08:09:20 EDT Position: +037 106221 / -080 054033 (±32.0m) Altitude: 1378ft (±36.1m) Datum: WGS-84 Azimuth/Bearing: 284° N74W 5049mils True (±10°) Elevation Angle: -00.7° Horizon Angle: +00.3° Zoom: 1.0X 13309+09 S-GH7</p>

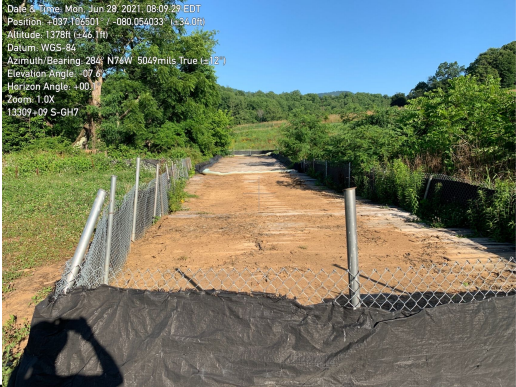
GPS Location	0	GPS Location	0		
Field Station#	13309+09	Field Station#	13308+00		
Pic 3 Desc.	MVP-S-GH7 in good condition		Pic 4 Desc.	ROW and ECDs in good condition, with good vegetation establishing across LOD.	
<p>Date & Time: Mon, Jun 28, 2021 08:30:14 EDT Position: +037 115714 / -080 056795 (±15.8m) Altitude: 1621ft (±40.6m) Datum: WGS-84 Azimuth/Bearing: 244° N16W 5110mils True (±12°) Elevation Angle: -04.7° Horizon Angle: +01.0° Zoom: 1.0X 13262+62 Flanders Road Crossing</p>

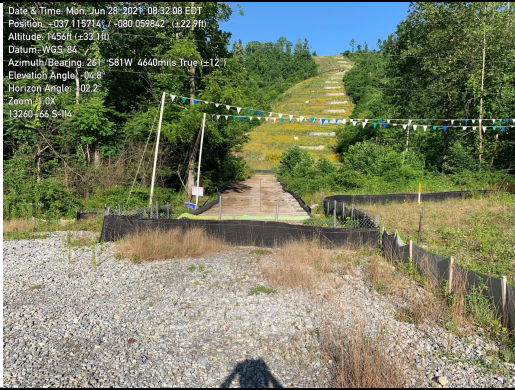
GPS Location	0	GPS Location	0		
Field Station#	13262+62	Field Station#	13360+66		
Pic 5 Desc.	Flanders Road Crossing in good condition, RCE in good condition and functioning properly		Pic 6 Desc.	MVP-S-II4 in good condition

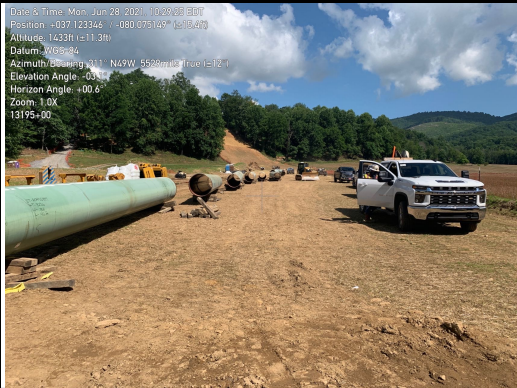
GPS Location			0			
Field Station#			13195+00			
Pic 9 Desc.			Pipe stung out and welders are preparing to begin welding			
GPS Location			0			
Field Station#			13189+00			
Pic 10 Desc.			ROW and ECDs in good condition			
<div><div><div>Date & Time: Mon, Jun 28, 2021, 11:11:46 EDT Position: +037.132267 / -080.075394 (+51.4ft) Altitude: 1522ft (+47.4ft) Datum: WGS-84 Azimuth/Bearing: 110° S15E 2804mils True (+12.1°) Elevation Angle: -07.0° Horizon Angle: +01.5° Zoom: 1.0X 13181+00</div><div>

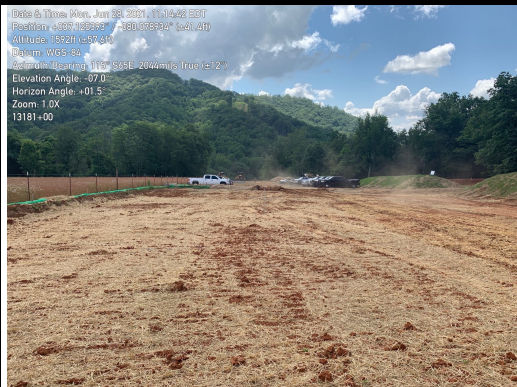
</div></div></div>			
GPS Location			0			
Field Station#			13181+00			
Pic 11 Desc.			ROW and ECDs in good condition

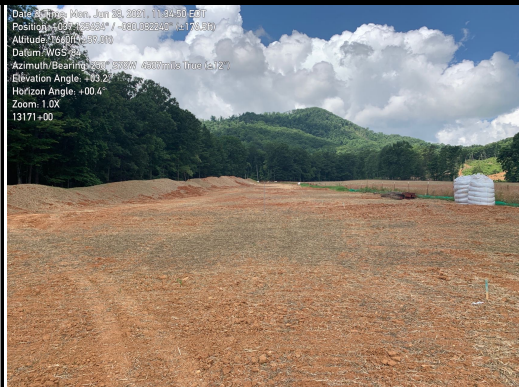
GPS Location			0			
Field Station#			13171+00			
Pic 12 Desc.			ROW and ECDs in good condition

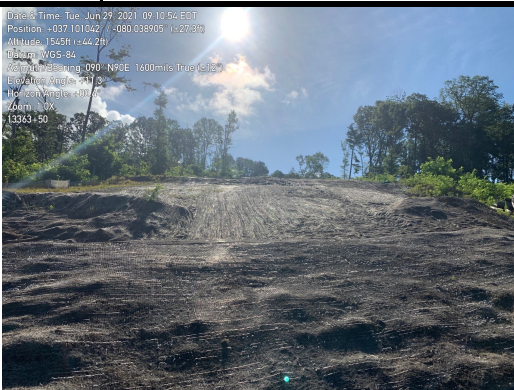
GPS Location	0	GPS Location	0		
Field Station#	13363+50	Field Station#	13358+64		
Pic 5 Desc.	ROW and ECDs in good condition and stable		Pic 6 Desc.	MVP-S-RR11 in good condition

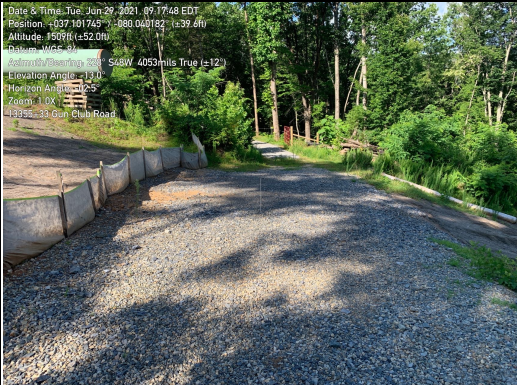
GPS Location			0		GPS Location		0	
Field Station#			13355+33		Field Station#		13355+33	
Pic 7 Desc.			Private road (Gun Club road) in good condition		Pic 8 Desc.		ROW and ECDs in good condition and stable

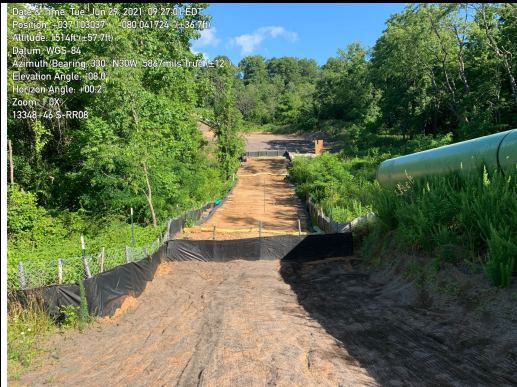
GPS Location			0		GPS Location		0	
Field Station#			13348+46		Field Station#		13342+67	
Pic 11 Desc.			MVP-S-RR08 in good condition		Pic 12 Desc.		Webster's Corner Road Crossing in good condition and RCE in good condition and functioning properly

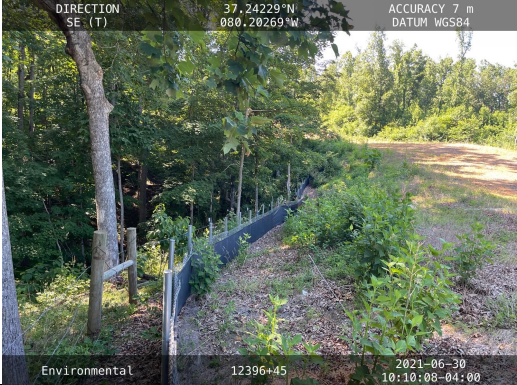
GPS Location	See photo		GPS Location	see photo	
Field Station#	12396+45		Field Station#	12393+23	
Pic 7 Desc.	SSF perimeter controls protecting off row karst features		Pic 8 Desc.	Stabilized ROW In Acceptable condition

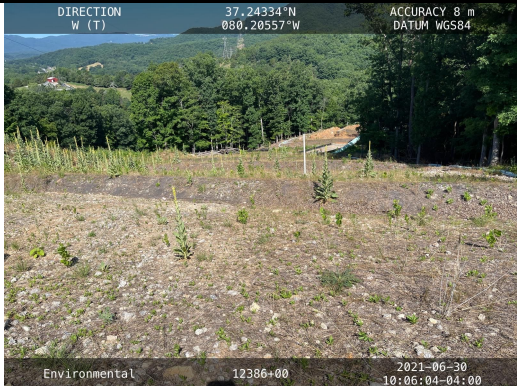
GPS Location	See photo		GPS Location	See photo	
Field Station#	12386+00		Field Station#	12383+93	
Pic 9 Desc.	Stabilized ROW in acceptable condition		Pic 10 Desc.	Clean water crossing in acceptable condition

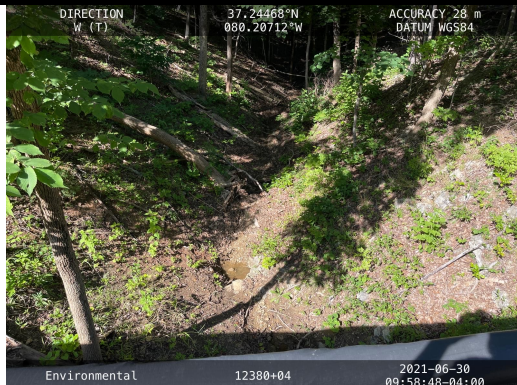
GPS Location	See photo		GPS Location	See photo	
Field Station#	12380+04		Field Station#	12380+04	
Pic 11 Desc.	Down stream of S-NN19 in acceptable condition		Pic 12 Desc.	Bridge and ECDs crossing stream S-NN19 in acceptable condition

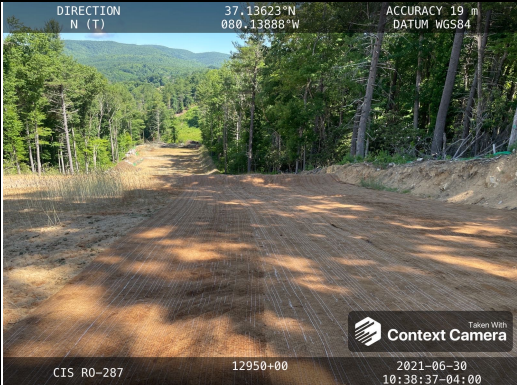
GPS Location	See photo		GPS Location	See photo	
Field Station#	12950+00		Field Station#	12957+38	
Pic 13 Desc.	Rills have been raked out, and area was seeded and Curlex placed.		Pic 14 Desc.	P1 Silt Fence has been replaced

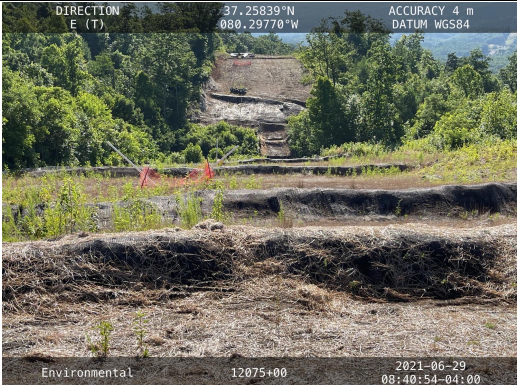
GPS Location	See photo		GPS Location	See photo	
Field Station#	12075+00		Field Station#	12070+00	
Pic 17 Desc.	Stabilized ROW in acceptable condition		Pic 18 Desc.	Stabilized slope in acceptable condition

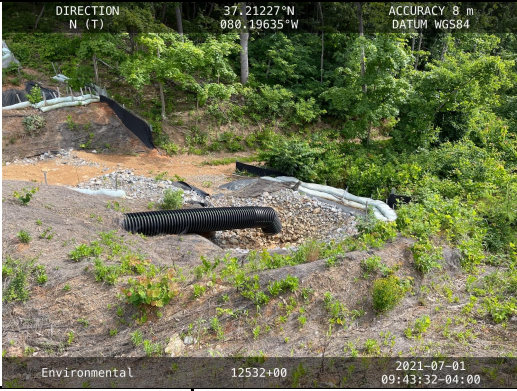
GPS Location	See photo		GPS Location	See photo	
Field Station#	12532+00		Field Station#	12534+00	
Pic 13 Desc.	Clean water crossing pipe outlet in acceptable condition		Pic 14 Desc.	Stabilized ROW in acceptable condition

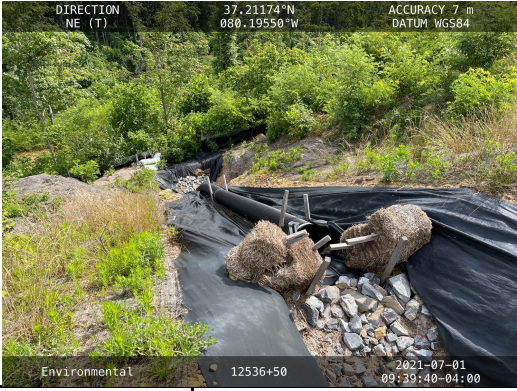
GPS Location	See photo		GPS Location	See photo	
Field Station#	12536+50		Field Station#	12542+00	
Pic 15 Desc.	Fill slope drain in acceptable condition		Pic 16 Desc.	Stabilized spoil pile in acceptable condition

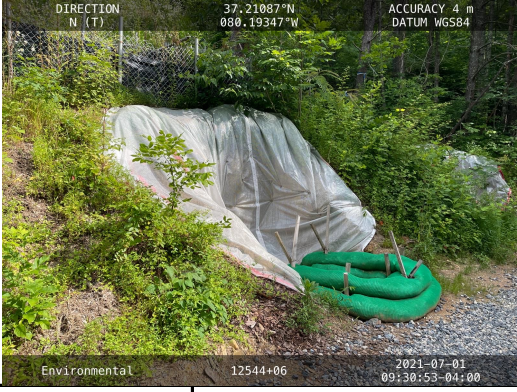
GPS Location	See photo		GPS Location	See photo	
Field Station#	12544+10		Field Station#	12544+06	
Pic 17 Desc.	ROW conditions		Pic 18 Desc.	Stabilized cut caused by the opposition extraction

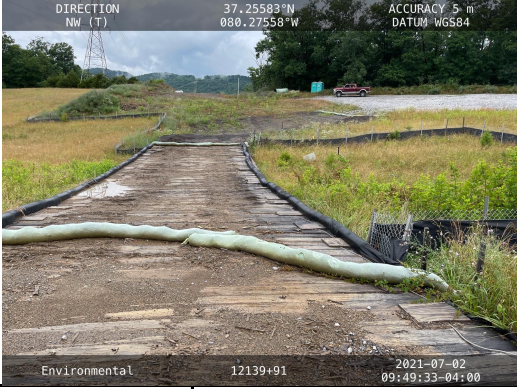
GPS Location	See photo		GPS Location	See photo	
Field Station#	12139+91		Field Station#	12144+47	
Pic 13 Desc.	Wetland crossing W-C6 in acceptable condition		Pic 14 Desc.	Bridge and ECDs at wetland crossing W-C5 in acceptable condition
