Visual Site Inspection Report

Project Name	H-600 Pipeline Spread H	AFE	124300138	Spread	H-600 Pipeline Spread H
Contractor	Precision			Report #	25411
Inspector	Bryan Cole			Date/Time	7/5/2021 6:26 PM
Permit #	TBD	Inspection Type	VA SWPP	Station Begin	13316+21
State	VA	Inspection Area	Partial	Station End	13422+00
County	Franklin	Ground	Dry	Temperature (°F)	93.00
Municipality	N/A	Weather	Sunny	Rain Gauge (in)	0.00
				Rain Accumulation Time (days)	0.00

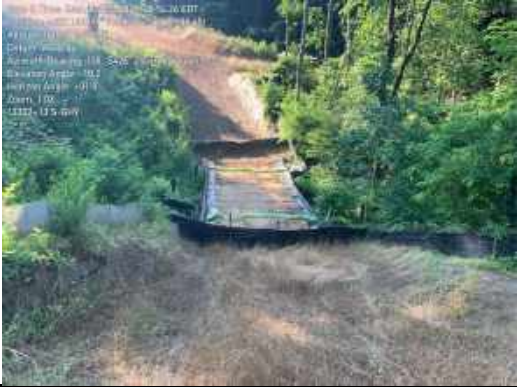
GPS Location	0	GPS Location	0		
Field Station#	13337+13	Field Station#	13339+50		
Pic 7 Desc.	MVP-S-GH9 in good condition	Pic 8 Desc.	ROW and ECDs in good condition, with good vegetation establishing across LOD

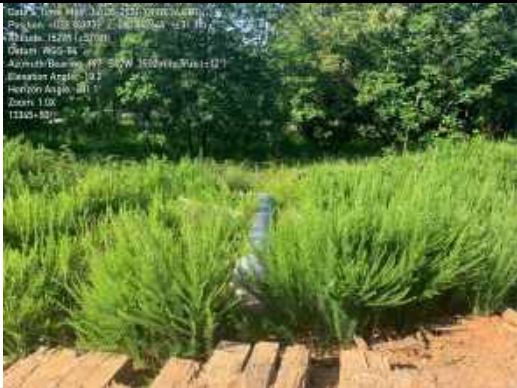
GPS Location	0	GPS Location	0		
Field Station#	13342+67	Field Station#	13345+50		
Pic 9 Desc.	Webster's Corner Road Crossing in good condition and RCE in good condition and functioning properly	Pic 10 Desc.	Clean water diversion pipe in good condition

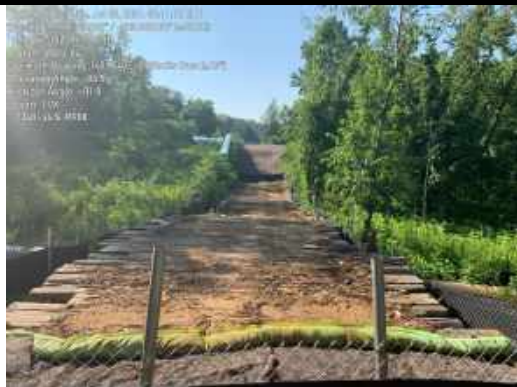
GPS Location	0	GPS Location	0		
Field Station#	13348+46	Field Station#	13352+23		
Pic 11 Desc.	MVP-S-RR08 in good condition	Pic 12 Desc.	MVP-S-RR09 in good condition

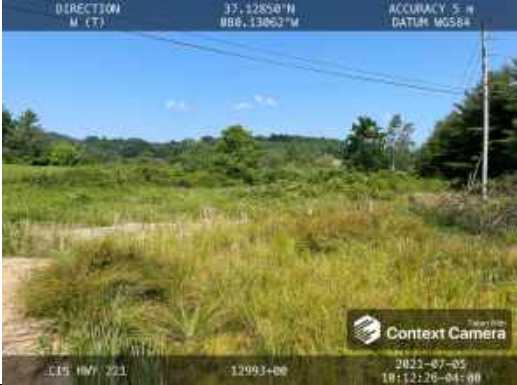
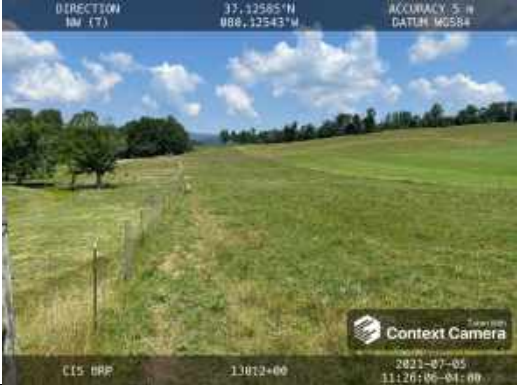
GPS Location	See photo		GPS Location	See photo	
Field Station#	12993+00		Field Station#	13012+00	
Pic 7 Desc.	Current ROW conditions on CIS of 221		Pic 8 Desc.	Current ROW on CIS of BRP

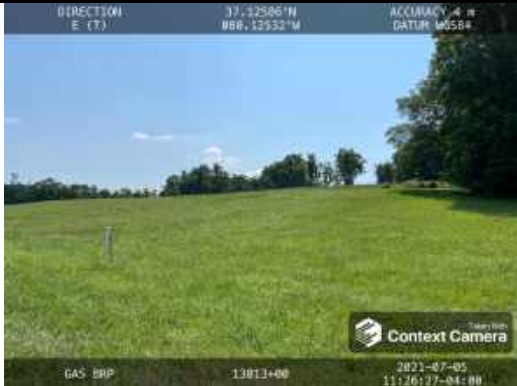
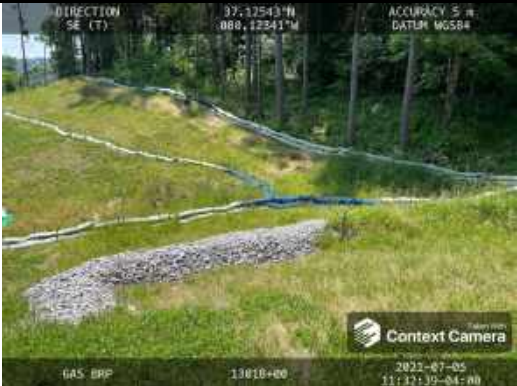
GPS Location	See photo		GPS Location	See photo	
Field Station#	13013+00		Field Station#	13018+00	
Pic 9 Desc.	Current ROW conditions on GAS of BRP		Pic 10 Desc.	Level spreader in compliance

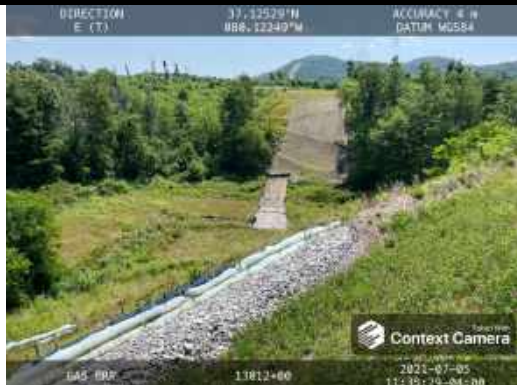
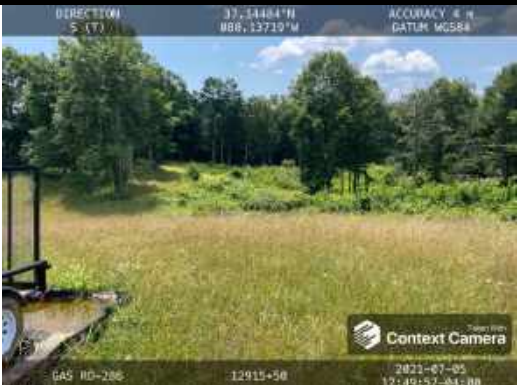
GPS Location	See photo		GPS Location	See photo	
Field Station#	13022+00		Field Station#	12915+50	
Pic 11 Desc.	Current ROW conditions on GAS BRP		Pic 12 Desc.	Current ROW conditions on GAS RO-286

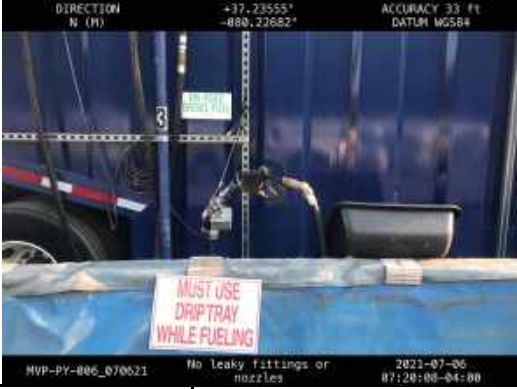
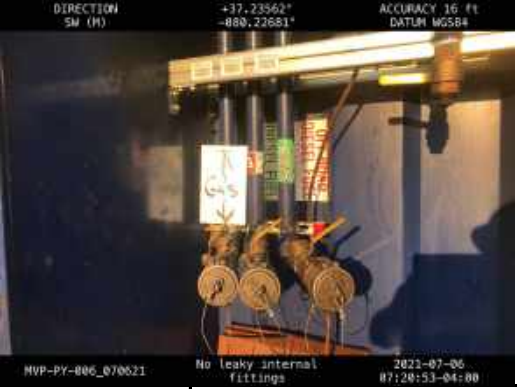
GPS Location	MVP-PY-006 See photo for gps data		GPS Location	MVP-PY-006 See photo for gps data	
Field Station#	+0		Field Station#	+0	
Pic 7 Desc.	Blue Bulk Fuel tanks no leaky fittings or nozzles. Looking N.		Pic 8 Desc.	Blue Bulk Fuel tanks no leaky internal fittings. Looking SW.

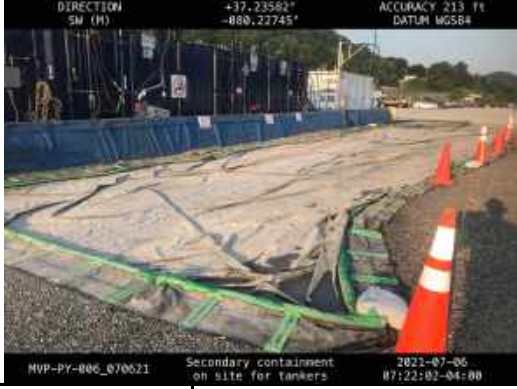
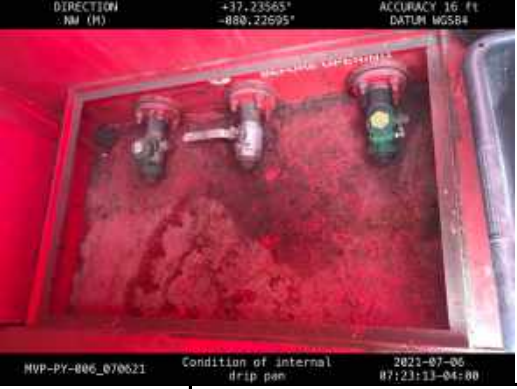
GPS Location	MVP-PY-006 See photo for gps data		GPS Location	MVP-PY-006 See photo for gps data	
Field Station#	+0		Field Station#	+0	
Pic 9 Desc.	Both secondary containments in place for tankers offloading fuel. Looking SW.		Pic 10 Desc.	Off Road Fuel unit condition of internal drip pan. Free of fluids. Looking NW.

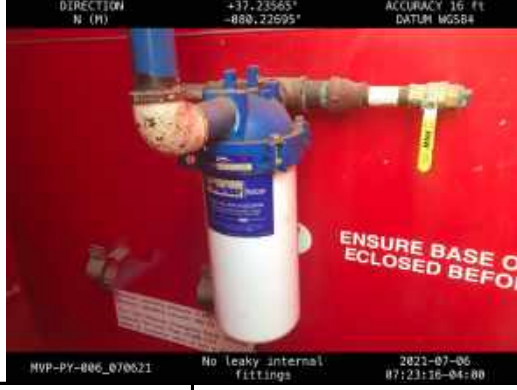
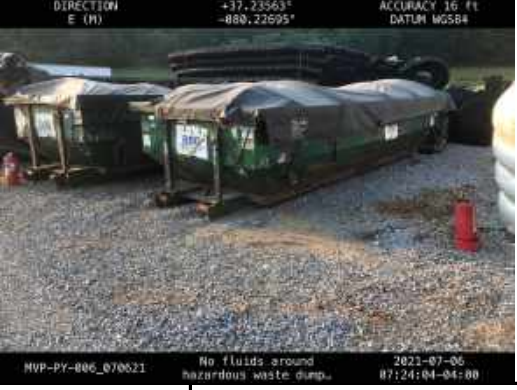
GPS Location	MVP-PY-006 See photo for gps data		GPS Location	MVP-PY-006 See photo for gps data	
Field Station#	+0		Field Station#	+0	
Pic 11 Desc.	Off Road Fuel unit no leaky internal fittings. Looking NW.		Pic 12 Desc.	No fluids or deposits around hazardous waste dumpsters. Looking E.

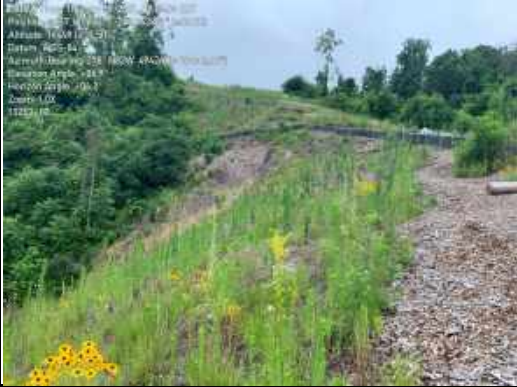
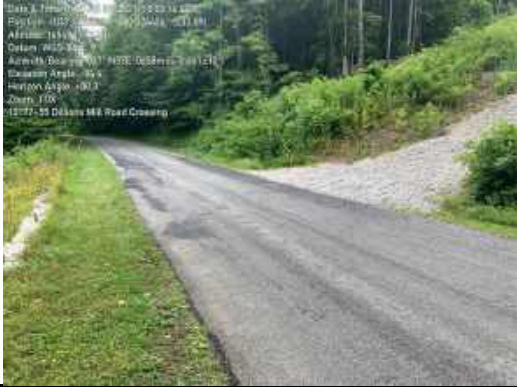
GPS Location	0		GPS Location	0	
Field Station#	13353+00		Field Station#	13197+55	
Pic 7 Desc.	Slip observed to be stable, no notable changes, vegetation establishing.		Pic 8 Desc.	Dillion's Mill Road Crossing in good condition

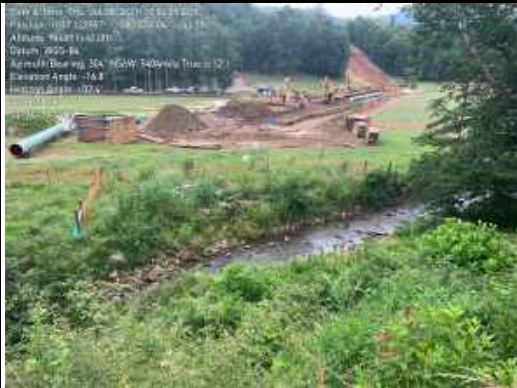
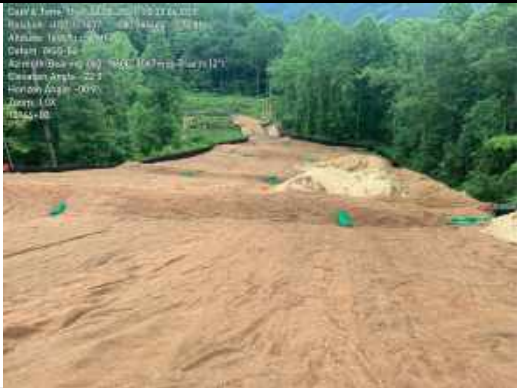
GPS Location	0		GPS Location	0	
Field Station#	13196+79		Field Station#	13144+00	
Pic 9 Desc.	MVP-S-D8 in good condition		Pic 10 Desc.	ROW and ECDs in good condition and ROW stabilized with Curlex

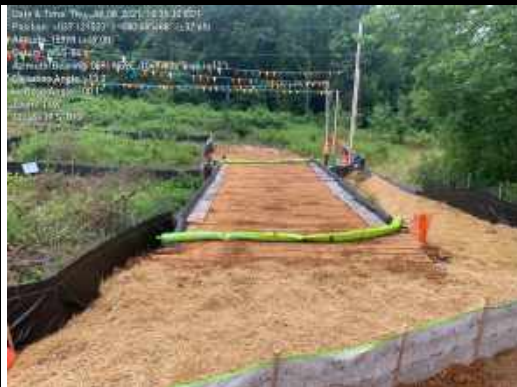
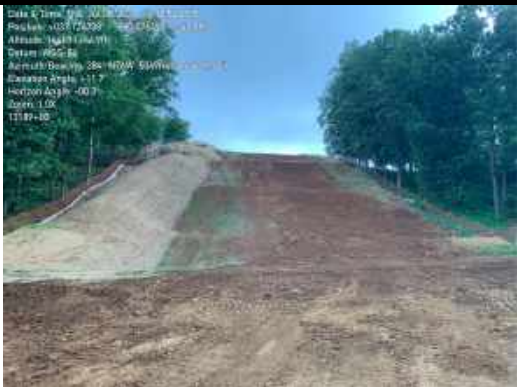
GPS Location	0		GPS Location	0	
Field Station#	13146+39		Field Station#	13189+00	
Pic 11 Desc.	Bridge installed over MVP-S-D13 since last inspection, in good condition		Pic 12 Desc.	ROW and ECDs in good condition and stable
