Visual Site Inspection Report

Project Name	H-600 Pipeline Spread I	AFE	124300139	Spread	H-600 Pipeline Spread I
Contractor	Precision			Report #	25093
Inspector	Charles Head			Date/Time	6/28/2021 3:38 PM
Permit #	TBD	Inspection Type	VA SWPP	Station Begin	14454+22
State	VA	Inspection Area	Full	Station End	14546+75
County	Franklin	Ground	Dry	Temperature (°F)	92.00
Municipality	N/A	Weather	Sunny	Rain Gauge (in)	0.00
				Rain Accumulation Time (days)	1.00

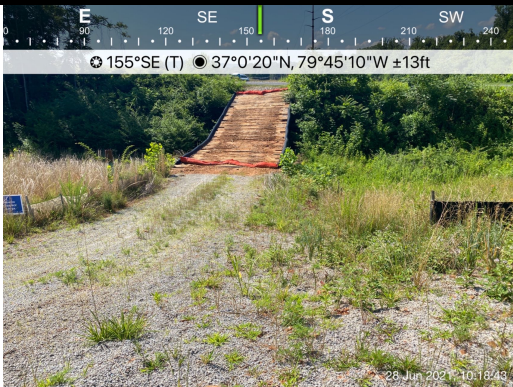
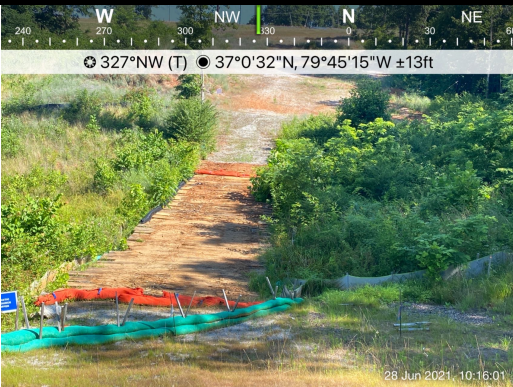
GPS Location	0	GPS Location	0		
Field Station#	14546+33	Field Station#	14531+58		
Pic 1 Desc.	Approximately 14546+33. Overview of stream crossing, equipment bridge and ECDs at stream S-G17.		Pic 2 Desc.	Approximately 14531+58. Overview of stream crossing, equipment bridge and ECDs at stream S-G18.

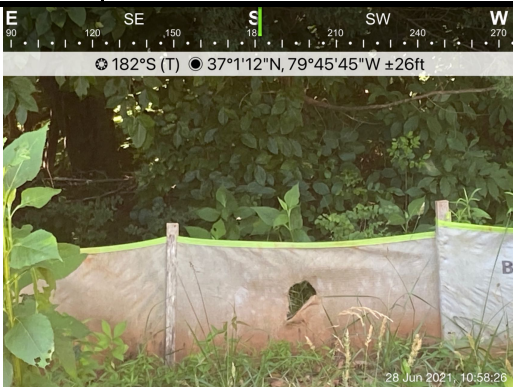
GPS Location	0	GPS Location	0		
Field Station#	14484+50	Field Station#	14457+00		
Pic 5 Desc.	Approximately 14484+50. P-1 requires maintenance. Damaged by livestock.		Pic 6 Desc.	Approximately 14457+00. Overview of ROW.

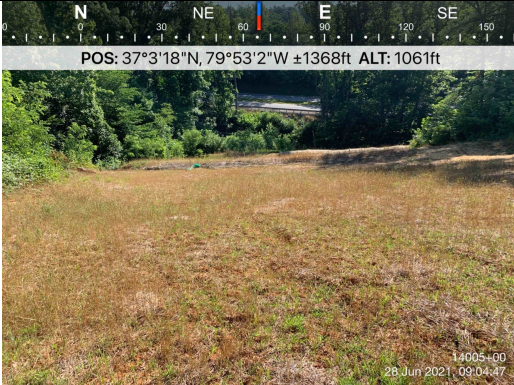
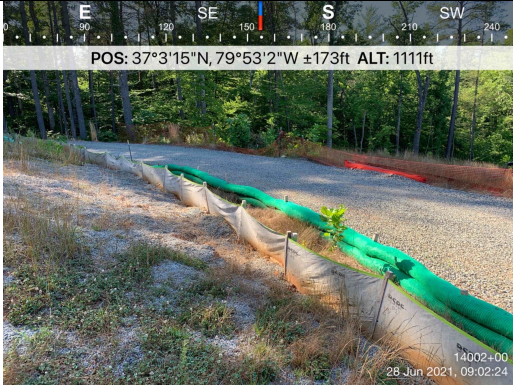
GPS Location	0	GPS Location	0		
Field Station#	14005+00	Field Station#	14002+00		
Pic 1 Desc.	Temporary vegetative stabilization in acceptable condition	Pic 2 Desc.	P1 silt fence and CFS in acceptable condition

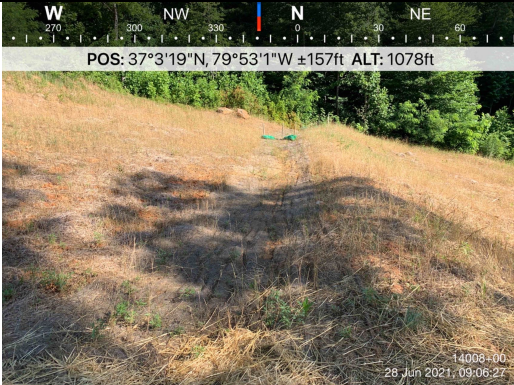
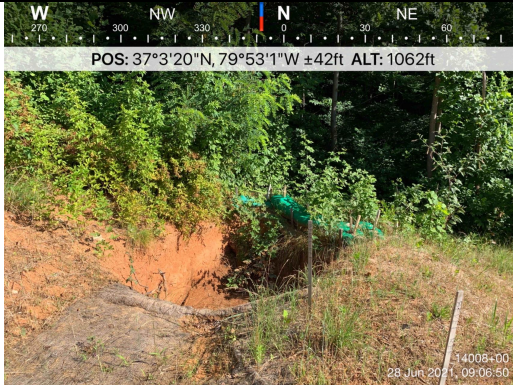
GPS Location	0	GPS Location	0		
Field Station#	14008+00	Field Station#	14008+00		
Pic 3 Desc.	Waterbar in acceptable condition	Pic 4 Desc.	Waterbar end treatment in acceptable condition

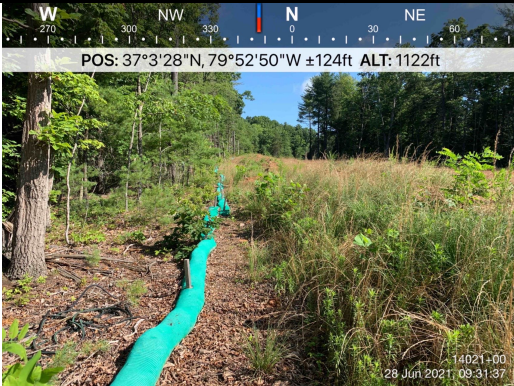
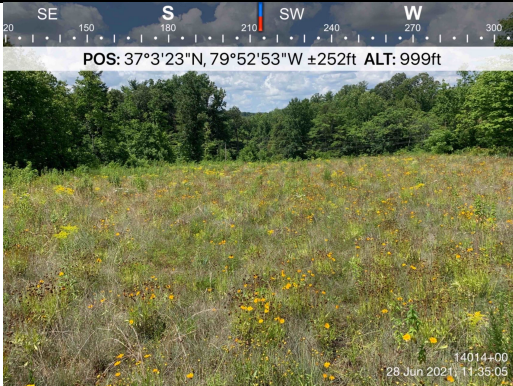
GPS Location	0	GPS Location	0		
Field Station#	14021+00	Field Station#	14014+00		
Pic 5 Desc.	Perimeter CFS in acceptable condition	Pic 6 Desc.	Permanent vegetative stabilization in acceptable condition

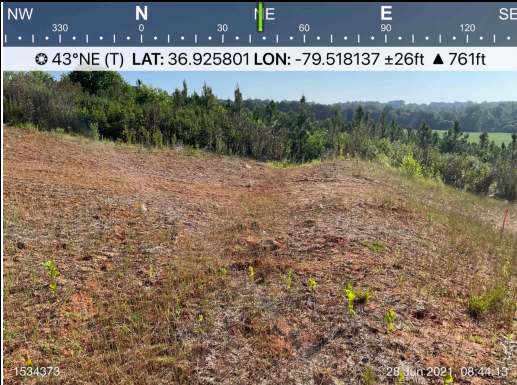
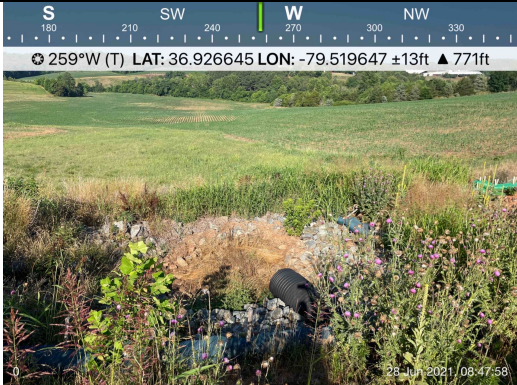
GPS Location	See photo		GPS Location	See photo	
Field Station#	15343+73		Field Station#	15338+00	
Pic 7 Desc.	Waterbars are in good condition.		Pic 8 Desc.	CWDs are functioning as intended.

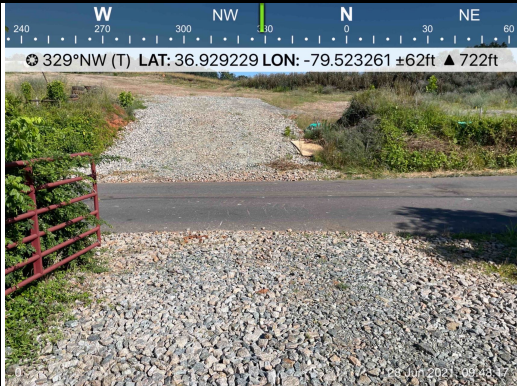
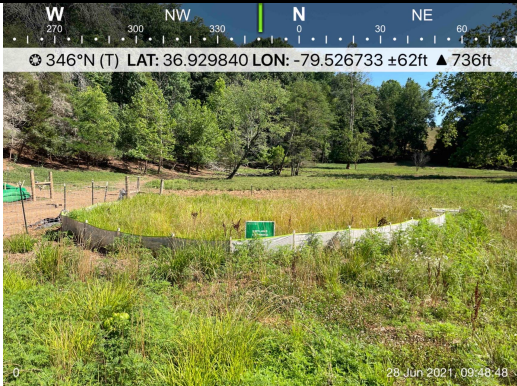
GPS Location	See photo		GPS Location	See photo	
Field Station#	15323+24		Field Station#	15311+78	
Pic 9 Desc.	RCEs are in good condition at all road crossings.		Pic 10 Desc.	Wetland buffer P1 is in good condition.

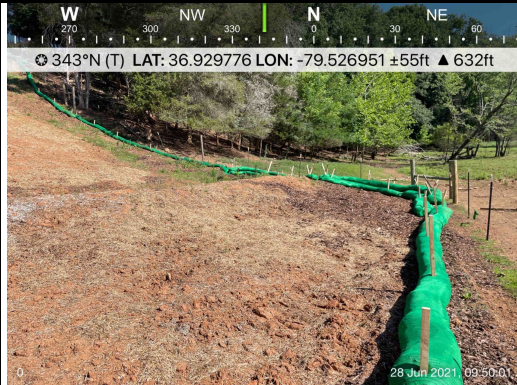
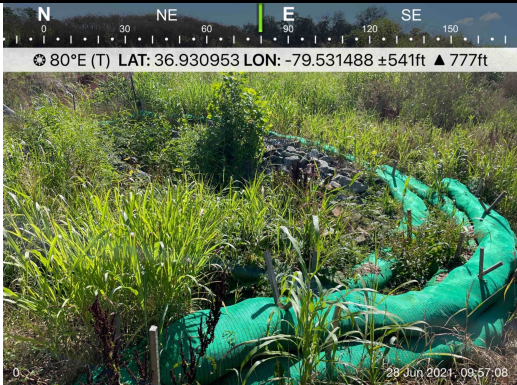
GPS Location	See photo		GPS Location	See photo	
Field Station#	15310+00		Field Station#	15299+00	
Pic 11 Desc.	CFS in good condition on this slope.		Pic 12 Desc.	CWD is functioning as intended.

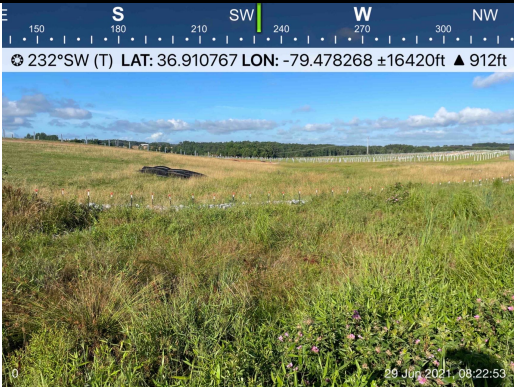
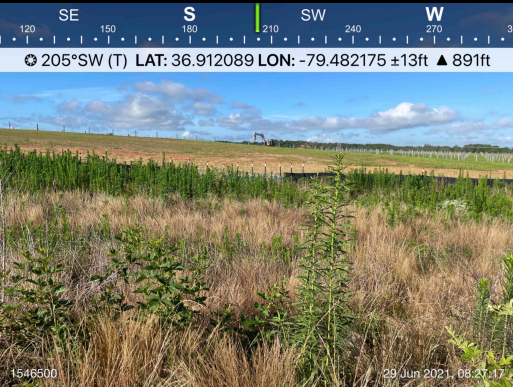
GPS Location	See photo		GPS Location	See photo	
Field Station#	15475+00		Field Station#	15465+00	
Pic 1 Desc.	3rd party rock outlet appears to be in good condition.		Pic 2 Desc.	No evidence of sedimentation from 3rd party rock outlet.

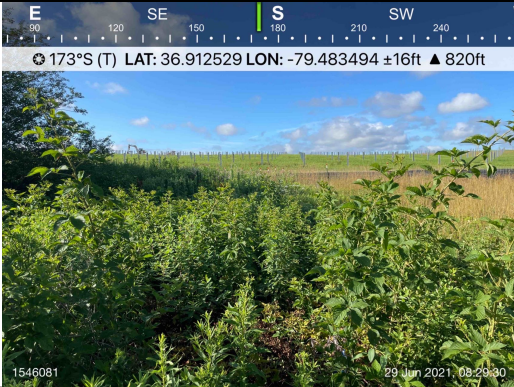
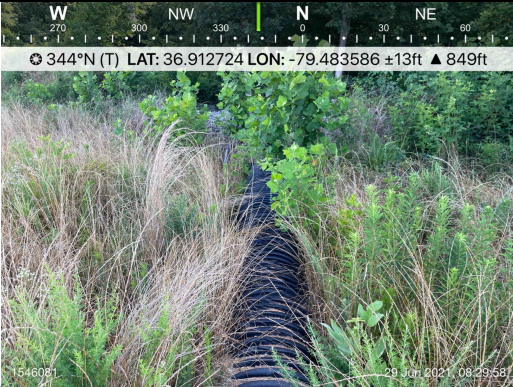
GPS Location	See photo		GPS Location	See photo	
Field Station#	15460+81		Field Station#	15460+81	
Pic 3 Desc.	No evidence of sedimentation from 3rd party rock outlet.		Pic 4 Desc.	CWD is in good condition.

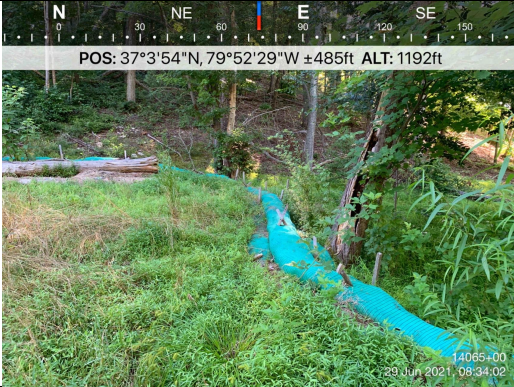
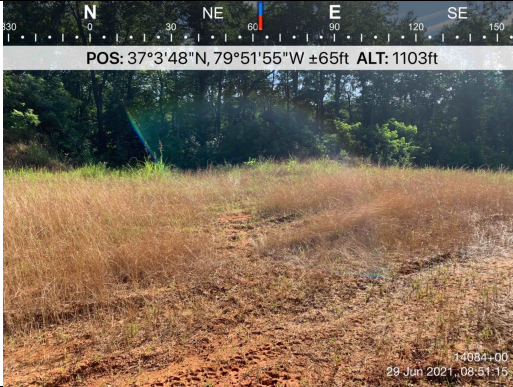
GPS Location	0	GPS Location	0		
Field Station#	14065+00	Field Station#	14084+00		
Pic 1 Desc.	perimeter CFS in acceptable condition		Pic 2 Desc.	Waterbar in acceptable condition

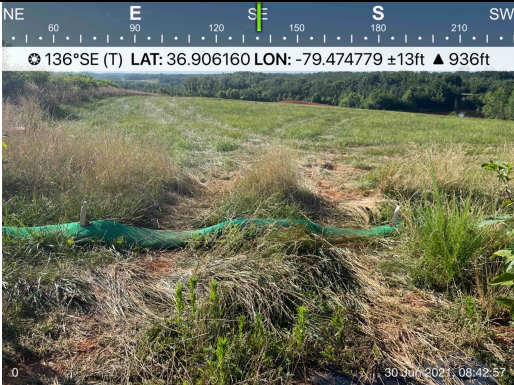
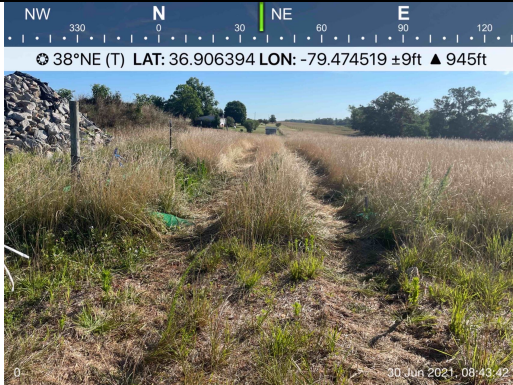
GPS Location	See photo		GPS Location	See photo	
Field Station#	15498+19		Field Station#	15498+19	
Pic 3 Desc.	CFS has been damaged by 3rd party. 3rd party to be made aware of this issue.		Pic 4 Desc.	CFS has been damaged by 3rd party. 3rd party to be made aware of this issue.

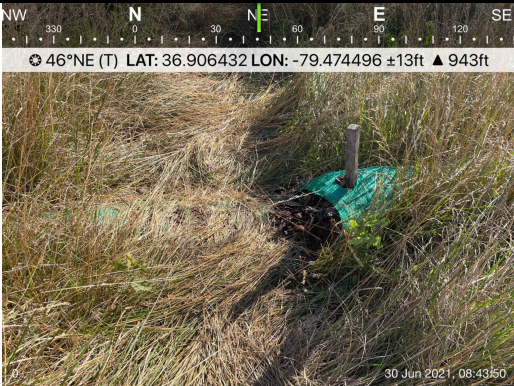
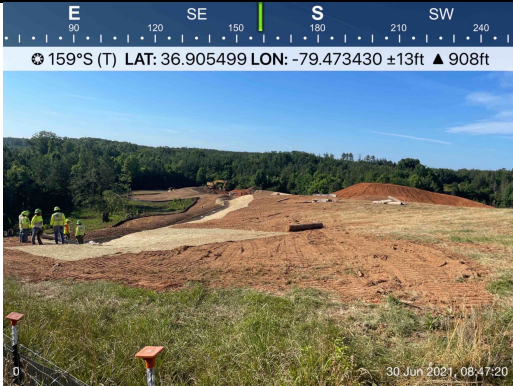
GPS Location	See photo		GPS Location	See photo	
Field Station#	15498+19		Field Station#	15505+00	
Pic 5 Desc.	CFS has been damaged by 3rd party. 3rd party to be made aware of this issue.		Pic 6 Desc.	3rd party disturbance occurring next to MVP ROW. EI will continue to monitor this area.

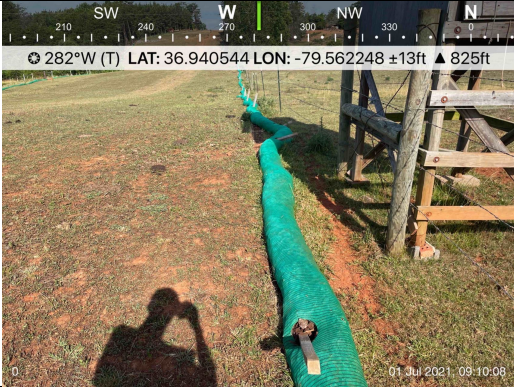
GPS Location	See photo		GPS Location	See photo	
Field Station#	15197+00		Field Station#	15260+00	
Pic 1 Desc.	CFS needs to be restaked at this location.		Pic 2 Desc.	Vegetation continues to fill in throughout this section.

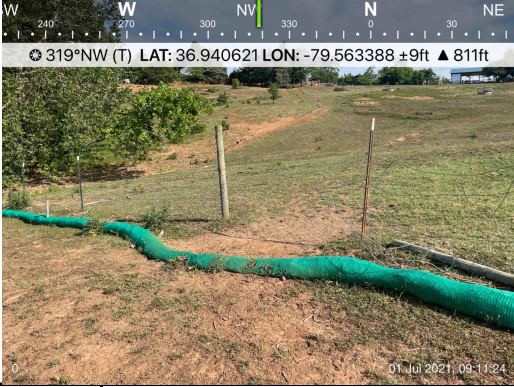
GPS Location	See photo		GPS Location	See photo	
Field Station#	15195+50		Field Station#	15195+00	
Pic 5 Desc.	Fence gap remains open by 3rd party allowing livestock onto ROW.		Pic 6 Desc.	Drainage ECDs are in good condition.

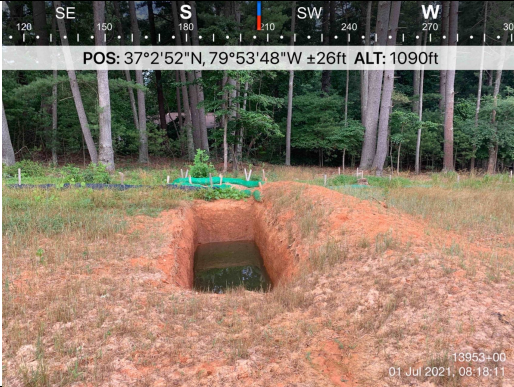
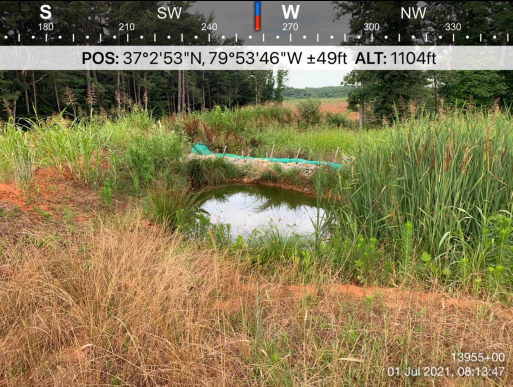
GPS Location	0	GPS Location	0		
Field Station#	13953+00	Field Station#	13955+00		
Pic 1 Desc.	Waterbar end treatment in acceptable condition	Pic 2 Desc.	Sump pit in acceptable condition

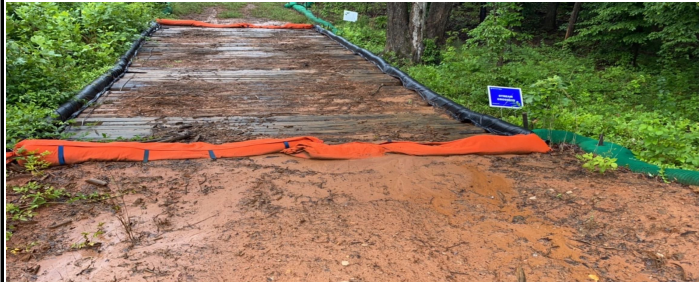
36°58'31" N 79°40'30" W 130°SE COURSE 38' GPS Penhook, VA 24137, United States 07.02.2021 09:18:31 Accur +/-110.5 Ft ALT 965 Ft			36°58'31" N 79°40'30" W 155°SE COURSE 140' GPS Penhook, VA 24137, United States 07.02.2021 09:19:58 Accur +/-1254.6 Ft ALT 947 Ft		
GPS Location	1		GPS Location	2	
Field Station#	14812+00		Field Station#	14816+07	
Pic 1 Desc.	Routine maintenance. Replace damaged perimeter CFS with wattles where landowner is crossing ROW.		Pic 2 Desc.	Routine maintenance. Remove sediment from wattles at equipment bridge. Seed and stabilize denuded area.
