Visual Site Inspection Report

Project Name	H-600 Pipeline Spread I	AFE	124300139	Spread	H-600 Pipeline Spread I
Contractor	Precision			Report #	25791
Inspector	Ben Farmer			Date/Time	7/12/2021 6:33 PM
Permit #	TBD	Inspection Type	VA SWPP	Station Begin	15480+67
State	VA	Inspection Area	Partial	Station End	15584+23
County	Pittsylvania	Ground	Dry	Temperature (°F)	82.00
Municipality	Chatham	Weather	Sunny	Rain Gauge (in)	0.10
				Rain Accumulation Time (days)	0.00

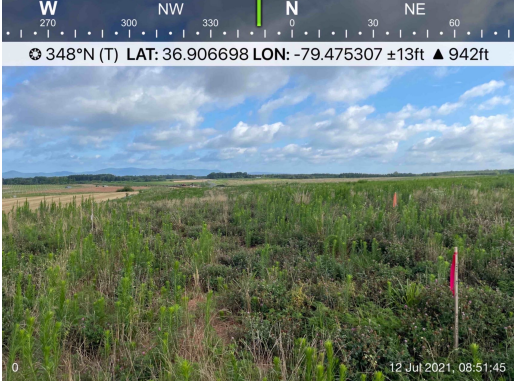
GPS Location	See photo		GPS Location	See photo	
Field Station#	15495+00		Field Station#	15496+70	
Pic 1 Desc.	Vegetation continues to fill in throughout this section.		Pic 2 Desc.	RCEs are in good condition at all road crossings.

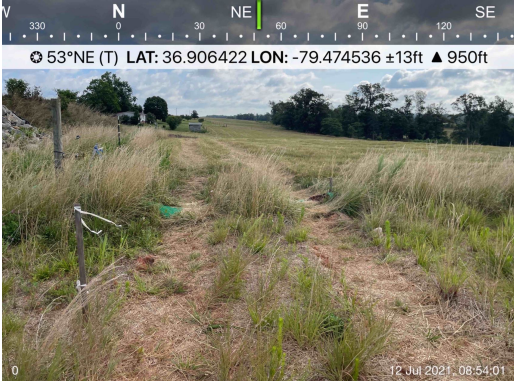
GPS Location	See photo		GPS Location	See photo	
Field Station#	15498+12		Field Station#	15498+19	
Pic 3 Desc.	3rd party has damaged CFS.		Pic 4 Desc.	3rd party has damaged CFS.

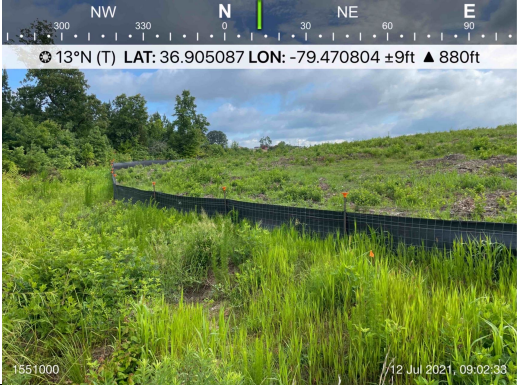
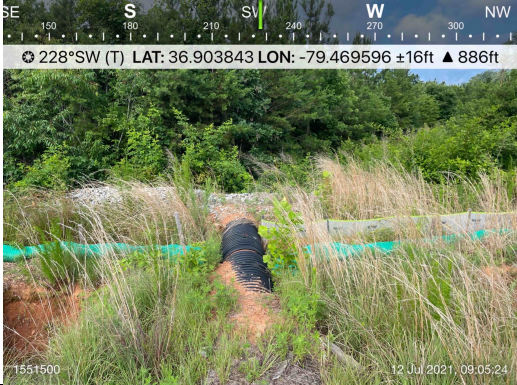
GPS Location	See photo		GPS Location	See photo	
Field Station#	15510+00		Field Station#	15515+00	
Pic 7 Desc.	3rd party ECDs appear to be in good condition.		Pic 8 Desc.	CWDs are functioning as intended throughout this section.

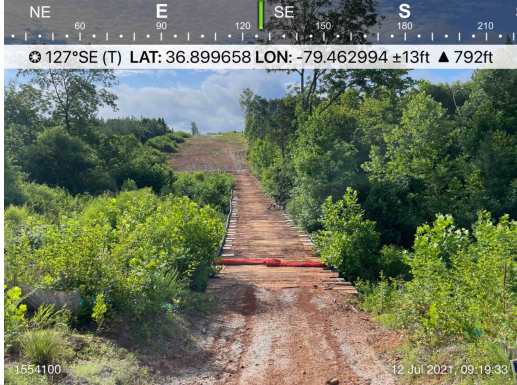
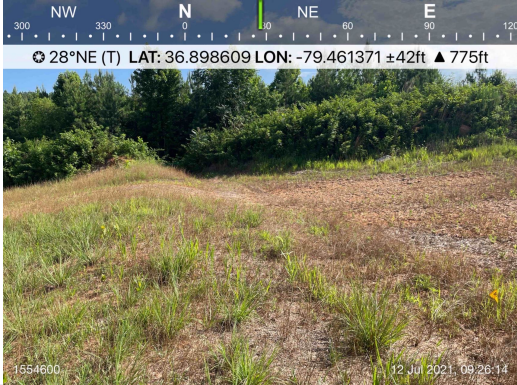
GPS Location	See photo		GPS Location	See photo	
Field Station#	15541+00		Field Station#	15546+00	
Pic 9 Desc.	Equipment bridge ECDs are in place and functioning.		Pic 10 Desc.	Waterbars are in good condition.

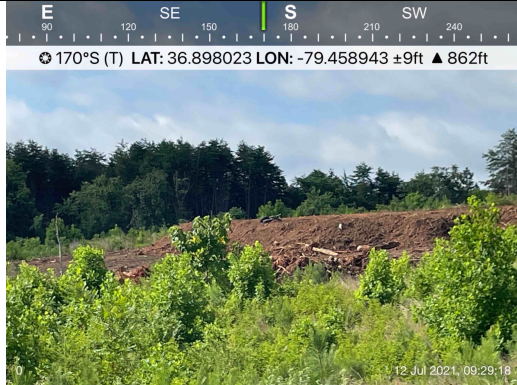
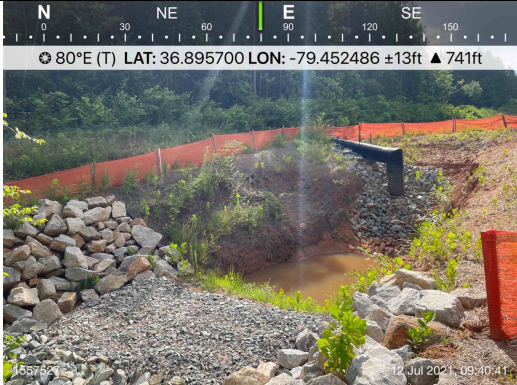
GPS Location	See photo		GPS Location	See photo	
Field Station#	15556+83		Field Station#	15575+27	
Pic 11 Desc.	No evidence of sedimentation from 3rd party disturbance.		Pic 12 Desc.	Slope drain is functioning as intended.

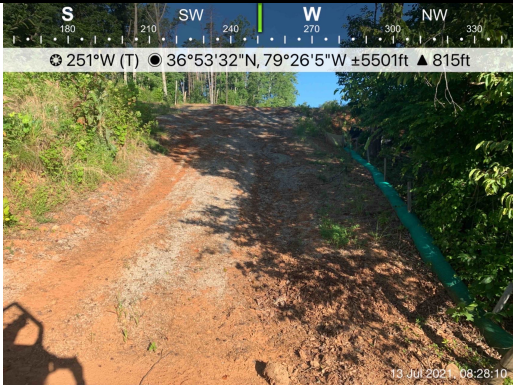
GPS Location	O	GPS Location	O		
Field Station#	15636+00	Field Station#	15632+00		
Pic 1 Desc.	Observing location that requires additional stabilization	Pic 2 Desc.	Observing temporary stabilization, CWD outlet and ECD's

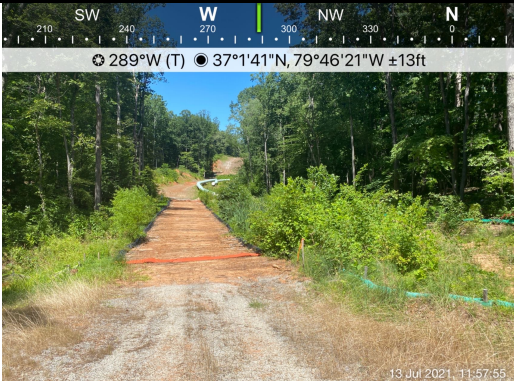
GPS Location	0	GPS Location	0		
Field Station#	14438+49	Field Station#	14454+00		
Pic 5 Desc.	Approximately 14438+49. Overview of stream crossing, equipment bridge and ECDs at stream S-IJ47.	Pic 6 Desc.	Approximately 14454+00. P-1 requires maintenance. Damaged by third party vehicle.

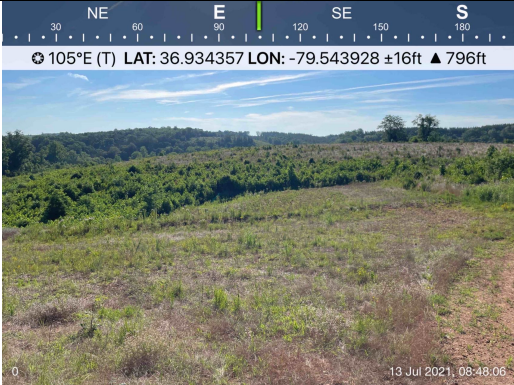
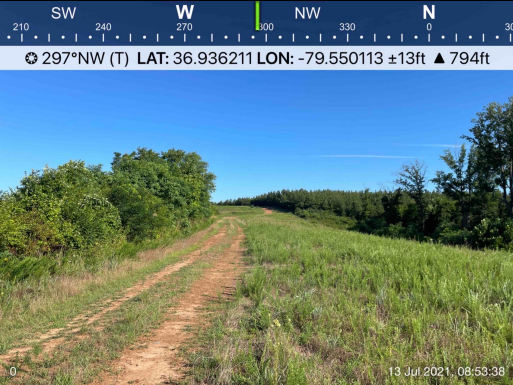
GPS Location	See photo		GPS Location	See photo	
Field Station#	15260+00		Field Station#	15230+00	
Pic 1 Desc.	Vegetation continues to fill in throughout this section.		Pic 2 Desc.	Vegetation continues to fill in throughout this section.

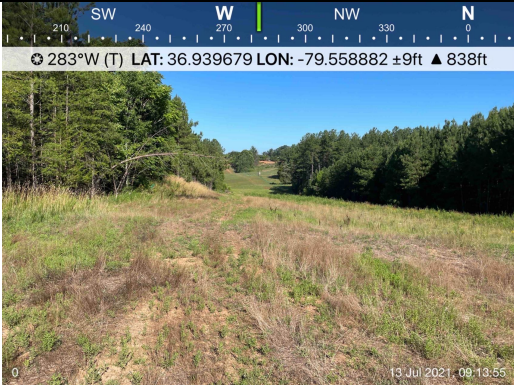
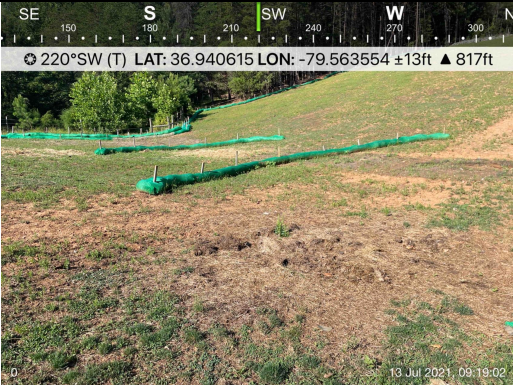
GPS Location	See photo		GPS Location	See photo	
Field Station#	15209+00		Field Station#	15195+00	
Pic 3 Desc.	Vegetation continues to fill in throughout this section.		Pic 4 Desc.	Drainage ECDs are in good condition and functioning.

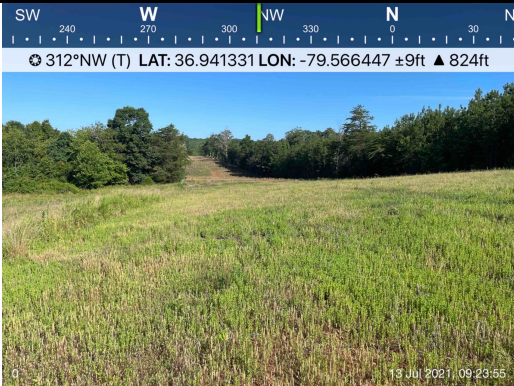
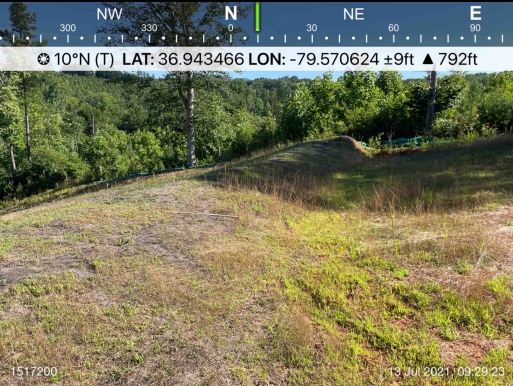
GPS Location	See photo		GPS Location	See photo	
Field Station#	15188+00		Field Station#	15172+00	
Pic 5 Desc.	Vegetation continues to fill in throughout this section.		Pic 6 Desc.	Waterbars are functioning as intended.

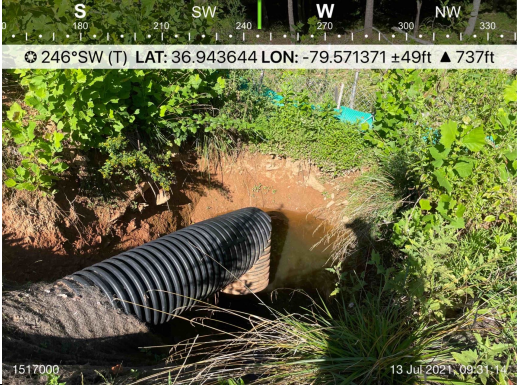
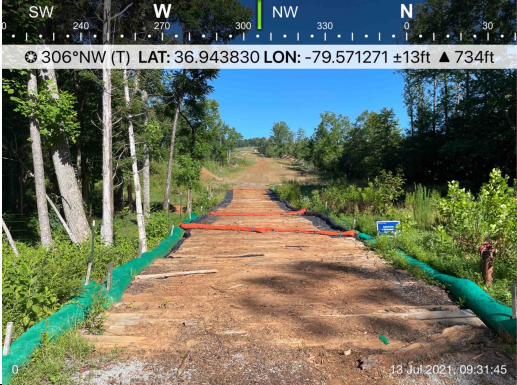
GPS Location	See photo		GPS Location	See photo	
Field Station#	15170+00		Field Station#	15168+00	
Pic 7 Desc.	Slope drain is in good condition and functioning.		Pic 8 Desc.	Equipment bridge ECDs are in place and functioning.

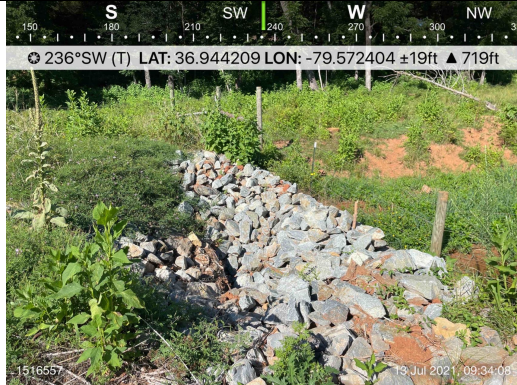
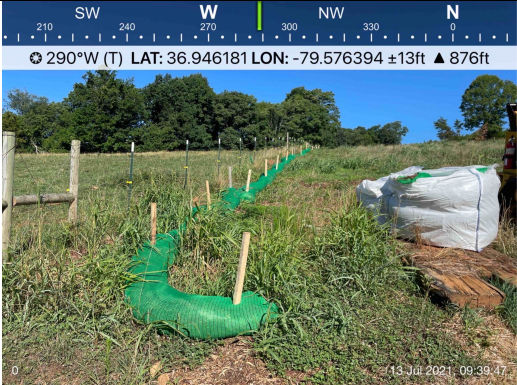
GPS Location	See photo		GPS Location	See photo	
Field Station#	15165+57		Field Station#	15152+84	
Pic 11 Desc.	Rock filter is in good condition.		Pic 12 Desc.	Perimeter CFS is in good condition throughout this section.

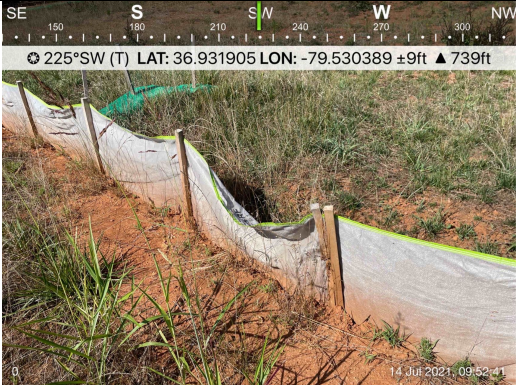
GPS Location	See photo		GPS Location	See photo	
Field Station#	15299+00		Field Station#	15299+00	
Pic 1 Desc.	P1 needs to be restaked.		Pic 2 Desc.	Environmental crew has corrected this issue.

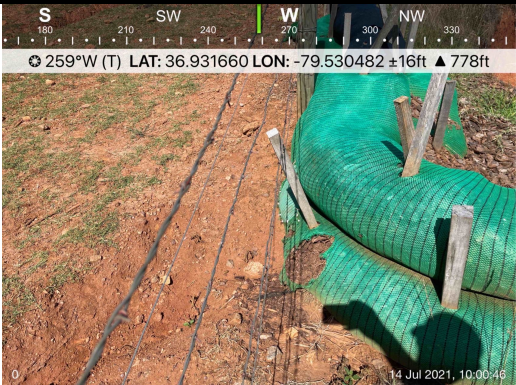
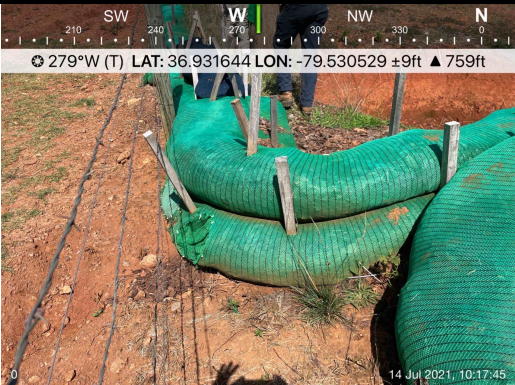
GPS Location	See photo		GPS Location	See photo	
Field Station#	15298+50		Field Station#	15298+50	
Pic 3 Desc.	CFS needs to be repaired.		Pic 4 Desc.	Environmental crew has corrected this issue.

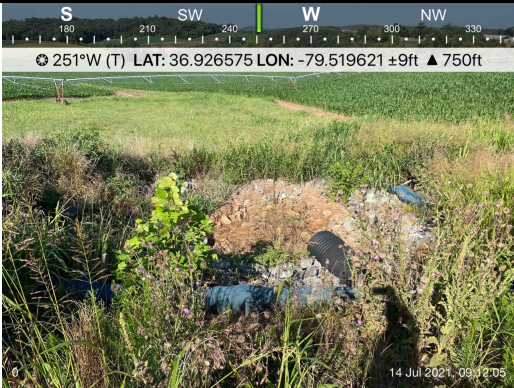
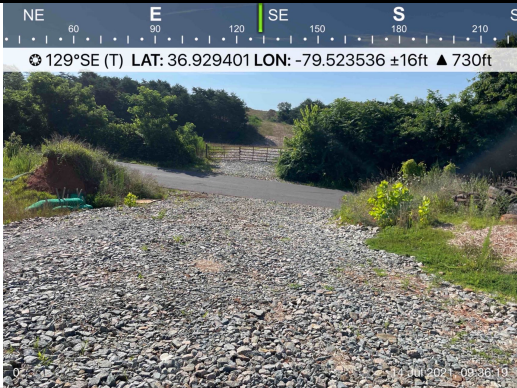
GPS Location	See photo		GPS Location	See photo	
Field Station#	15338+00		Field Station#	15323+24	
Pic 9 Desc.	CWD is in good condition.		Pic 10 Desc.	RCEs are in good condition at all road crossings.

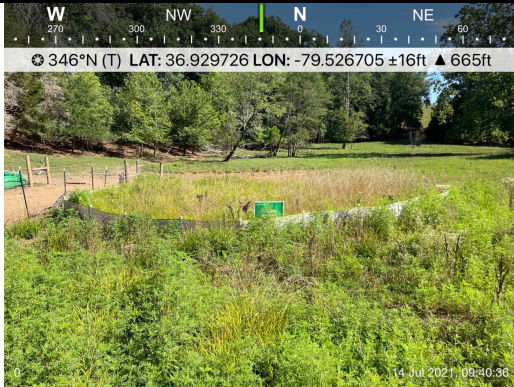
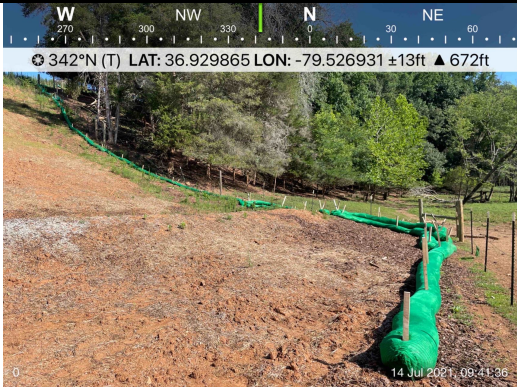
GPS Location	See photo		GPS Location	See photo	
Field Station#	15311+78		Field Station#	15310+00	
Pic 11 Desc.	Buffer area P1 is in good condition.		Pic 12 Desc.	Perimeter CFS is in good condition on this slope.

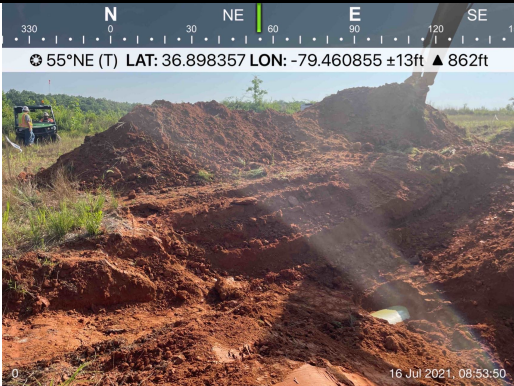
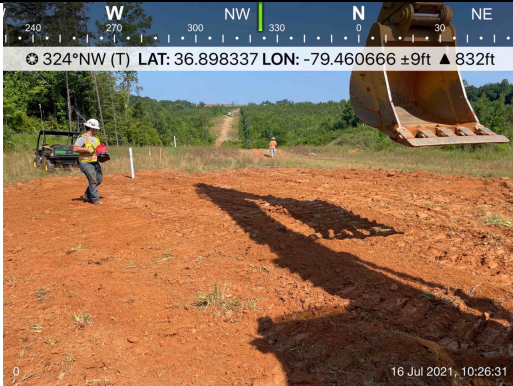
GPS Location	See photo		GPS Location	See photo	
Field Station#	15549+13		Field Station#	15549+13	
Pic 5 Desc.	Dig up crew working at this location.		Pic 6 Desc.	Environmental crew has stabilized this area.

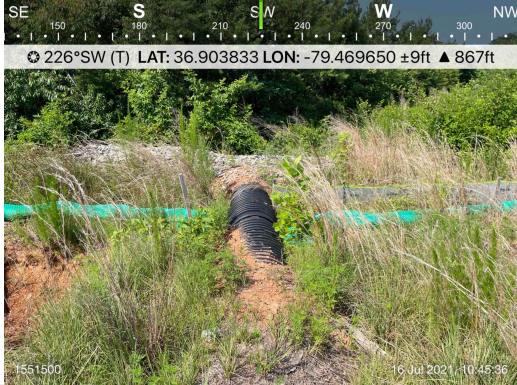
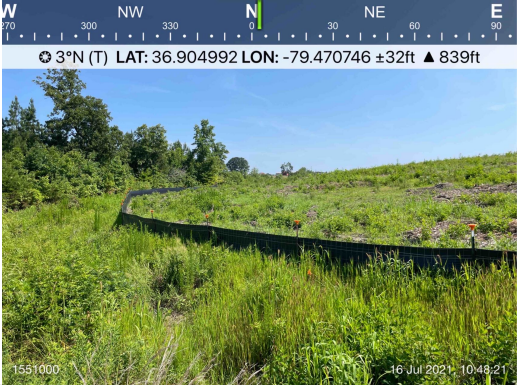
GPS Location	See photo		GPS Location	See photo	
Field Station#	15515+00		Field Station#	15510+00	
Pic 9 Desc.	CWDs are functioning as intended.		Pic 10 Desc.	3rd party ECDs appear to be in good condition.

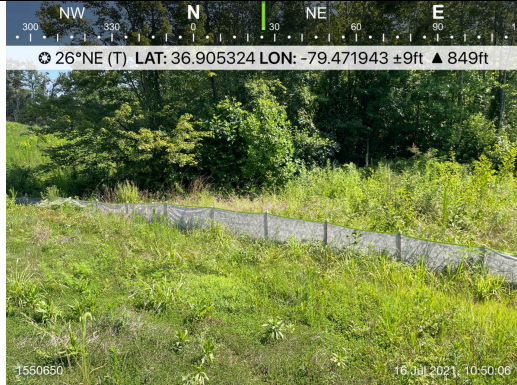
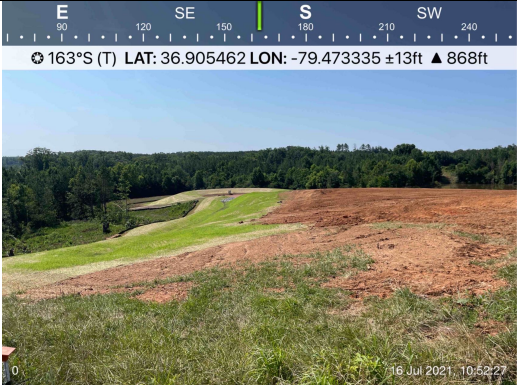
GPS Location	See photo		GPS Location	See photo	
Field Station#	15506+50		Field Station#	15505+00	
Pic 11 Desc.	P1 is in good condition at all stream and wetland buffers.		Pic 12 Desc.	No evidence of sedimentation from 3rd party disturbance.

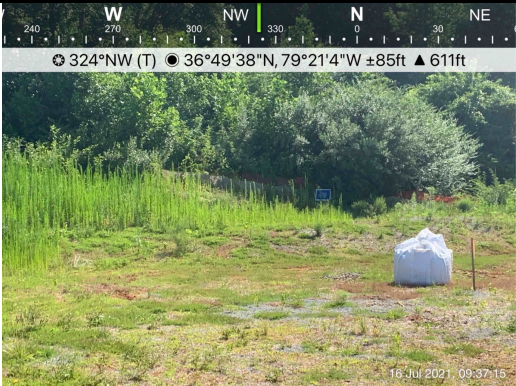
GPS Location	O	GPS Location	O		
Field Station#	15999+00	Field Station#	15996+00		
Pic 5 Desc.	Observing temporary stabilization, signage and buffer	Pic 6 Desc.	Observing erosion that was repaired and erosion control blanket installed

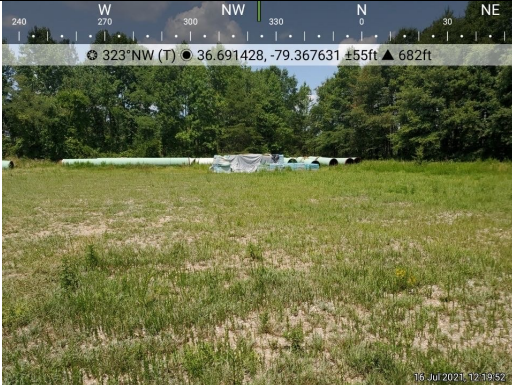
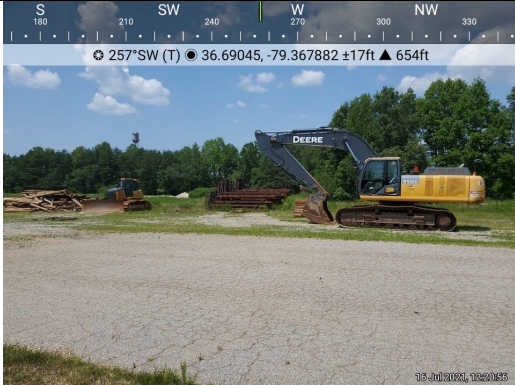
GPS Location	0	GPS Location	0		
Field Station#	0+00	Field Station#	0+00		
Pic 1 Desc.	LY-048 Temporary vegetation north end		Pic 2 Desc.	LY-048 Equipment staging
