Visual Site Inspection Report

Project Name	H-600 Pipeline Spread G	AFE	124300137	Spread	H-600 Pipeline Spread G
Contractor	Precision			Report #	31163
Inspector	Chris Burns			Date/Time	11/15/2021 7:49 AM
Permit #	TBD	Inspection Type	VA SWPP	Station Begin	11023+80
State	VA	Inspection Area	Partial	Station End	11098+47
County	Giles	Ground	Wet	Temperature (°F)	43.00
Municipality	N/A	Weather	Cloudy	Rain Gauge (in)	0.00
				Rain Accumulation Time (days)	1.00

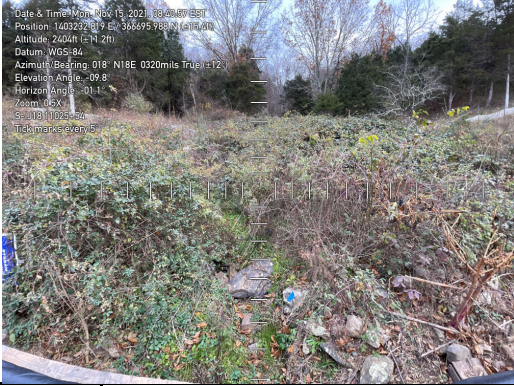
GPS Location	1	GPS Location	2		
Field Station#	11025+54	Field Station#	11034+00		
Pic 1 Desc.	S-IJ18.	Pic 2 Desc.	Section of RoW showing conditions and controls.

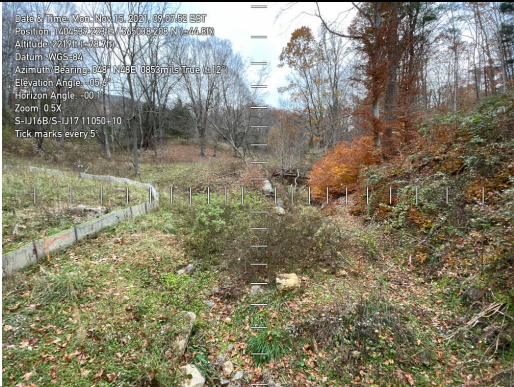
GPS Location	3	GPS Location	4		
Field Station#	11050+10	Field Station#	11050+10		
Pic 3 Desc.	S-IJ16B/S-IJ17.	Pic 4 Desc.	Overview of S-IJ16B/S-IJ17

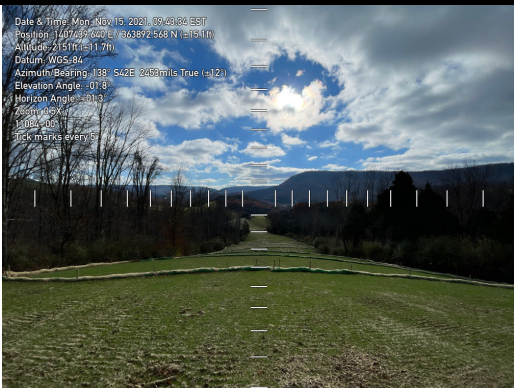
GPS Location	5	GPS Location	6		
Field Station#	11084+00	Field Station#	11098+43		
Pic 5 Desc.	Section of RoW showing conditions and controls.	Pic 6 Desc.	Section of RoW showing conditions and controls.

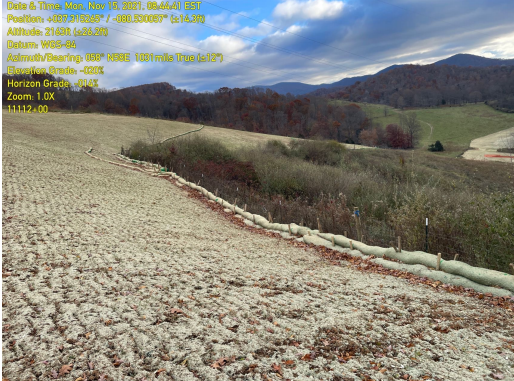
GPS Location	See photo		GPS Location	See photo	
Field Station#	11112+00		Field Station#	11120+00	
Pic 1 Desc.	CFS triple stack perimeter control in place		Pic 2 Desc.	Temporary CFS waterbars in place

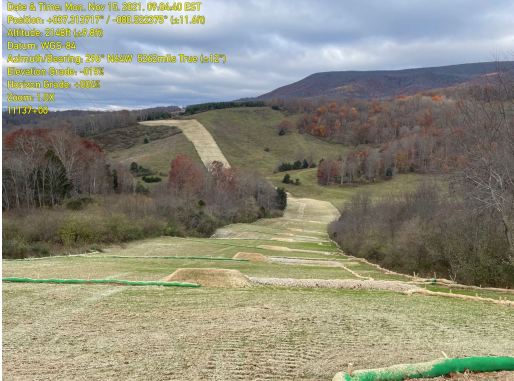
GPS Location	See photo		GPS Location	See photo	
Field Station#	11137+00		Field Station#	11146+00	
Pic 3 Desc.	Permanent waterbars in place		Pic 4 Desc.	Cleanwater diversion berm in place

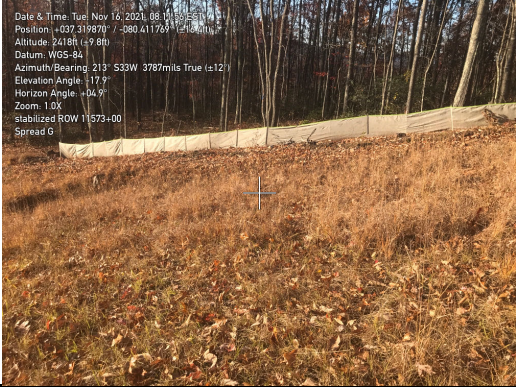
GPS Location	See photo		GPS Location	see photo	
Field Station#	11573+00		Field Station#	11584+92	
Pic 13 Desc.	New P1		Pic 14 Desc.	Equipment bridge

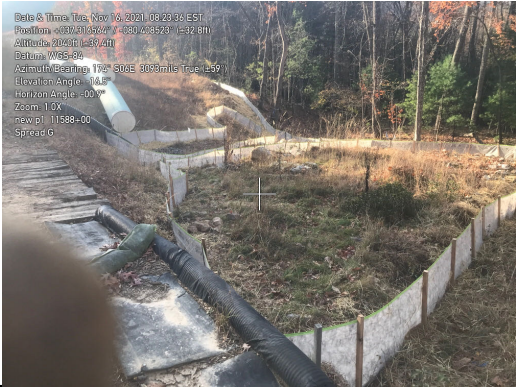
GPS Location	see photo		GPS Location	see photo	
Field Station#	11588+00		Field Station#	115900+00	
Pic 15 Desc.	New P1		Pic 16 Desc.	New P1

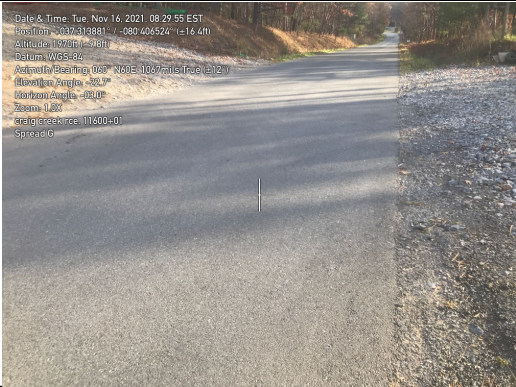
Insert image here	
GPS Location	see photo		GPS Location		
Field Station#	11600+01		Field Station#		
Pic 17 Desc.	Craig Creek RCE		Pic 18 Desc.

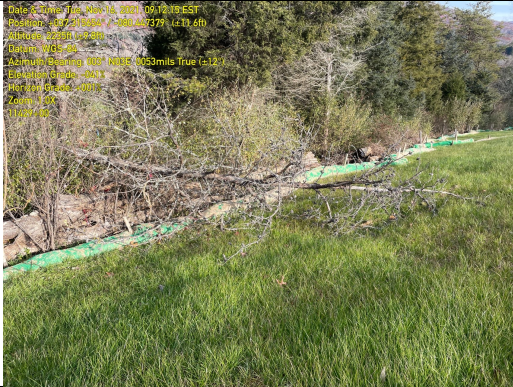
<p>Date & Time: Tue, Nov 16, 2021, 09:12:19 EST Position: +037.232301° / -085.434839° (-11.64N) Altitude: 2245ft (+13.1ft) Datum: WGS-84 Azimuth/Bearing: 000° N00W 453mils True (+13°) Elevation Grade: +00% Horizon Grade: +00% Zoom: 1.0X 11429+00</p>		GPS Location	See photo
Field Station#	11465+30	Field Station#	11429+00	GPS Location	See photo
Pic 1 Desc.	Broken P1 silt fence stake	Pic 2 Desc.	Tree needs removed from perimeter control

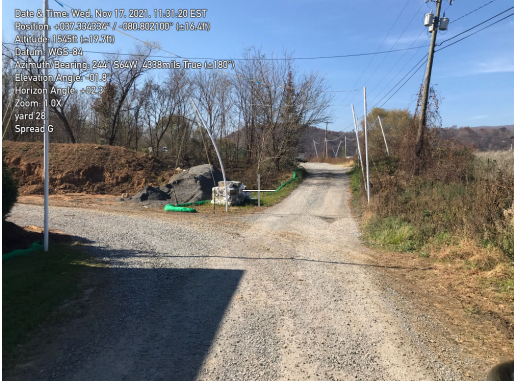
GPS Location	See photo		GPS Location	see photo	
Field Station#	12005+00		Field Station#	12005+00	
Pic 1 Desc.	Rock entrance		Pic 2 Desc.	Yard 28

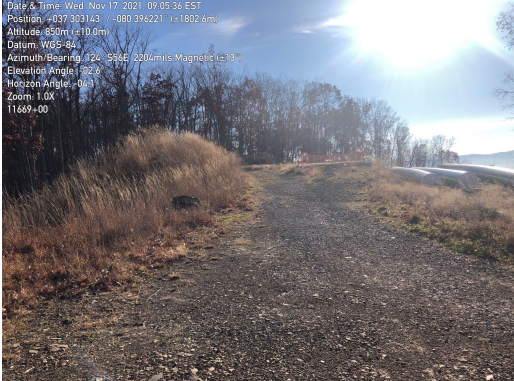
GPS Location	On photo	GPS Location	On photo		
Field Station#	11669+00	Field Station#	11655+75		
Pic 1 Desc.	Stable conditions at FS Road 188 on top of Brush Mountain.	Pic 2 Desc.	Perimeter ECDs are in place.

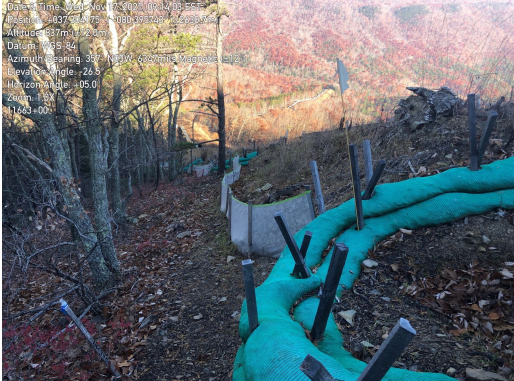
GPS Location	On photo	GPS Location	On photo		
Field Station#	11663+00	Field Station#	11659+00		
Pic 3 Desc.	Perimeter ECDs found functional.	Pic 4 Desc.	Perimeter ECDs are in place.

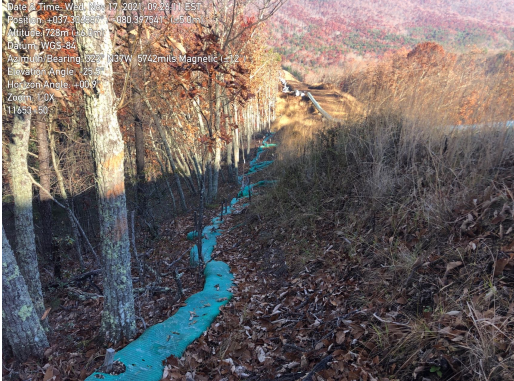
GPS Location	On photo	GPS Location	On photo		
Field Station#	11653+50	Field Station#	11630+00		
Pic 5 Desc.	ROW stable. CFS to be replaced when construction resumes.	Pic 6 Desc.	Slope breakers functioning properly.

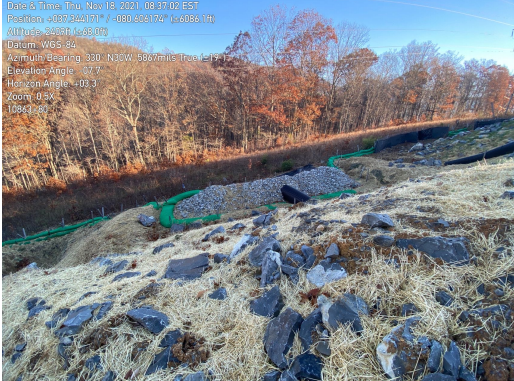
GPS Location		See Photo		GPS Location	
Field Station#		10863+80		Field Station#	
Pic 1 Desc.		Plung Pool		Pic 2 Desc.	
				Section of ROW showing stabilization

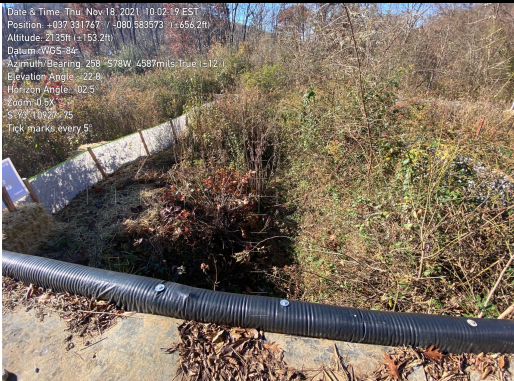
GPS Location		See Photo		GPS Location	
Field Station#		10927+75		Field Station#	
Pic 5 Desc.		S-Y3		Pic 6 Desc.	
				S-Y2
