Visual Site Inspection Report

Project Name	H-600 Pipeline Spread H	AFE	124300138	Spread	H-600 Pipeline Spread H
Contractor	Precision			Report #	29614
Inspector	Jason Nielsen			Date/Time	10/11/2021 6:45 PM
Permit #	TBD	Inspection Type	VA SWPP	Station Begin	12284+75
State	VA	Inspection Area	Partial	Station End	12443+75
County	Montgomery	Ground	Dry	Temperature (°F)	69.00
Municipality	N/A	Weather	Cloudy	Rain Gauge (in)	0.00
				Rain Accumulation Time (days)	0.00

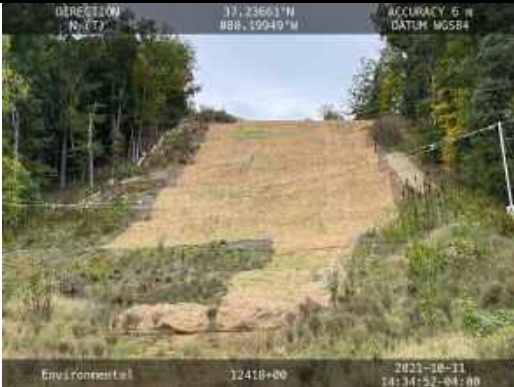
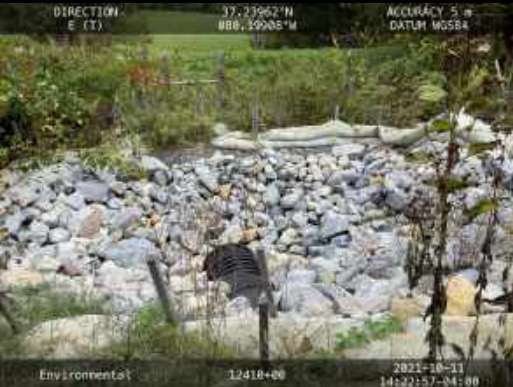
GPS Location	see photo		GPS Location	see photo	
Field Station#	12418+00		Field Station#	12410+00	
Pic 1 Desc.	Stabilized ROW in acceptable condition		Pic 2 Desc.	Clean water crossing pipe outlet in acceptable condition

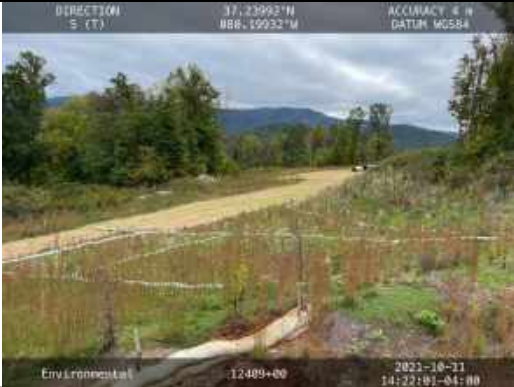
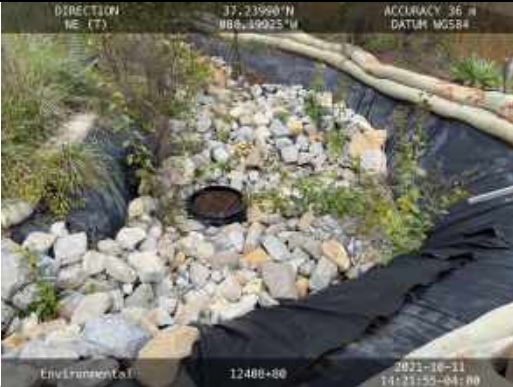
GPS Location	See photo		GPS Location	See photo	
Field Station#	12409+00		Field Station#	12408+80	
Pic 3 Desc.	Stabilized ROW in acceptable condition		Pic 4 Desc.	Clean water crossing pipe inlet in acceptable condition

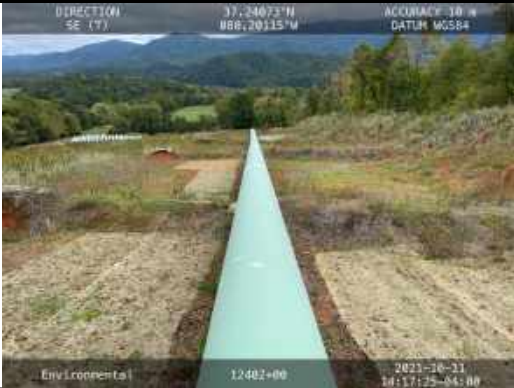
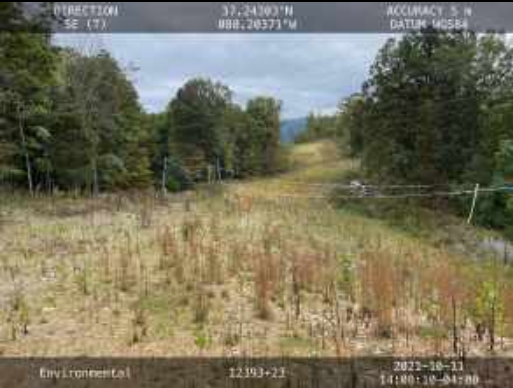
GPS Location	See photo		GPS Location	See photo	
Field Station#	12402+00		Field Station#	12393+23	
Pic 5 Desc.	Stabilized ROW in acceptable condition		Pic 6 Desc.	Stabilized ROW in acceptable condition

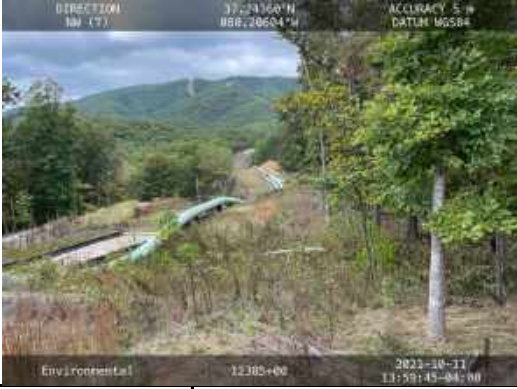
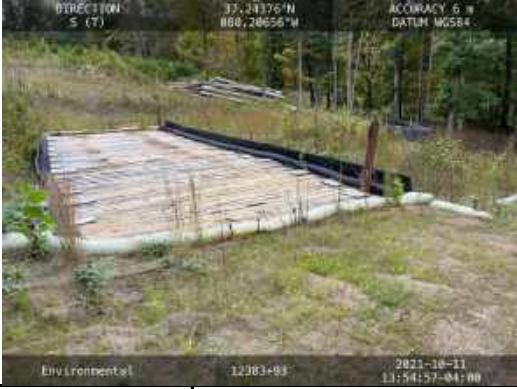
GPS Location	See photo		GPS Location	See photo	
Field Station#	12385+00		Field Station#	12383+93	
Pic 7 Desc.	Stabilized ROW in acceptable condition		Pic 8 Desc.	Clean water crossing in acceptable condition

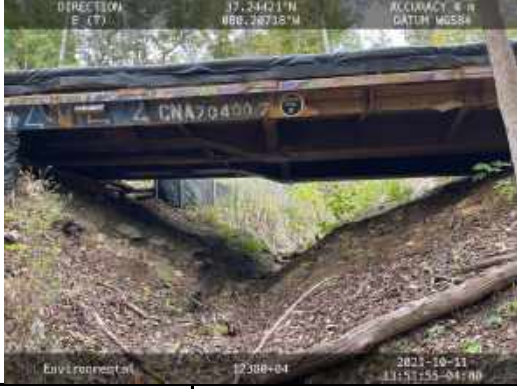
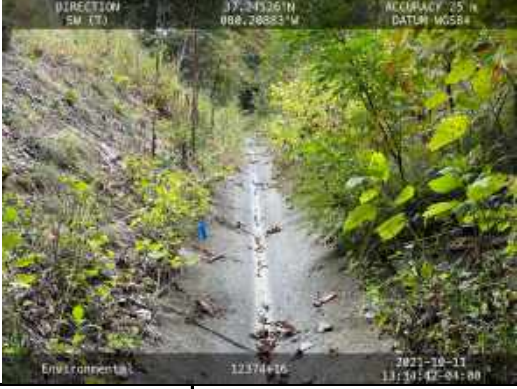
GPS Location	See photo		GPS Location	See photo	
Field Station#	12380+04		Field Station#	12374+16	
Pic 9 Desc.	Bridge crossing S-NN19 in acceptable condition		Pic 10 Desc.	Stream crossing S-OO16 in acceptable condition

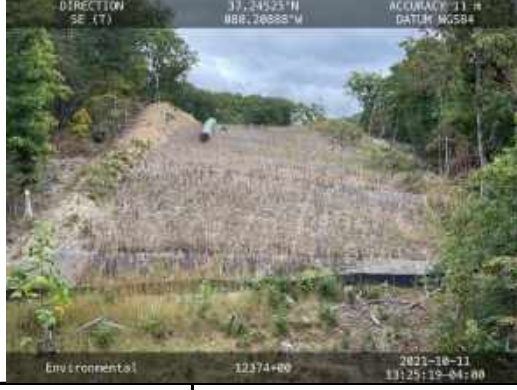
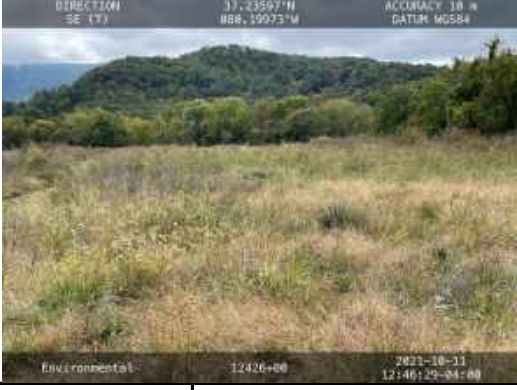
GPS Location	See photo		GPS Location	See photo	
Field Station#	12374+00		Field Station#	12426+00	
Pic 11 Desc.	Stabilized ROW in acceptable condition		Pic 12 Desc.	Stabilized ROW in acceptable condition

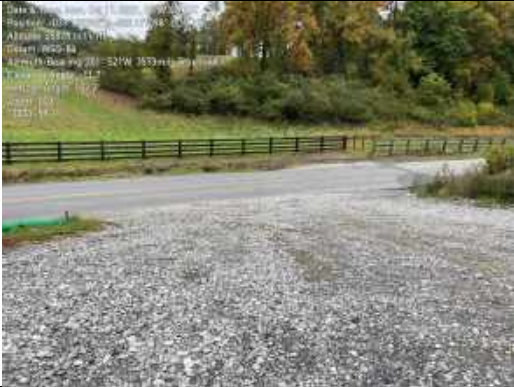
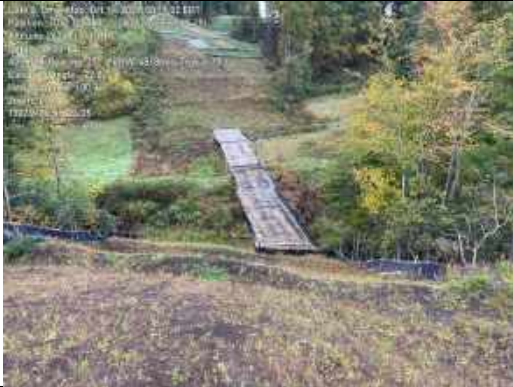
GPS Location	0	GPS Location	0		
Field Station#	13033+59	Field Station#	13024+06		
Pic 1 Desc.	RCE in good condition and functioning properly	Pic 2 Desc.	MVP-S-G24/25 and Corresponding buffer zone in good condition

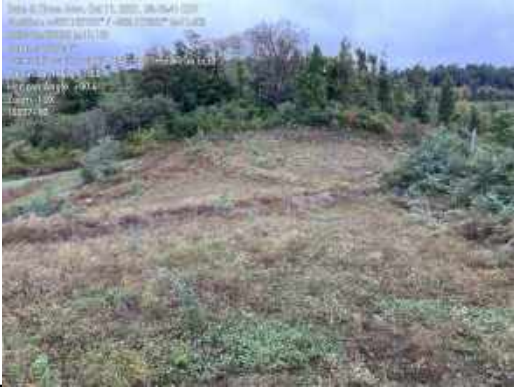
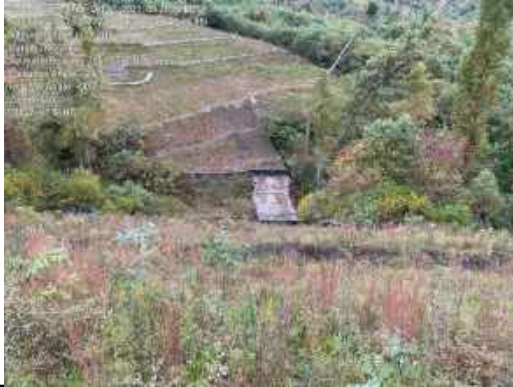
GPS Location	0	GPS Location	0		
Field Station#	13037+00	Field Station#	13042+61		
Pic 3 Desc.	ROW and ECDs in good condition with good vegetation established across ROW	Pic 4 Desc.	MVP-S-H1 and Corresponding buffer zone in good condition

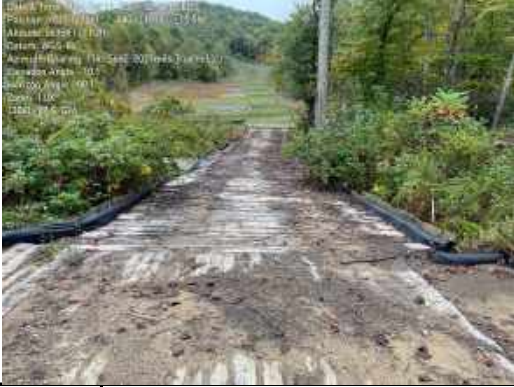
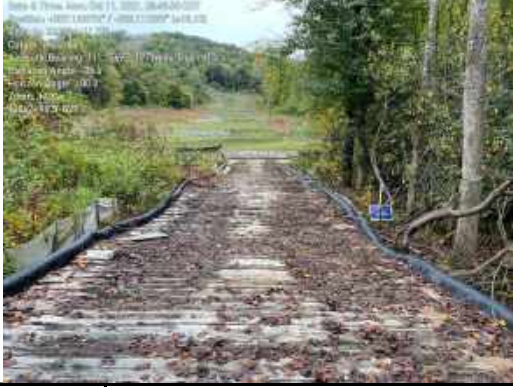
GPS Location	0	GPS Location	0		
Field Station#	13061+89	Field Station#	13062+96		
Pic 5 Desc.	MVP-S-G26 and Corresponding buffer zone in good condition	Pic 6 Desc.	MVP-S-G26 and Corresponding buffer zone in good condition

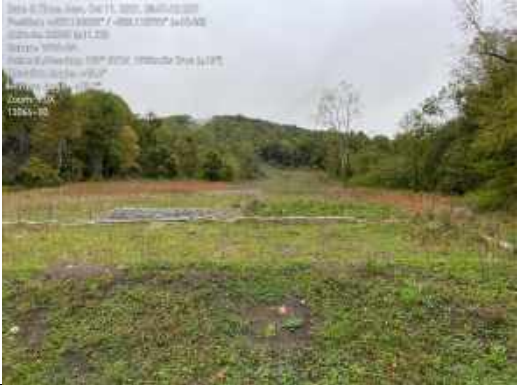
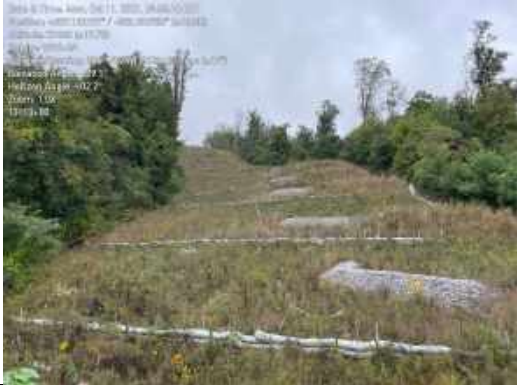
GPS Location	0	GPS Location	0		
Field Station#	13064+00	Field Station#	13113+00		
Pic 7 Desc.	ROW and ECDs in good condition with good vegetation established across ROW		Pic 8 Desc.	ROW and ECDs in good condition with good vegetation established across ROW

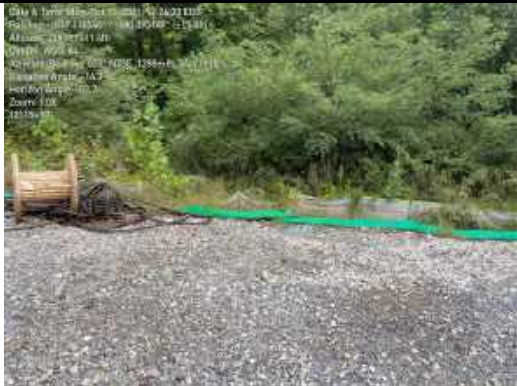
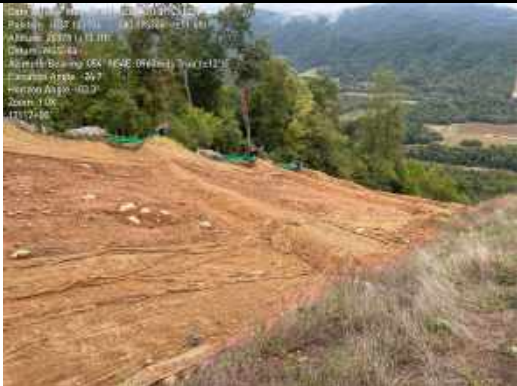
GPS Location	0	GPS Location	0		
Field Station#	13115+97	Field Station#	13117+00		
Pic 9 Desc.	Repair/Replace P1 - 72hr item		Pic 10 Desc.	ROW and ECDs in good condition and stable

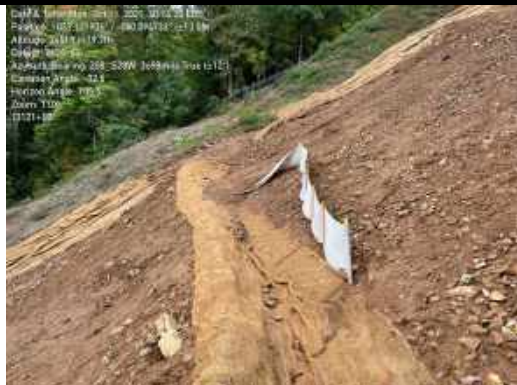
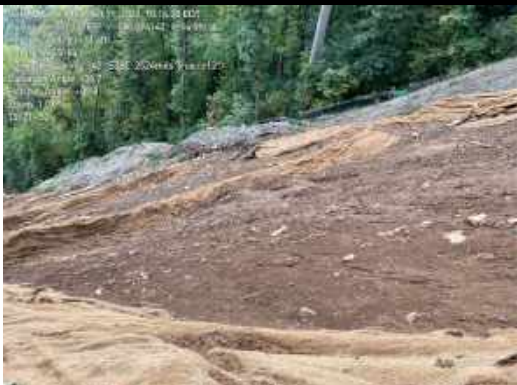
GPS Location	0	GPS Location	0		
Field Station#	13121+00	Field Station#	13121+50		
Pic 11 Desc.	Clean throat of waterbar and repair P1 - 72hr item		Pic 12 Desc.	Clean out throat of waterbar - 72hr item

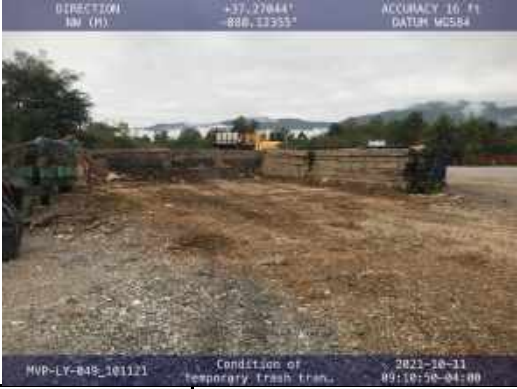
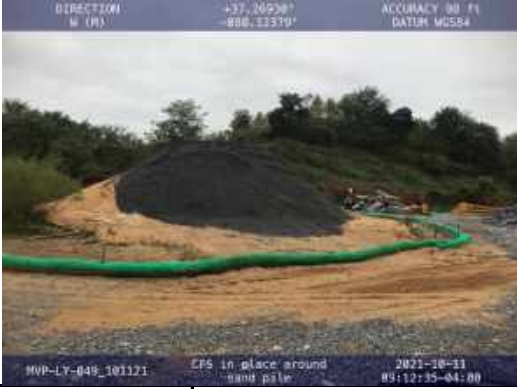
GPS Location	MVP-LY-049 See photo for gps data	GPS Location	MVP-LY-049 See photo for gps data		
Field Station#	+0	Field Station#	+0		
Pic 7 Desc.	Condition of temporary trash transfer pit. Debris has been placed in dumpsters. Looking NW.	Pic 8 Desc.	Compost filter sock in place around sand pile. Looking W.

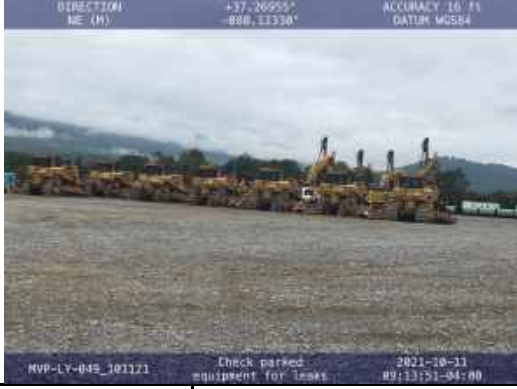
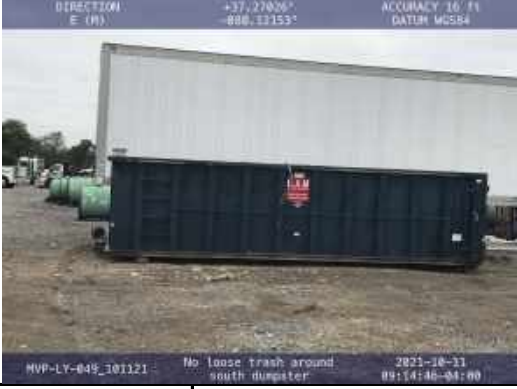
GPS Location	MVP-LY-049 See photo for gps data	GPS Location	MVP-LY-049 See photo for gps data		
Field Station#	+0	Field Station#	+0		
Pic 9 Desc.	Check parked equipment for leaks. No leaks located. Looking NE.	Pic 10 Desc.	No loose trash around south dumpster or in the yard. Looking E.

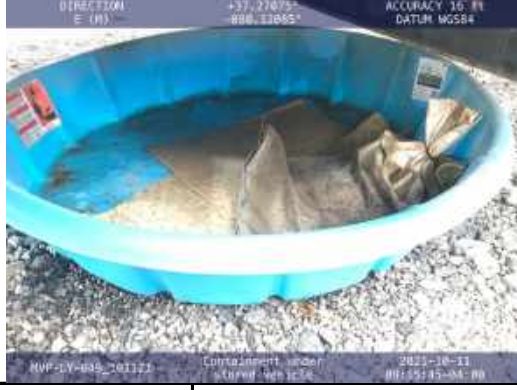
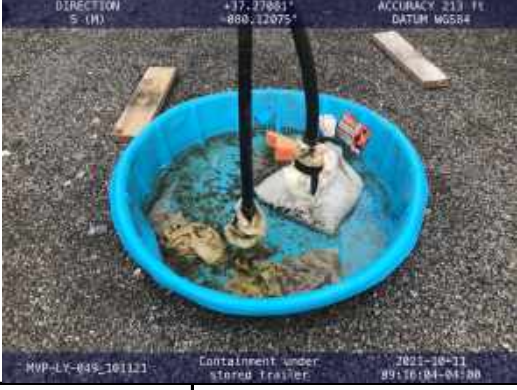
GPS Location	MVP-LY-049 See photo for gps data	GPS Location	MVP-LY-049 See photo for gps data		
Field Station#	+0	Field Station#	+0		
Pic 11 Desc.	Containment under stored vehicle. Free of fluids. Looking E.	Pic 12 Desc.	Containment under stored trailer. Holding some fluids. Looking S.

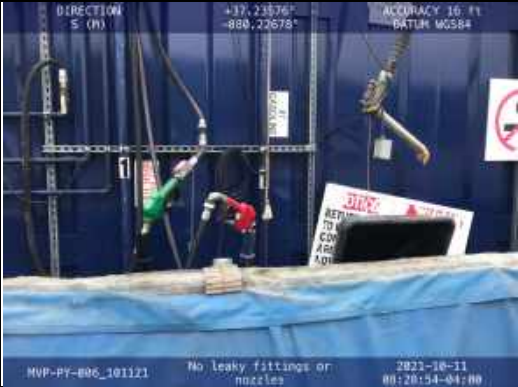
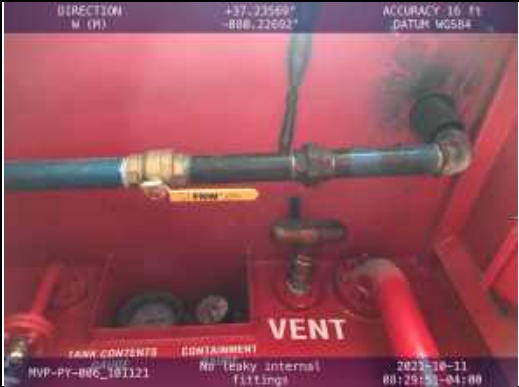
GPS Location	MVP-PY-006 See photo for gps data	GPS Location	MVP-PY-006 See photo for gps data		
Field Station#	+0	Field Station#	+0		
Pic 13 Desc.	Blue Bulk Fuel tanks no leaky fittings or nozzles. Looking S.	Pic 14 Desc.	Off Road Fuel unit no leaky internal fittings. Looking W.

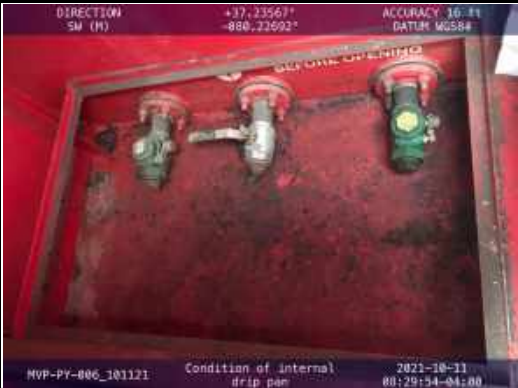
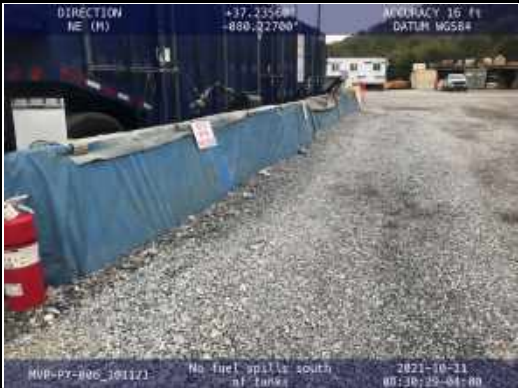
GPS Location	MVP-PY-006 See photo for gps data	GPS Location	MVP-PY-006 See photo for gps data		
Field Station#	+0	Field Station#	+0		
Pic 15 Desc.	Off Road Fuel unit condition of internal drip pan. Free of fluids. Looking SW.	Pic 16 Desc.	Blue Bulk Fuel tanks no fuel spills south of the tanks. Looking NE.

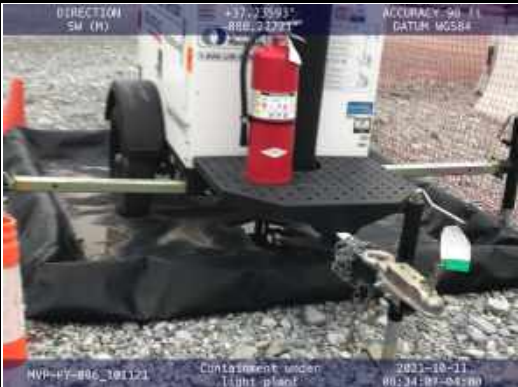
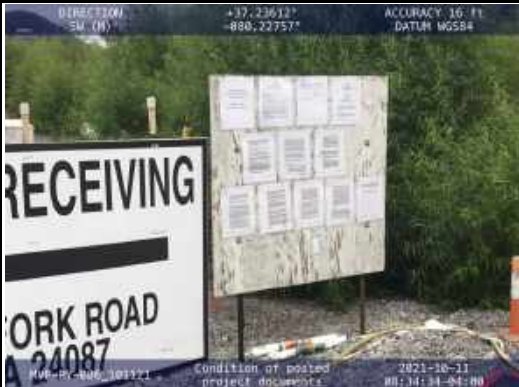
GPS Location	MVP-PY-006 See photo for gps data	GPS Location	MVP-PY-006 See photo for gps data		
Field Station#	+0	Field Station#	+0		
Pic 17 Desc.	Secondary containment under light plant free of fluids. Looking SW.	Pic 18 Desc.	Check condition of posted project documents at the main entrance. Looking NW.

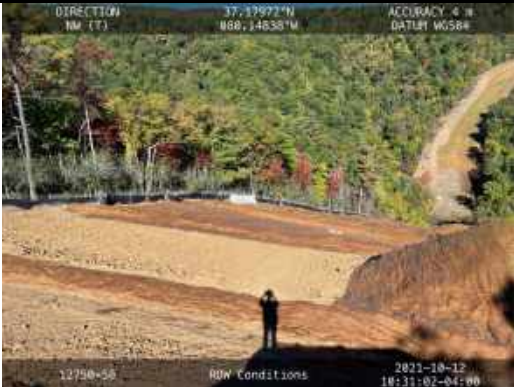
GPS Location	See photo		GPS Location	See photo	
Field Station#	12750+50		Field Station#	12750+00	
Pic 1 Desc.	Current ROW conditions. Waterbars are functional.		Pic 2 Desc.	Current ROW conditions. ROW is stable

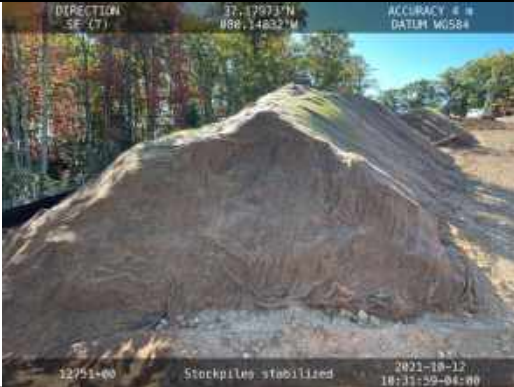
GPS Location	See photo		GPS Location	See photo	
Field Station#	12751+00		Field Station#	12754+00	
Pic 3 Desc.	Stockpiles are well stabilized with curlex		Pic 4 Desc.	Fill slope stabilized and slope drains functional

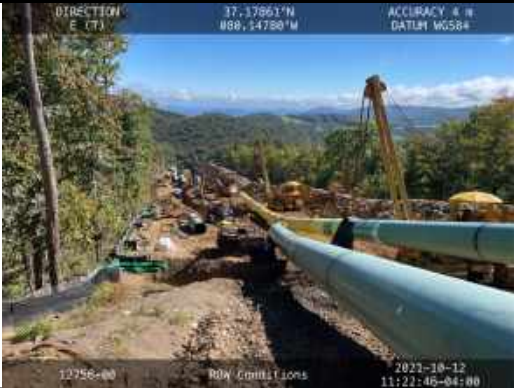
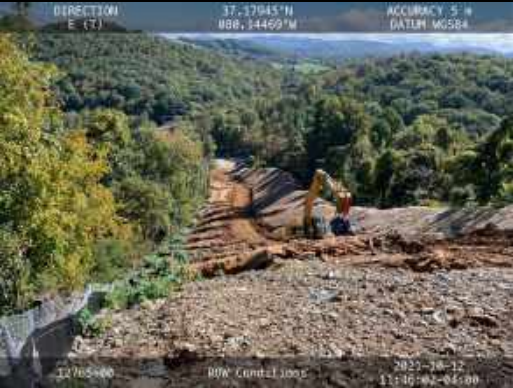
GPS Location	See photo		GPS Location	See photo	
Field Station#	12756+00		Field Station#	12765+00	
Pic 5 Desc.	Current ROW conditions. ROW is stable. Preparing to lower in pipe.		Pic 6 Desc.	Current ROW conditions. ROW is stable.

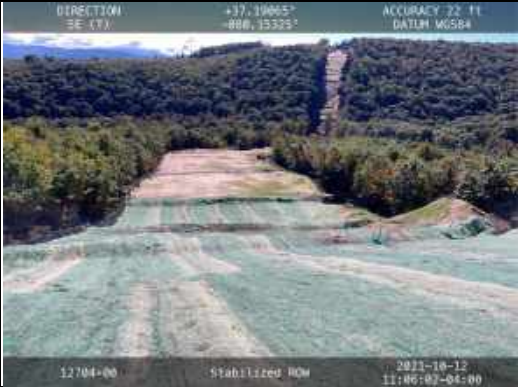
GPS Location	See photo		GPS Location	See photo	
Field Station#	12704+00		Field Station#	12692+00	
Pic 13 Desc.	Current ROW conditions. ROW is stable.		Pic 14 Desc.	Current ROW conditions. Waterbars are functional.

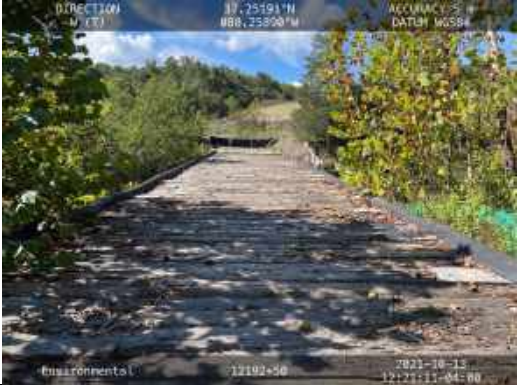
GPS Location	see photo		GPS Location	See photo	
Field Station#	12192+50		Field Station#	12132+74	
Pic 7 Desc.	Bridge and ECDs crossing stream S-C21 in acceptable condition		Pic 8 Desc.	Bridge and ECDs crossing stream S-C29 in acceptable condition

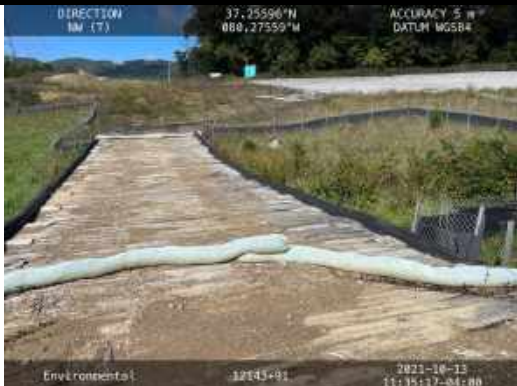
GPS Location	See photo		GPS Location	See photo	
Field Station#	12143+91		Field Station#	12144+47	
Pic 9 Desc.	Wetland W-C6 in acceptable condition		Pic 10 Desc.	Wetland crossing W-C5 in acceptable condition

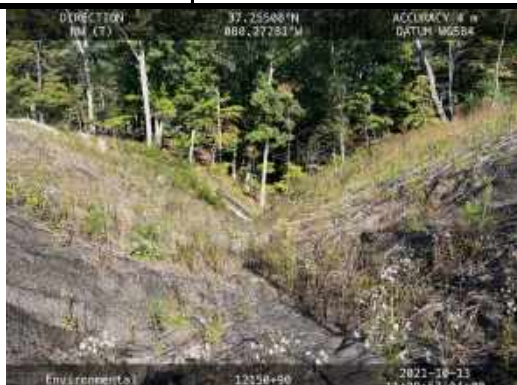
GPS Location	See photo		GPS Location	See photo	
Field Station#	12150+90		Field Station#	12173+00	
Pic 11 Desc.	Stabilized drainage feature in acceptable condition		Pic 12 Desc.	Stabilized ROW conditions acceptable

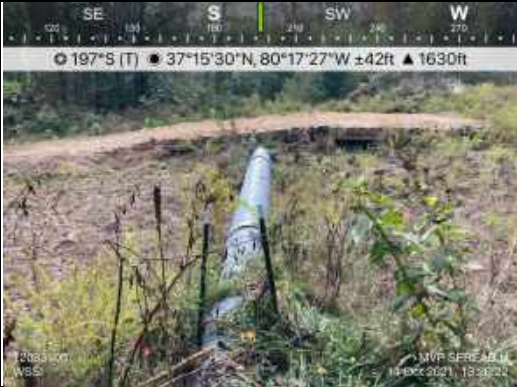
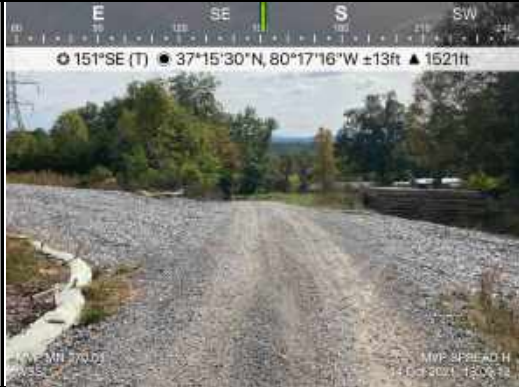
GPS Location	See picture watermark		GPS Location	See picture watermark	
Field Station#	12091+25		Field Station#	270+01	
Pic 13 Desc.	CWD pipe installed and functioning properly. No maintenance needed.		Pic 14 Desc.	Access roads and construction entrances in good condition. No maintenance needed.

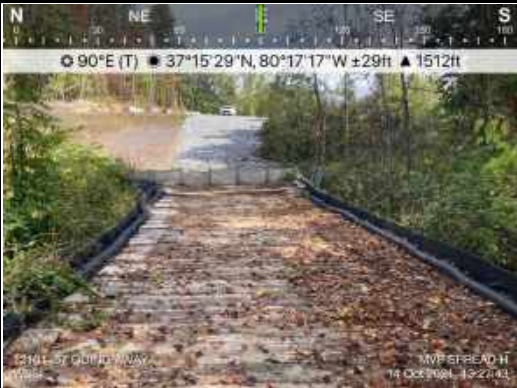
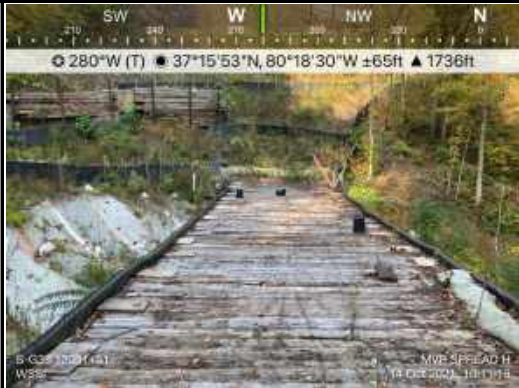
GPS Location	See picture watermark		GPS Location	See picture watermark	
Field Station#	12101+57		Field Station#	12031+51	
Pic 15 Desc.	Stream Crossing and perimeter controls in good condition. No maintenance needed.		Pic 16 Desc.	S-G39 crossing and perimeter controls in good condition. No maintenance needed.

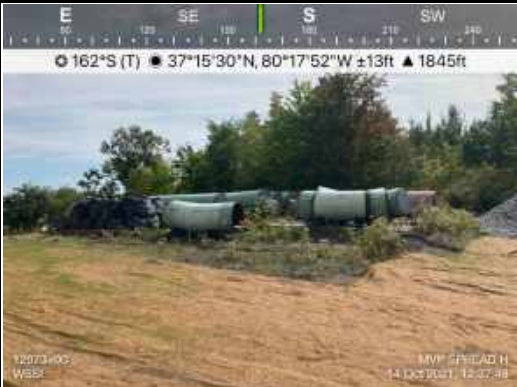
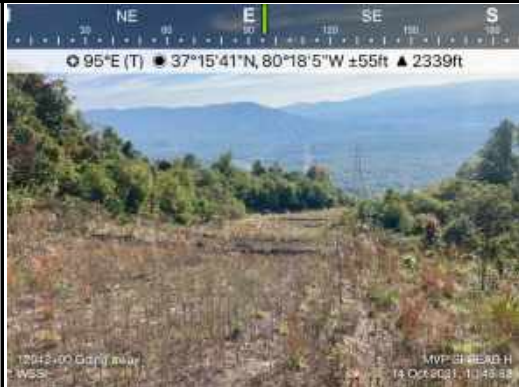
GPS Location	See picture watermark		GPS Location	See picture watermark	
Field Station#	12073+00		Field Station#	12042+00	
Pic 17 Desc.	Materials properly stored on ROW and in good condition. No maintenance needed.		Pic 18 Desc.	Temporary vegetation established on ROW and in good condition. No maintenance needed.

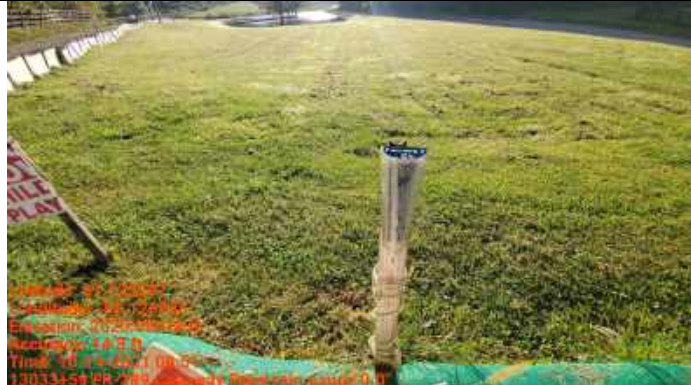
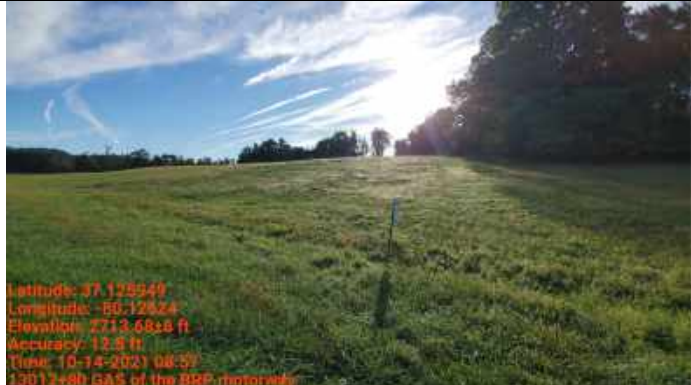
GPS Location	See pic for GPS location.		GPS Location	See pic for GPS location.	
Field Station#	13033+59		Field Station#	13012+80	
Pic 1 Desc.	0.0" of precipitation accumulation at Callaway Road.		Pic 2 Desc.	Current ROW conditions on the GAS of the BRP.

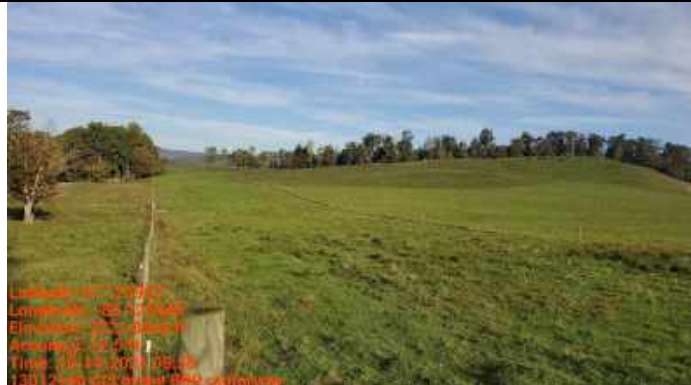
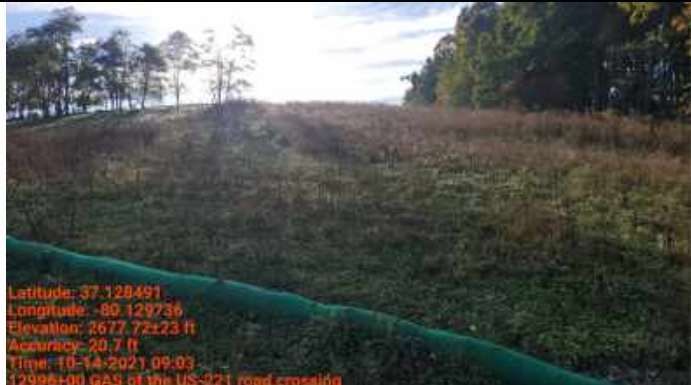
GPS Location	See pic for GPS location.		GPS Location	See pic for GPS location.	
Field Station#	13012+40		Field Station#	12996+00	
Pic 3 Desc.	Current ROW conditions on the CIS of the BRP.		Pic 4 Desc.	Current ROW conditions on the GAS of the US-221 road crossing.

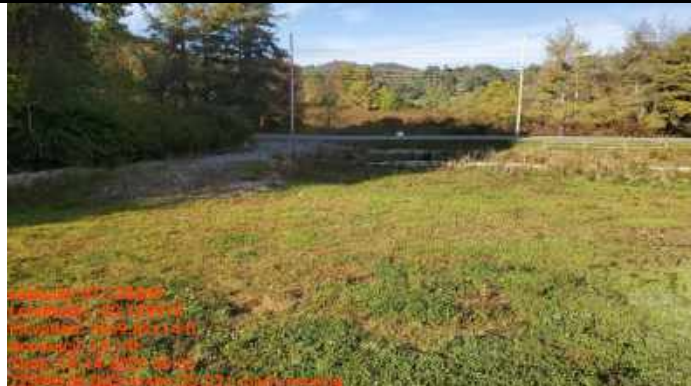
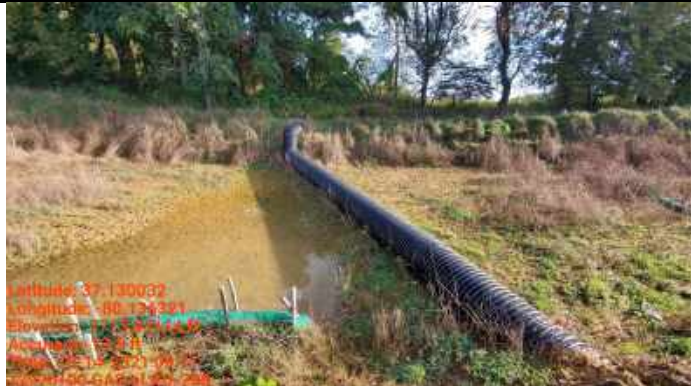
GPS Location	See pic for GPS location.		GPS Location	See pic for GPS location.	
Field Station#	12995+50		Field Station#	12976+00	
Pic 5 Desc.	Current ROW conditions on the GAS of the US-221 road crossing.		Pic 6 Desc.	CWDB and CWDP on the GAS of RO-288.

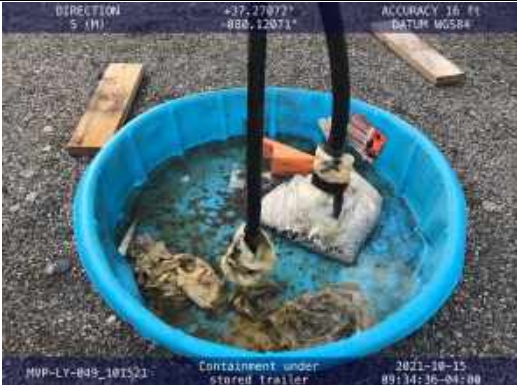
GPS Location	MVP-LY-049 See photo for gps data		GPS Location	MVP-LY-049 See photo for gps data	
Field Station#	+0		Field Station#	+0	
Pic 17 Desc.	Secondary containment under stored vehicle. Holding fluids. Looking SE.		Pic 18 Desc.	Secondary containment under stored trailer. Holding fluids. Looking S.

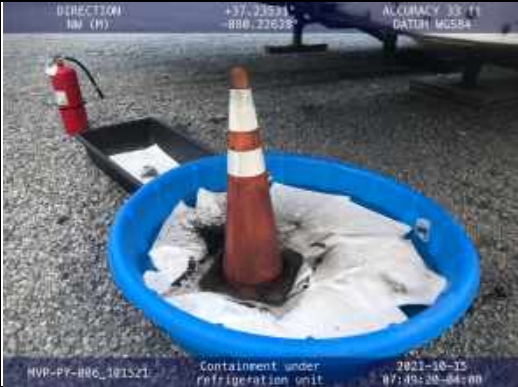
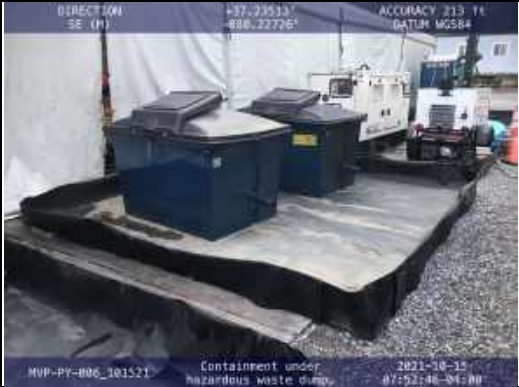
GPS Location	MVP-PY-006 See photo for gps data		GPS Location	MVP-PY-006 See photo for gps data	
Field Station#	+0		Field Station#	+0	
Pic 13 Desc.	Containment under refrigeration unit on ice trailer holding fluids. Looking NW.		Pic 14 Desc.	Containment under hazardous waste dumpsters, free of fluids. Looking SE.

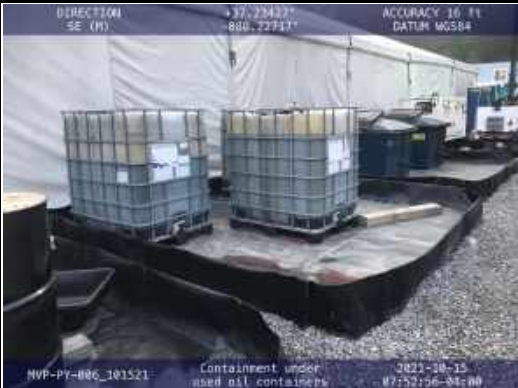
GPS Location	MVP-PY-006 See photo for gps data		GPS Location	MVP-PY-006 See photo for gps data	
Field Station#	+0		Field Station#	+0	
Pic 15 Desc.	Containment under used oil containers free of fluids. Looking SE.		Pic 16 Desc.	Condition of poly lined rock berm containments, holding some fluids. Looking SE.

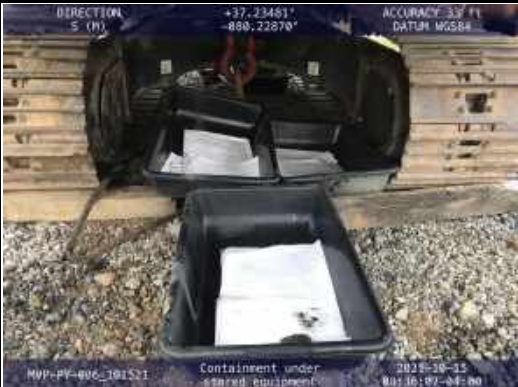
GPS Location	MVP-PY-006 See photo for gps data		GPS Location	MVP-PY-006 See photo for gps data	
Field Station#	+0		Field Station#	+0	
Pic 17 Desc.	Containments under stored equipment, holding some fluids. Looking S.		Pic 18 Desc.	Condition of posted project documents at the main entrance. Looking N.

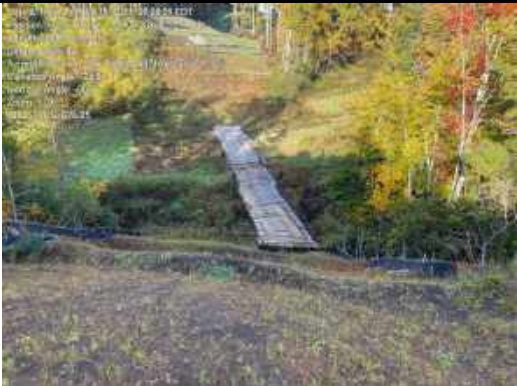
GPS Location	0	GPS Location	0		
Field Station#	13030+00	Field Station#	13024+06		
Pic 9 Desc.	ROW and ECDs in good condition with good vegetation established across ROW		Pic 10 Desc.	MVP-S-G24/25 and Corresponding buffer zone in good condition

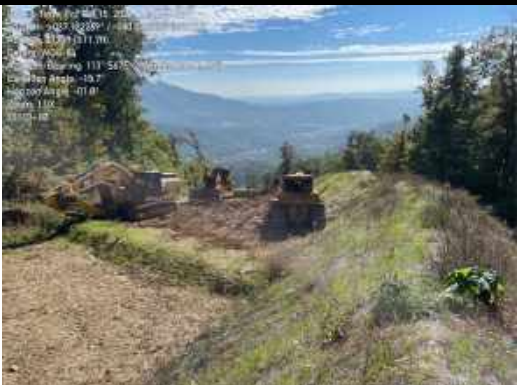
GPS Location	0	GPS Location	0		
Field Station#	13113+00	Field Station#	13113+00		
Pic 11 Desc.	ROW and ECDs in good condition with good vegetation established across ROW		Pic 12 Desc.	ROW and ECDs in good condition and stable

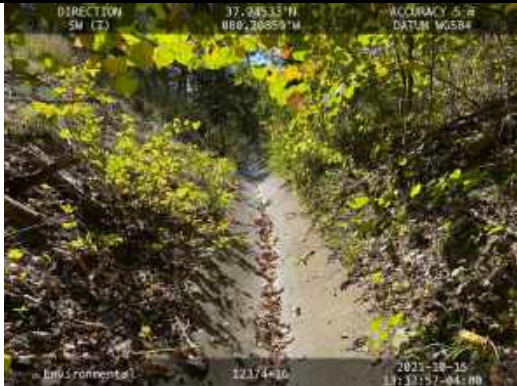
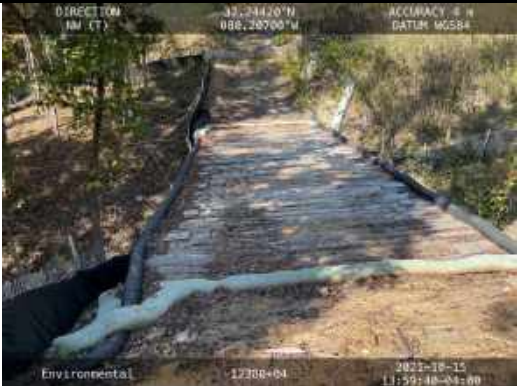
GPS Location	See photo		GPS Location	See photo	
Field Station#	12374+16		Field Station#	12380+04	
Pic 9 Desc.	Stream crossing S-0016		Pic 10 Desc.	Bridge and ECDs crossing stream S-NN19

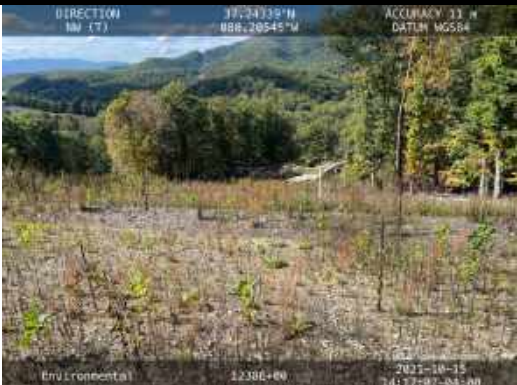
GPS Location	See photo		GPS Location	See photo	
Field Station#	12383+93		Field Station#	12386+00	
Pic 11 Desc.	Clean water crossing		Pic 12 Desc.	Stabilized ROW Conditions

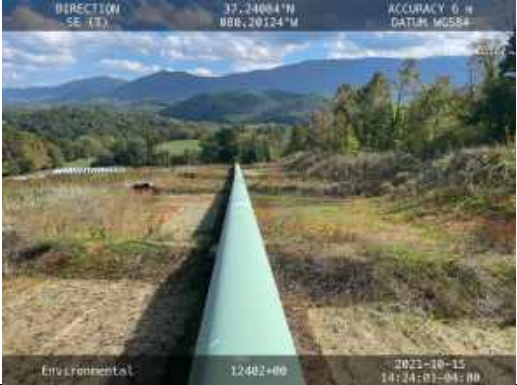
GPS Location	See photo		GPS Location	See photo	
Field Station#	12393+23		Field Station#	12402+00	
Pic 13 Desc.	Stabilized ROW Conditions		Pic 14 Desc.	Stabilized ROW Conditions

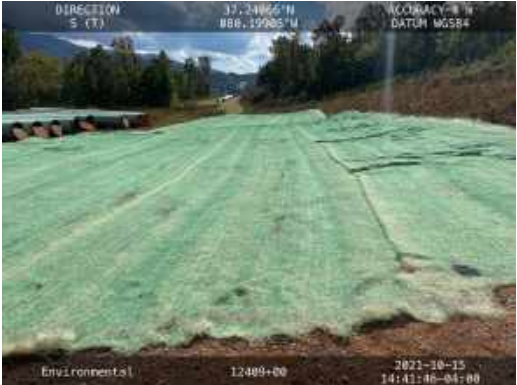
GPS Location	See photo		GPS Location	See photo	
Field Station#	12408+80		Field Station#	12409+00	
Pic 15 Desc.	Clean water crossing pipe inlet		Pic 16 Desc.	Stabilized ROW Conditions

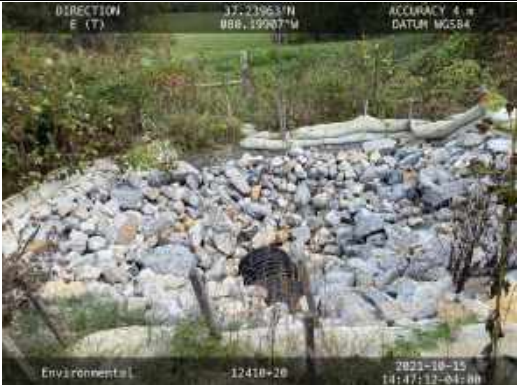
GPS Location	See photo		GPS Location	See photo	
Field Station#	12410+20		Field Station#	12418+00	
Pic 17 Desc.	Clean water crossing pipe outlet		Pic 18 Desc.	Stabilized ROW Conditions
