# Visual Site Inspection Report

<b>Project Name</b> H-600 Pipeline Spread H		<b>AFE</b> 124300138	<b>Spread</b> H-600 Pipeline Spread H
<b>Contractor</b> Precision		<b>Report #</b> 30576	
<b>Inspector</b> Joe Scott		<b>Date/Time</b> 11/1/2021 5:45 PM	
<b>Permit #</b> TBD	<b>Inspection Type</b> VA SWPP	<b>Station Begin</b> 12865+00	
<b>State</b> VA	<b>Inspection Area</b> Partial	<b>Station End</b> 13024+00	
<b>County</b> Roanoke	<b>Ground</b> Damp	<b>Temperature (°F)</b> 56.00	
<b>Municipality</b> N/A	<b>Weather</b> Sunny	<b>Rain Gauge (in)</b> 0.00	
			<b>Rain Accumulation Time (days)</b> 1.00

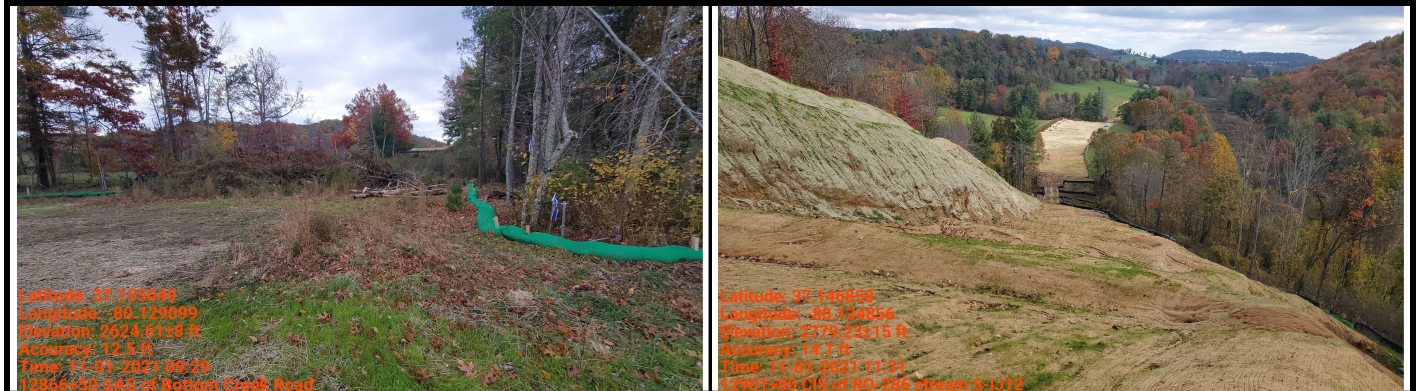
<b>GPS Location</b>	See pic for GPS location.	<b>GPS Location</b>	See pic for GPS location.
<b>Field Station#</b>	12866+50	<b>Field Station#</b>	12901+00
<b>Pic 3 Desc.</b>	No maintenance issues or impacts observed on the GAS of the Bottom Creek Road crossing.	<b>Pic 4 Desc.</b>	Current ROW conditions on the CIS of RO-286 and stream crossing S-IJ12 at the bottom of the slope.

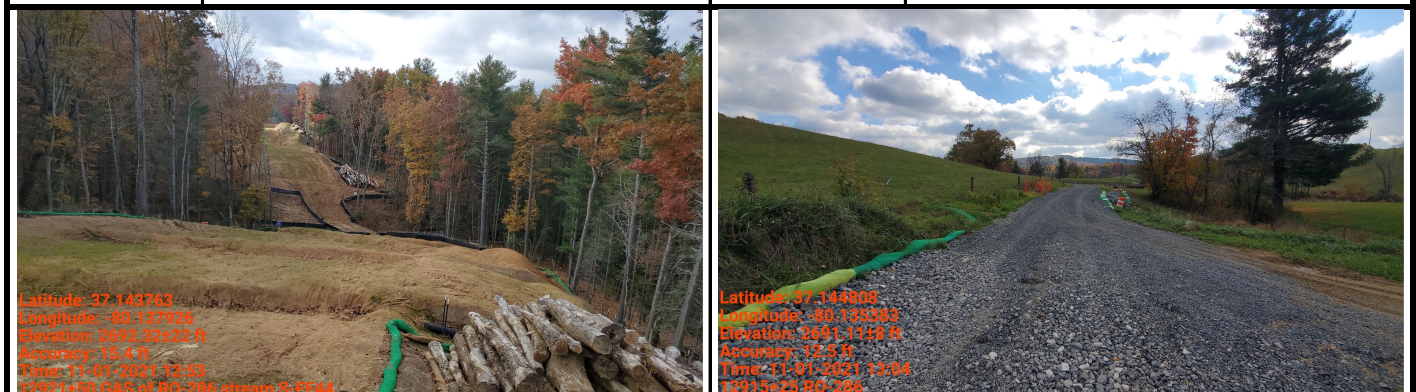
<b>GPS Location</b>	See pic for GPS location.	<b>GPS Location</b>	See pic for GPS location.
<b>Field Station#</b>	112921+50	<b>Field Station#</b>	12915+25
<b>Pic 5 Desc.</b>	Current ROW conditions on the GAS of RO-286 and stream crossing S-EF44 at the bottom of the slope.	<b>Pic 6 Desc.</b>	CWD crossing and level spreader along access RO-286.

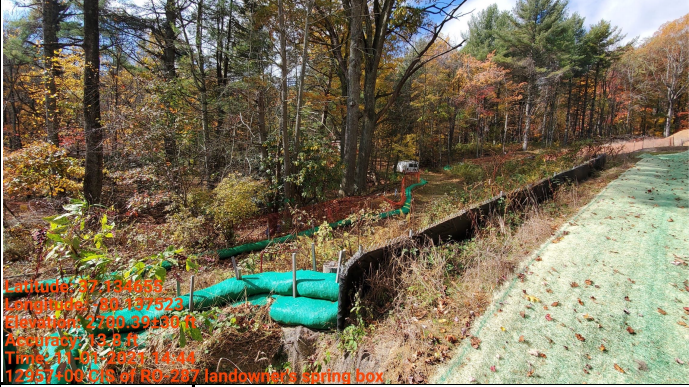
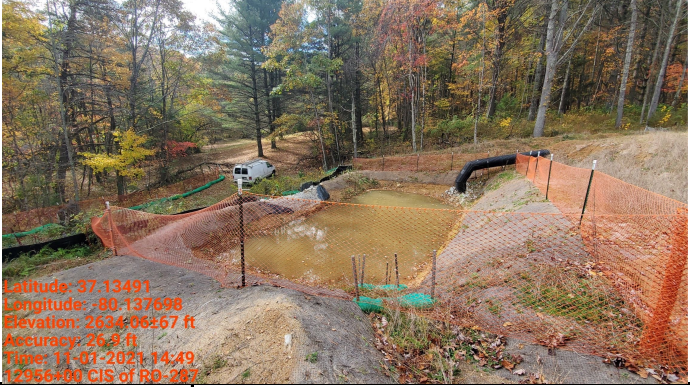
<b>GPS Location</b>	See pic for GPS location.	<b>GPS Location</b>	See pic for GPS location.
<b>Field Station#</b>	12957+00	<b>Field Station#</b>	12956+00
<b>Pic 7 Desc.</b>	No issues or impacts observed near the landowners spring box at RO-287.	<b>Pic 8 Desc.</b>	Sediment trap, ECD's and BMP's in the area remain functional and no maintenance need at this time.

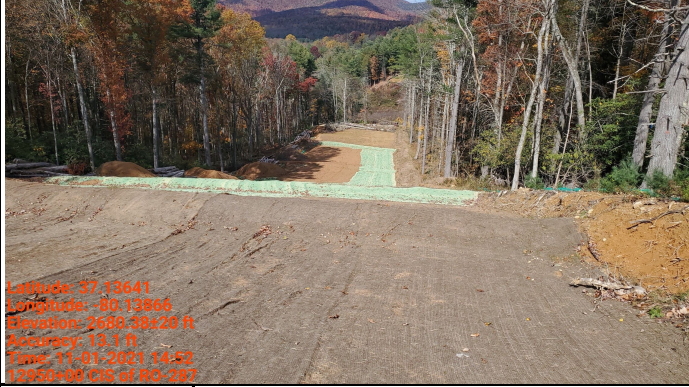
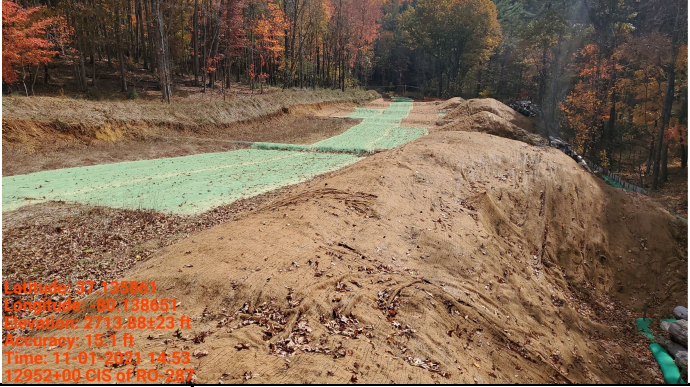
<b>GPS Location</b>	See pic for GPS location.	<b>GPS Location</b>	See pic for GPS location.
<b>Field Station#</b>	12950+00	<b>Field Station#</b>	12952+00
<b>Pic 9 Desc.</b>	Current ROW conditions on the GAS of stream S-IJ43.	<b>Pic 10 Desc.</b>	Current ROW conditions on the CIS of RO-287.

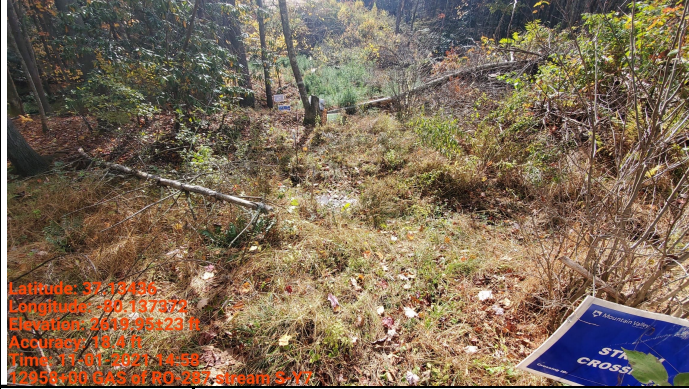
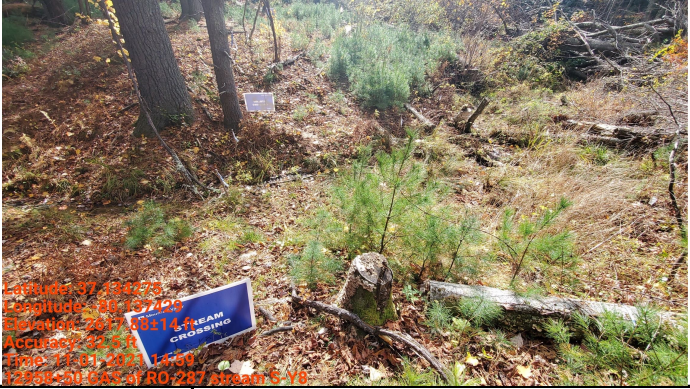
<b>GPS Location</b>	See pic for GPS location.	<b>GPS Location</b>	See pic for GPS location.
<b>Field Station#</b>	12958+00	<b>Field Station#</b>	12958+50
<b>Pic 11 Desc.</b>	Stream S-Y7 on the downstream side of the ROW.	<b>Pic 12 Desc.</b>	Stream S-Y8 on the downstream side of the ROW.

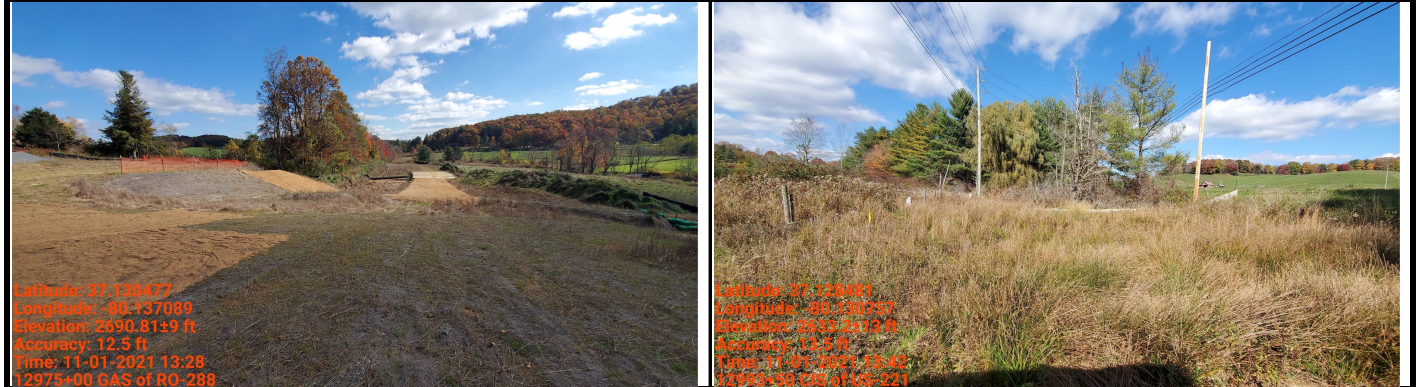
<b>GPS Location</b>	See pic for GPS location.	<b>GPS Location</b>	See pic for GPS location.
<b>Field Station#</b>	12975+00	<b>Field Station#</b>	12993+50
<b>Pic 13 Desc.</b>	Current ROW conditions on the GAS of RO-288.	<b>Pic 14 Desc.</b>	Current ROW conditions on the CIS of US-221.

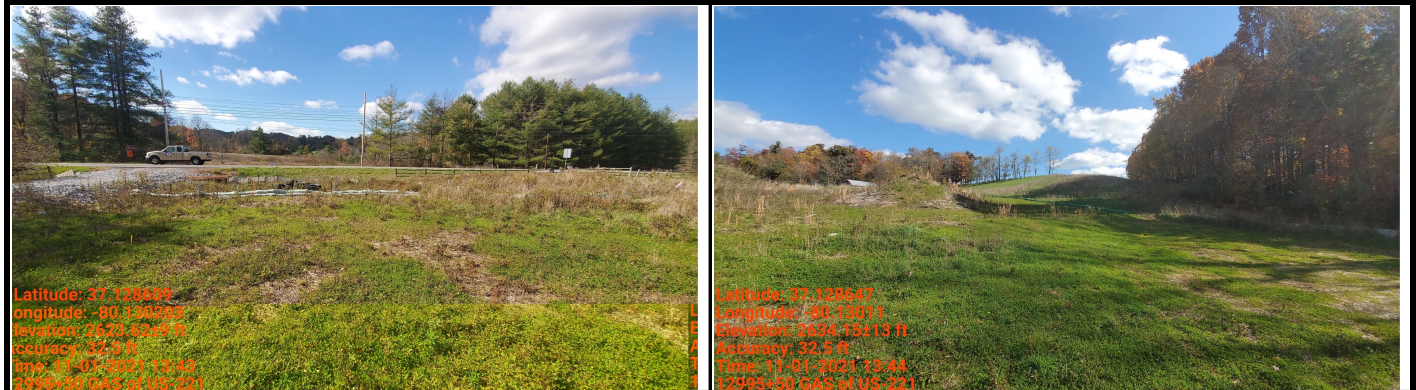
<b>GPS Location</b>	See pic for GPS location.	<b>GPS Location</b>	See pic for GPS location.
<b>Field Station#</b>	12995+50	<b>Field Station#</b>	12995+50
<b>Pic 15 Desc.</b>	Current ROW conditions on the GAS of US-221.	<b>Pic 16 Desc.</b>	Current ROW conditions on the GAS of US-221.

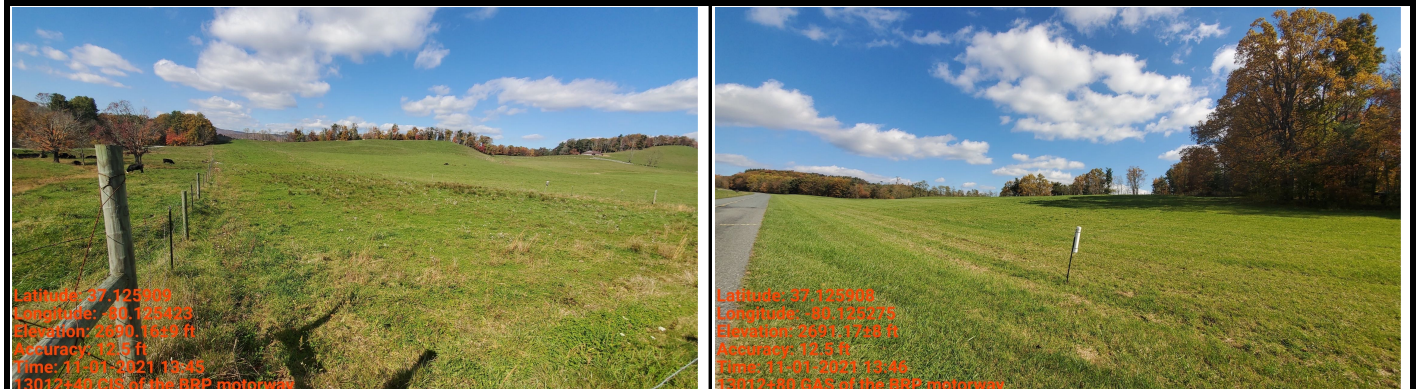
<b>GPS Location</b>	See pic for GPS location.	<b>GPS Location</b>	See pic for GPS location.
<b>Field Station#</b>	13012+40	<b>Field Station#</b>	13012+80
<b>Pic 17 Desc.</b>	Current ROW conditions on the CIS of the BRP motorway.	<b>Pic 18 Desc.</b>	Current ROW conditions on the GAS of the BRP motorway.

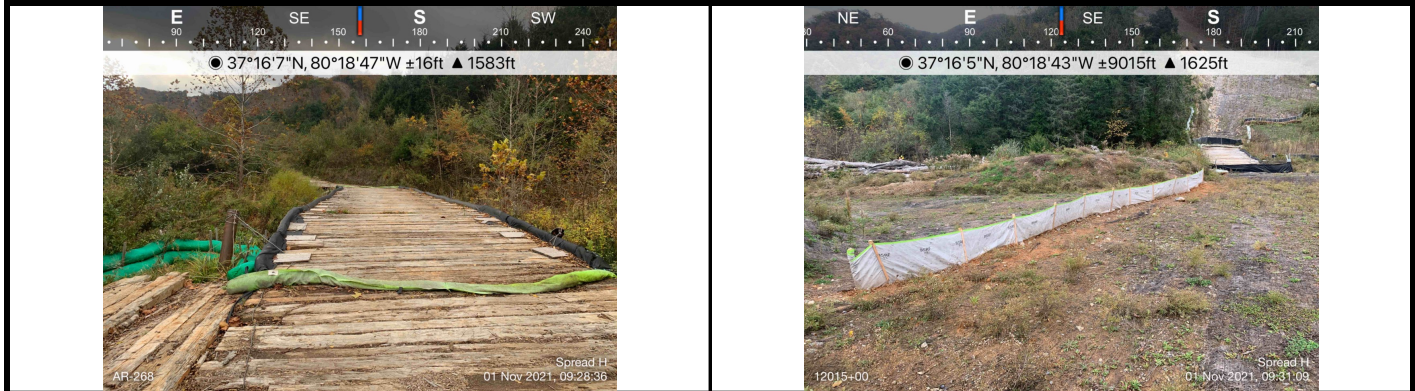
<b>Pic 3 Desc.</b>	Access road 268 is in acceptable condition.	<b>Pic 4 Desc.</b>	Newly installed silt fence is in acceptable condition.
--------------------	---	--------------------	--

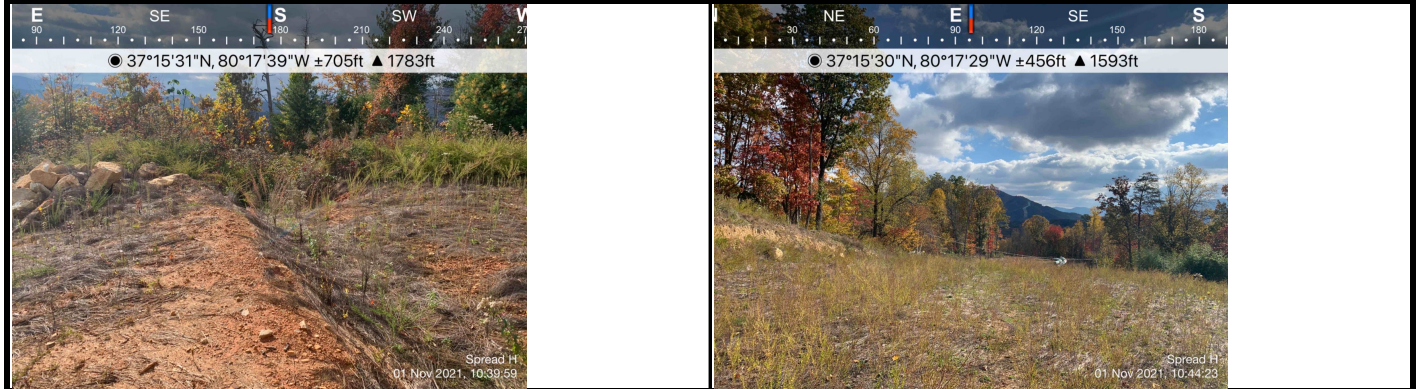
<b>GPS Location</b>	See Photograph	<b>GPS Location</b>	See Photograph
<b>Field Station#</b>	12086+00	<b>Field Station#</b>	12090+00
<b>Pic 13 Desc.</b>	Waterbars, end treatments, and sumps are in acceptable condition.	<b>Pic 14 Desc.</b>	ROW is stable with temporary vegetation in acceptable condition.

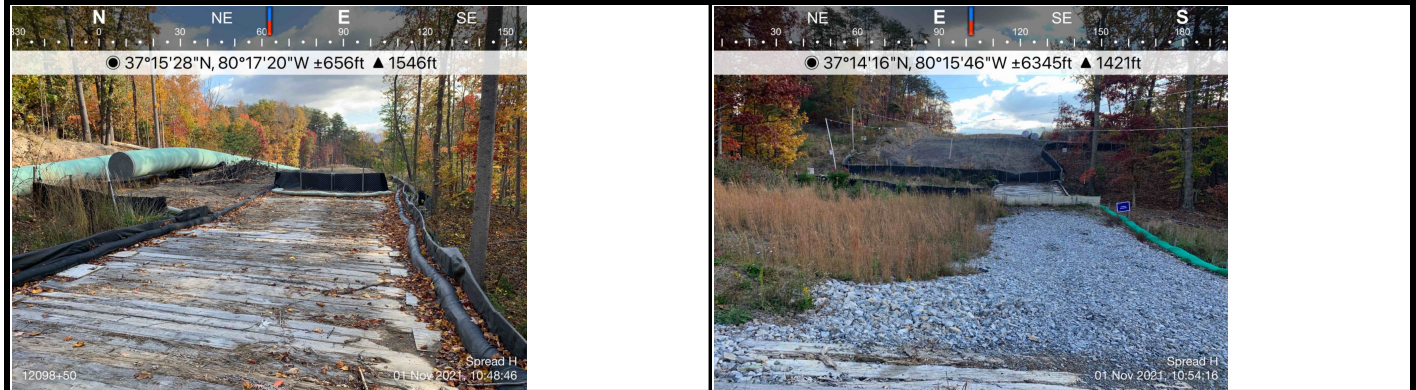
<b>GPS Location</b>	See Photograph	<b>GPS Location</b>	See Photograph
<b>Field Station#</b>	12092+00	<b>Field Station#</b>	12110+00
<b>Pic 15 Desc.</b>	Equipment bridge crossing is in acceptable condition.	<b>Pic 16 Desc.</b>	Rock construction entrance is in acceptable condition.

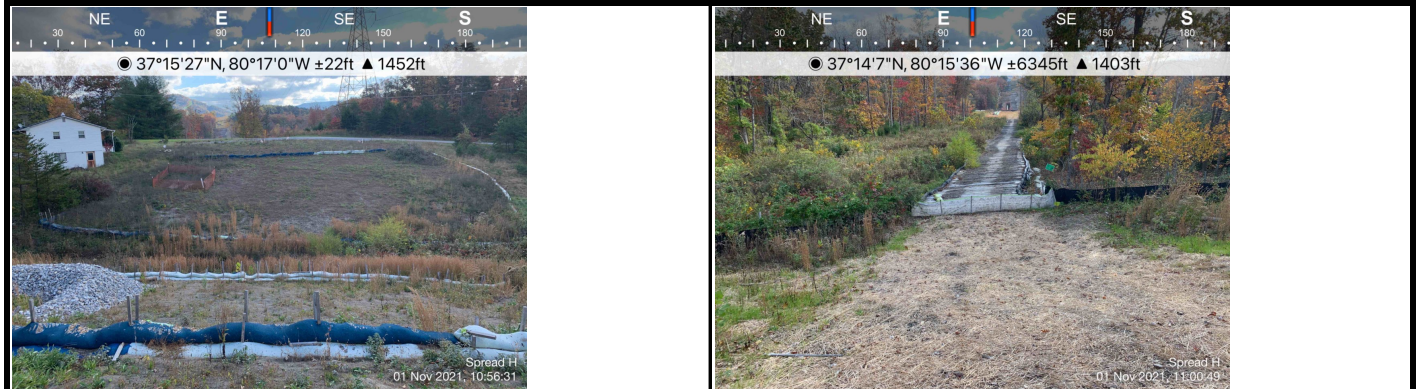
<b>GPS Location</b>	See Photograph	<b>GPS Location</b>	See Photograph
<b>Field Station#</b>	12117+00	<b>Field Station#</b>	12119+17
<b>Pic 17 Desc.</b>	Compost filter sock is in acceptable condition.	<b>Pic 18 Desc.</b>	ROW is in acceptable condition.

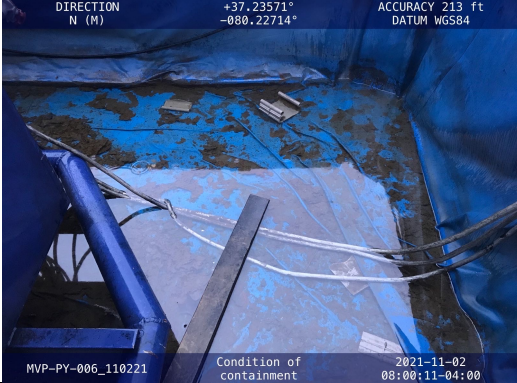
<p>DIRECTION N (M) +37.23571° -080.22714° ACCURACY 213 ft DATUM WGS84</p> <p>MVP-PY-006_110221 Condition of containment 2021-11-02 08:00:11-04:00</p>

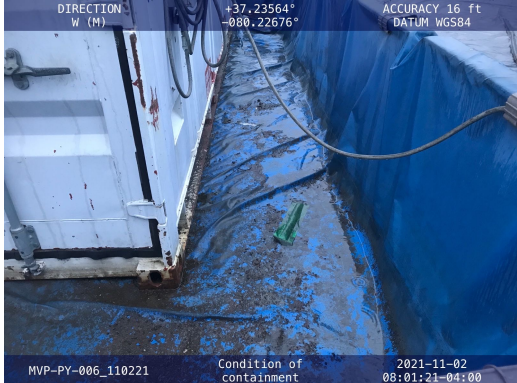
<p>DIRECTION W (M) +37.23564° -080.22676° ACCURACY 16 ft DATUM WGS84</p> <p>MVP-PY-006_110221 Condition of containment 2021-11-02 08:01:21-04:00</p>

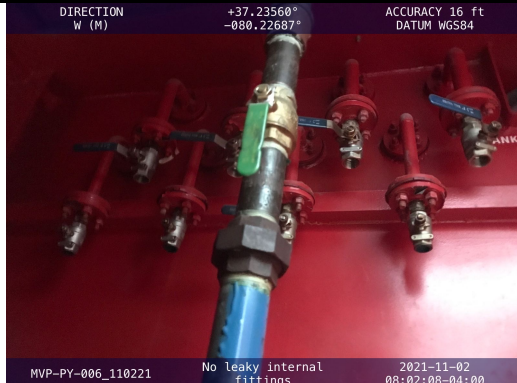
<p>DIRECTION W (M) +37.23560° -080.22687° ACCURACY 16 ft DATUM WGS84</p> <p>MVP-PY-006_110221 No leaky internal fittings 2021-11-02 08:02:08-04:00</p>

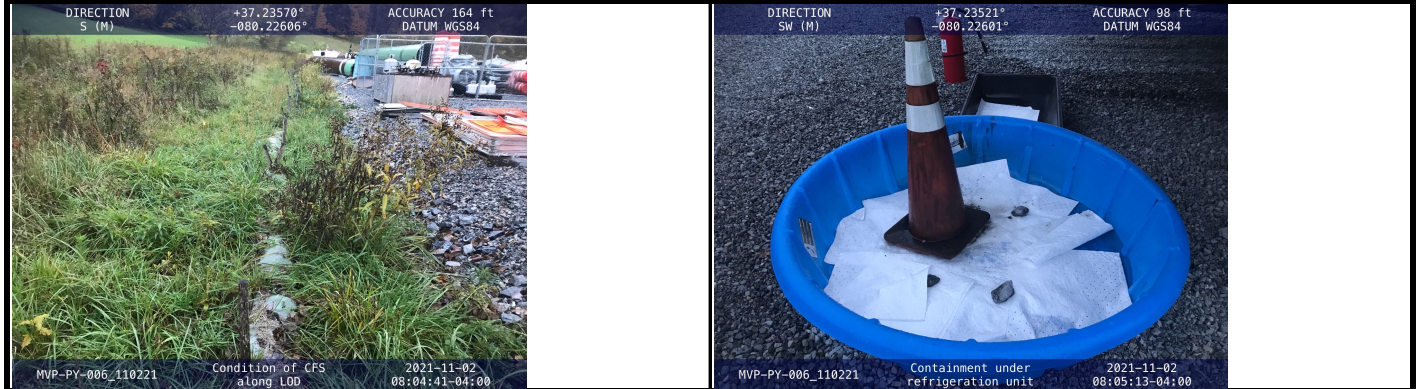
<b>GPS Location</b> MVP-PY-006 See photo for gps data	<b>GPS Location</b> MVP-PY-006 See photo for gps data
<b>Field Station#</b> +0	<b>Field Station#</b> +0
<b>Pic 13 Desc.</b> Condition of triple stack compost filter sock along east LOD. Over grown with vegetation. Looking S.	<b>Pic 14 Desc.</b> Secondary containments under refrigeration unit on ice trailer. Catching fluids. Looking SW.

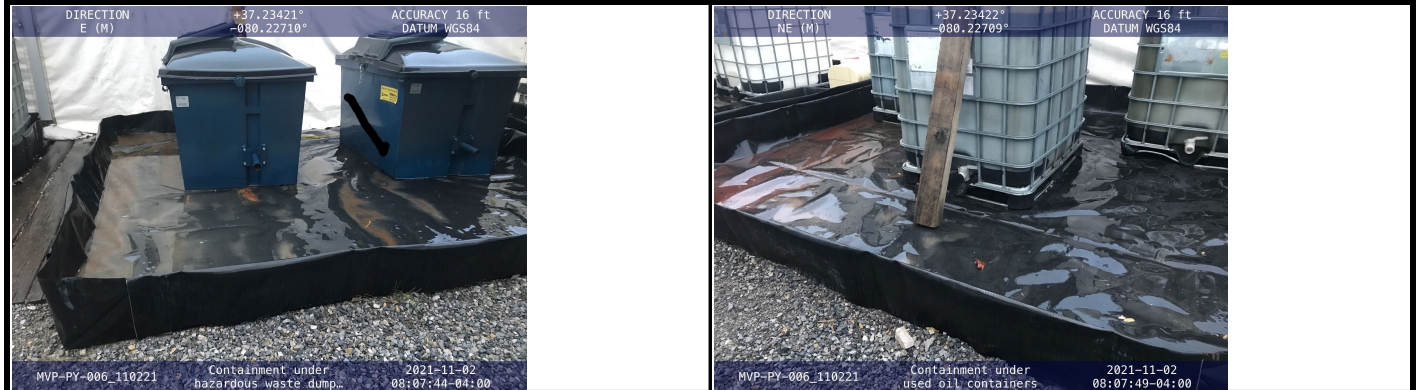
<b>GPS Location</b> MVP-PY-006 See photo for gps data	<b>GPS Location</b> MVP-PY-006 See photo for gps data
<b>Field Station#</b> +0	<b>Field Station#</b> +0
<b>Pic 15 Desc.</b> Secondary containment under hazardous waste dumpsters holding some fluids. Looking E.	<b>Pic 16 Desc.</b> Secondary containment under used oil containers. Holding some fluids. Looking NE.

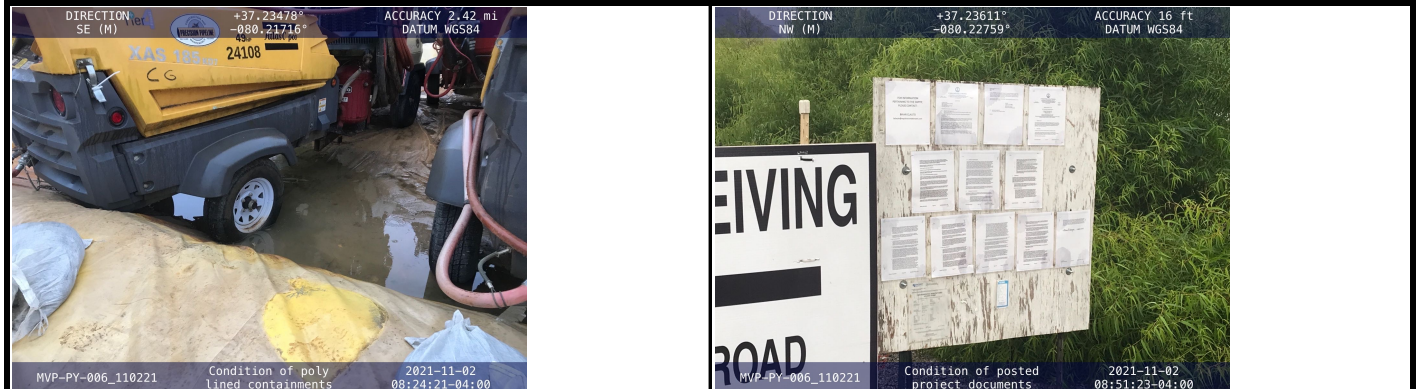
<b>GPS Location</b> MVP-PY-006 See photo for gps data	<b>GPS Location</b> MVP-PY-006 See photo for gps data
<b>Field Station#</b> +0	<b>Field Station#</b> +0
<b>Pic 17 Desc.</b> Condition of poly lined rock berm containments. Holding some stormwater. Looking SE.	<b>Pic 18 Desc.</b> Condition of posted project documents at main entrance. Looking NW.

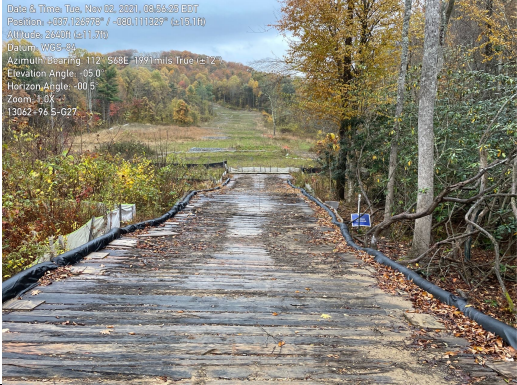
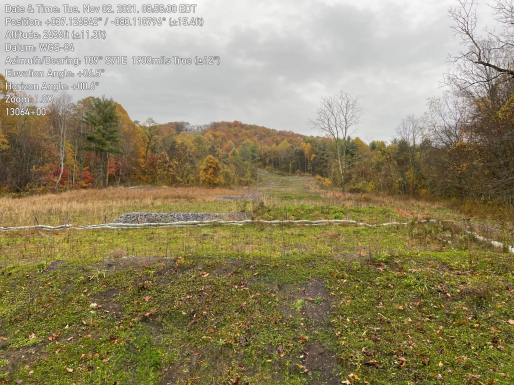
<b>GPS Location</b>	0	<b>GPS Location</b>	0		
<b>Field Station#</b>	13062+96	<b>Field Station#</b>	13064+00		
<b>Pic 7 Desc.</b>	MVP-S-G27 and Corresponding buffer zone in good condition	<b>Pic 8 Desc.</b>	ROW and ECDs In good condition with good vegetation established across ROW

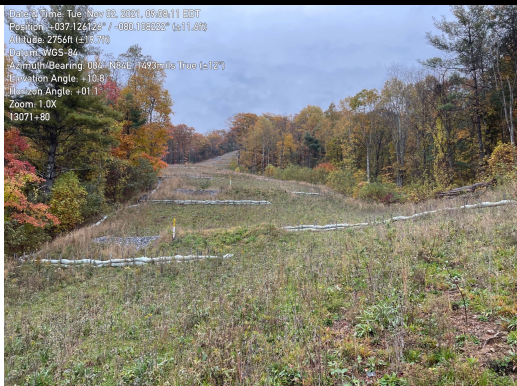
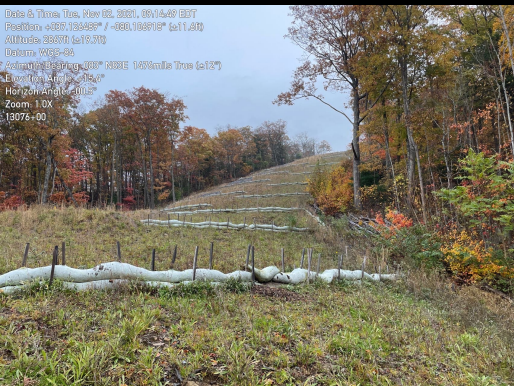
<b>GPS Location</b>	0	<b>GPS Location</b>	0		
<b>Field Station#</b>	13071+80	<b>Field Station#</b>	13076+00		
<b>Pic 9 Desc.</b>	ROW and ECDs In good condition with good vegetation established across ROW	<b>Pic 10 Desc.</b>	ROW and ECDs In good condition with good vegetation established across ROW

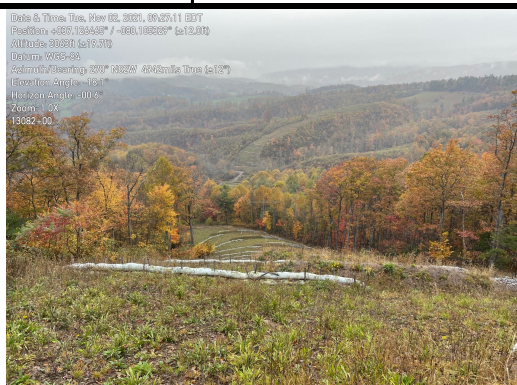
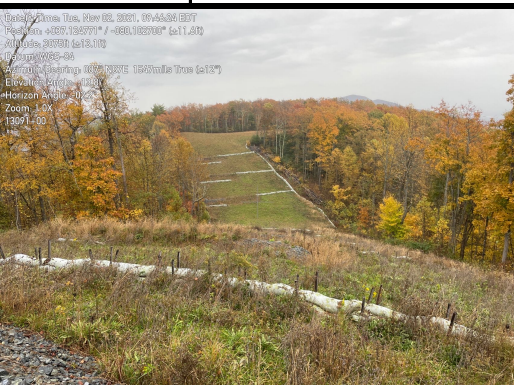
<b>GPS Location</b>	0	<b>GPS Location</b>	0		
<b>Field Station#</b>	13082+00	<b>Field Station#</b>	13091+00		
<b>Pic 11 Desc.</b>	ROW and ECDs In good condition with good vegetation established across ROW	<b>Pic 12 Desc.</b>	ROW and ECDs In good condition with good vegetation established across ROW

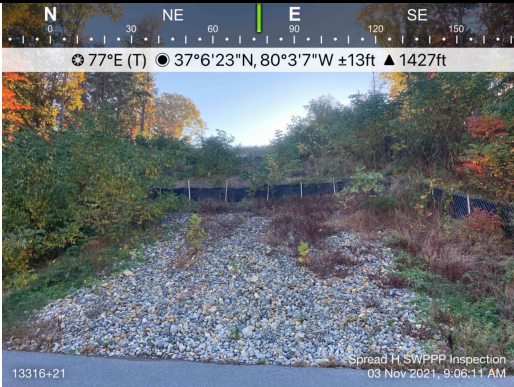
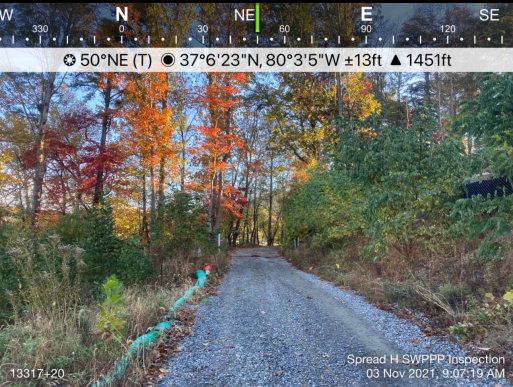
<b>GPS Location</b>	See photo above		<b>GPS Location</b>	See photo above	
<b>Field Station#</b>	13316+21		<b>Field Station#</b>	13317+20	
<b>Pic 1 Desc.</b>	Gravel construction entrance and silt fence along Wades Gap Road are in good condition.		<b>Pic 2 Desc.</b>	Compost filter sock is functioning properly and no maintenance is needed.

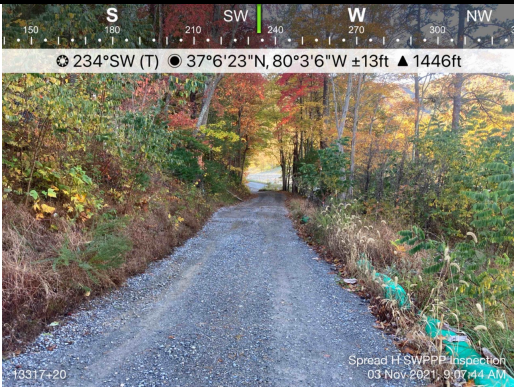
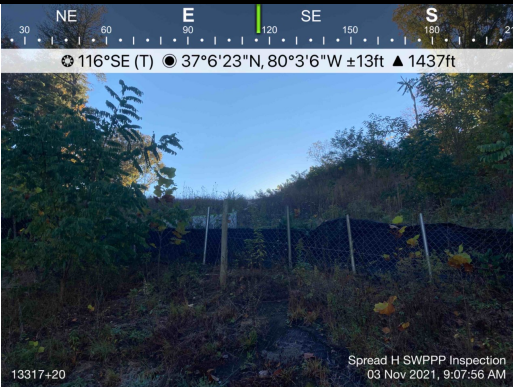
<b>GPS Location</b>	See photo above		<b>GPS Location</b>	See photo above	
<b>Field Station#</b>	13317+20		<b>Field Station#</b>	13317+20	
<b>Pic 3 Desc.</b>	Gravel path crossing the ROW is in good condition.		<b>Pic 4 Desc.</b>	Super silt fence along slopes is functioning properly and in acceptable condition.

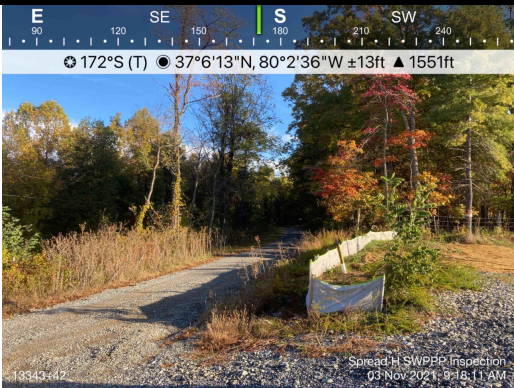
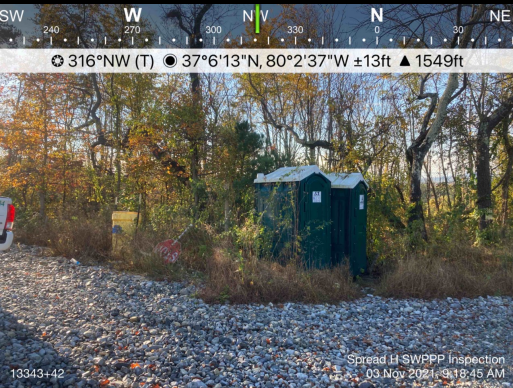
<b>GPS Location</b>	See photo above		<b>GPS Location</b>	See photo above	
<b>Field Station#</b>	13343+42		<b>Field Station#</b>	13343+42	
<b>Pic 5 Desc.</b>	Access road and construction entrance is clear and well maintained.		<b>Pic 6 Desc.</b>	Portable toilets are within secondary containments and no leaks are present.

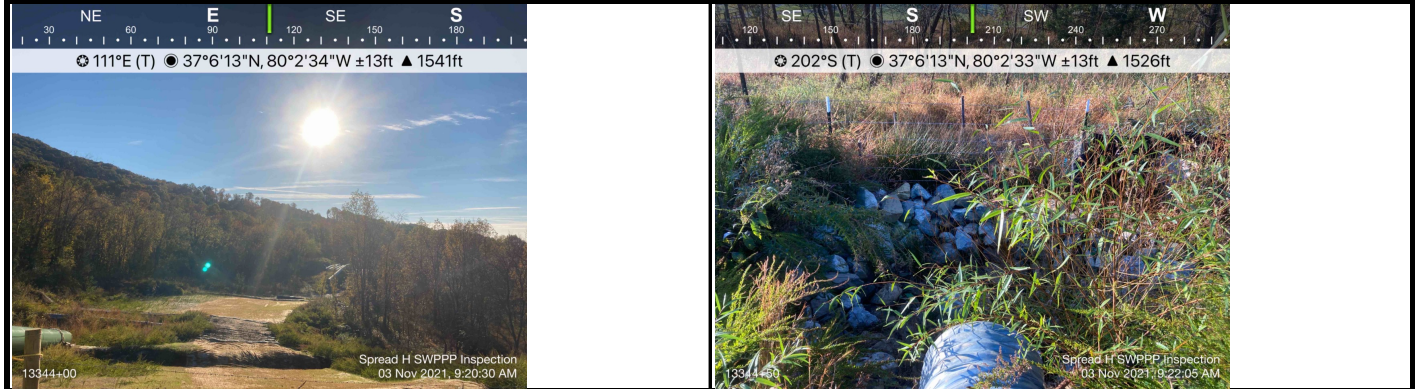
<b>GPS Location</b>	See photo above	<b>GPS Location</b>	See photo above
<b>Field Station#</b>	13344+00	<b>Field Station#</b>	13344+50
<b>Pic 7 Desc.</b>	Erosion control blanketing is present with signs of germination and in good condition.	<b>Pic 8 Desc.</b>	Clean water diversion pipe is functioning properly and no maintenance is needed.

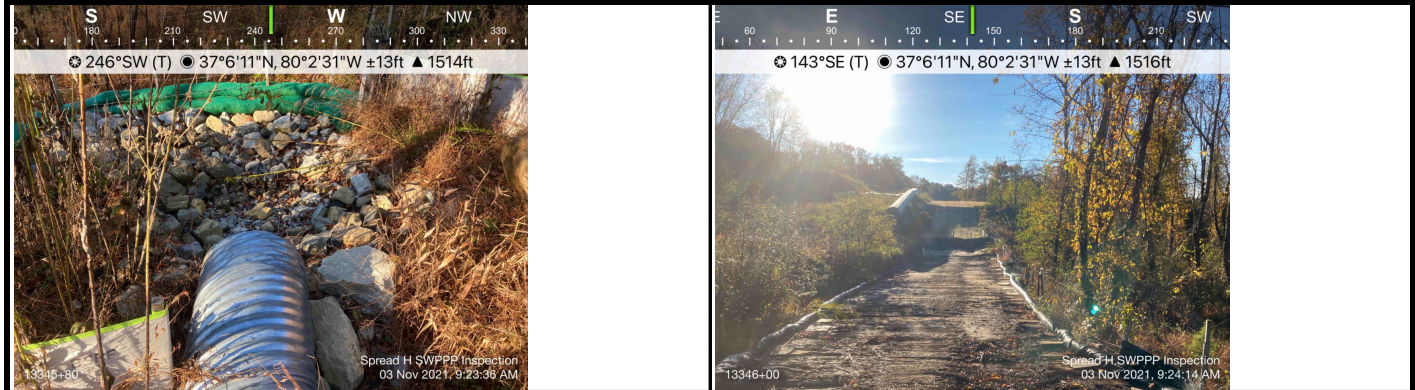
<b>GPS Location</b>	See photo above	<b>GPS Location</b>	See photo above
<b>Field Station#</b>	13345+80	<b>Field Station#</b>	13346+00
<b>Pic 9 Desc.</b>	Clean water diversion pipe end treatment is in good condition.	<b>Pic 10 Desc.</b>	Timber mat crossing is in acceptable condition and needs no maintenance.

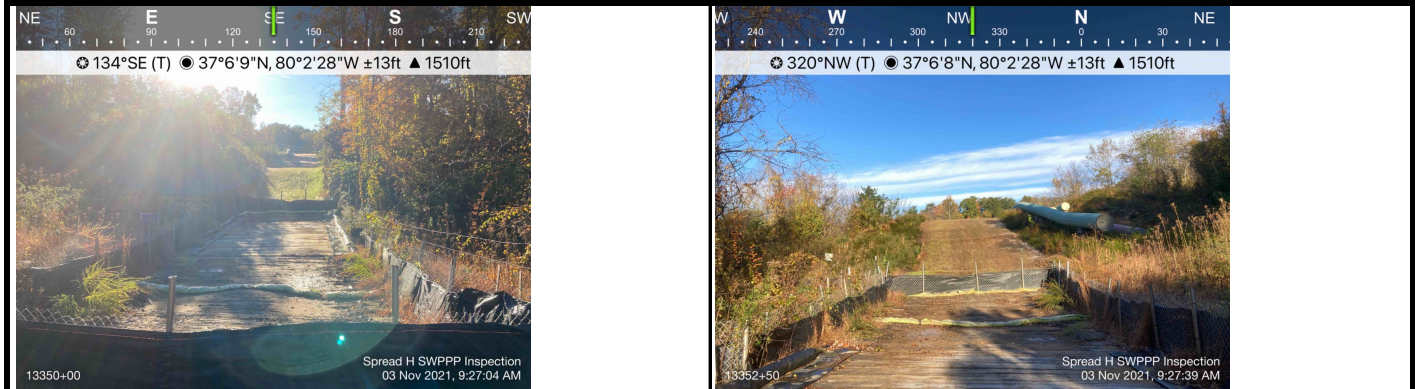
<b>GPS Location</b>	See photo above	<b>GPS Location</b>	See photo above
<b>Field Station#</b>	13350+00	<b>Field Station#</b>	13352+50
<b>Pic 11 Desc.</b>	Silt fence and erosion controls along stream crossing are in good condition.	<b>Pic 12 Desc.</b>	Materials stored along ROW are in good condition and silt fence is functioning properly.

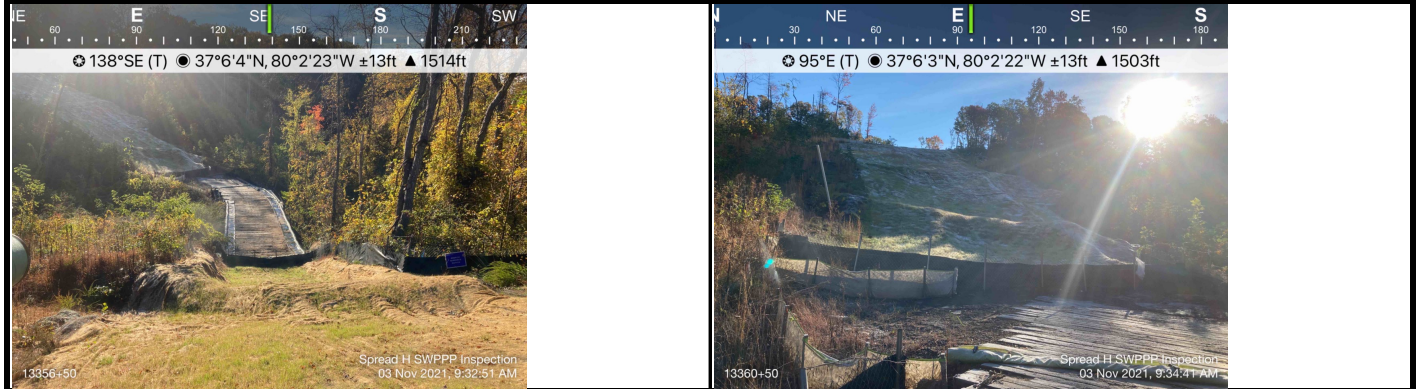
<b>GPS Location</b>	See photo above	<b>GPS Location</b>	See photo above
<b>Field Station#</b>	13356+50	<b>Field Station#</b>	13360+50
<b>Pic 13 Desc.</b>	Erosion control blanketing along waterbars is germinating and in good condition.	<b>Pic 14 Desc.</b>	Waterbars and sump pit end treatments are functioning properly. No maintenance needed.

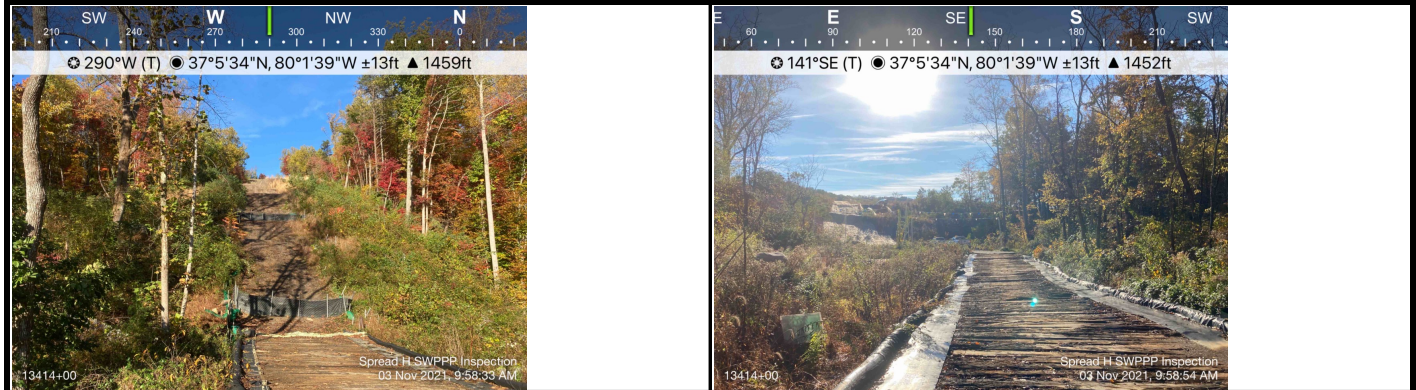
<b>GPS Location</b>	See photo above	<b>GPS Location</b>	See photo above
<b>Field Station#</b>	13414+00	<b>Field Station#</b>	13413+00
<b>Pic 15 Desc.</b>	Erosion control measures along slopes are present and functioning properly.	<b>Pic 16 Desc.</b>	Timber mat stream crossing is in acceptable condition.

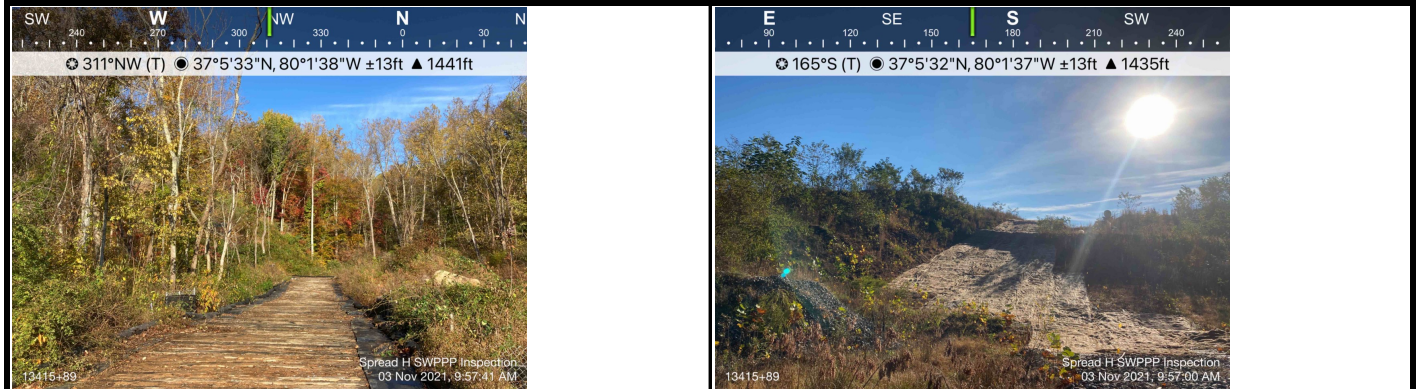
<b>GPS Location</b>	See photo above	<b>GPS Location</b>	See photo above
<b>Field Station#</b>	13415+89	<b>Field Station#</b>	13415+89
<b>Pic 17 Desc.</b>	Timber matting approaching Cahas Road are in good condition and need no maintenance.	<b>Pic 18 Desc.</b>	Erosion control blanketing across Cahas Road is present and there are signs of germination.

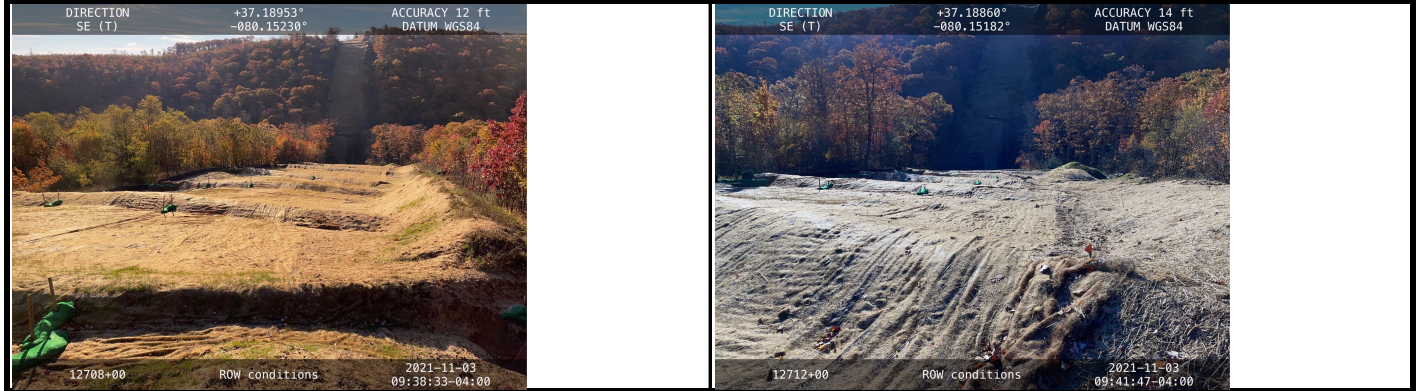
<b>GPS Location</b>	See photo for gps location data	<b>GPS Location</b>	See photo for gps location data
<b>Field Station#</b>	12708+00	<b>Field Station#</b>	12712+00
<b>Pic 7 Desc.</b>	Photo shows the ROW condition. ECDs are installed and functioning as designed.	<b>Pic 8 Desc.</b>	Photo shows the ROW condition. ECDs are installed and functioning as designed.

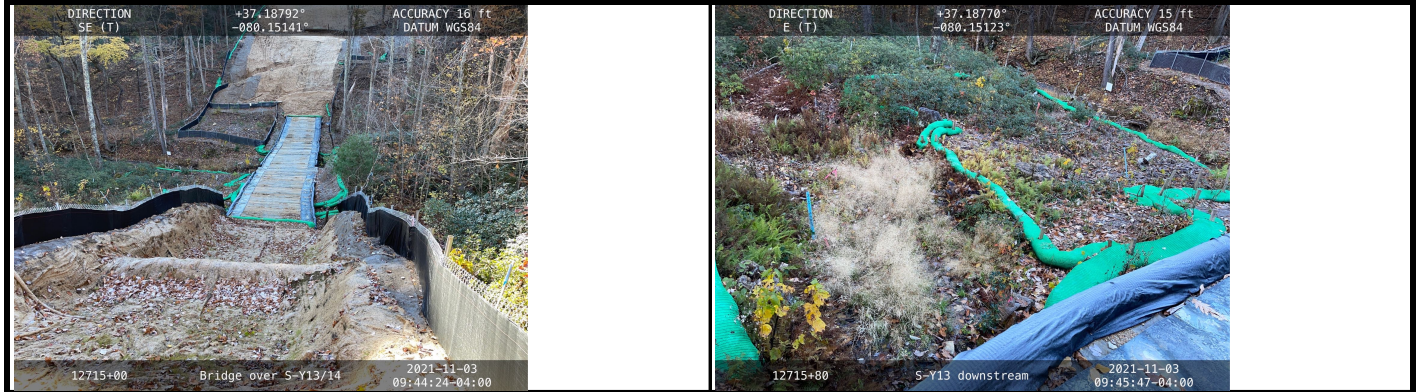
<b>GPS Location</b>	See photo for gps location data	<b>GPS Location</b>	See photo for gps location data
<b>Field Station#</b>	12715+00	<b>Field Station#</b>	12715+80
<b>Pic 9 Desc.</b>	Photo shows the bridge over streams S-Y13/14. ECDs are installed and functioning as designed.	<b>Pic 10 Desc.</b>	Photo shows stream S-Y13 downstream from the bridge

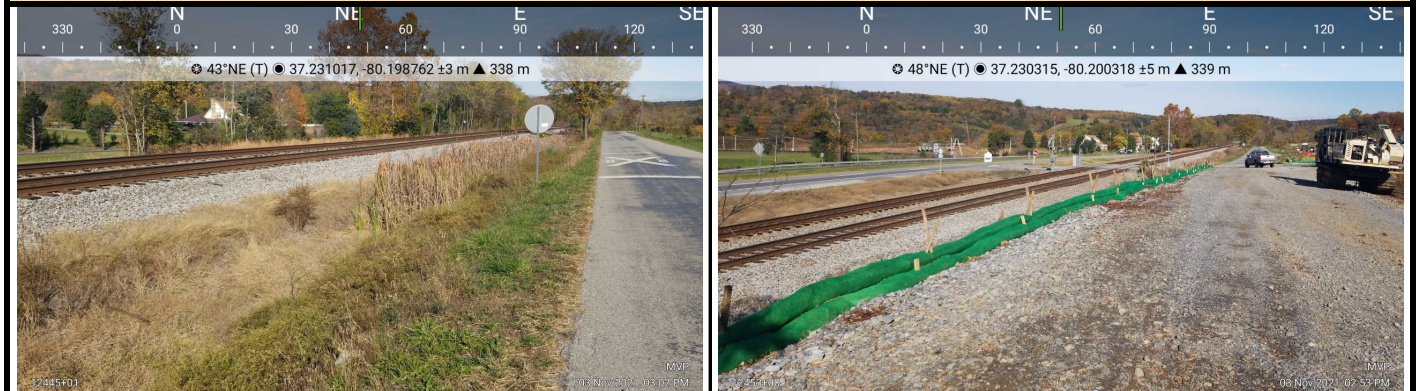
<b>GPS Location</b> See Above	<b>GPS Location</b> See Above
<b>Field Station#</b> 12445+01	<b>Field Station#</b> 12453+00
<b>Pic 1 Desc.</b> Overview of Waterbody S-I1. ROW is stable. No erosion or sedimentation concerns noted.	<b>Pic 2 Desc.</b> ROW Overview (temporary stabilization). ECDs are functional and ROW is stable.

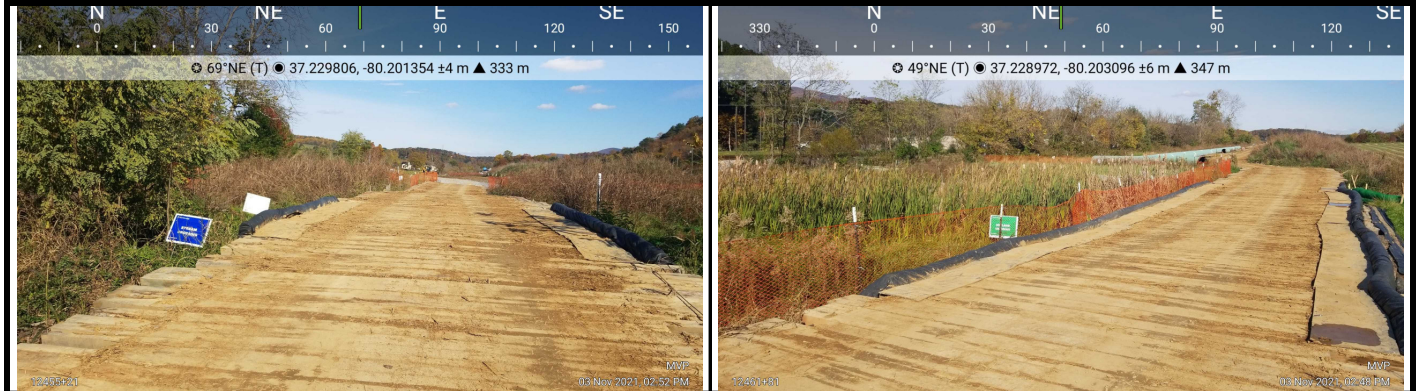
<b>GPS Location</b> See Above	<b>GPS Location</b> See Above
<b>Field Station#</b> 12455+21	<b>Field Station#</b> 12461+81
<b>Pic 3 Desc.</b> Overview of Waterbody S-CD12b. ECDs are functional and ROW is stable.	<b>Pic 4 Desc.</b> Overview of Wetland W-KL58. ECDs are functional and ROW is stable.

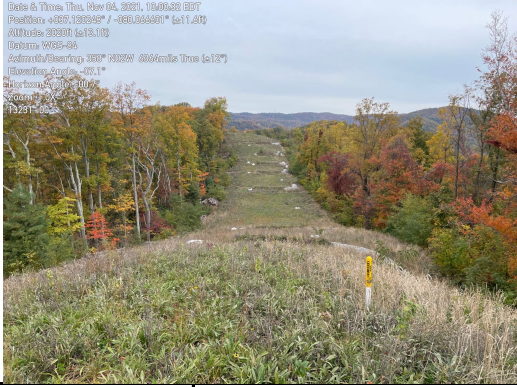
<p> <small>Date &amp; Time Thu, Nov 04, 2021, 10:02:29 EDT            Position: +35.109945° / -80.044401° (±11.81)            Altitude: 3090 ft (±1.10)            Datum: WGS-84            Azimuth/Bearing: 307° 40SW 301mils True (±12°)            Elevation Angle: +01°            Horizon Angle: +01°            Zoom: 1.0X            13231+00</small> </p>	
<b>GPS Location</b>	0	<b>GPS Location</b>	0
<b>Field Station#</b>	13244+00	<b>Field Station#</b>	13231+00
<b>Pic 7 Desc.</b>	ROW and ECDs In Good condition with good vegetation established across ROW	<b>Pic 8 Desc.</b>	ROW and ECDs In Good condition with good vegetation established across ROW

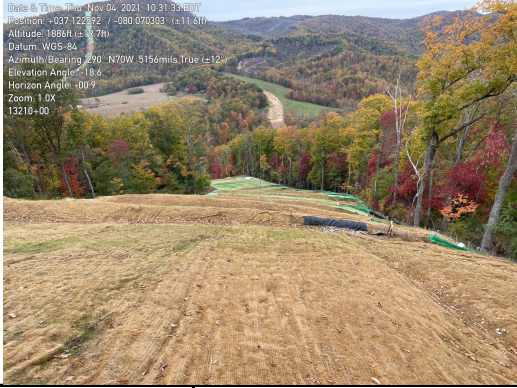
<p> <small>Date &amp; Time Thu, Nov 04, 2021, 10:31:34 EDT            Position: +35.122232° / -80.070333° (±11.81)            Altitude: 1886 ft (±1.70)            Datum: WGS-84            Azimuth/Bearing: 290° 107W 515mils True (±12°)            Elevation Angle: +04°            Horizon Angle: +00°            Zoom: 1.0X            13210+00</small> </p>	
<b>GPS Location</b>	0	<b>GPS Location</b>	0
<b>Field Station#</b>	13212+00	<b>Field Station#</b>	13210+00
<b>Pic 11 Desc.</b>	ROW and ECDs In Good condition with good vegetation established across ROW	<b>Pic 12 Desc.</b>	ROW and ECDs In good condition and stable

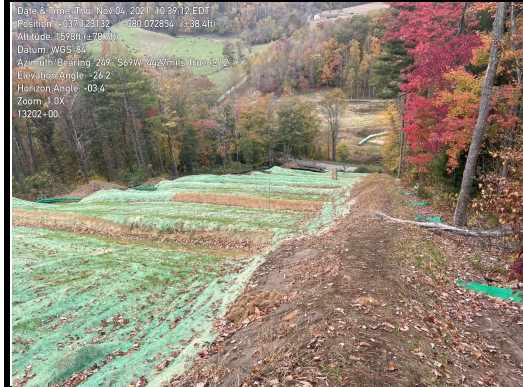
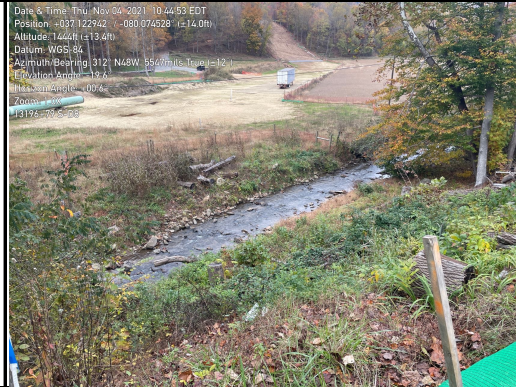
<b>GPS Location</b>	0
<b>Field Station#</b>	13202+00
<b>Pic 13 Desc.</b>	ROW and ECDs In good condition and stable

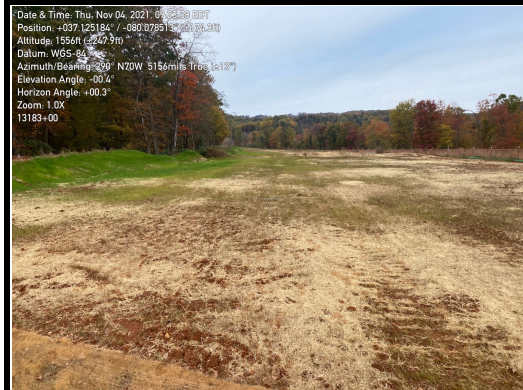
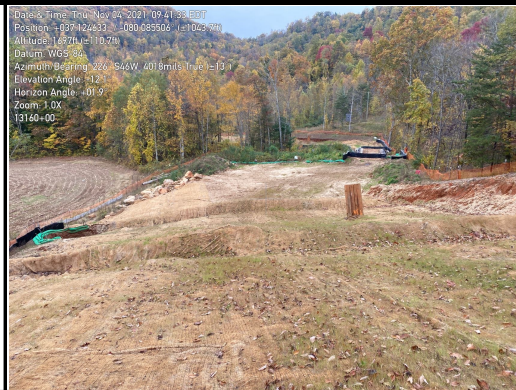
<b>GPS Location</b>	0
<b>Field Station#</b>	13183+00
<b>Pic 15 Desc.</b>	ROW and ECDs In good condition and stable

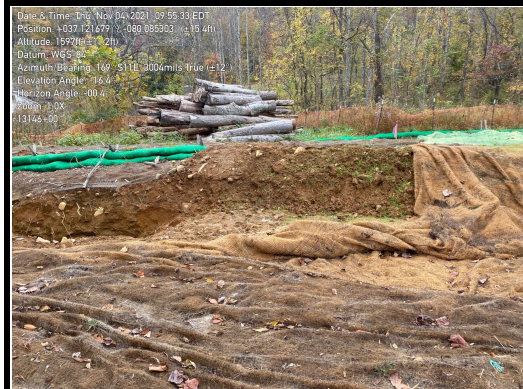
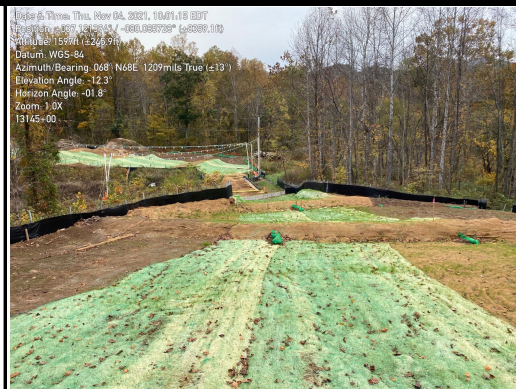
<b>GPS Location</b>	0
<b>Field Station#</b>	13146+00
<b>Pic 17 Desc.</b>	Curlex needs fixed and pinned - 72hr maintenance item

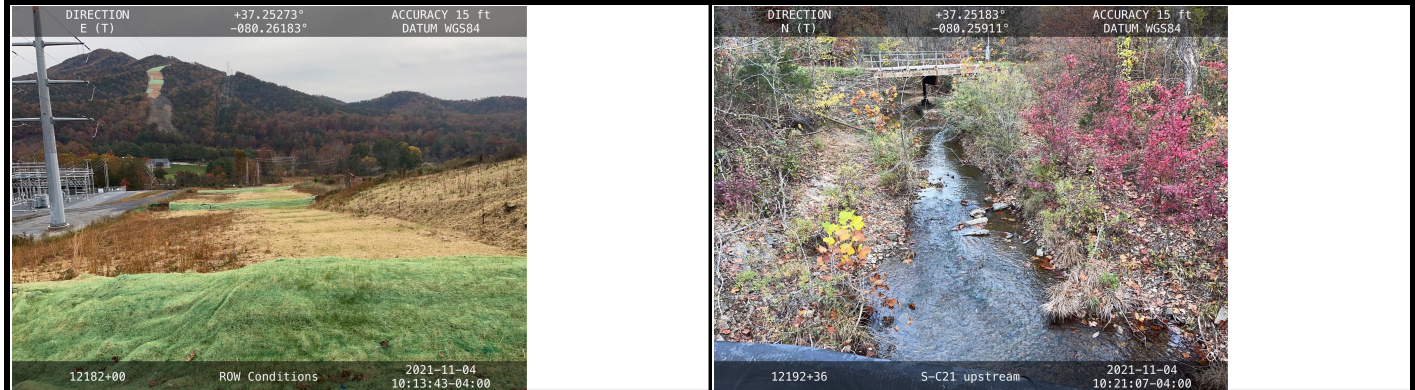
<b>GPS Location</b>	See photo for gps location data	<b>GPS Location</b>	See photo for gps location data
<b>Field Station#</b>	12182+00	<b>Field Station#</b>	12192+36
<b>Pic 15 Desc.</b>	Photo shows the ROW condition. ECDs are installed and functioning as designed	<b>Pic 16 Desc.</b>	Photo shows stream S-C21
