# Visual Site Inspection Report

<b>Project Name</b> H-600 Pipeline Spread H		<b>AFE</b> 124300138	<b>Spread</b> H-600 Pipeline Spread H
<b>Contractor</b> Precision		<b>Report #</b> 30576	
<b>Inspector</b> Joe Scott		<b>Date/Time</b> 11/1/2021 5:45 PM	
<b>Permit #</b> TBD	<b>Inspection Type</b> VA SWPP	<b>Station Begin</b> 12865+00	
<b>State</b> VA	<b>Inspection Area</b> Partial	<b>Station End</b> 13024+00	
<b>County</b> Roanoke	<b>Ground</b> Damp	<b>Temperature (°F)</b> 56.00	
<b>Municipality</b> N/A	<b>Weather</b> Sunny	<b>Rain Gauge (in)</b> 0.00	
			<b>Rain Accumulation Time (days)</b> 1.00

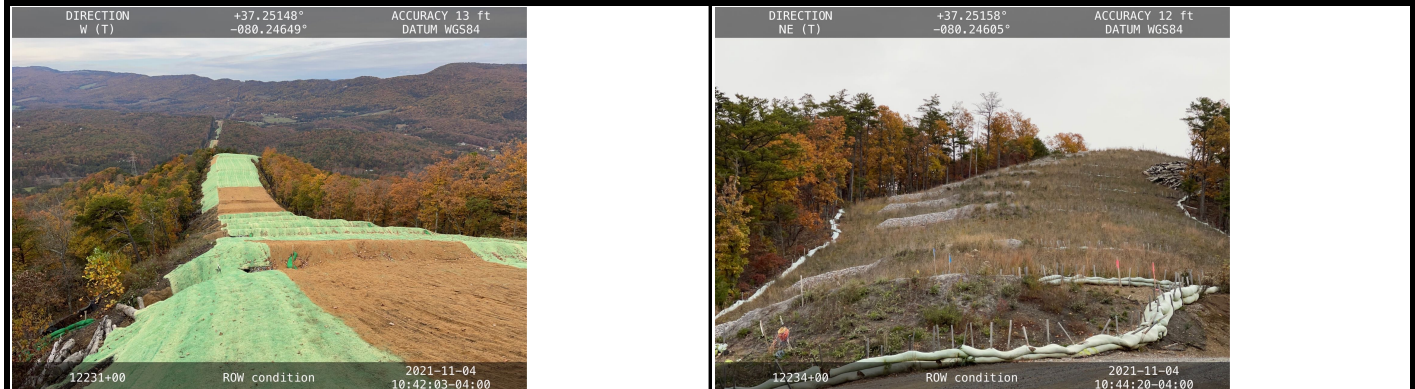
<b>GPS Location</b>	See photo for gps location data	<b>GPS Location</b>	See photo for gps location data
<b>Field Station#</b>	12231+00	<b>Field Station#</b>	12234+00
<b>Pic 17 Desc.</b>	Photo shows the ROW condition. ECDs are installed and functioning as designed	<b>Pic 18 Desc.</b>	Photo shows the ROW condition. ECDs are installed and functioning as designed

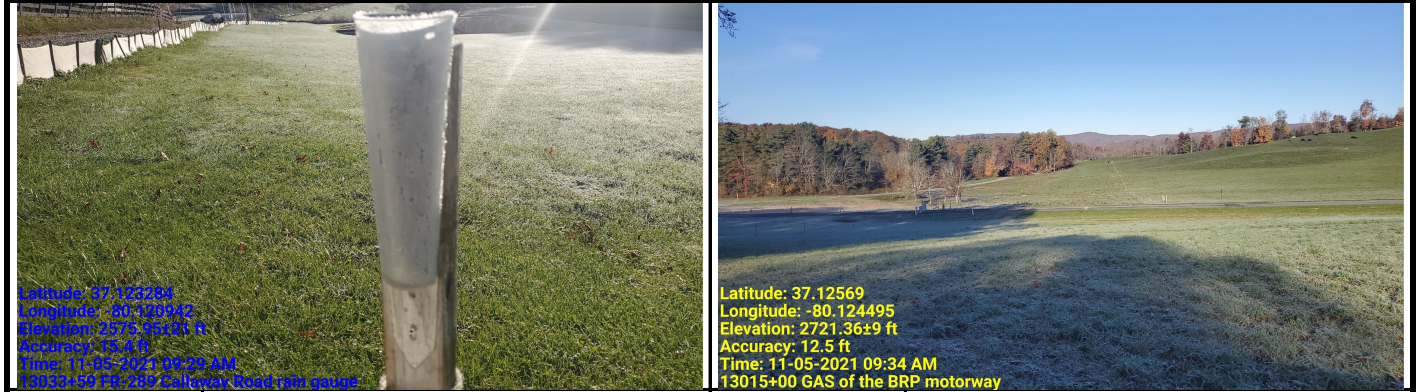
<b>GPS Location</b>	See pic for GPS location.	<b>GPS Location</b>	See pic for GPS location.
<b>Field Station#</b>	13033+59	<b>Field Station#</b>	13015+00
<b>Pic 1 Desc.</b>	0.0" total precipitation at Callaway Road.	<b>Pic 2 Desc.</b>	Current ROW conditions at the BRP motorway.

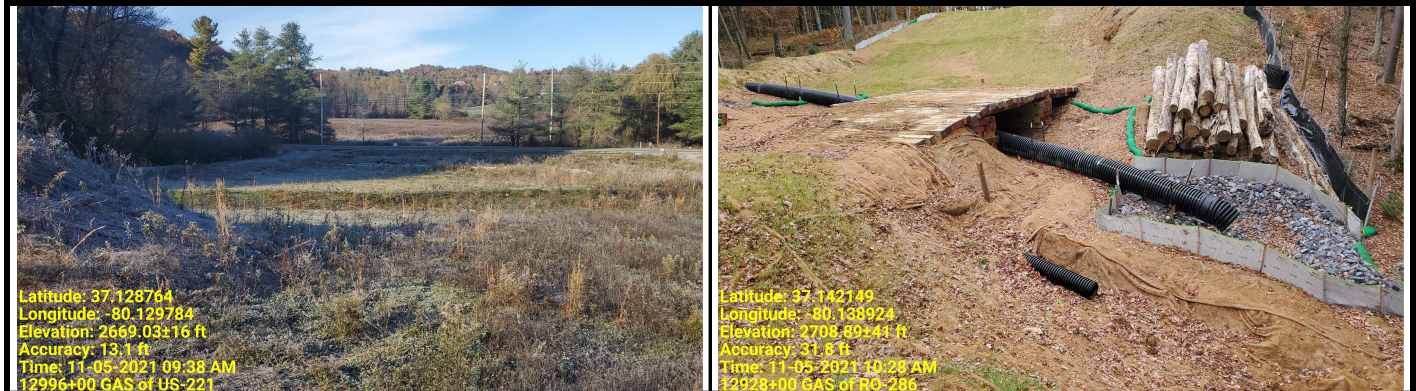
<b>GPS Location</b>	See pic for GPS location.	<b>GPS Location</b>	See pic for GPS location.
<b>Field Station#</b>	12966+00	<b>Field Station#</b>	12928+00
<b>Pic 3 Desc.</b>	Current ROW conditions on the GAS of US-221.	<b>Pic 4 Desc.</b>	CWDP and Plunge Pool on the GAS of RO-286.

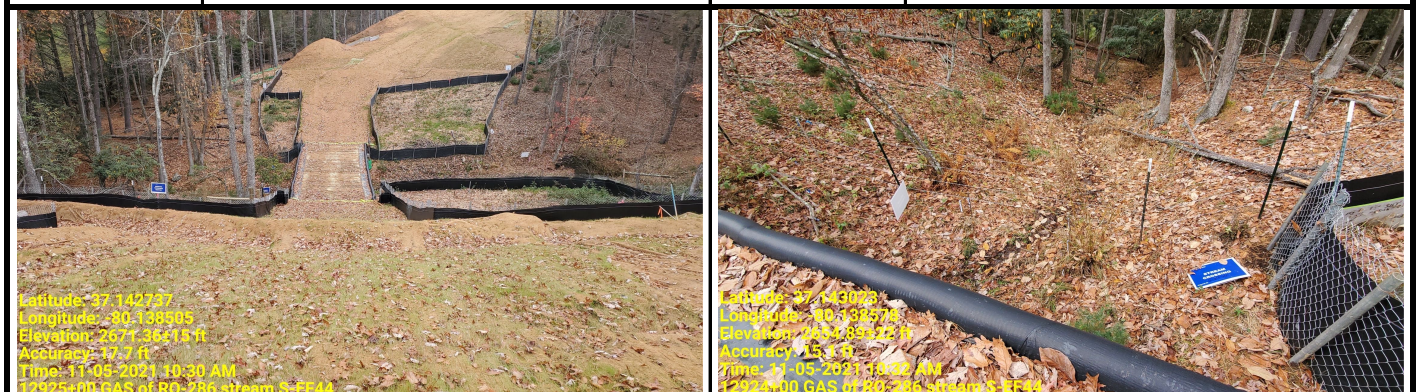
<b>GPS Location</b>	See pic for GPS location.	<b>GPS Location</b>	See pic for GPS location.
<b>Field Station#</b>	12925+00	<b>Field Station#</b>	12924+00
<b>Pic 5 Desc.</b>	Stream S-EF44 from the GAS.	<b>Pic 6 Desc.</b>	Downstream side of stream S-EF44.

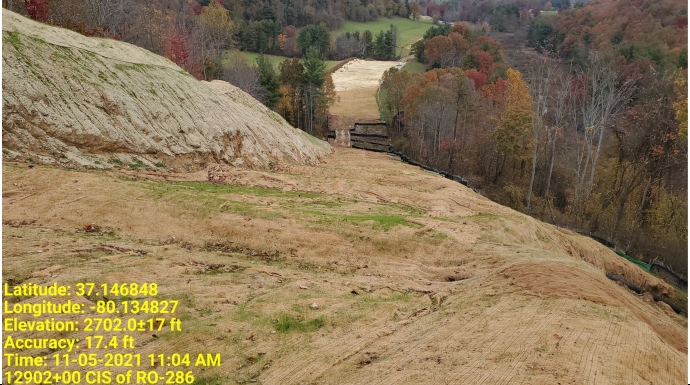
<p>Latitude: 37.146848 Longitude: -80.134827 Elevation: 2702.0±17 ft Accuracy: 17.4 ft Time: 11-05-2021 11:04 AM 12902+00 CIS of RO-286</p>	
<b>GPS Location</b>	See pic for GPS location.	<b>GPS Location</b>	See pic for GPS location.
<b>Field Station#</b>	12924+00	<b>Field Station#</b>	12902+00
<b>Pic 7 Desc.</b>	Upstream side of stream S-EF44.	<b>Pic 8 Desc.</b>	Current ROW conditions on the CIS of RO-286.

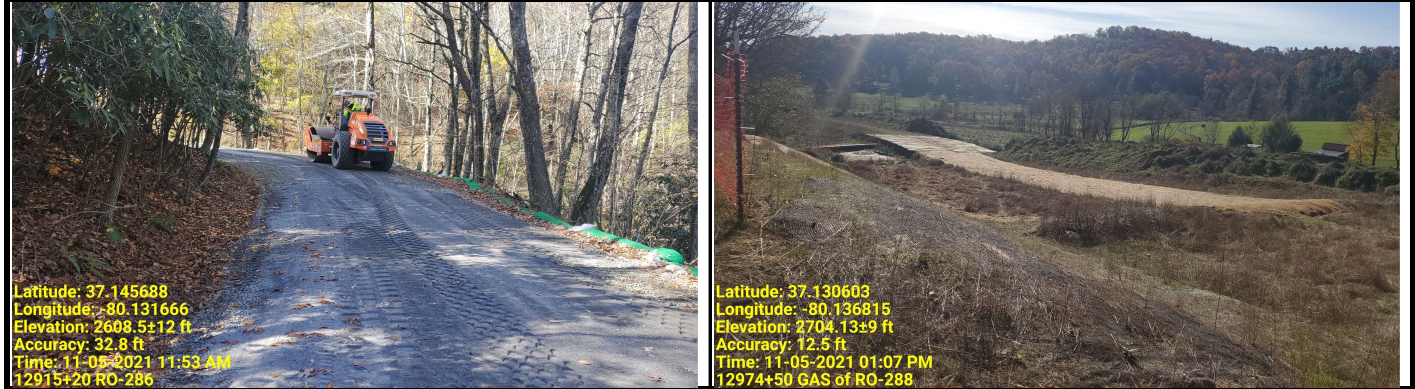
<b>GPS Location</b>	See pic for GPS location.	<b>GPS Location</b>	See pic for GPS location.
<b>Field Station#</b>	12915+20	<b>Field Station#</b>	12974+50
<b>Pic 13 Desc.</b>	Contractor rolling the gravel access road RO-286.	<b>Pic 14 Desc.</b>	Current ROW conditions on the GAS of RO-288.

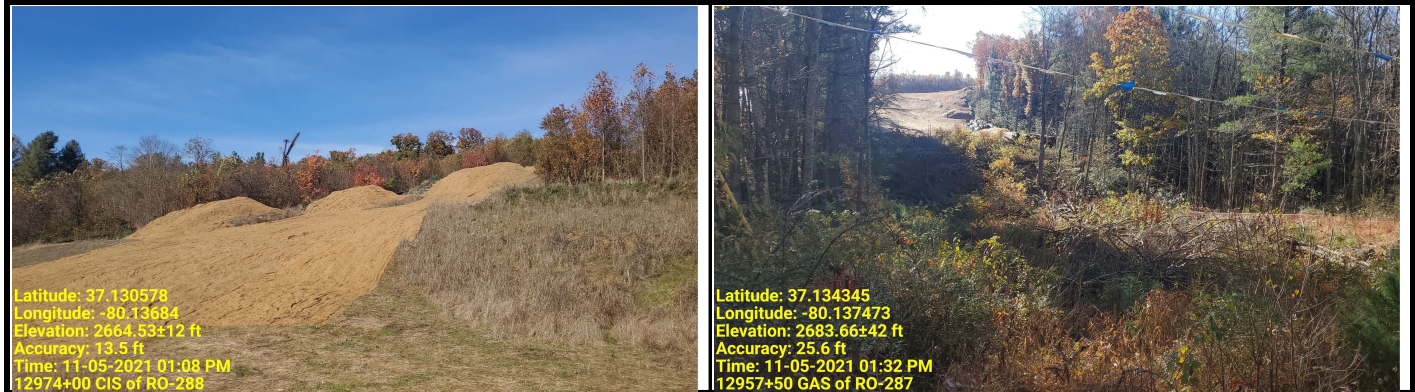
<b>GPS Location</b>	See pic for GPS location.	<b>GPS Location</b>	See pic for GPS location.
<b>Field Station#</b>	12974+00	<b>Field Station#</b>	12957+50
<b>Pic 15 Desc.</b>	Current ROW conditions on the CIS of RO-288.	<b>Pic 16 Desc.</b>	GAS of RO-287 streams S-Y7 and S-Y8.
