# Visual Site Inspection Report

<b>Project Name</b>	H-600 Pipeline Spread H	<b>AFE</b>	124300138	<b>Spread</b>	H-600 Pipeline Spread H
<b>Contractor</b>	Precision			<b>Report #</b>	30940
<b>Inspector</b>	Jason Nielsen			<b>Date/Time</b>	11/8/2021 7:09 PM
<b>Permit #</b>	TBD	<b>Inspection Type</b>	VA SWPP	<b>Station Begin</b>	12284+75
<b>State</b>	VA	<b>Inspection Area</b>	Partial	<b>Station End</b>	12443+75
<b>County</b>	Montgomery	<b>Ground</b>	Dry	<b>Temperature (°F)</b>	68.00
<b>Municipality</b>	N/A	<b>Weather</b>	Sunny	<b>Rain Gauge (in)</b>	0.00
				<b>Rain Accumulation Time (days)</b>	0.00

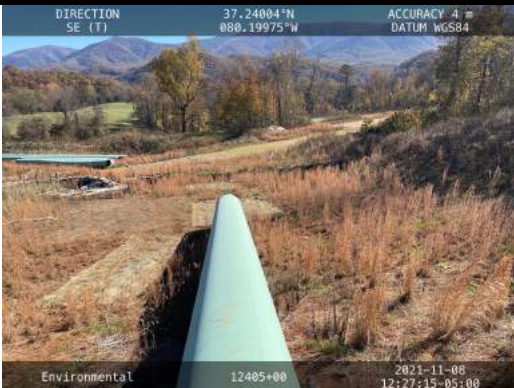
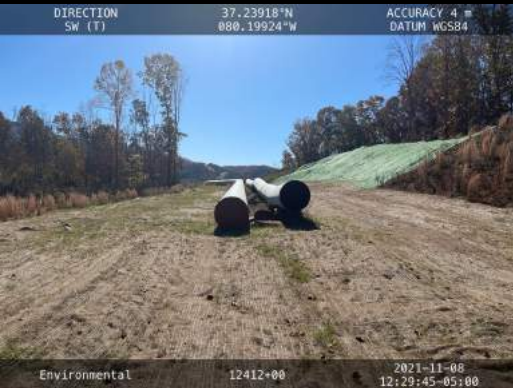
<b>GPS Location</b>	See photo		<b>GPS Location</b>	See photo	
<b>Field Station#</b>	12405+00		<b>Field Station#</b>	12412+00	
<b>Pic 5 Desc.</b>	Stabilized ROW Conditions		<b>Pic 6 Desc.</b>	Stabilized ROW Conditions

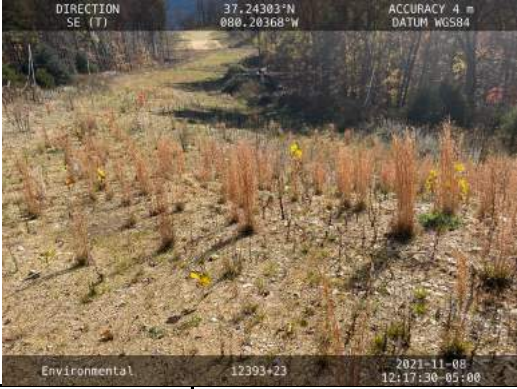
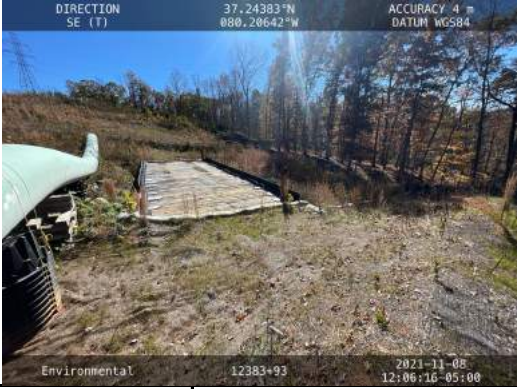
<b>GPS Location</b>	See photo		<b>GPS Location</b>	see photo	
<b>Field Station#</b>	12393+23		<b>Field Station#</b>	12383+93	
<b>Pic 7 Desc.</b>	Stabilized ROW Conditions		<b>Pic 8 Desc.</b>	Clean water crossing in acceptable condition

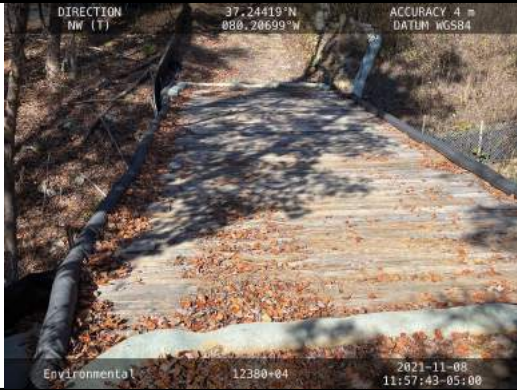
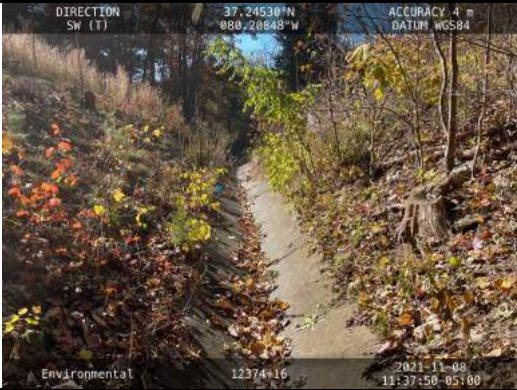
<b>GPS Location</b>	See photo		<b>GPS Location</b>	See photo	
<b>Field Station#</b>	12380+04		<b>Field Station#</b>	12374+16	
<b>Pic 9 Desc.</b>	Bridge and ECDs crossing stream S-NN19		<b>Pic 10 Desc.</b>	Stream crossing S-OO16 in acceptable condition

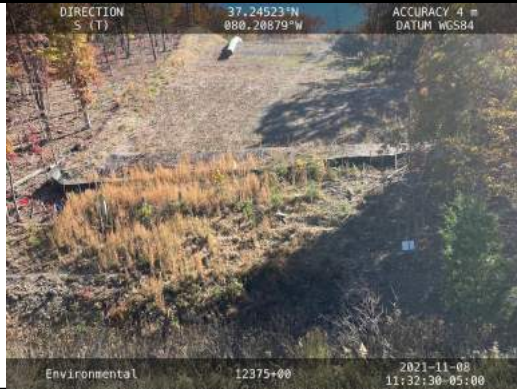
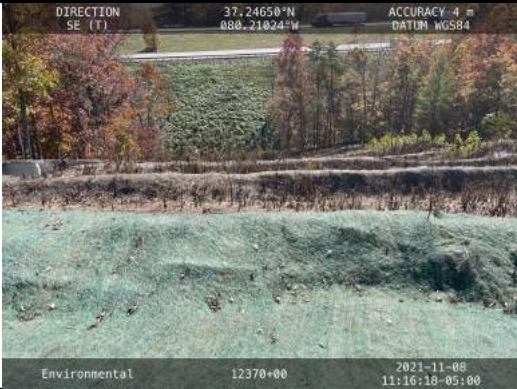
<b>GPS Location</b>	See photo		<b>GPS Location</b>	See photo	
<b>Field Station#</b>	12375+00		<b>Field Station#</b>	12370+00	
<b>Pic 11 Desc.</b>	Stabilized ROW Conditions		<b>Pic 12 Desc.</b>	Stabilized ROW Conditions

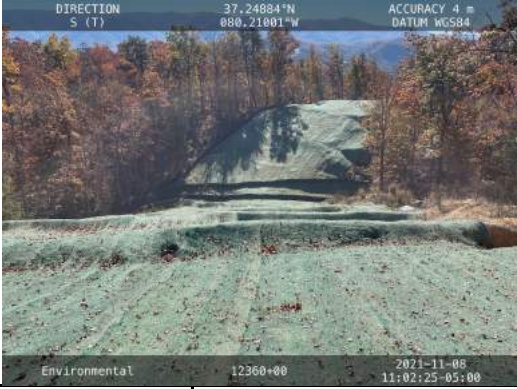
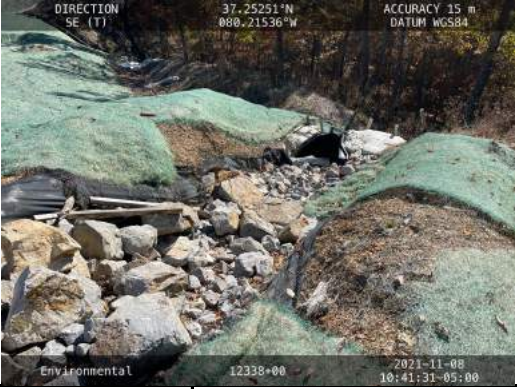
<b>GPS Location</b>	See photo		<b>GPS Location</b>	See photo	
<b>Field Station#</b>	12360+00		<b>Field Station#</b>	12338+00	
<b>Pic 13 Desc.</b>	Stabilized ROW Conditions		<b>Pic 14 Desc.</b>	Fill slope drain pipe inlet

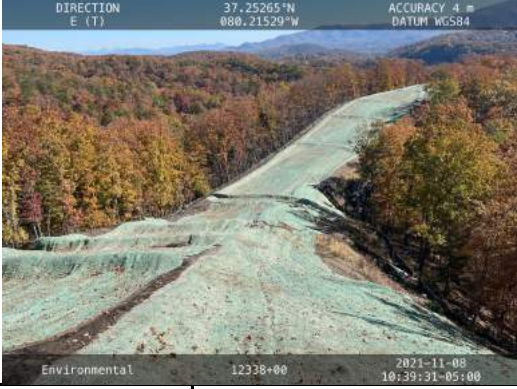
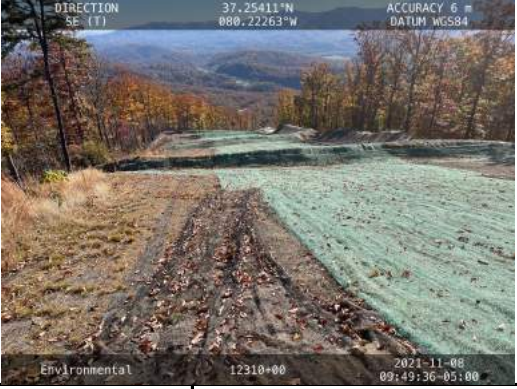
<b>GPS Location</b>	See photo		<b>GPS Location</b>	See photo	
<b>Field Station#</b>	12338+00		<b>Field Station#</b>	12310+00	
<b>Pic 15 Desc.</b>	Stabilized ROW Conditions		<b>Pic 16 Desc.</b>	Stabilized ROW Conditions

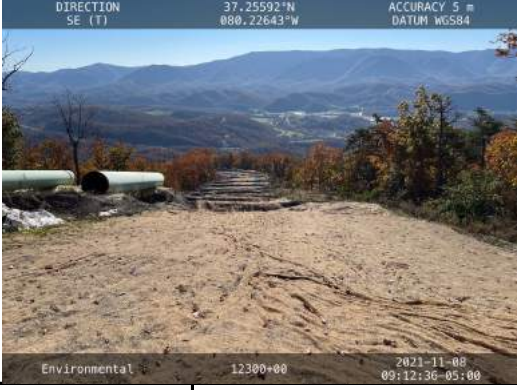
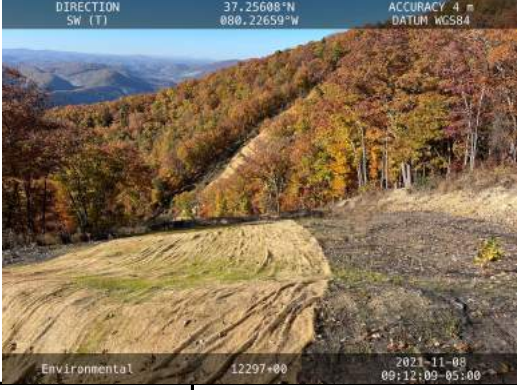
<b>GPS Location</b>	See photo		<b>GPS Location</b>	See photo	
<b>Field Station#</b>	12300+00		<b>Field Station#</b>	12297+00	
<b>Pic 17 Desc.</b>	Stabilized ROW Conditions		<b>Pic 18 Desc.</b>	Stabilized ROW Conditions

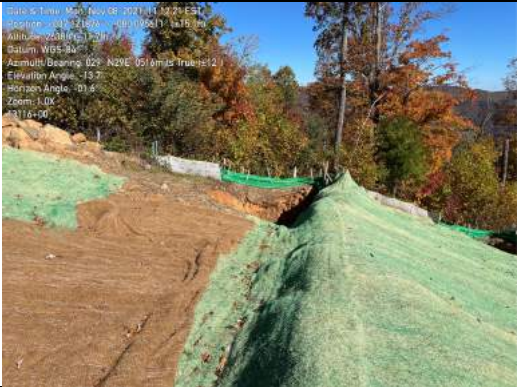
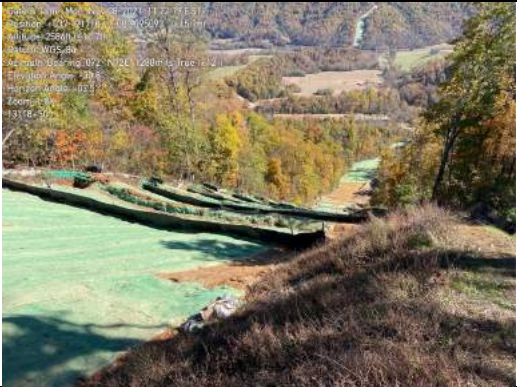
<b>GPS Location</b>	0	<b>GPS Location</b>	0		
<b>Field Station#</b>	13116+00	<b>Field Station#</b>	13118+50		
<b>Pic 13 Desc.</b>	Waterbar and sump in good condition and functioning properly		<b>Pic 14 Desc.</b>	ROW and ECDs in good condition and stable

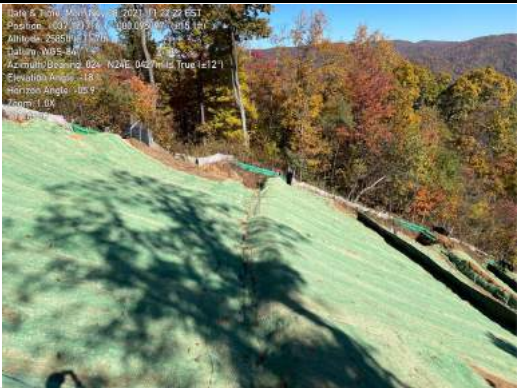
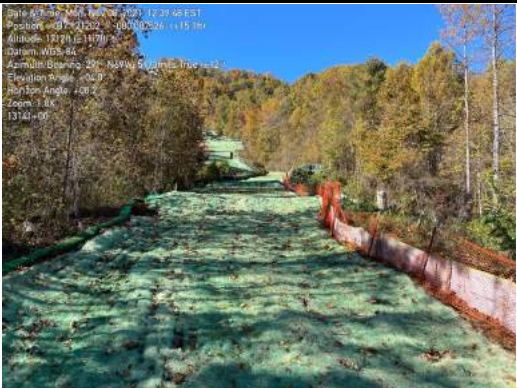
<b>GPS Location</b>	0	<b>GPS Location</b>	0		
<b>Field Station#</b>	13118+50	<b>Field Station#</b>	13141+00		
<b>Pic 15 Desc.</b>	ROW and ECDs in good condition and stable		<b>Pic 16 Desc.</b>	ROW and ECDs in good condition and stable

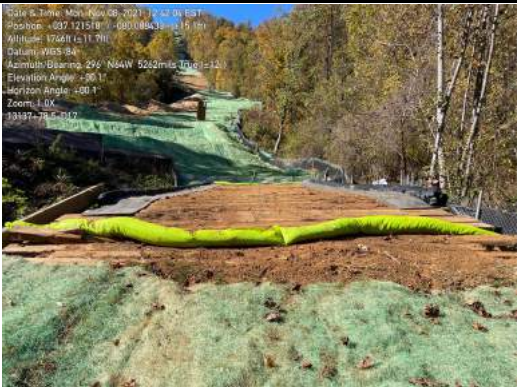
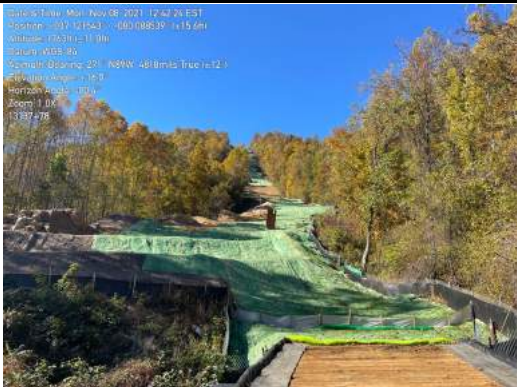
<b>GPS Location</b>	0	<b>GPS Location</b>	0		
<b>Field Station#</b>	13137+78	<b>Field Station#</b>	13137+78		
<b>Pic 17 Desc.</b>	MVP-S-D17 and Corresponding buffer zone in good condition		<b>Pic 18 Desc.</b>	ROW and ECDs in good condition and stable

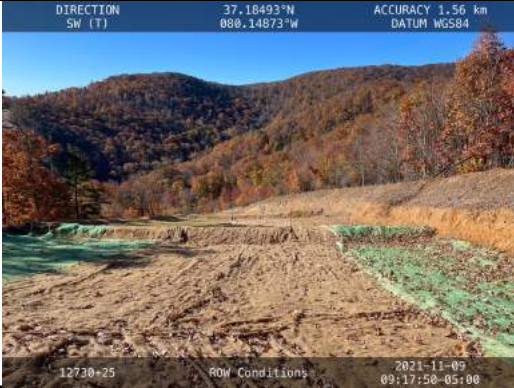
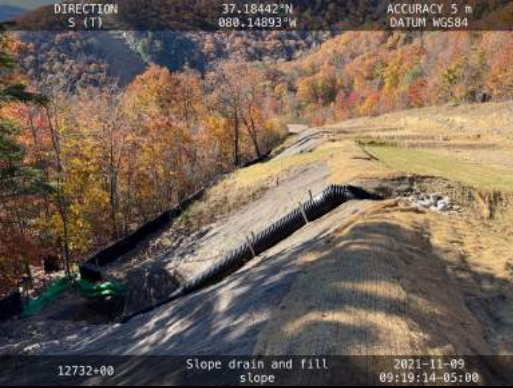
<b>GPS Location</b>	See photo		<b>GPS Location</b>	See photo	
<b>Field Station#</b>	12771+00		<b>Field Station#</b>	12727+00	
<b>Pic 3 Desc.</b>	Current ROW conditions. ROW is stable		<b>Pic 4 Desc.</b>	Current ROW conditions. ROW is stable

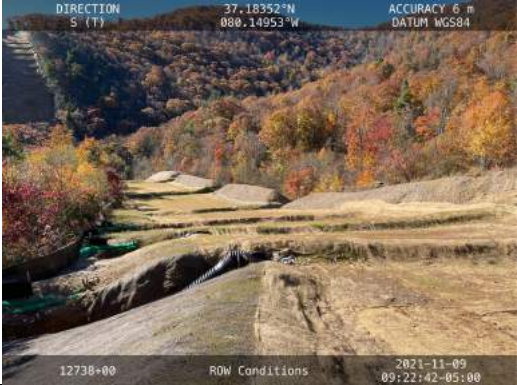
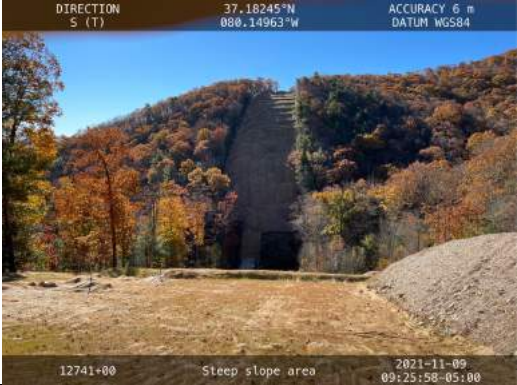
<b>GPS Location</b>	See photo		<b>GPS Location</b>	See photo	
<b>Field Station#</b>	12738+00		<b>Field Station#</b>	12741+00	
<b>Pic 7 Desc.</b>	ROW is stable. ECDs are functional.		<b>Pic 8 Desc.</b>	Steep slope area adjacent to S-EF34B is stable.

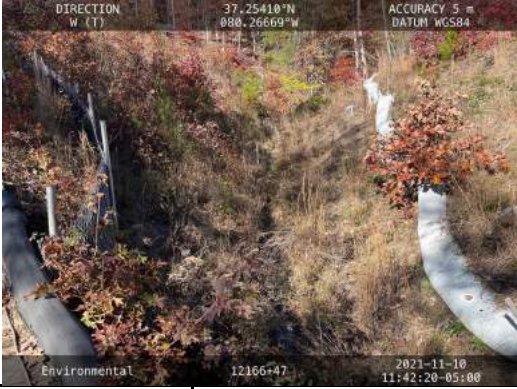
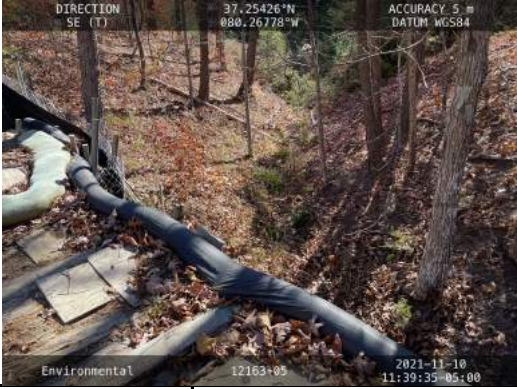
<b>GPS Location</b>	See photo		<b>GPS Location</b>	See photo	
<b>Field Station#</b>	12166+47		<b>Field Station#</b>	12163+05	
<b>Pic 7 Desc.</b>	Up stream of stream crossing S-C24 in acceptable condition		<b>Pic 8 Desc.</b>	Down stream of S-C25 in acceptable condition

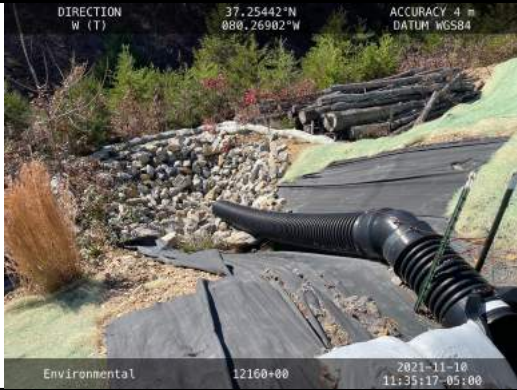
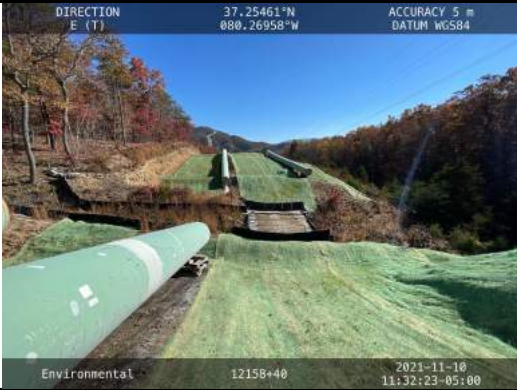
<b>GPS Location</b>	See photo		<b>GPS Location</b>	See photo	
<b>Field Station#</b>	12160+00		<b>Field Station#</b>	12158+40	
<b>Pic 9 Desc.</b>	Fill slope drain in acceptable condition		<b>Pic 10 Desc.</b>	Clean water crossing in acceptable condition

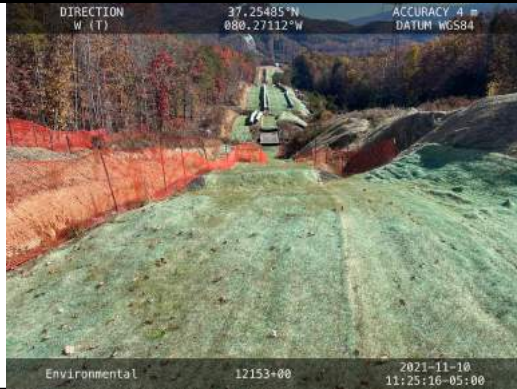
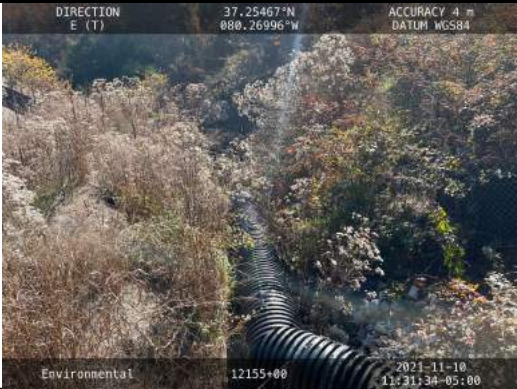
<b>GPS Location</b>	See photo		<b>GPS Location</b>	See photo	
<b>Field Station#</b>	12153+00		<b>Field Station#</b>	12155+00	
<b>Pic 11 Desc.</b>	Stabilized ROW conditions		<b>Pic 12 Desc.</b>	End sump drains outlets in acceptable condition

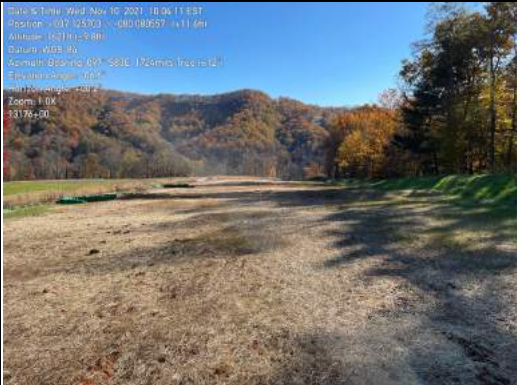
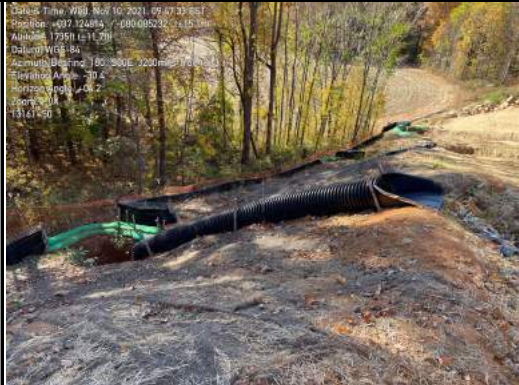
GPS Location	0	GPS Location	0		
Field Station#	13176+00	Field Station#	13116+50		
Pic 13 Desc.	ROW and ECDs In good condition and stable		Pic 14 Desc.	Slope drain in good condition and functioning properly

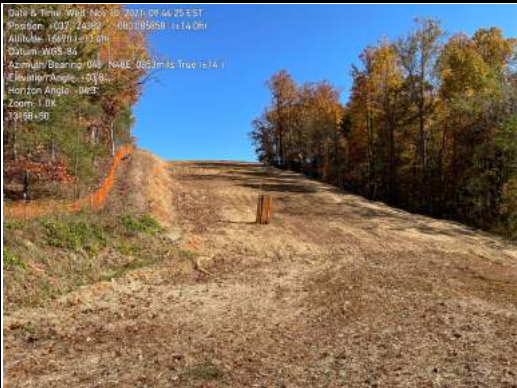
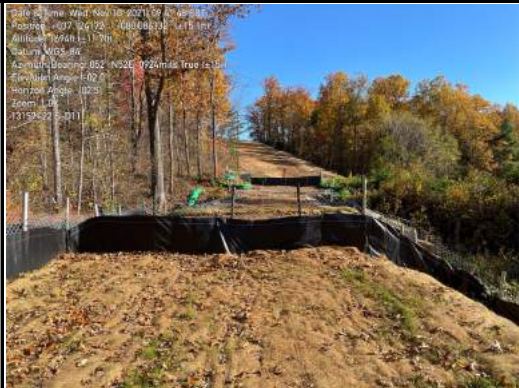
GPS Location	0	GPS Location	0		
Field Station#	13158+50	Field Station#	13157+22		
Pic 15 Desc.	ROW and ECDs In good condition and stable		Pic 16 Desc.	MVP-S-D11 and Corresponding buffer zone in good condition

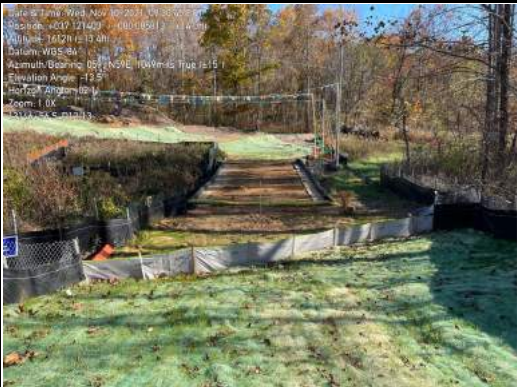
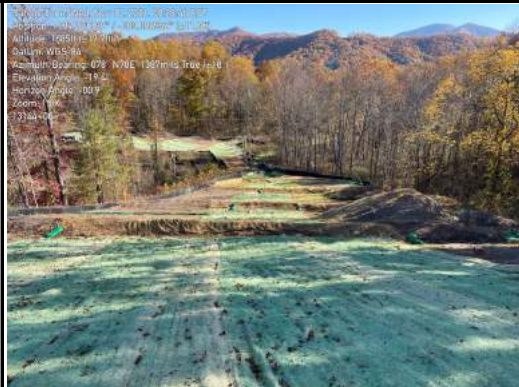
GPS Location	0	GPS Location	0		
Field Station#	13146+56	Field Station#	13144+00		
Pic 17 Desc.	MVP-S-D12/13 and Corresponding buffer zone in good condition		Pic 18 Desc.	ROW and ECDs In good condition and stable

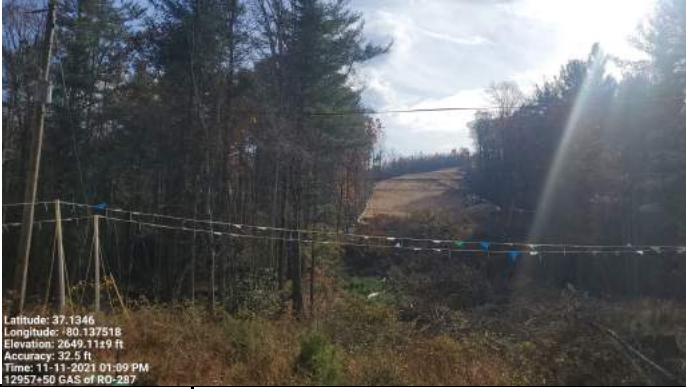
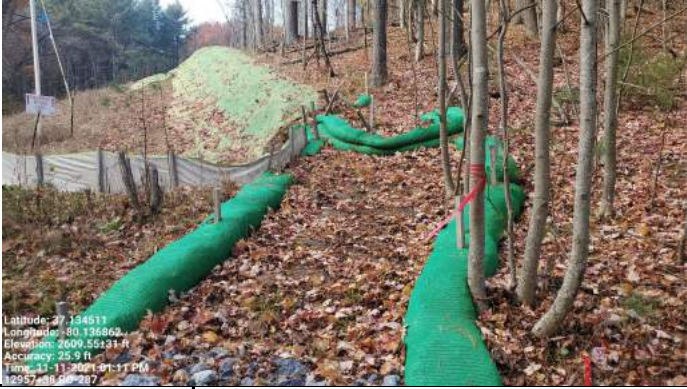
<b>GPS Location</b>	See pic for GPS location.		<b>GPS Location</b>	See pic for GPS location.	
<b>Field Station#</b>	12957+50		<b>Field Station#</b>	12957+38	
<b>Pic 13 Desc.</b>	Current ROW conditions on the GAS of RO-287.		<b>Pic 14 Desc.</b>	CWDB and clean water crossing at RO-287.

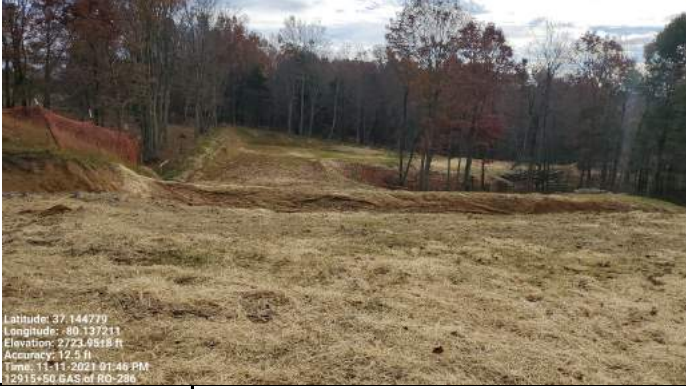
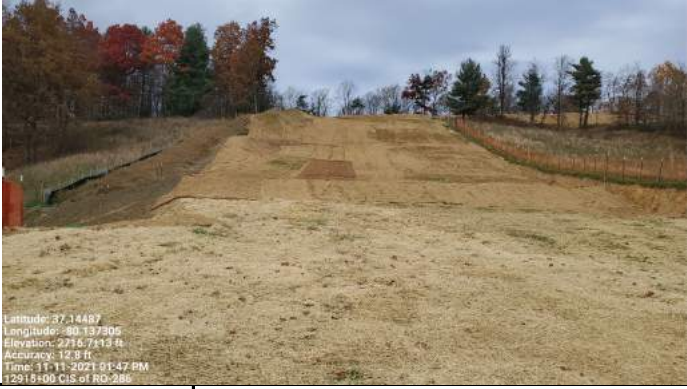
<b>GPS Location</b>	See pic for GPS location.		<b>GPS Location</b>	See pic for GPS location.	
<b>Field Station#</b>	12915+50		<b>Field Station#</b>	12915+00	
<b>Pic 15 Desc.</b>	Current ROW conditions on the GAS of RO-286.		<b>Pic 16 Desc.</b>	Current ROW conditions on the CIS of RO-286.

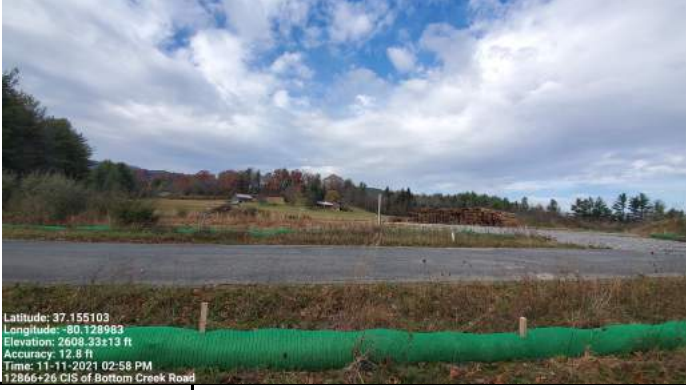
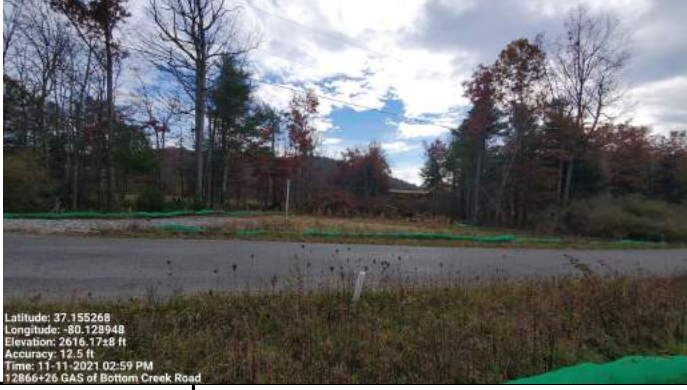
<b>GPS Location</b>	See pic for GPS location.		<b>GPS Location</b>	See pic for GPS location.	
<b>Field Station#</b>	12866+26		<b>Field Station#</b>	12866+26	
<b>Pic 17 Desc.</b>	CIS of the Bottom Creek Road crossing from the GAS.		<b>Pic 18 Desc.</b>	GAS of the Bottom Creek Road crossing from the CIS.
