Visual Site Inspection Report

Project Name	H-600 Pipeline Spread I	AFE	124300139	Spread	H-600 Pipeline Spread I
Contractor	Precision			Report #	31445
Inspector	John White			Date/Time	11/22/2021 10:22 AM
Permit #	TBD	Inspection Type	VA SWPP	Station Begin	15772+27
State	VA	Inspection Area	Full	Station End	15947+64
County	Pittsylvania	Ground	Dry	Temperature (°F)	50.00
Municipality	Chatham	Weather	Cloudy	Rain Gauge (in)	0.00
				Rain Accumulation Time (days)	6.00

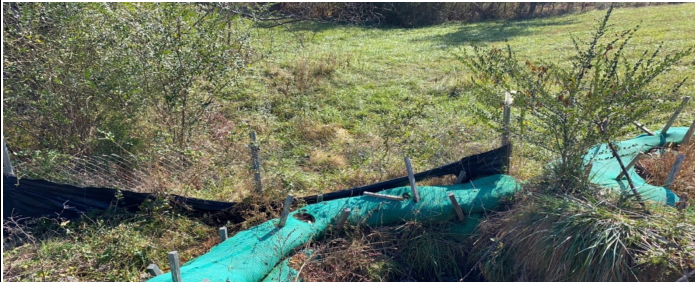
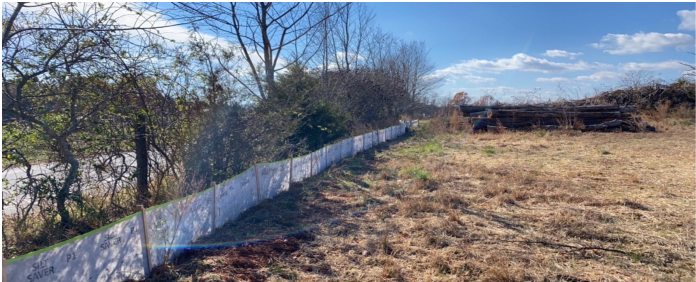
36°57'51" N 79°36'50" W 197°S COURSE 183' GPS Penhook, VA 24137, United States 11.22.2021 13:25:14 Accur +/-29.2 Ft ALT 903 Ft			36°57'47" N 79°35'36" W 299°NW COURSE -1' GPS 1918-2164 Armstrong Rd, Penhook, VA 24137, United States 11.22.2021 12:08:49 Accur +/-72.6 Ft ALT 931 Ft		
GPS Location	1	GPS Location	2		
Field Station#	15001+00	Field Station#	15063+75		
Pic 1 Desc.	Routine maintenance. Replace damaged SSF at base of plunge pool/sump pit.		Pic 2 Desc.	Contractor replaced P1 silt fence per punch list item.

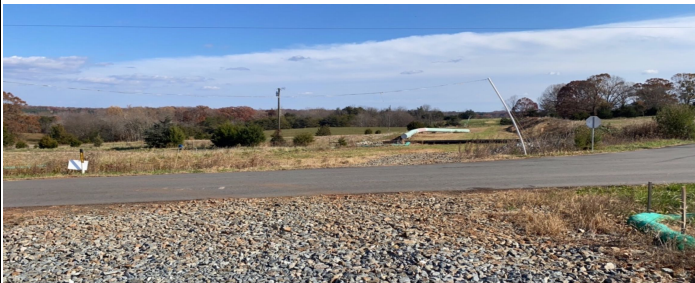
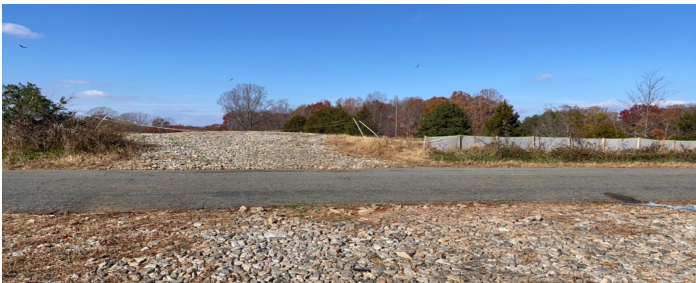
GPS Location	3	GPS Location	4		
Field Station#	14981+55	Field Station#	15063+85		
Pic 3 Desc.	RCE at Snow Creek Rd in good condition.		Pic 4 Desc.	RCE at Armstrong Rd in good condition.

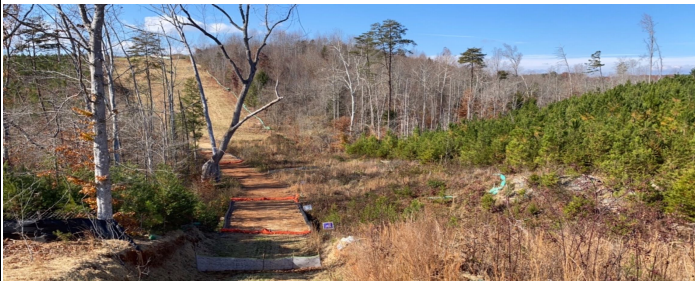
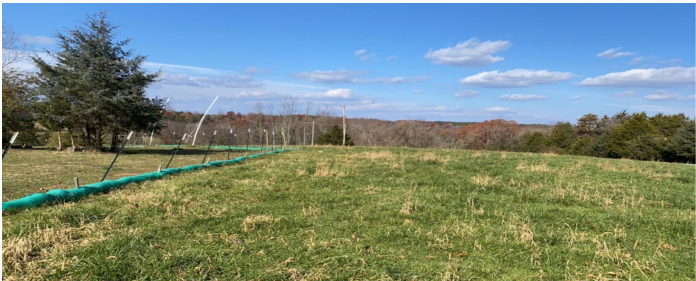
36°57'55" N 79°36'16" W 300°NW COURSE 262' GPS Penhook, VA 24137, United States 11.22.2021 12:27:44 Accur +/-68.6 Ft ALT 0 Ft			36°57'50" N 79°36'58" W 345°N COURSE 254' GPS 121-175 Ashworth Rd, Penhook, VA 24137, United States 11.22.2021 13:02:18 Accur +/-28.4 Ft ALT 942 Ft		
GPS Location	5	GPS Location	6		
Field Station#	15027+97	Field Station#	14993+00		
Pic 5 Desc.	Equipment bridge and surrounding ECDs in place and functional at stream crossings and resource buffers.		Pic 6 Desc.	Perimeter CFS in good condition. Permanent vegetation growing in final cleanup area.

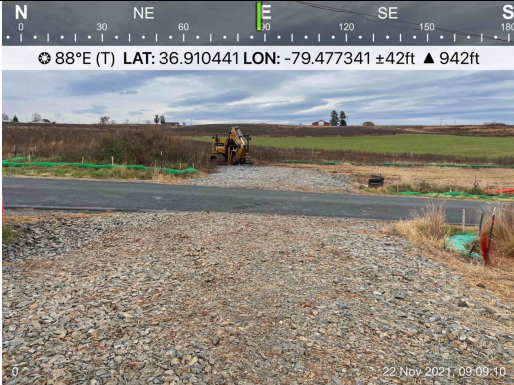
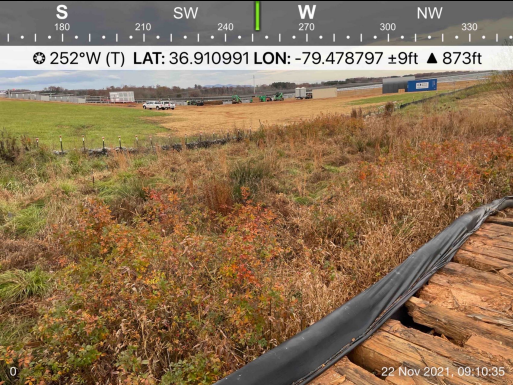
GPS Location	See photo	GPS Location	See photo		
Field Station#	15480+67	Field Station#	15475+00		
Pic 1 Desc.	RCEs are in good condition at all road crossings.	Pic 2 Desc.	3rd party rock outlet appears to be in good condition.

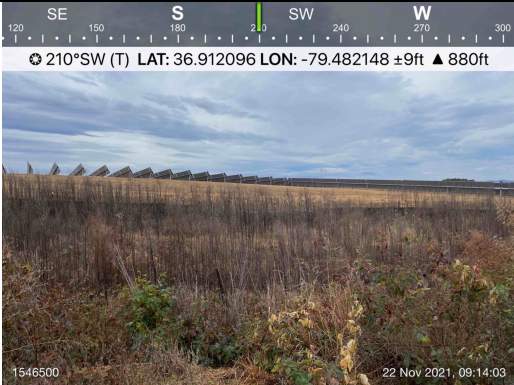
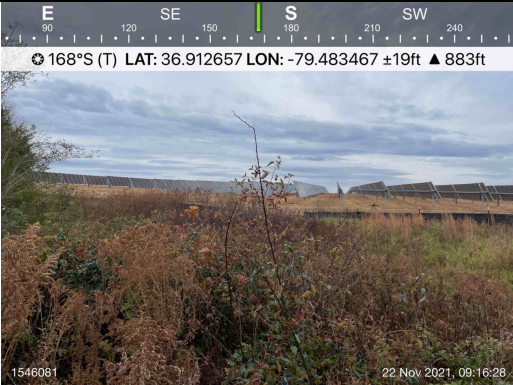
GPS Location	See photo	GPS Location	See photo		
Field Station#	15465+00	Field Station#	15460+81		
Pic 3 Desc.	No evidence of sedimentation from 3rd party disturbance.	Pic 4 Desc.	No evidence of sedimentation into CWD inlet.

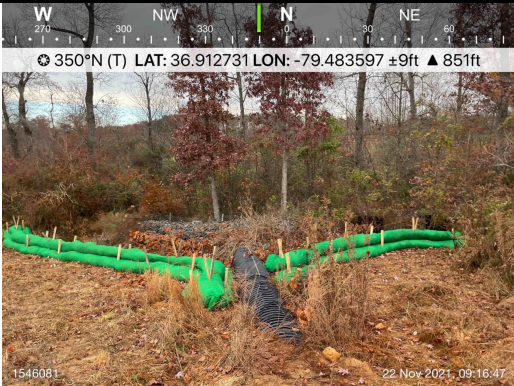
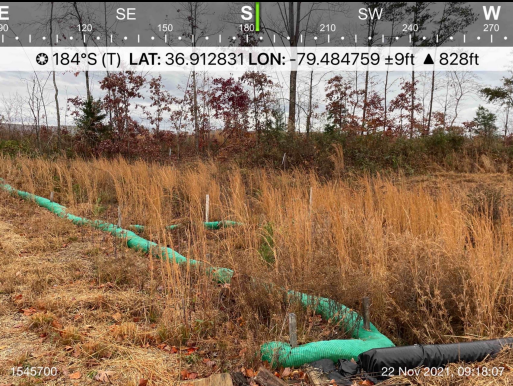
GPS Location	See photo	GPS Location	See photo		
Field Station#	15460+81	Field Station#	15457+00		
Pic 5 Desc.	CWD remains in good condition.	Pic 6 Desc.	No evidence of sedimentation from 3rd party disturbance within drainage feature.

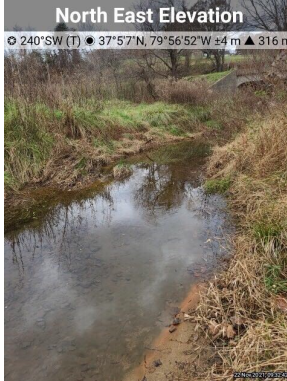
GPS Location	00000	GPS Location	0000		
Field Station#	13691+25	Field Station#	13692+77		
Pic 1 Desc.	P1 requires maintenance due to wildlife damages, documented and added to the punch list for repairs.	Pic 2 Desc.	Stream observation photo facing upstream during routine inspection today, no environmental issues observed at the time of inspection.		
	North Elevation

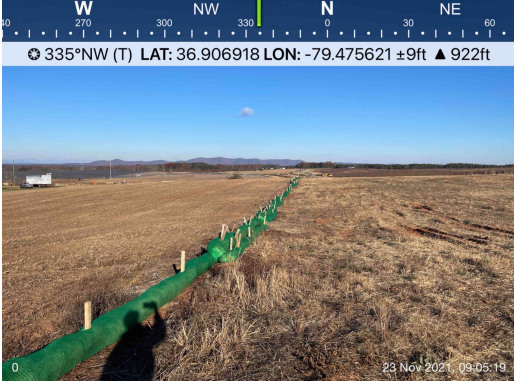
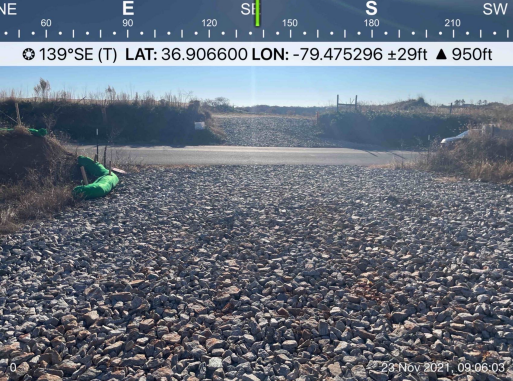
GPS Location	See photo		GPS Location	See photo	
Field Station#	15495+00		Field Station#	15496+70	
Pic 1 Desc.	Perimeter CFS is in good condition.		Pic 2 Desc.	RCEs are in good condition at all road crossings.

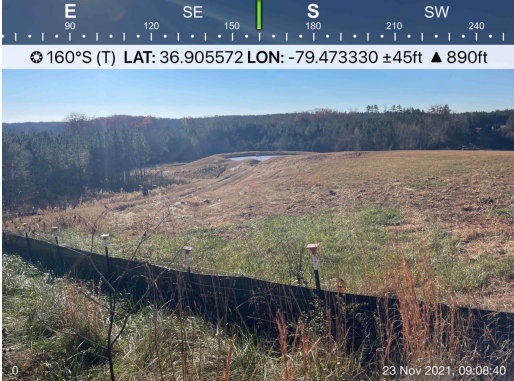
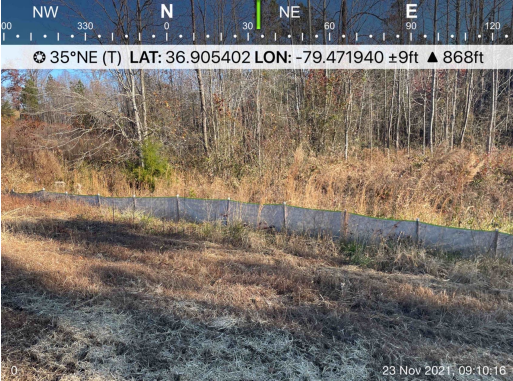
GPS Location	See photo		GPS Location	See photo	
Field Station#	15501+00		Field Station#	15507+54	
Pic 3 Desc.	No evidence of sedimentation from 3rd party disturbance.		Pic 4 Desc.	P1 is in good condition at all stream and wetland buffers.

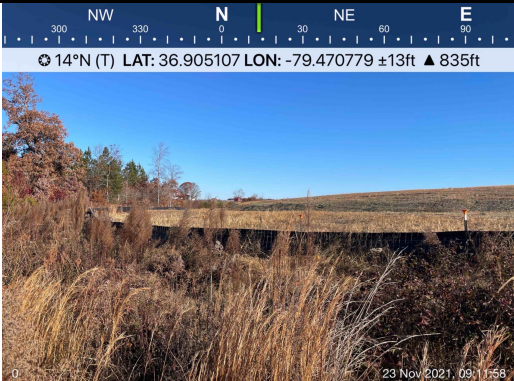
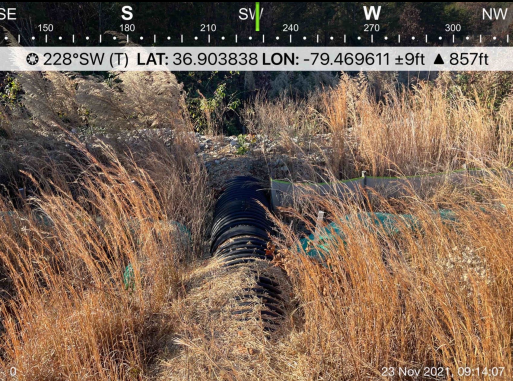
GPS Location	See photo		GPS Location	See photo	
Field Station#	15510+00		Field Station#	15515+00	
Pic 5 Desc.	3rd party ECDs appear to be in good condition.		Pic 6 Desc.	CWDs are in good condition throughout this section.

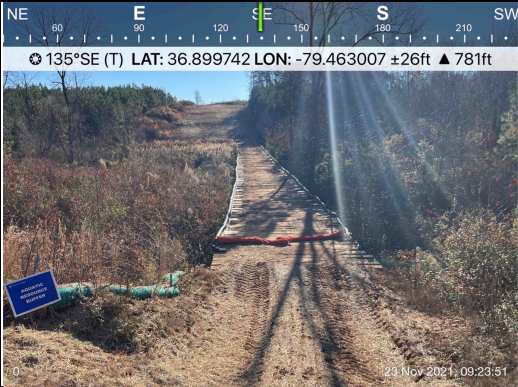
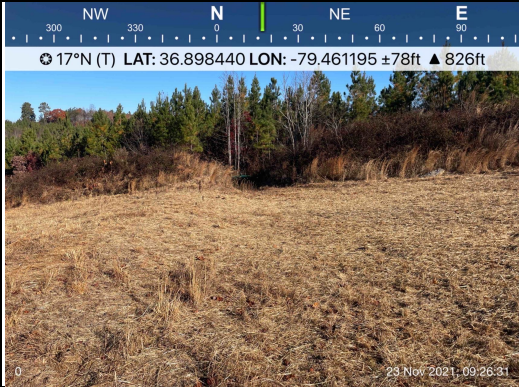
GPS Location	See photo	GPS Location	See photo		
Field Station#	15540+00	Field Station#	15548+00		
Pic 7 Desc.	Equipment bridge ECDs are in place and functioning.	Pic 8 Desc.	Waterbars are in good condition.

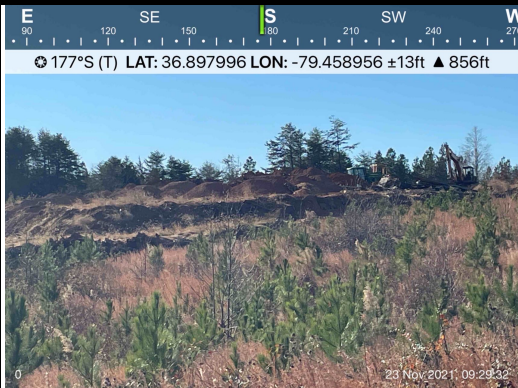
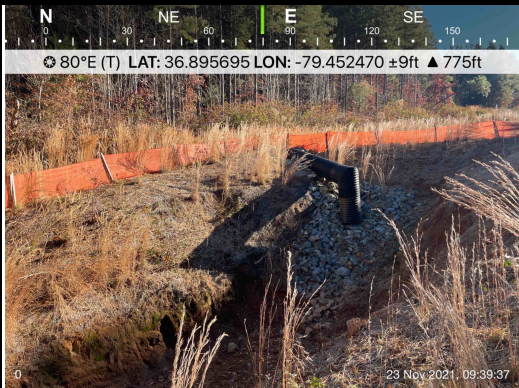
GPS Location	See photo	GPS Location	See photo		
Field Station#	15556+83	Field Station#	15575+00		
Pic 9 Desc.	No evidence of sedimentation from 3rd party disturbance.	Pic 10 Desc.	Slope drain is in good condition and functioning as intended.

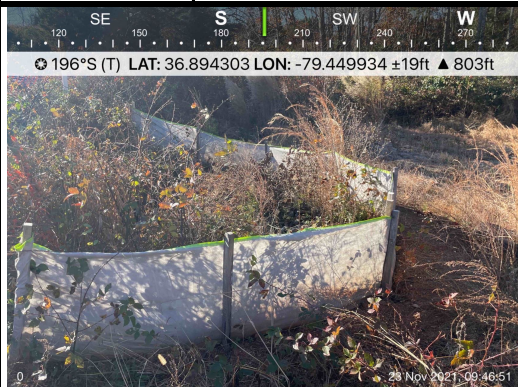
<p>Insert image here</p>	
GPS Location	See photo	GPS Location			
Field Station#	15584+20	Field Station#			
Pic 11 Desc.	P1 is in good condition at road pipe outlet.	Pic 12 Desc.

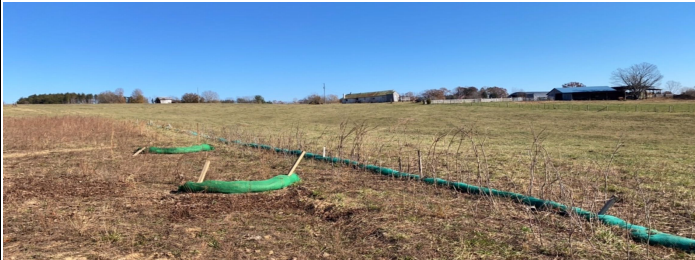
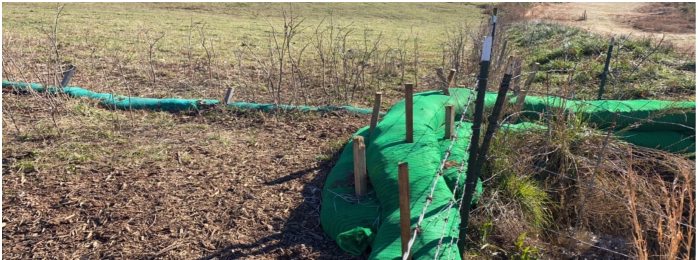
36°57'43" N 79°35'15" W 85°E COURSE 38° GPS Sandy Level, VA 24161, United States 11.23.2021 10:38:47 Accur +/-16.2 Ft ALT 891 Ft			36°57'43" N 79°35'15" W 180°S COURSE -1° GPS Sandy Level, VA 24161, United States 11.23.2021 10:38:52 Accur +/-17.8 Ft ALT 890 Ft		
GPS Location	1		GPS Location	2	
Field Station#	15081+60		Field Station#	15081+60	
Pic 1 Desc.	Contractor repaired CFS check dams per punch list item.		Pic 2 Desc.	Contractor replaced CFS end treatment per punch list item.

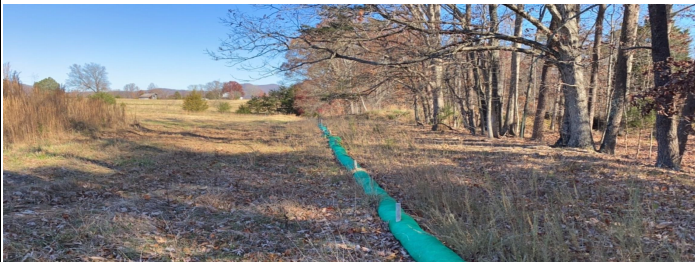
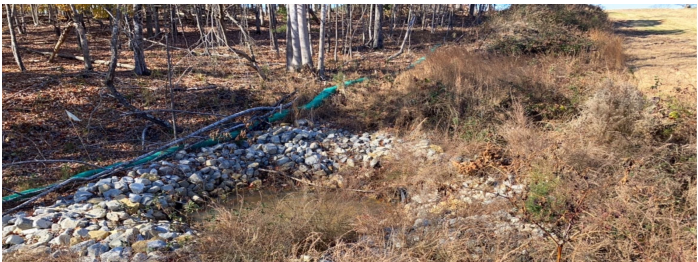
Pic 3 Desc.	Perimeter CFS in good condition.		Pic 4 Desc.	Plunge pool performing intended function.

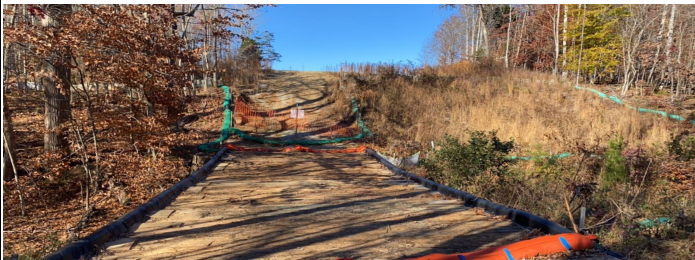
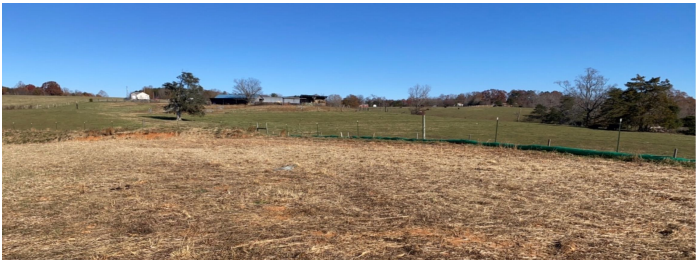
36°57'44" N 79°35'28" W 8°N COURSE 15° GPS Penhook, VA 24137, United States 11.23.2021 10:34:16 Accur +/-403.8 Ft ALT 906 Ft			36°57'37" N 79°35'10" W 26°NE COURSE 318° GPS Sandy Level, VA 24161, United States 11.23.2021 10:42:32 Accur +/-32.7 Ft ALT 875 Ft		
GPS Location	5		GPS Location	6	
Field Station#	15072+86		Field Station#	15087+42	
Pic 5 Desc.	Equipment bridge and surrounding ECDs in place and functional at stream crossing and resource buffer.		Pic 6 Desc.	ROW stabilized in temporary area.

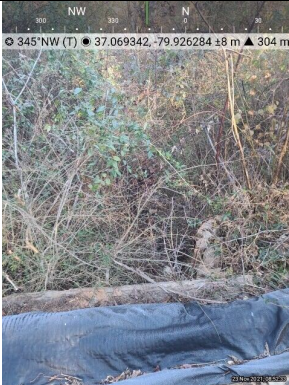
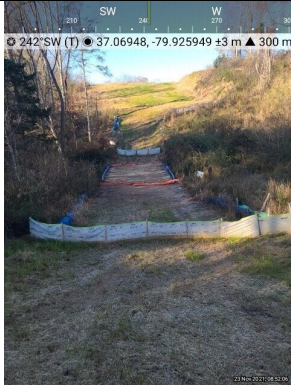
GPS Location	00000	GPS Location	00000		
Field Station#	13805+90	Field Station#	13806+00		
Pic 1 Desc.	Stream observation photo facing downstream during routine inspection today, no environmental issues observed at the time of inspection.		Pic 2 Desc.	Monitored ECDs and equipment bridge at stream crossings. No environmental issues observed at the time of inspection.

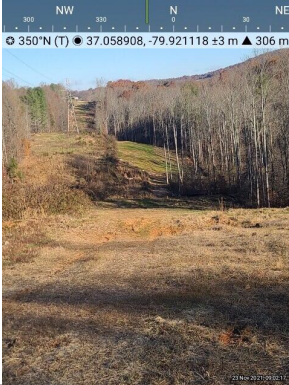
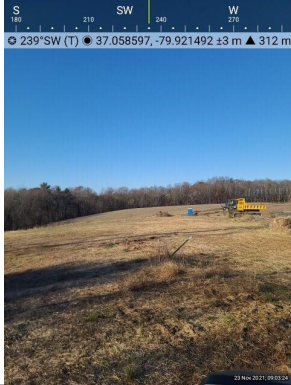
GPS Location	00000	GPS Location	00000		
Field Station#	13847+99	Field Station#	13853+40		
Pic 3 Desc.	Row photo showing stabilization and vegetation, no environmental issues observed at the time of inspection.		Pic 4 Desc.	Observed stabilization in work space area, winter vegetation growing after recent seeding activities .

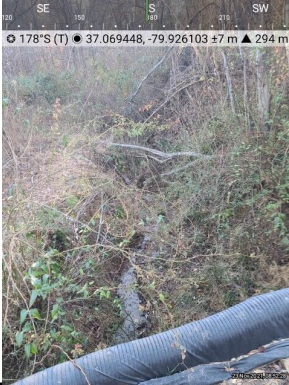
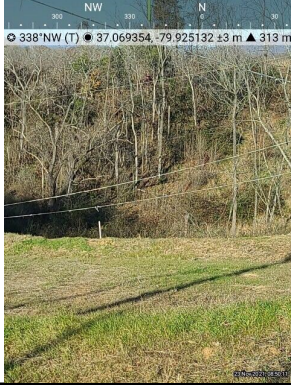
GPS Location	00000	GPS Location	00000		
Field Station#	13805+90	Field Station#	13807+12		
Pic 5 Desc.	Stream observation photo facing downstream during routine inspection today, no environmental issues observed at the time of inspection. stream banks stabilized.		Pic 6 Desc.	Row photo showing winter stabilization, no environmental issues observed at the time of inspection.

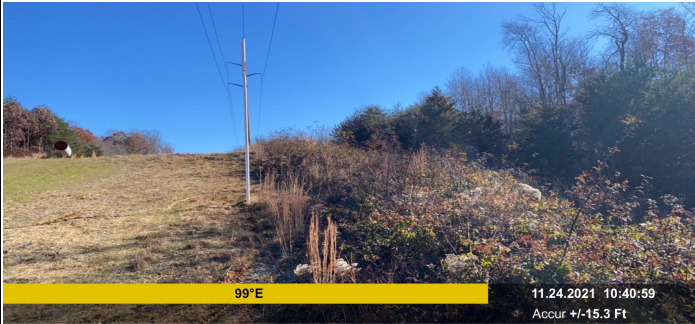
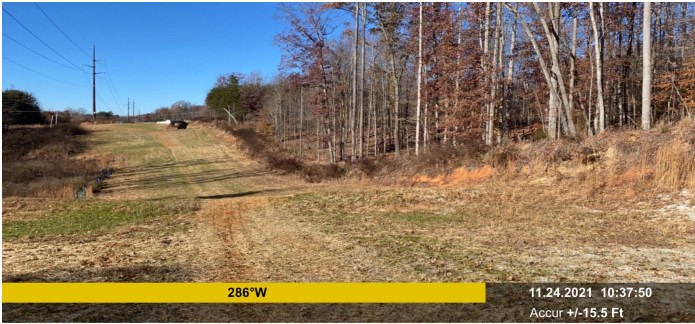
GPS Location	1		GPS Location	2	
Field Station#	14702+00		Field Station#	14710+00	
Pic 1 Desc.	Temporary diversion berm stabilized and vegetated.		Pic 2 Desc.	ROW stabilized and vegetated in temporary area.

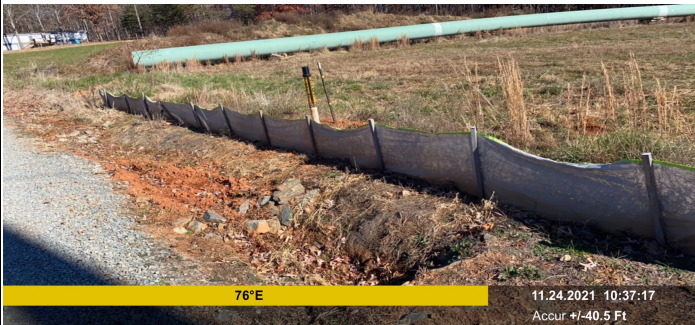
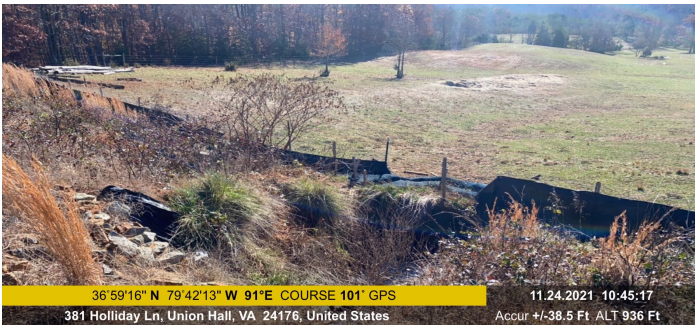
GPS Location	3		GPS Location	4	
Field Station#	14712+20		Field Station#	14714+00	
Pic 3 Desc.	Perimeter P1 silt fence and culvert in good condition at access road.		Pic 4 Desc.	Sump pit and CFS end treatment in good condition; perimeter SSF in place and functional.

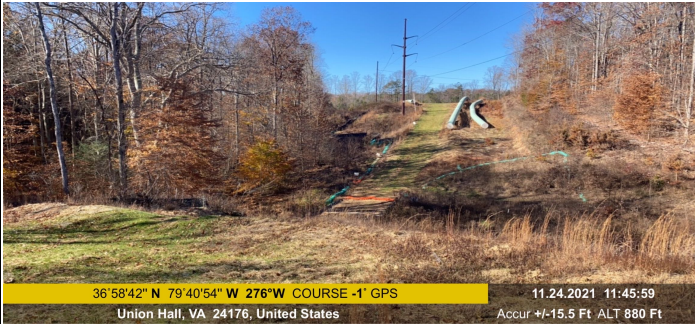
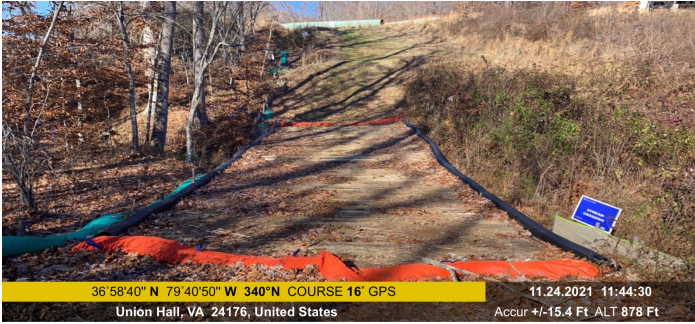
GPS Location	5		GPS Location	6	
Field Station#	14788+77		Field Station#	14793+78	
Pic 5 Desc.	Equipment bridge and surrounding ECDs in place and functional at stream crossing and resource buffer. ROW stabilized and vegetated in temporary area.		Pic 6 Desc.	Equipment bridge and surrounding ECDs in place and functional at stream crossing and resource buffer.

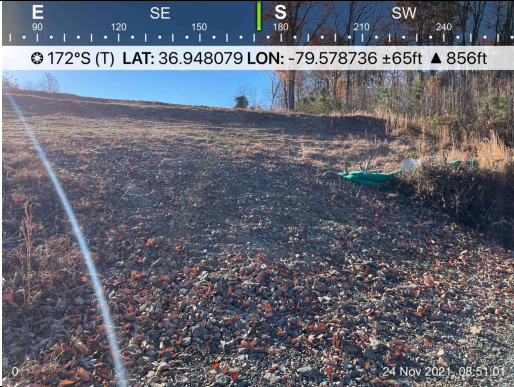
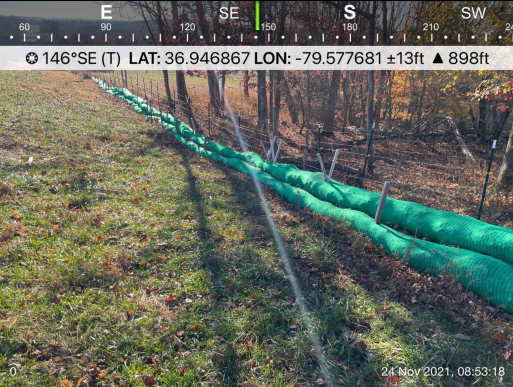
GPS Location	See photo		GPS Location	See photo	
Field Station#	15142+66		Field Station#	15150+00	
Pic 1 Desc.	RCE is in good condition at Rockcreek Rd.		Pic 2 Desc.	Perimeter CFS is in good condition.

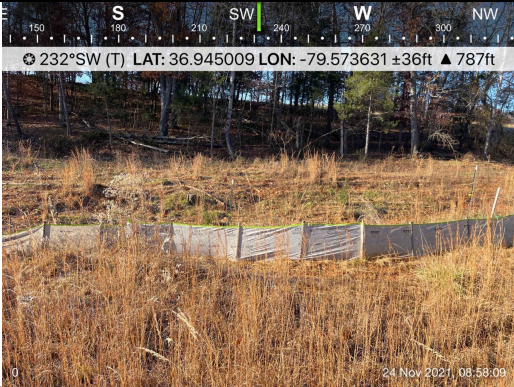
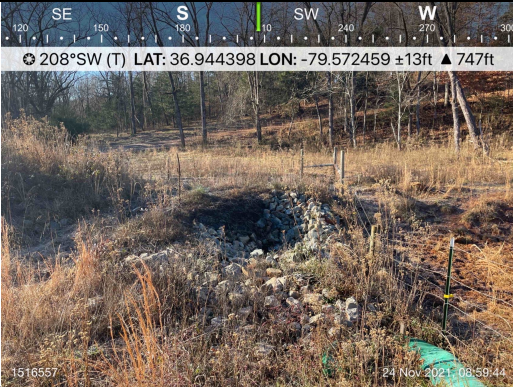
GPS Location	See photo		GPS Location	See photo	
Field Station#	15160+00		Field Station#	15165+57	
Pic 3 Desc.	Perimeter P1 remains in good condition.		Pic 4 Desc.	Rock inlet is in good condition.

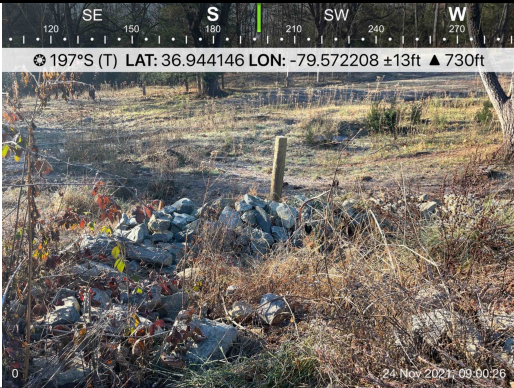
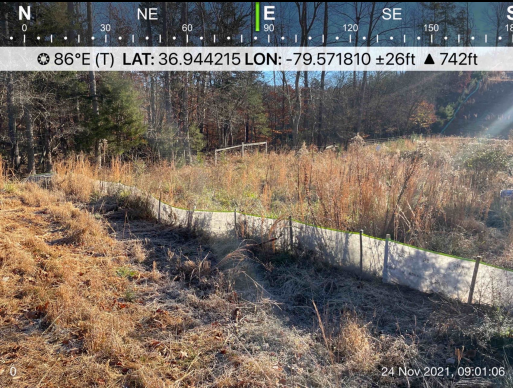
GPS Location	See photo		GPS Location	See photo	
Field Station#	15166+00		Field Station#	15168+00	
Pic 5 Desc.	Rock outlet remains in good condition.		Pic 6 Desc.	P1 is in good condition at stream buffer.

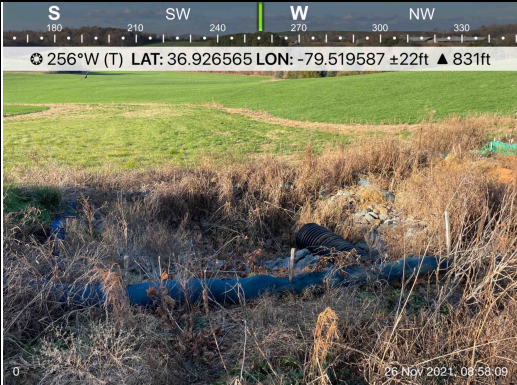
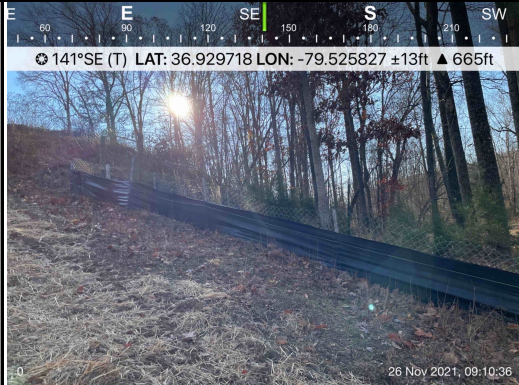
GPS Location	See photo		GPS Location	See photo	
Field Station#	15338+00		Field Station#	15316+00	
Pic 7 Desc.	CWD is functioning as intended.		Pic 8 Desc.	Perimeter SSF is in good condition.

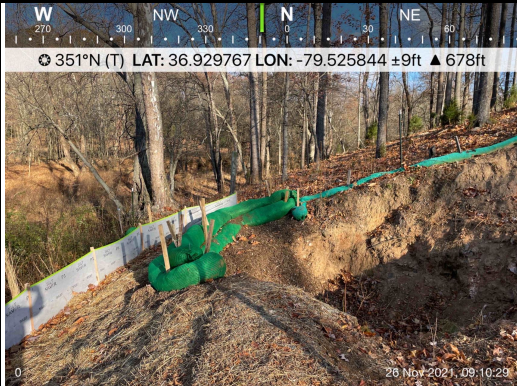
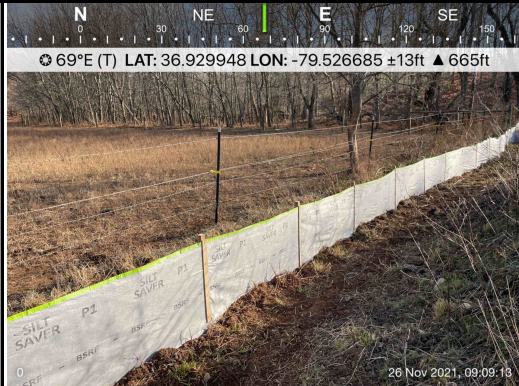
GPS Location	See photo		GPS Location	See photo	
Field Station#	15315+00		Field Station#	15312+00	
Pic 9 Desc.	CFS end treatments are in good condition and functioning.		Pic 10 Desc.	Perimeter P1 is in good condition throughout this section.

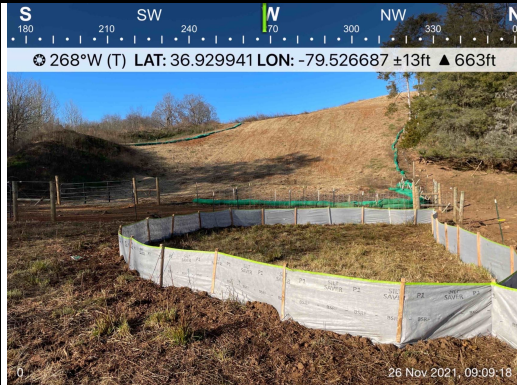
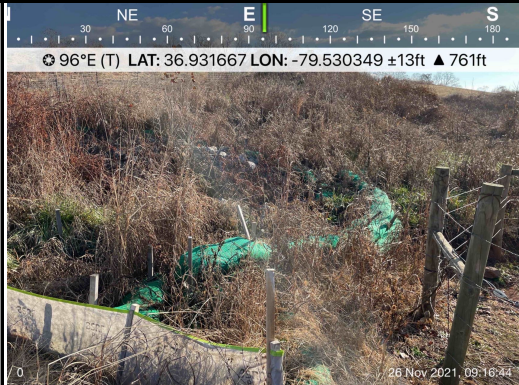
GPS Location	See photo		GPS Location	See photo	
Field Station#	15311+78		Field Station#	15299+00	
Pic 11 Desc.	Wetland buffer P1 remains in good condition.		Pic 12 Desc.	CWD is functioning as intended.

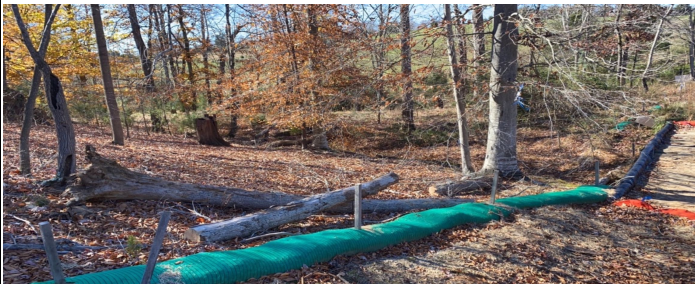
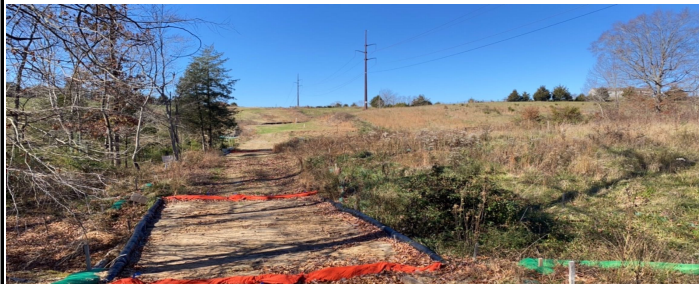
36°58'18" N 79°39'44" W 273°W COURSE 178° GPS 2201 Bar Ridge Rd, Penhook, VA 24137, United States 11.26.2021 10:37:47 Accur +/-28.1 Ft ALT 935 Ft			36°58'18" N 79°39'44" W 317°NW COURSE -1° GPS 2201 Bar Ridge Rd, Penhook, VA 24137, United States 11.26.2021 10:37:50 Accur +/-21.4 Ft ALT 935 Ft		
GPS Location	1		GPS Location	2	
Field Station#	14854+75		Field Station#	14853+59	
Pic 1 Desc.	Contractor repaired fallen tree on perimeter CFS and equipment bridge per punch list item.		Pic 2 Desc.	Equipment bridge and surrounding ECDs in place and functional at stream crossing and resource buffer.

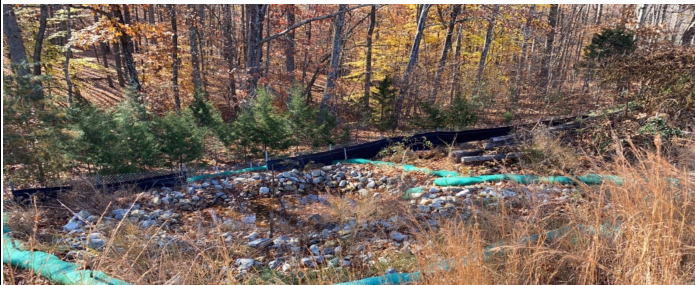
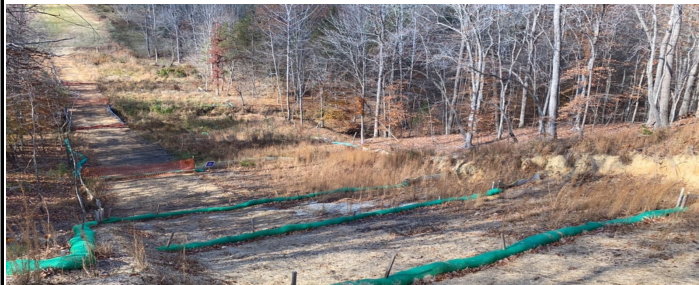
GPS Location	3		GPS Location	4	
Field Station#	14833+00		Field Station#	14868+00	
Pic 3 Desc.	Plunge pool performing intended function. Perimeter controls in place and functional.		Pic 4 Desc.	CFS check dams helping to prevent erosion on slope. No issues observed.

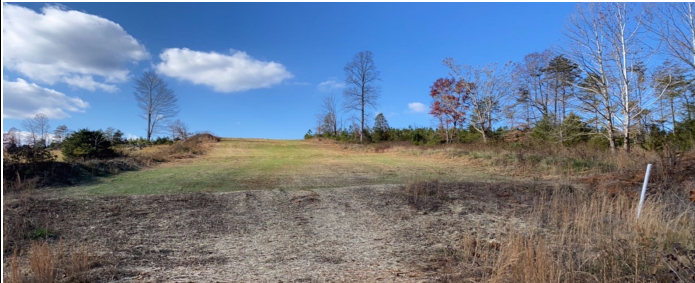
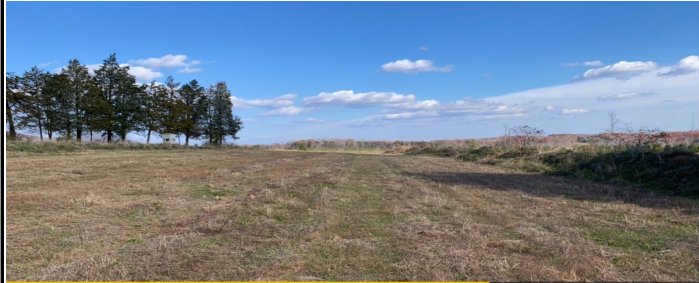
36°57'55" N 79°36'0" W 309°NW COURSE 231° GPS 11.26.2021 11:21:19 Accur +/-17.3 Ft ALT 777 Ft			36°57'53" N 79°36'45" W 97°E COURSE 342° GPS Penhook, VA 24137, United States 11.26.2021 11:08:13 Accur +/-33.2 Ft ALT 924 Ft		
GPS Location	5		GPS Location	6	
Field Station#	14900+00		Field Station#	14811+00	
Pic 5 Desc.	ROW stabilized and vegetated in temporary area.		Pic 6 Desc.	ROW stabilized and vegetated in temporary area.

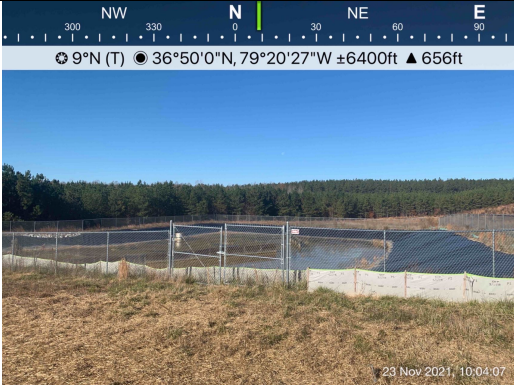
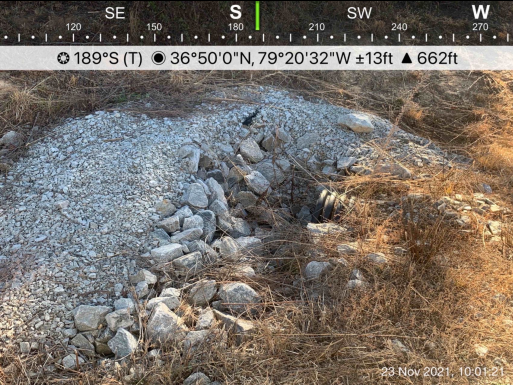
GPS Location	O	GPS Location	O		
Field Station#	00+00	Field Station#	00+00		
Pic 1 Desc.	Observing temporary stabilization, storm water pond and ECD's		Pic 2 Desc.	Observing outlet and outlet protection
