Visual Site Inspection Report

Project Name	H-600 Pipeline Spread G	AFE	124300137	Spread	H-600 Pipeline Spread G
Contractor	Precision			Report #	32462
Inspector	Chris Burns			Date/Time	12/20/2021 11:08 AM
Permit #	TBD	Inspection Type	VA SWPP	Station Begin	11254+99
State	VA	Inspection Area	Partial	Station End	11353+67
County	Giles	Ground	Damp	Temperature (°F)	44.00
Municipality	N/A	Weather	Sunny	Rain Gauge (in)	0.20
				Rain Accumulation Time (days)	1.00

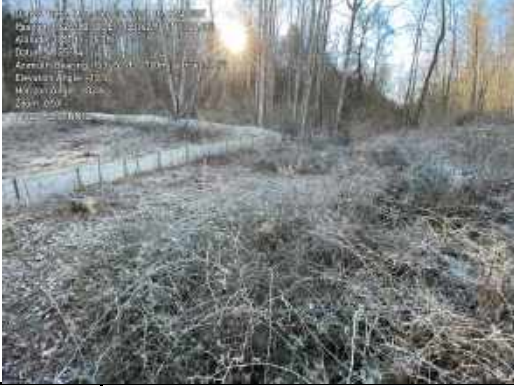
GPS Location	1	GPS Location	2		
Field Station#	11327+86	Field Station#	11292+80		
Pic 1 Desc.	S-NN12.	Pic 2 Desc.	S-MM18.

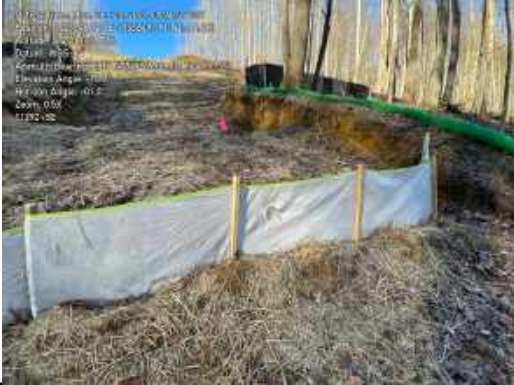
GPS Location	5	GPS Location	6		
Field Station#	11292+50	Field Station#	11301+00		
Pic 5 Desc.	Damaged P-1.	Pic 6 Desc.	Section of RoW showing conditions and controls.

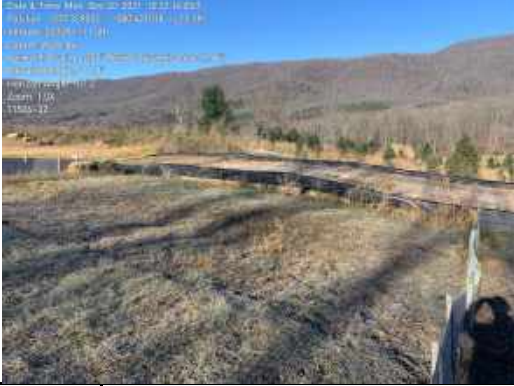
GPS Location	See photo		GPS Location	See photo	
Field Station#	11524+22		Field Station#	11523+50	
Pic 1 Desc.	Equipment bridge is maintained in acceptable condition		Pic 2 Desc.	P1 silt fence is in acceptable condition

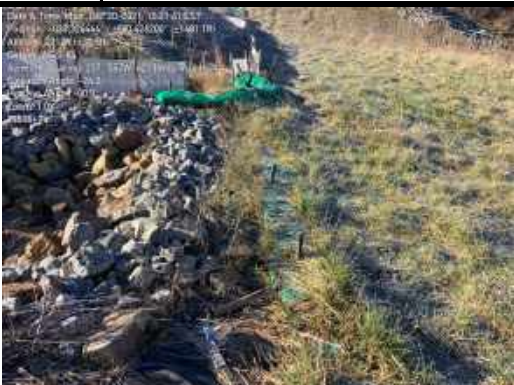
GPS Location	See photo		GPS Location	See photo	
Field Station#	11505+74		Field Station#	11503+80	
Pic 5 Desc.	12" CFS needs replaced		Pic 6 Desc.	Rock lined channel is in acceptable condition

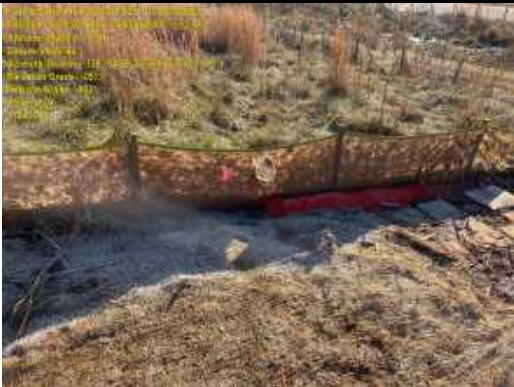
GPS Location	See photo		GPS Location	See photo	
Field Station#	11360+85		Field Station#	11353+50	
Pic 1 Desc.	Hole in P1 silt fence		Pic 2 Desc.	RCE in place

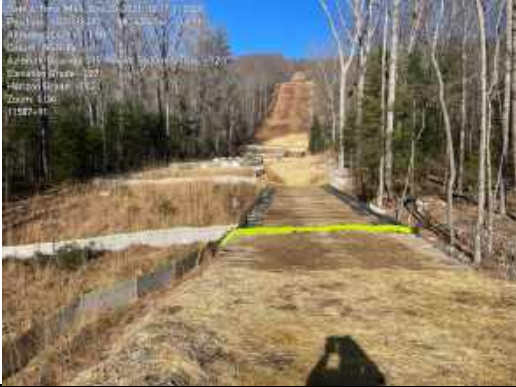
GPS Location	See Photo	GPS Location	See Photo		
Field Station#	11587+91	Field Station#	11596+00		
Pic 13 Desc.	S-PP21 Equipment bridge conditions. No issues at this time	Pic 14 Desc.	View of replaced P1 silt fencing around timber pile.

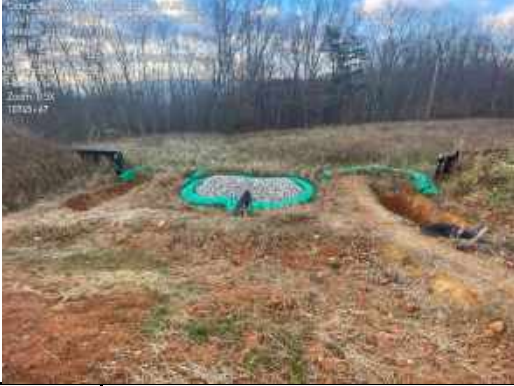
GPS Location	See Photo	GPS Location	See Photo		
Field Station#	10745+67	Field Station#	10743+47		
Pic 1 Desc.	TLS and adjacent sump pit conditions. No Issues at this time.	Pic 2 Desc.	Vegetated Drainage feature upslope. No Issues

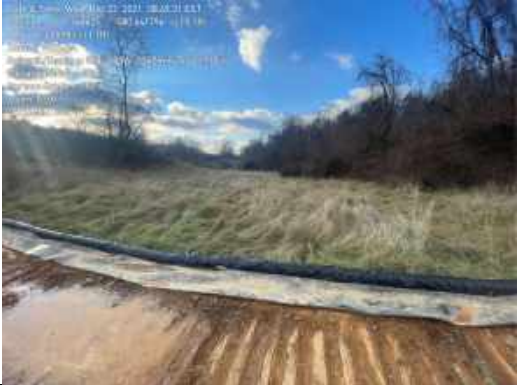
GPS Location	See Photo		GPS Location	See Photo	
Field Station#	10733+00		Field Station#	10728+00	
Pic 7 Desc.	Undisturbed wetland W-Z11 vegetation down slope. No Issues.		Pic 8 Desc.	Temporary stabilization of water bar and row.

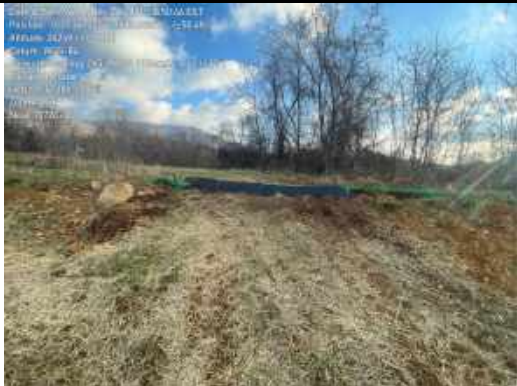
GPS Location	See Photo		GPS Location	See Photo	
Field Station#	10724+00		Field Station#	10712+63	
Pic 9 Desc.	Foam diversion dike installed at L/O access point.		Pic 10 Desc.	Equipment bridge, and vegetated buffer zone condition at the S-G33 stream resource. No Issues.

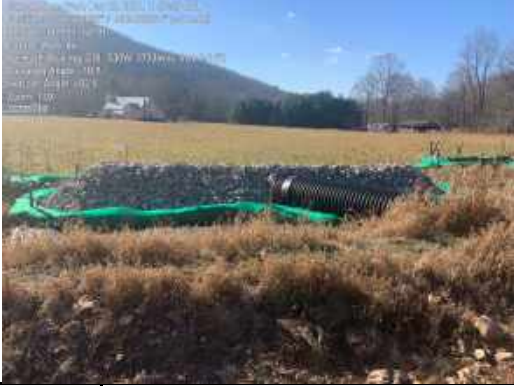
GPS Location	See photo		GPS Location	See photo	
Field Station#	10795+00		Field Station#	10794+00	
Pic 1 Desc.	Clean water diversion pipe and level spreader functional		Pic 2 Desc.	New CFS installed from previous punch list

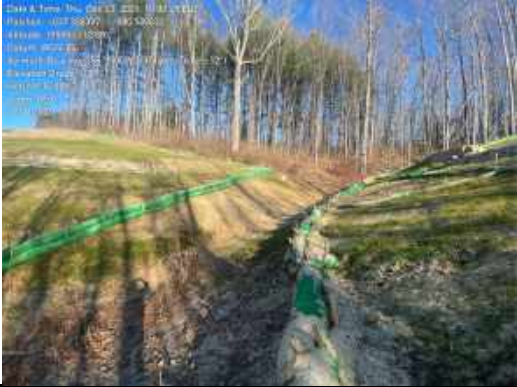
GPS Location	See Photo	GPS Location	See Photo		
Field Station#	11191+00	Field Station#	11193+00		
Pic 13 Desc.	View looking upslope at drainage feature. Limited vegetation growth	Pic 14 Desc.	Additional stabilization along the upslope LOD perimeter.

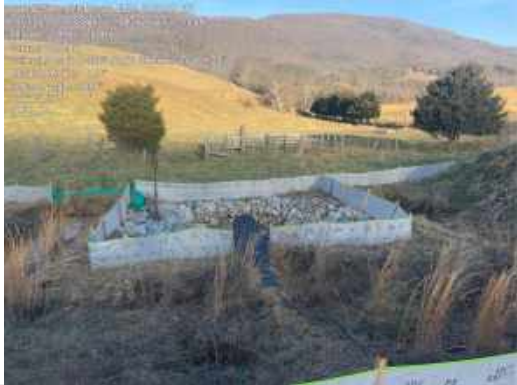
GPS Location	See photo		GPS Location	See photo	
Field Station#	11505+74		Field Station#	11514+00	
Pic 9 Desc.	Perimeter controls have been replaced per punch list from previous day		Pic 10 Desc.	Slope drain pipe is in acceptable condition
