Visual Site Inspection Report

Project Name	H-600 Pipeline Spread G	AFE	124300137	Spread	H-600 Pipeline Spread G
Contractor	Precision			Report #	32662
Inspector	Eric Hanlon			Date/Time	12/27/2021 9:27 AM
Permit #	TBD	Inspection Type	VA SWPP	Station Begin	12005+00
State	VA	Inspection Area	Full	Station End	12005+00
County	Giles	Ground	Dry	Temperature (°F)	48.00
Municipality	N/A	Weather	Cloudy	Rain Gauge (in)	0.00
				Rain Accumulation Time (days)	1.00

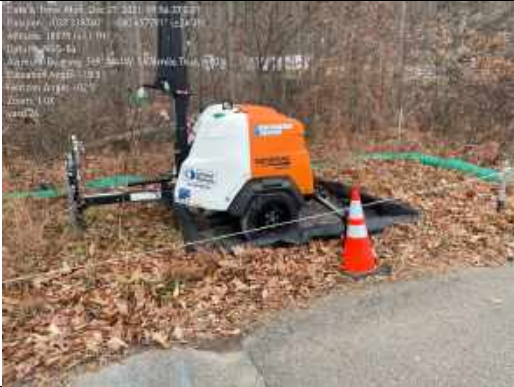
GPS Location	See photo	GPS Location	See photo		
Field Station#	12005+00	Field Station#	12005+00		
Pic 1 Desc.	Secondary containment functional	Pic 2 Desc.	CFS perimeter controls functional

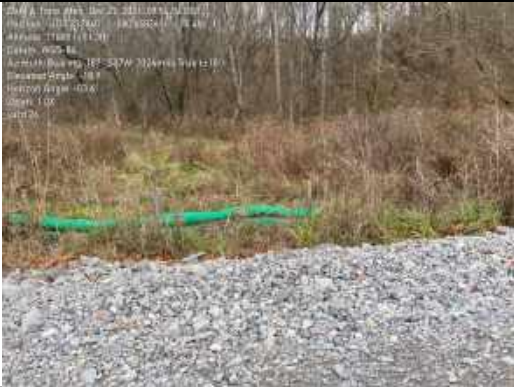
GPS Location	See photo	GPS Location	See photo		
Field Station#	12005+00	Field Station#	12005+00		
Pic 3 Desc.	CFS perimeter controls functional	Pic 4 Desc.	Secondary containment functional

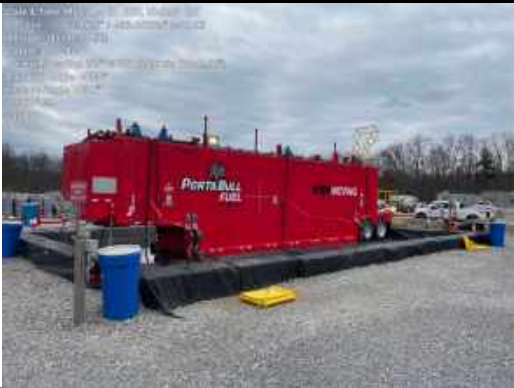
GPS Location	See photo	GPS Location	See photo		
Field Station#	12005+00	Field Station#	12005+00		
Pic 5 Desc.	Secondary containment functional	Pic 6 Desc.	Disposal area functional

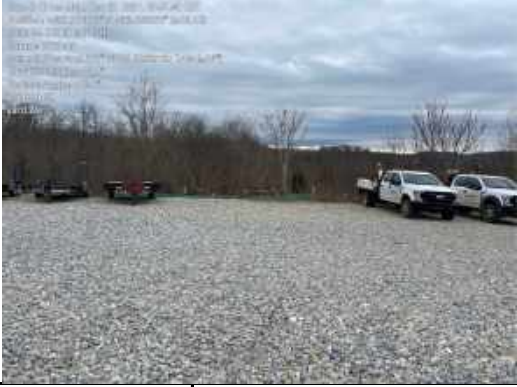
<div>Insert image here</div>			
GPS Location	See photo	GPS Location			
Field Station#	12005+00	Field Station#			
Pic 7 Desc.	CFS perimeter controls functional	Pic 8 Desc.			
<div>Insert image here</div>		<div>Insert image here</div>			
GPS Location		GPS Location			
Field Station#		Field Station#			
Pic 9 Desc.		Pic 10 Desc.			
<div>Insert image here</div>		<div>Insert image here</div>			
GPS Location		GPS Location			
Field Station#		Field Station#			
Pic 11 Desc.		Pic 12 Desc.

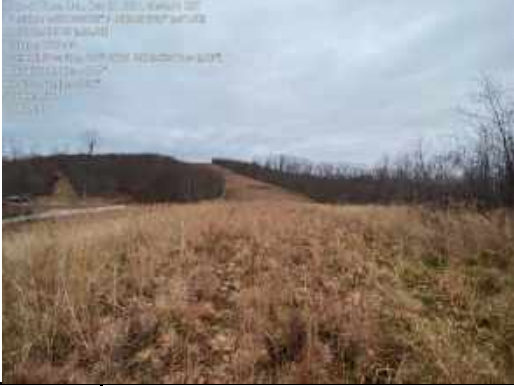
GPS Location	See Photo		GPS Location	See Photo	
Field Station#	11917+00		Field Station#	11929+78	
Pic 1 Desc.	Section of ROW showing conditions and controls		Pic 2 Desc.	AR 266

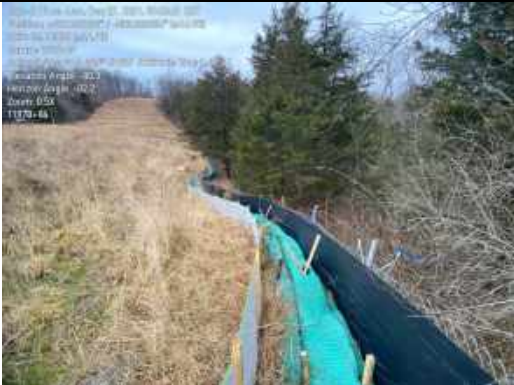
GPS Location	See Photo		GPS Location	See Photo	
Field Station#	11978+86		Field Station#	11990+00	
Pic 3 Desc.	Karst Protection ECDs		Pic 4 Desc.	Stabilization

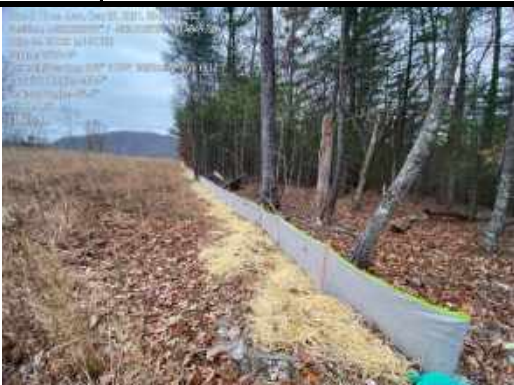
GPS Location	See Photo		GPS Location	See Photo	
Field Station#	11960+00		Field Station#	12005+00	
Pic 5 Desc.	Parameter controls		Pic 6 Desc.	Stabilization

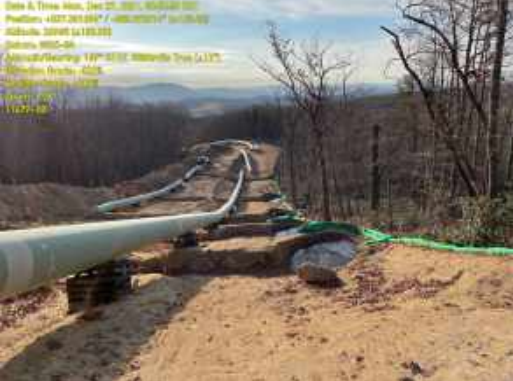
GPS Location	See photo	GPS Location	See photo		
Field Station#	11670+00	Field Station#	11679+00		
Pic 1 Desc.	P1 silt fence perimeter control in place	Pic 2 Desc.	End treatments in place

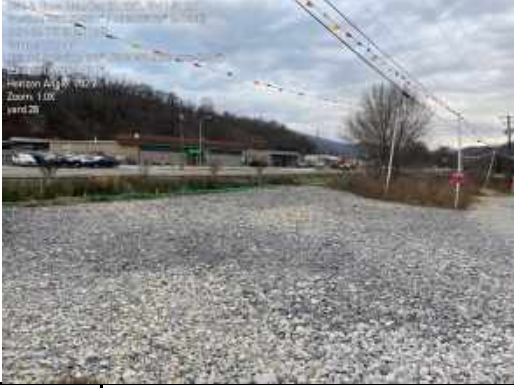
GPS Location	See photo		GPS Location	See photo	
Field Station#	12005+00		Field Station#	12005+00	
Pic 1 Desc.	CFS perimeter controls functional		Pic 2 Desc.	CFS perimeter controls functional

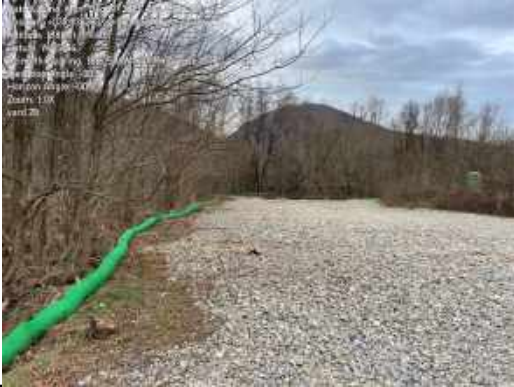
GPS Location	See photo		GPS Location	See photo	
Field Station#	12005+00		Field Station#	12005+00	
Pic 3 Desc.	CFS refreshed & rock clean and functional		Pic 4 Desc.	CFS functional

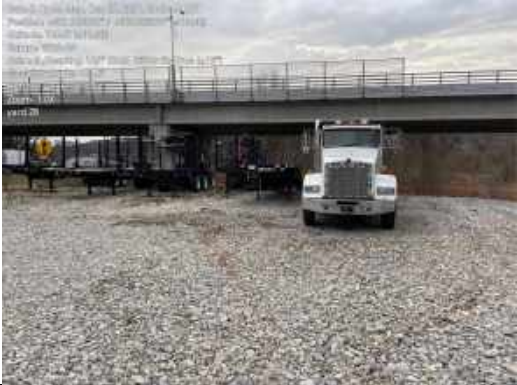
<div style="text-align: center;">Insert image here</div>			
GPS Location	See photo	GPS Location			
Field Station#	12005+00	Field Station#			
Pic 7 Desc.	Rock is clean and functional	Pic 8 Desc.			
<div style="text-align: center;">Insert image here</div>		<div style="text-align: center;">Insert image here</div>			
GPS Location		GPS Location			
Field Station#		Field Station#			
Pic 9 Desc.		Pic 10 Desc.			
<div style="text-align: center;">Insert image here</div>		<div style="text-align: center;">Insert image here</div>			
GPS Location		GPS Location			
Field Station#		Field Station#			
Pic 11 Desc.		Pic 12 Desc.

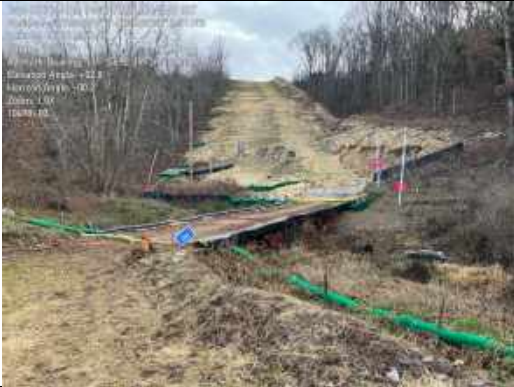
GPS Location	See photo		GPS Location	See photo	
Field Station#	10698+00		Field Station#	10708+10	
Pic 1 Desc.	Equipment bridge functional		Pic 2 Desc.	RCE & AR 241.01 in good condition

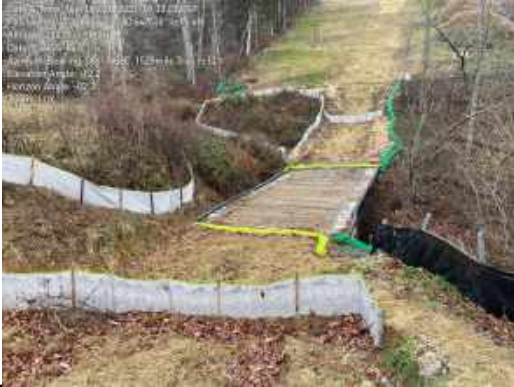
GPS Location	See photo		GPS Location	See photo	
Field Station#	10712+21		Field Station#	10717+00	
Pic 3 Desc.	P1 in place		Pic 4 Desc.	ET functional

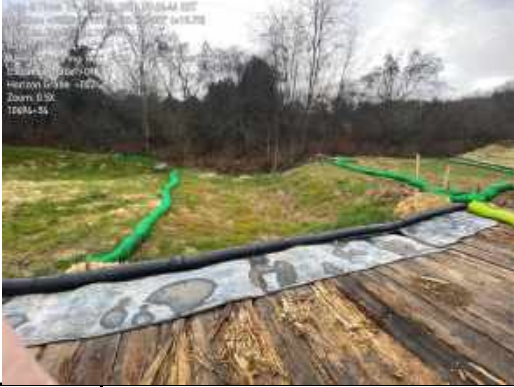
GPS Location	See photo		GPS Location	See photo	
Field Station#	10694+54		Field Station#	10680+00	
Pic 5 Desc.	Clean water drainage feature functional		Pic 6 Desc.	Equipment bridge functional

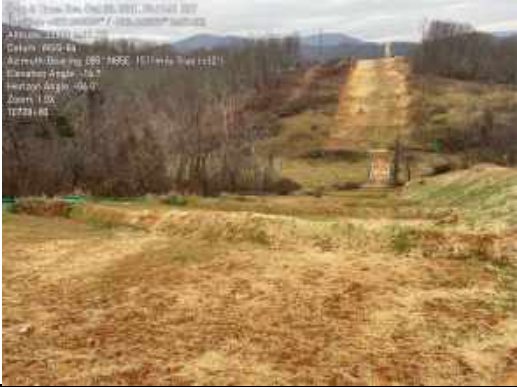
GPS Location	See photo		GPS Location	See photo	
Field Station#	10728+00		Field Station#	10732+21	
Pic 7 Desc.	Water bars in place and functional		Pic 8 Desc.	50' buffers in place

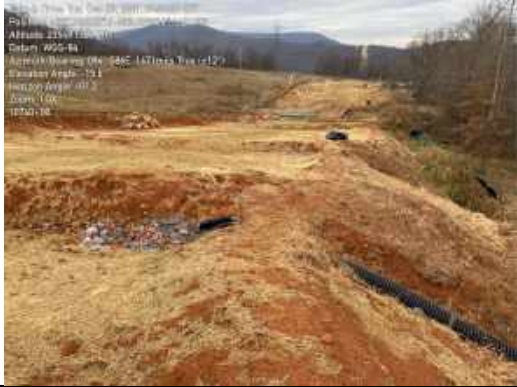
GPS Location	See photo		GPS Location	See photo	
Field Station#	10740+00		Field Station#	10742+69	
Pic 9 Desc.	Stone inlets functional		Pic 10 Desc.	Clean water drainage feature functional

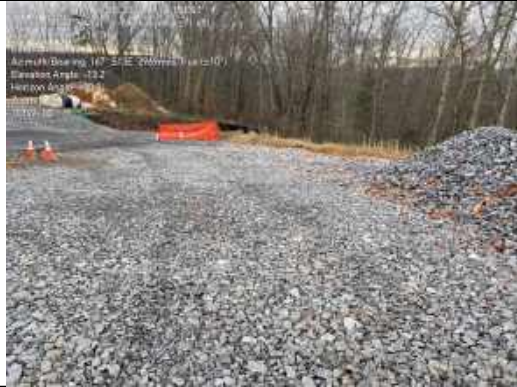
GPS Location	See photo		GPS Location	See photo	
Field Station#	10749+00		Field Station#	10742+09	
Pic 11 Desc.	RCE functional		Pic 12 Desc.	Inlet in good condition

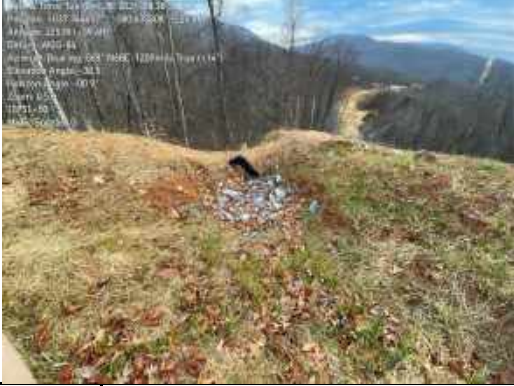
GPS Location	See photo		GPS Location	see photo	
Field Station#	10751+50		Field Station#	10770+00	
Pic 1 Desc.	Stone inlet protection is in acceptable condition		Pic 2 Desc.	Sump pit and CFS perimeter controls are in acceptable condition

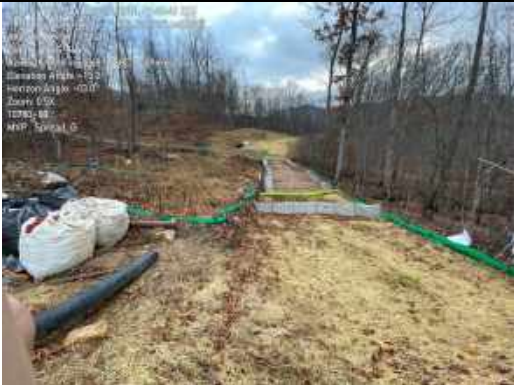
GPS Location	See photo		GPS Location	See photo	
Field Station#	10780+00		Field Station#	10766+00	
Pic 3 Desc.	Sensitive resource signage functional and buffer zones are in acceptable condition		Pic 4 Desc.	Clean water diversion pipe and level spreader are in acceptable condition

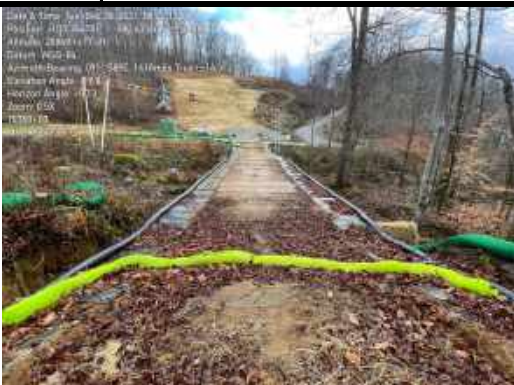
GPS Location	See photo		GPS Location	See photo	
Field Station#	10758+00		Field Station#	10754+50	
Pic 5 Desc.	Equipment bridge is maintained in acceptable condition		Pic 6 Desc.	Daylight drain and water bars are in acceptable condition

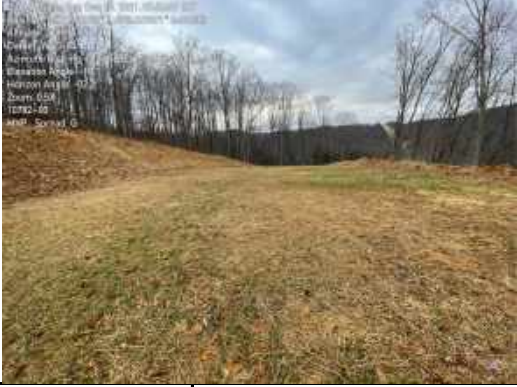
GPS Location		See photo		GPS Location	
Field Station#		10782+00		Field Station#	
Pic 7 Desc.		Temporary stabilization is acceptable		Pic 8 Desc.	
Insert image here		Insert image here			
GPS Location				GPS Location	
Field Station#				Field Station#	
Pic 9 Desc.				Pic 10 Desc.	
Insert image here		Insert image here			
GPS Location				GPS Location	
Field Station#				Field Station#	
Pic 11 Desc.				Pic 12 Desc.

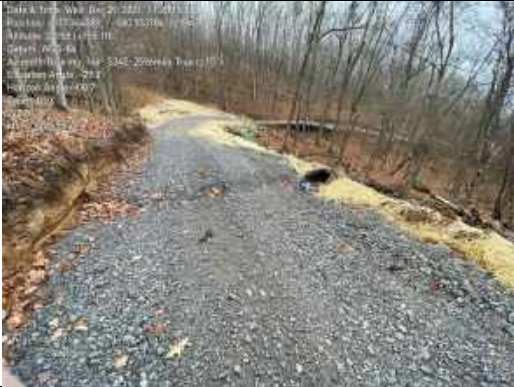
GPS Location	See photo	GPS Location	See photo		
Field Station#	10971+74	Field Station#	10930+45		
Pic 1 Desc.	AR242.01 is in acceptable condition, denuded soils have been stabilized.	Pic 2 Desc.	Rock surface of RCE is in acceptable condition

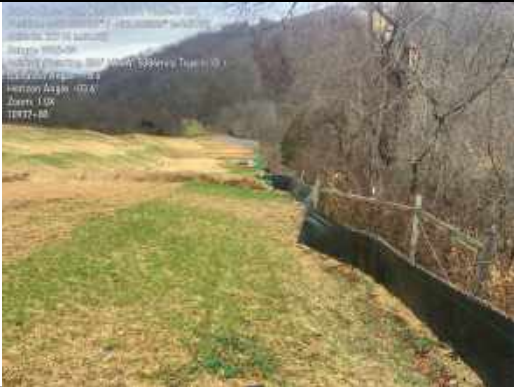
GPS Location	See photo	GPS Location	See photo		
Field Station#	10937+00	Field Station#	10949+72		
Pic 3 Desc.	Temporary vegetation and stabilization are acceptable	Pic 4 Desc.	CFS perimeter controls are in acceptable condition

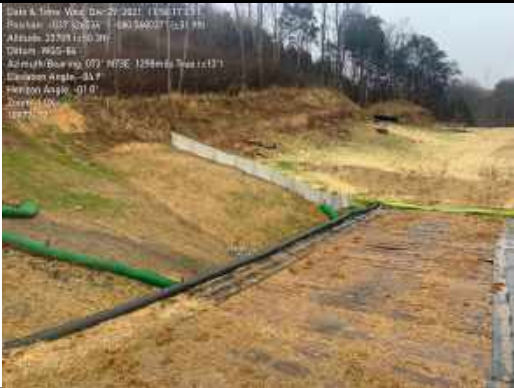
GPS Location	See photo	GPS Location	See photo		
Field Station#	10977+72	Field Station#	10984+92		
Pic 5 Desc.	Equipment bridge and erosion control blanket are in acceptable condition	Pic 6 Desc.	Slope drain pipe is in place

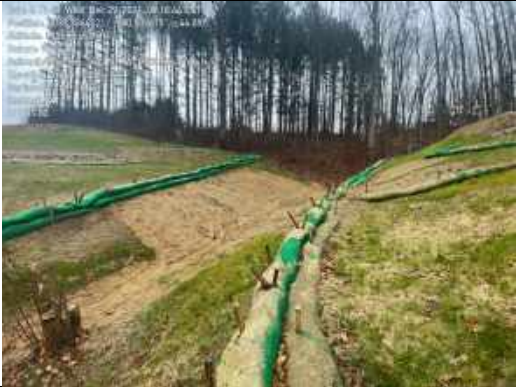
GPS Location	See photo		GPS Location	See photo	
Field Station#	11191+00		Field Station#	11194+00	
Pic 1 Desc.	Clean water drainage feature functional		Pic 2 Desc.	Permanent stabilization functional

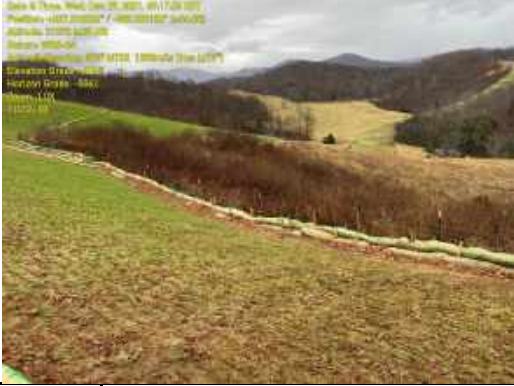
GPS Location	See photo	GPS Location	See photo		
Field Station#	11112+00	Field Station#	11123+00		
Pic 1 Desc.	Triple stack CFS perimeter control	Pic 2 Desc.	Erosion control blanket in place at drainage feature

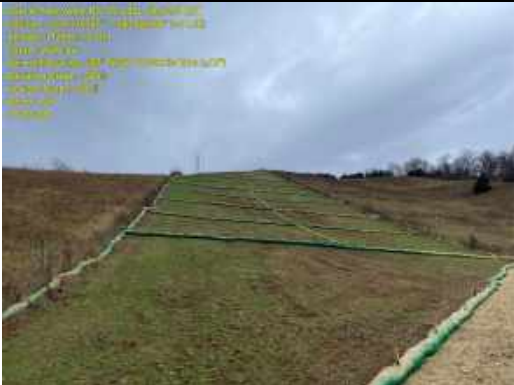
GPS Location	See photo	GPS Location	See photo		
Field Station#	11120+00	Field Station#	11134+00		
Pic 3 Desc.	Temporary CFS waterbars in place	Pic 4 Desc.	Permanent waterbars in place

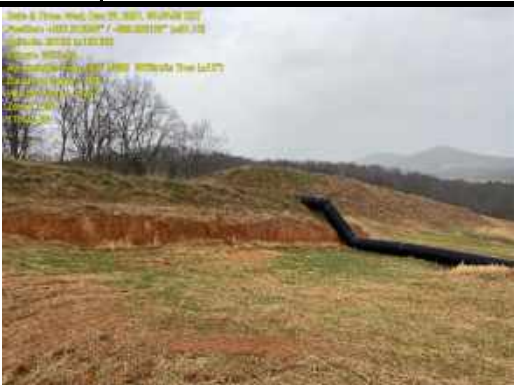
GPS Location	See photo	GPS Location	See photo		
Field Station#	11146+20	Field Station#	11147+00		
Pic 5 Desc.	Cleanwater diversion pipe in place	Pic 6 Desc.	Stone inlet protection in place

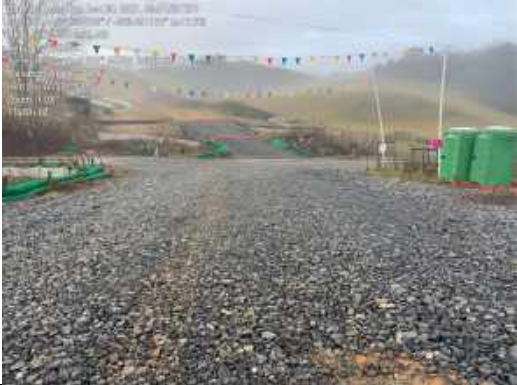
GPS Location	See photo	GPS Location	See photo		
Field Station#	11490+02	Field Station#	11494+00		
Pic 7 Desc.	Rock surface of RCE is in acceptable condition	Pic 8 Desc.	P1 silt fence is in acceptable condition

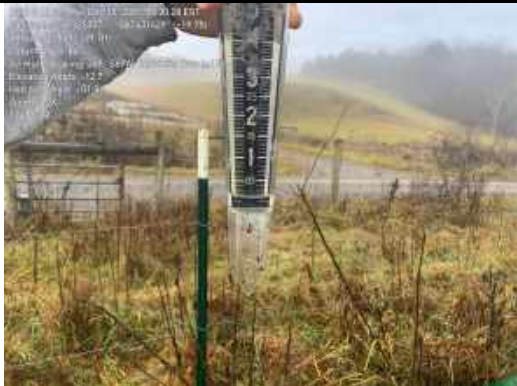
GPS Location	See photo	GPS Location	See photo		
Field Station#	11490+02	Field Station#	11486+87		
Pic 9 Desc.	Rain gage at Stevers Gap with 0.25" inches of rain	Pic 10 Desc.	Inlet to clean water diversion pipe is in acceptable condition		
Insert image here		Insert image here			
GPS Location		GPS Location			
Field Station#		Field Station#			
Pic 11 Desc.		Pic 12 Desc.

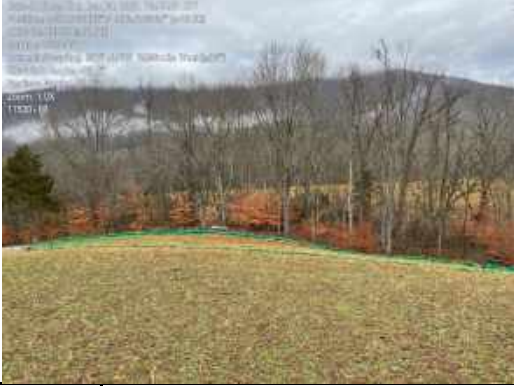
GPS Location	See photo		GPS Location	See photo	
Field Station#	11530+00		Field Station#	11533+00	
Pic 1 Desc.	Permanent stabilization functional		Pic 2 Desc.	CFS perimeter controls functional

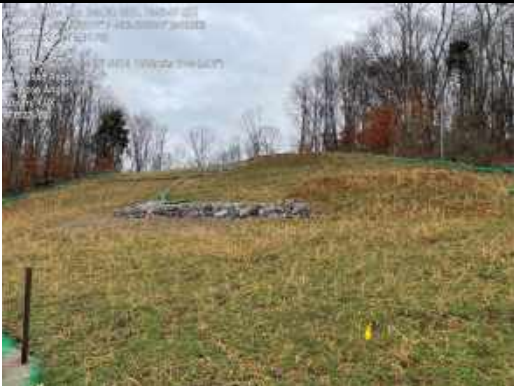
GPS Location	See photo		GPS Location	See photo	
Field Station#	11527+00		Field Station#	11526+00	
Pic 5 Desc.	Water bars in place		Pic 6 Desc.	Clean water drainage feature functional

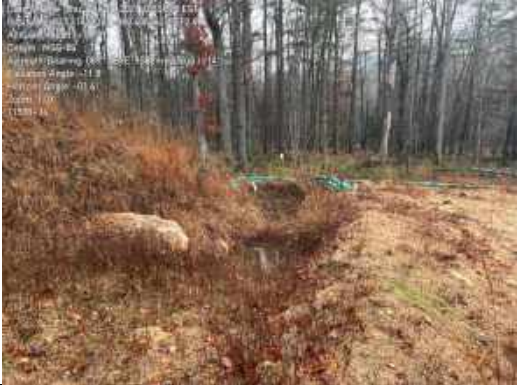
GPS Location	See photo	GPS Location	See photo		
Field Station#	11598+34	Field Station#	11600+01		
Pic 13 Desc.	ET functional	Pic 14 Desc.	RCE functional		
Insert image here		Insert image here			
GPS Location		GPS Location			
Field Station#		Field Station#			
Pic 15 Desc.		Pic 16 Desc.			
Insert image here		Insert image here			
GPS Location		GPS Location			
Field Station#		Field Station#			
Pic 17 Desc.		Pic 18 Desc.

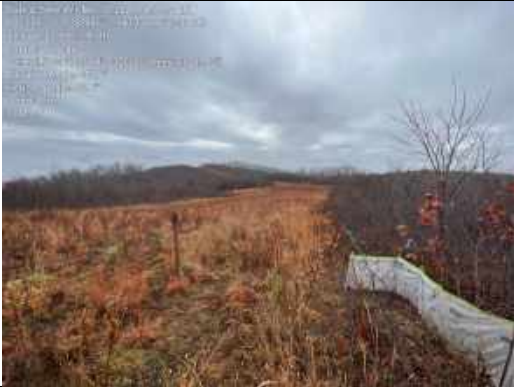
GPS Location	See Photo		GPS Location	See Photo	
Field Station#	11905+00		Field Station#	11918+00	
Pic 1 Desc.	Section of ROW showing conditions and controls		Pic 2 Desc.	Waterbars

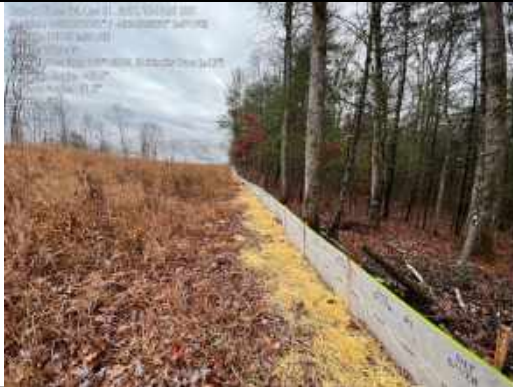
GPS Location	See Photo		GPS Location	See Photo	
Field Station#	11929+78		Field Station#	11961+25	
Pic 3 Desc.	AR 266		Pic 4 Desc.	Parameter Controls

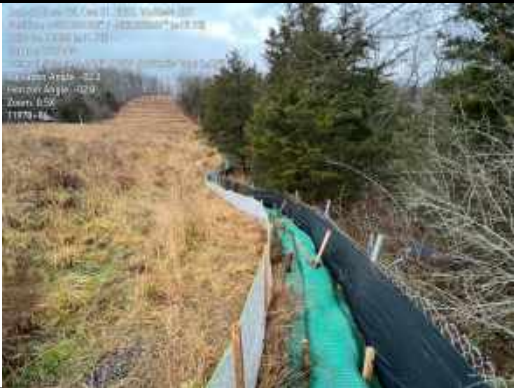
GPS Location	See Photo		GPS Location	See Photo	
Field Station#	11978+86		Field Station#	11990+25	
Pic 5 Desc.	Karst Protection ECDs		Pic 6 Desc.	Section of ROW showing conditions and controls

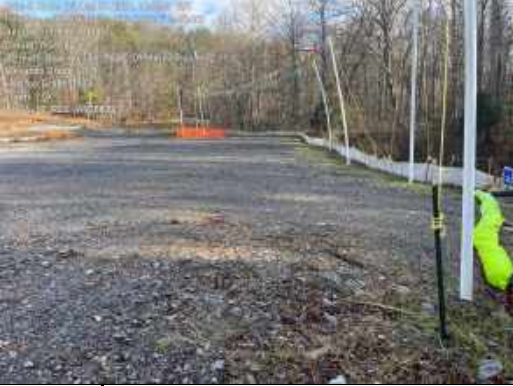
GPS Location	See Photo		GPS Location	See Photo	
Field Station#	11614+00		Field Station#	11614+00	
Pic 1 Desc.	Perimeter P1 silt fence along the RCE		Pic 2 Desc.	RCE conditions. No Issues.

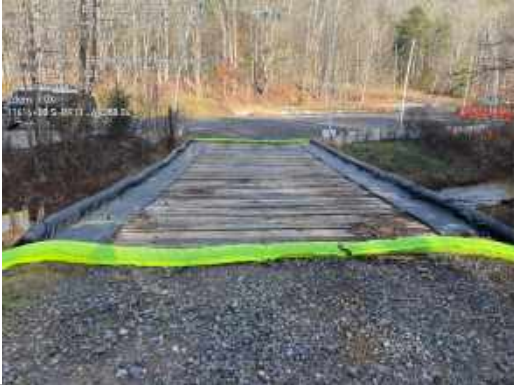
GPS Location	See Photo		GPS Location	See Photo	
Field Station#	11614+00		Field Station#	11614+00	
Pic 3 Desc.	AR 258.04 S-RR13		Pic 4 Desc.	Access Road at 258.04

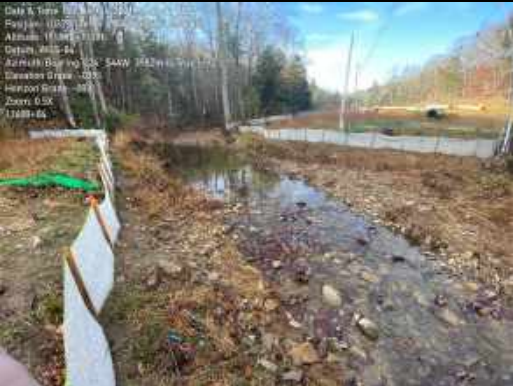
GPS Location	See Photo		GPS Location	See Photo	
Field Station#	11606+00		Field Station#	11608+04	
Pic 5 Desc.	temporary stabilization of row.		Pic 6 Desc.	S-006 Current stream conditions.

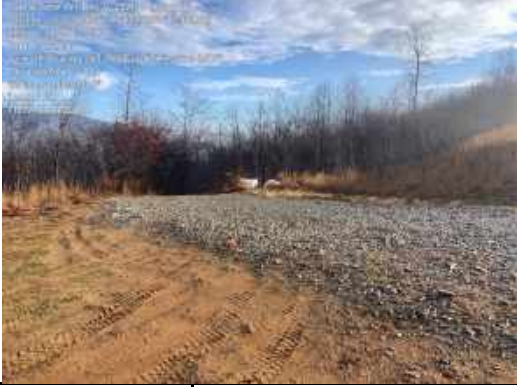
<div style="text-align: center;">Insert image here</div>			
GPS Location	See photo	GPS Location			
Field Station#	11899+89	Field Station#			
Pic 7 Desc.	Ar266.03 is maintained in acceptable condition	Pic 8 Desc.			
<div style="text-align: center;">Insert image here</div>		<div style="text-align: center;">Insert image here</div>			
GPS Location		GPS Location			
Field Station#		Field Station#			
Pic 9 Desc.		Pic 10 Desc.			
<div style="text-align: center;">Insert image here</div>		<div style="text-align: center;">Insert image here</div>			
GPS Location		GPS Location			
Field Station#		Field Station#			
Pic 11 Desc.		Pic 12 Desc.

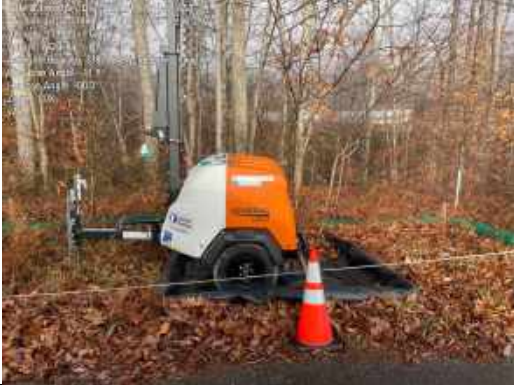
GPS Location	See photo	GPS Location	See photo		
Field Station#	12005+00	Field Station#	12005+00		
Pic 1 Desc.	Secondary containment functional	Pic 2 Desc.	Perimeter controls functional
