Visual Site Inspection Report

Project Name	H-600 Pipeline Spread G	AFE	124300137	Spread	H-600 Pipeline Spread G
Contractor	Precision			Report #	34919
Inspector	Eric Hanlon			Date/Time	2/28/2022 7:31 AM
Permit #	TBD	Inspection Type	VA SWPP	Station Begin	12005+00
State	VA	Inspection Area	Full	Station End	12005+00
County	Giles	Ground	Dry	Temperature (°F)	40.00
Municipality	N/A	Weather	Sunny	Rain Gauge (in)	0.00
				Rain Accumulation Time (days)	1.00

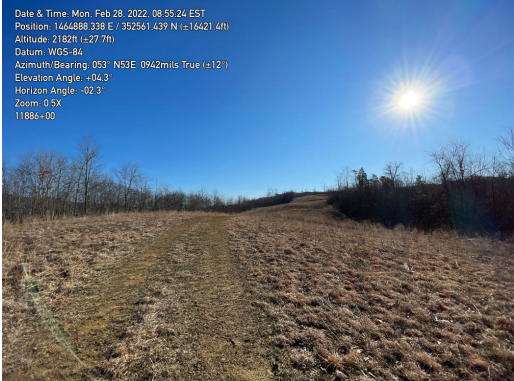
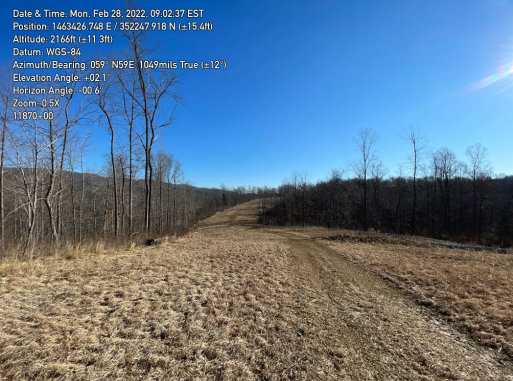
GPS Location	1	GPS Location	2		
Field Station#	11886+00	Field Station#	11870+00		
Pic 1 Desc.	Section of restored RoW showing conditions and controls.		Pic 2 Desc.	Section of restored RoW showing conditions and controls.	
<p>Date & Time: Mon, Feb 28, 2022, 09:05:56 EST Position: 1462883.199 E / 352074.583 N (±122.0ft) Altitude: 2134ft (±105.0ft) Datum: WGS-84 Azimuth/Bearing: 302° N28W 5502mils True (±12°) Elevation Angle: -01.4° Horizon Angle: -00.5° Zoom: 0.5X 11863+65 P-KL2 11863+00</p>

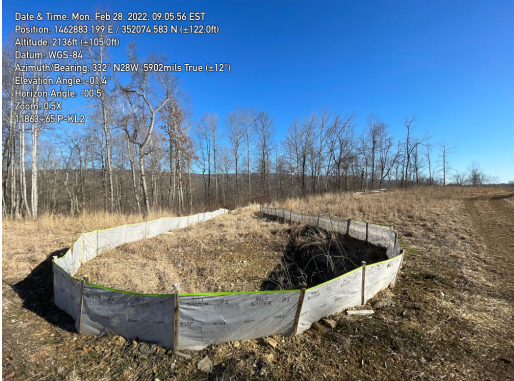
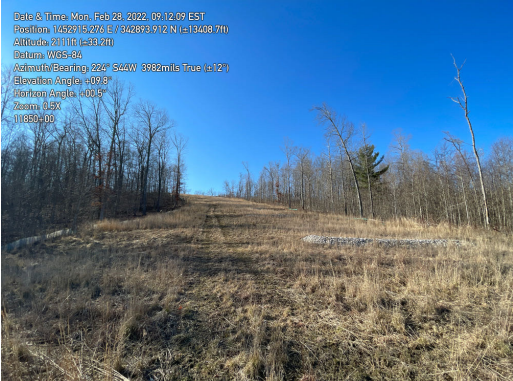
GPS Location	3	GPS Location	4		
Field Station#	11863+65	Field Station#	11850+00		
Pic 3 Desc.	P-KL2.		Pic 4 Desc.	Section of restored RoW showing conditions and controls.	
<p>Date & Time: Mon, Feb 28, 2022, 09:16:31 EST Position: 1462267.042 E / 353472.116 N (±11.6ft) Altitude: 2171ft (±9.8ft) Datum: WGS-84 Azimuth/Bearing: 307° N53W 5458mils True (±12°) Elevation Angle: -15.4° Horizon Angle: -02.8° Zoom: 0.5X 11840+00</p>

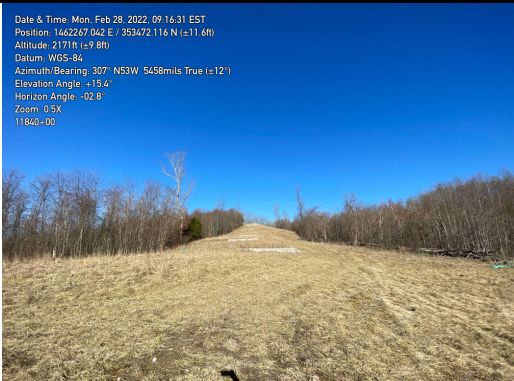
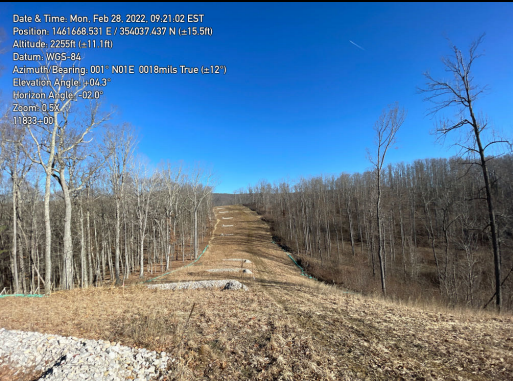
GPS Location	5	GPS Location	6		
Field Station#	11840+00	Field Station#	11833+00		
Pic 5 Desc.	Section of restored RoW showing conditions and controls.		Pic 6 Desc.	Section of restored RoW showing conditions and controls.

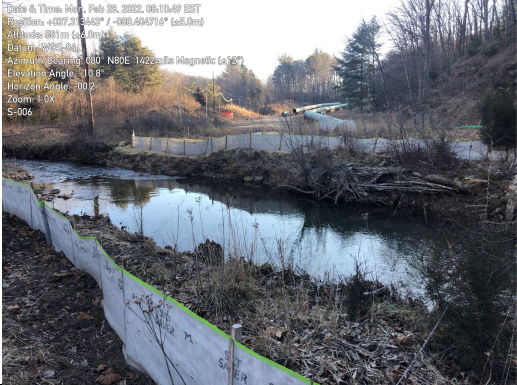
GPS Location	On photo	GPS Location			
Field Station#	11608+17	Field Station#			
Pic 13 Desc.	The S-006 crossing is stable.	Pic 14 Desc.			
Insert image here		Insert image here			
GPS Location		GPS Location			
Field Station#		Field Station#			
Pic 15 Desc.		Pic 16 Desc.			
Insert image here		Insert image here			
GPS Location		GPS Location			
Field Station#		Field Station#			
Pic 17 Desc.		Pic 18 Desc.

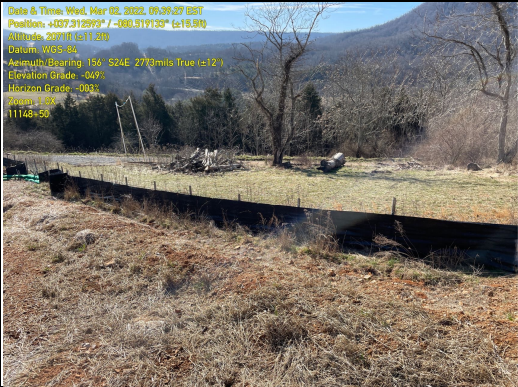
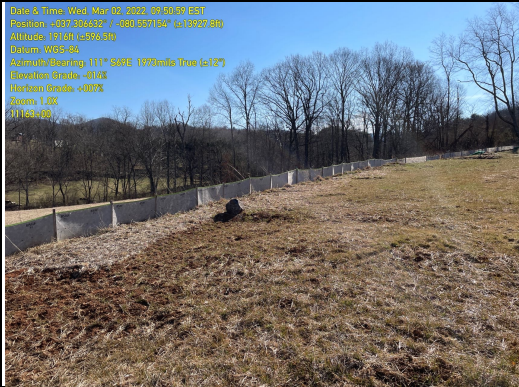
GPS Location	See photo		GPS Location	See photo	
Field Station#	11148+50		Field Station#	11163+00	
Pic 7 Desc.	Supersilt fence perimeter control in place		Pic 8 Desc.	P1 silt fence perimeter control in place	
<p><small>Date & Time: Wed, Mar 02, 2022, 09:43:40 EST Position: +037.311836° / -080.510250° (+18.00) Altitude: 1890ft (+26.20) Datum: WGS-84 Azimuth/Bearing: 208° S09W 470mils True (+12°) Elevation Grade: -018° Horizon Grade: +003° Zoom: 1.0X 11167+50</small></p>

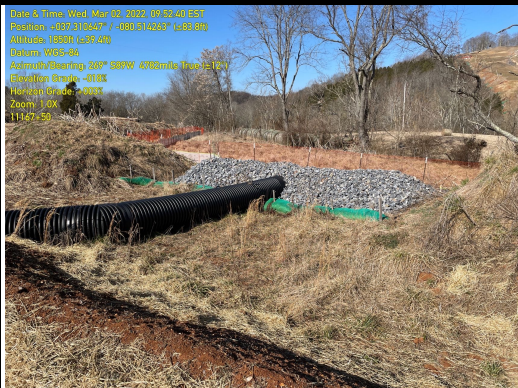
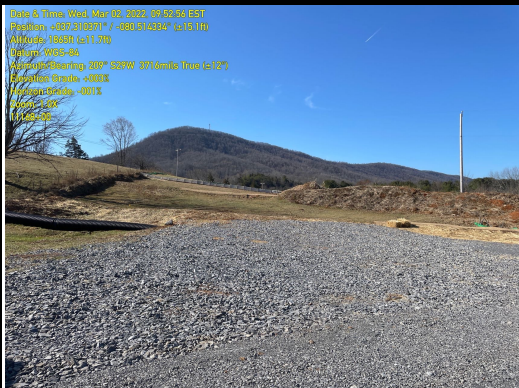
GPS Location	See photo		GPS Location	See photo	
Field Station#	11167+50		Field Station#	11168+00	
Pic 9 Desc.	Cleanwater diversion outlet protection in place		Pic 10 Desc.	RCE in place	
<p><small>Date & Time: Wed, Mar 02, 2022, 10:01:43 EST Position: +037.308437° / -080.511873° (+20.10) Altitude: 1912ft (+26.20) Datum: WGS-84 Azimuth/Bearing: 102° S78E 189mils True (+12°) Elevation Grade: +010° Horizon Grade: +005° Zoom: 1.0X 11178+00</small></p>

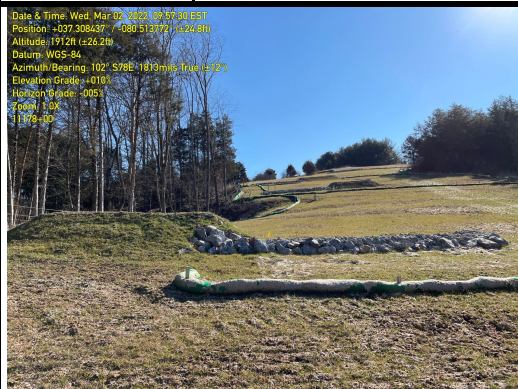
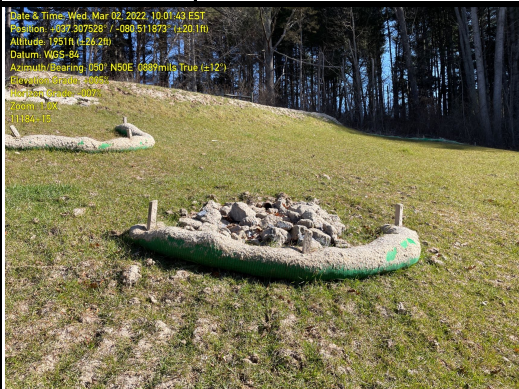
GPS Location	See photo		GPS Location	See photo	
Field Station#	11178+00		Field Station#	11184+15	
Pic 11 Desc.	Level spreader in place		Pic 12 Desc.	Daylight drain in place

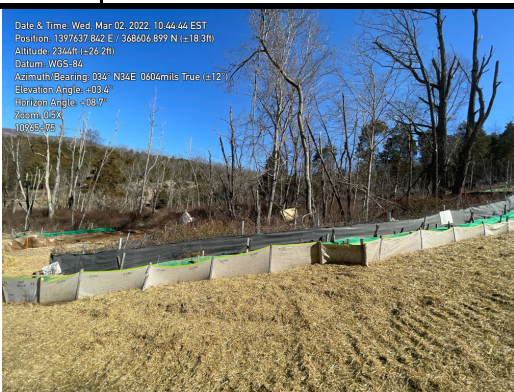
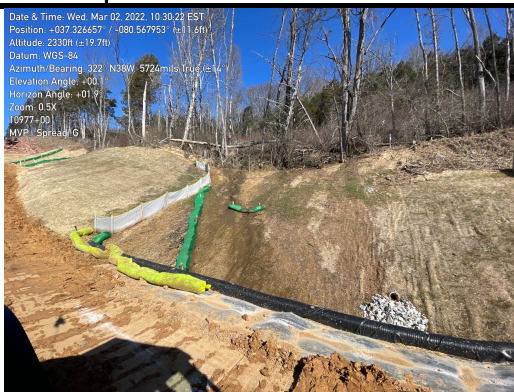
GPS Location	5	GPS Location	6		
Field Station#	10965+75	Field Station#	10977+00		
Pic 5 Desc.	Karst feature protection functional.	Pic 6 Desc.	Section of RoW showing conditions and controls.

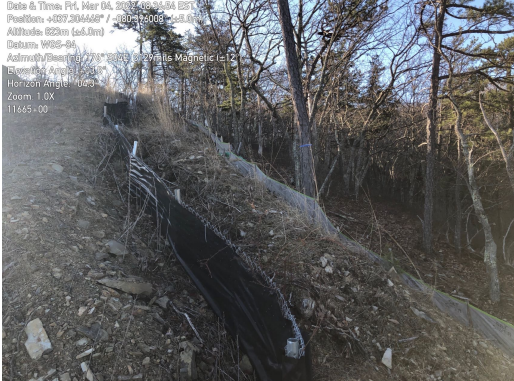
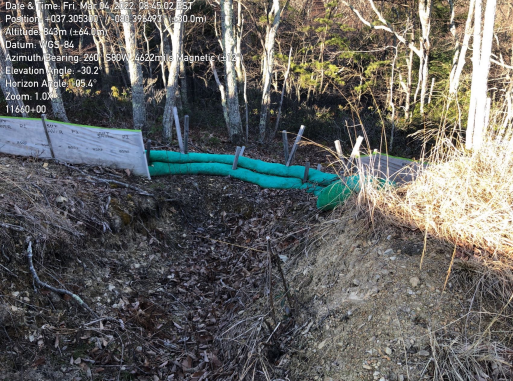
GPS Location	On photo	GPS Location	On photo		
Field Station#	11665+00	Field Station#	11660+00		
Pic 1 Desc.	Perimeter ECDs are in place.	Pic 2 Desc.	Sump and end treatment acceptable. Maintenance will be completed before any ground disturbance occurs.

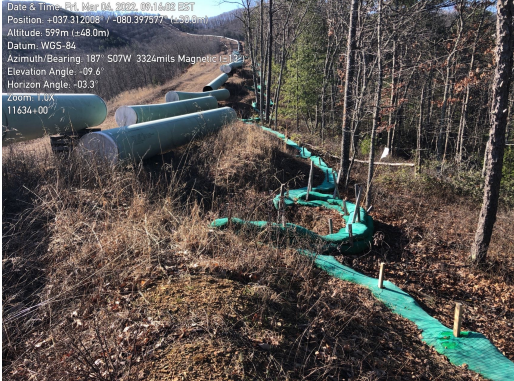
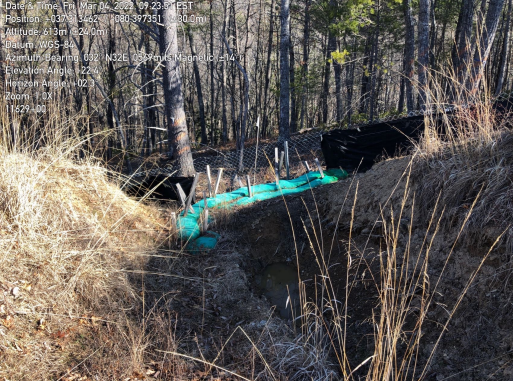
GPS Location	On photo	GPS Location	On photo		
Field Station#	11634+00	Field Station#	11629+00		
Pic 5 Desc.	CFS will be replaced before any ground disturbance occurs. ROW surface is stable.	Pic 6 Desc.	Sumps and end treatments are in place. CFS to be replaced before any ground disturbance occurs.

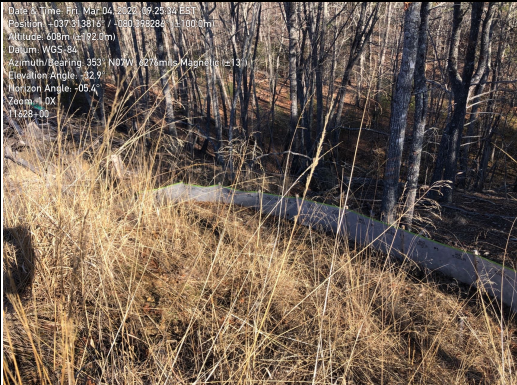
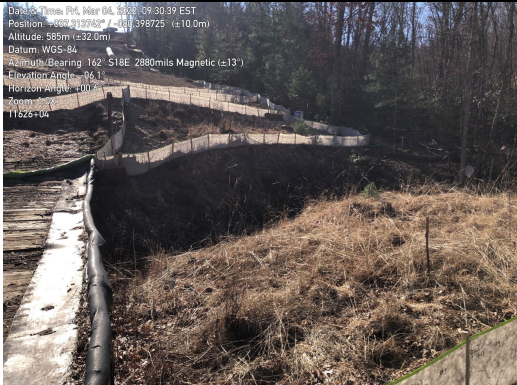
GPS Location	On photo	GPS Location	On photo		
Field Station#	11628+00	Field Station#	11626+04		
Pic 7 Desc.	Perimeter ECDs are in place.	Pic 8 Desc.	The S-HH18 crossing is stable.

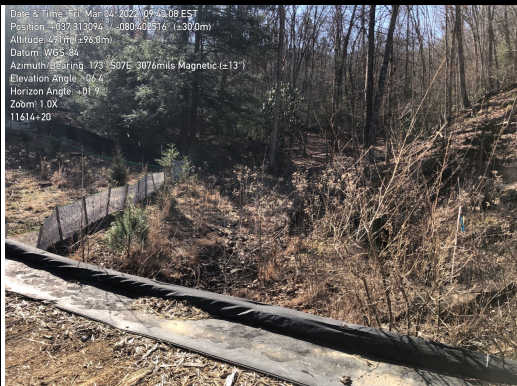
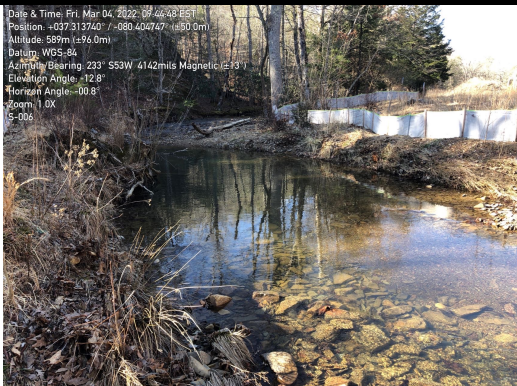
GPS Location	On photo	GPS Location	On photo		
Field Station#	11614+20	Field Station#	11608+17		
Pic 9 Desc.	The S-RR14 crossing is stable.	Pic 10 Desc.	The S-006 crossing is stable. No impact discovered.

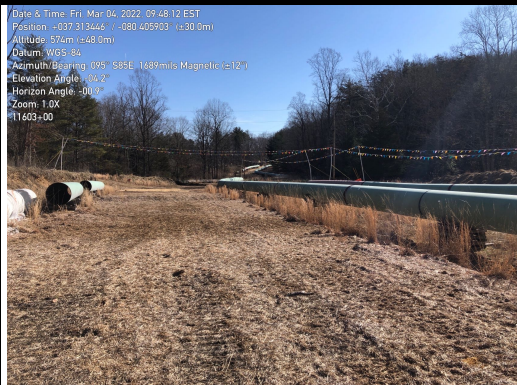
<div>Insert image here</div>			
GPS Location	On photo	GPS Location			
Field Station#	11603+00	Field Station#			
Pic 11 Desc.	Adequate mulch present on private tract to prevent soil movement.	Pic 12 Desc.

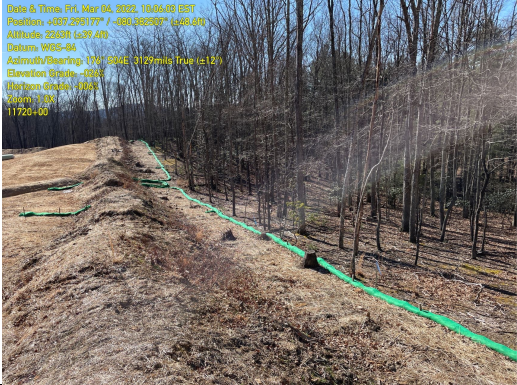
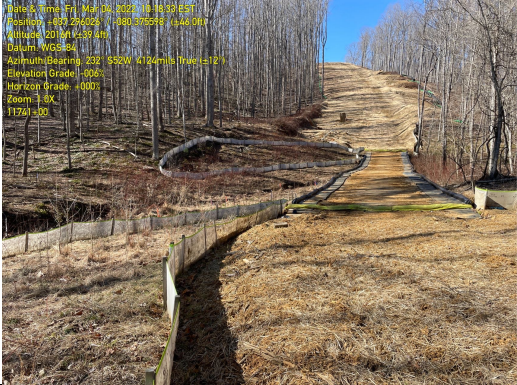
GPS Location	See photo	GPS Location	See photo		
Field Station#	11720+00	Field Station#	11741+00		
Pic 7 Desc.	CFS perimeter control in place	Pic 8 Desc.	Stream buffer in place		
<p><small>Date & Time Fri Mar 04 2022 10:54:08 EST Position: +007.293177° / -88.323287° (±45.4m) Altitude: 2333ft (±39.4m) Datum: WGS-84 Azimuth/Bearing: 09° S01E 1100mils True (±12°) Elevation Grade: +01% Horizon Grade: -00% Zoom: 1.0X 11726+00</small></p>

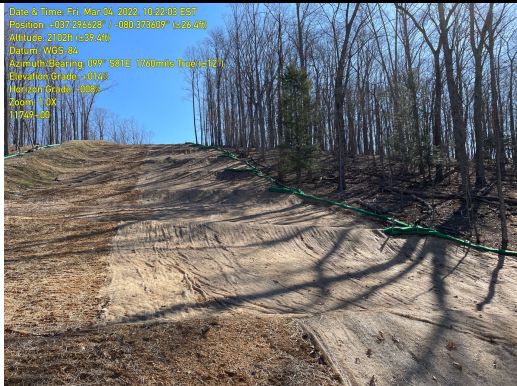
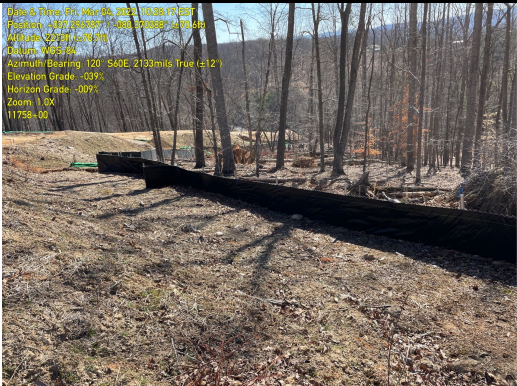
GPS Location	See photo	GPS Location	See photo		
Field Station#	11749+00	Field Station#	11758+00		
Pic 9 Desc.	End treatments in place	Pic 10 Desc.	Supersilt fence perimeter control in place		
<p><small>Date & Time Fri Mar 04 2022 10:54:08 EST Position: +007.293177° / -88.323287° (±45.4m) Altitude: 2333ft (±39.4m) Datum: WGS-84 Azimuth/Bearing: 106° S70E 1480mils True (±12°) Elevation Grade: -01% Horizon Grade: -00% Zoom: 1.0X 11744+35</small></p>
