# Visual Site Inspection Report

<b>Project Name</b>	H-600 Pipeline Spread H	<b>AFE</b>	124300138	<b>Spread</b>	H-600 Pipeline Spread H
<b>Contractor</b>	Precision			<b>Report #</b>	33107
<b>Inspector</b>	Jonathan Altizer			<b>Date/Time</b>	1/10/2022 4:37 PM
<b>Permit #</b>	TBD	<b>Inspection Type</b>	VA SWPP	<b>Station Begin</b>	12284+75
<b>State</b>	VA	<b>Inspection Area</b>	Partial	<b>Station End</b>	12443+75
<b>County</b>	Montgomery	<b>Ground</b>	Wet	<b>Temperature (°F)</b>	35.00
<b>Municipality</b>	N/A	<b>Weather</b>	Sunny	<b>Rain Gauge (in)</b>	0.20
				<b>Rain Accumulation Time (days)</b>	3.00

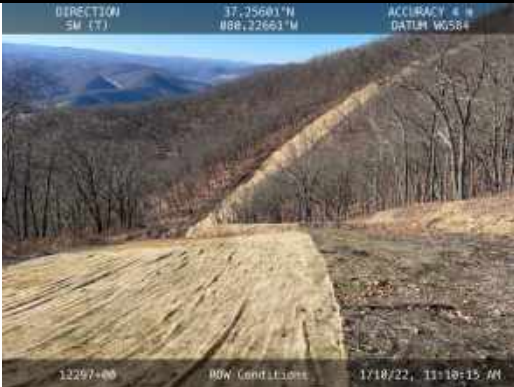
<b>GPS Location</b>	See photo		<b>GPS Location</b>	See photo	
<b>Field Station#</b>	12297+00		<b>Field Station#</b>	12301+00	
<b>Pic 1 Desc.</b>	Current ROW conditions. ROW is stable. ECDs are functional.		<b>Pic 2 Desc.</b>	Current ROW conditions. ROW is stable. ECDs are functional.

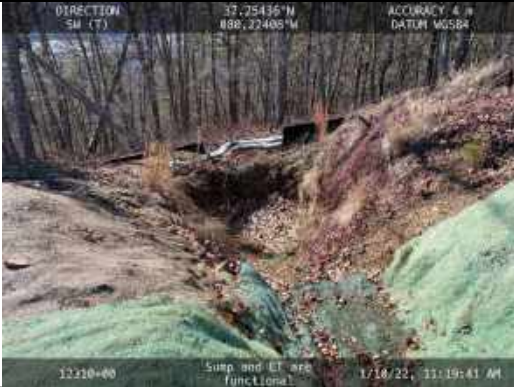
<b>GPS Location</b>	See photo		<b>GPS Location</b>	See photo	
<b>Field Station#</b>	12310+00		<b>Field Station#</b>	12318+00	
<b>Pic 3 Desc.</b>	Sump and ET are functional		<b>Pic 4 Desc.</b>	Current ROW conditions. ROW is stable. ECDs are functional.

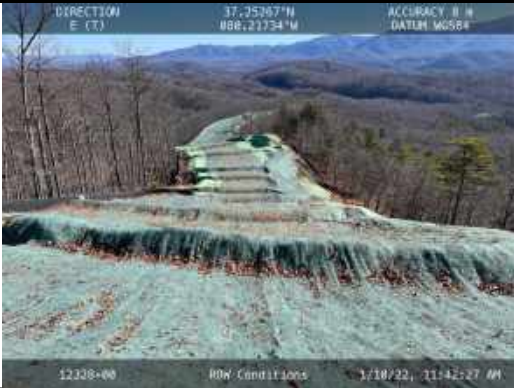
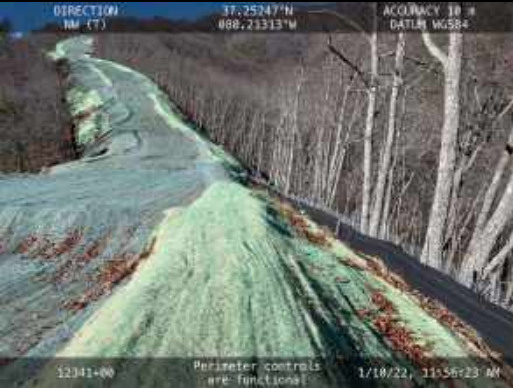
<b>GPS Location</b>	See photo		<b>GPS Location</b>	See photo	
<b>Field Station#</b>	12328+00		<b>Field Station#</b>	12341+00	
<b>Pic 5 Desc.</b>	Current ROW conditions. ROW is stable. ECDs are functional.		<b>Pic 6 Desc.</b>	Perimeter controls are functional

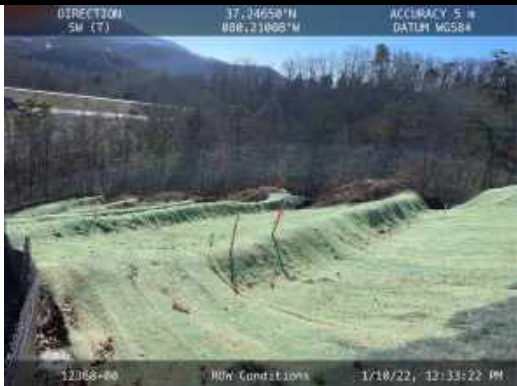
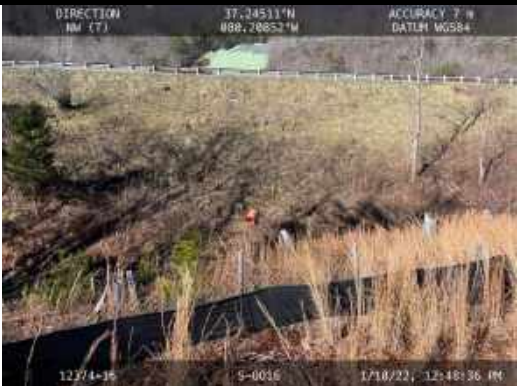
<b>GPS Location</b>	See photo		<b>GPS Location</b>	See photo	
<b>Field Station#</b>	12368+00		<b>Field Station#</b>	12374+16	
<b>Pic 9 Desc.</b>	Current ROW conditions. ROW is stable. ECDs are functional.		<b>Pic 10 Desc.</b>	Overview of Stream S-0016

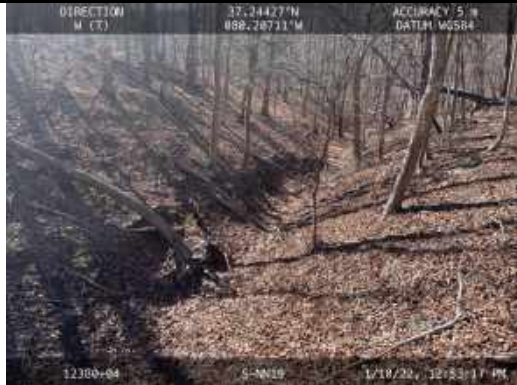
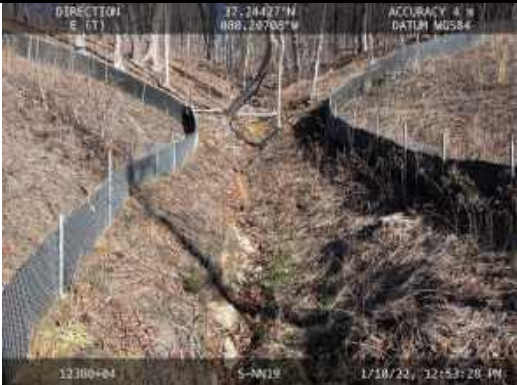
<b>GPS Location</b>	See photo		<b>GPS Location</b>	See photo	
<b>Field Station#</b>	12380+04		<b>Field Station#</b>	12380+04	
<b>Pic 11 Desc.</b>	Downstream of crossing at Stream S-NN19		<b>Pic 12 Desc.</b>	Upstream of crossing at Stream S-NN19

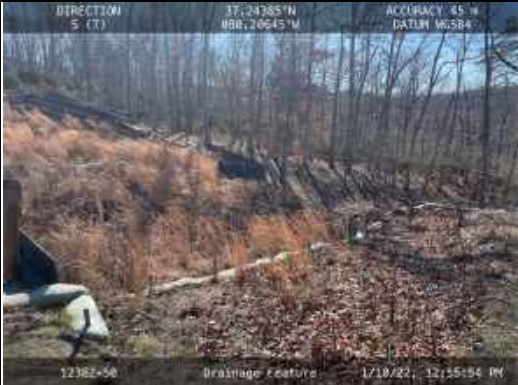
<b>GPS Location</b>	See photo		<b>GPS Location</b>	See photo	
<b>Field Station#</b>	12382+50		<b>Field Station#</b>	12382+50	
<b>Pic 13 Desc.</b>	Drainage Feature is functional		<b>Pic 14 Desc.</b>	Equipment Bridge over drainage feature is functional

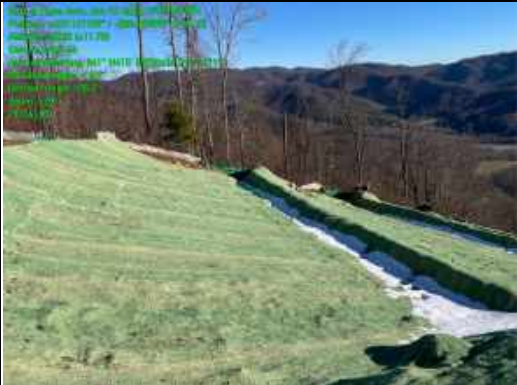
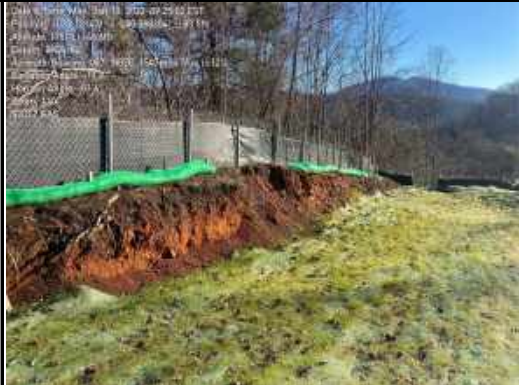
GPS Location	0		GPS Location	0	
Field Station#	13116+00		Field Station#	13185+50	
Pic 13 Desc.	ROW and ECDs In good condition and stable		Pic 14 Desc.	Area needs curlex stabilization

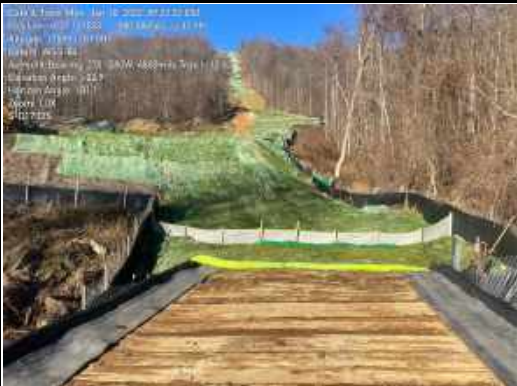
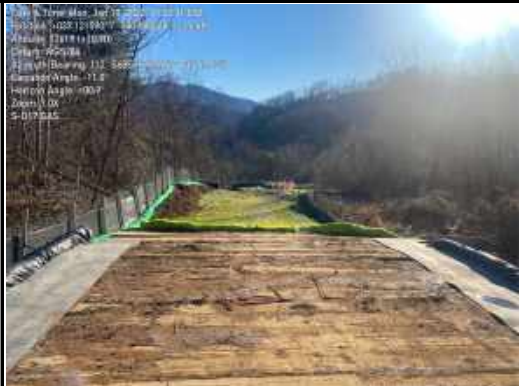
GPS Location	0		GPS Location	0	
Field Station#	13137+78		Field Station#	13137+78	
Pic 15 Desc.	MVP-S-D17 and Corresponding buffer zone in good condition		Pic 16 Desc.	MVP-S-D17 and Corresponding buffer zone in good condition

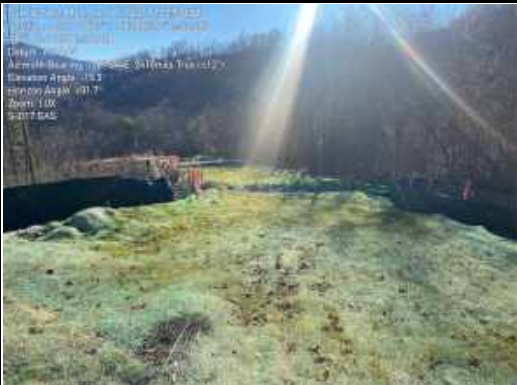
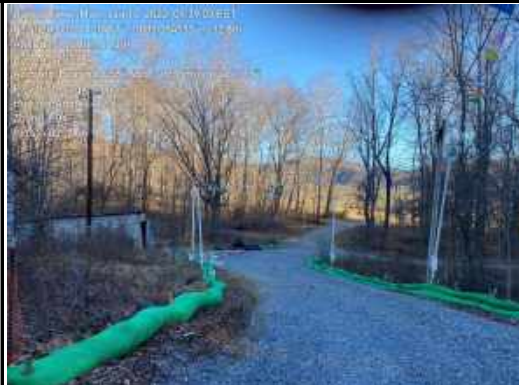
GPS Location	0		GPS Location	0	
Field Station#	13139+00		Field Station#	13142+00	
Pic 17 Desc.	ROW and ECDs In good condition and stable		Pic 18 Desc.	Access road 292 in good condition

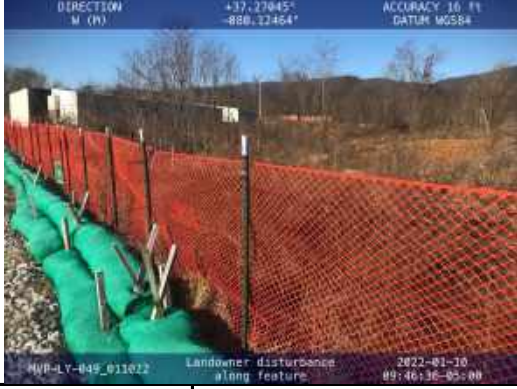
<b>GPS Location</b>	MVP-LY-049 See photo for gps data		<b>GPS Location</b>	MVP-LY-049 See photo for gps data	
<b>Field Station#</b>	+0		<b>Field Station#</b>	+0	
<b>Pic 9 Desc.</b>	Landowner soil disturbance along edge of feature W-CV21A. Area not stabilized. Looking W.		<b>Pic 10 Desc.</b>	Landowner soil disturbance west of feature W-CV21B. Areas not stabilized. Looking SW.

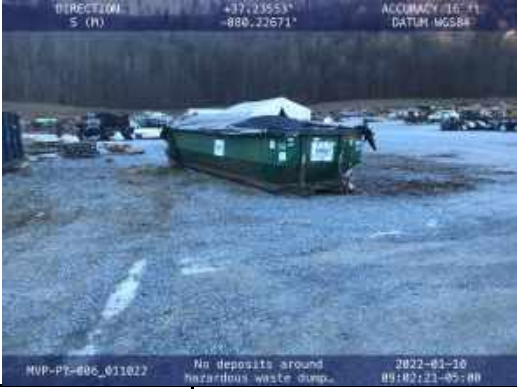
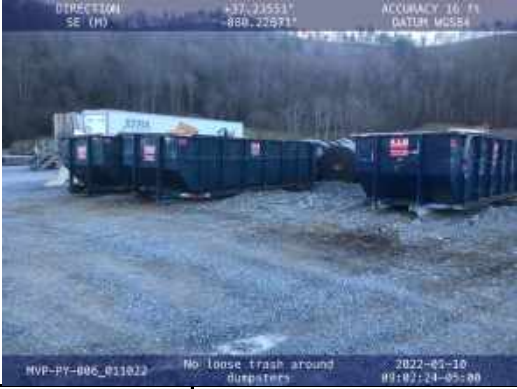
<b>GPS Location</b>	MVP-PY-006 See photo for gps data		<b>GPS Location</b>	MVP-PY-006 See photo for gps data	
<b>Field Station#</b>	+0		<b>Field Station#</b>	+0	
<b>Pic 7 Desc.</b>	No fluids or deposits around hazardous waste dumpster. Looking S.		<b>Pic 8 Desc.</b>	No loose trash around dumpsters or in the yard. Looking SE.

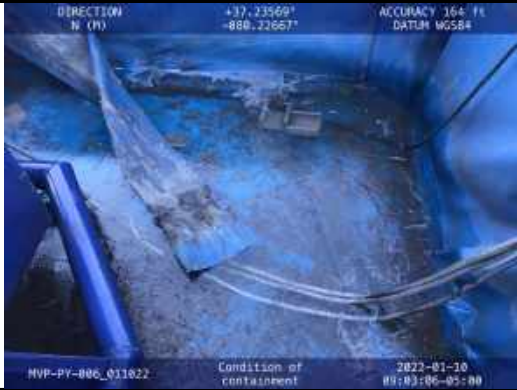
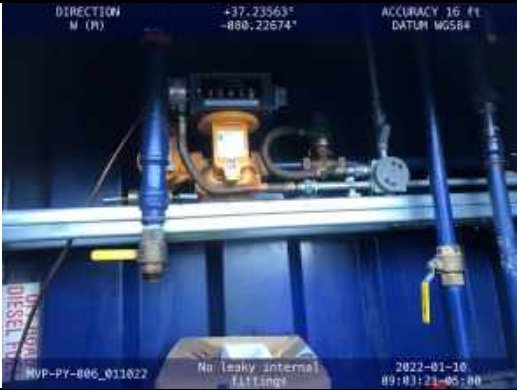
<b>GPS Location</b>	MVP-PY-006 See photo for gps data		<b>GPS Location</b>	MVP-PY-006 See photo for gps data	
<b>Field Station#</b>	+0		<b>Field Station#</b>	+0	
<b>Pic 9 Desc.</b>	Blue Bulk Fuel tanks containment holding stormwater and ice. Looking N.		<b>Pic 10 Desc.</b>	Blue Bulk Fuel tanks no leaky internal fittings. Looking W.

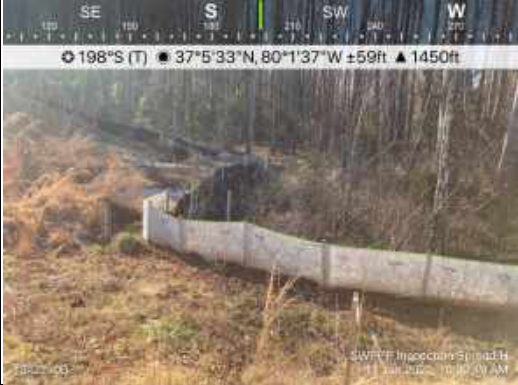
<b>GPS Location</b>	See photo above		<b>GPS Location</b>	See photo above	
<b>Field Station#</b>	13422+00		<b>Field Station#</b>	13422+00	
<b>Pic 13 Desc.</b>	SF and SSF along the ROW perimeters are in acceptable condition.		<b>Pic 14 Desc.</b>	Construction entrance off of Cahas Mountain Rd is cleared of debris and in good condition.

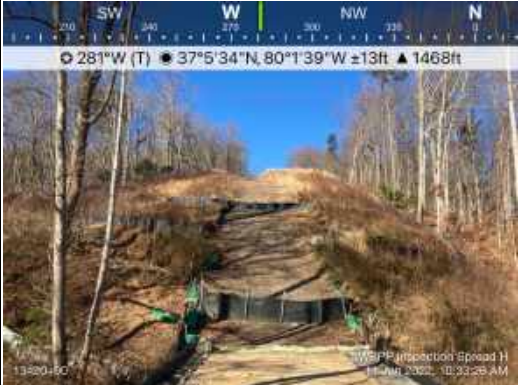
<b>GPS Location</b>	See photo above		<b>GPS Location</b>	See photo above	
<b>Field Station#</b>	13420+00		<b>Field Station#</b>	13422+00	
<b>Pic 15 Desc.</b>	Erosion control measures along steep slopes are in good condition.		<b>Pic 16 Desc.</b>	Wetland crossing area is in good condition. No maintenance is needed.

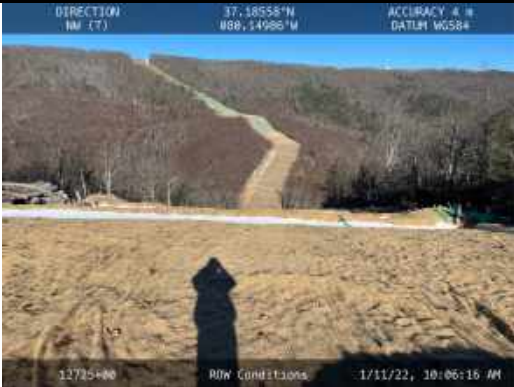
<b>GPS Location</b>	See photo		<b>GPS Location</b>	See photo	
<b>Field Station#</b>	12725+00		<b>Field Station#</b>	12730+00	
<b>Pic 1 Desc.</b>	Current ROW conditions. ROW is stable. ECDs are functional.		<b>Pic 2 Desc.</b>	Current ROW conditions. ROW is stable. ECDs are functional.

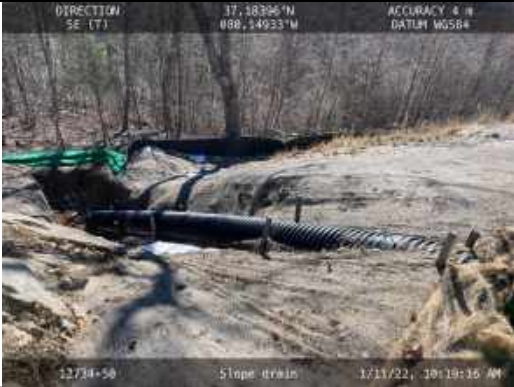
<b>GPS Location</b>	See photo		<b>GPS Location</b>	See photo	
<b>Field Station#</b>	12734+50		<b>Field Station#</b>	12738+00	
<b>Pic 3 Desc.</b>	Slope drain and sump are functional.		<b>Pic 4 Desc.</b>	Current ROW conditions. ROW is stable. ECDs are functional.

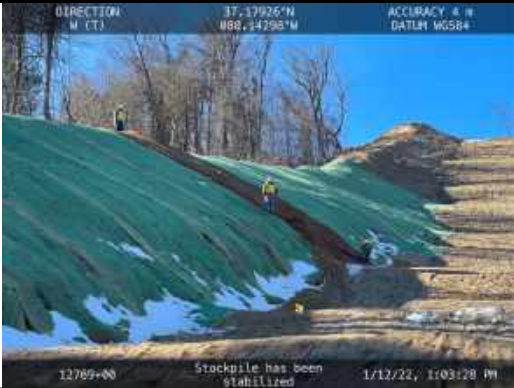
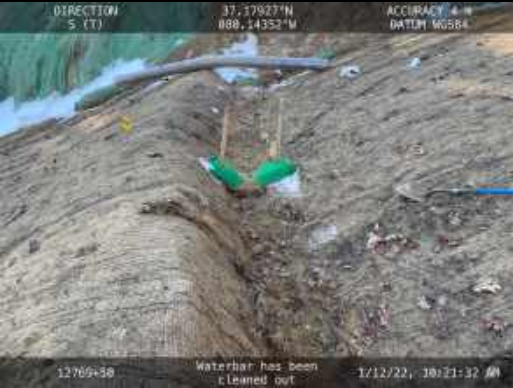
<b>GPS Location</b>	See photo		<b>GPS Location</b>	See photo	
<b>Field Station#</b>	12769+00		<b>Field Station#</b>	12769+50	
<b>Pic 5 Desc.</b>	Stockpiles has been stabilized		<b>Pic 6 Desc.</b>	Waterbar and CFS checks have been cleaned out

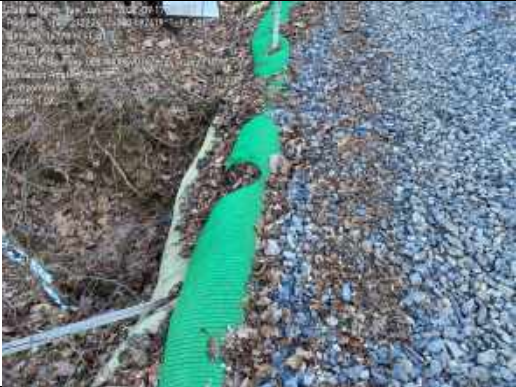
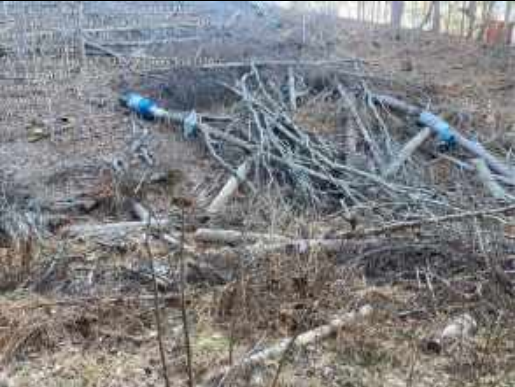
<b>GPS Location</b>	See photo for coordinates.		<b>GPS Location</b>	See photo for coordinates.	
<b>Field Station#</b>	12544+06		<b>Field Station#</b>	12544+06	
<b>Pic 1 Desc.</b>	CFS damaged near S-EF54; added as Punch List item.		<b>Pic 2 Desc.</b>	S-EF20a, W-EF5, no ground disturbance.

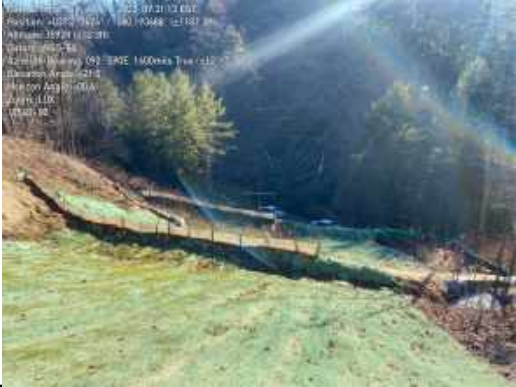
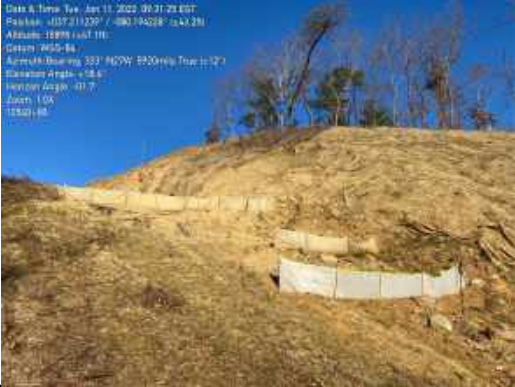
<b>GPS Location</b>	See photo for coordinates.		<b>GPS Location</b>	See photo for coordinates.	
<b>Field Station#</b>	12540+00		<b>Field Station#</b>	12540+00	
<b>Pic 3 Desc.</b>	ROW stabilized.		<b>Pic 4 Desc.</b>	ROW stabilized.

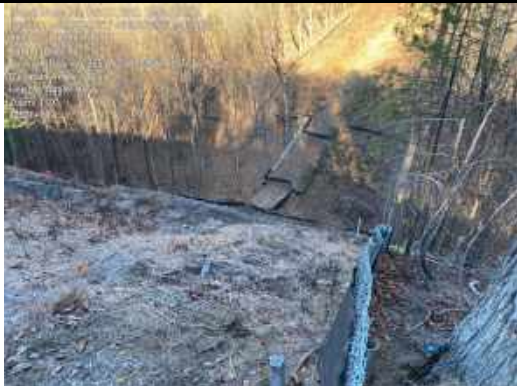
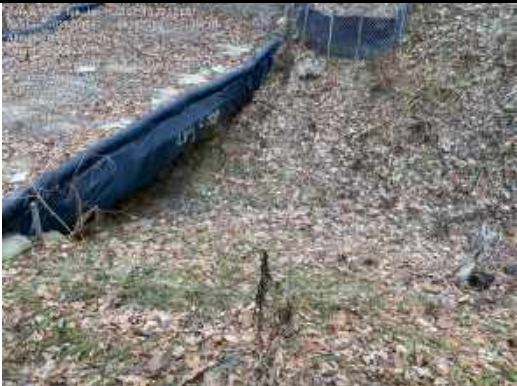
<b>GPS Location</b>	See photo for coordinates.		<b>GPS Location</b>	See photo for coordinates.	
<b>Field Station#</b>	12521+00		<b>Field Station#</b>	12519+41	
<b>Pic 9 Desc.</b>	S-EF19, perimeter controls in acceptable condition at stream crossing.		<b>Pic 10 Desc.</b>	S-EF19, upstream, no flow noted, standing water observed in stream channel upstream of ROW.

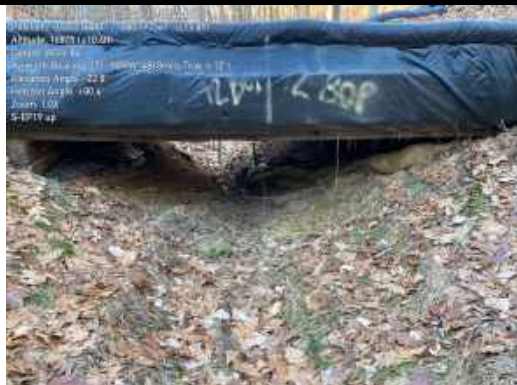
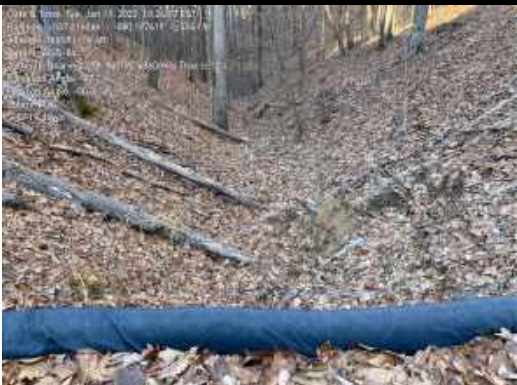
<b>GPS Location</b>	See photo for coordinates.		<b>GPS Location</b>	See photo for coordinates.	
<b>Field Station#</b>	12519+41		<b>Field Station#</b>	12519+41	
<b>Pic 11 Desc.</b>	S-EF19, upstream looking downstream, no flow noted.		<b>Pic 12 Desc.</b>	S-EF19, downstream, no ROW impacts, no flow noted.

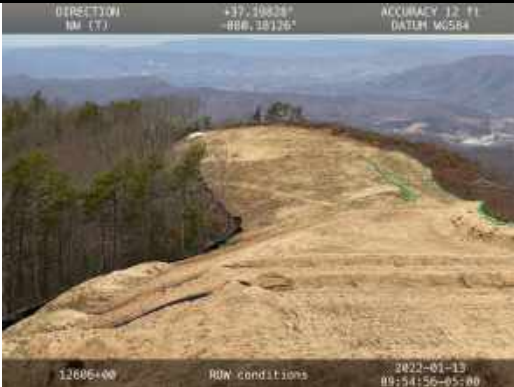
<b>GPS Location</b>	See photo for gps location data.		<b>GPS Location</b>	See photo for gps location data.	
<b>Field Station#</b>	12606+00		<b>Field Station#</b>	12607+00	
<b>Pic 1 Desc.</b>	Photo shows the ROW conditions. ECDs are installed and functioning as designed.		<b>Pic 2 Desc.</b>	Photo shows the slope drain.

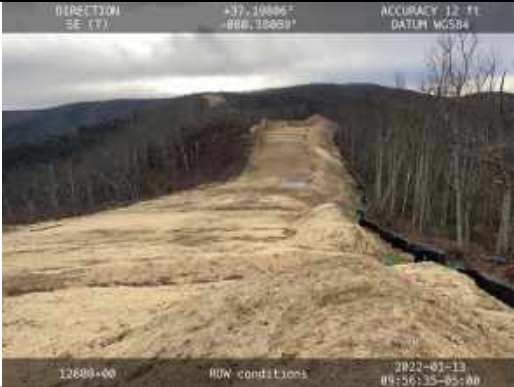
<b>GPS Location</b>	See photo for gps location data.		<b>GPS Location</b>	See photo for gps location data.	
<b>Field Station#</b>	12608+00		<b>Field Station#</b>	12619+00	
<b>Pic 3 Desc.</b>	Photo shows the ROW conditions. ECDs are installed and functioning as designed.		<b>Pic 4 Desc.</b>	Photo shows the ROW conditions. ECDs are installed and functioning as designed.

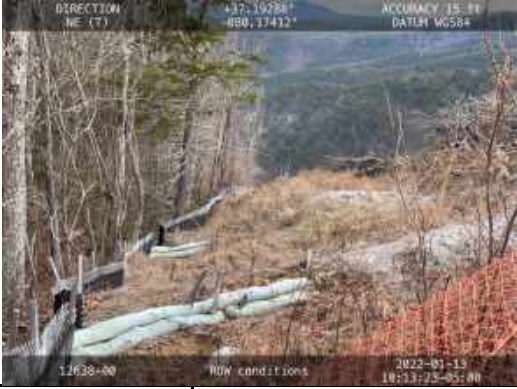
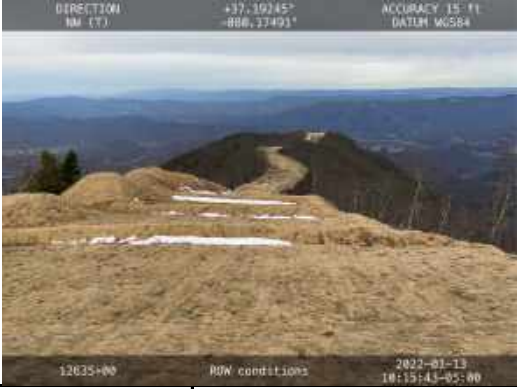
<b>GPS Location</b>	See photo for gps location data.		<b>GPS Location</b>	See photo for gps location data.	
<b>Field Station#</b>	12638+00		<b>Field Station#</b>	12635+00	
<b>Pic 7 Desc.</b>	Photo shows the ROW conditions. ECDs are installed and functioning as designed.		<b>Pic 8 Desc.</b>	Photo shows the ROW conditions. ECDs are installed and functioning as designed.

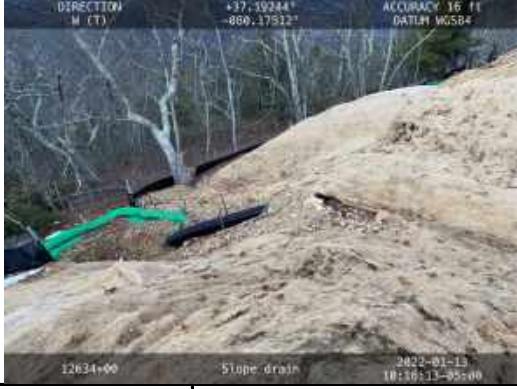
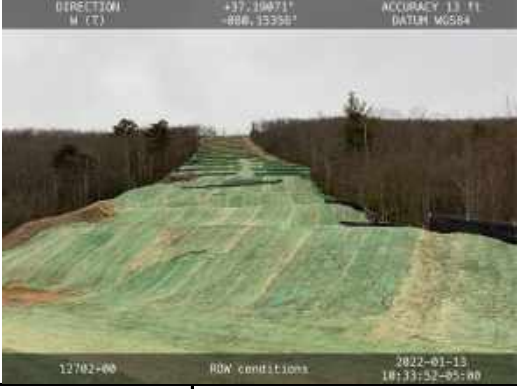
<b>GPS Location</b>	See photo for gps location data.		<b>GPS Location</b>	See photo for gps location data.	
<b>Field Station#</b>	12634+00		<b>Field Station#</b>	12702+00	
<b>Pic 9 Desc.</b>	Photo shows slope drain.		<b>Pic 10 Desc.</b>	Photo shows the ROW conditions. ECDs are installed and functioning as designed.

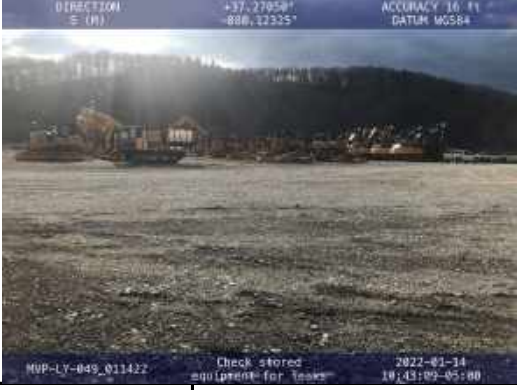
<b>GPS Location</b>	MVP-LY-049 See photo for gps data	<b>GPS Location</b>	MVP-LY-049 See photo for gps data		
<b>Field Station#</b>	+0	<b>Field Station#</b>	+0		
<b>Pic 17 Desc.</b>	Check stored equipment for new leaks. No new leaks found. Looking S.	<b>Pic 18 Desc.</b>	No debris around metal only dumpster. Looking SW.

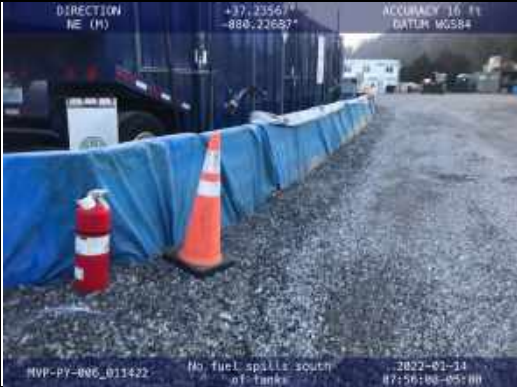
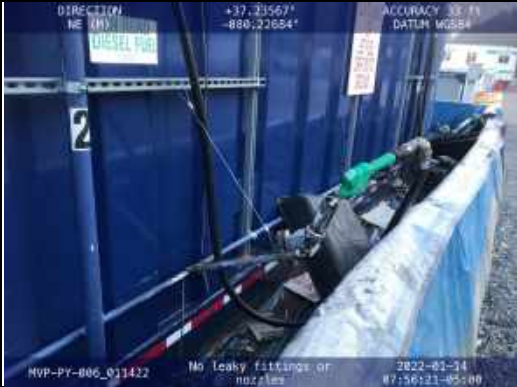
<b>GPS Location</b>	MVP-PY-006 See photo for gps data	<b>GPS Location</b>	MVP-PY-006 See photo for gps data		
<b>Field Station#</b>	+0	<b>Field Station#</b>	+0		
<b>Pic 13 Desc.</b>	Blue Bulk Fuel tanks no fuel spills south of the tanks. Looking NE.	<b>Pic 14 Desc.</b>	Blue Bulk Fuel tanks no leaky fittings or nozzles. Catch pans on site. Looking NE.

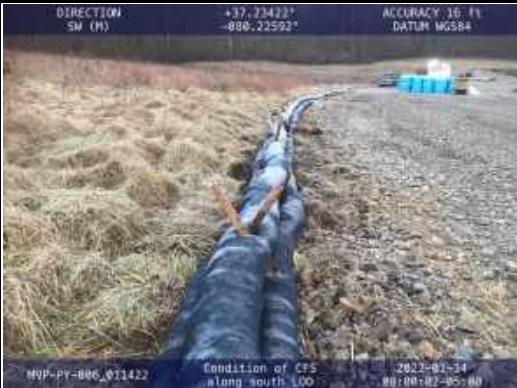
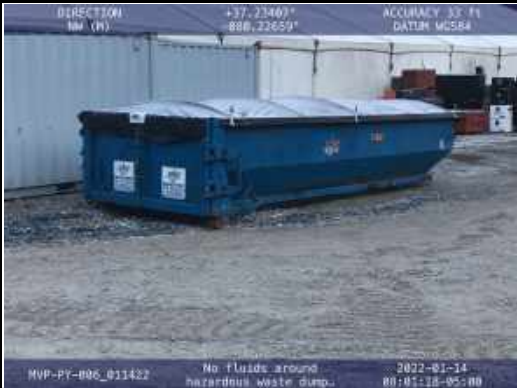
<b>GPS Location</b>	MVP-PY-006 See photo for gps data	<b>GPS Location</b>	MVP-PY-006 See photo for gps data		
<b>Field Station#</b>	+0	<b>Field Station#</b>	+0		
<b>Pic 15 Desc.</b>	Condition of triple stack compost filter sock along south LOD. Looking SW.	<b>Pic 16 Desc.</b>	No fluids or deposits around hazardous waste dumpster. Looking NW.

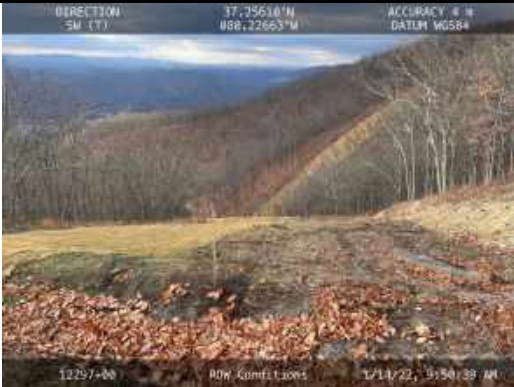
<b>GPS Location</b>	See photo		<b>GPS Location</b>	See photo	
<b>Field Station#</b>	12297+00		<b>Field Station#</b>	12305+00	
<b>Pic 1 Desc.</b>	Current ROW conditions. ROW is stable. ECDs are functional.		<b>Pic 2 Desc.</b>	Sump and End Treatment are functional

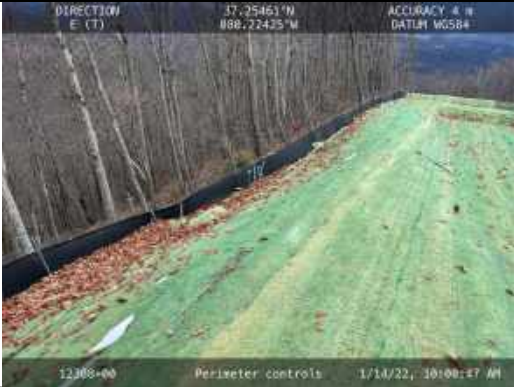
<b>GPS Location</b>	See photo		<b>GPS Location</b>	See photo	
<b>Field Station#</b>	12308+00		<b>Field Station#</b>	12310+00	
<b>Pic 3 Desc.</b>	Perimeter controls are functional		<b>Pic 4 Desc.</b>	Current ROW conditions. ROW is stable. ECDs are functional.

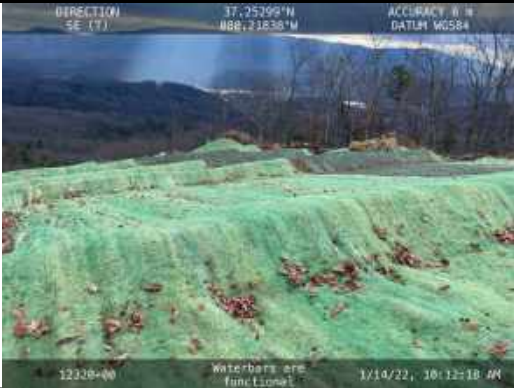
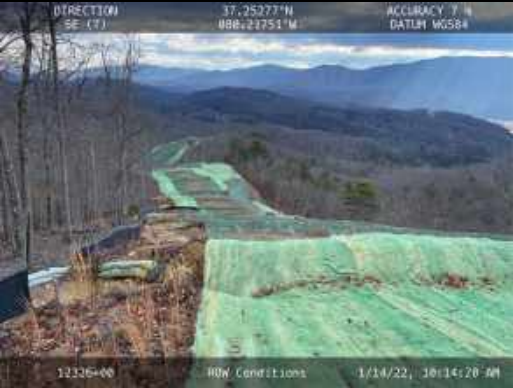
<b>GPS Location</b>	See photo		<b>GPS Location</b>	See photo	
<b>Field Station#</b>	12320+00		<b>Field Station#</b>	12326+00	
<b>Pic 5 Desc.</b>	Current ROW conditions. ROW is stable. ECDs are functional.		<b>Pic 6 Desc.</b>	Current ROW conditions. ROW is stable. ECDs are functional.

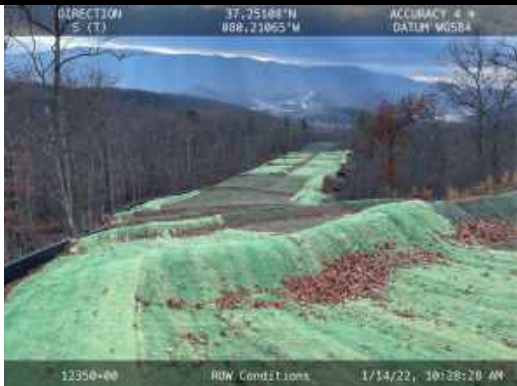
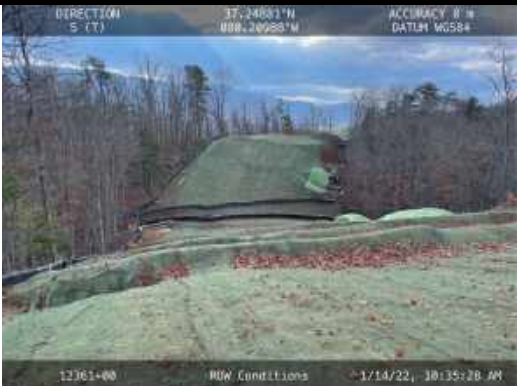
<b>GPS Location</b>	See photo		<b>GPS Location</b>	See photo	
<b>Field Station#</b>	12350+00		<b>Field Station#</b>	12361+00	
<b>Pic 9 Desc.</b>	Current ROW conditions. ROW is stable. ECDs are functional.		<b>Pic 10 Desc.</b>	Current ROW conditions. ROW is stable. ECDs are functional.

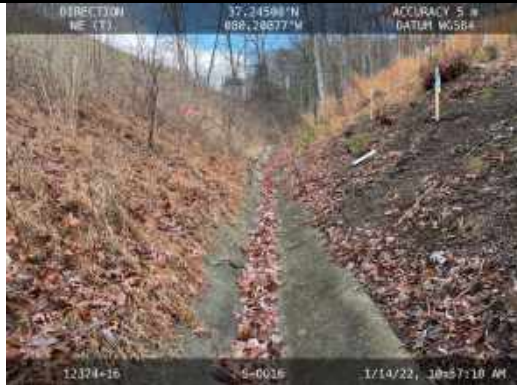
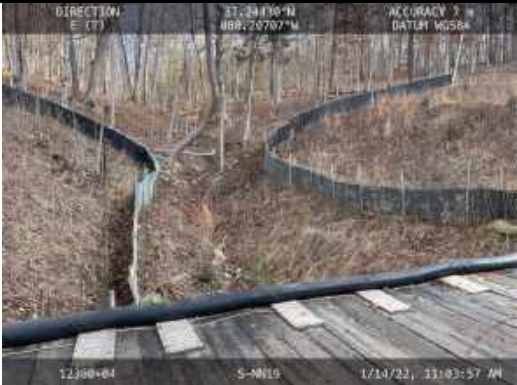
<b>GPS Location</b>	See photo		<b>GPS Location</b>	See photo	
<b>Field Station#</b>	12374+16		<b>Field Station#</b>	12380+04	
<b>Pic 11 Desc.</b>	Looking upstream at Stream S-0016		<b>Pic 12 Desc.</b>	Upstream of crossing at Stream S-NN19

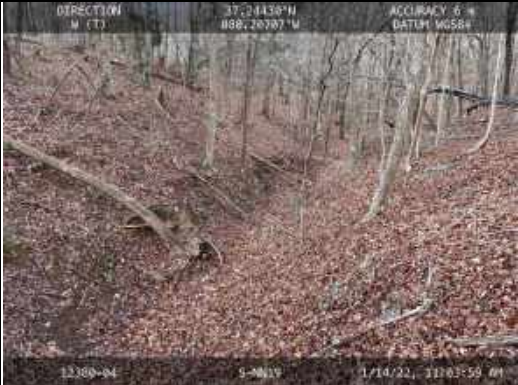
<b>GPS Location</b>	See photo		<b>GPS Location</b>	See photo	
<b>Field Station#</b>	12380+04		<b>Field Station#</b>	12393+00	
<b>Pic 13 Desc.</b>	Downstream of crossing at Stream S-NN19		<b>Pic 14 Desc.</b>	Current ROW conditions. ROW is stable. ECDs are functional.

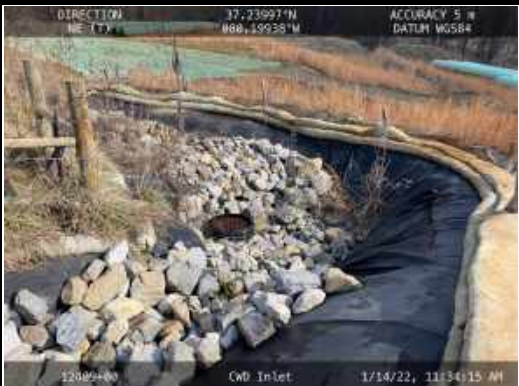
<b>GPS Location</b>	See photo		<b>GPS Location</b>	See photo	
<b>Field Station#</b>	12403+00		<b>Field Station#</b>	12409+00	
<b>Pic 15 Desc.</b>	Current ROW conditions. ROW is stable. ECDs are functional.		<b>Pic 16 Desc.</b>	CWD Inlet is functional

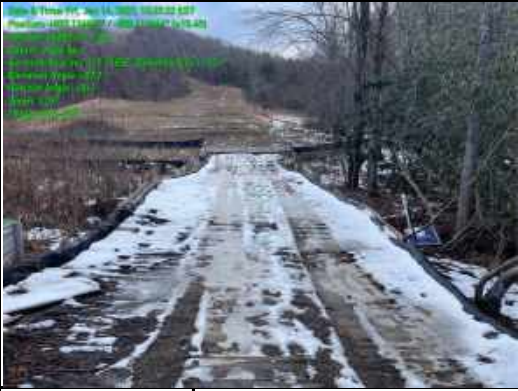
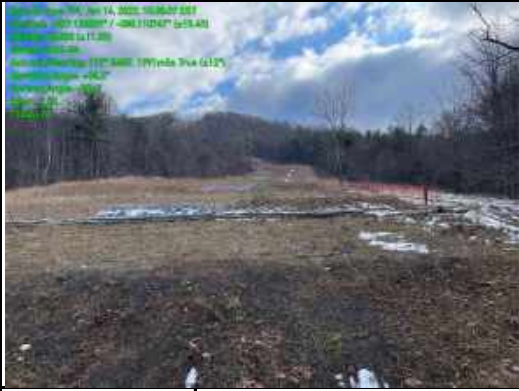
GPS Location	0	GPS Location	0		
Field Station#	13062+96	Field Station#	13064+00		
Pic 7 Desc.	MVP-S-G27 and Corresponding buffer zone In good condition		Pic 8 Desc.	ROW and ECDs In good condition and stable

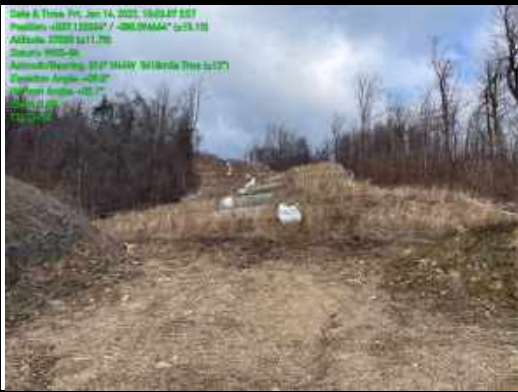
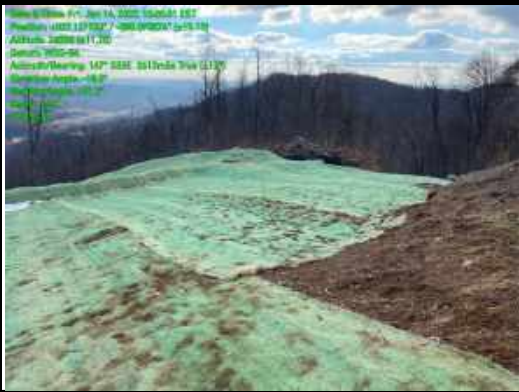
GPS Location	0	GPS Location	0		
Field Station#	13113+50	Field Station#	13115+00		
Pic 9 Desc.	ROW and ECDs In good condition and stable		Pic 10 Desc.	ROW and ECDs In good condition and stable

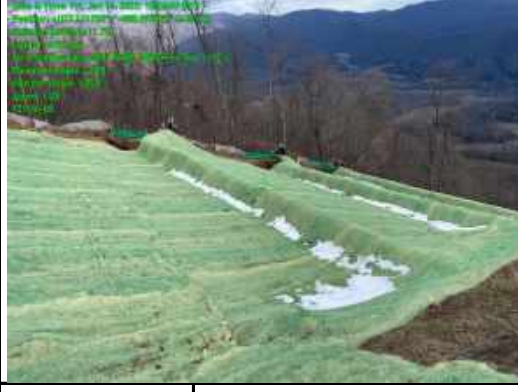
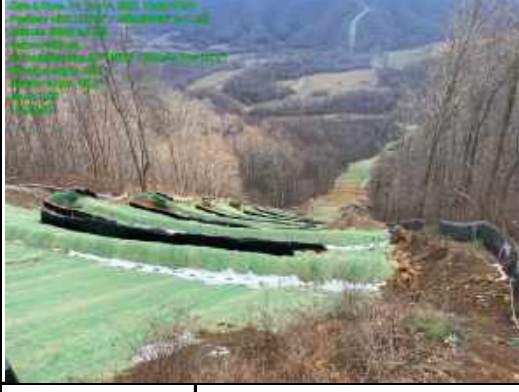
GPS Location	0	GPS Location	0		
Field Station#	13118+00	Field Station#	13120+00		
Pic 11 Desc.	ROW and ECDs In good condition and stable		Pic 12 Desc.	ROW and ECDs In good condition and stable
