# Visual Site Inspection Report

<b>Project Name</b>	H-600 Pipeline Spread H	<b>AFE</b>	124300138	<b>Spread</b>	H-600 Pipeline Spread H
<b>Contractor</b>	Precision			<b>Report #</b>	33330
<b>Inspector</b>	Logan Box			<b>Date/Time</b>	1/18/2022 3:03 PM
<b>Permit #</b>	TBD	<b>Inspection Type</b>	VA SWPP	<b>Station Begin</b>	13525+99
<b>State</b>	VA	<b>Inspection Area</b>	Partial	<b>Station End</b>	13670+00
<b>County</b>	Franklin	<b>Ground</b>	Frozen	<b>Temperature (°F)</b>	40.00
<b>Municipality</b>	N/A	<b>Weather</b>	Sunny	<b>Rain Gauge (in)</b>	0.00
				<b>Rain Accumulation Time (days)</b>	0.00

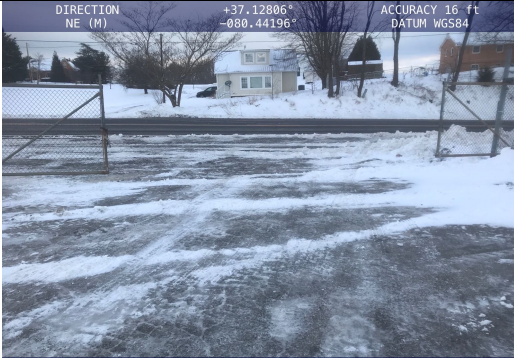
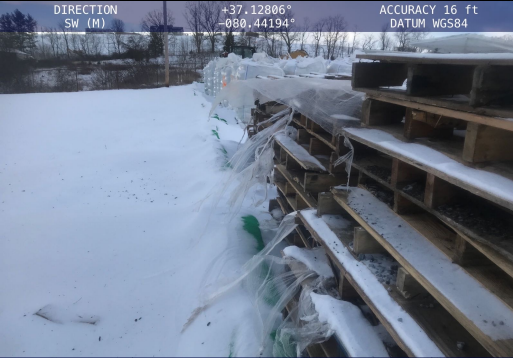
<b>GPS Location</b>	MVP-LY-071 See photo for gps data	<b>GPS Location</b>	MVP-LY-071 See photo for gps data		
<b>Field Station#</b>	+0	<b>Field Station#</b>	+0		
<b>Pic 1 Desc.</b>	Condition of main entrance. Ice covered. Looking NE.	<b>Pic 2 Desc.</b>	Condition of triple stack compost along east LOD. Looking SW.

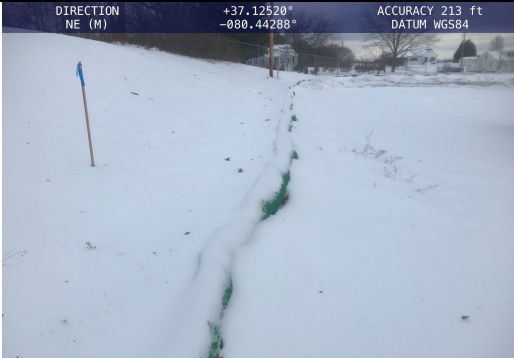
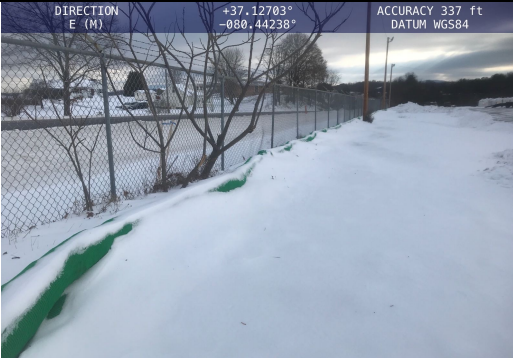
<b>GPS Location</b>	MVP-LY-071 See photo for gps data	<b>GPS Location</b>	MVP-LY-071 See photo for gps data		
<b>Field Station#</b>	+0	<b>Field Station#</b>	+0		
<b>Pic 3 Desc.</b>	Condition of triple stack compost filter sock along west LOD. Looking NE.	<b>Pic 4 Desc.</b>	Condition of triple stack compost filter sock along north LOD. Looking E.

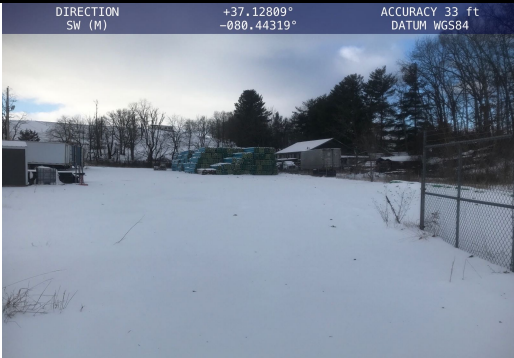
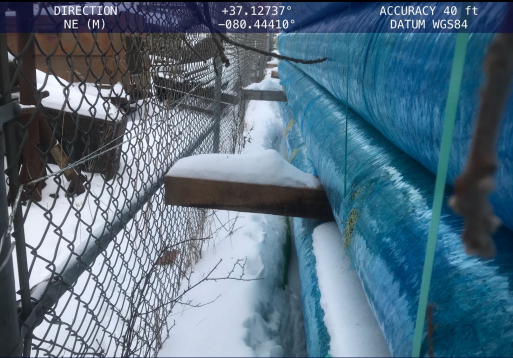
<b>Pic 5 Desc.</b>	No loose trash in south west section of yard. Looking SW.	<b>Pic 6 Desc.</b>	Condition of triple stack compost filter sock along west LOD. Looking NE.

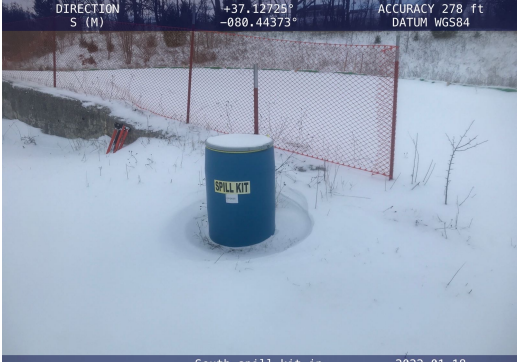
<p>DIRECTION S (M) +37.12725° -080.44373° ACCURACY 278 ft DATUM WGS84</p> <p>MVP-LY-071_011822 South spill kit in place 2022-01-18 09:35:23-05:00</p>

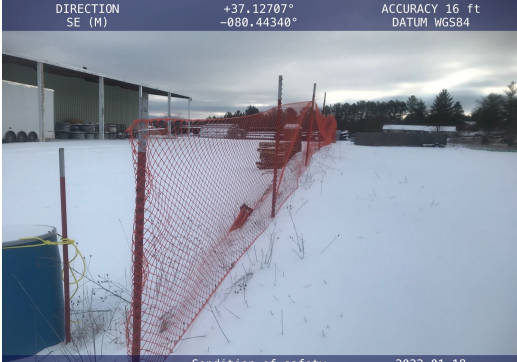
<p>DIRECTION SE (M) +37.12707° -080.44340° ACCURACY 16 ft DATUM WGS84</p> <p>MVP-LY-071_011822 Condition of safety fence along ramp 2022-01-18 09:35:33-05:00</p>			
<b>GPS Location</b>	MVP-LY-071 See photo for gps data		<b>GPS Location</b>	MVP-LY-071 See photo for gps data	
<b>Field Station#</b>	+0		<b>Field Station#</b>	+0	
<b>Pic 7 Desc.</b>	South spill kit in place. Looking S.		<b>Pic 8 Desc.</b>	Condition of safety fence along ramp. Looking SE.

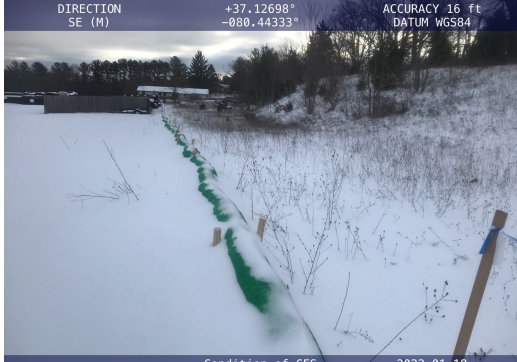
<p>DIRECTION SE (M) +37.12698° -080.44333° ACCURACY 16 ft DATUM WGS84</p> <p>MVP-LY-071_011822 Condition of CFS along south LOD 2022-01-18 09:35:52-05:00</p>

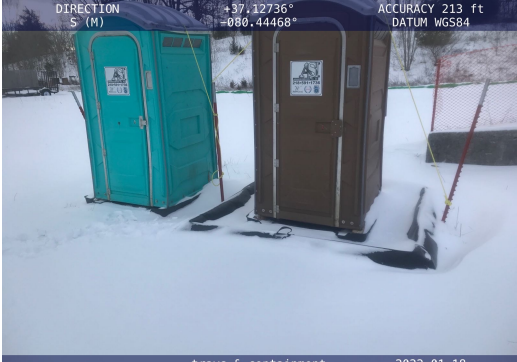
<p>DIRECTION S (M) +37.12736° -080.44468° ACCURACY 213 ft DATUM WGS84</p> <p>MVP-LY-071_011822 trays &amp; containment under toilets 2022-01-18 09:36:59-05:00</p>

<b>GPS Location</b>	MVP-LY-071 See photo for gps data		<b>GPS Location</b>	MVP-LY-071 See photo for gps data	
<b>Field Station#</b>	+0		<b>Field Station#</b>	+0	
<b>Pic 9 Desc.</b>	Condition of triple stack compost filter sock along south LOD. Looking SE.		<b>Pic 10 Desc.</b>	Trays and containment under toilets holding snow and ice. Looking S.

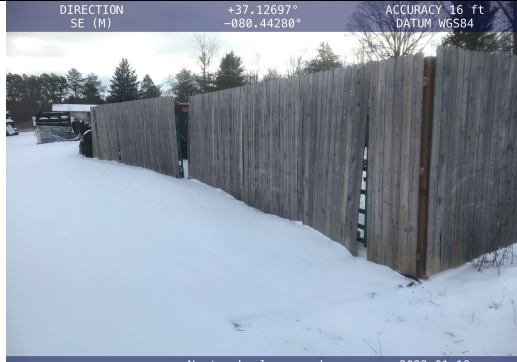
<p>DIRECTION SE (M) +37.12697° -080.44280° ACCURACY 16 ft DATUM WGS84</p> <p>MVP-LY-071_011822 No trash along wooden fence dumpster area 2022-01-18 09:38:01-05:00</p>		  <p>DIRECTION SE (M) +37.12692° -080.44270° ACCURACY 16 ft DATUM WGS84</p> <p>MVP-LY-071_011822 No loose trash around dumpster 2022-01-18 09:38:18-05:00</p>			
<b>GPS Location</b>	MVP-LY-071 See photo for gps data		<b>GPS Location</b>	MVP-LY-071 See photo for gps data	
<b>Field Station#</b>	+0		<b>Field Station#</b>	+0	
<b>Pic 11 Desc.</b>	No loose trash around wooden fence dumpster area. Looking SE.		<b>Pic 12 Desc.</b>	No loose trash around dumpster inside wood fence. Looking SE.

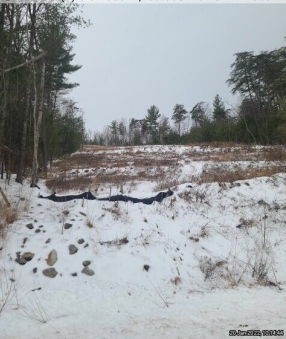
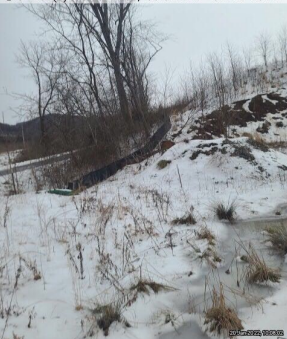
<b>GPS Location</b>	00000	<b>GPS Location</b>	00000		
<b>Field Station#</b>	13496+62	<b>Field Station#</b>	13415+70		
<b>Pic 1 Desc.</b>	Monitored ECDs and visible vegetation, no environmental issues observed at the time of inspection.		<b>Pic 2 Desc.</b>	Observed wire back silt fence along the LOD during today's inspection, no environmental issues observed at the time of inspection.	
	<b>West Elevation</b>

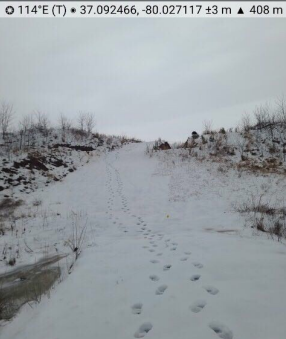
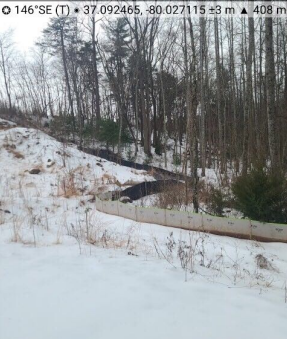
<b>GPS Location</b>	0000	<b>GPS Location</b>	00000		
<b>Field Station#</b>	13418+00	<b>Field Station#</b>	13415+60		
<b>Pic 3 Desc.</b>	Row photo on hill side above road crossing, row stabilized at the time of inspection, no environmental issues observed at the time of inspection.		<b>Pic 4 Desc.</b>	Monitored ECDs along the row , all functioning at the time of inspection.

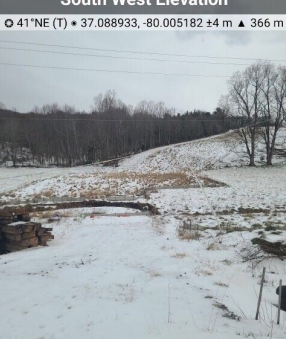
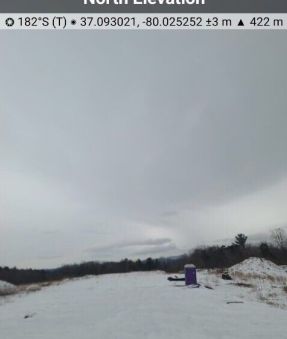
<b>GPS Location</b>	00000	<b>GPS Location</b>	00000		
<b>Field Station#</b>	13497+00	<b>Field Station#</b>	13420+00		
<b>Pic 5 Desc.</b>	Observed stream crossing at CAHAS#2 , monitored visible ECDs, no environmental issues observed at the time of inspection.		<b>Pic 6 Desc.</b>	Row photo in work space area showing row conditions after recent snow events and rain events throughout today.

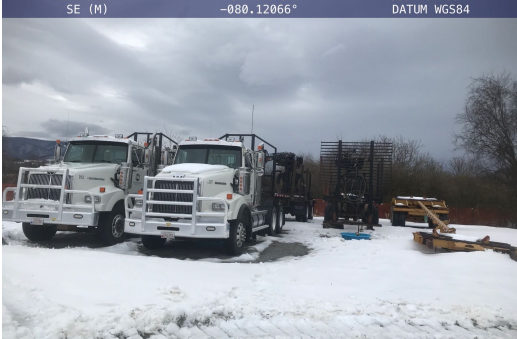
MVP-LY-049_012022 Check stored trucks for leaks 2022-01-20 10:19:29-05:00		DIRECTION S (M) +37.26945° -080.12389° ACCURACY 98 ft DATUM WGS84

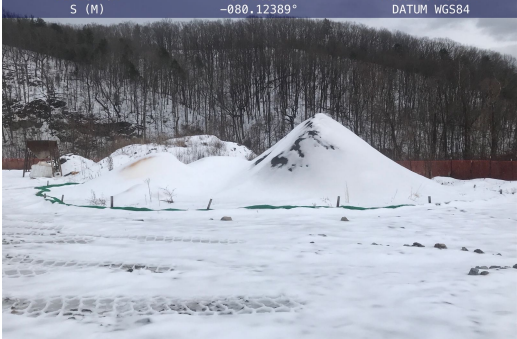
MVP-LY-049_012022 CFS in place around sand pile 2022-01-20 10:10:50-05:00			
<b>GPS Location</b>	MVP-LY-049 See photo for gps data		<b>GPS Location</b>	MVP-LY-049 See photo for gps data	
<b>Field Station#</b>	+0		<b>Field Station#</b>	+0	
<b>Pic 7 Desc.</b>	Check stored trucks for fluid leaks. No new leaks found. Looking SE.		<b>Pic 8 Desc.</b>	Compost filter sock in place and functioning around sand pile. Looking S.	
DIRECTION SE (M) +37.27517° -080.11430° ACCURACY 1.01 mi DATUM WGS84

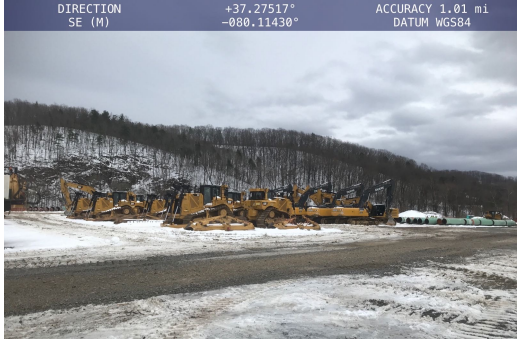
MVP-LY-049_012022 Check stored equipment for leaks 2022-01-20 10:09:40-05:00		DIRECTION SE (M) +37.26958° -080.12405° ACCURACY 328 ft DATUM WGS84

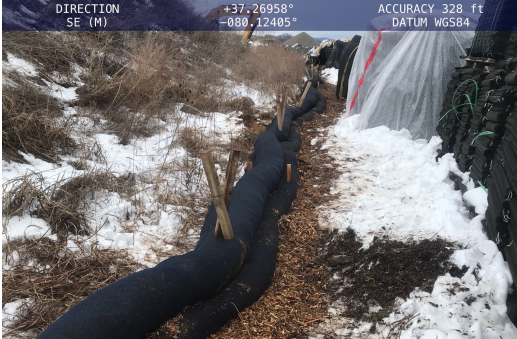
MVP-LY-049_012022 Condition of CFS along LOD 2022-01-20 10:11:40-05:00

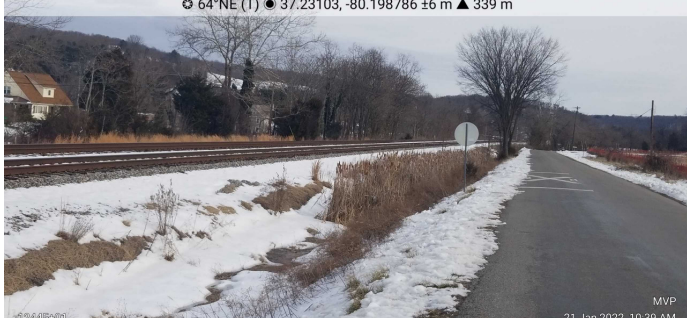
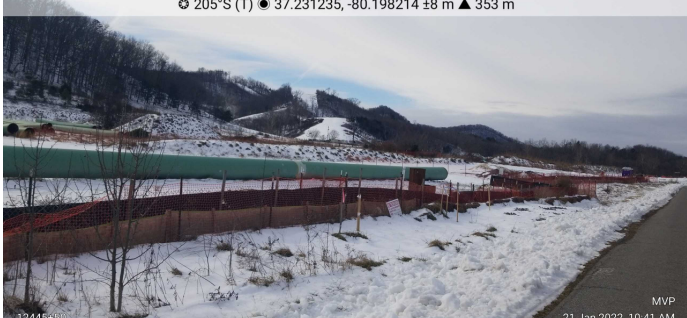
MVP 21 Jan 2022, 10:41 AM		
<b>GPS Location</b>	See Above		<b>GPS Location</b>	See Above	
<b>Field Station#</b>	12445+01		<b>Field Station#</b>	12445+50	
<b>Pic 1 Desc.</b>	Overview of Waterbody S-I1. ROW is stable. No erosion or sedimentation concerns noted.		<b>Pic 2 Desc.</b>	ROW Overview (temporary stabilization). ECDs are functional and ROW is stable.

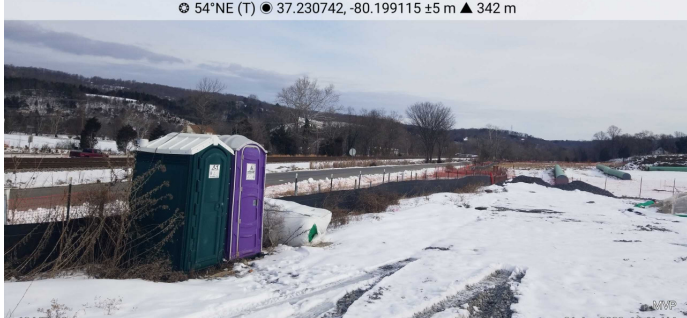
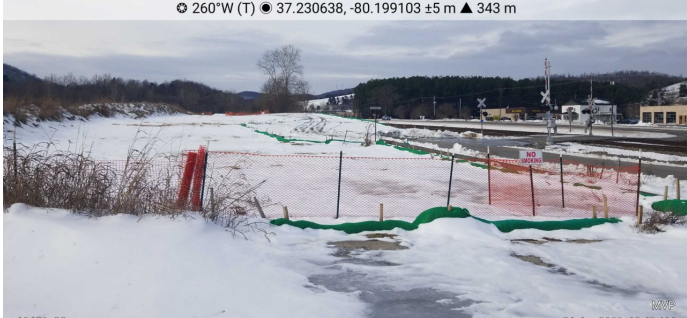
MVP 21 Jan 2022, 10:43 AM		
<b>GPS Location</b>	See Above		<b>GPS Location</b>	See Above	
<b>Field Station#</b>	12447+00		<b>Field Station#</b>	12450+00	
<b>Pic 3 Desc.</b>	ROW Overview (temporary stabilization). ECDs are functional and ROW is stable.		<b>Pic 4 Desc.</b>	ROW Overview (temporary stabilization). ECDs are functional and ROW is stable.

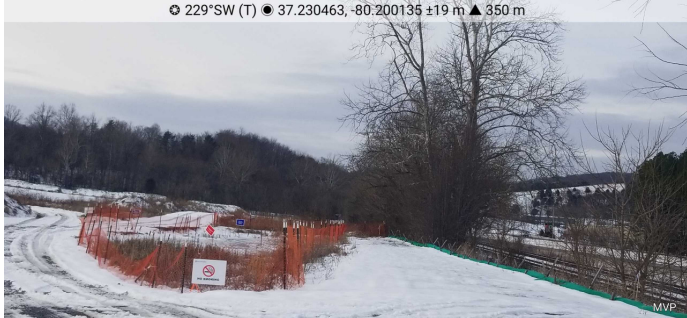
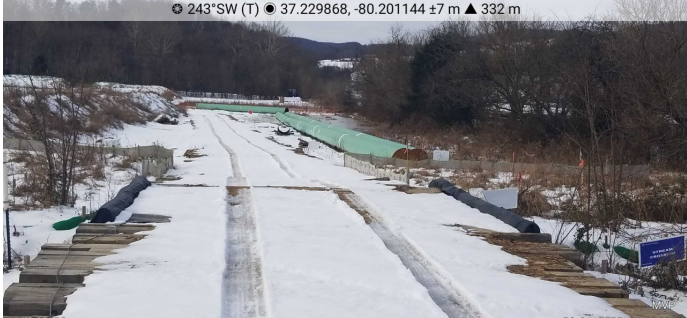
MVP 21 Jan 2022, 10:44 AM		
<b>GPS Location</b>	See Above		<b>GPS Location</b>	See Above	
<b>Field Station#</b>	12454+00		<b>Field Station#</b>	12455+21	
<b>Pic 5 Desc.</b>	ROW Overview (temporary stabilization). ECDs are functional and ROW is stable.		<b>Pic 6 Desc.</b>	Overview of Waterbody S-CD12b. ECDs are functional and ROW is stable.

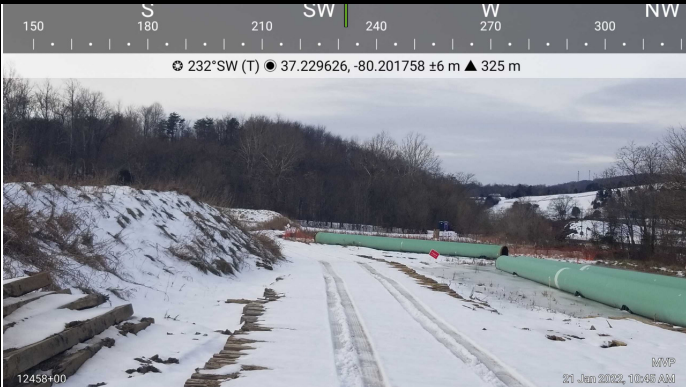
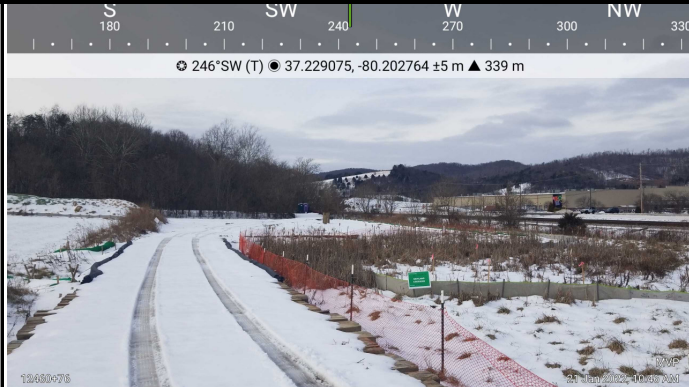
GPS Location	See Above		GPS Location	See Above	
Field Station#	12458+00		Field Station#	12460+76	
Pic 7 Desc.	Overview of Waterbody S-CD12b. ECDs are functional and ROW is stable.		Pic 8 Desc.	Overview of Wetland W-KL58. ECDs are functional and ROW is stable.

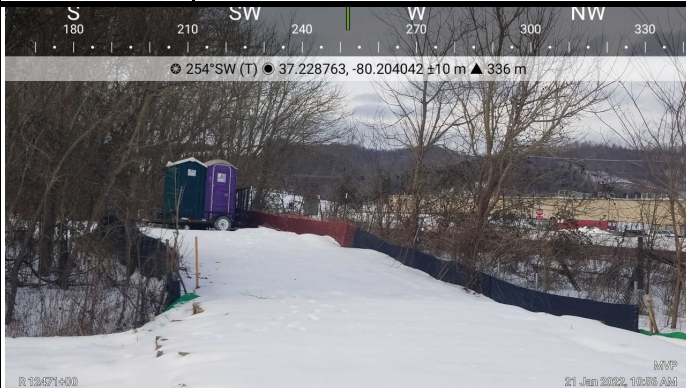
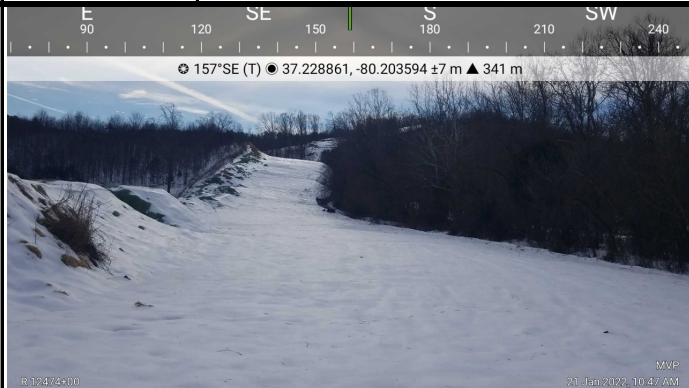
GPS Location	See Above		GPS Location	See Above	
Field Station#	12471+00		Field Station#	12474+00	
Pic 9 Desc.	(reroute stationing) ROW Overview (temporary stabilization). ECDs are functional and ROW is stable.		Pic 10 Desc.	(reroute stationing) ROW Overview (temporary stabilization). ECDs are functional and ROW is stable.

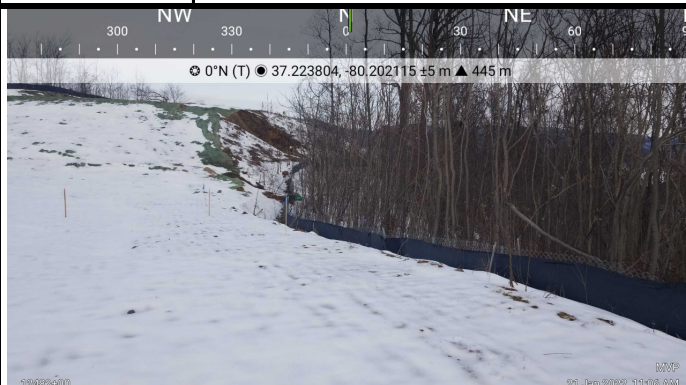
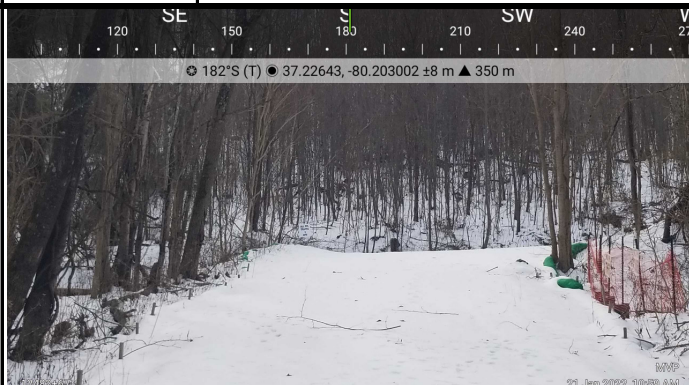
GPS Location	See Above		GPS Location	See Above	
Field Station#	12482+00		Field Station#	12482+67	
Pic 11 Desc.	ROW Overview (temporary stabilization). ECDs are functional and ROW is stable.		Pic 12 Desc.	MLV-28 overview. ECDs are functional and area is stable.

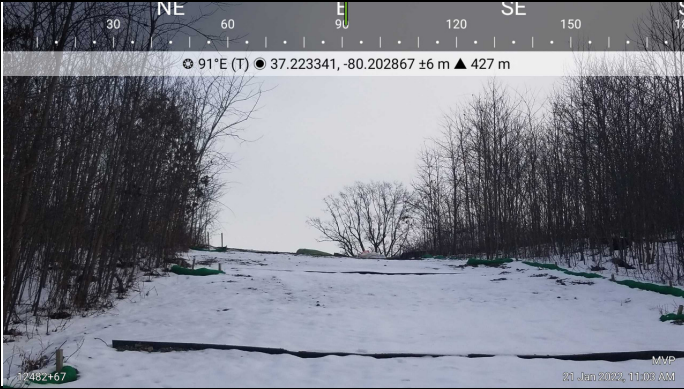
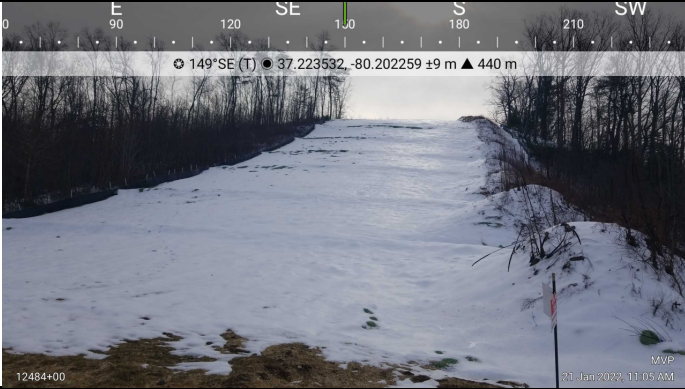
GPS Location	See Above		GPS Location	See Above	
Field Station#	12482+67		Field Station#	12484+00	
Pic 13 Desc.	MLV-28 overview. ECDs are functional and area is stable.		Pic 14 Desc.	ROW Overview (temporary stabilization). ECDs are functional and ROW is stable.

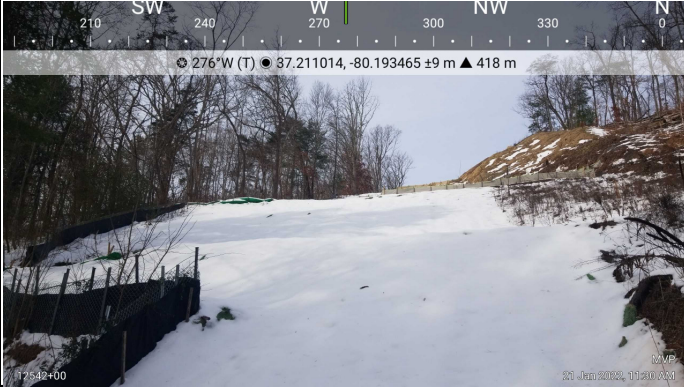
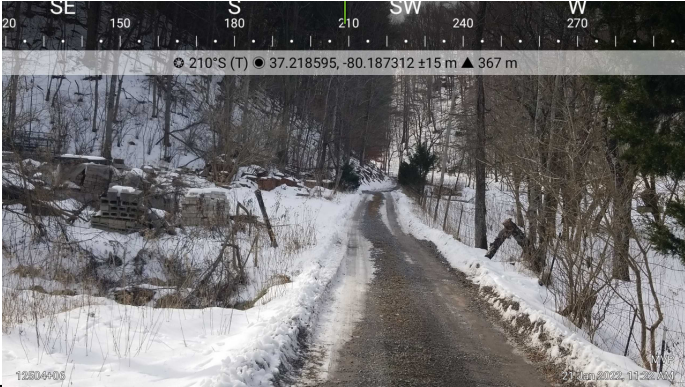
GPS Location	See Above		GPS Location	See Above	
Field Station#	12542+00		Field Station#	12544+06	
Pic 15 Desc.	ROW Overview (temporary stabilization). ECDs are functional and ROW is stable.		Pic 16 Desc.	Waterbody S-KL32 (Acc 276.01). ECDs are functional and Access road MN-278.01 area is stable.

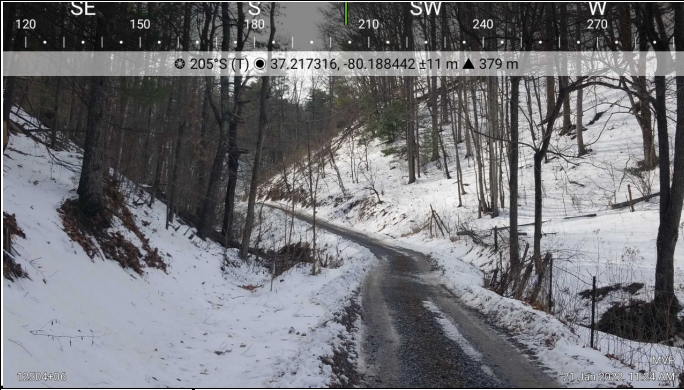
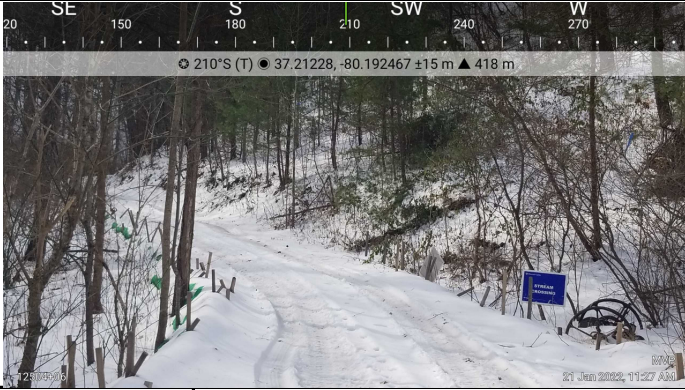
GPS Location	See Above		GPS Location	See Above	
Field Station#	12544+06		Field Station#	12544+06	
Pic 17 Desc.	Waterbody S-EF20b (Acc 276.01). ECDs are functional and Access road MN-278.01 area is stable.		Pic 18 Desc.	Waterbody S-EF54 (Acc 276.01). ECDs are functional and Access road MN-278.01 area is stable.

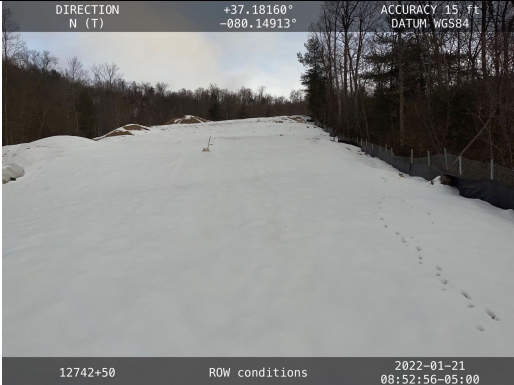
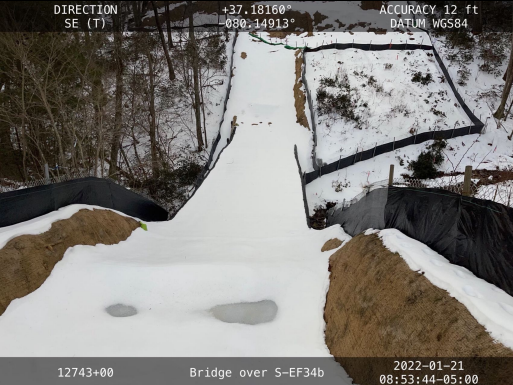
<b>GPS Location</b>	See photo		<b>GPS Location</b>	See photo	
<b>Field Station#</b>	12742+50		<b>Field Station#</b>	12743+00	
<b>Pic 1 Desc.</b>	ROW is snow covered. ROW is stable. ECDs are functional.		<b>Pic 2 Desc.</b>	Equipment Bridge over Stream S-EF34B

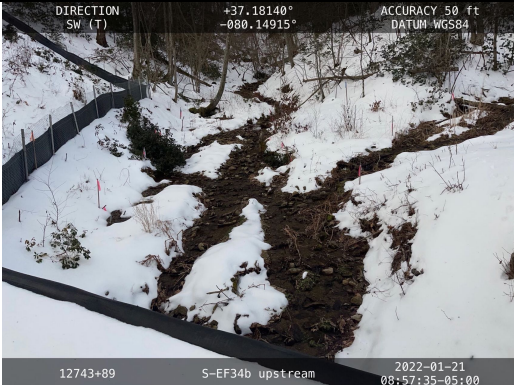
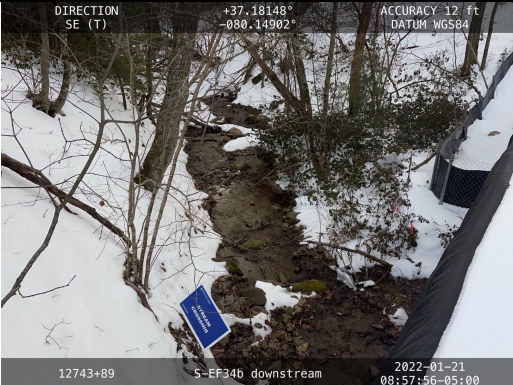
<b>GPS Location</b>	See photo		<b>GPS Location</b>	See photo	
<b>Field Station#</b>	12743+89		<b>Field Station#</b>	12743+89	
<b>Pic 3 Desc.</b>	Upstream of crossing at Stream S-EF34B		<b>Pic 4 Desc.</b>	Downstream of crossing at Stream S-EF34B

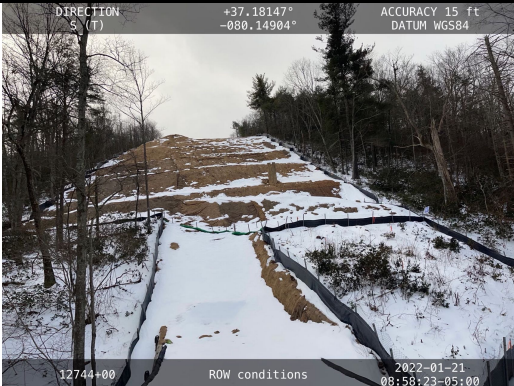
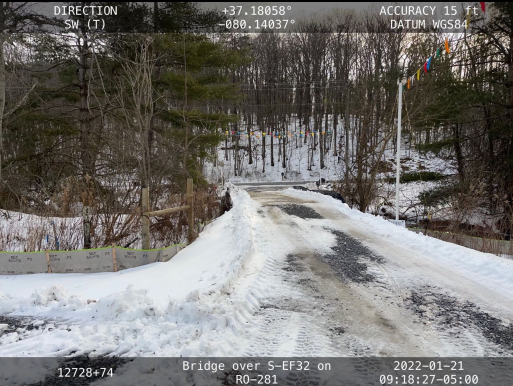
<b>GPS Location</b>	See photo		<b>GPS Location</b>	See photo	
<b>Field Station#</b>	12744+00		<b>Field Station#</b>	12728+74	
<b>Pic 5 Desc.</b>	ROW is snow covered. ROW is stable. ECDs are functional.		<b>Pic 6 Desc.</b>	Equipment Bridge over Stream S-EF32

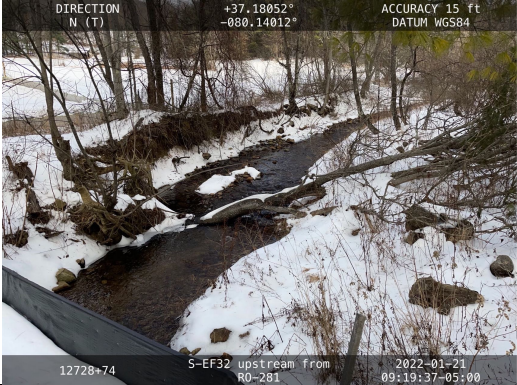
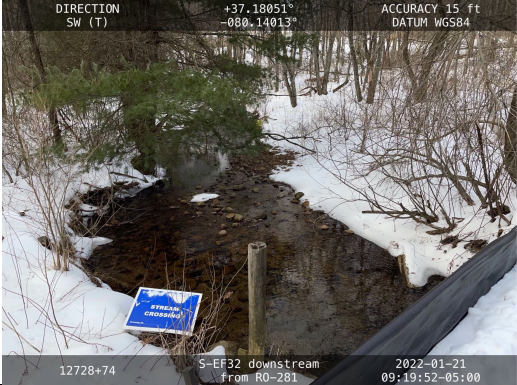
<b>GPS Location</b>	See photo		<b>GPS Location</b>	See photo	
<b>Field Station#</b>	12728+74		<b>Field Station#</b>	12728+74	
<b>Pic 7 Desc.</b>	Upstream of crossing at Stream S-EF32		<b>Pic 8 Desc.</b>	Downstream of crossing at Stream S-EF32

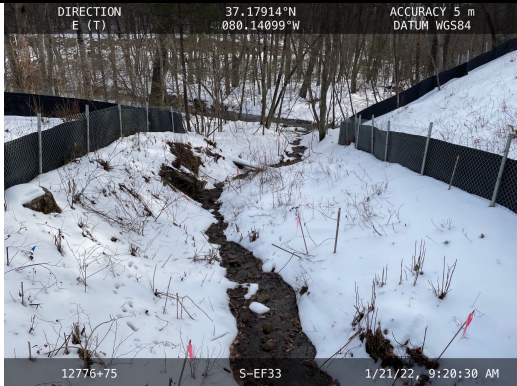
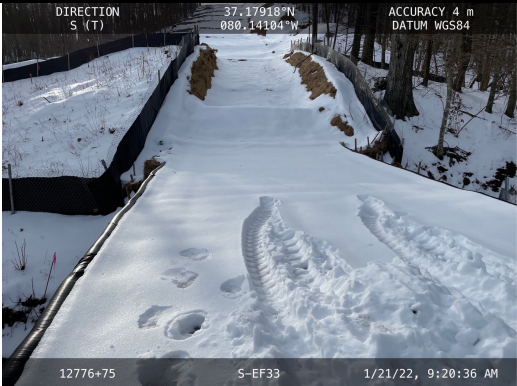
<b>GPS Location</b>	See photo		<b>GPS Location</b>	See photo	
<b>Field Station#</b>	12776+75		<b>Field Station#</b>	12776+75	
<b>Pic 9 Desc.</b>	Downstream of crossing at Stream S-EF33		<b>Pic 10 Desc.</b>	Equipment Bridge over stream S-EF33

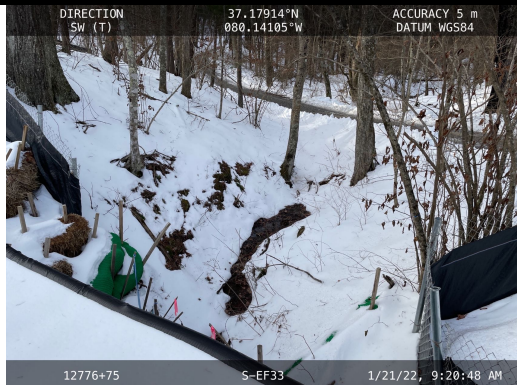
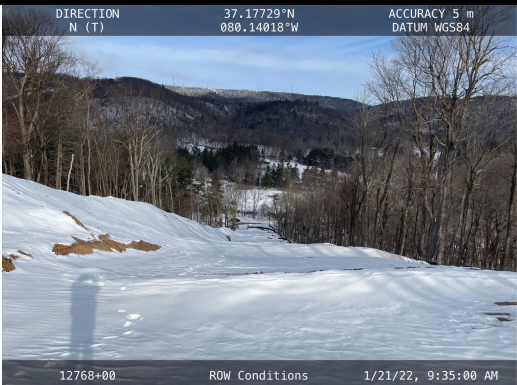
<b>GPS Location</b>	See photo		<b>GPS Location</b>	See photo	
<b>Field Station#</b>	12776+75		<b>Field Station#</b>	12768+00	
<b>Pic 11 Desc.</b>	Upstream of crossing at Stream S-EF33		<b>Pic 12 Desc.</b>	ROW is snow covered. ROW is stable. ECDs are functional.

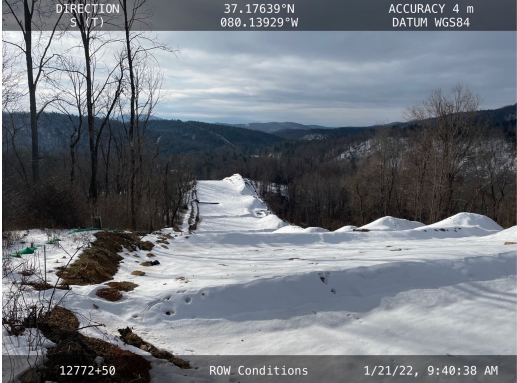
<b>GPS Location</b>	See photo		<b>GPS Location</b>	See photo	
<b>Field Station#</b>	12772+50		<b>Field Station#</b>	12781+00	
<b>Pic 13 Desc.</b>	ROW is snow covered. ROW is stable. ECDs are functional.		<b>Pic 14 Desc.</b>	ROW is snow covered. ROW is stable. ECDs are functional.

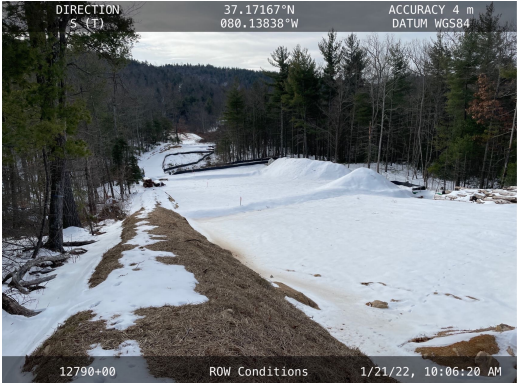
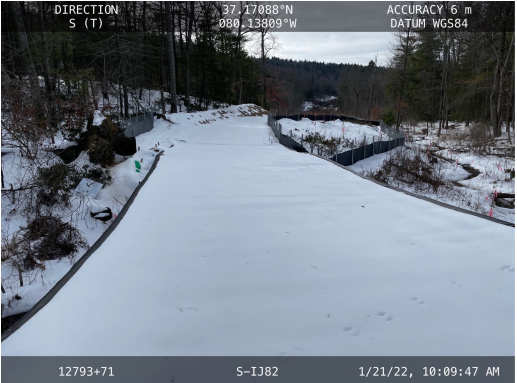
<b>GPS Location</b>	See photo		<b>GPS Location</b>	See photo	
<b>Field Station#</b>	12790+00		<b>Field Station#</b>	12793+71	
<b>Pic 15 Desc.</b>	ROW is snow covered. ROW is stable. ECDs are functional.		<b>Pic 16 Desc.</b>	Equipment Bridge over stream S-IJ82

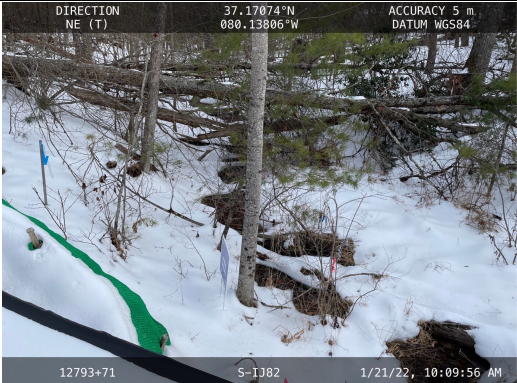
<b>GPS Location</b>	See photo		<b>GPS Location</b>	See photo	
<b>Field Station#</b>	12793+71		<b>Field Station#</b>	12793+71	
<b>Pic 17 Desc.</b>	Upstream of crossing at Stream S-IJ82		<b>Pic 18 Desc.</b>	Downstream of crossing at Stream S-IJ82

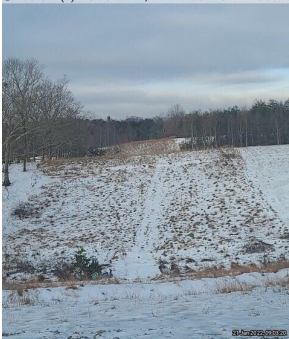
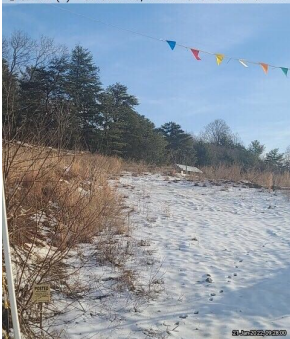
<b>GPS Location</b>	00000	<b>GPS Location</b>	0000		
<b>Field Station#</b>	13540+00	<b>Field Station#</b>	13575+40		
<b>Pic 1 Desc.</b>	Row photo showing frozen conditions from below freezing temps overnight, monitored equipment bridges and ECDs , no environmental issues observed at the time of		<b>Pic 2 Desc.</b>	Monitored RCEs at road crossings, photo showing visible vegetation, no environmental issues observed at the time of inspection.	
	<b>North East Elevation</b>

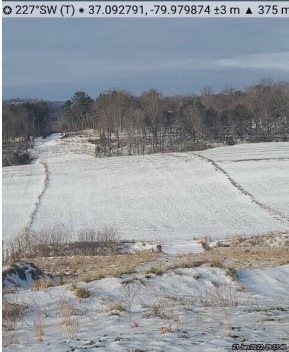
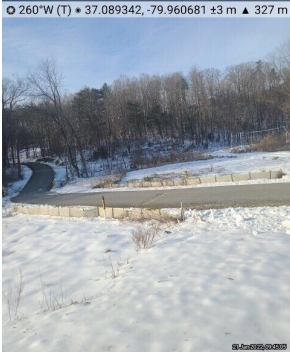
<b>GPS Location</b>	0000	<b>GPS Location</b>	00000		
<b>Field Station#</b>	13574+93	<b>Field Station#</b>	13644+95		
<b>Pic 3 Desc.</b>	Row photo showing frozen conditions from below freezing temps overnight, monitored equipment bridges and ECDs , no environmental issues observed at the time of		<b>Pic 4 Desc.</b>	Monitored ECDs at road crossing at Leaning Oak. Due to thawing of snow yesterday and below freezing temps last night , row is now ice making row travel cautious in areas

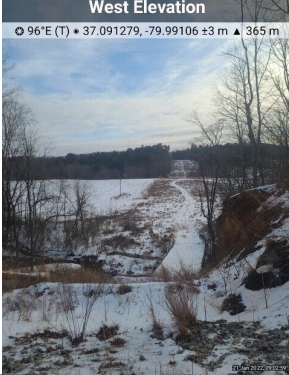
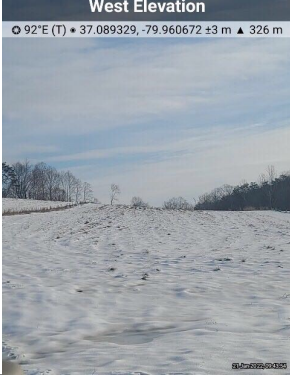
<b>GPS Location</b>	0000	<b>GPS Location</b>	0000		
<b>Field Station#</b>	13541+55	<b>Field Station#</b>	13645+90		
<b>Pic 5 Desc.</b>	Row photo showing frozen conditions from below freezing temps overnight, monitored equipment bridges and ECDs , no environmental issues observed at the time of		<b>Pic 6 Desc.</b>	Row photo showing ECDs along the edge of row and frozen conditions from below freezing temps overnight.
