# Visual Site Inspection Report

<b>Project Name</b>	H-600 Pipeline Spread H	<b>AFE</b>	124300138	<b>Spread</b>	H-600 Pipeline Spread H
<b>Contractor</b>	Precision			<b>Report #</b>	32187
<b>Inspector</b>	Pat Davis			<b>Date/Time</b>	12/13/2021 4:00 PM
<b>Permit #</b>	TBD	<b>Inspection Type</b>	VA SWPP	<b>Station Begin</b>	+0
<b>State</b>	VA	<b>Inspection Area</b>	Partial	<b>Station End</b>	+0
<b>County</b>	Montgomery	<b>Ground</b>	Dry	<b>Temperature (°F)</b>	27.00
<b>Municipality</b>	N/A	<b>Weather</b>	Sunny	<b>Rain Gauge (in)</b>	0.20
				<b>Rain Accumulation Time (days)</b>	0.00

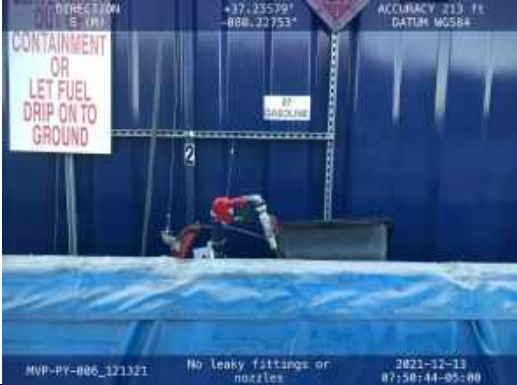
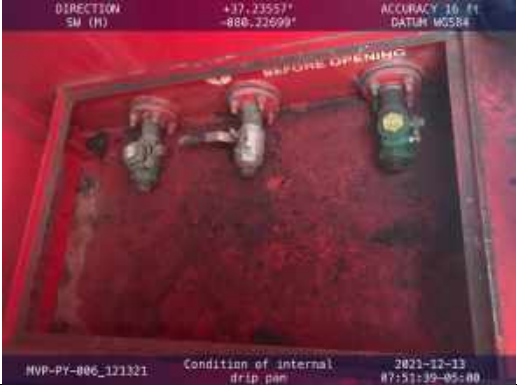
<b>GPS Location</b>	MVP-PY-006 See photo for gps data	<b>GPS Location</b>	MVP-PY-006 See photo for gps data		
<b>Field Station#</b>	+0	<b>Field Station#</b>	+0		
<b>Pic 13 Desc.</b>	Blue Bulk Fuel tanks no leaky fittings or nozzles. Looking S.	<b>Pic 14 Desc.</b>	Off Road Fuel unit condition of internal drip pan. Free of fluids. Looking SW.

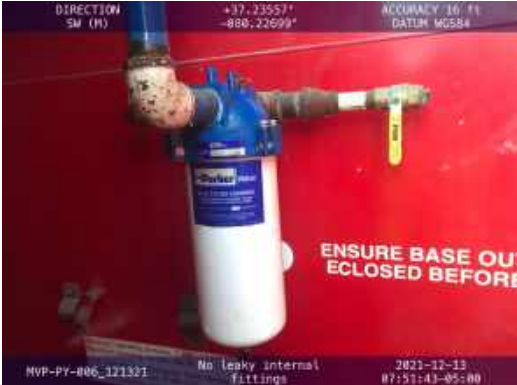
<b>GPS Location</b>	MVP-PY-006 See photo for gps data	<b>GPS Location</b>	MVP-PY-006 See photo for gps data		
<b>Field Station#</b>	+0	<b>Field Station#</b>	+0		
<b>Pic 15 Desc.</b>	Off Road Fuel unit no leaky internal fittings. Looking SW.	<b>Pic 16 Desc.</b>	No deposits or fluids around hazardous waste dumpsters. Looking S.

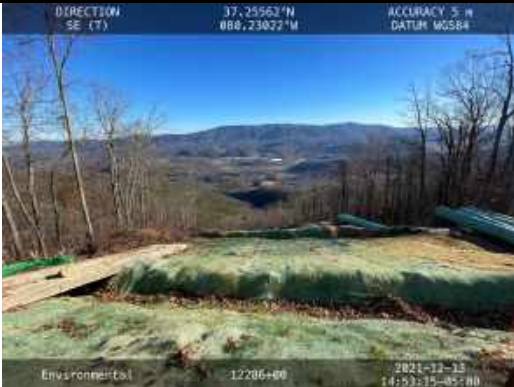
<b>GPS Location</b>	See photo		<b>GPS Location</b>	See photo	
<b>Field Station#</b>	12286+00		<b>Field Station#</b>	12284+75	
<b>Pic 1 Desc.</b>	Stabilized ROW conditions		<b>Pic 2 Desc.</b>	Access Road MVP-MN-276.03 road crossing in acceptable condition

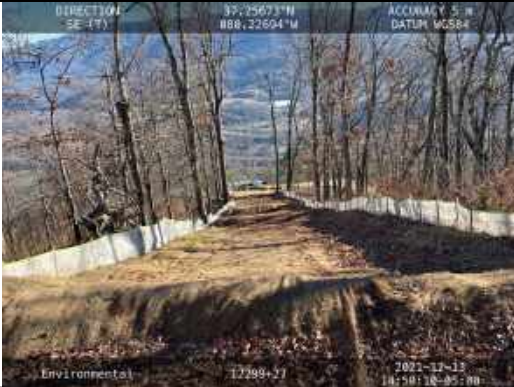
<b>GPS Location</b>	See photo		<b>GPS Location</b>	See photo	
<b>Field Station#</b>	12299+27		<b>Field Station#</b>	12435+50	
<b>Pic 3 Desc.</b>	Stabilized access Road in acceptable condition		<b>Pic 4 Desc.</b>	Stream crossing S-NN16 in acceptable condition

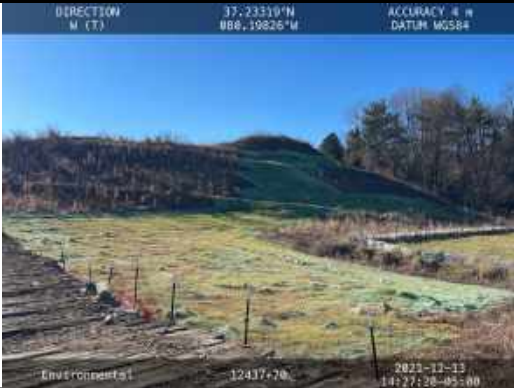
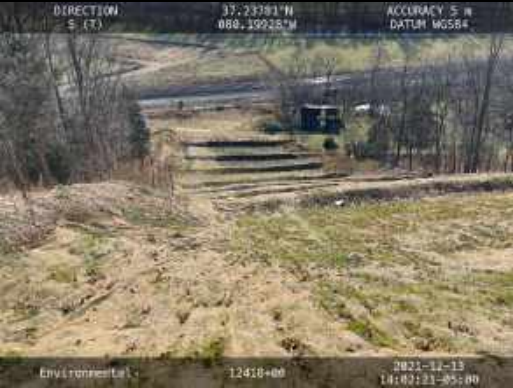
<b>GPS Location</b>	See photo		<b>GPS Location</b>	See photo	
<b>Field Station#</b>	12437+70		<b>Field Station#</b>	12418+00	
<b>Pic 5 Desc.</b>	Stabilized ROW conditions		<b>Pic 6 Desc.</b>	Stabilized ROW conditions

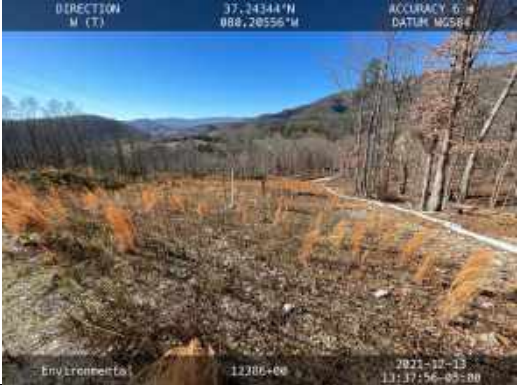
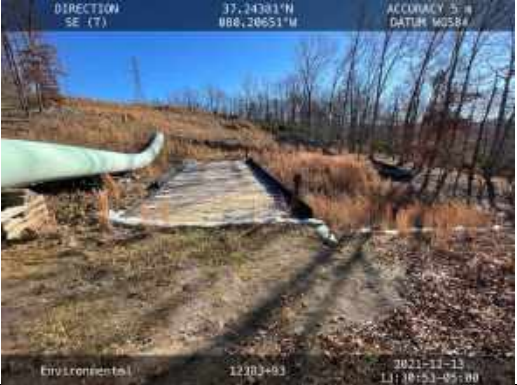
<b>GPS Location</b>	See photo		<b>GPS Location</b>	see photo	
<b>Field Station#</b>	12386+00		<b>Field Station#</b>	12383+93	
<b>Pic 13 Desc.</b>	Stabilized ROW conditions		<b>Pic 14 Desc.</b>	Clean water crossing in acceptable condition

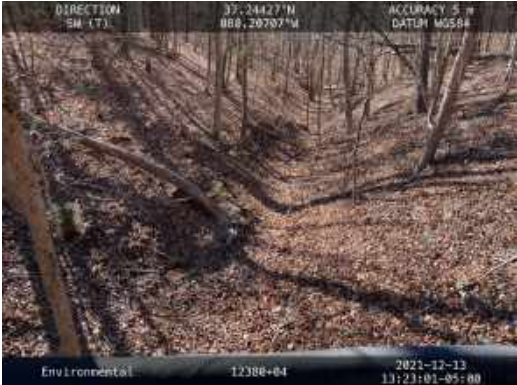
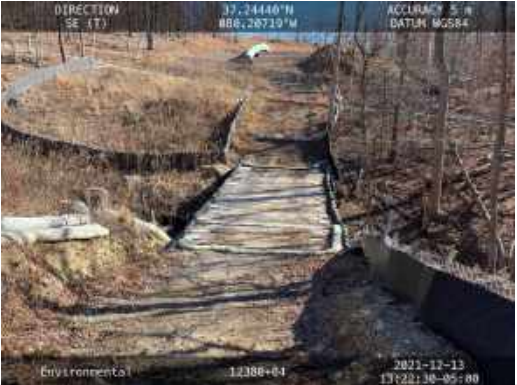
<b>GPS Location</b>	See photo		<b>GPS Location</b>	See photo	
<b>Field Station#</b>	12380+04		<b>Field Station#</b>	12380+04	
<b>Pic 15 Desc.</b>	Down stream of stream crossing S-NN19 in acceptable condition		<b>Pic 16 Desc.</b>	Bridge and ECDs at stream crossing S-NN19 in acceptable condition

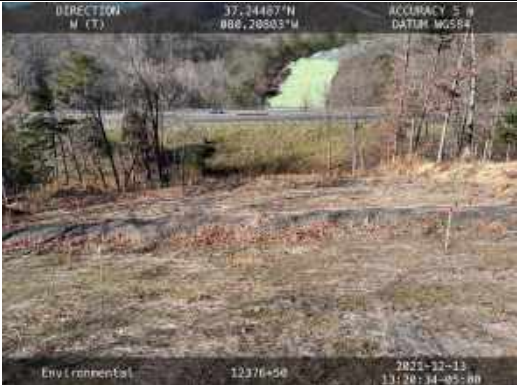
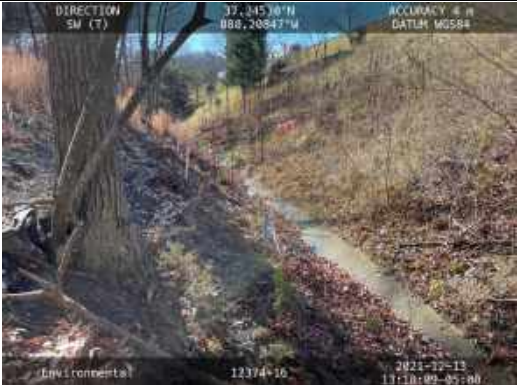
<b>GPS Location</b>	See photo		<b>GPS Location</b>	See photo	
<b>Field Station#</b>	12376+50		<b>Field Station#</b>	12374+16	
<b>Pic 17 Desc.</b>	Stabilized ROW conditions		<b>Pic 18 Desc.</b>	Stream crossing S-0016 in acceptable condition

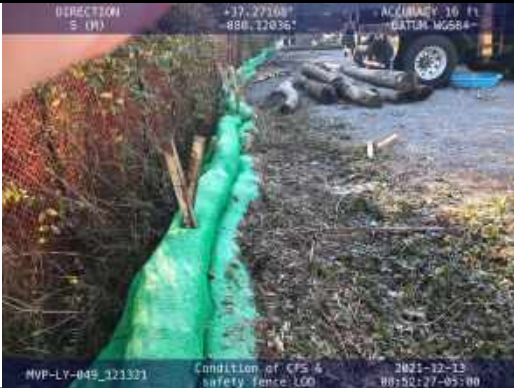
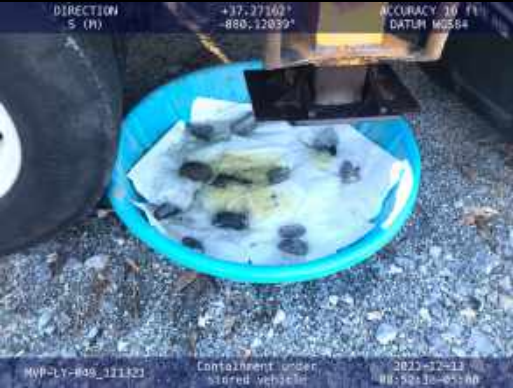
<b>Field Station#</b>	+0	<b>Field Station#</b>	+0		
<b>Pic 5 Desc.</b>	Condition of triple stack compost filter sock and safety fence along east LOD. Only half have been replaced. Looking S.	<b>Pic 6 Desc.</b>	Secondary containment under stored vehicle. Catching fluids. Looking S.

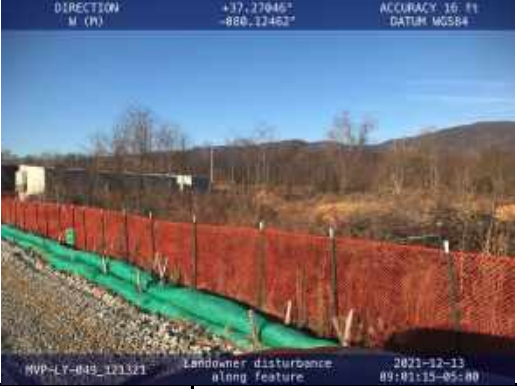
<b>GPS Location</b>	MVP-LY-049 See photo for gps data	<b>GPS Location</b>	MVP-LY-049 See photo for gps data		
<b>Field Station#</b>	+0	<b>Field Station#</b>	+0		
<b>Pic 15 Desc.</b>	Landowner soil disturbance along triple stack compost filter sock. No new damage to installed ECD's. Looking S.	<b>Pic 16 Desc.</b>	Landowner soil disturbance along feature W-CV21A. Area not stabilized. Looking NW.

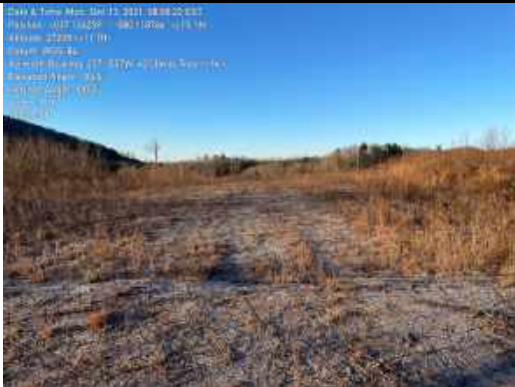
<b>GPS Location</b>		0		<b>GPS Location</b>	
<b>Field Station#</b>		13033+59		<b>Field Station#</b>	
<b>Pic 1 Desc.</b>		RCE in good condition and functioning properly		<b>Pic 2 Desc.</b>

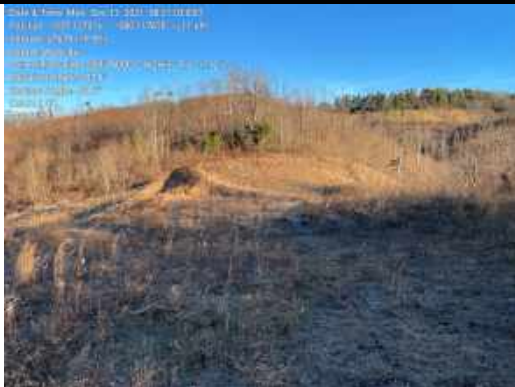
<b>GPS Location</b>		0		<b>GPS Location</b>	
<b>Field Station#</b>		13024+06		<b>Field Station#</b>	
<b>Pic 3 Desc.</b>		MVP-S-G24/25 and Corresponding buffer zone in good condition		<b>Pic 4 Desc.</b>

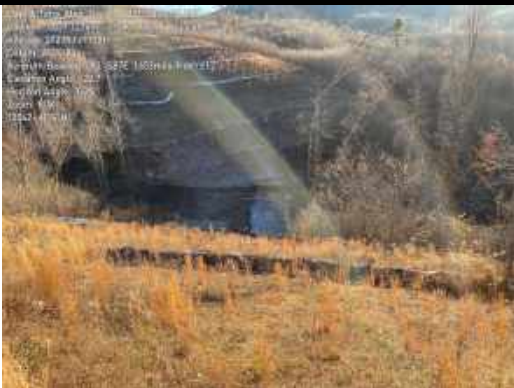
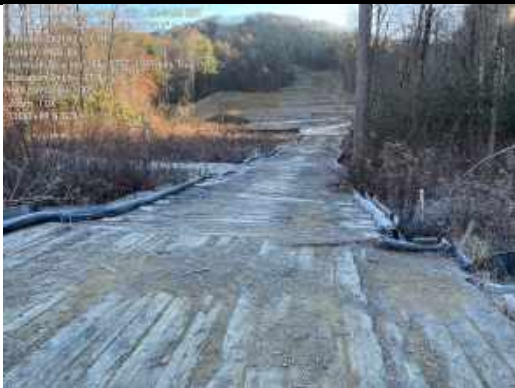
<b>GPS Location</b>		0		<b>GPS Location</b>	
<b>Field Station#</b>		13042+61		<b>Field Station#</b>	
<b>Pic 5 Desc.</b>		MVP-S-H1 and Corresponding buffer zone in good condition		<b>Pic 6 Desc.</b>

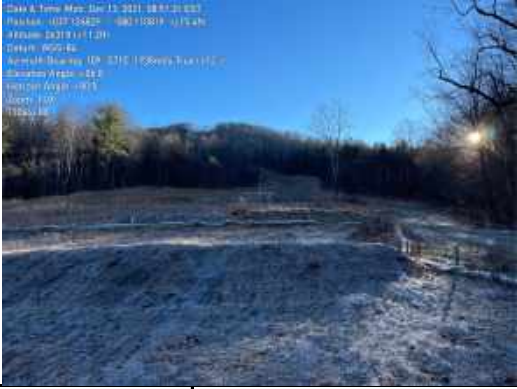
<b>GPS Location</b>	0	<b>GPS Location</b>	0		
<b>Field Station#</b>	13062+96	<b>Field Station#</b>	13064+00		
<b>Pic 7 Desc.</b>	MVP-S-G27 and Corresponding buffer zone in good condition	<b>Pic 8 Desc.</b>	ROW and ECDs In good condition with good vegetation established across ROW

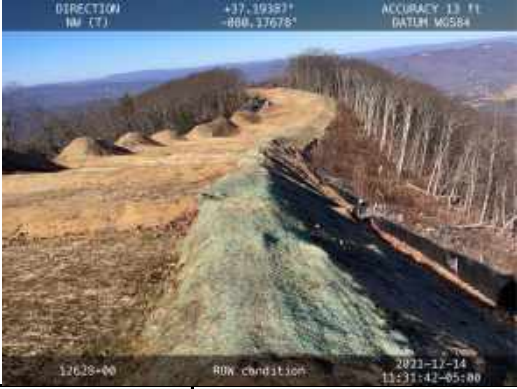
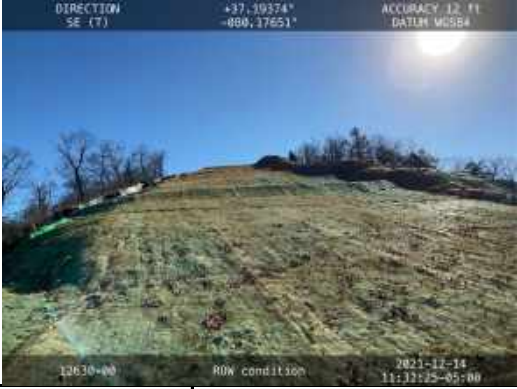
<b>GPS Location</b>	See photo for gps location data.		<b>GPS Location</b>	See photo for gps location data.	
<b>Field Station#</b>	12628+00		<b>Field Station#</b>	12630+00	
<b>Pic 7 Desc.</b>	Photo shows the ROW condition. ECDs are installed and functioning as designed.		<b>Pic 8 Desc.</b>	Photo shows the ROW condition. ECDs are installed and functioning as designed.

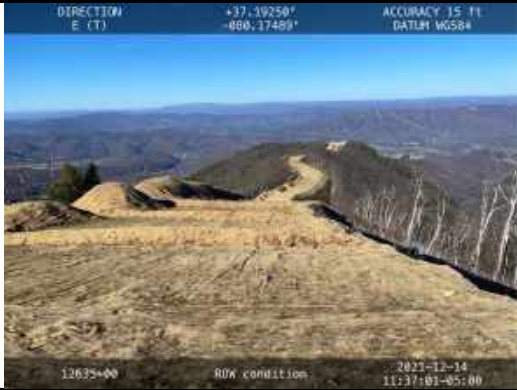
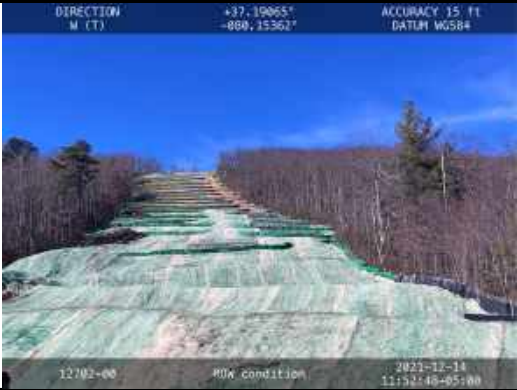
<b>GPS Location</b>	See photo for gps location data.		<b>GPS Location</b>	See photo for gps location data.	
<b>Field Station#</b>	12635+00		<b>Field Station#</b>	12702+00	
<b>Pic 9 Desc.</b>	Photo shows the ROW condition. ECDs are installed and functioning as designed.		<b>Pic 10 Desc.</b>	Photo shows the ROW condition. ECDs are installed and functioning as designed.

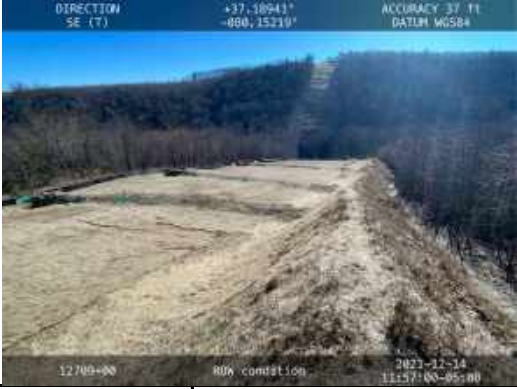
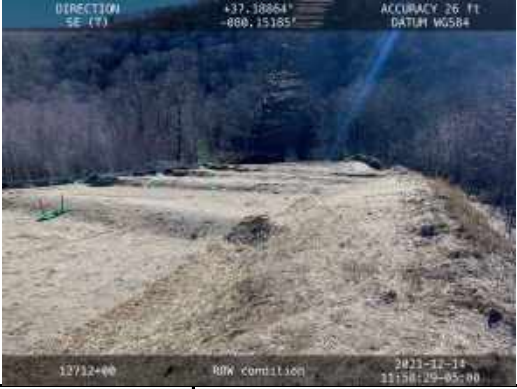
<b>GPS Location</b>	See photo for gps location data.		<b>GPS Location</b>	See photo for gps location data.	
<b>Field Station#</b>	12709+00		<b>Field Station#</b>	12712+00	
<b>Pic 13 Desc.</b>	Photo shows the ROW condition. ECDs are installed and functioning as designed.		<b>Pic 14 Desc.</b>	Photo shows the ROW condition. ECDs are installed and functioning as designed.

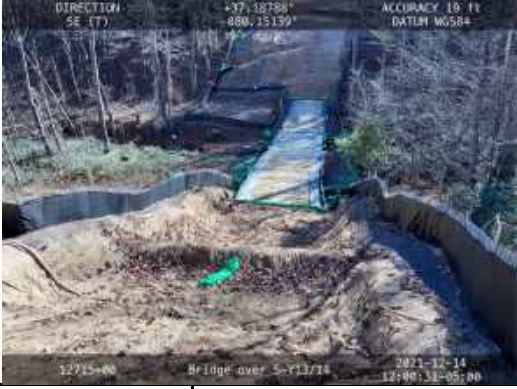
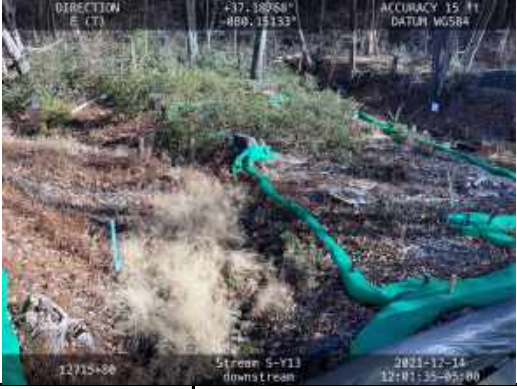
<b>GPS Location</b>	See photo for gps location data.		<b>GPS Location</b>	See photo for gps location data.	
<b>Field Station#</b>	12715+00		<b>Field Station#</b>	12715+80	
<b>Pic 15 Desc.</b>	Photo shows the bridge over streams S-Y13 and S-Y14.		<b>Pic 16 Desc.</b>	Photo shows stream S-Y13 downstream from the bridge.

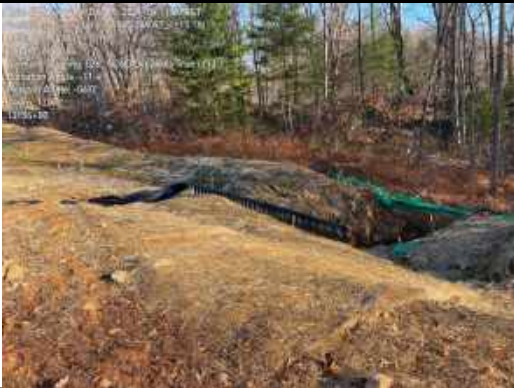
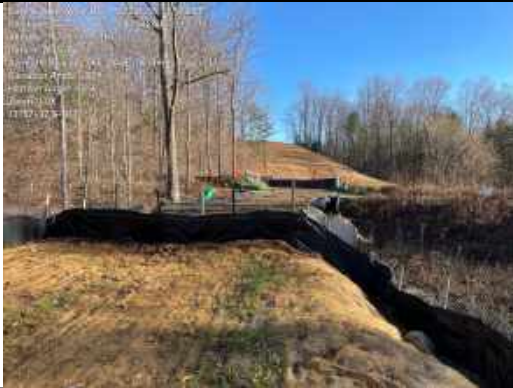
<b>GPS Location</b>	0	<b>GPS Location</b>	0		
<b>Field Station#</b>	13154+00	<b>Field Station#</b>	13157+22		
<b>Pic 5 Desc.</b>	Slope drain pipe in good condition and functioning properly	<b>Pic 6 Desc.</b>	MVP-S-D11 and Corresponding buffer zone in good condition

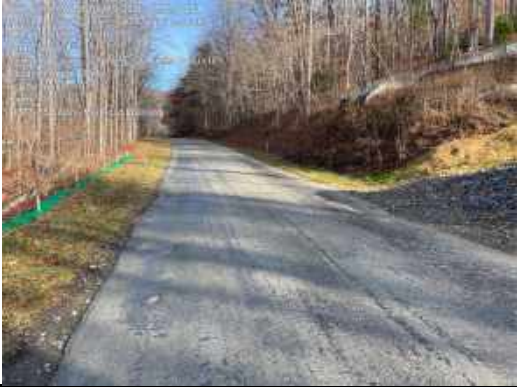
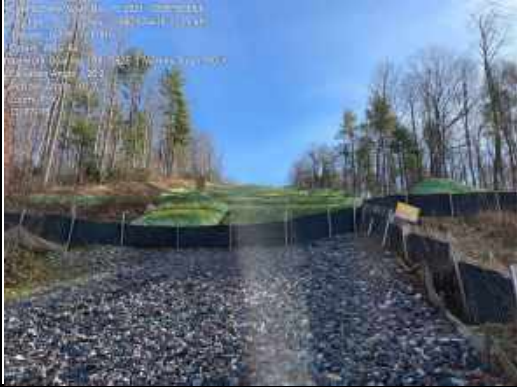
<b>GPS Location</b>	0	<b>GPS Location</b>	0		
<b>Field Station#</b>	13197+55	<b>Field Station#</b>	13197+75		
<b>Pic 13 Desc.</b>	Dillion Mill Road Crossing in good condition	<b>Pic 14 Desc.</b>	ROW and ECDs in good condition and stable

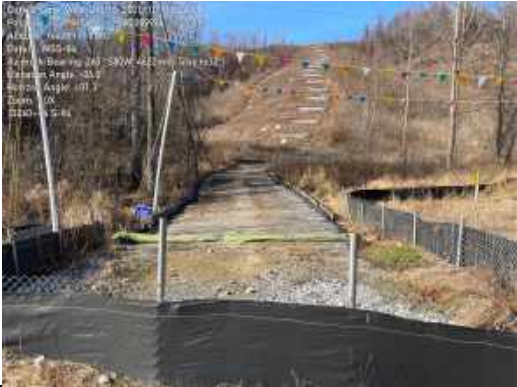
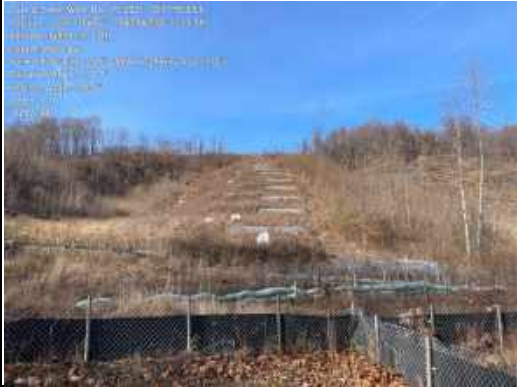
<b>GPS Location</b>	0	<b>GPS Location</b>	0		
<b>Field Station#</b>	13260+66	<b>Field Station#</b>	13259+00		
<b>Pic 15 Desc.</b>	MVP-S-II4 and Corresponding buffer zone in good condition	<b>Pic 16 Desc.</b>	ROW and ECDs in good condition and stable

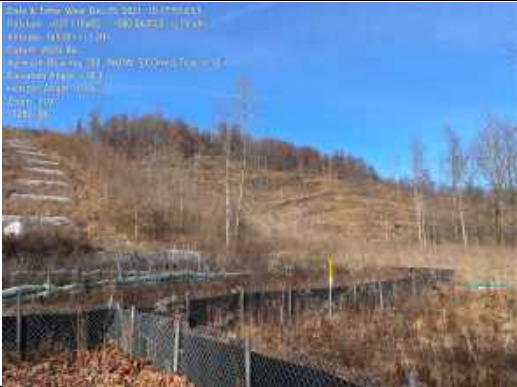
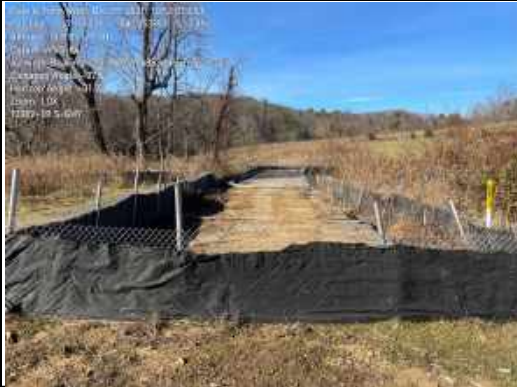
<b>GPS Location</b>	0	<b>GPS Location</b>	0		
<b>Field Station#</b>	13259+00	<b>Field Station#</b>	13309+09		
<b>Pic 17 Desc.</b>	Monitoring logging operations adjacent to ROW	<b>Pic 18 Desc.</b>	MVP-S-D14 and Corresponding buffer zone in good condition

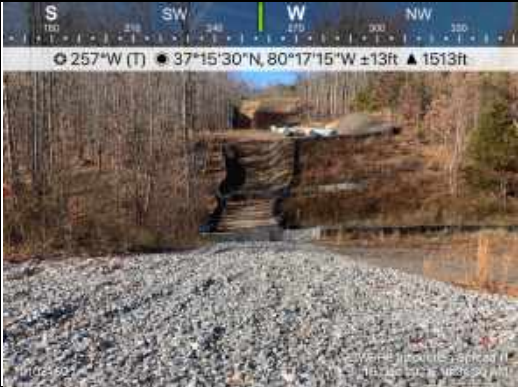
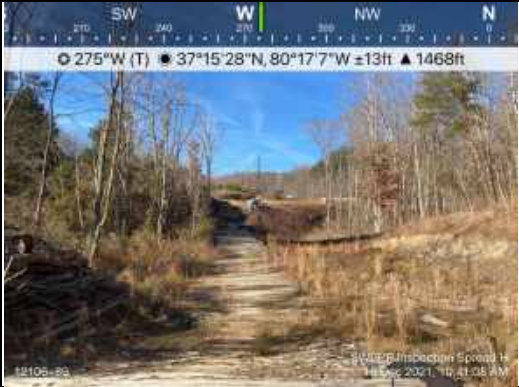
<b>GPS Location</b>	See photo		<b>GPS Location</b>	See photo	
<b>Field Station#</b>	12102+50		<b>Field Station#</b>	12106+89	
<b>Pic 13 Desc.</b>	Rock CE access point in good condition.		<b>Pic 14 Desc.</b>	Timbermat bridges across wetlands and other resource crossings in acceptable condition.

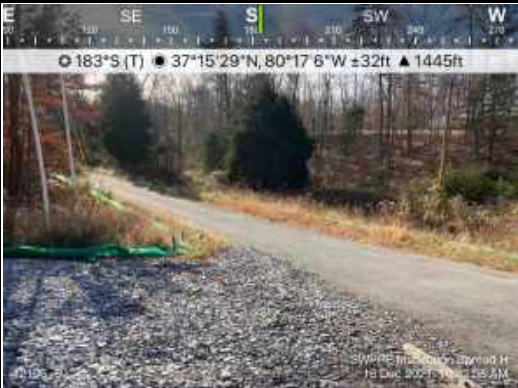
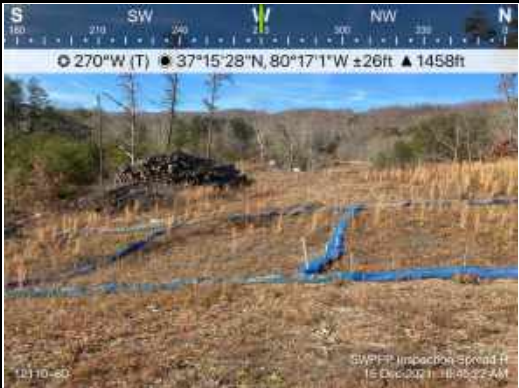
<b>GPS Location</b>	See photo		<b>GPS Location</b>	See photo	
<b>Field Station#</b>	12106+89		<b>Field Station#</b>	12110+60	
<b>Pic 15 Desc.</b>	Access road is maintained and in good condition.		<b>Pic 16 Desc.</b>	CFS berm in good condition.

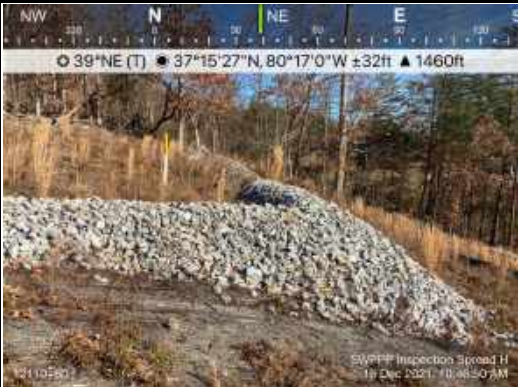
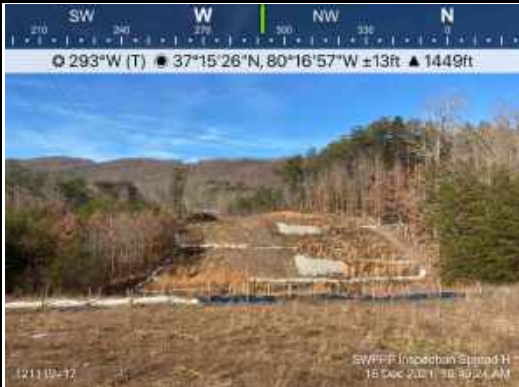
<b>GPS Location</b>	See photo		<b>GPS Location</b>	See photo	
<b>Field Station#</b>	12110+60		<b>Field Station#</b>	12119+17	
<b>Pic 17 Desc.</b>	Permanent waterbar and level spreader in good condition.		<b>Pic 18 Desc.</b>	End of inspection area at Flatwoods Rd. Controls are in good condition and functioning.

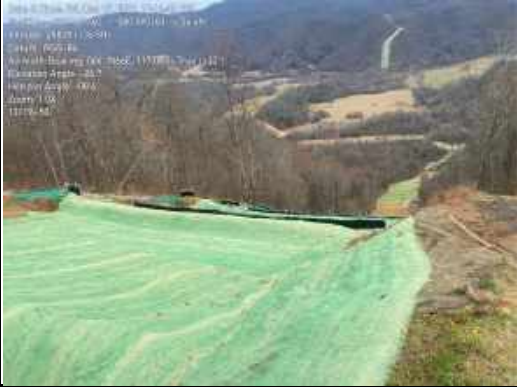
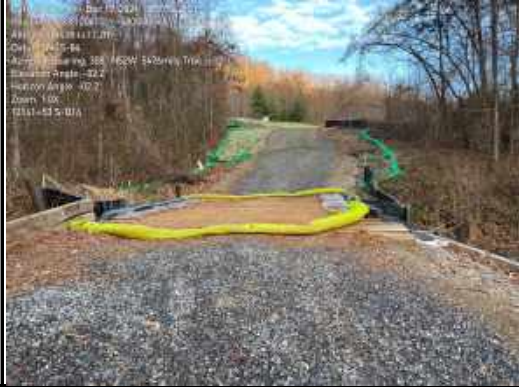
GPS Location	0		GPS Location	0	
Field Station#	13119+50		Field Station#	13141+53	
Pic 13 Desc.	ROW and ECDs In good condition and stable		Pic 14 Desc.	MVP-S-D14 and Corresponding buffer zone in good condition

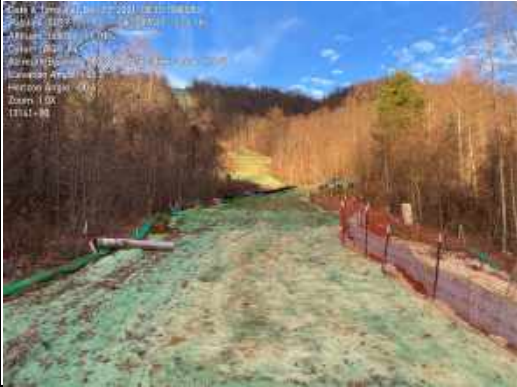
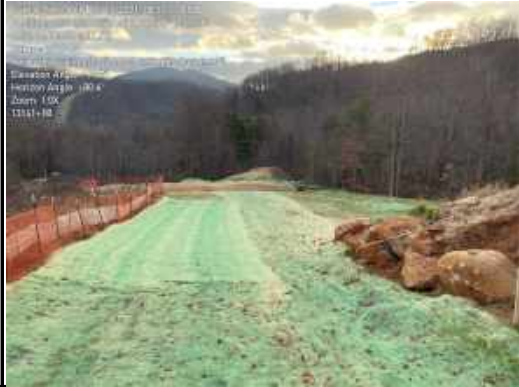
GPS Location	0		GPS Location	0	
Field Station#	13141+00		Field Station#	13141+00	
Pic 15 Desc.	ROW and ECDs In good condition and stable		Pic 16 Desc.	ROW and ECDs In good condition and stable

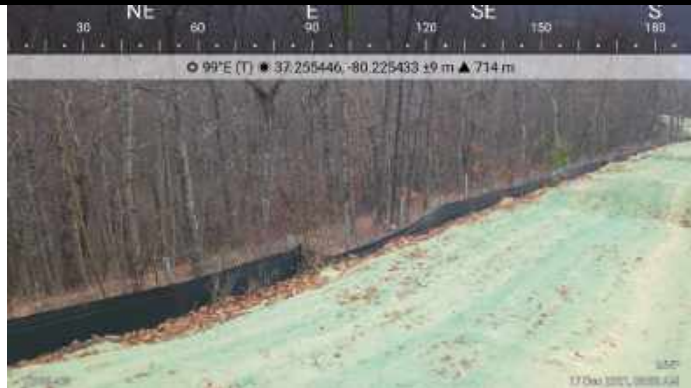
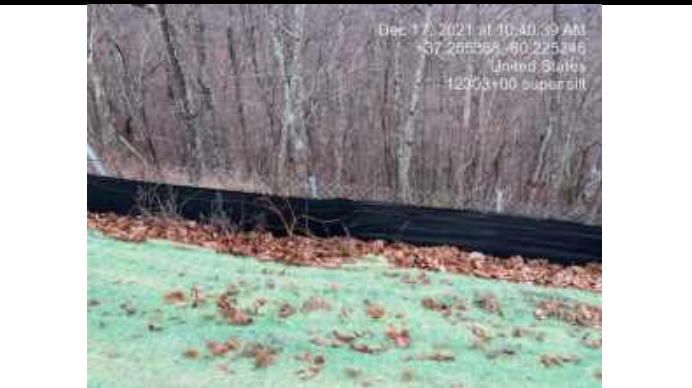
<b>GPS Location</b>	See Above	<b>GPS Location</b>	See Above		
<b>Field Station#</b>	12303+00	<b>Field Station#</b>	12303+00		
<b>Pic 5 Desc.</b>	Punchlist item: Repair Super Silt Fence.	<b>Pic 6 Desc.</b>	Punchlist item Completed: Super Silt Fence Repaired.

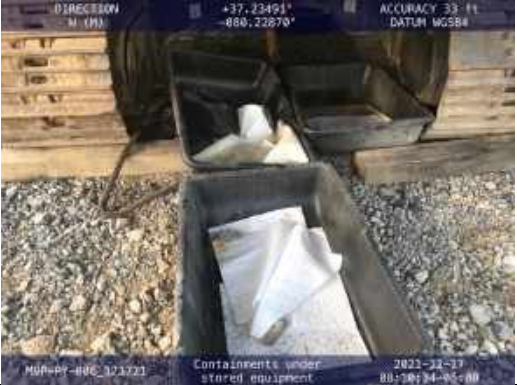
<b>GPS Location</b>	MVP-PY-006 See photo for gps data	<b>GPS Location</b>	MVP-PY-006 See photo for gps data		
<b>Field Station#</b>	+0	<b>Field Station#</b>	+0		
<b>Pic 13 Desc.</b>	Secondary containment under stored vehicle. Holding fluids. Looking N.	<b>Pic 14 Desc.</b>	Secondary containments under stored vehicle. Catching fluids. Looking W.

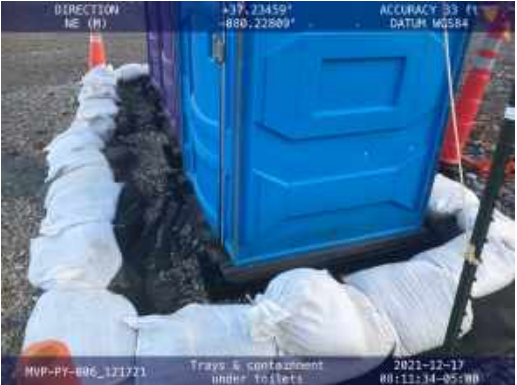
<b>GPS Location</b>	MVP-PY-006 See photo for gps data	<b>GPS Location</b>	MVP-PY-006 See photo for gps data		
<b>Field Station#</b>	+0	<b>Field Station#</b>	+0		
<b>Pic 15 Desc.</b>	Status of spoil pile adjacent to LOD. Soil pile not stabilized. Looking SE.	<b>Pic 16 Desc.</b>	Trays and containment under toilets. Trays free of fluids. Looking NE.
