# Visual Site Inspection Report

<b>Project Name</b>	H-600 Pipeline Spread H	<b>AFE</b>	124300138	<b>Spread</b>	H-600 Pipeline Spread H
<b>Contractor</b>	Precision			<b>Report #</b>	32678
<b>Inspector</b>	Norm Kitchen			<b>Date/Time</b>	12/27/2021 5:00 PM
<b>Permit #</b>	TBD	<b>Inspection Type</b>	VA SWPP	<b>Station Begin</b>	12119+17
<b>State</b>	VA	<b>Inspection Area</b>	Partial	<b>Station End</b>	12284+75
<b>County</b>	Montgomery	<b>Ground</b>	Dry	<b>Temperature (°F)</b>	52.00
<b>Municipality</b>	N/A	<b>Weather</b>	Cloudy	<b>Rain Gauge (in)</b>	0.00
				<b>Rain Accumulation Time (days)</b>	1.00

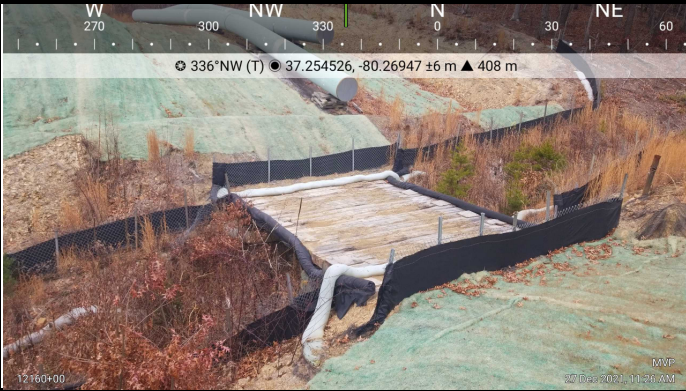
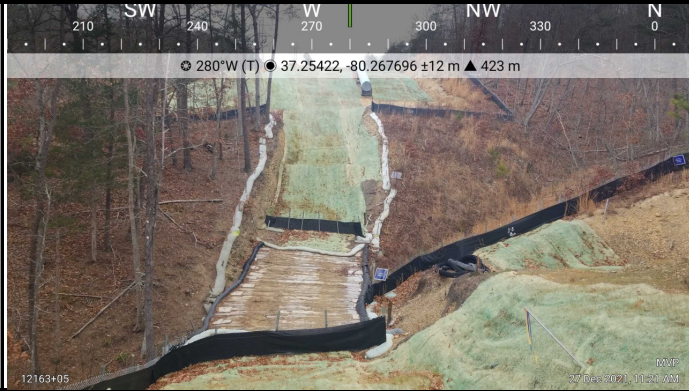
GPS Location	See Above		GPS Location	See Above	
Field Station#	12160+00		Field Station#	12163+05	
Pic 7 Desc.	Overview of Waterbody "headwaters". ECDs functional and in good condition.		Pic 8 Desc.	Overview of Waterbody S-C25. ECDs functional and in good condition.

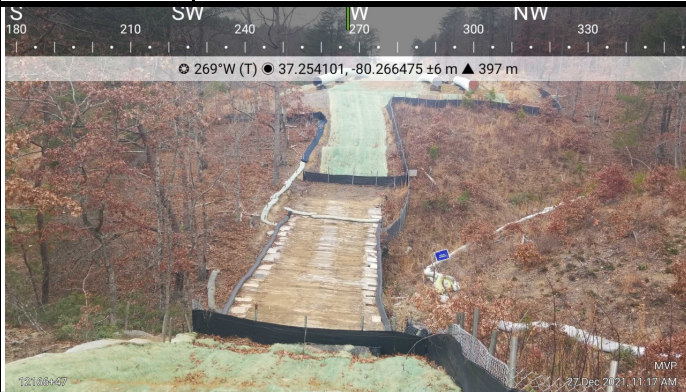
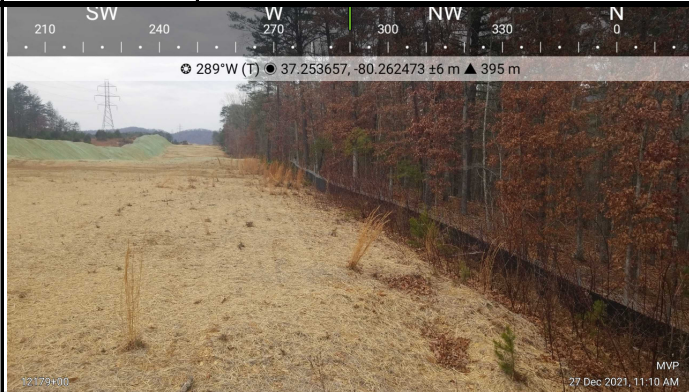
GPS Location	See Above		GPS Location	See Above	
Field Station#	12166+47		Field Station#	12179+00	
Pic 9 Desc.	Overview of Waterbody S-C24. ECDs functional and in good condition.		Pic 10 Desc.	ROW Overview. ECDs functional and in good condition and ROW is stable.

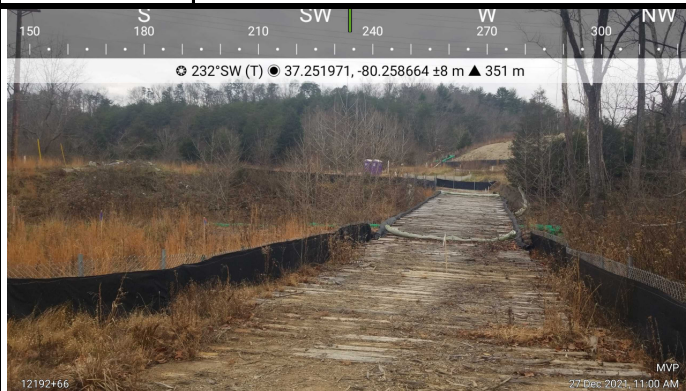
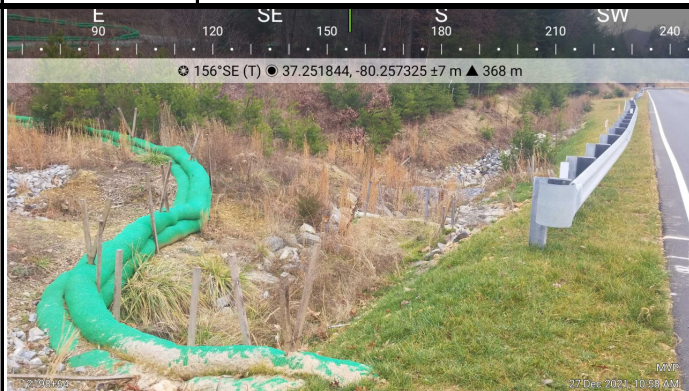
GPS Location	See Above		GPS Location	See Above	
Field Station#	12192+66		Field Station#	12198+64	
Pic 11 Desc.	Overview of Waterbody S-C21. ECDs functional and in good condition.		Pic 12 Desc.	ECDs near stream S-0011 are functional and in good condition. CFS is trapping sediment from off ROW before it enters creek.

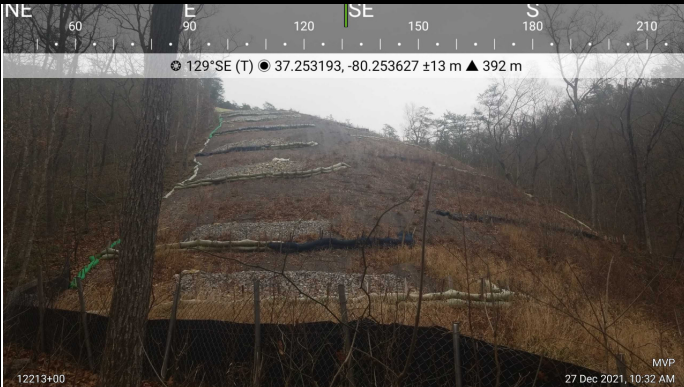
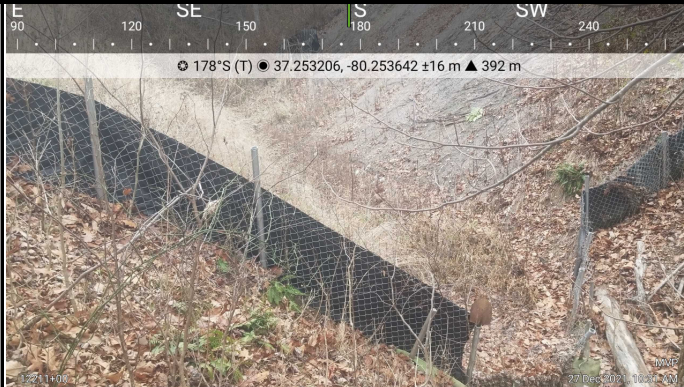
GPS Location	See Above		GPS Location	See Above	
Field Station#	12213+00		Field Station#	12211+00	
Pic 13 Desc.	ROW Overview. ECDs functional and in good condition and ROW is stable.		Pic 14 Desc.	ROW Overview. ECDs functional and in good condition and ROW is stable.

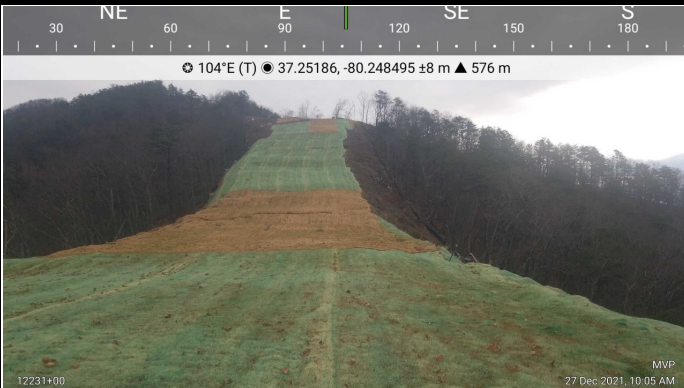
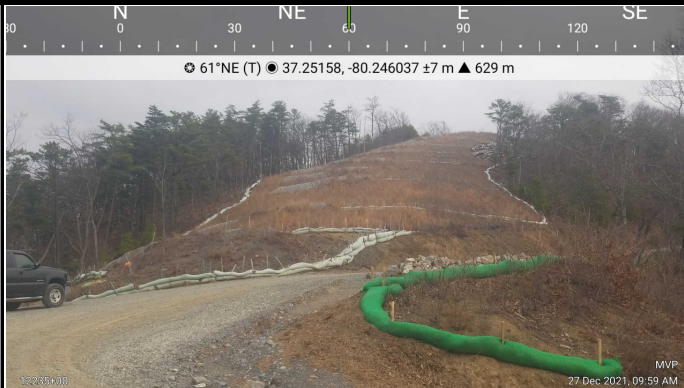
GPS Location	See Above		GPS Location	See Above	
Field Station#	12231+00		Field Station#	12235+00	
Pic 15 Desc.	ROW Overview. ECDs functional and in good condition and ROW is stable.		Pic 16 Desc.	ROW Overview. ECDs functional and in good condition and ROW is stable.

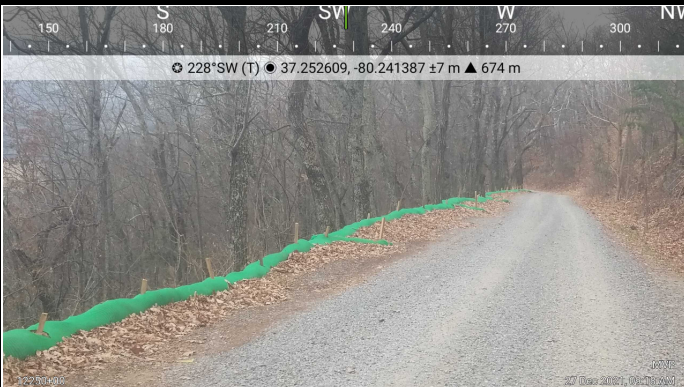
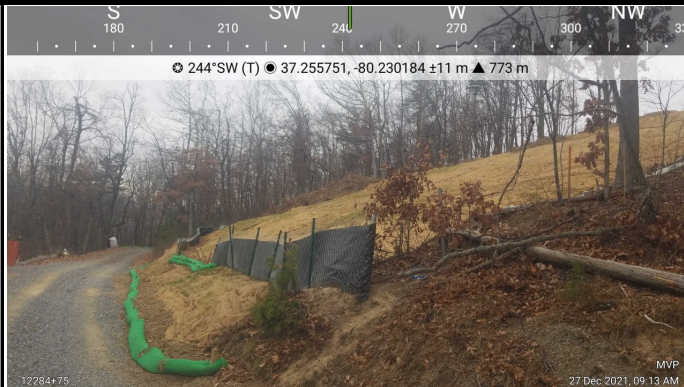
GPS Location	See Above		GPS Location	See Above	
Field Station#	12250+00		Field Station#	12284+75	
Pic 17 Desc.	ECDs are functional at Access road MN-276.01 (Reese Mountain Rd) area is stable.		Pic 18 Desc.	ROW Overview. ECDs functional and in good condition and ROW is stable.

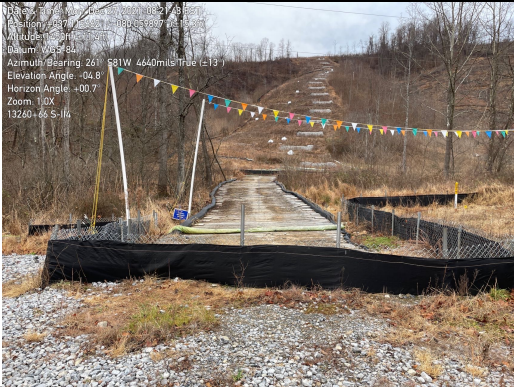
<p>Date &amp; Time: Mon, Dec 27, 2021, 01:53:18 EST Position: +40° 18' 51" N / -82° 02' 57" W (±1.0") Altitude: 1459 (±1.10) Datum: WGS-84 Azimuth/Bearing: 33° 33' 7" 450m True (±1°) Elevation Angle: +10.2° Horizon Angle: +02.0° Zoom: 1.0X 13260+66 S-II4</p>

<b>GPS Location</b>	0	<b>GPS Location</b>	0		
<b>Field Station#</b>	13260+66	<b>Field Station#</b>	13259+00		
<b>Pic 3 Desc.</b>	MVP-S-II4 and Corresponding buffer zone In good condition	<b>Pic 4 Desc.</b>	ROW and ECDs In good condition with good vegetation established across ROW

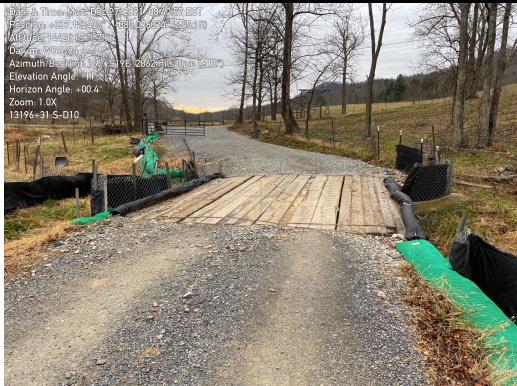
<p>Date &amp; Time: Mon, Dec 27, 2021 08:37:49 EST Position: +037.122982 / -080.074426 (+28.9ft) Altitude: 1457ft (+11.3ft) Datum: WGS-84 Azimuth/Bearing: 307.851W 305.851mils True (+10°) Elevation Angle: -00.1° Horizon Angle: +00.1° Zoom: 1.0X 13196+31 S-D10</p>

<b>GPS Location</b>	0	<b>GPS Location</b>	0		
<b>Field Station#</b>	13196+31	<b>Field Station#</b>	13141+53		
<b>Pic 9 Desc.</b>	MVP-S-D10 and Corresponding buffer zone In good condition	<b>Pic 10 Desc.</b>	MVP-S-D14 and Corresponding buffer zone In good condition

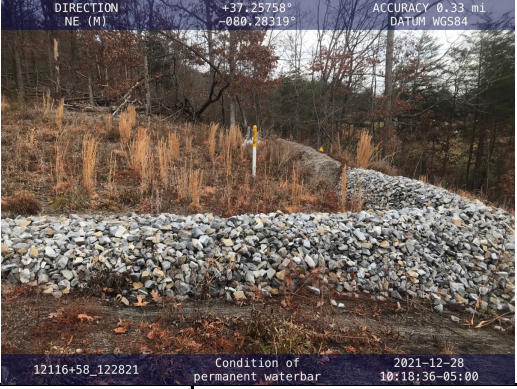
<p>DIRECTION NE (M) +37.25758° -080.28319° ACCURACY 0.33 m DATUM WGS84</p> <p>12116+58_122821 Condition of permanent waterbar 2021-12-28 10:18:36-05:00</p>

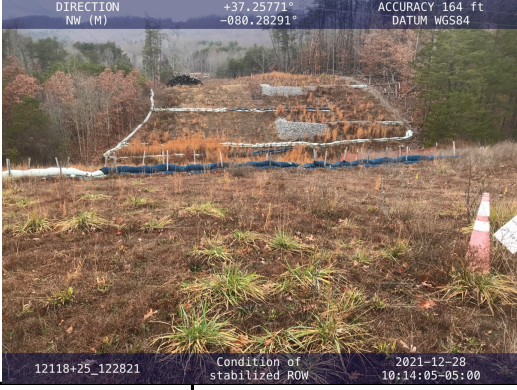
<p>DIRECTION NW (M) +37.25771° -080.28291° ACCURACY 164 ft DATUM WGS84</p> <p>12118+25_122821 Condition of stabilized ROW 2021-12-28 10:14:05-05:00</p>

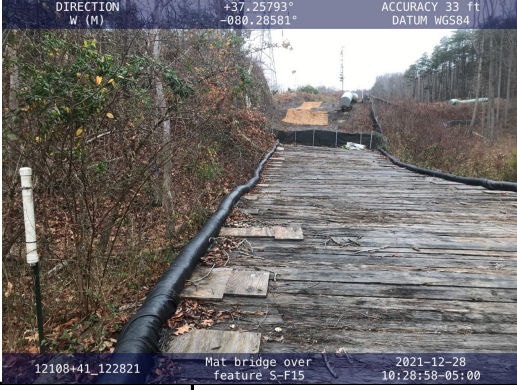
<p>DIRECTION W (M) +37.25793° -080.28581° ACCURACY 33 ft DATUM WGS84</p> <p>12108+41_122821 Mat bridge over feature S-F15 2021-12-28 10:20:58-05:00</p>			
<b>GPS Location</b>	See Above		<b>GPS Location</b>	See Above	
<b>Field Station#</b>	12118+25		<b>Field Station#</b>	12108+41	
<b>Pic 17 Desc.</b>	ROW Overview. ECDs are functional and ROW is stable.		<b>Pic 18 Desc.</b>	Overview of Waterbody S-F15. ECDs are functional and ROW is stable.

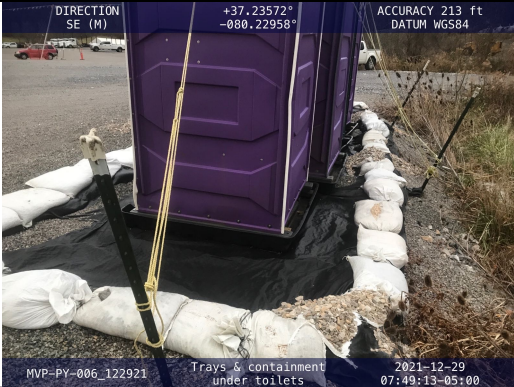
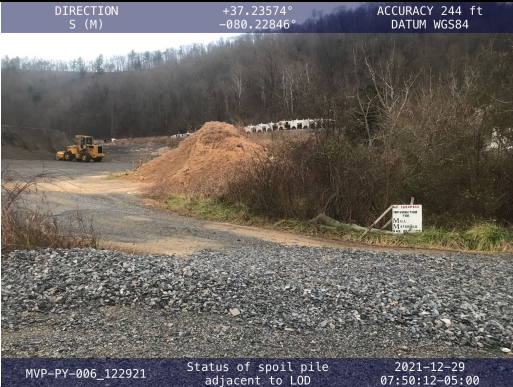
<b>GPS Location</b>	MVP-PY-006 See photo for gps data		<b>GPS Location</b>	MVP-PY-006 See photo for gps data	
<b>Field Station#</b>	+0		<b>Field Station#</b>	+0	
<b>Pic 3 Desc.</b>	Trays and containment under toilets. Trays free of fluids. Looking SE.		<b>Pic 4 Desc.</b>	Status of spoil pile adjacent to LOD. Soil pile not stabilized. Looking S.

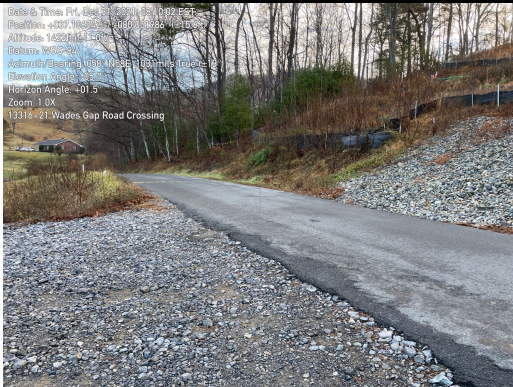
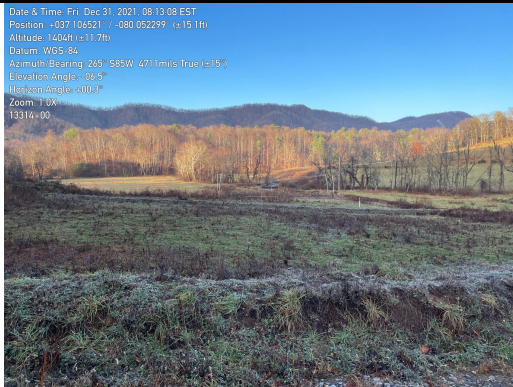
GPS Location				0		GPS Location				0	
Field Station#				13316+21		Field Station#				13314+00	
Pic 1 Desc.				Wades Gap Road Crossing in good condition		Pic 2 Desc.				ROW and ECDs In good condition with good vegetation established across ROW

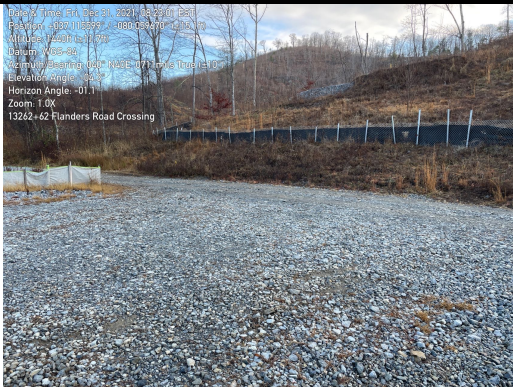
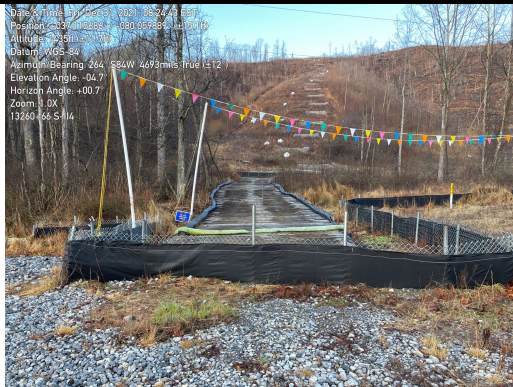
GPS Location				0		GPS Location				0	
Field Station#				13262+62		Field Station#				13260+66	
Pic 3 Desc.				Flanders Road Crossing in good condition		Pic 4 Desc.				MVP-S-II4 and Corresponding buffer zone in good condition

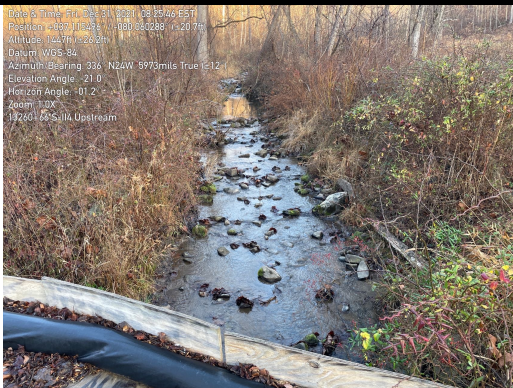
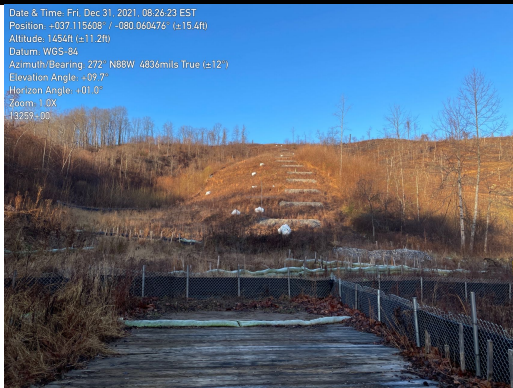
GPS Location				0		GPS Location				0	
Field Station#				13260+66		Field Station#				13259+00	
Pic 5 Desc.				MVP-S-II4 Upstream and Corresponding buffer zone in good condition		Pic 6 Desc.				ROW and ECDs In good condition with good vegetation established across ROW

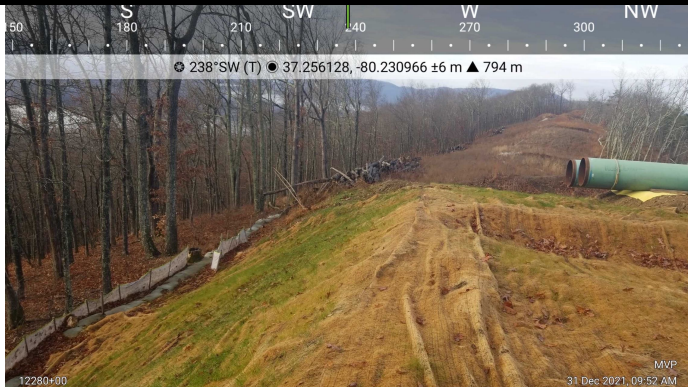
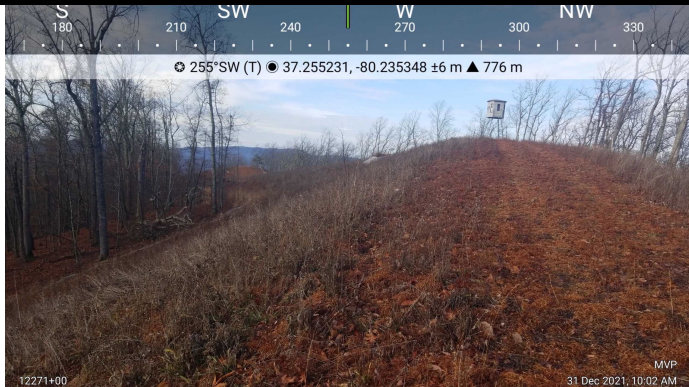
GPS Location	See photo		GPS Location	See photo	
Field Station#	12284+00		Field Station#	12271+00	
Pic 1 Desc.	Current ROW conditions. ROW is stable. ECDs are functional.		Pic 2 Desc.	Current ROW conditions. ROW is stable. ECDs are functional.

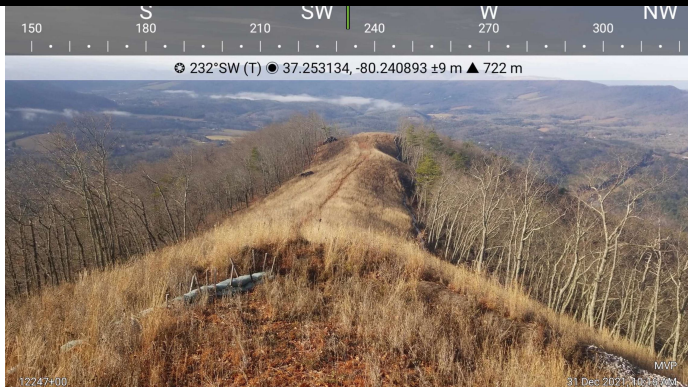
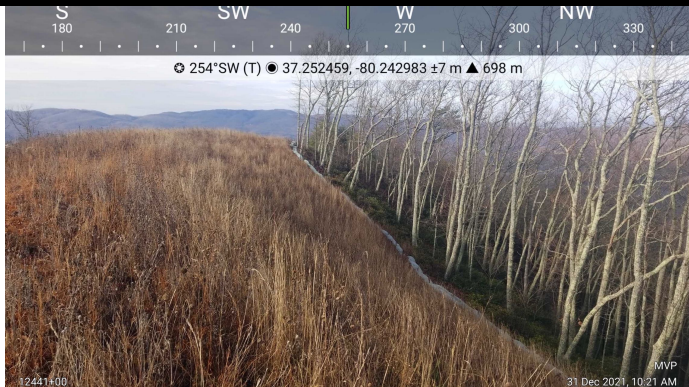
GPS Location	See photo		GPS Location	See photo	
Field Station#	12247+00		Field Station#	12241+00	
Pic 3 Desc.	Current ROW conditions. ROW is stable. ECDs are functional.		Pic 4 Desc.	Current ROW conditions. ROW is stable. ECDs are functional.
